**Investigation of Flash Explosion and Injuries
South Timbalier Block 151, Production Platform
OCS 00463
June 15, 2002**

Gulf of Mexico
Off the Louisiana Coast

U.S. Department of the Interior
Minerals Management Service
Gulf of Mexico OCS Regional Office

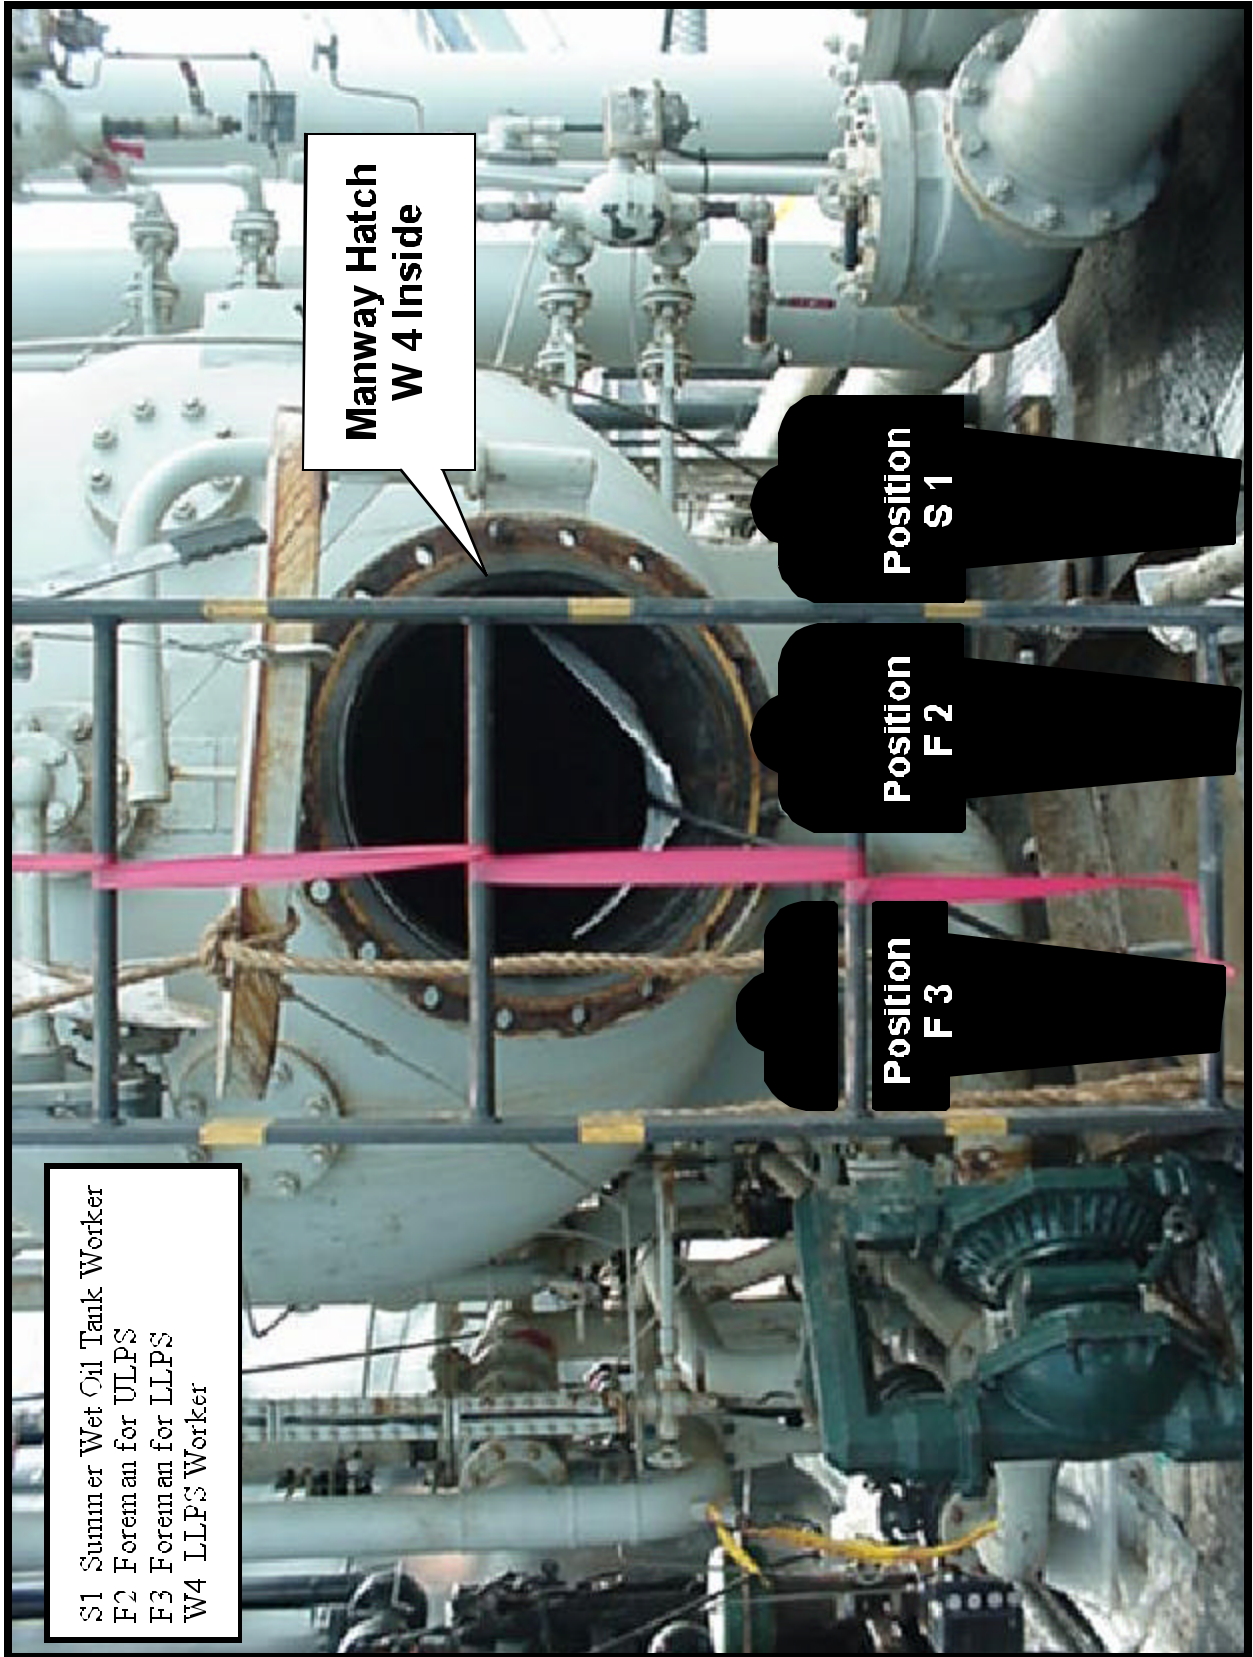
Lower Low Pressure Separator, Manway Hatch, Position of Crew

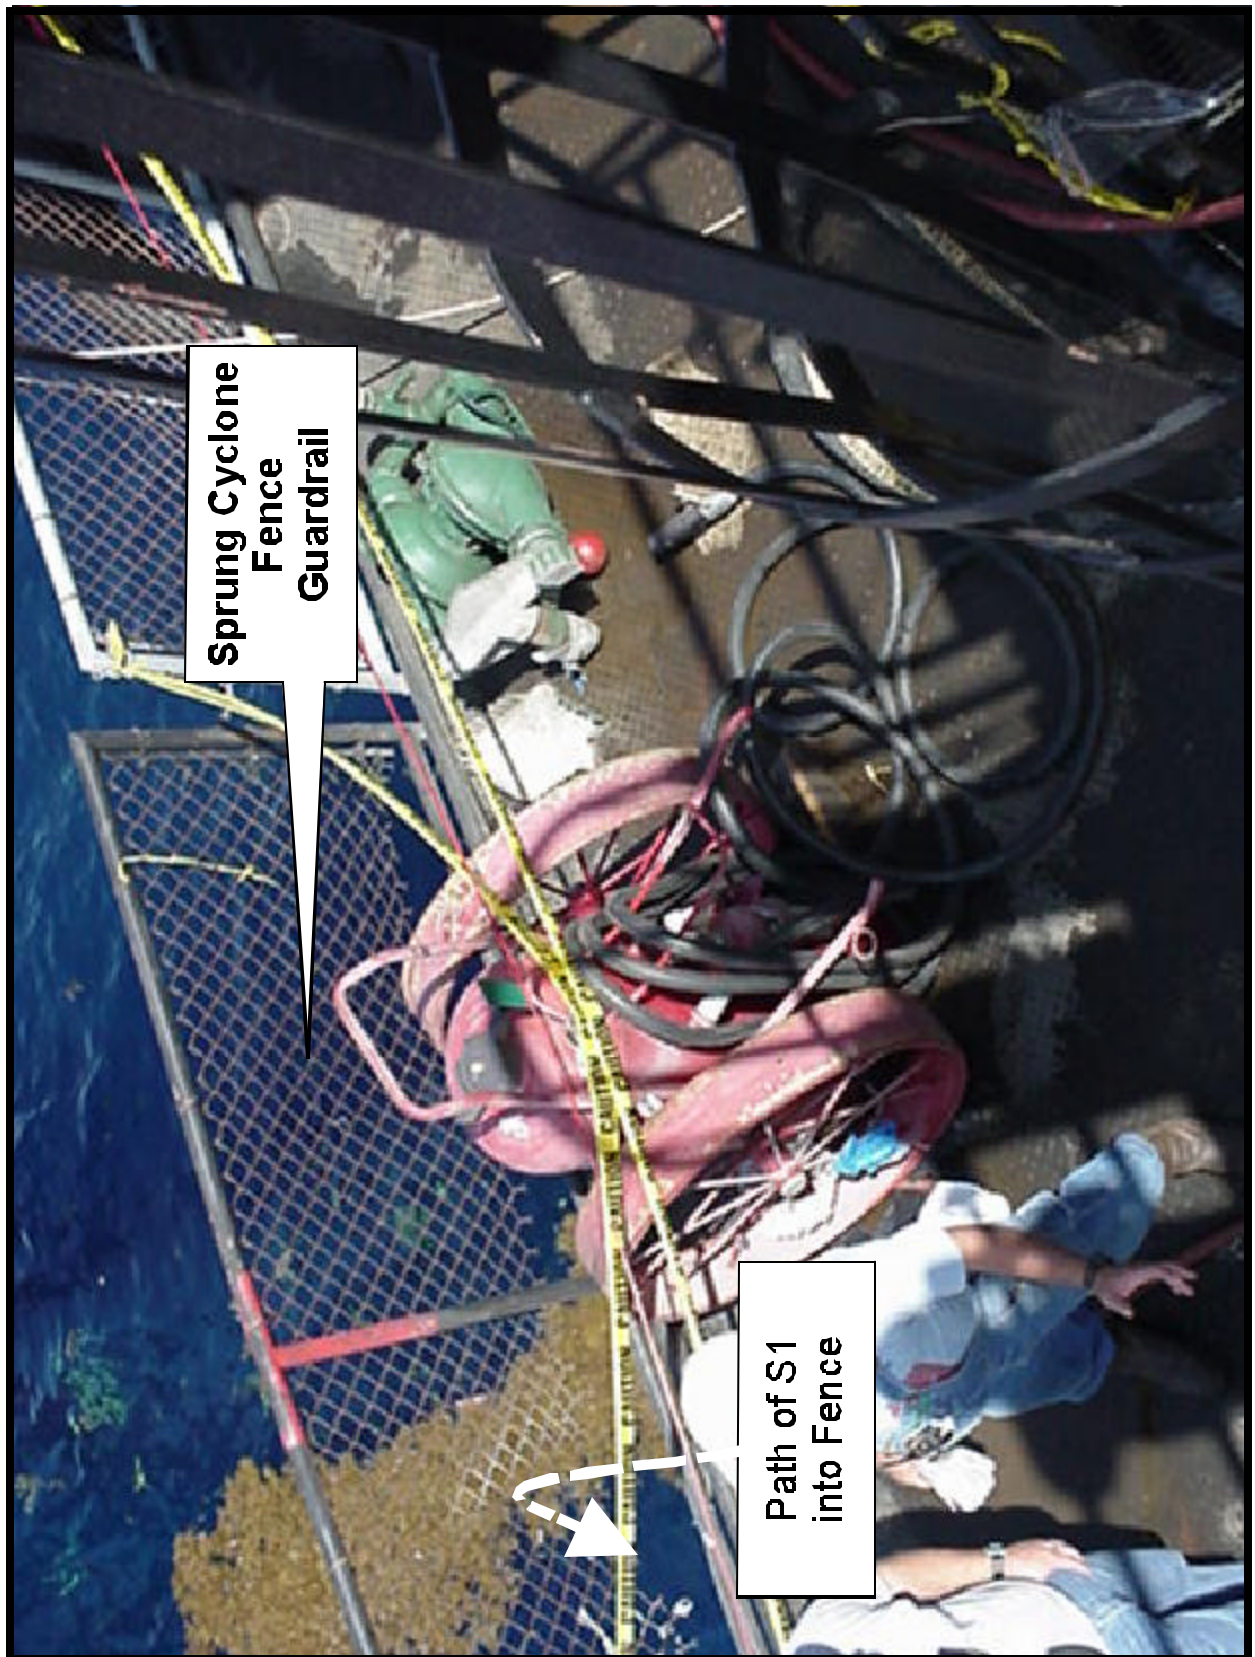
pressure separator. The summer employee was blown backward into the guardrail. (*See Attachment 6 for picture of guardrail after explosion.*) The guardrail in this area of the platform consists of a regulation-height pipe frame with cyclone fencing attached to the frame with plastic ties and/or cyclone material fasteners spaced about every four feet located around the rail and through the fencing. The bottom of the cyclone fencing in a 6- to 8-foot-long guardrail panel next to the one that was impacted was held in place by a single plastic wire tie. It is unknown how the guardrail fence panel impacted by the summer employee and foreman was secured to the frame. The guardrail frame the summer employee impacted was bent outward, and the cyclone fencing was sprung and deformed outward, leaving a significant gap at the bottom. Pieces of clothing were later discovered on the bottom of the fencing material (*see Attachment 7*).

The guardrail in the path of the flash explosion, opposite the open manway hatch of the lower low-pressure separator in this area of the Platform, was bent outward and the cyclone fencing was sprung loose at the bottom and deformed outward, leaving a significant gap at the bottom. The cyclone fencing material was imbedded with debris, work materials, cloth, cardboard boxes, etc. that were apparently blown into the fence by the force of the explosion (*see Attachment 7*).

Guard Rail Opposite Manway Hatch, LLPS, after Explosion
S1 Summer Wet Oil Tank Worker

- Operators should review guard barrier ability to contain standard impacts, especially in the vicinity of major production equipment, vessels, and work areas.

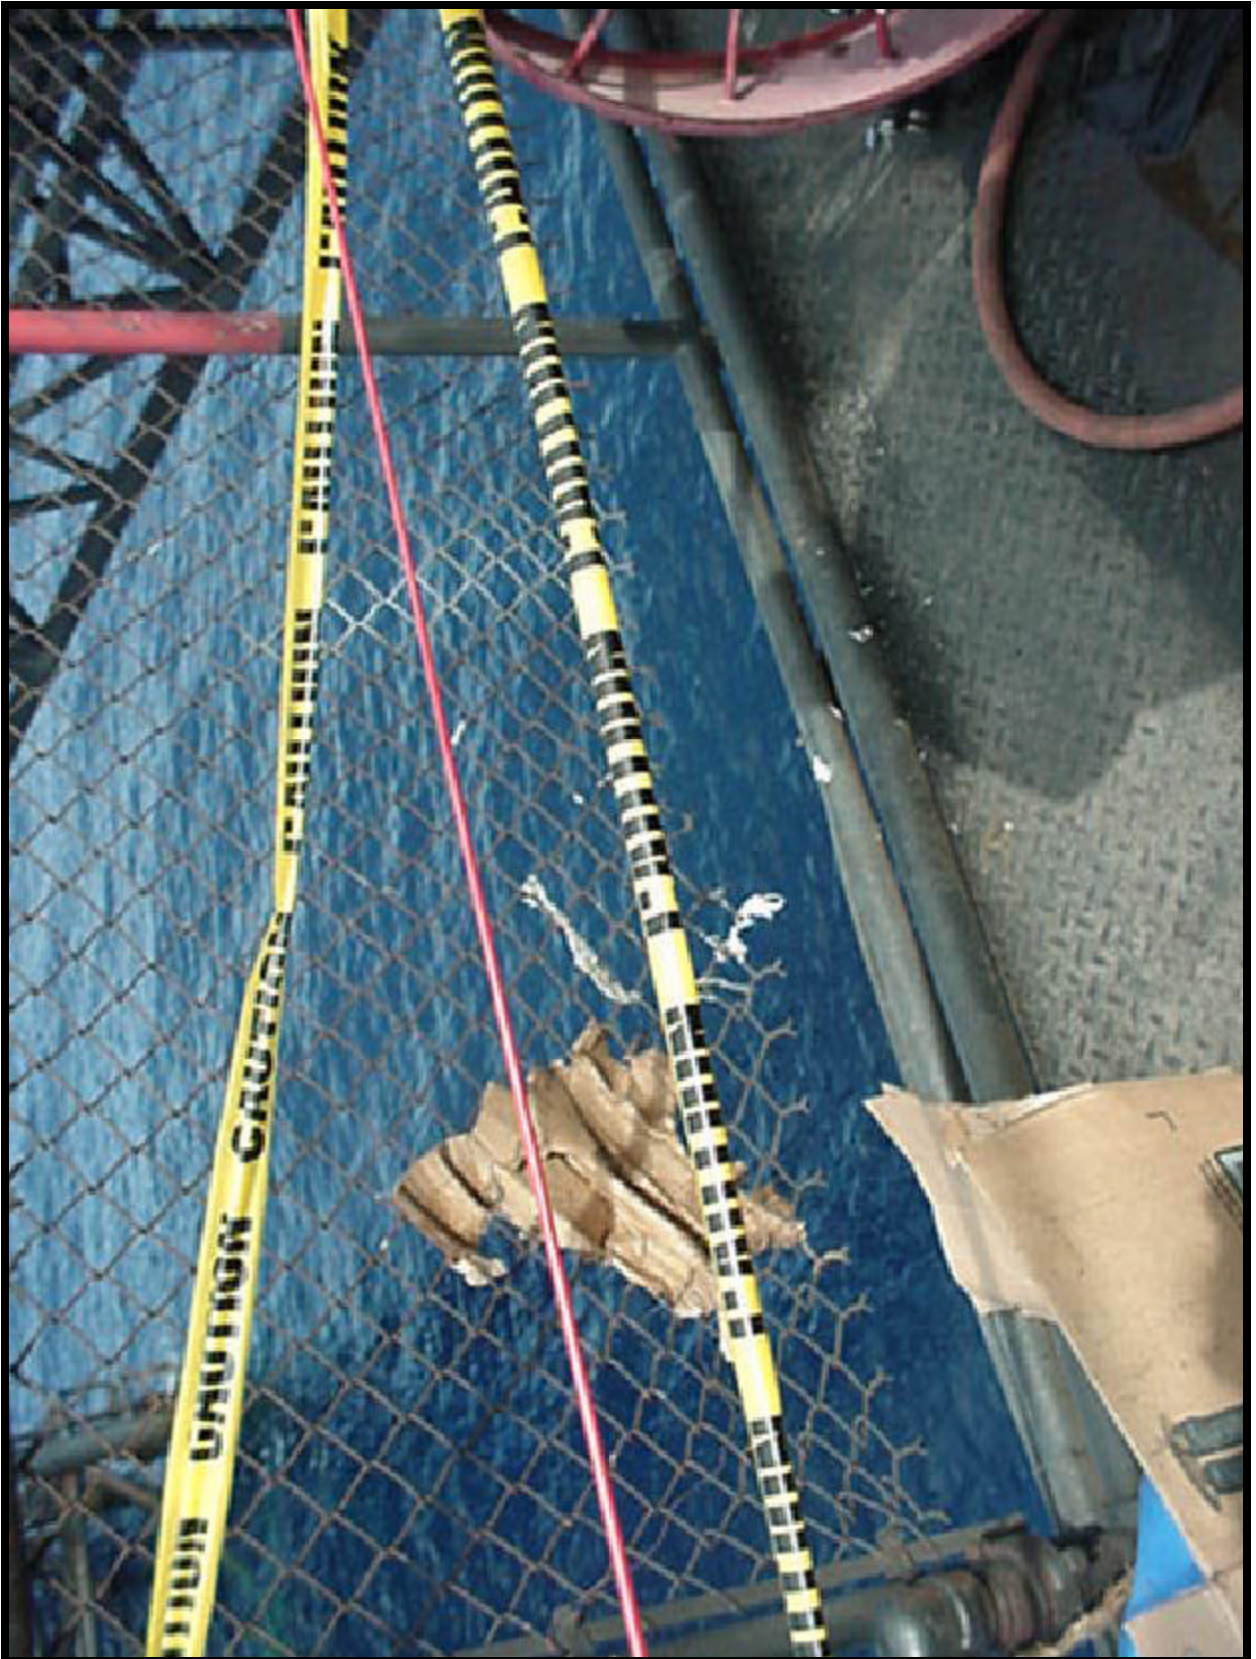
The crew member who was blown into the water was propelled by the blast into the fence, springing the fencing material outward and breaking any plastic ties holding the fencing to the rail frame. This most likely allowed him to fall through the gap created at the bottom of the fencing possibly adding additional injuries to the burns from the direct blast and other injuries sustained from bodily impact with barriers or debris.

Sprung Handrail Fencing and Debris from Explosion
