**Investigation of Fatality
Grand Isle Block 37 Platform Z
OCS 00392
February 28, 2006**

**Gulf of Mexico
Off the Louisiana Coast**

**U.S. Department of the Interior
Minerals Management Service
Gulf of Mexico OCS Regional Office**

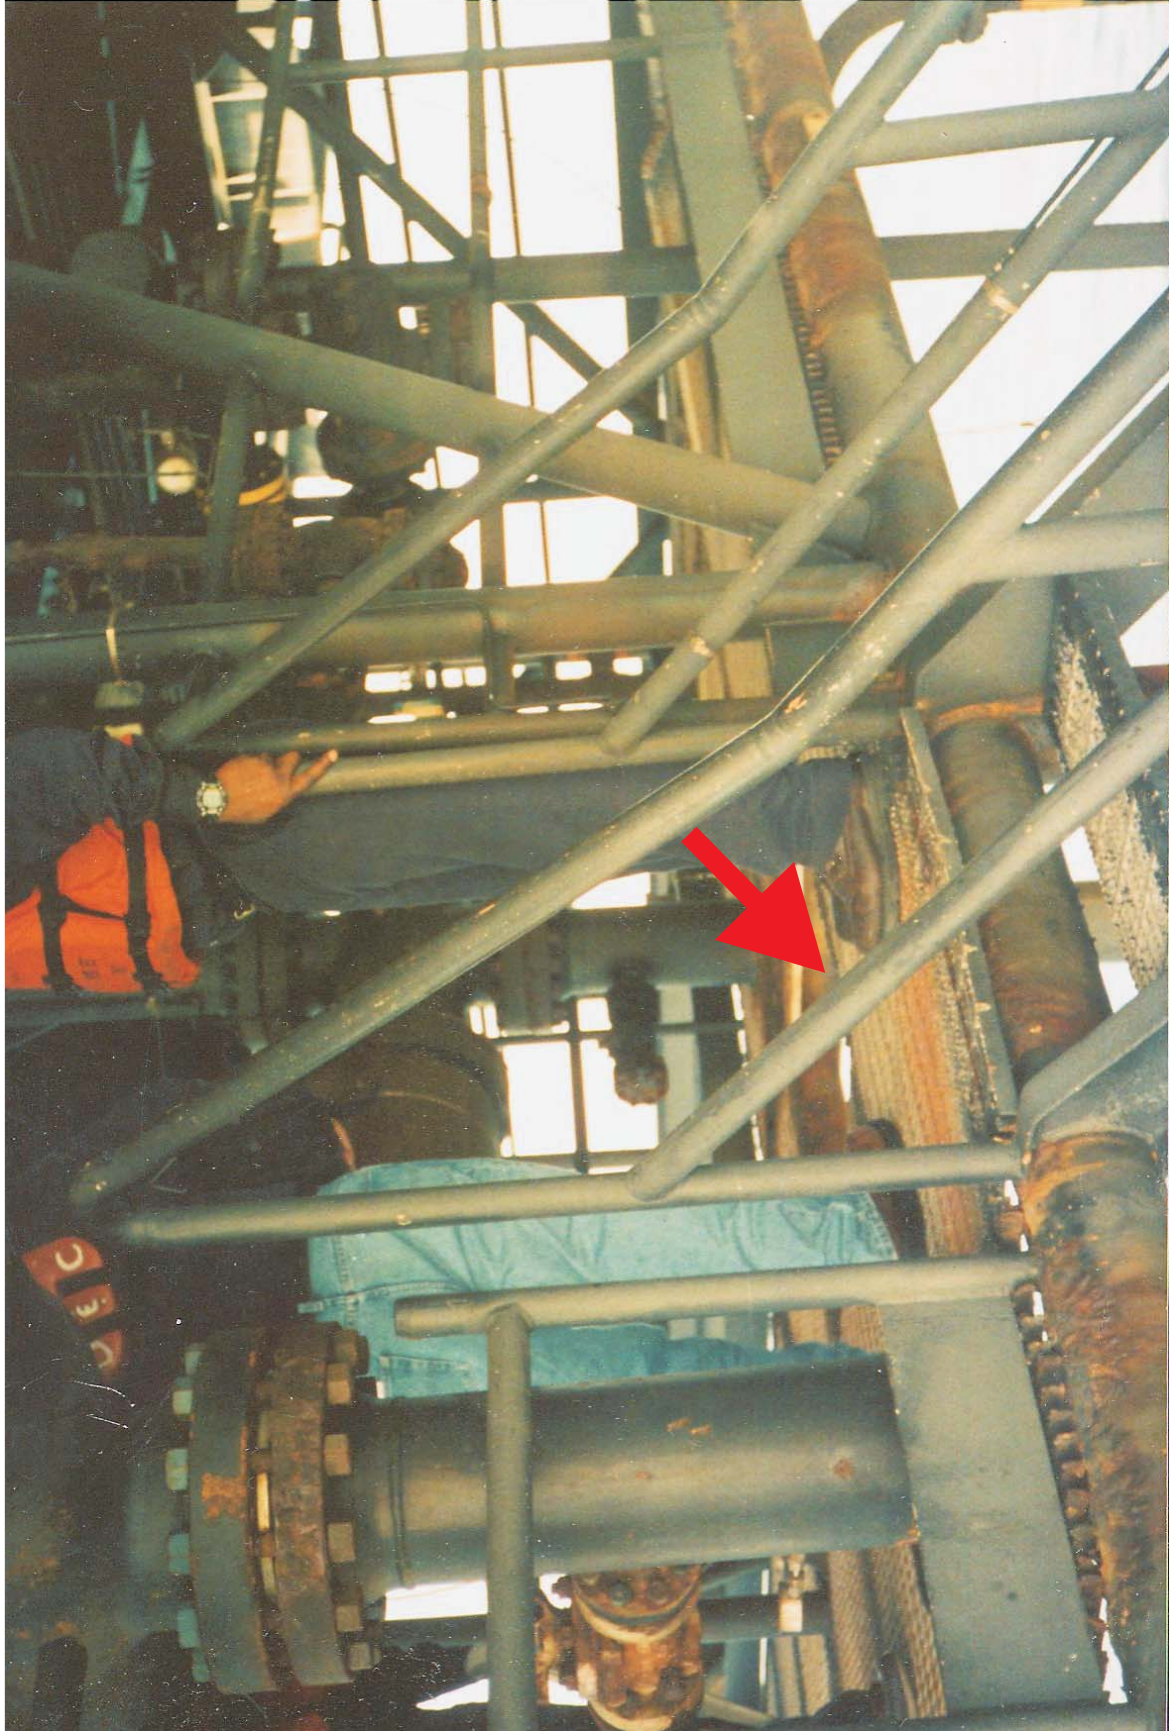
The CD rep. went up to the cellar deck (see attachment 2) and, after about ten minutes, fell approximately 20 feet to the plus-10 deck (see attachment 3), striking the grating, and subsequently falling into the water. After recovery from the water, he was given emergency treatment, flown to Our Lady of the Sea Hospital in Galliano, Louisiana, but was pronounced deceased early that afternoon.

The CD rep. deviated from the original plan of action, which was to go by boat to the GI 37 W platform. Once he reached the GI 37 Z platform, he boarded the platform and walked around for approximately ten minutes before falling to his death. Judging from the point of impact, and the missing grating directly above the impact, the panel concluded that the CD rep. fell through the open hole created by the missing grating.

Missing Grating; Employee Fell Through Consequent Hole.

1. A brief description of the accident,
2. A summary of the causes, and
3. The following recommendations:
 - a) Lessees and Operators should review their policies regarding access and boarding damaged platforms.
 - b) Lessees and Operators should communicate clearly and in writing what is expected of their field representatives with respect to boarding damaged, unrepaired structures or platforms in the Gulf of Mexico.
 - c) Prior to boarding a closed structure or platform, a hazard mitigation plan must be prepared that addresses all issues concerning damage.
 - d) Signs should be posted on platform access points advising that the platform is “closed.”
 - e) Metal bars should be installed across all stairwell entry points.
 - f) Helicopter landing decks should have the stairways leading to the platform barricaded.

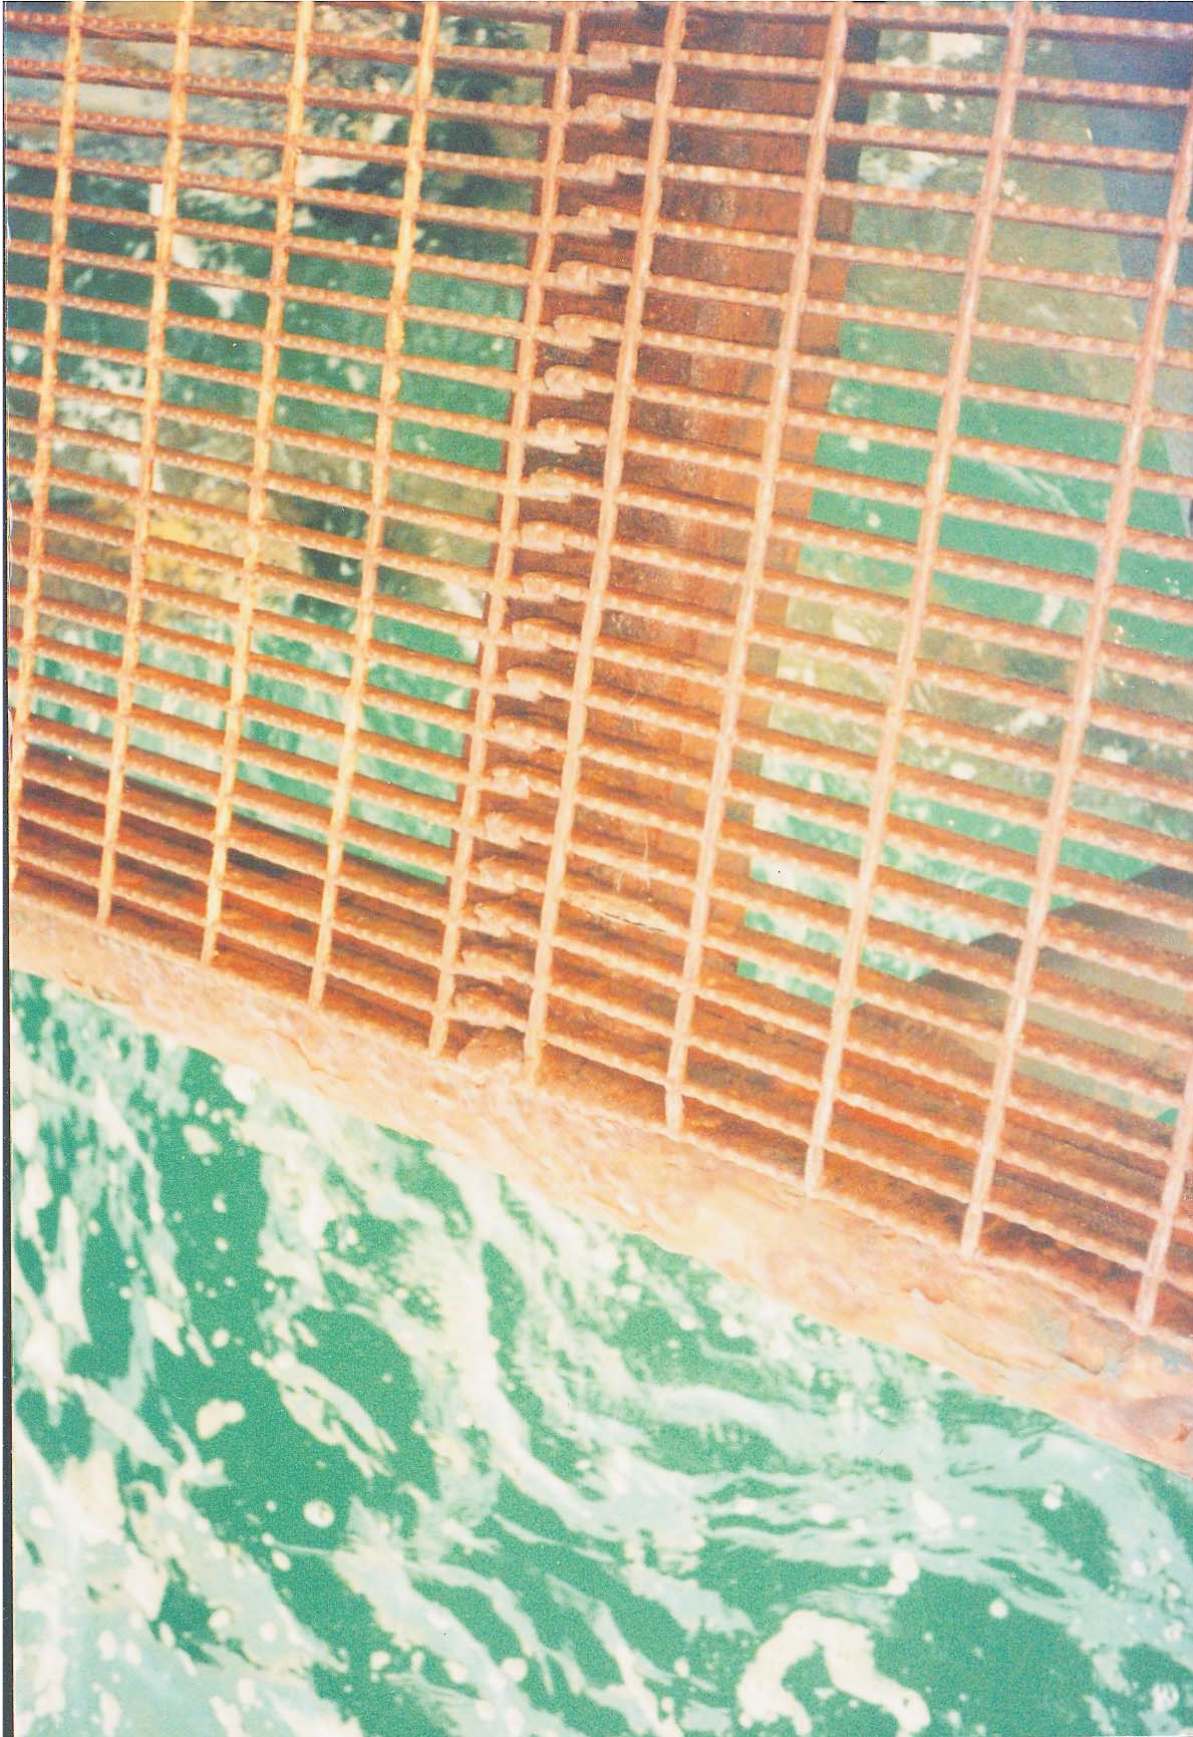
The boat captain was alone and remained on the boat. In interviews, the boat captain stated that he saw the CD rep. on the cellar deck. After looking away briefly, the captain looked back and saw the CD rep. falling approximately 20 feet from the cellar deck, striking his head on the plus-10 deck, and entering the water. The boat captain was unable to determine if the victim was deceased or unconscious. Being unable to retrieve the victim by himself, the boat captain traveled to a neighboring structure for help. The CD rep. was retrieved from the water and brought to the Bay Marchand shore base, from where the CD rep. was flown to Our Lady of the Sea Hospital in Galliano, Louisiana, where he was pronounced deceased early that afternoon. The CD rep. was wearing a personal flotation device (PFD) and was seen by the captain only in a face-up position while in the water.

Walkway Employee Struck Prior to Entering Water.

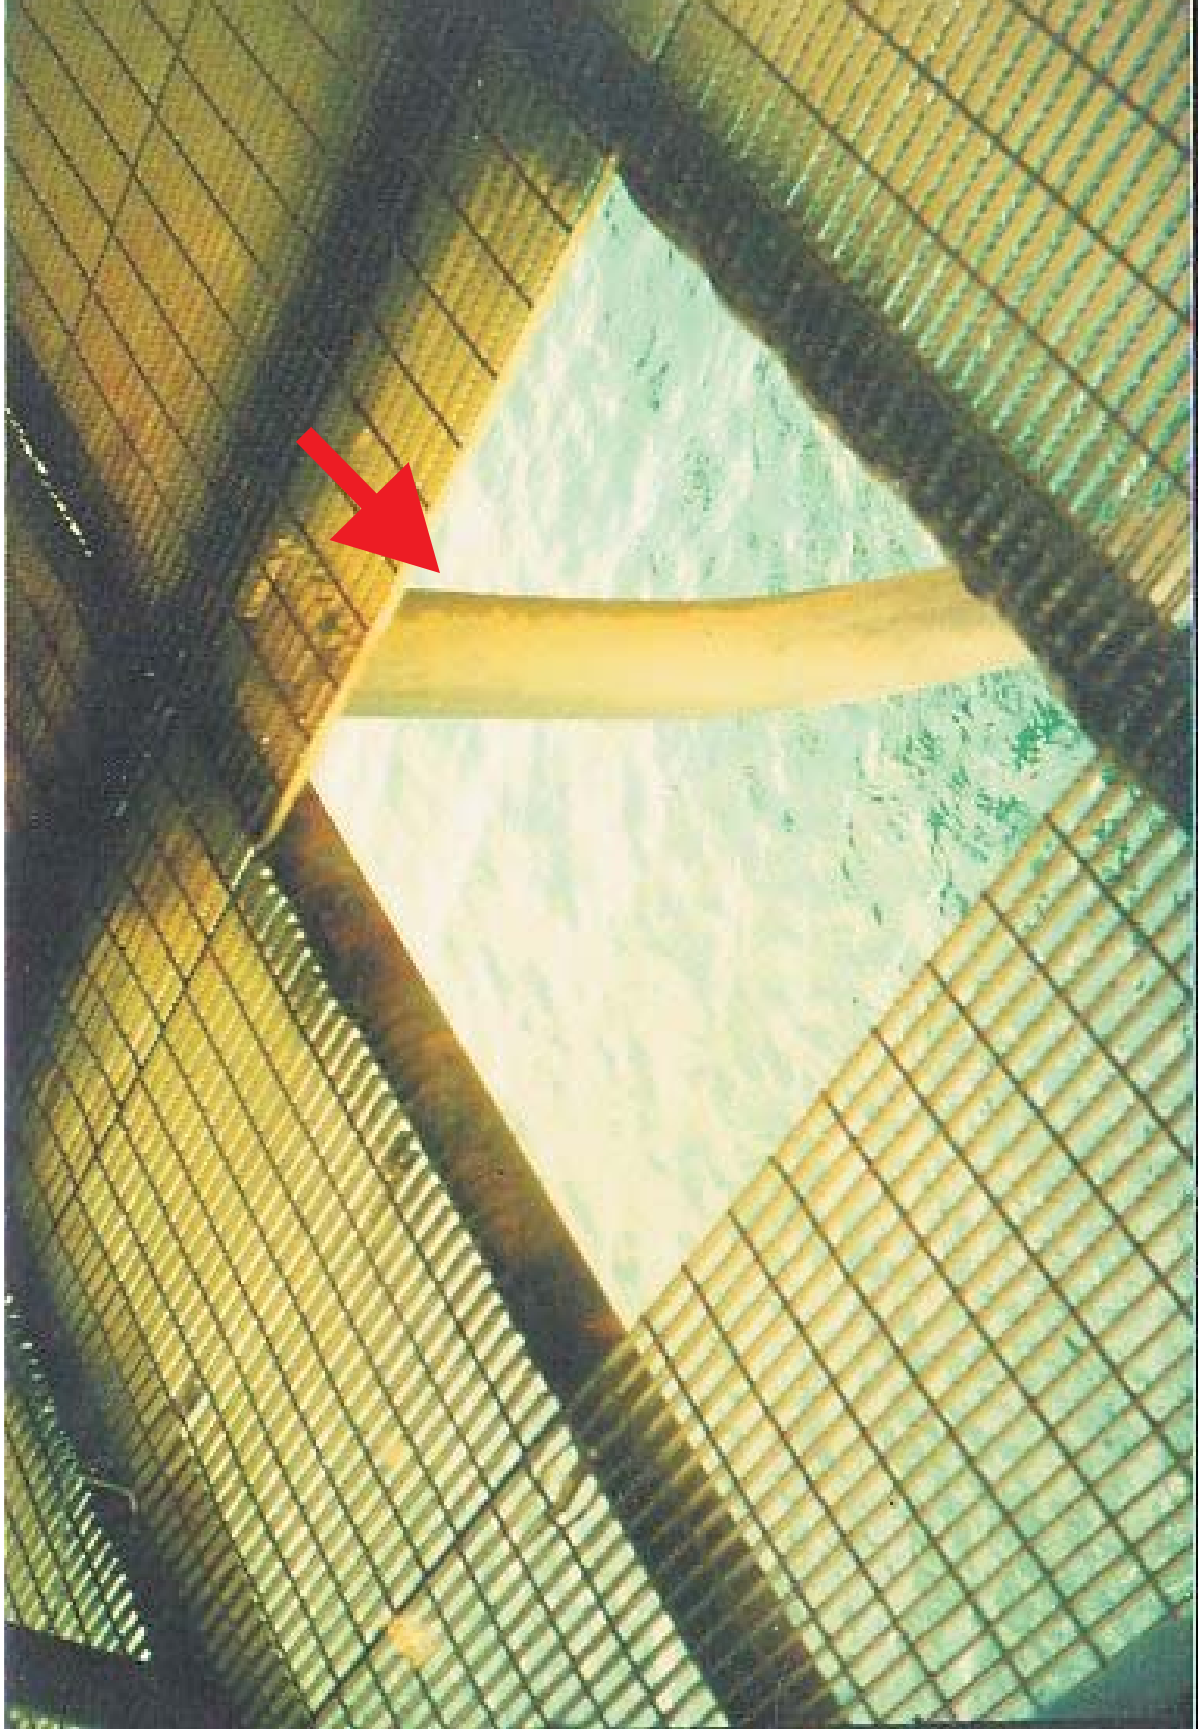
Platform Z, located in GI 37, was damaged by the storm surge and winds associated with Hurricane Katrina in August of 2005, with some of the gratings torn away, leaving holes of various sizes in the deck (see attachments 4, 5, and 6). The platform repair needs had been previously identified, with that work pending a commencement schedule.

Additional Hole #1 Missing Grating

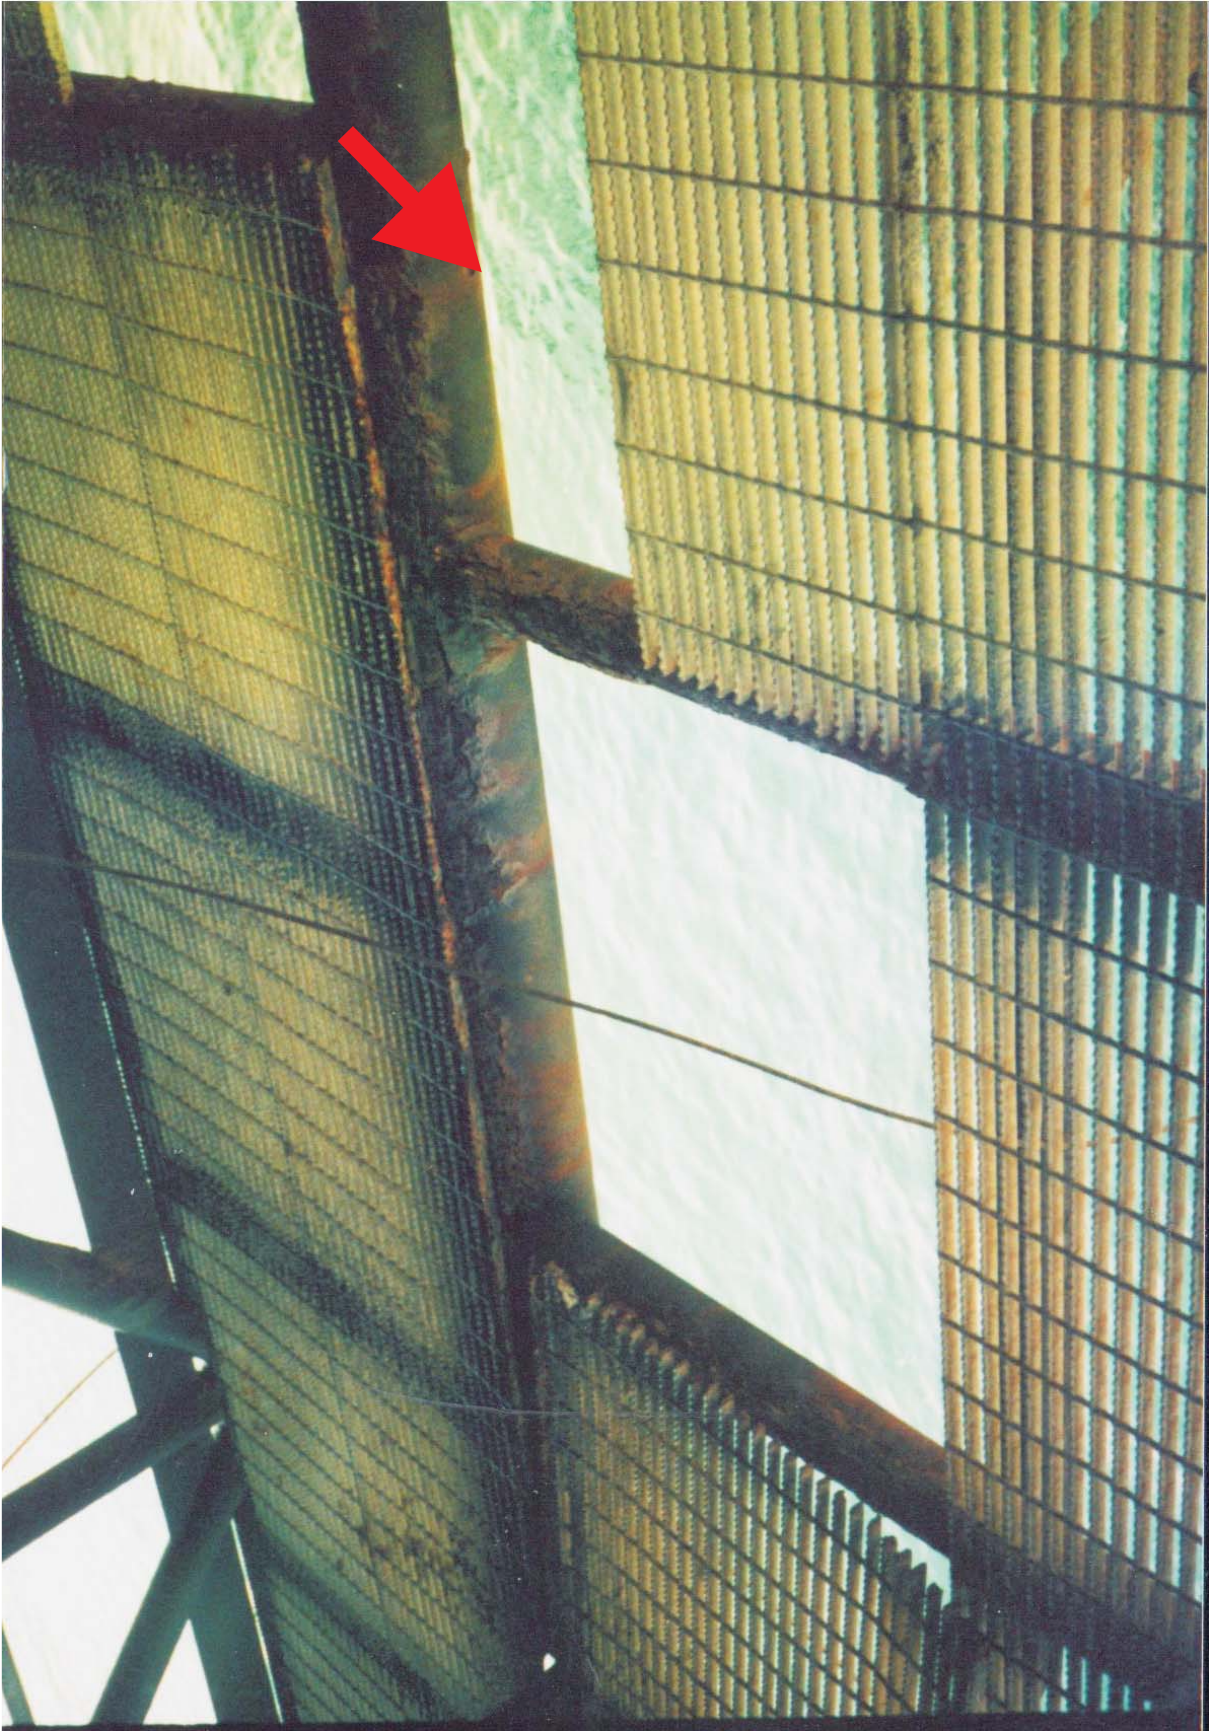
Additional Hole #2 Missing Grating

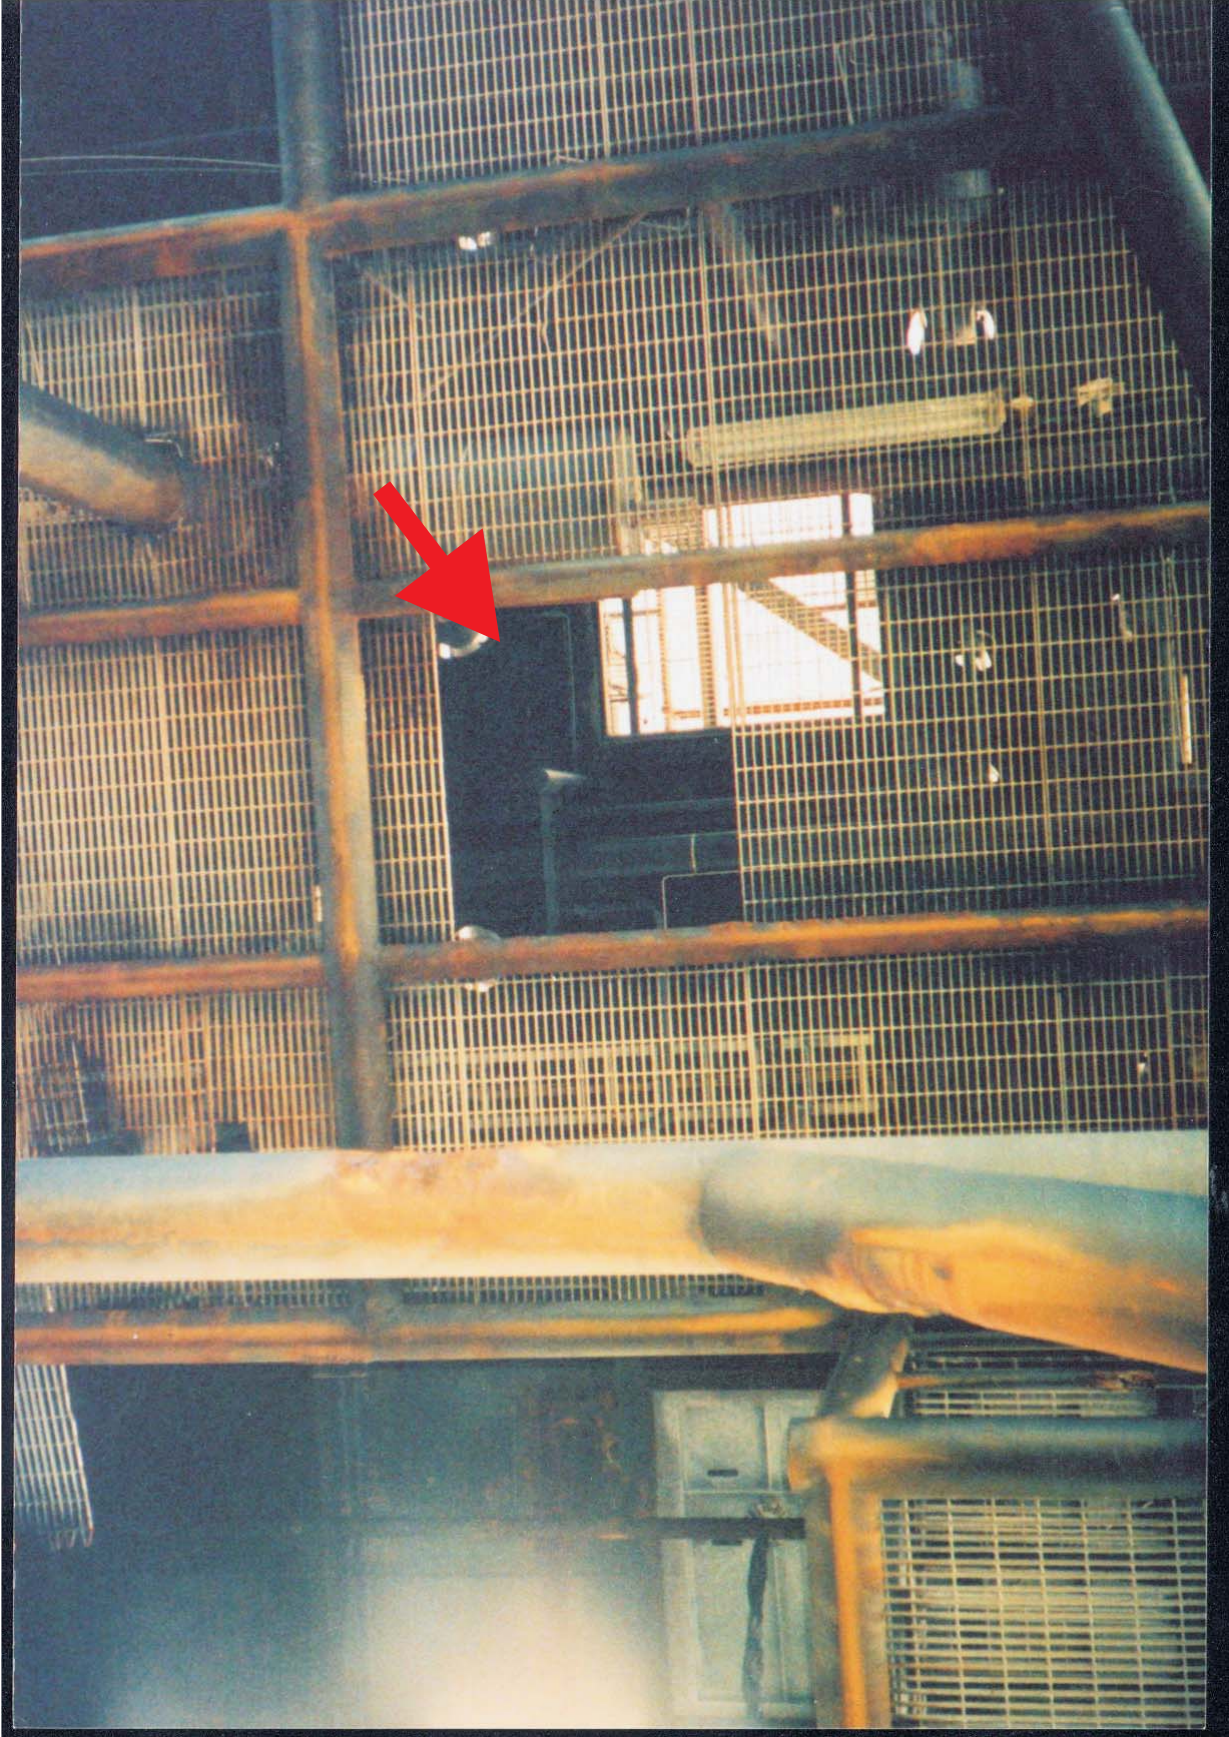
Additional Hole #3 Missing Grating
