**Investigation of Blowout  
Eugene Island Block 28 Well No. 4  
OCS-G 05479  
December 03, 2007**

**Gulf of Mexico  
Off the Louisiana Coast**

**OCS Report  
MMS 2008-049**

**Partek Job #62210-FA-001**

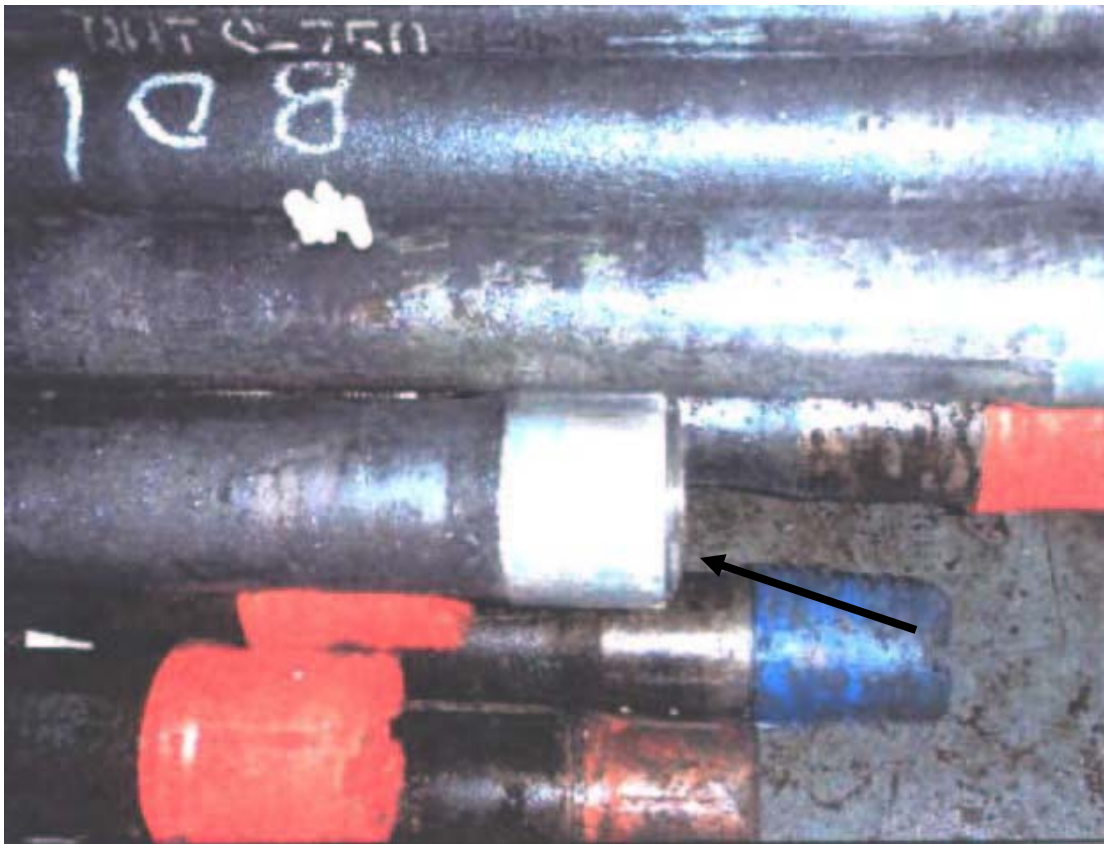
Side View of Broken Connection

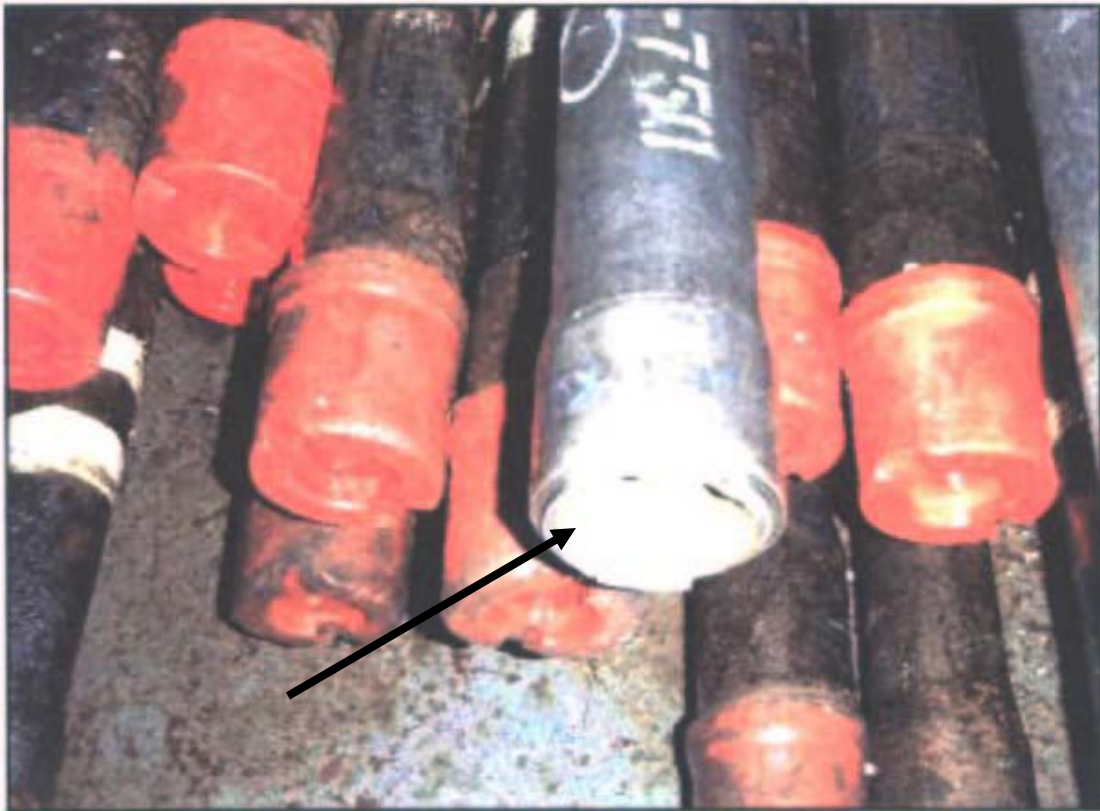
End View Showing Pin Twisted Off

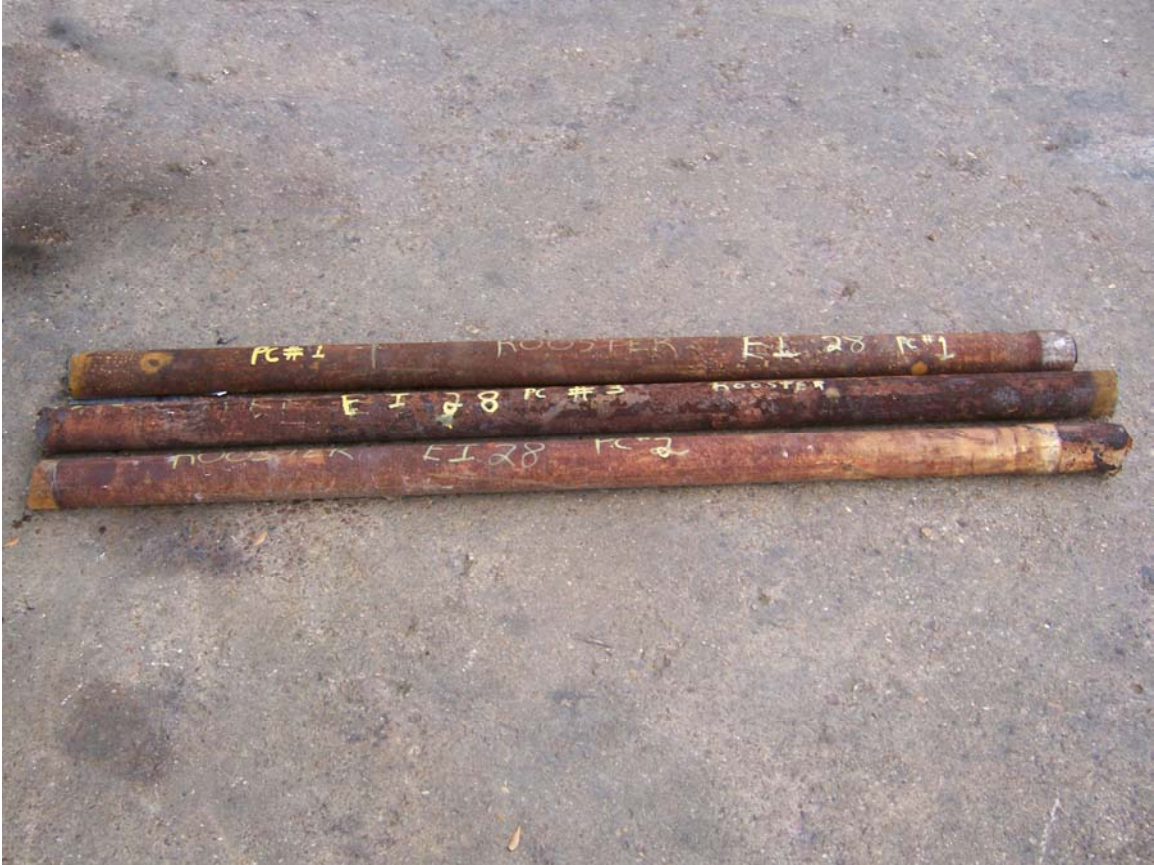
Photograph 1

Photograph showing the as-received tubing sections.

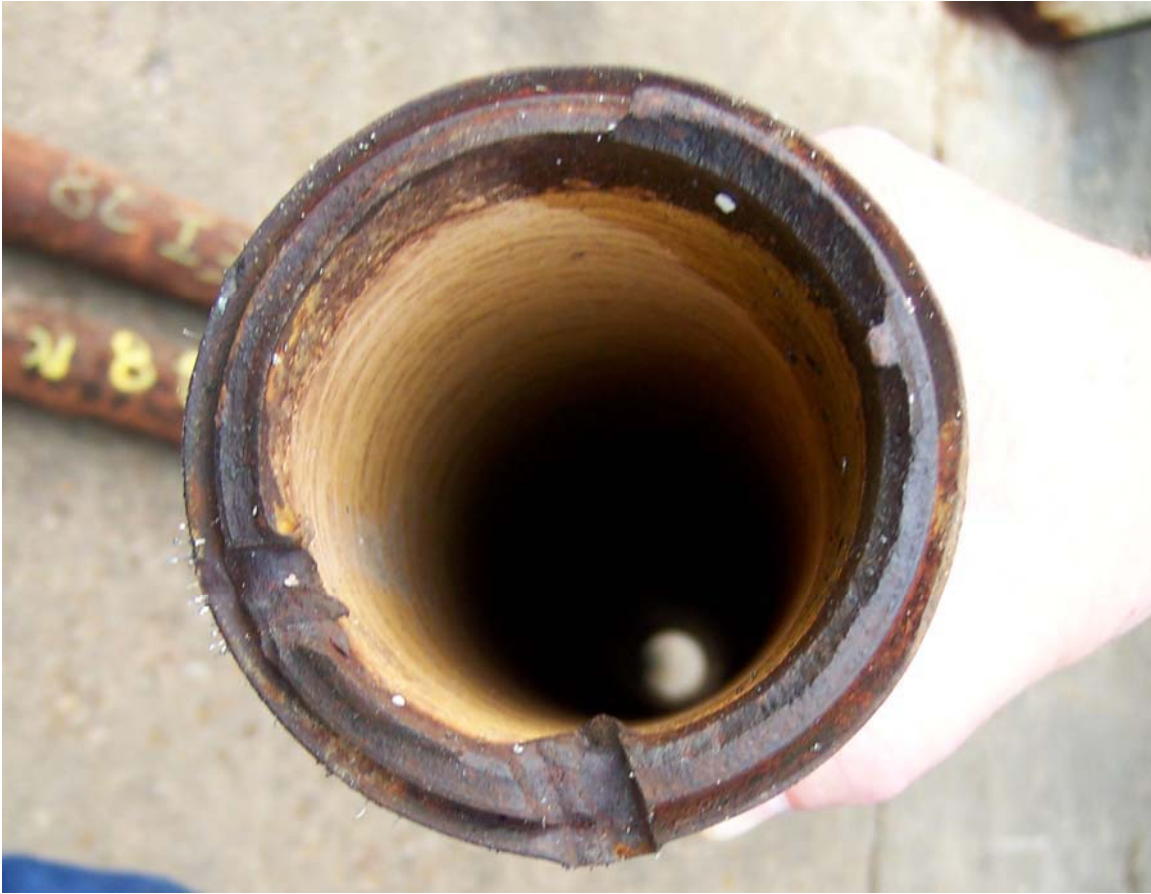
Photograph 2

The fracture surface of the first tubing section was cleaned using a mild caustic solution to remove all traces of surface contamination/oxidation and staining. This surface was then examined using an optical microscope at magnifications up to 20X. The fracture exhibited a relatively flat, fine-textured area for approximately 1/2 of the circumference and 45° shear for the remaining surface area. There was evidence that progressive crack growth had occurred prior to failure. There was also evidence of deep surface gouges mostly likely the result of subsequent fishing operations. All of these features are suggestive of a fatigue type failure. Reference photographs are attached to this report.

Photomicrograph showing the failure surface of the first failed tube prior to cleaning. Note the deep indentations most likely the caused by the fishing operation.

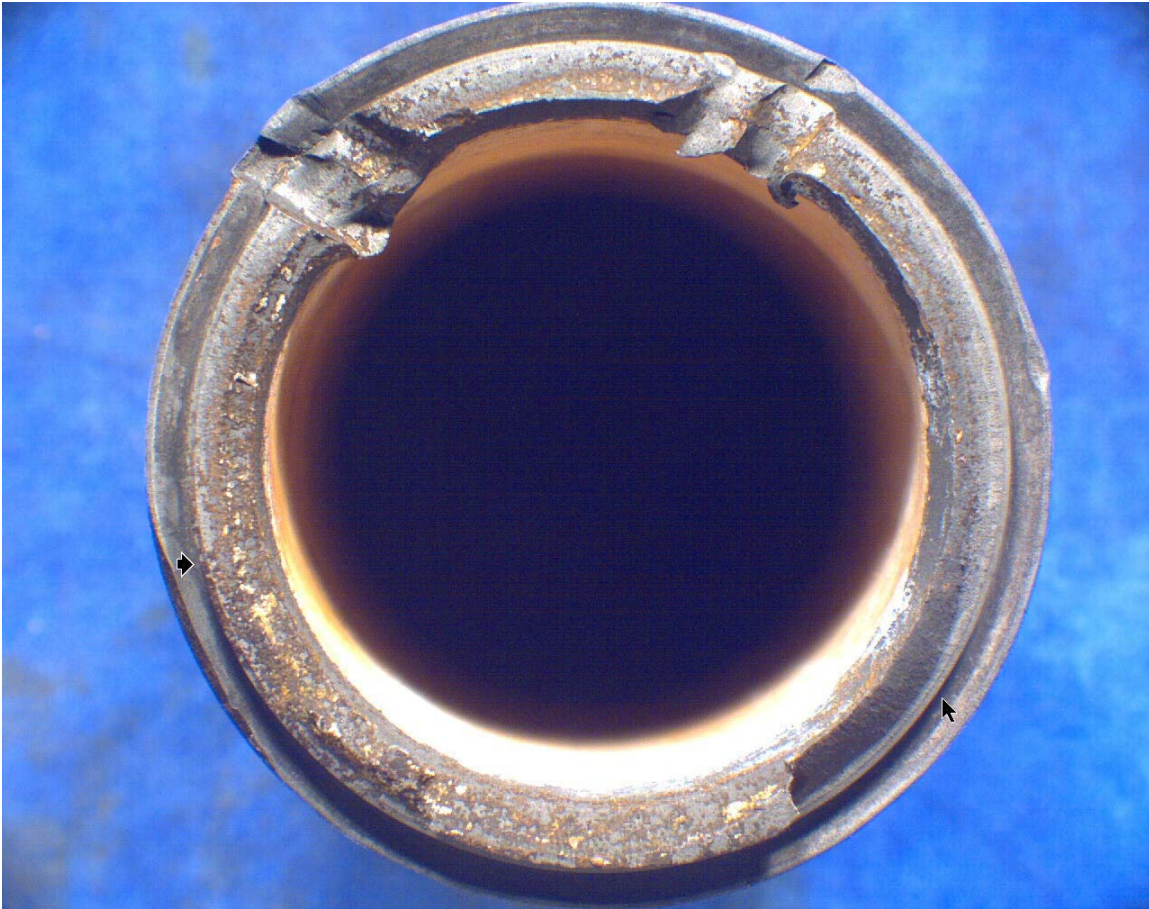
Photograph 3

Based on available information and laboratory observation the first tubing most likely failed as a result of fatigue cracking that would greatly reduce the load carrying capacity of the tubing. Final failure was the result of ductile tensile overload. The second tubing section failed as a result of ductile tensile overload most likely because the load carrying capacity was decreased as a result of the extreme flow cuts.

Photomicrograph showing the fracture surface of Piece# 1 shown in Photograph# 2 after cleaning. Note the flat fine textured area between the arrows. This feature is typical of fatigue type cracking which would greatly reduce the load carrying capacity of the tubing.

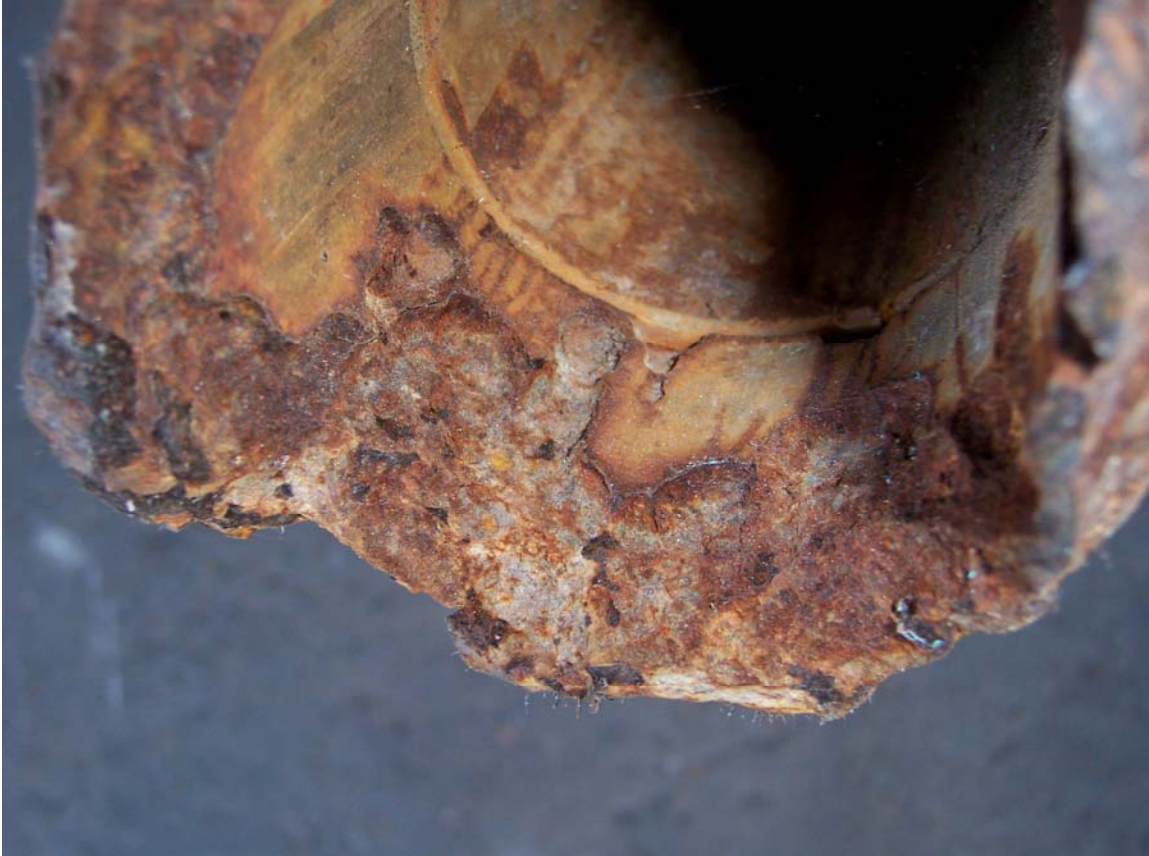
Photograph 4

The sections 2 & 3, which represent the second failure, were examined and found to exhibit extreme wall thinning the result of flow cuts. Reference photographs are attached to this report.

Photomicrograph showing the fracture surface of Piece#2. Note the extreme flow cut areas which caused extreme wall thinning. This would also greatly reduce the load carrying capacity of the tubing.
