**Investigation of Blowout  
Main Pass Block 91 Platform A  
OCS-G 14576  
August 23, 2007**

Gulf of Mexico  
Off the Louisiana Coast

U.S. Department of the Interior  
Minerals Management Service  
Gulf of Mexico OCS Regional Office

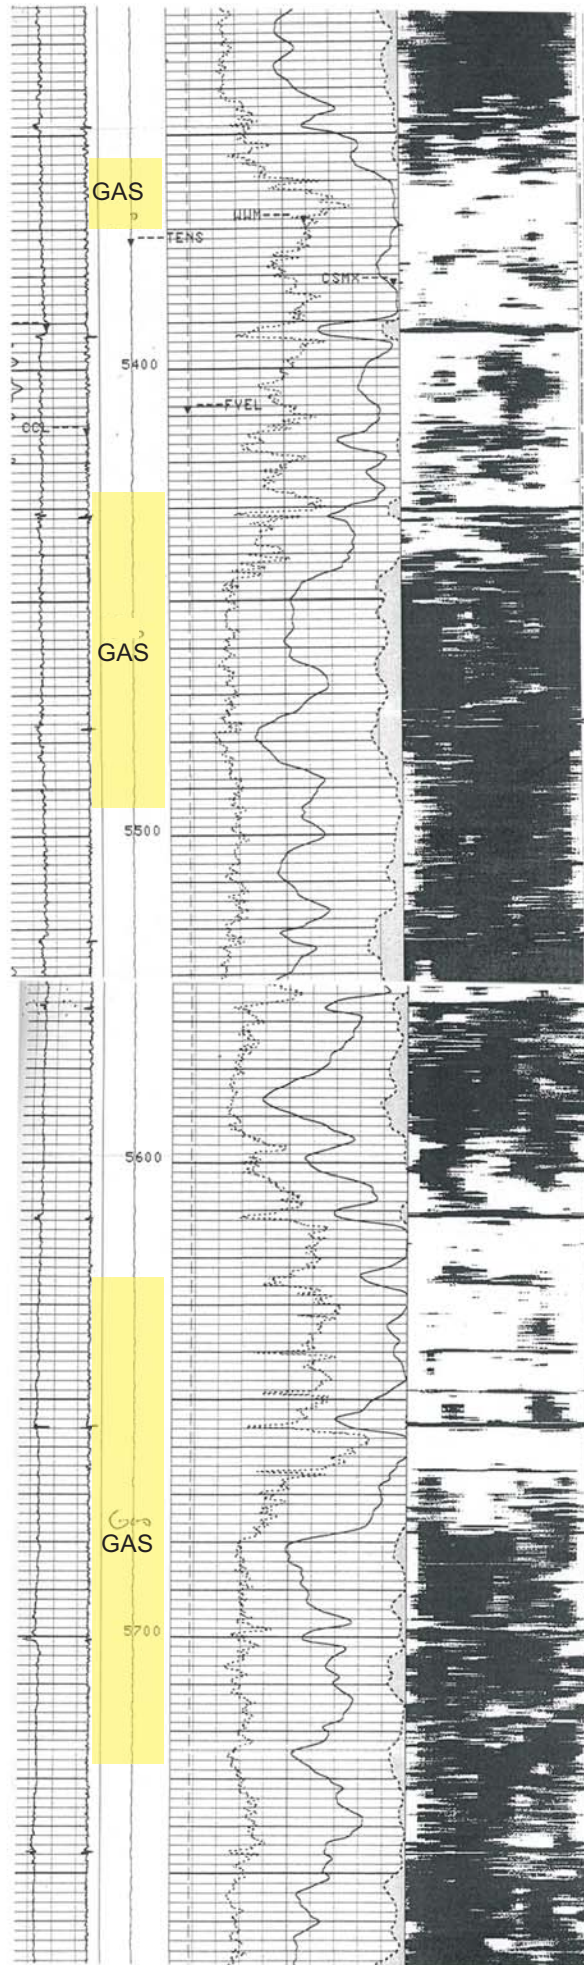
- The 9 5/8-inch casing was initially cemented with 1,860 cubic feet of Class H cement. According to the Cement Evaluation Log, the cement was gas cut. There appeared to be large areas of no cement at the depth of each gas zone in the well, indicating that the cement quality was very poor. This trend exists from 7,200 feet MD to the top of the cement. (*See attachment 3 for cement bond log.*)

The original cementing of the 9 5/8-inch casing is considered to be a contributing cause. The cement evaluation logs, produced by Apache, indicate that the cement was gas cut. At the depth of each gas zone in the well, the cement quality is very poor, showing what looks like large areas of no cement. This trend exists from 7,200 feet MD to the top of the cement at 2200 feet. (*See attachment 3 for cement bond log.*)

Gas cut cement from cement bond log.
