**Investigation of Pipeline Leak
Pipeline Segment No. 4582
Main Pass Area Block 288
23 June 2007**

Gulf of Mexico
Off the Louisiana Coast

OCS Report
MMS 2008-056

**U.S. Department of the Interior
Minerals Management Service
Gulf of Mexico OCS Regional Office**

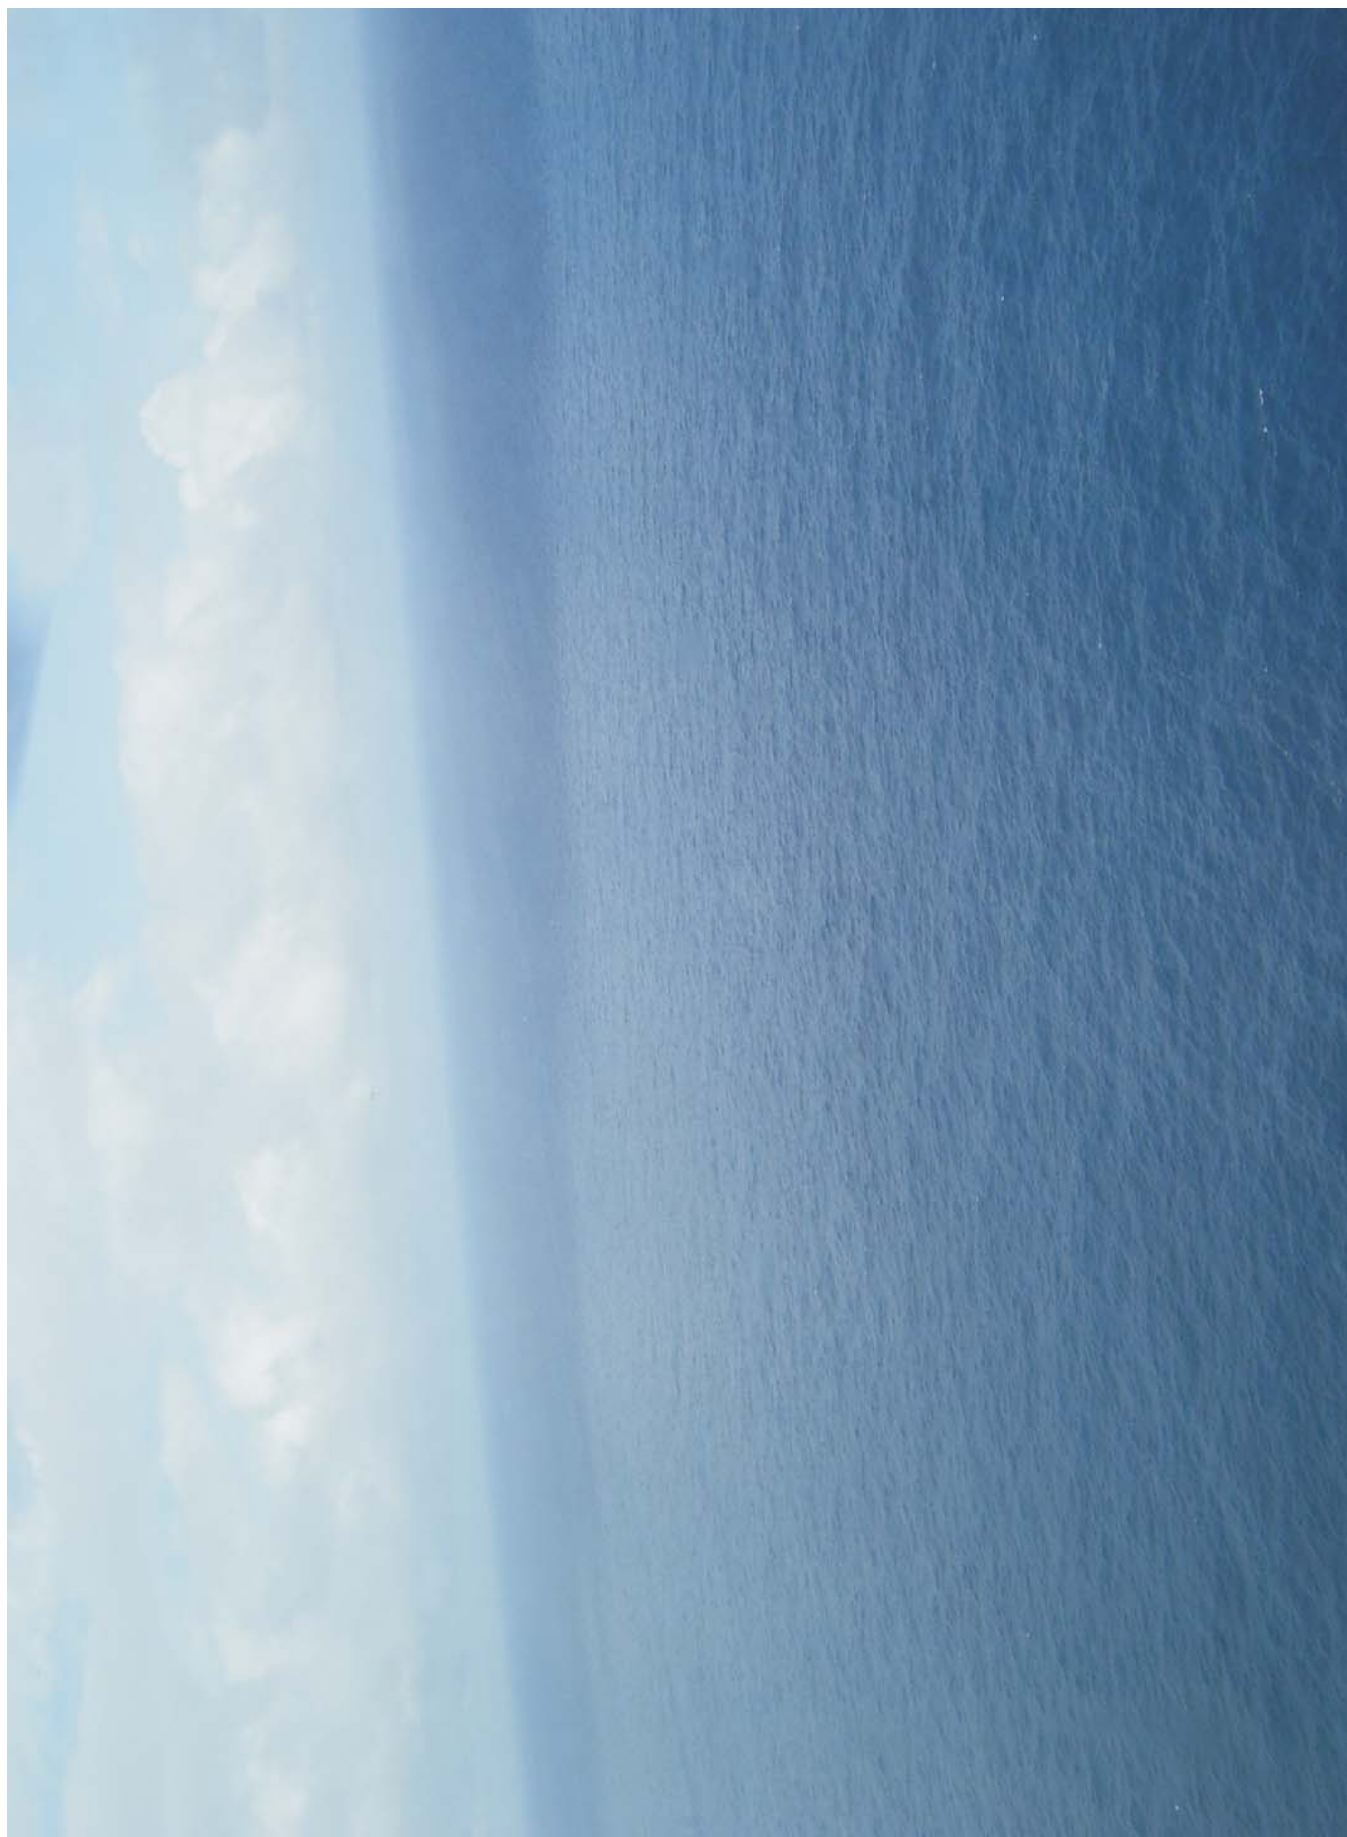
Photograph of Oil Slick, Block 288 Main Pass Area, June 2007

On *23 June 2007*, the Spill occurred. An oil slick, 30 miles in length by 6 miles wide, of unknown origin was reported near the Platform (NRC Report No. 839690). An overflight by MMS personnel confirmed the presence of the slick, but its origin could not be determined from aerial reconnaissance. (*See Attachment No. 3*)

The volume of the spill was estimated to be 187 bbls based on slick size and sheen appearance. Estimates that up to 214 bbls were lost in the two weeks preceding the Spill were later amended by the Operator. Stone personnel stated that they did not believe the previous reports of sheens in the area originated from the Pipeline. It was reported that there was no metering at the departure point for the 4.5-inch OD oil pipeline (PSN 4582) from the MP-288 "A" Platform. At the time of the Spill, the pipeline was averaging a throughput of approximately 2,600 BOPD and either was

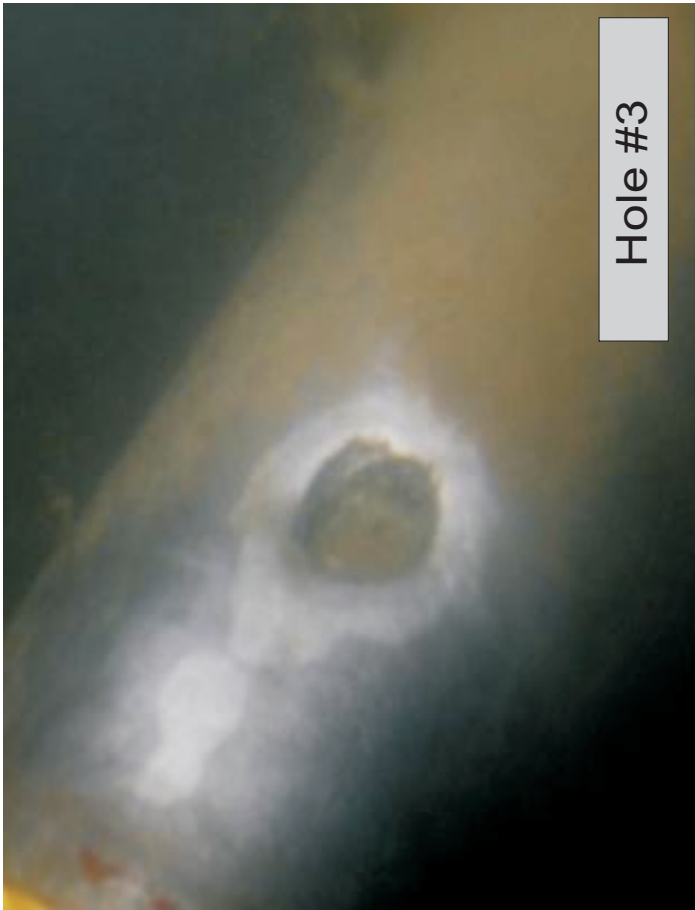
Hole #3

Divers then cleaned around all four holes and covered them with duct tape after inspecting the pipe for external damage and finding none of critical significance. Hole No. 4 was found to be $\frac{1}{8}$ -inches x $\frac{7}{8}$ -inches; Holes Nos. 3 and 2 were both approximately $\frac{1}{4}$ -inch diameter (*see Attachment No. 4*). The divers found some damage to coatings and pipe in several places. They also reported that almost all the anodes they checked on both PSN's 4582 and 4581 were fully depleted.

1. The 4.5-inch oil pipeline PSN 4582 was found to have four holes within a 100-foot long section, which allowed the release of the crude oil. The holes were caused by corrosion.
2. The CP prior to the Spill had deteriorated below the minimum level required to protect the pipeline and had remained in that state for at least six months. The failure of the CP was responsible for the corrosion of the pipeline. In April 2007, the level of CP was found to be below minimum acceptable levels for PSN 4582. The Operator failed to take timely action to remedy the deficiency. This allowed the ongoing corrosion to form the holes in PSN 4582.
