NATIONAL AERONAUTICS AND SPACE ADMINISTRATION

APOLLO 15 MISSION REPORT

MSC-05161

NATIONAL AERONAUTICS AND SPACE ADMINISTRATION
MANNED SPACECRAFT CENTER
HOUSTON, TEXAS
December 1971

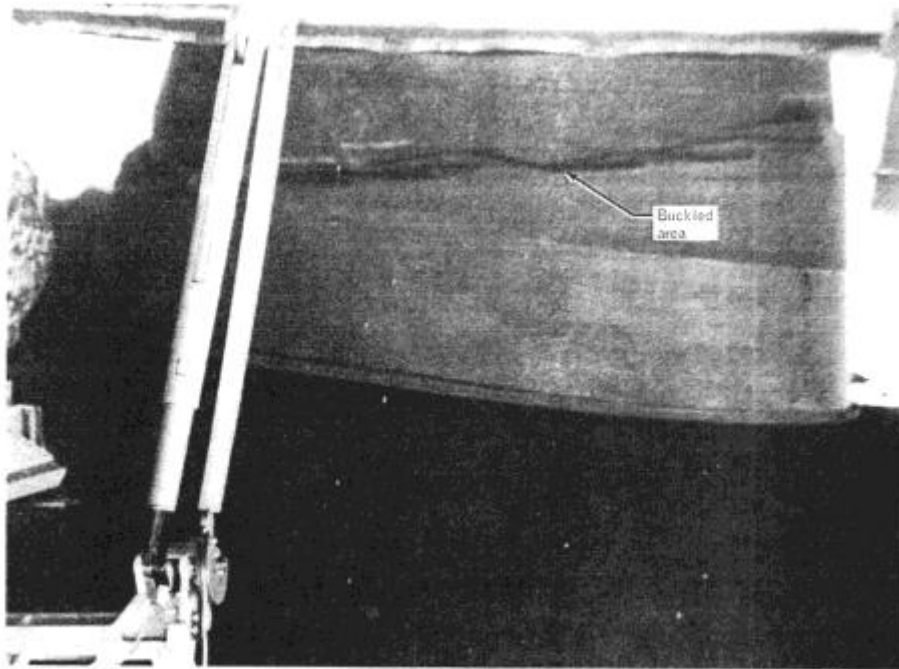
Figure 7-1.- Buckling of descent engine skirt.

At touchdown, the lunar module was located partially inside a small crater with the rim of the crater directly underneath the descent engine skirt. The descent engine skirt buckled during landing. This is accounted for in the touchdown dynamic analysis, and was expected as the skirt length had been extended 10 inches over that of previous vehicles. This buckling was noted by the crew and confirmed by photographs of the damaged skirt (**Fig. 7-1**).

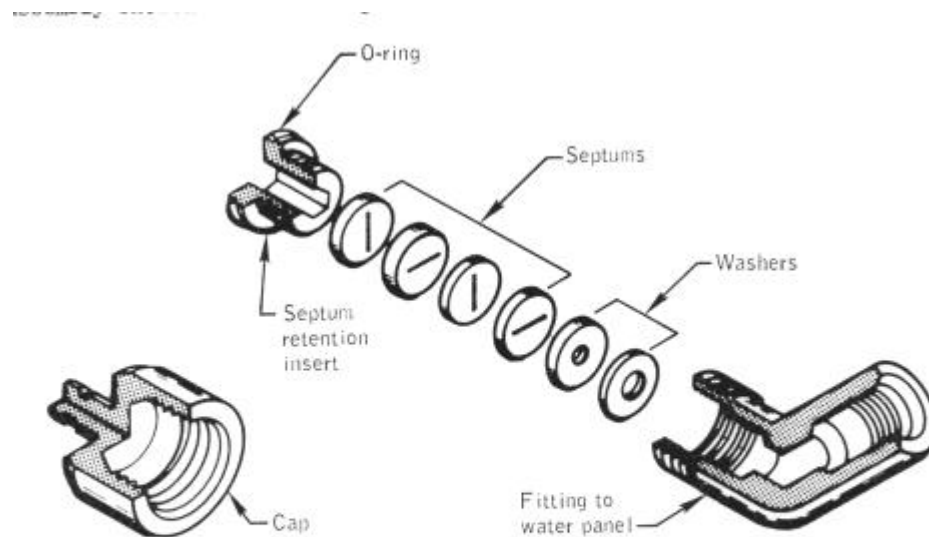
Figure 14-2.- Water panel chlorine injection port.

Minor leakage was noted from the chlorination injection port when the cap was removed to perform the prelaunch water chlorination. The cap was reinstalled and the leak ceased. A leak of approximately 1 quart in 20 minutes also was noted at the chlorine injection port as the crew removed the injection port cap for the third injection at about 61 hours. The crew tightened the septum retention insert (**Fig. 14-2**) and satisfactorily stopped the leakage. Leakage recurred at about 204 1/2 hours and was corrected.

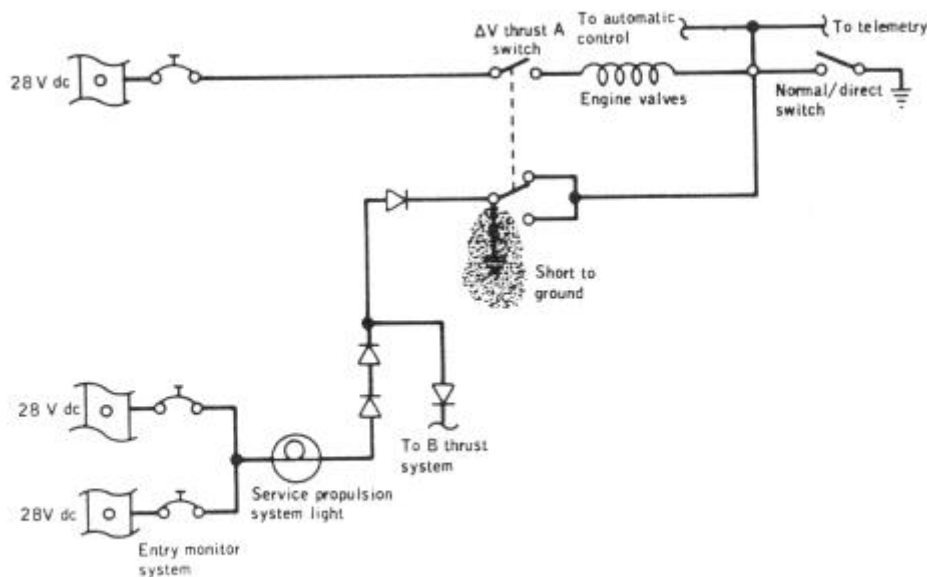
Figure 14-3.- Service propulsion system thrust light circuitry.

The short was isolated to the system A delta-V thrust switch which was found to be intermittently shorted to ground (**Fig. 14-3**).

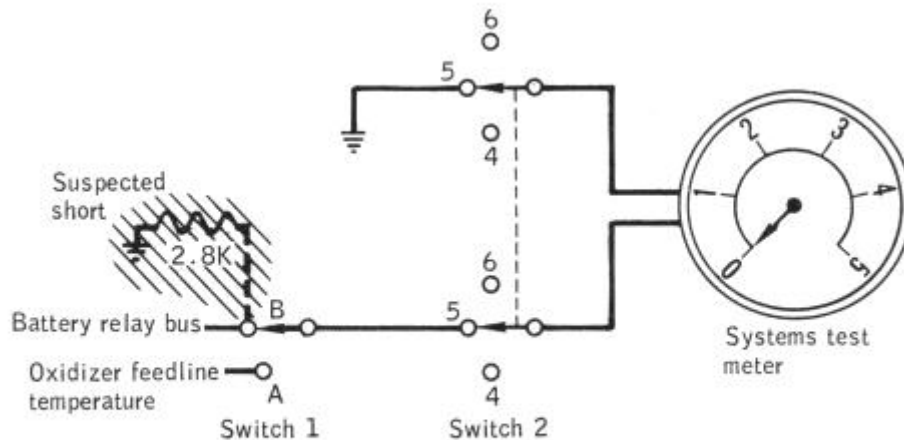
Figure 14-6.- Systems test meter switch.

Postflight testing of the vehicle and all of the involved components revealed no anomalous condition which could have caused the problem but did isolate the problem to the instrumentation circuitry and verify that the functional operation of the bus was not impaired. Analysis indicates that the only way to duplicate the flight problem would be to connect a resistance of 2800 ohms from ground to the battery relay bus measurement circuit (**Fig. 14-6**). No resistance near this magnitude was measured during postflight testing. The most probable cause of the anomaly was that insulation resistance at the output terminal of the switch was lowered because of humidity.

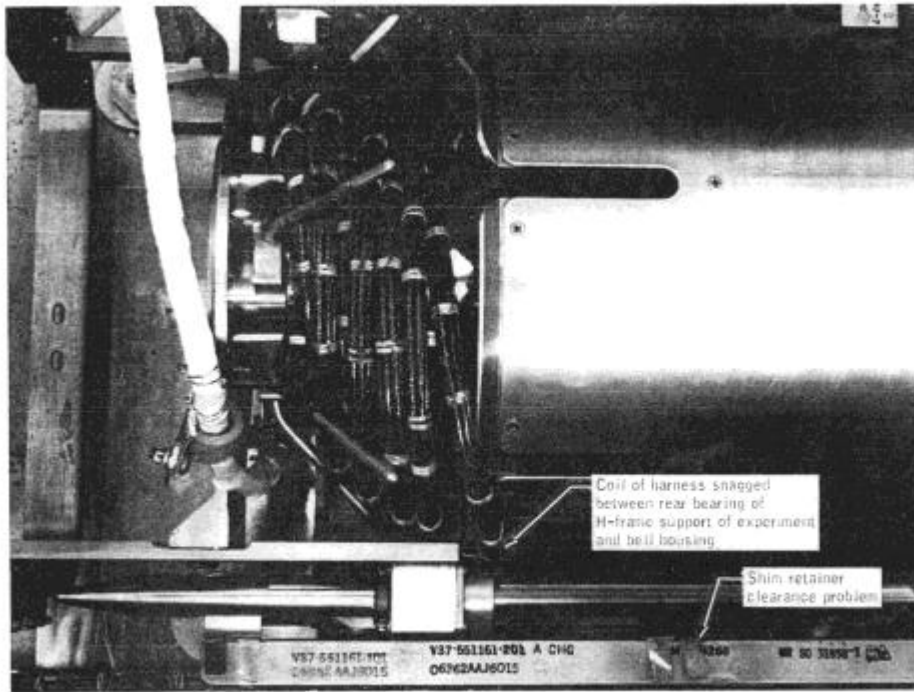
Figure 14-7.- Bottom view of mass spectrometer deployment mechanism (experiment removed).

An inflight test of the Apollo 15 boom indicated that the problem was a function of temperature. Testing and examination of the Apollo 16 spacecraft showed that the failure was possibly caused by pinching of the cable harness during the last several inches of boom retraction. The cable could have been pinched between the bell housing and rear H-frame bearing (**Fig. 14-7**), or a cable harness loop was jammed by a boom alignment finger against the bell housing (**Fig. 14-8**).

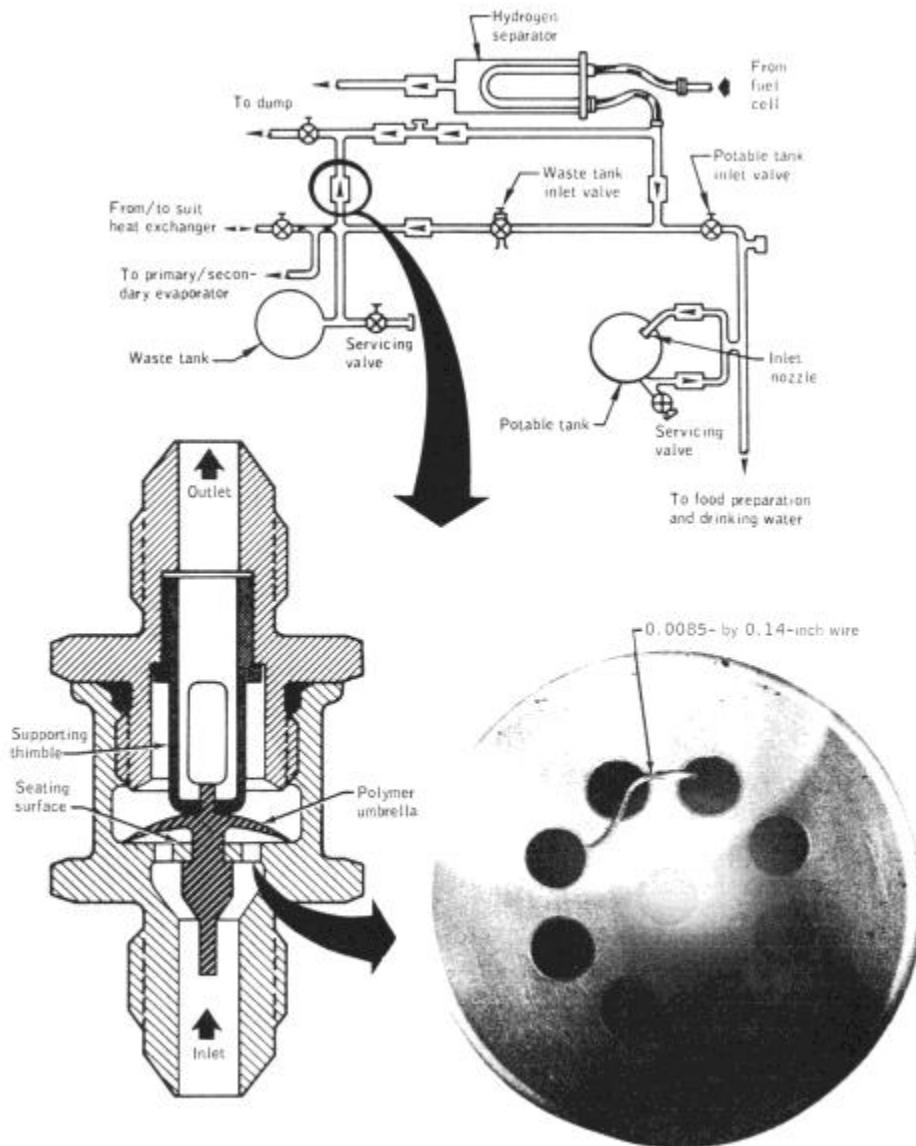
Figure 14-9.- Water management system and failed check valve details.

The check valve between the fuel cell and waste tank dump leg (**Fig. 14-9**) was tested and found to leak excessively. A tear-down analysis of the check valve was performed and a piece of 300-series stainless steel wire (approximately 0.0085 by 0.14 inch) was found between the umbrella and the seating surface (**Fig. 14-9**). This contaminant could cause the umbrella to leak and yet move around sufficiently to allow adequate seating at other times. The wire most probably came from a welder's cleaning brush and was introduced into the system during buildup. Safety wires and tag wires are of a larger diameter than the one found. The check valve at the potable water tank inlet is of a different configuration and is spring loaded closed. The 1-psi pressure required to open this valve is a large pressure drop compared to the other components at the low flow of 1-1/2 lb/hour, and would, therefore, cause the water to flow to the waste tank.

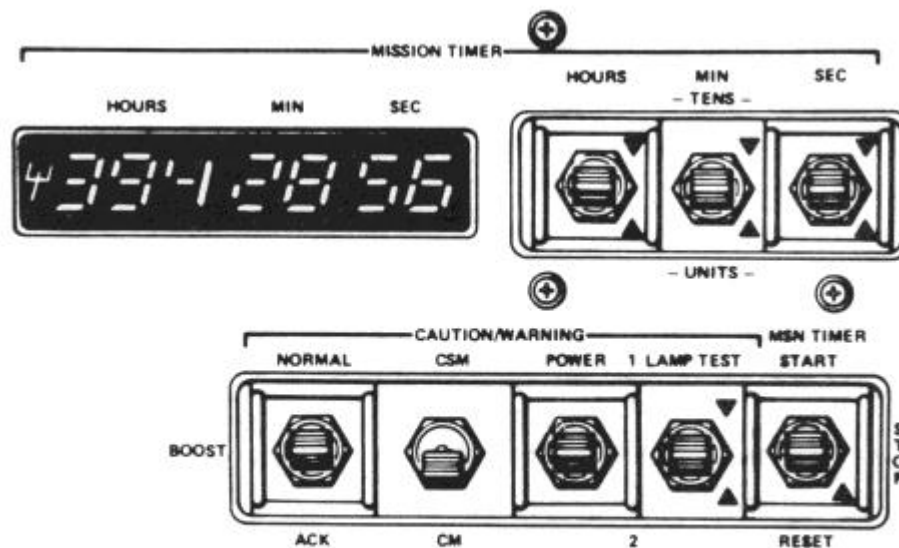
Figure 14-10.- Mission timer.

The panel 2 mission timer stopped at 124:47:37. Several attempts to start the clock by cycling the start /stop/reset switch from the stop to the start position failed (**Fig. 14-10**). The timer was reset to 124:59:00 using the hours, minutes, and seconds switches, and the timer again failed to start when the switch was cycled. The switch was then placed in the reset position. The timer reset to all zeros and started to count when the switch was placed in the start position. The timer was then set to the proper mission time using the hours, minutes, and seconds switches and operated properly for the remainder of the mission.

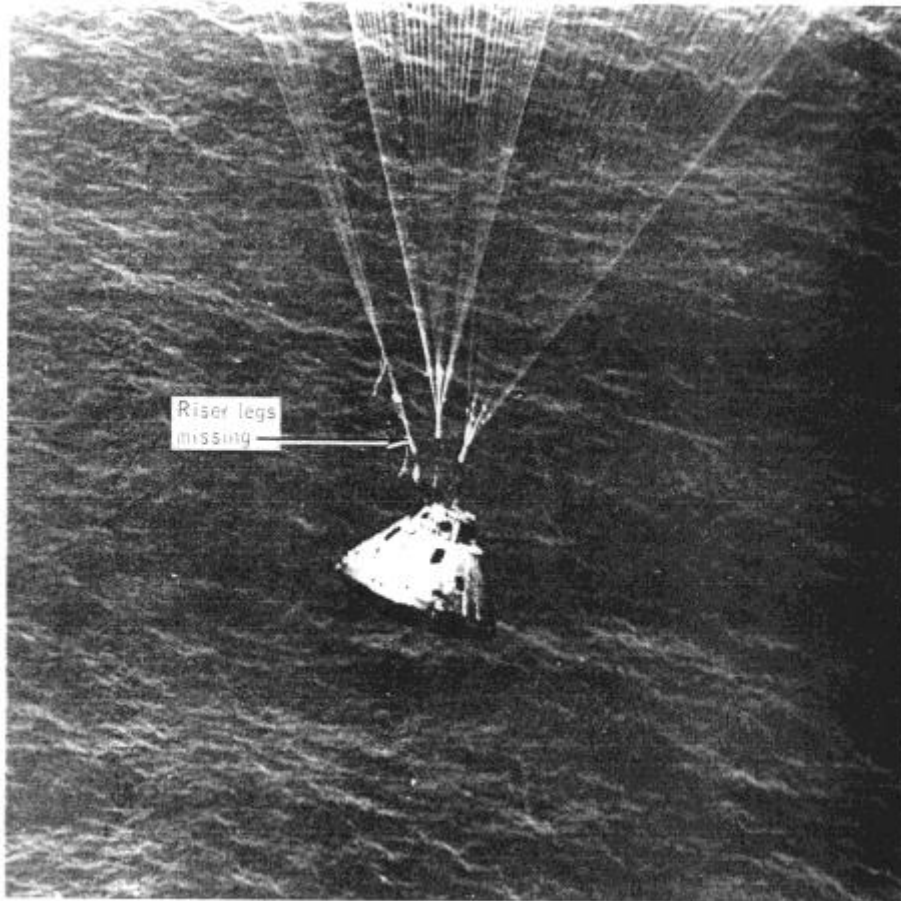
Figure 14-11.- Parachute riser damage noted during final descent.

One of the three main parachutes was deflated to approximately one fifth of its full diameter at about 6000 feet altitude. The command module descended in this configuration to landing. All three parachutes were disconnected and one good main parachute was recovered. Photographs of the descending spacecraft indicate that two or three of the six riser legs on the failed parachute were missing (**Fig. 14-11**).

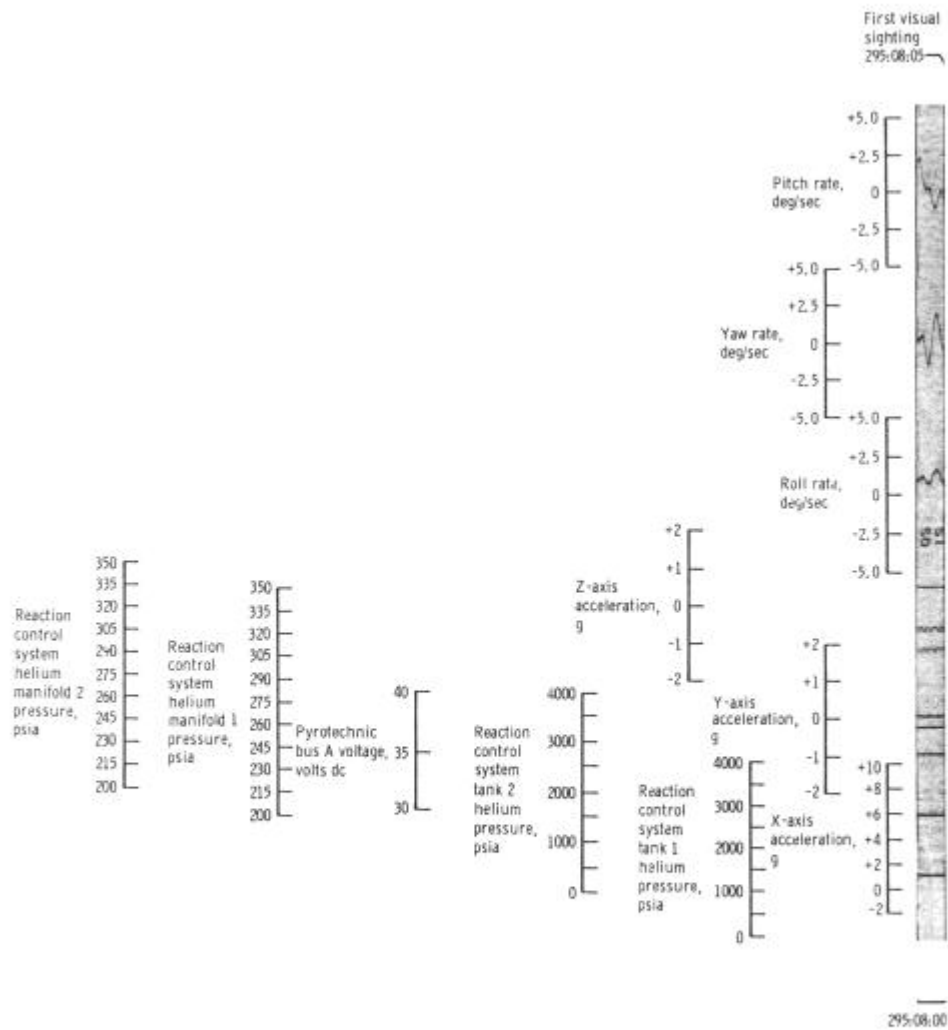
Figure 14-13.- Sequence of events during descent on the main parachutes.

occurred (Fig. 14-13). Further, the orientation of the main parachutes over the command module placed the failed parachute in close proximity to the reaction control system roll engines. Testing of a command module reaction control system engine simulating the fuel (monomethyl hydrazine) dump mode through a hot engine resulted in the fuel burning profusely; therefore, the fuel dump is considered to be the most likely cause of the anomaly.
