***Analysis of surface powered
haulage accidents***

January 1990 to July 1996

Mine Safety and Health Administration, U.S. Department of Labor, Arlington, Virginia

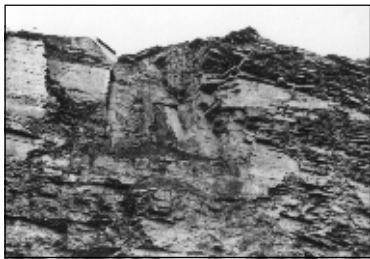
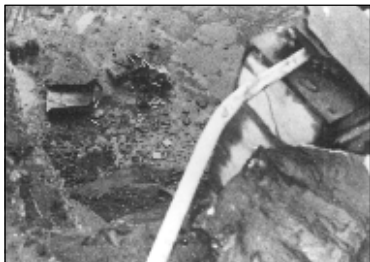
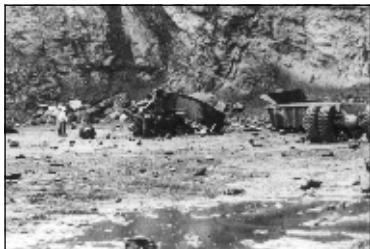
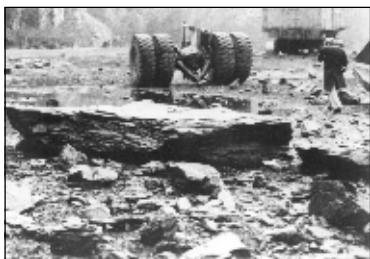
A series of photos detailing a fatality from the fall of a haulage truck over a cliff and the resultant destruction. The progression depicts an approach view from the top; the view from below showing the face of the cliff and the dumping overhang; the view straight down from the lip of the cliff; and two views of the complete damage to the vehicle.
