**Investigation of Loss of Well Control  
Well B-2, South Marsh Island Block 90  
Lease OCS-G 8684  
March 15, 1994**

**J.T. Gordon  
C.J. Schoennagel  
J.D. Serrette**

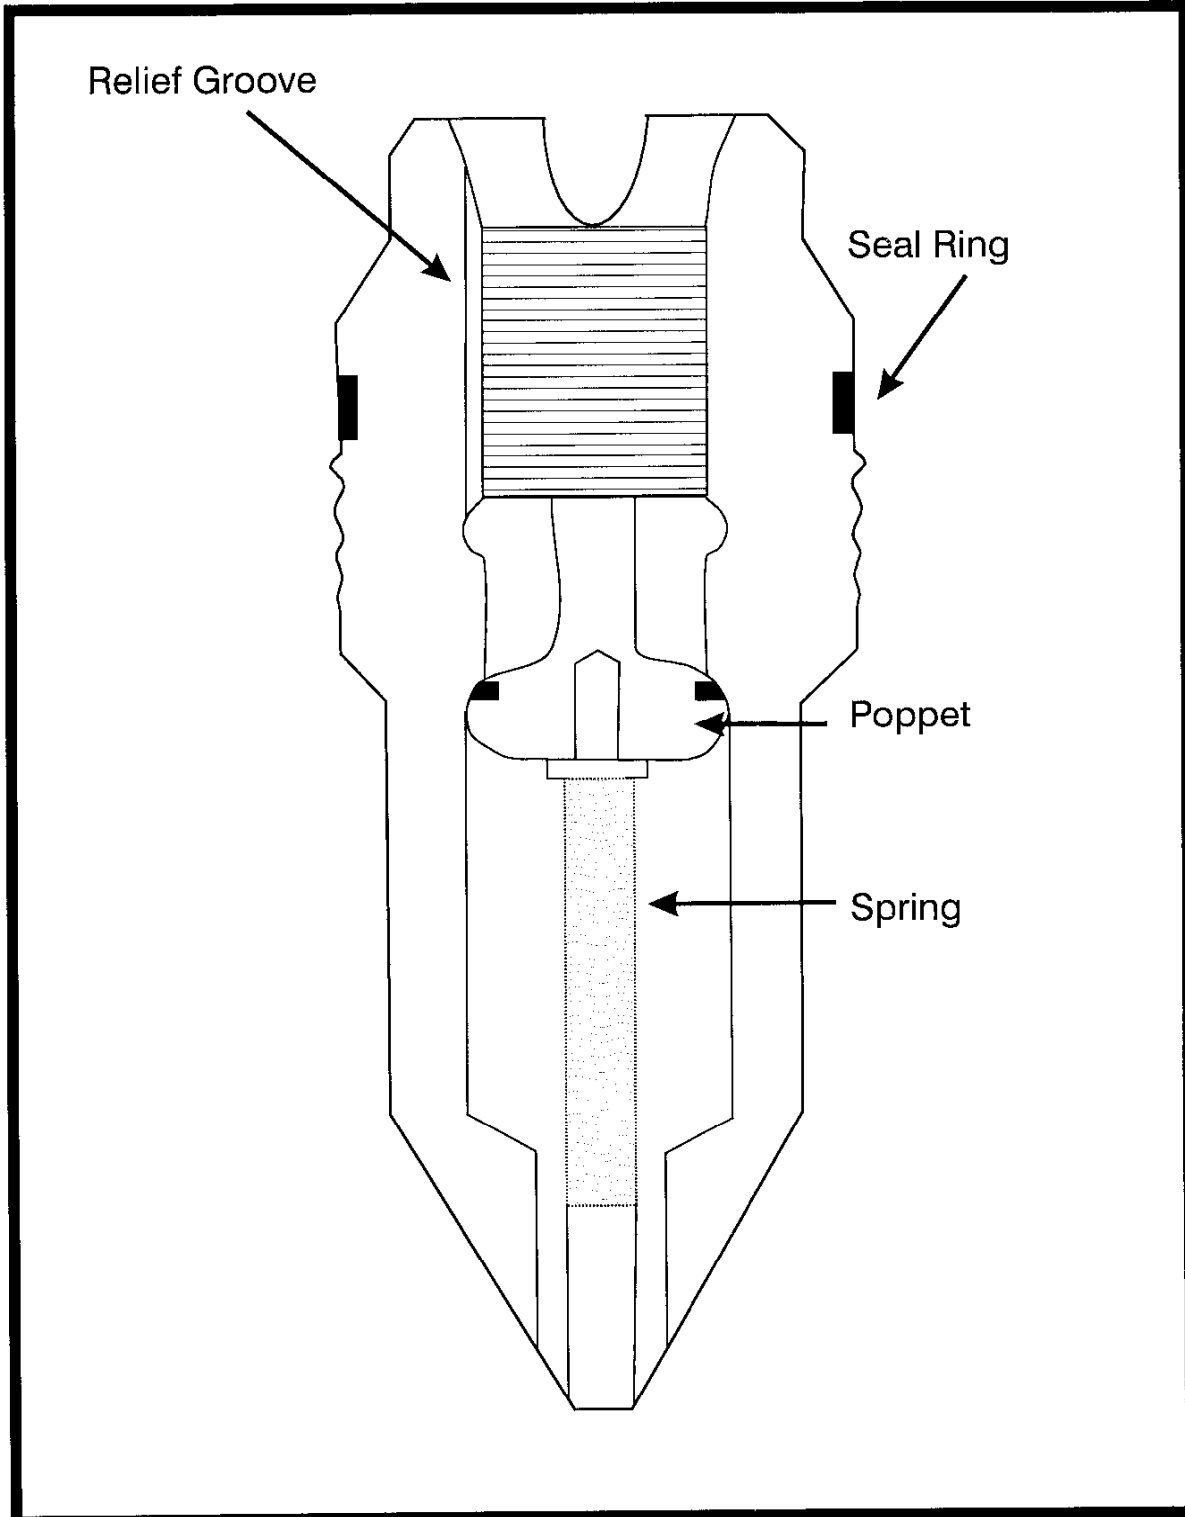
Schematic of back pressure valve

After several 360° turns are made on the retrieval tubing, the back-pressure valve is designed to detect pressure below the valve through a relief groove that allows communication between the wellbore and the tubing hanger. (For schematic of back-pressure valve, see attachment 4.) Subsequent inspection of the back-pressure valve found the relief groove completely full of debris.

2. The failure to attempt to pump into the well through the back-pressure valve prior to initiating its removal. If this were done *the pressure trapped below the valve may have been detected* prior to removal.
3. The failure to observe the pressure trapped below the back-pressure valve through the relief groove in the valve. Debris found in the relief groove may have prevented the pressure from being detected.
4. The failure to observe the pressure trapped below the back-pressure valve when the poppet was unseated from the profile. The poppet was found not free to move. This may have prevented the pressure from being detected.
5. The observations for the detection of pressure being done some 70 feet above the potential release point.

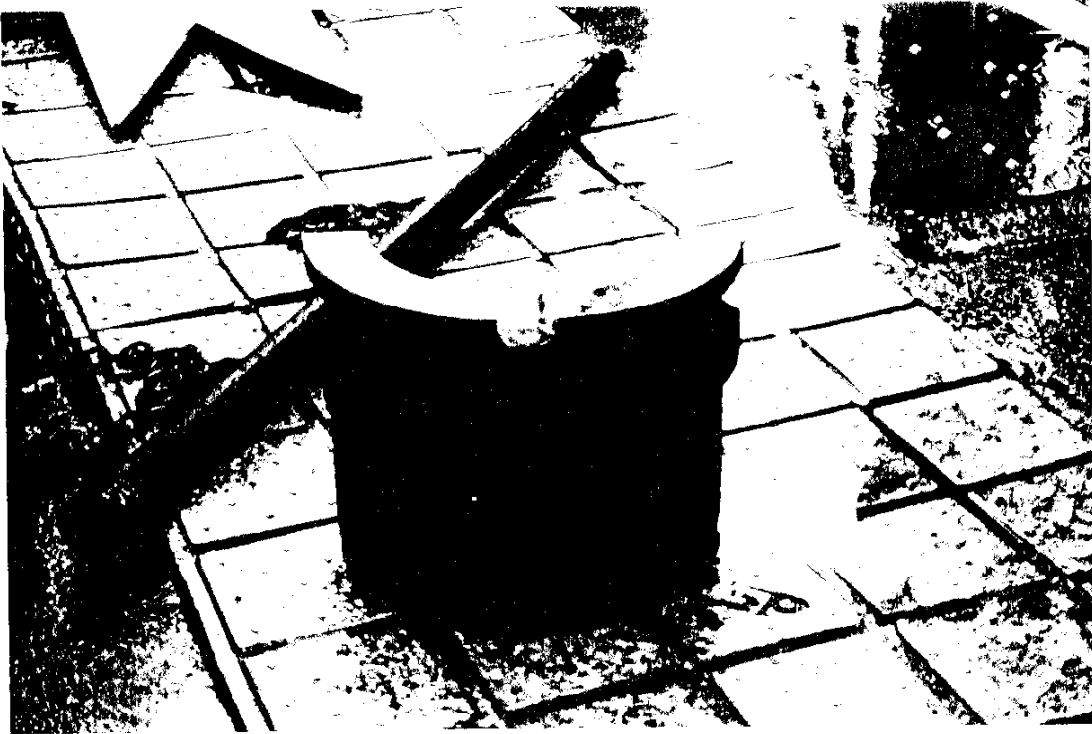
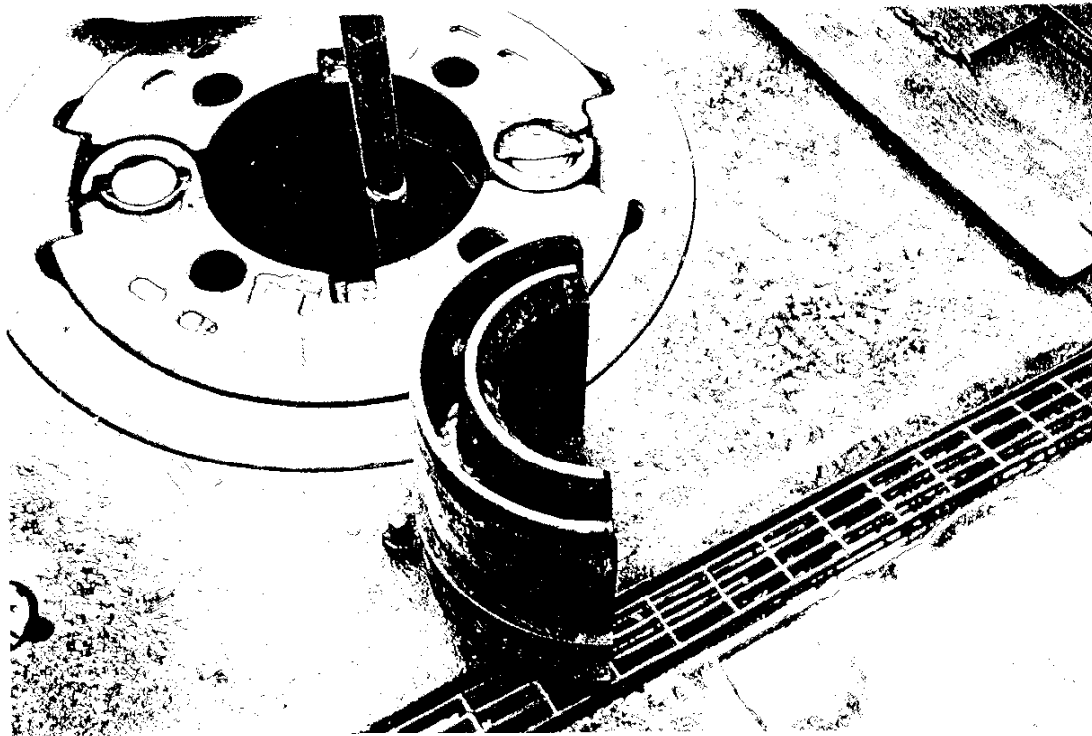
Photograph of rotary bushing insert

The release of pressure also caused the rotary bushing inserts that were in the rotary table to be blown onto the drill floor. (For photographs of rotary bushing inserts, see attachment 5.) Testimony from personnel on the drill floor at the time of the accident indicates that no other significant damage to equipment was observed as a result of the pressure release.

The probable cause of the fatality of Larry Rohan was injuries he received after being struck in the chest by something expelled from the wellbore during the initial release of trapped pressure. Although the matter is not conclusive, *it appears that Larry Rohan was struck by the rotary bushing insert.*

1. Lessees, drilling contractors, and other service personnel should ensure the well is killed before initiating installation and removal of a back-pressure valve.
2. Lessees, drilling contractors, and other service personnel should ensure all equipment is functioning properly before initiating installation of a back-pressure valve.
3. Lessees, drilling contractors, and other service personnel should attempt to determine if pressure is trapped below a back-pressure valve before initiating removal of the valve.
4. Lessees, drilling contractors, and other service personnel should ensure that the rotary bushing inserts are locked down when inserted in the rotary table.

The MMS should require that the rotary bushing inserts be locked down

when inserted in the rotary table.
