**Investigation of Blowout and Fire,
Platform A, Eugene Island Block 380,
Lease OCS-G 2327, January 24, 1996,
Gulf of Mexico,
Off the Louisiana Coast**

U.S. Department of the Interior
Minerals Management Service
Gulf of Mexico OCS Regional Office

D.J. Griffin
M.J. Saucier
C.J. Schoennagel

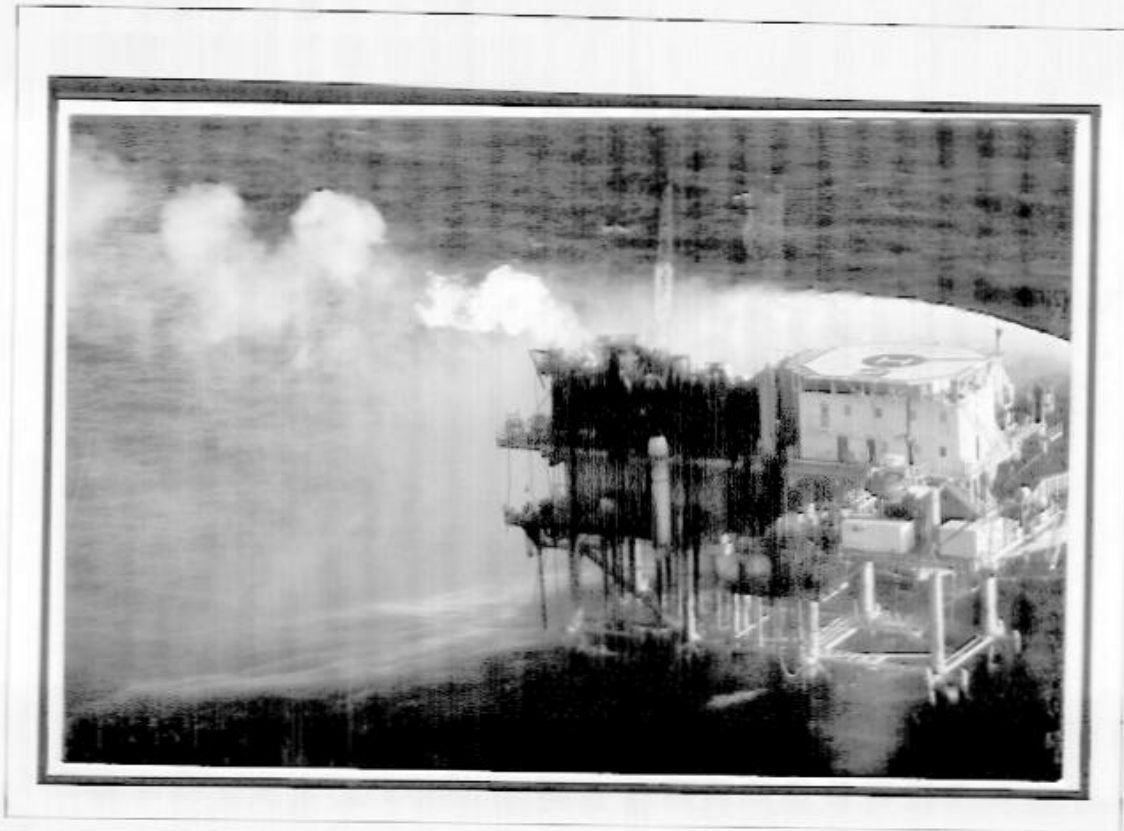
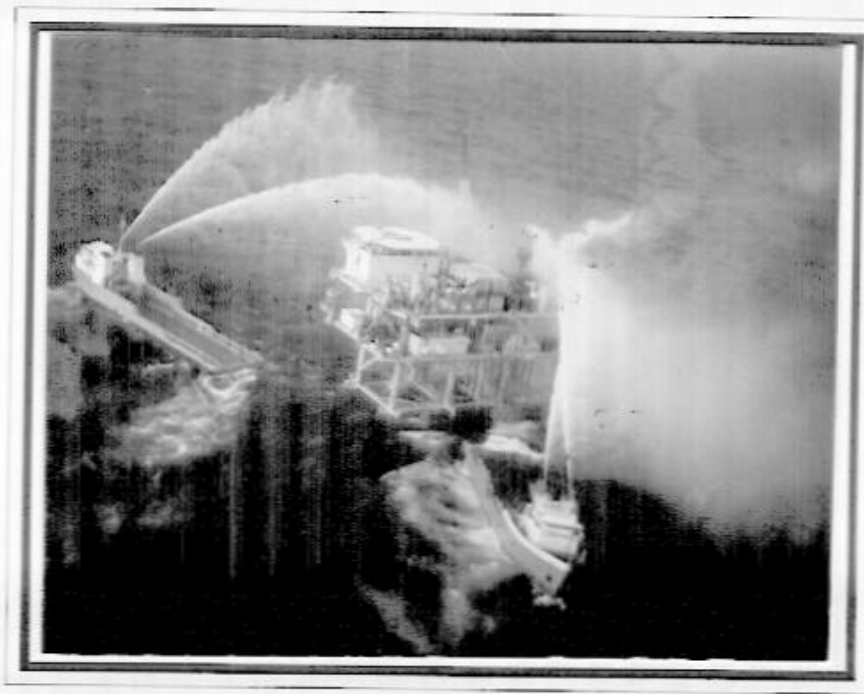
Photographs of scene

On January 25, 1996, Investigative Panel members flew to Eugene Island Block 380, Platform A and photographed the scene from a helicopter. (For photograph of scene, see Attachment 1.) After circling the structure several times, the Investigative Panel members flew to Lease OCS-G 6987, Platform A, Green Canyon Block 6, and conducted interviews and obtained statements from personnel onsite at the time of the blowout. These included the toolpusher, both drillers, and the company representative. The panel members also obtained information from three well control personnel.

The Sundowner 15 rig substructure and derrick were completely destroyed in the blowout and subsequent fire. There was severe damage to other parts of the rig and associated equipment. There was minimal damage to Oryx's Platform A. There was no damage to the other wellheads on the platform. The evacuation of the rig and platform was conducted without incident. There was no pollution as a result of the incident.

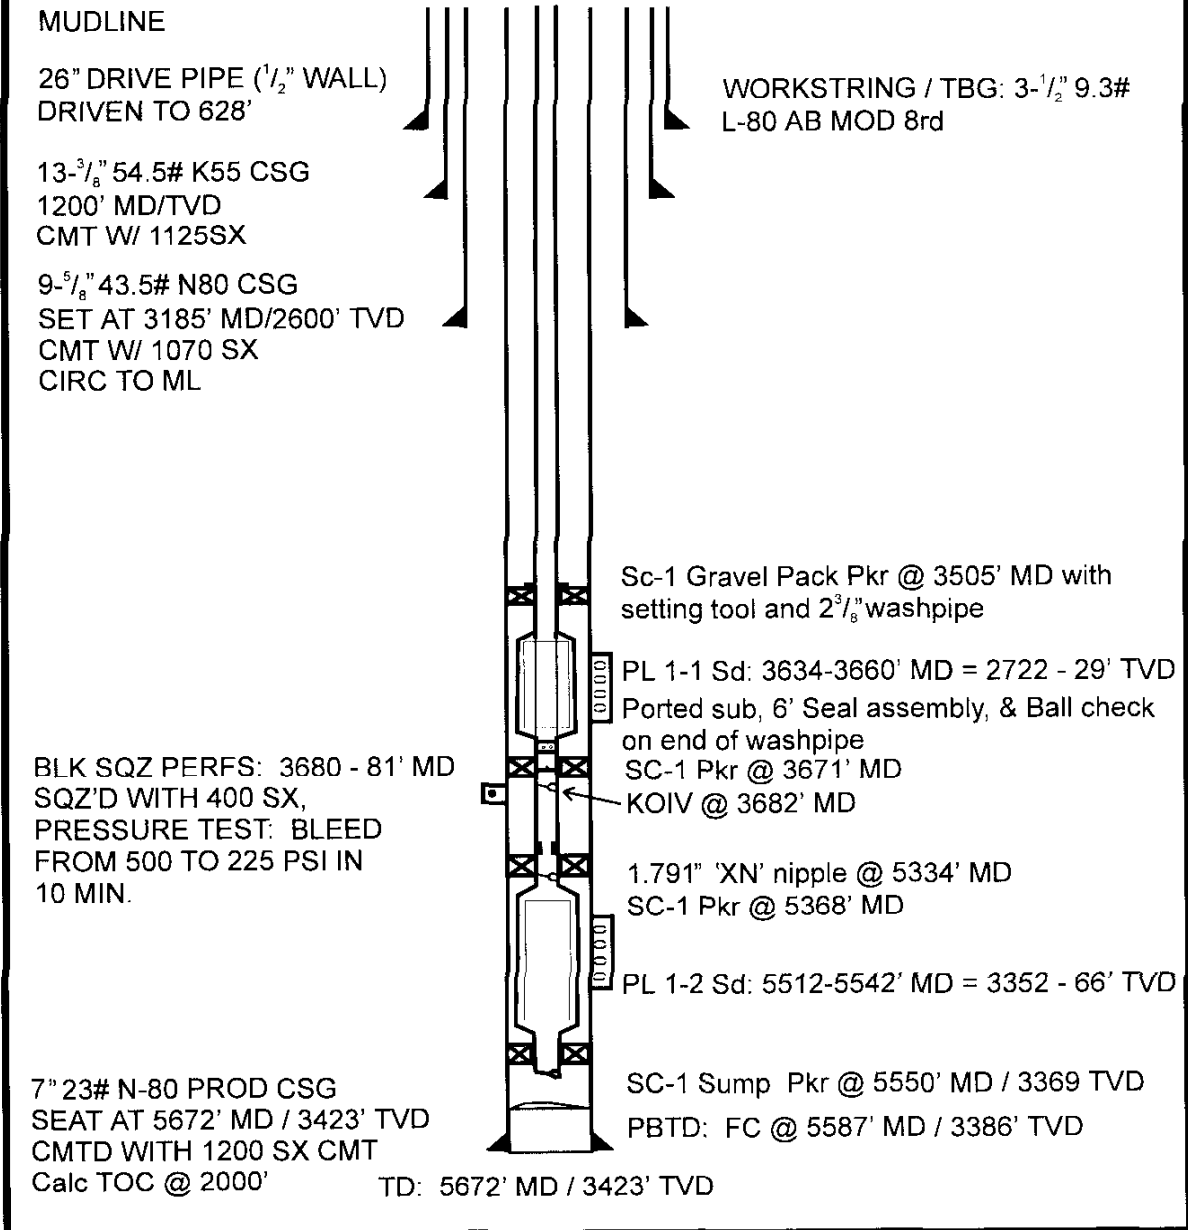
Schematic of PL 1-1 Sand Completion

The well continued to remain static as the tubing with a gravel pack assembly was tripped into the well. (For schematic of wellbore with PL 1-1 sand and gravel pack assembly, see attachment 5.) There were a 2 $\frac{7}{8}$ -inch washpipe and a low-pressure ball check located below the gravel pack assembly. Three feet of seals were added to the bottom hole assembly so that there would be seals in the packer bore prior to breaking the KOIV at 3,682 feet MD.

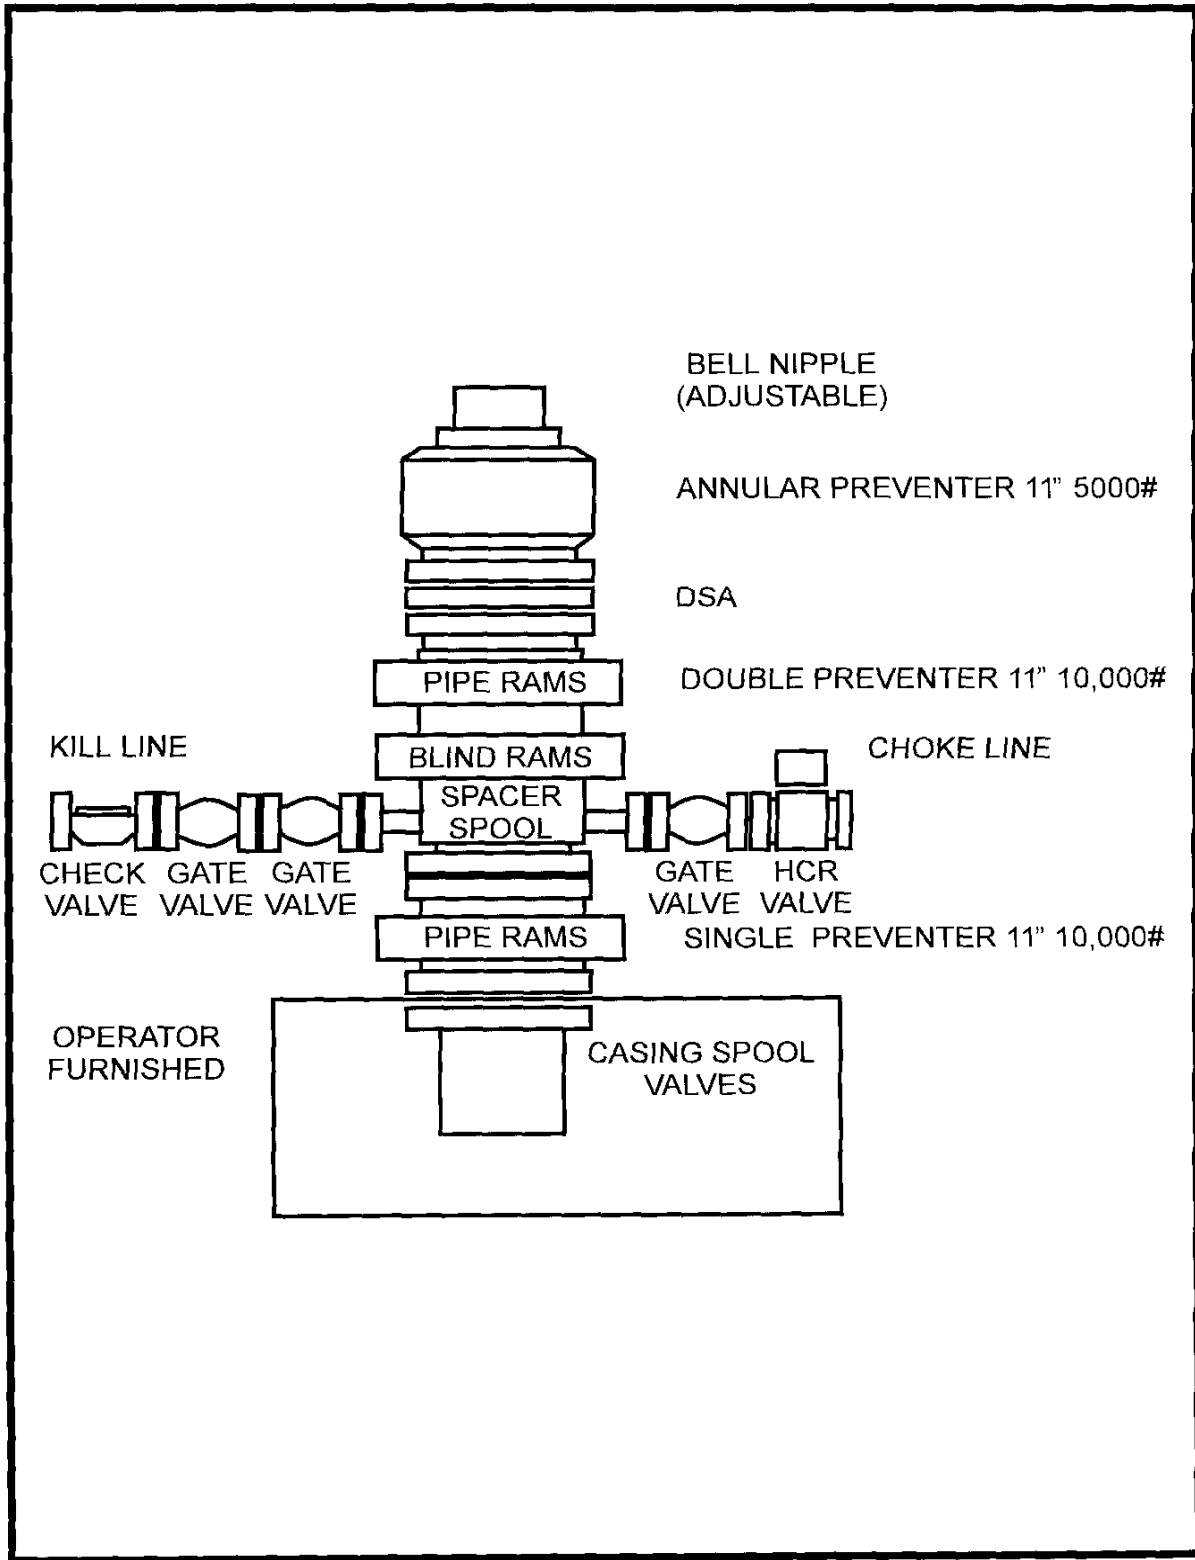
Schematic of BOP Stack

At this point the blind rams were closed in an attempt to reduce well flow. No change was observed in well flow as a result of this action. As gas began to flow out the top of the tubing, personnel evacuated the drill floor. As evacuation of the drill floor was occurring, the pipe rams, annular preventer, and hydraulic control remote (HCR) valves were closed in anticipation of possible annular flow. (For schematic of BOP stack, see attachment 6.) It had no effect on the current well flow.

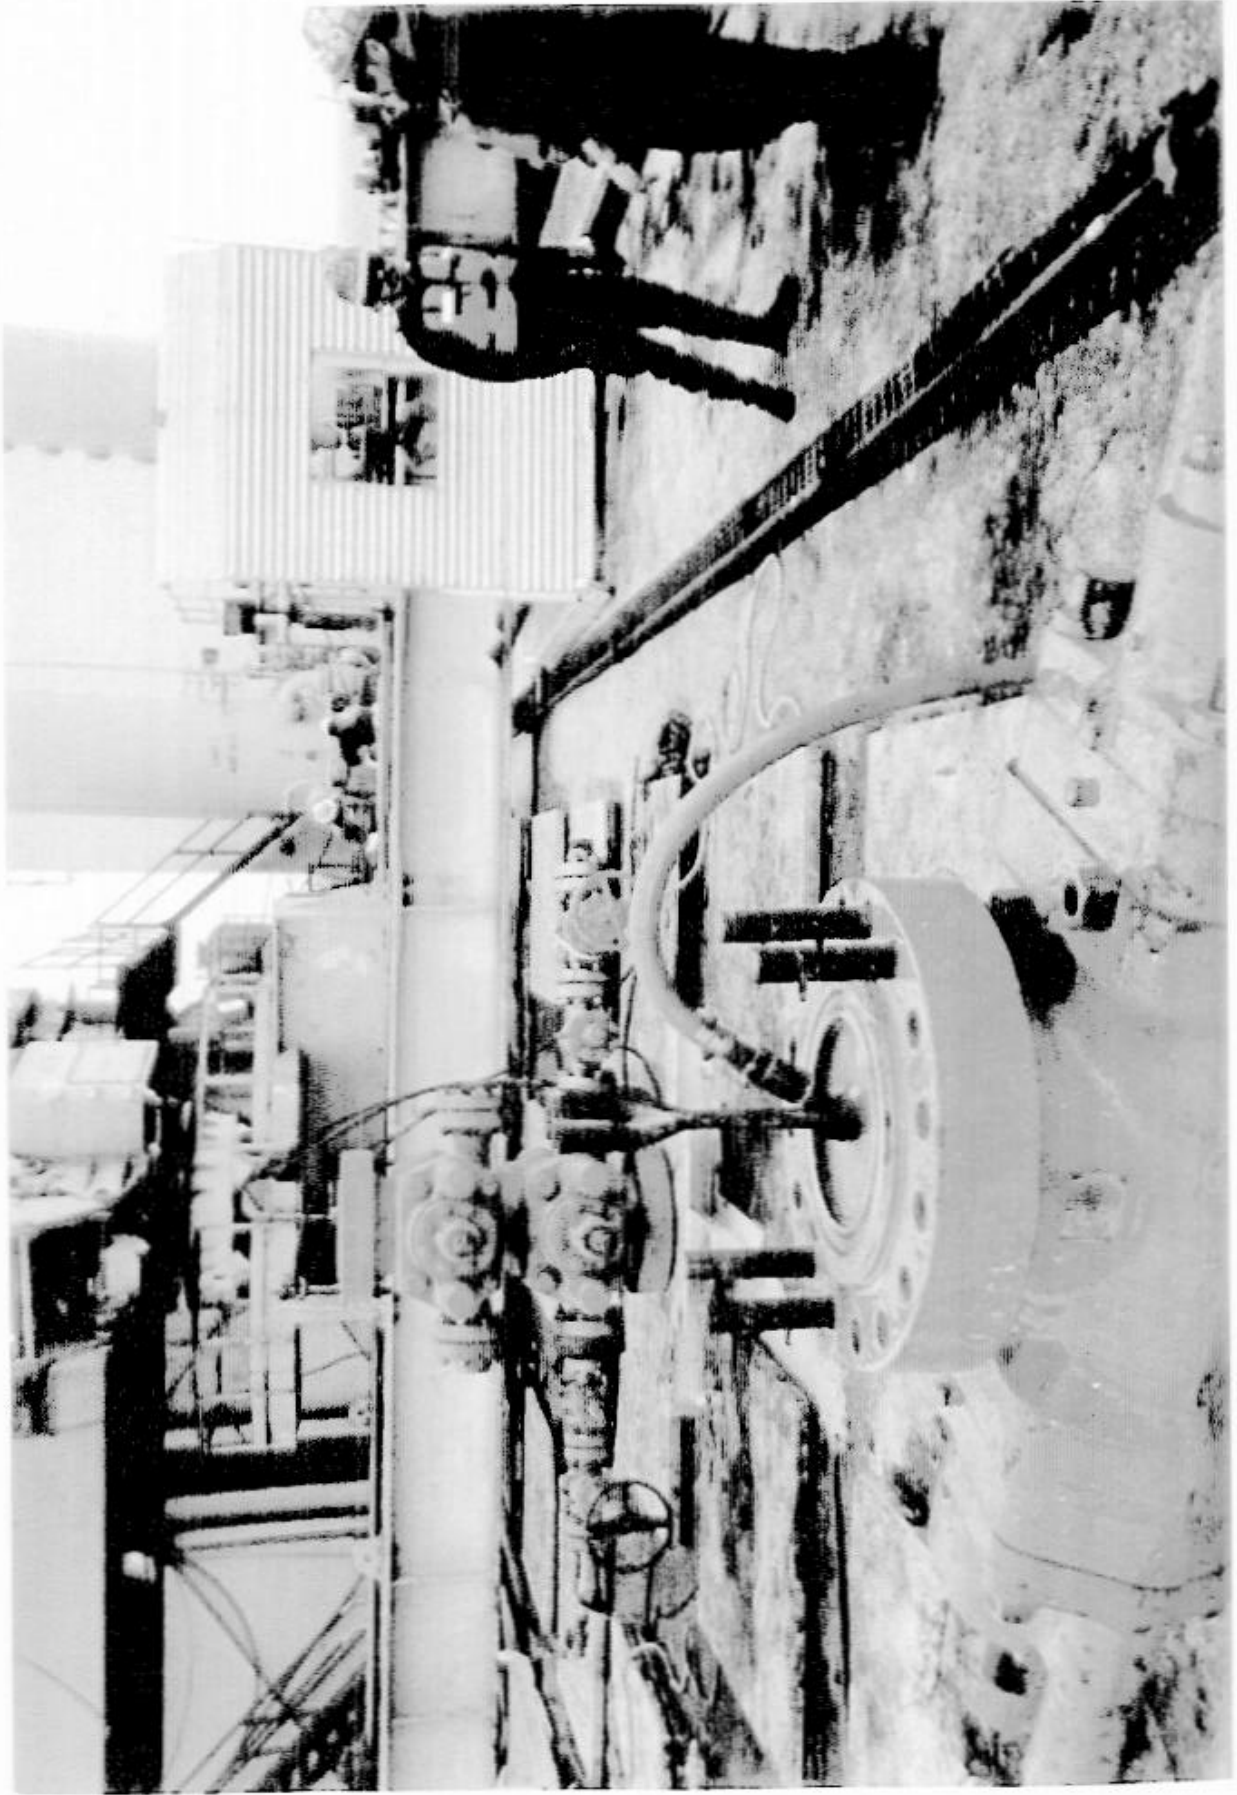
Photograph of Smashed Tubing.

On February 7, 1996, the BOP stack was removed except for the bottom set of pipe rams, which were left on the riser joint. After removal of the BOP stack, the tubing was found smashed where the blind rams closed after being activated during the initial phase of the loss of well control. (For photograph of smashed

tubing, see attachment 7.) After the tubing above the lower set of pipe rams was cut, a set of blind rams was installed above the set of lower pipe rams.

4. Not running blind shear rams in the BOP stack. Had blind shear rams been installed in the BOP stack instead of blind rams, they may have completely sealed off the well flow out of the tubing if they had been activated.

The MMS should consider requiring blind shear rams on all installations where blind rams are at present required.
