**Investigation of Rig Accident and Fatality
Grand Isle Block 19
Gulf of Mexico
Off the Louisiana Coast
September 24, 1996**

**U.S. Department of the Interior
Minerals Management Service
Gulf of Mexico OCS Regional Office**

**New Orleans
August 1998**

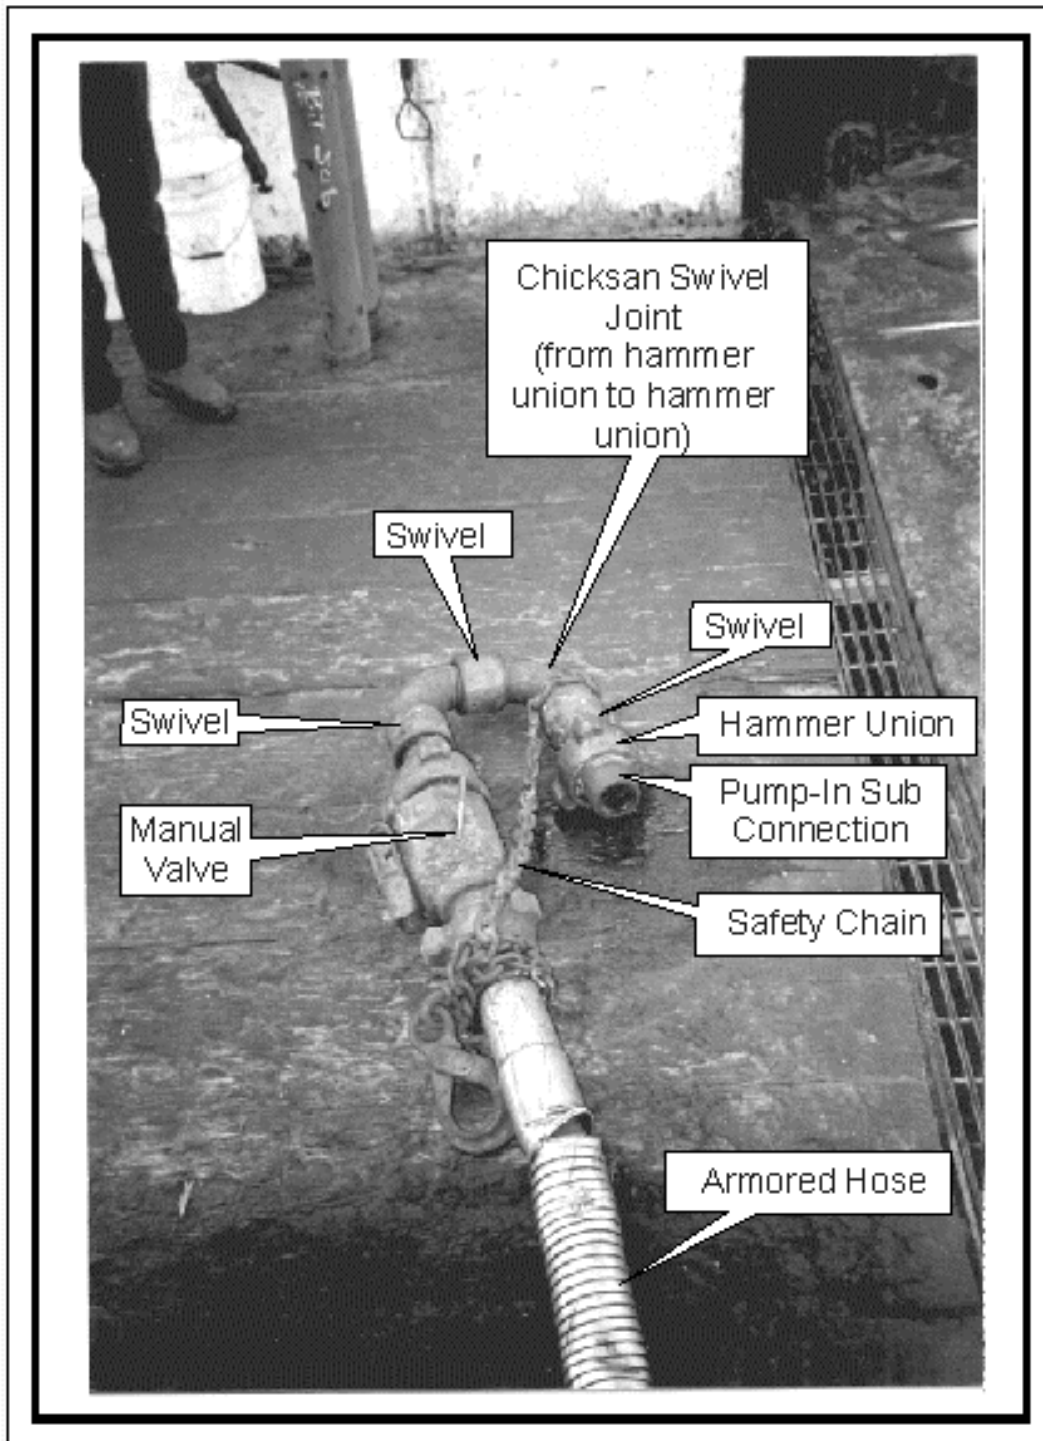
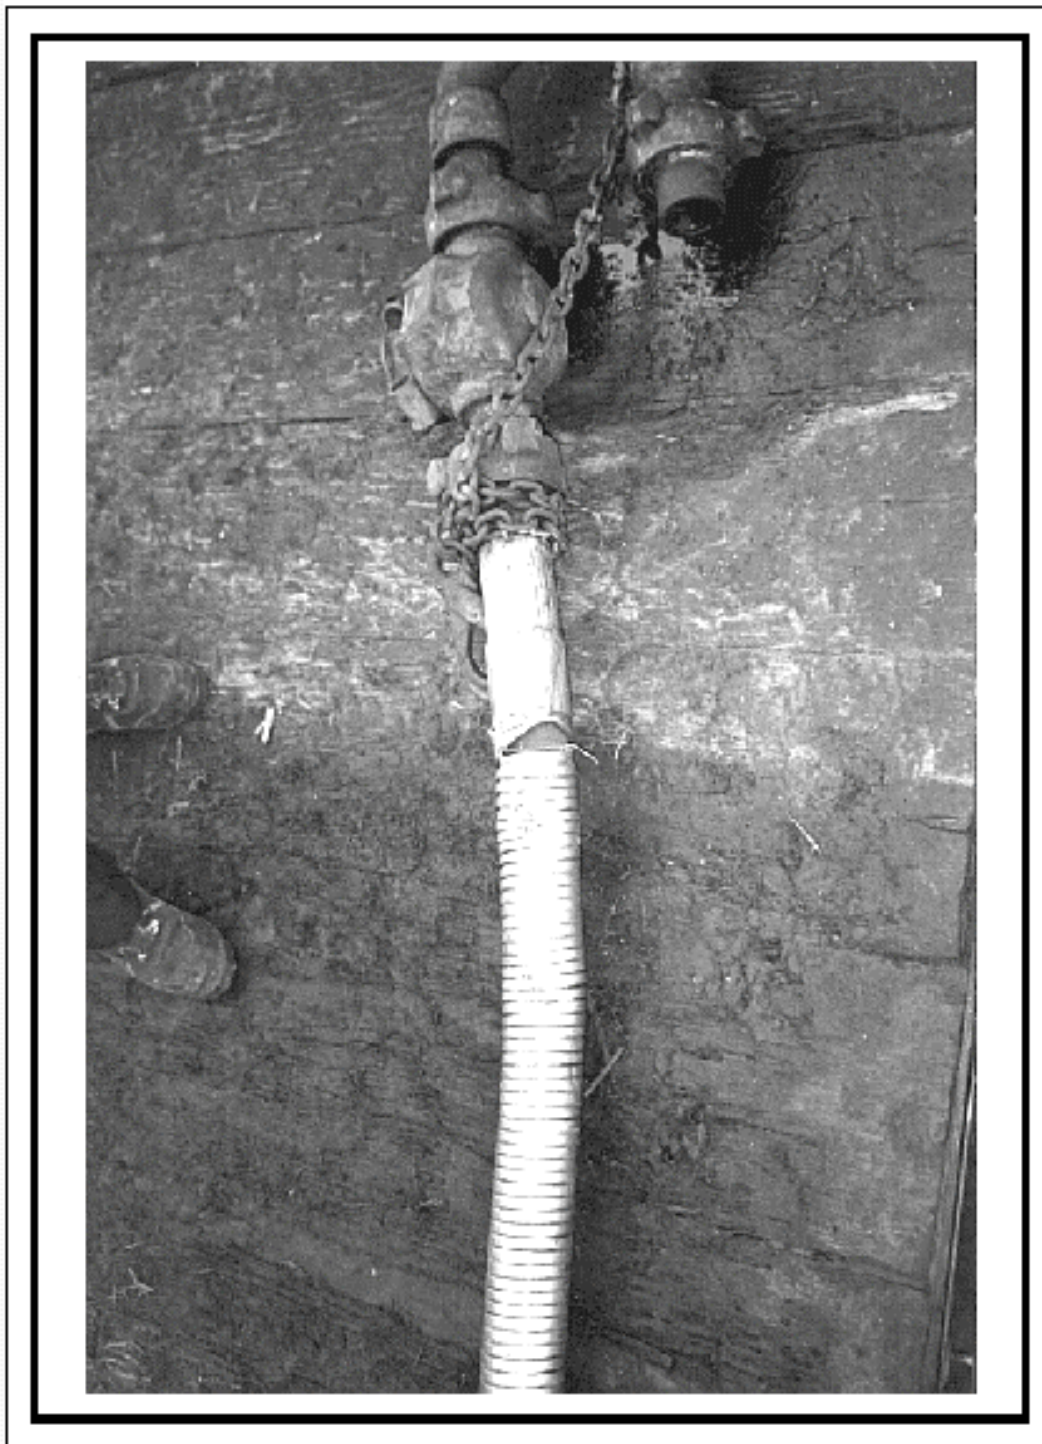
The safety chain as seen in Attachment 3 usually connected the armored hose to the elevators for the purpose of preventing the chicksan swivel joint from falling should it break out of the pump-in sub assembly. However, on the morning of the accident the safety chain connected the chicksan swivel joint to the armored hose. The chain was in that configuration when the

morning crew began their shift at 0600 hours. One of the crew members stated that the chain was attached in that configuration by a previous drilling crew and was simply overlooked.

Photograph of the pump-in sub connection, chicksan swivel joint, manual valve, armored hose, and safety chain as the unit lay on the rig floor following the accident.

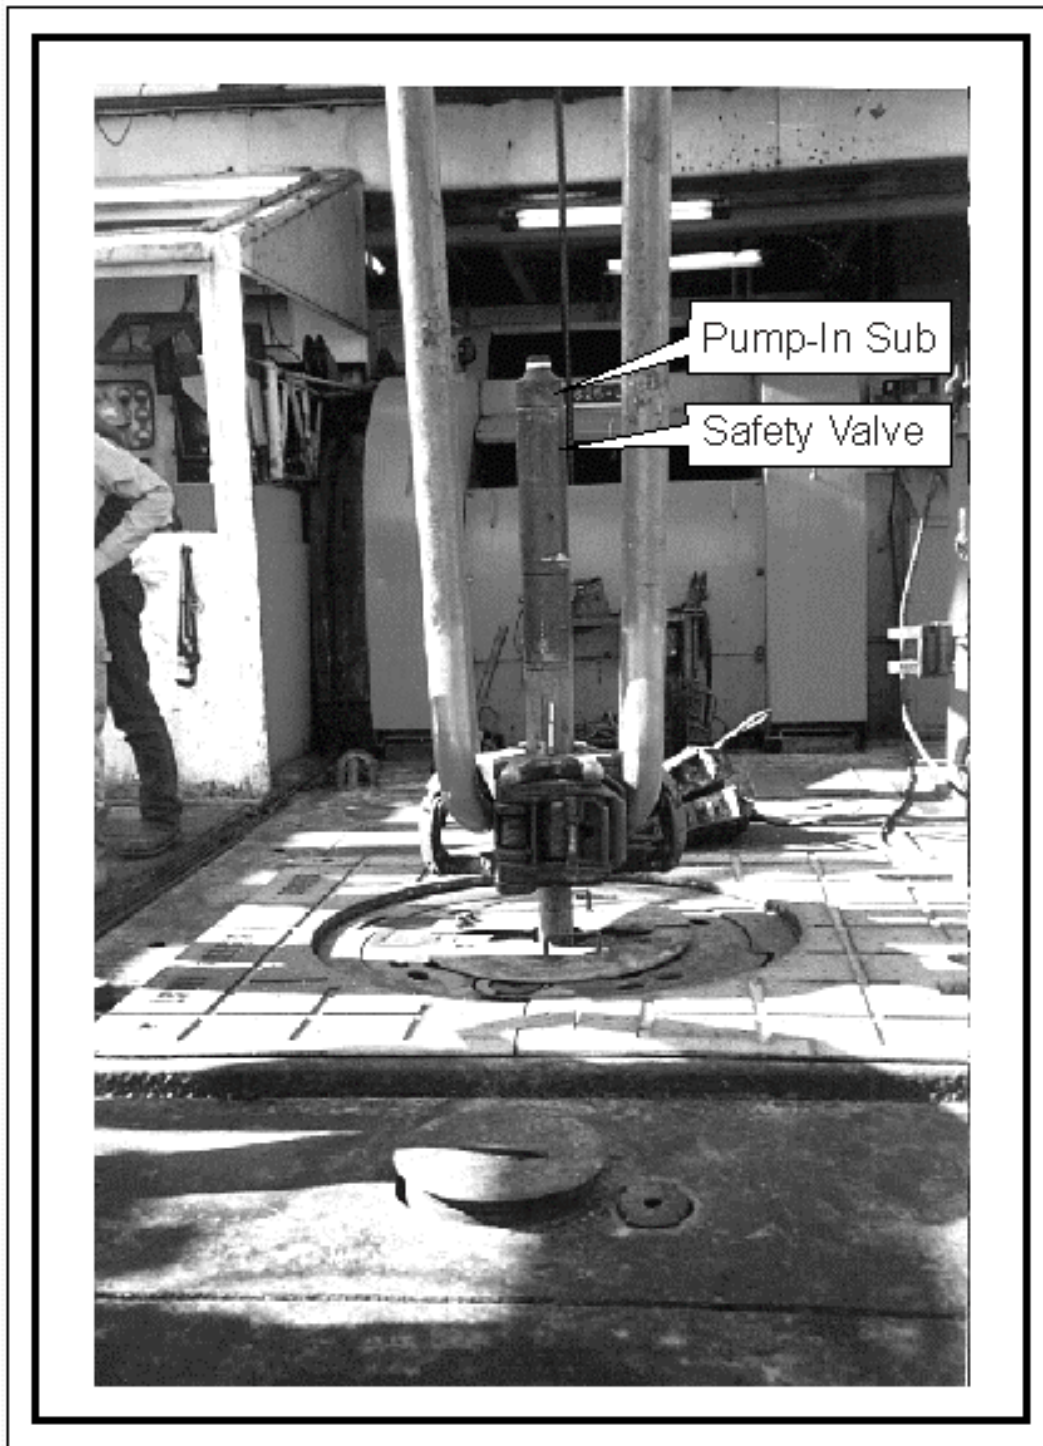
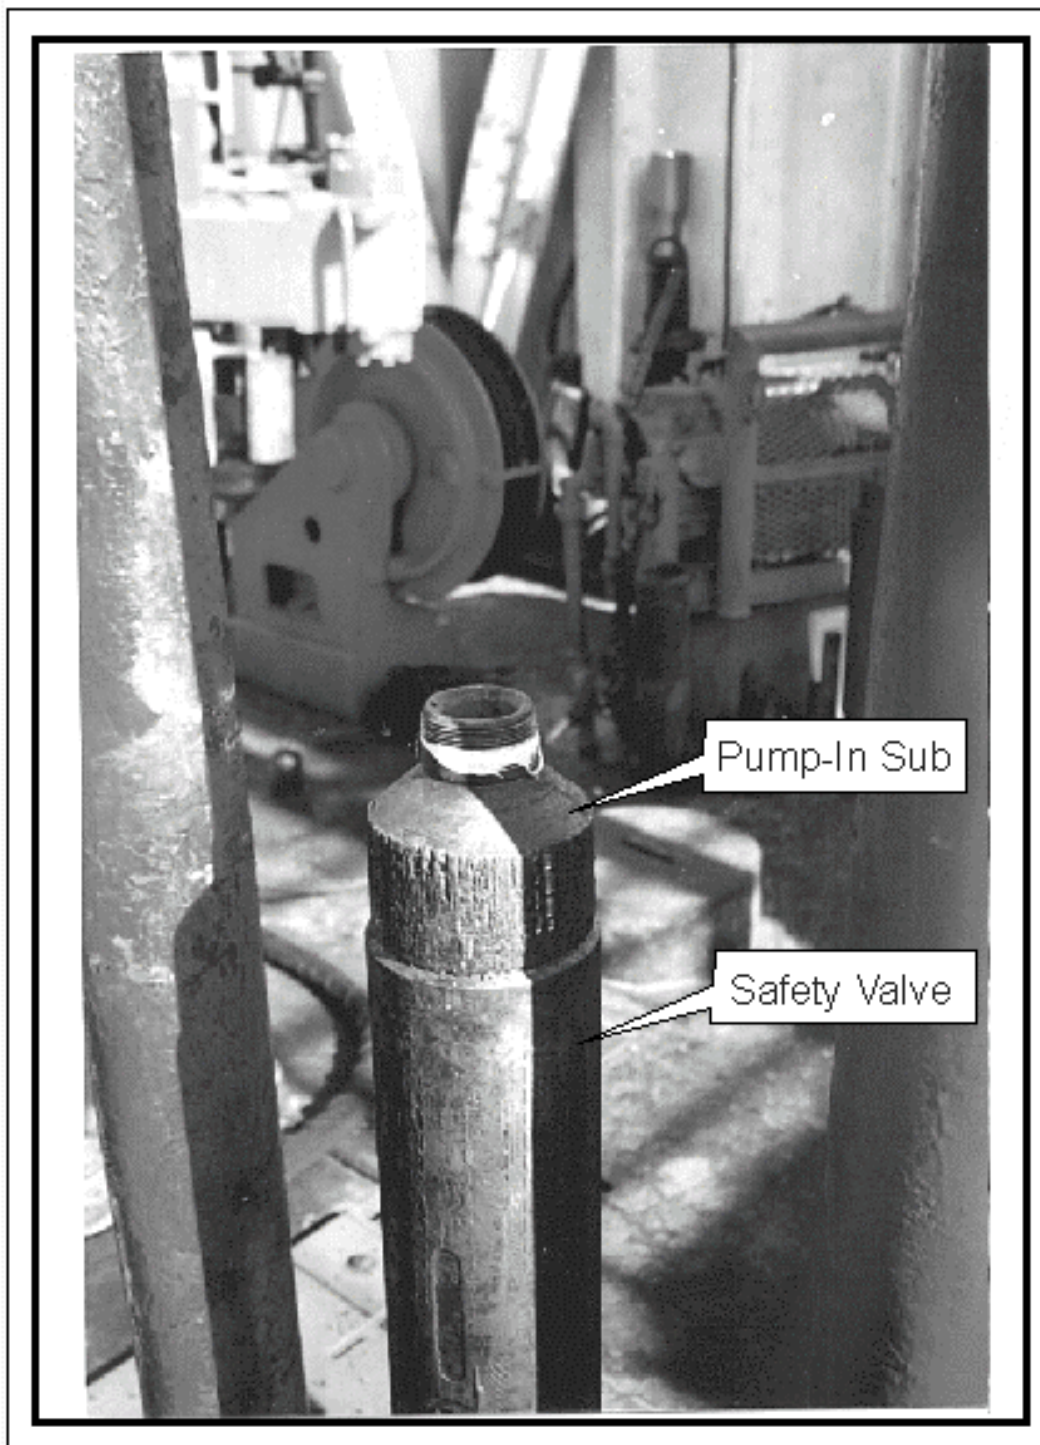
Photograph of pump-in sub and safety valve

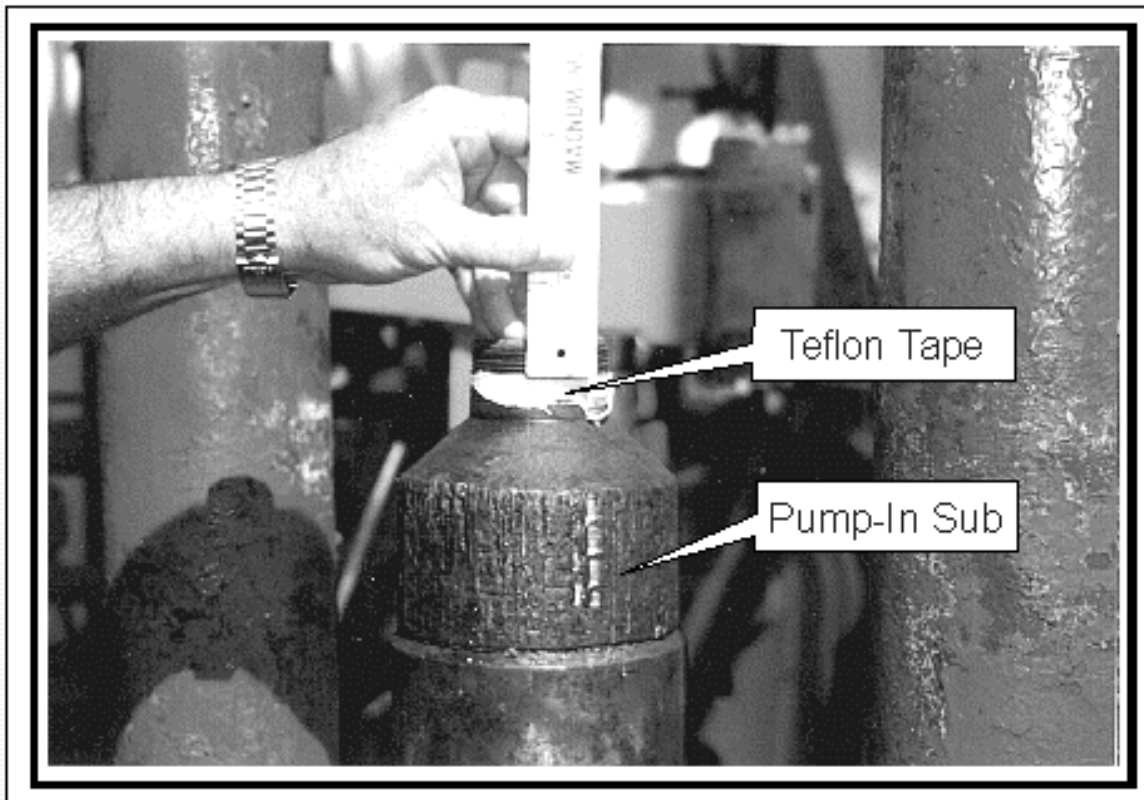
An examination of the threads of the male end of the pump-in sub revealed that it had been made up to a depth of approximately five threads to the female end of the pump-in sub connection with approximately that many threads left unused. This was determined by an inspection of the thread's Teflon coating. For a photograph of the male end of the pump-in sub, see Attachment 7. A visual inspection of the male and female threads of the connection did not reveal any significant damage to the threads. One interviewed crew member stated that more threads should have been used.

There was no indication that any torque wrenching of the connection occurred on the morning of the accident. Any such torquing would have probably resulted in the use of at least more threads in the connection.

4. The unused threads of the male end of the pump-in sub at the very least did not add to the integrity of the connection and at worst compromised that integrity. The degree to which the connection would have held had all threads been used is not known. However, when considered in conjunction with the possible interference of the swivel by the safety chain, not using all the threads available can be considered a possible cause of the accident.

Photograph of male end of pump-in sub

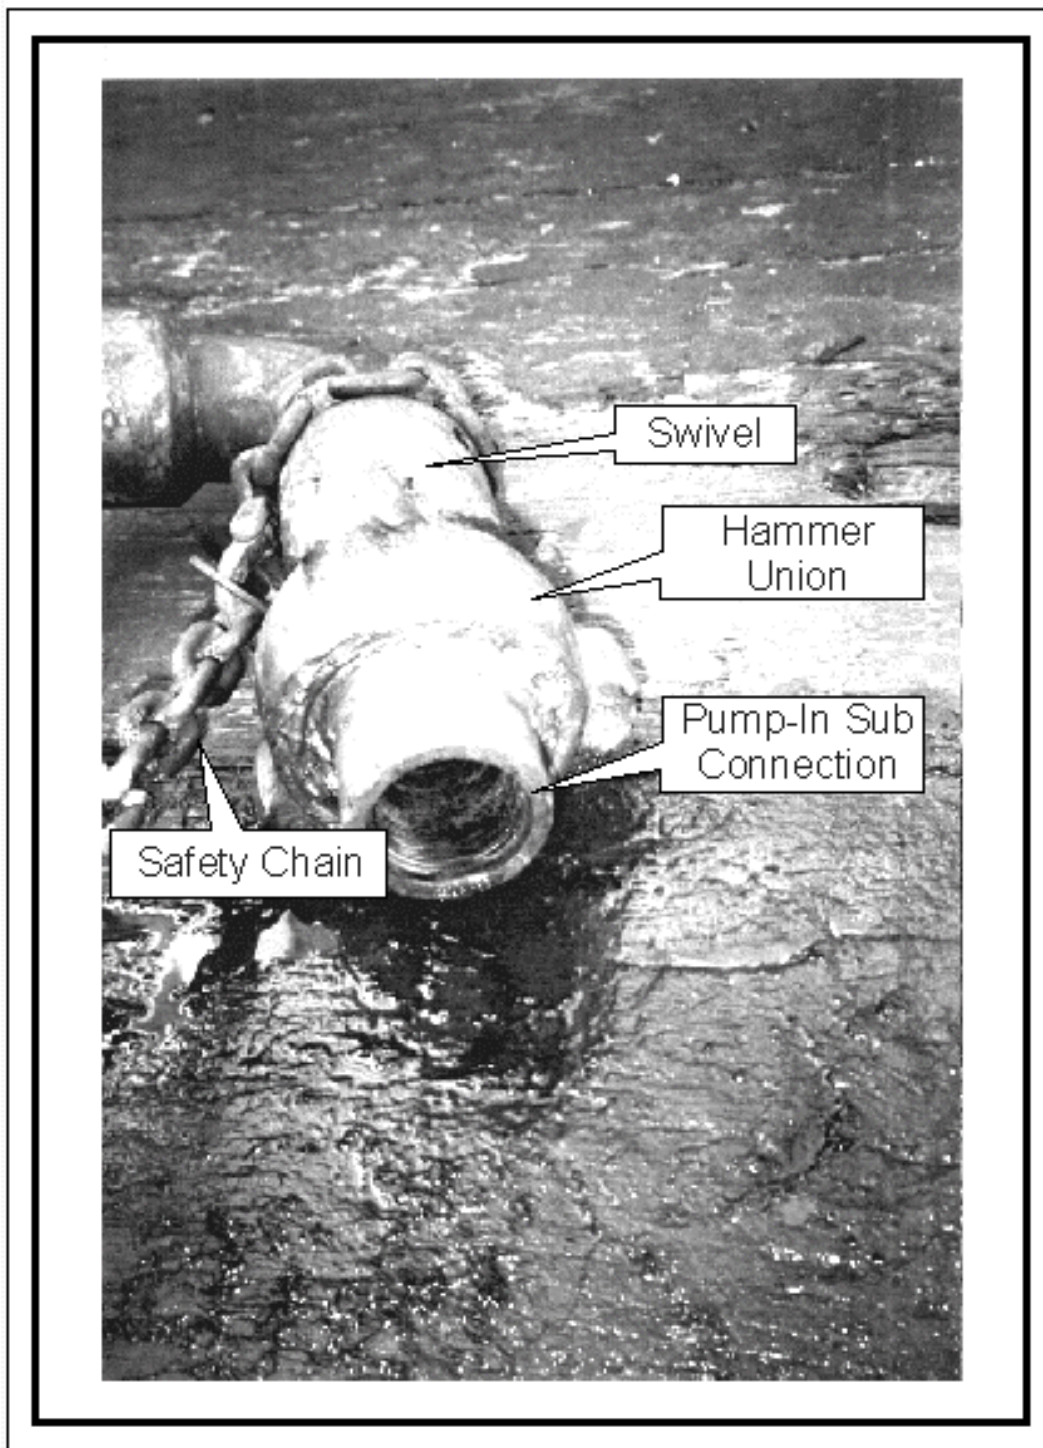
An observation was made by MMS panel members at the scene of the accident that the safety chain was pressing firmly against the chocks swivel joint's swivel nearest the pump-in sub connection. For a photograph of the safety chain and swivel, see Attachment 8.

3. Although the swivel nearest the pump-in sub connection was manually turned by panel members, it is possible that the pressing of the safety chain against the swivel interfered with its proper functioning. Given the forces of the weight of the hose, to which one end of the chain was attached, and the weight of the drill pipe hanging from the pump-in sub assembly, it is possible that the chain prevented the swivel from turning sufficiently enough to compensate for the multiple make-up rotations, thereby resulting in the eventual breaking-out of the pump-in sub from the pump-in sub connection.

Photograph of safety chain and swivel
