**Investigation of Fall and Fatality
Mississippi Canyon Block 109
August 16, 2000**

**Gulf of Mexico
Off the Louisiana Coast**

Frank Pausina
David Dykes
Charles Griffin

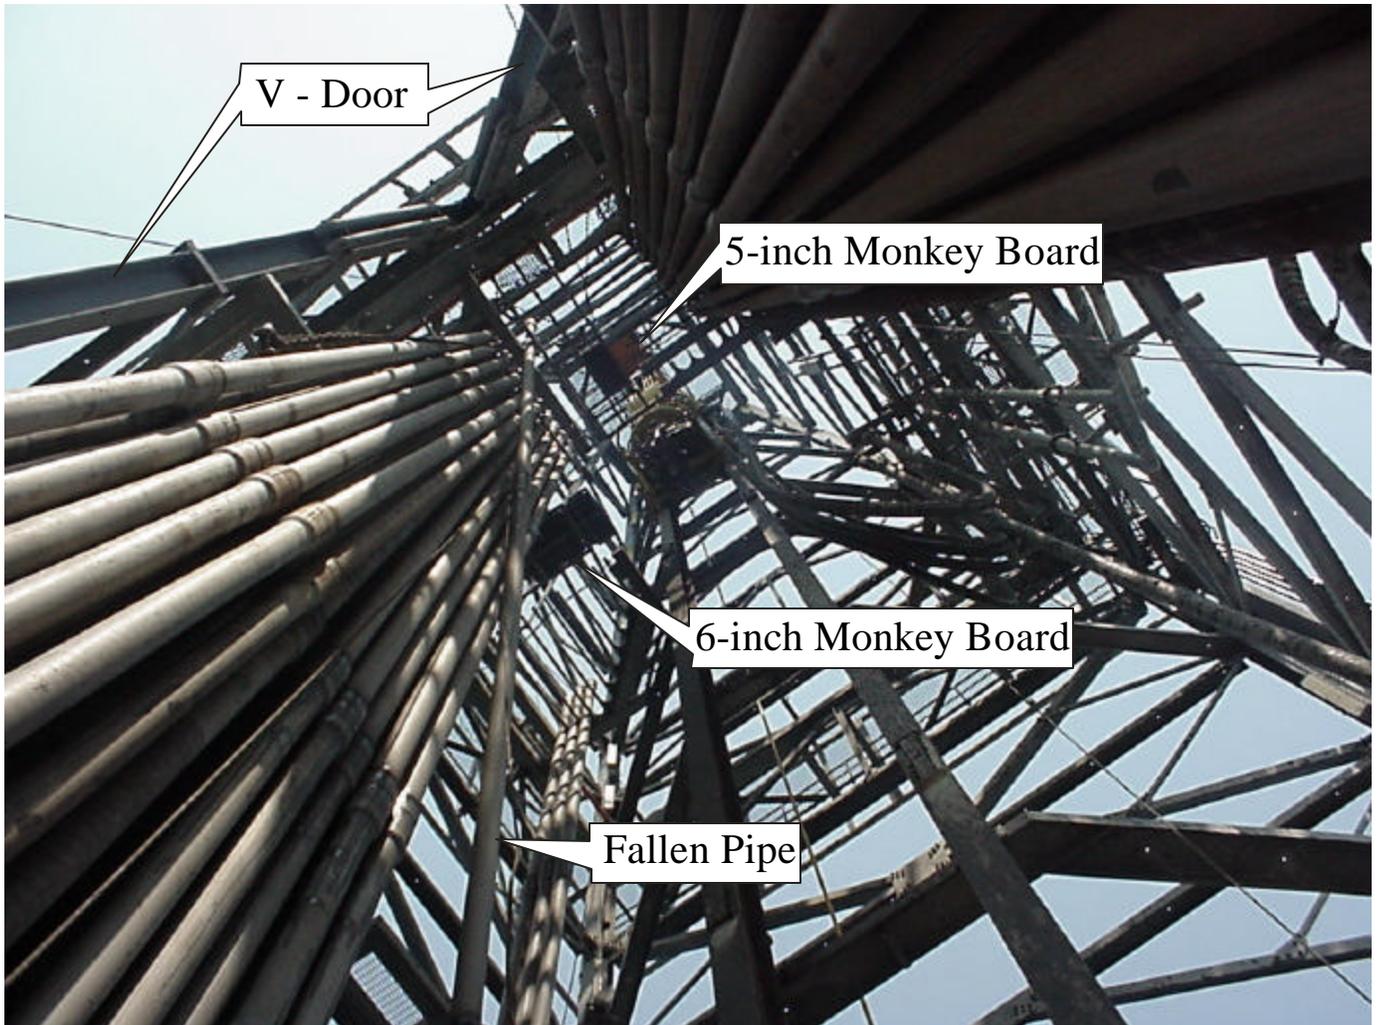
Photograph of Fallen Pipe

During drilling activities at approximately 2110 hours, a 6 5/8-inch stand of pipe fell across the rig and came to rest between the 5-inch monkey board and the fingers of the 6 5/8-inch pipe rack. *For photographs of the fallen pipe, see Attachments 2 and 3.* The derrickman at that time, henceforth referred to as H&P 1, was standing on the 6 5/8-inch monkey board and was not able to reach the fallen stand of pipe. In an attempt to assist H&P 1, a second H&P employee, henceforth referred to as H&P 2, strapped himself into a body harness with a built-in boatswain's chair (harness) and placed the "D" rings of the harness into the hook attached to the air hoist line. H&P 2 was then lifted, without any personal fall-protection, into the derrick by the air hoist to a stop position height of approximately 80 feet above the rig floor. This position placed H&P 2 approximately 4 to 10 feet below the monkey board level. As H&P 2 attempted to maneuver into a position to board the 5-inch monkey board, the harness "D" rings became detached from the air hoist hook, resulting in H&P 2 falling to the rig floor and sustaining fatal injuries. *For a diagram of the derrick layout, see Attachment 4.*

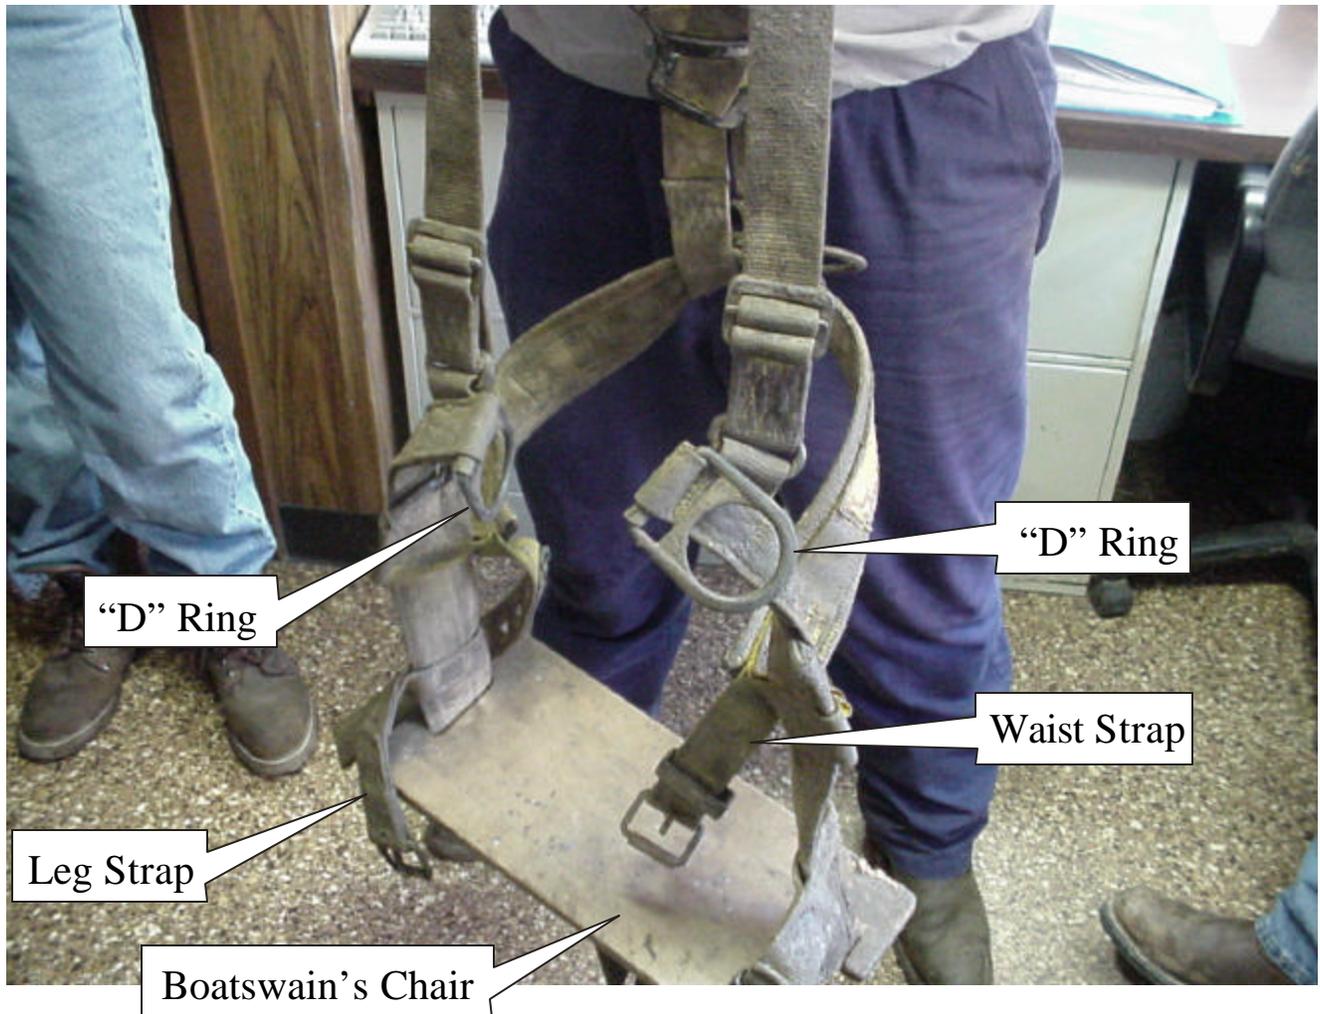
Photograph of Harness

The body harness used in this incident consists of a full body harness with a built-in boatswain chair. The harness is constructed with leg straps to provide support in a seated position and to prevent the individual from falling out of the harness. The harness is equipped with two D-rings on the front on each side at the waist. The harness is also equipped with a third D-ring located on the upper back of the harness in the center. This D-ring serves the purpose for attaching a fall protection lanyard or for attaching a retrieval line. *For photographs of the harness, see Attachments 5 and 6.*

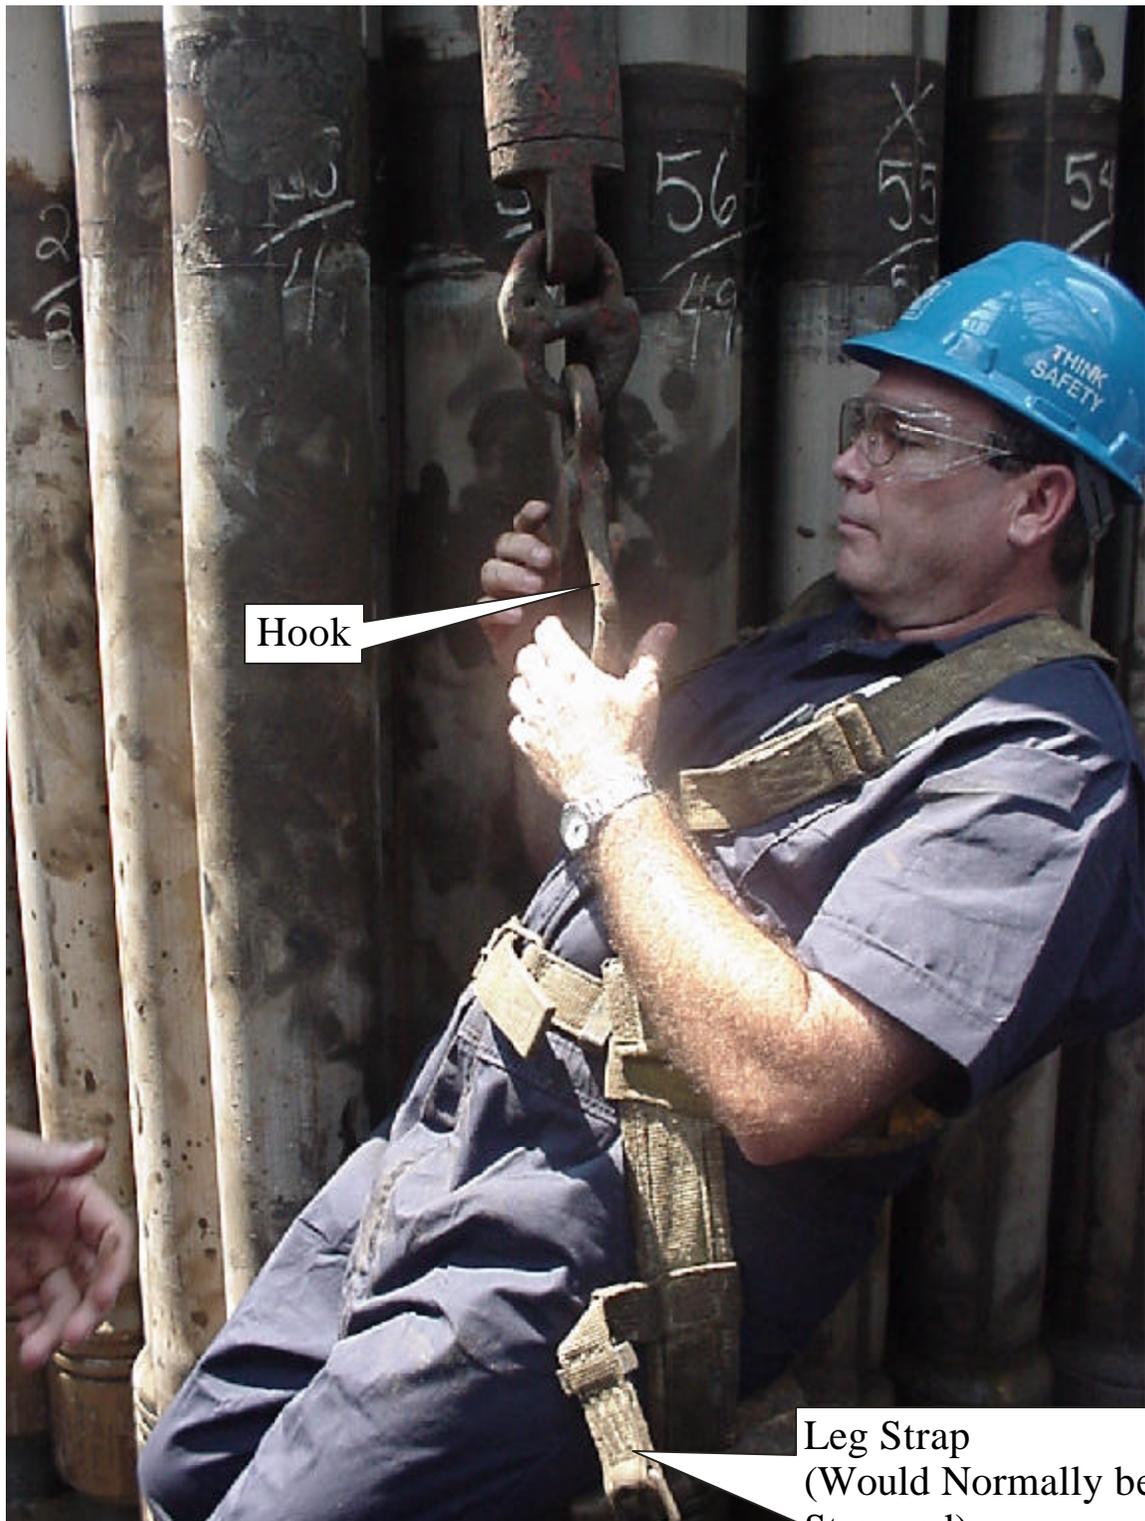
Photograph of Man in Harness

Leg Strap
(Would Normally be
Strapped)

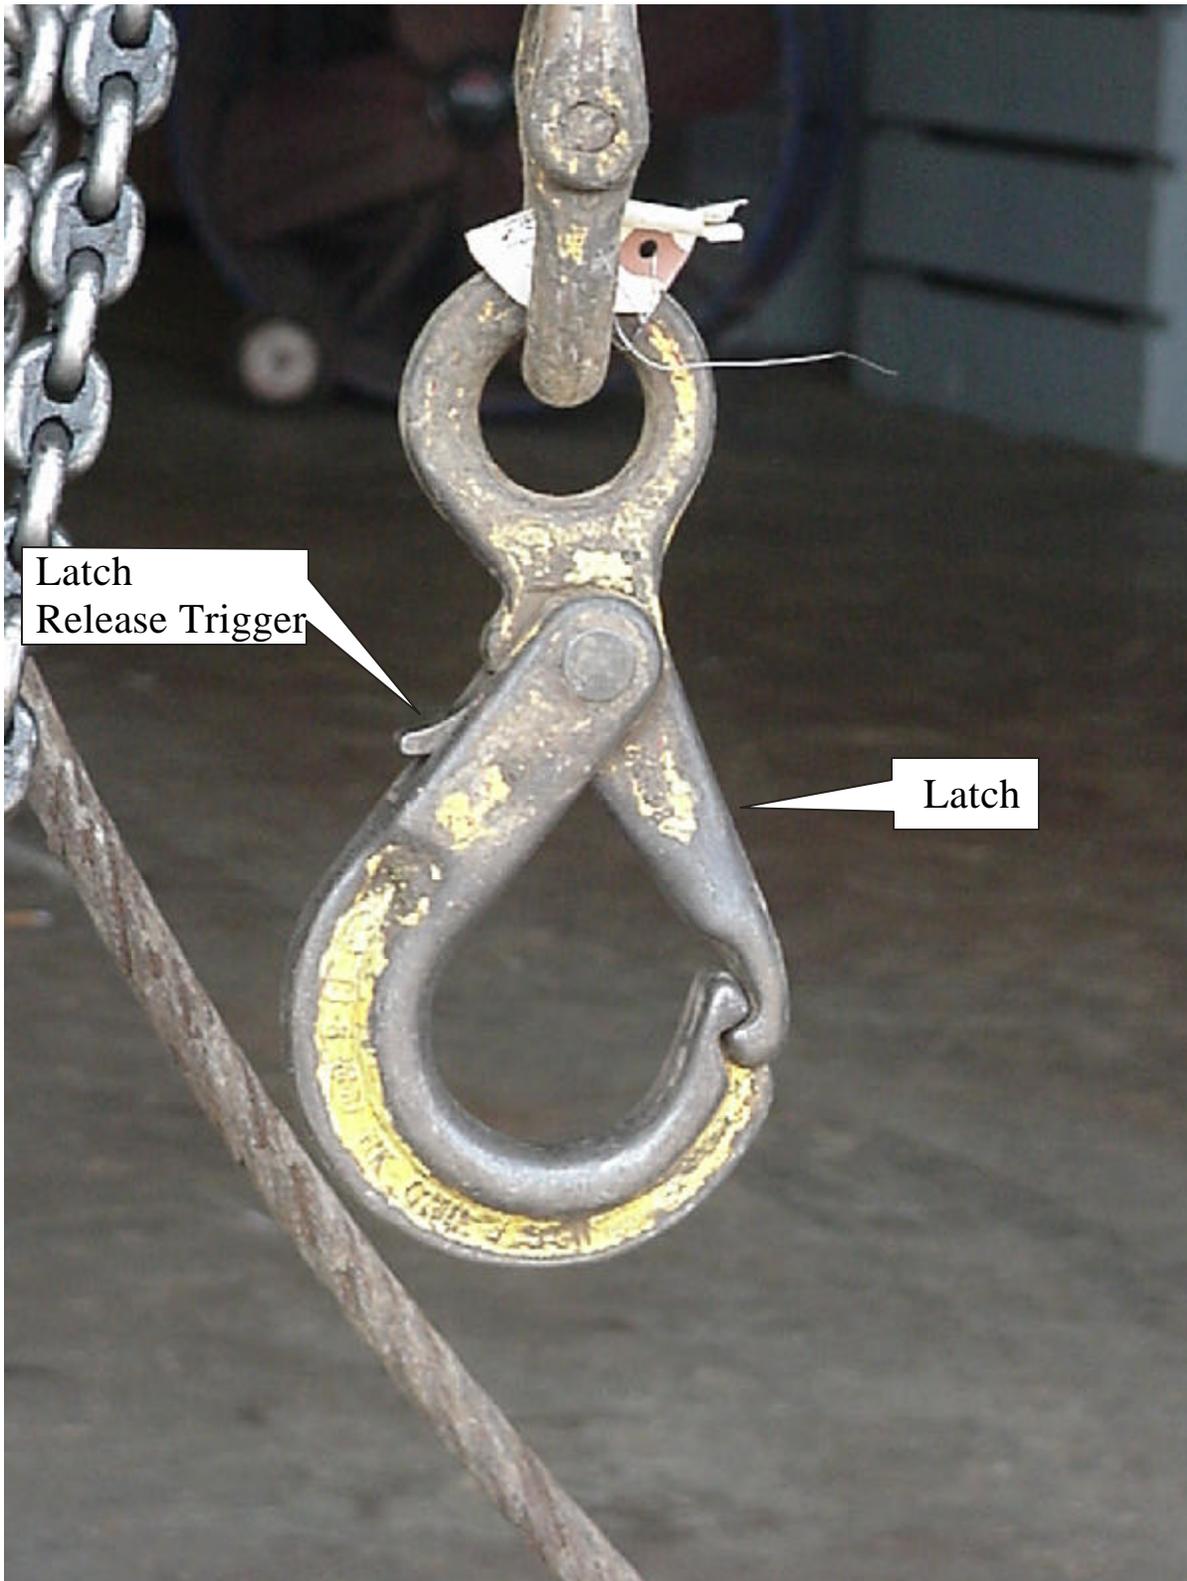
Photograph of Hook

The air hoist hook consists of an outward opening, self-locking latch, and a latch release trigger. Pressing the trigger inward releases the latch and allows separation between the latch and the hook. *For a photograph of the hook, see Attachment 8.*

- ◆ Using an air hoist hook with an outward opening latch.

The panel further recommends that MMS review their regulations and those of other agencies, which do reference personnel lifting, for the purpose of evaluating the possible need to add a specific MMS regulation(s) to 30 CFR 250 regarding the lifting of personnel. Specifically, the evaluation should consider the types of hooks used and the need for fall-arrest systems.

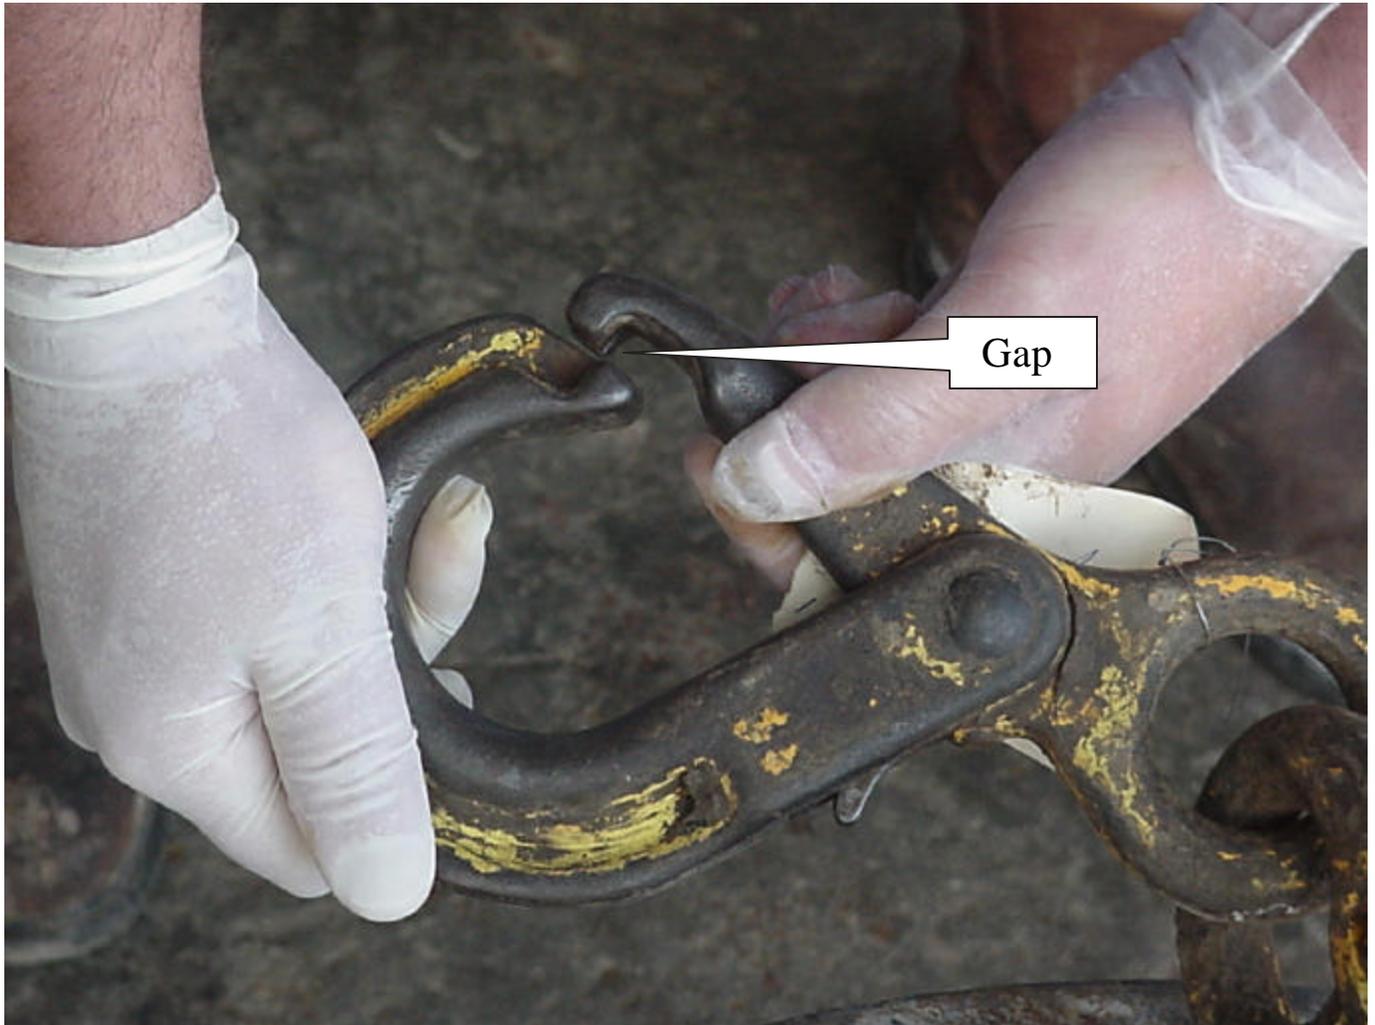
Photograph of Hook/Latch Gap

Equipment Analysis The hook was inspected by MMS district personnel at the accident site and by MMS panel members at H&P facilities in Jackson, Mississippi, where the hook and harness were secured. Both inspections revealed that a gap of approximately 4/10 inch between the latch and the hook can be produced by slightly pulling outward on the latch while the hook is in the closed position, i.e., with the latch release trigger not pressed inward. *For a photograph showing the gap, see Attachment 9.*

- ◆ Using the air hoist hook with a latch/hook gap.

- ◆ The failure of H&P's inspection/maintenance program to identify the latch/hook gap as a potential hazard by a more in-depth inspection of the hook.

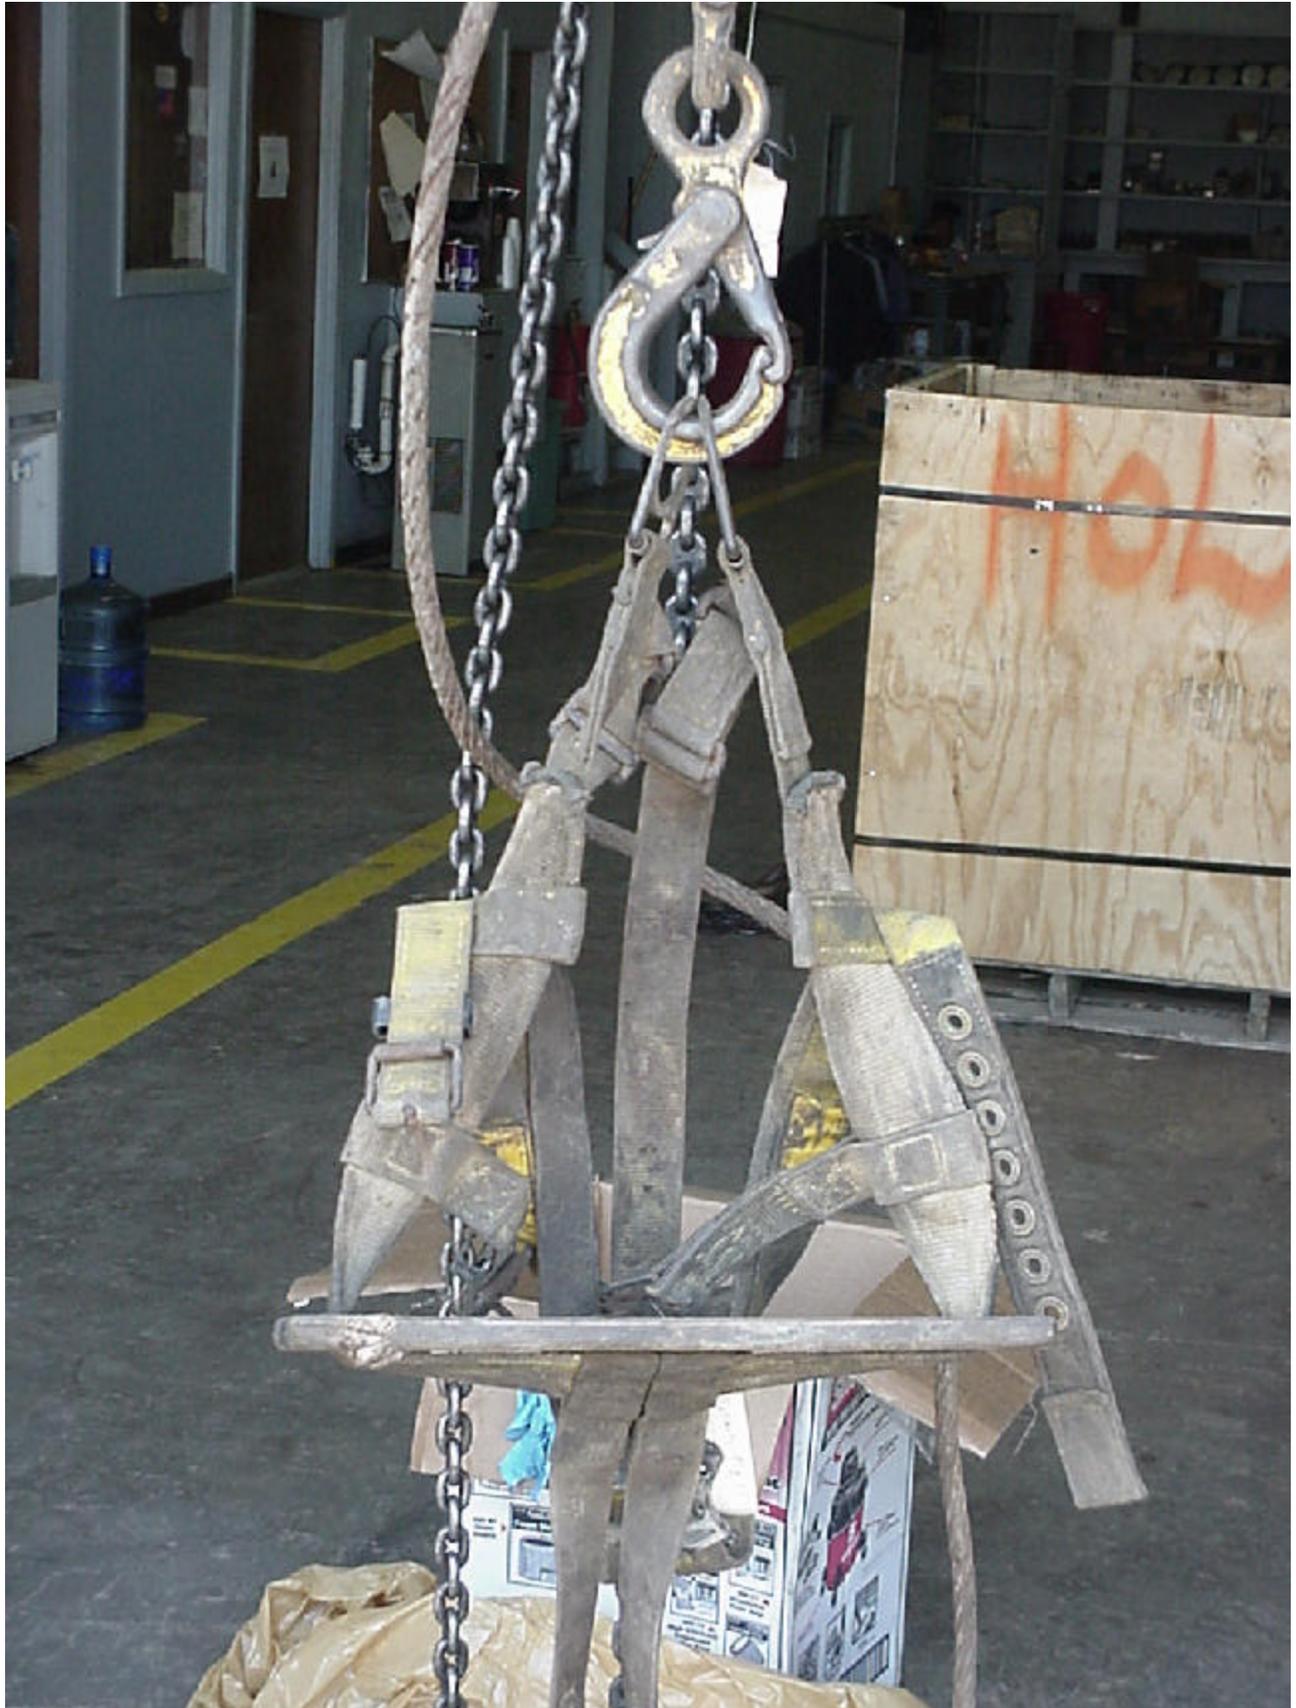
Photograph of Harness Suspended from Hook

At the Jackson facilities, panel members suspended the hook from an overhead crane and hung the harness from the hook by placing the chair's "D" rings in the hook. *For a photograph of the harness suspended from the hook, see Attachment 10.* It was revealed that the "D" rings fit into the latch/hook gap. *For photographs of the "D" rings in the gap, see Attachments 11 and 12.*

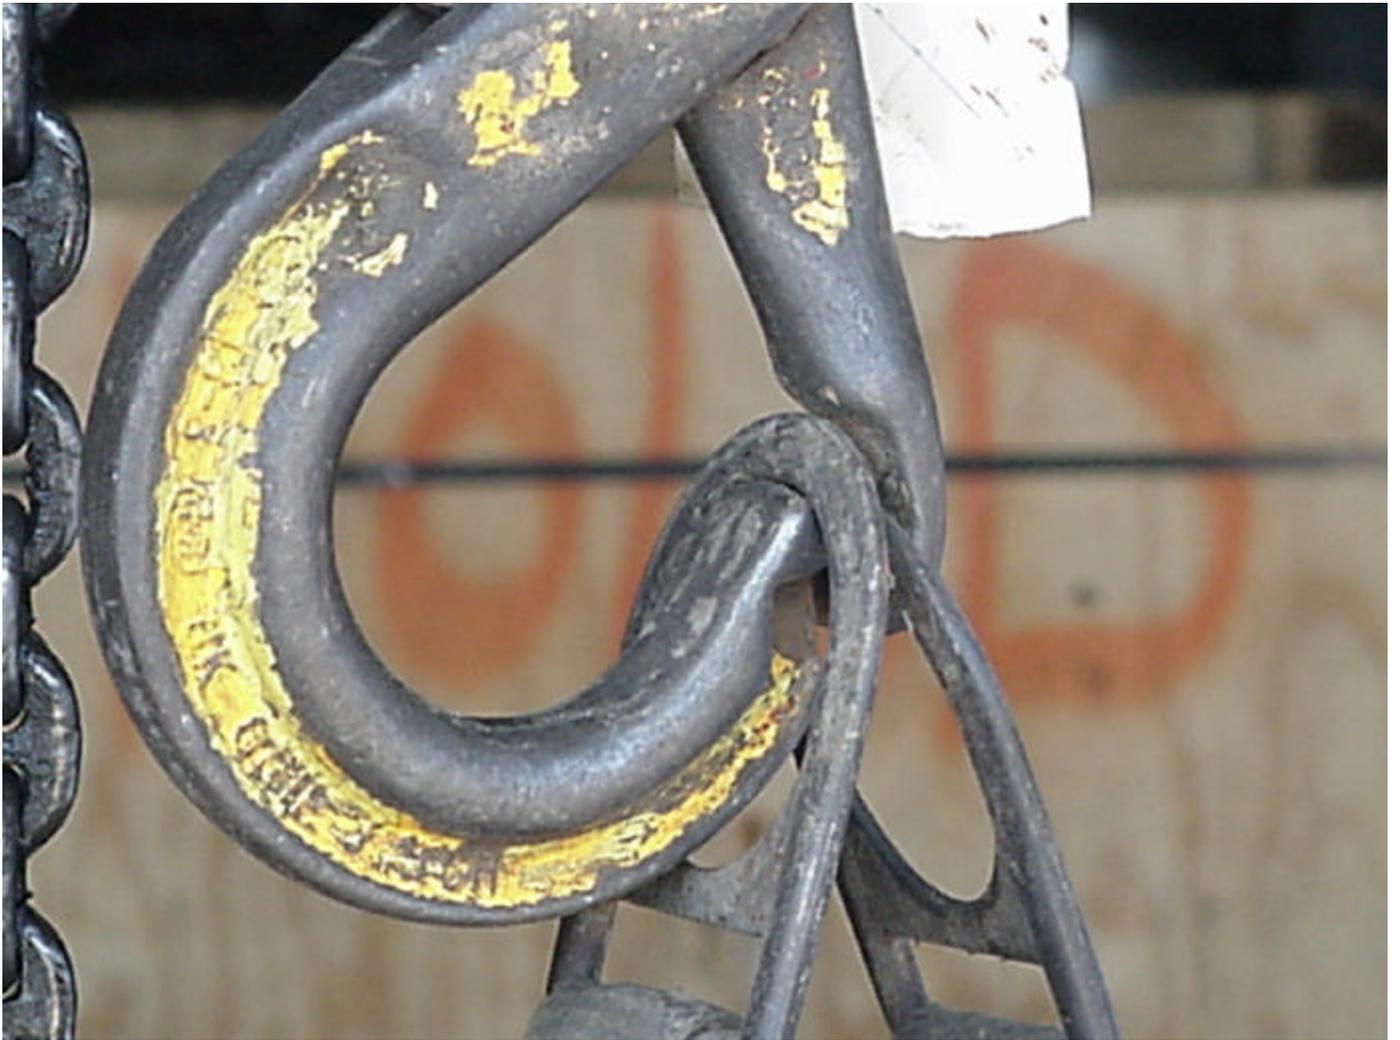
Photograph of “D”Rings in Hook/Latch Gap

With the "D" rings in the gap, panel members were unable to physically pull the "D" rings downward from the hook. With the "D" rings in the gap and with the latch release trigger fully depressed, the panel members were still unable to pull the "D" rings downward from the hook. However, with the "D" rings in the gap and with the latch release trigger fully depressed, the "D" rings separated from the hook as soon as the panel members stopped pulling downward on the "D" rings. It should be noted that in both of the above demonstrations with the trigger fully depressed, the trigger was not easily depressed. This indicates that it is possible that the "D" rings can detach from the hook during a personnel lifting operation if the rings are in the latch/hook gap, the trigger is depressed, and the occupant of the chair

It is the conclusion of the panel that, at some point in his elevation into the derrick, H&P 2's harness "D" rings fell into the latch/hook gap. While maneuvering into position to board the 5-inch monkey board, H&P 2 accidentally depressed the latch release trigger of the air hoist hook and simultaneously either pulled or pushed his weight off the boatswain's chair. At that point, the harness "D" rings slipped out of the hook, resulting in H&P 2 fatally falling approximately 80 feet to the rig floor.
