**Investigation of Fall and Fatality  
Main Pass Block 140  
May 19, 2000**

**Gulf of Mexico  
Off the Louisiana Coast**

**U.S. Department of the Interior  
Minerals Management Service  
Gulf of Mexico OCS Regional Office**

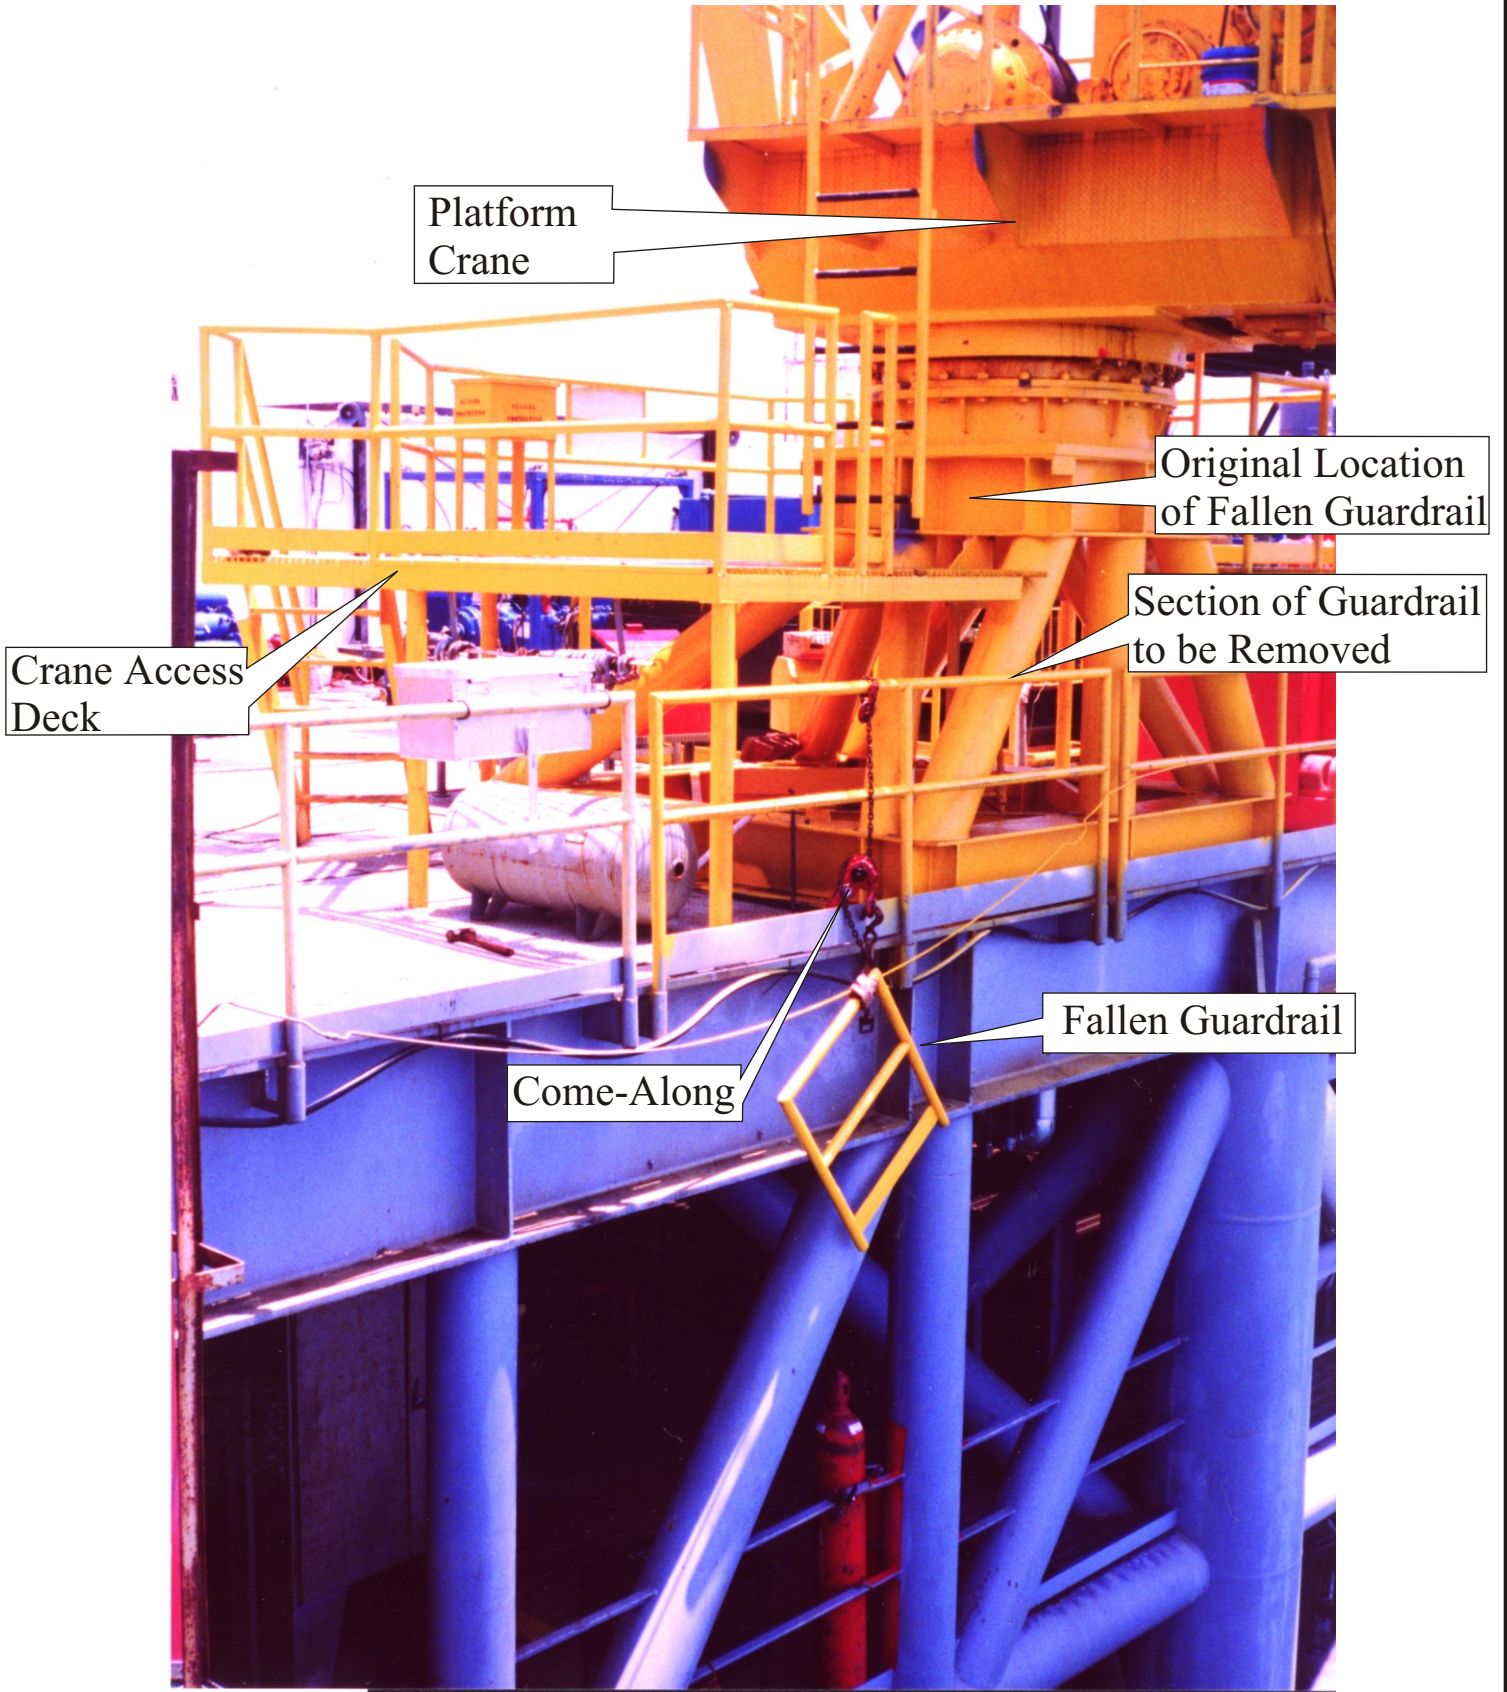
Photograph of Post-Accident Scene

**Material Analysis** A visual examination by a metallurgist of the base posts of the guardrail that failed revealed both incomplete and poor welding of the posts to the

platform's crane access deck. Paint and corrosion on the post surfaces indicated that portions of the posts were not welded, while flat weld metal surfaces indicated that some welded portions did not thoroughly fuse with the deck. Furthermore, where fusion did occur, the weld was very thin. It is the conclusion of the metallurgist that the failure was the result of all of the above.

It is the conclusion of the panel that the tensioning of the come-along caused an excessive force to be exerted on the guardrail which, in conjunction with poor and incomplete welding, caused the existing welds between the guardrail posts and the access deck to fail. The Mar-Con employee who was using the come-along fell with the guardrail as a result of either leaning against the guardrail or holding onto the guardrail as he tensioned the come-along. The employee was fatally injured as a result of the fall.

1. A summarization of the first Safety Alert for reference purposes.
2. A recommendation that designated operators and their contractors perform a second JSA for any activity for which an initial JSA was performed and whose steps have been changed since the initial JSA was performed.
3. A recommendation that operators instruct both their representatives and contractors to communicate regarding any change in the steps of an activity that is to be performed, especially when a JSA has been performed prior to the change.

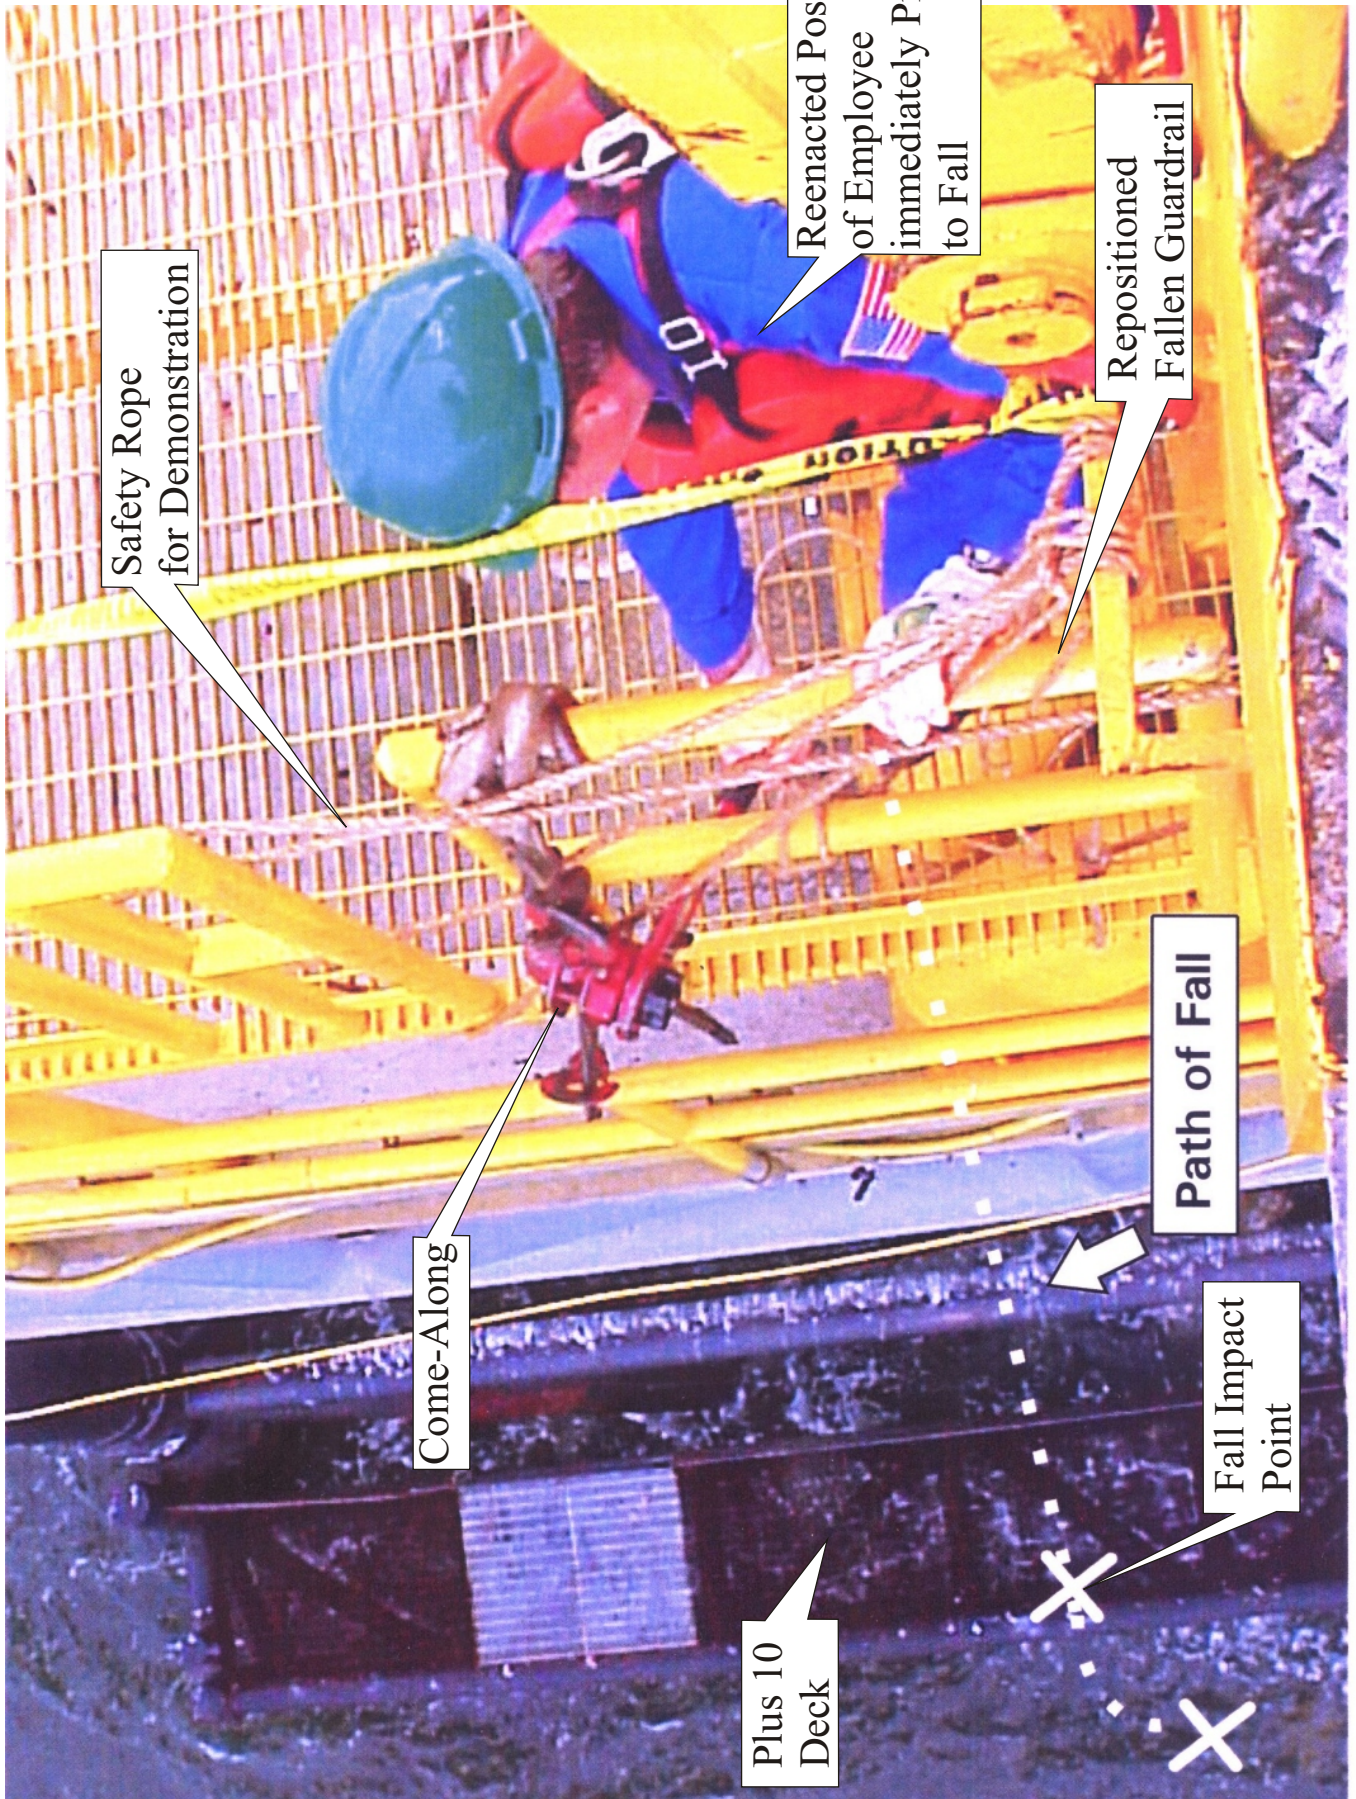
Photograph Demonstrating Fall

M-2 suggested to M-1 that, instead of removing the guardrail by cutting and then later welding it back into place, the guardrail could be lifted out of the sockets into which its vertical posts were inserted. M-1 accepted the suggestion and ordered the crew to use a come-along to lift the guardrail. One end of the 1½ -ton come-along was attached by a chain to the top portion of the guardrail to be removed on the main deck and the other end by a strap to the top portion of the guardrail on the platform's crane access deck. The crane's access deck is approximately five feet above the main deck. While M-1 and M-2 were hammering on one end of the guardrail to be removed and another Mar-Con employee, M-3, was attempting to loosen the other end by using a pry bar, a fourth Mar-Con employee, M-4, was tensioning the come-along. After experiencing difficulty in loosening the guardrail, M-1 instructed M-4 to put further tension on the come-along. At that point, approximately 0815 hours, various employees heard a sound from

the access deck and saw that the guardrail on that deck had fallen from the deck. M-4 was then witnessed to have fallen from the access deck. After having rushed to the edge of the platform, crewmembers saw that M-4 had fallen to the Plus 10 deck, approximately 60 feet below the main deck. They also saw M-4 roll off the deck into the water.
