## **NIOSH HEALTH HAZARD EVALUATION REPORT**

**HETA #2000-0400-2956**

**HETA #2002-0325-2956**

**Glen Canyon National Recreation Area  
Arizona and Utah**

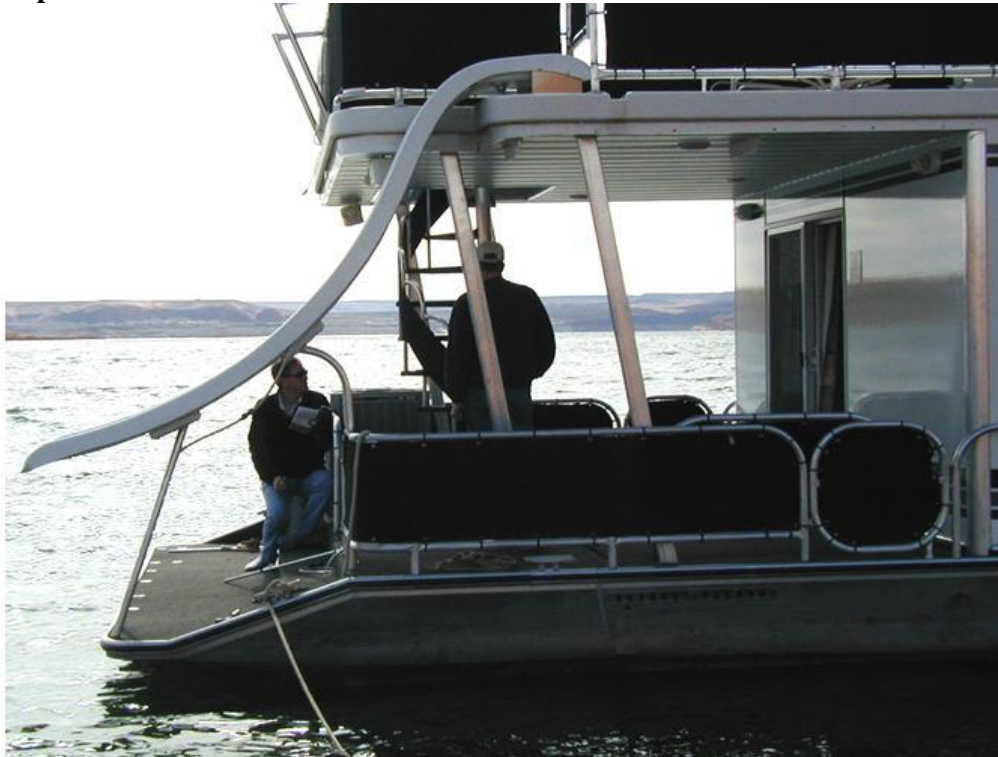
This initial air sampling investigation related to houseboats with extended rear decks and gas-powered generators with exhaust terminus exiting the boat transom under the deck (shown in pictures and diagram in Figures 1–3). The generators supply the boat with electrical power to operate on-board appliances (i.e., air-conditioner, refrigerator, lights, charging batteries, etc.

**Figure 1. Example of the Houseboat Extended Rear Deck Related to Seven Deaths at Lake Powell**

3. Manufacturers should examine options for modifying houseboat design to prevent the buildup of hazardous CO concentrations from any engine exhausting into the airspace under the deck. Design changes could include modification of the structure of the stern deck and/or sufficient pressurization of the airspace to reduce CO concentrations to safe concentrations within 1 minute of engine deactivation.

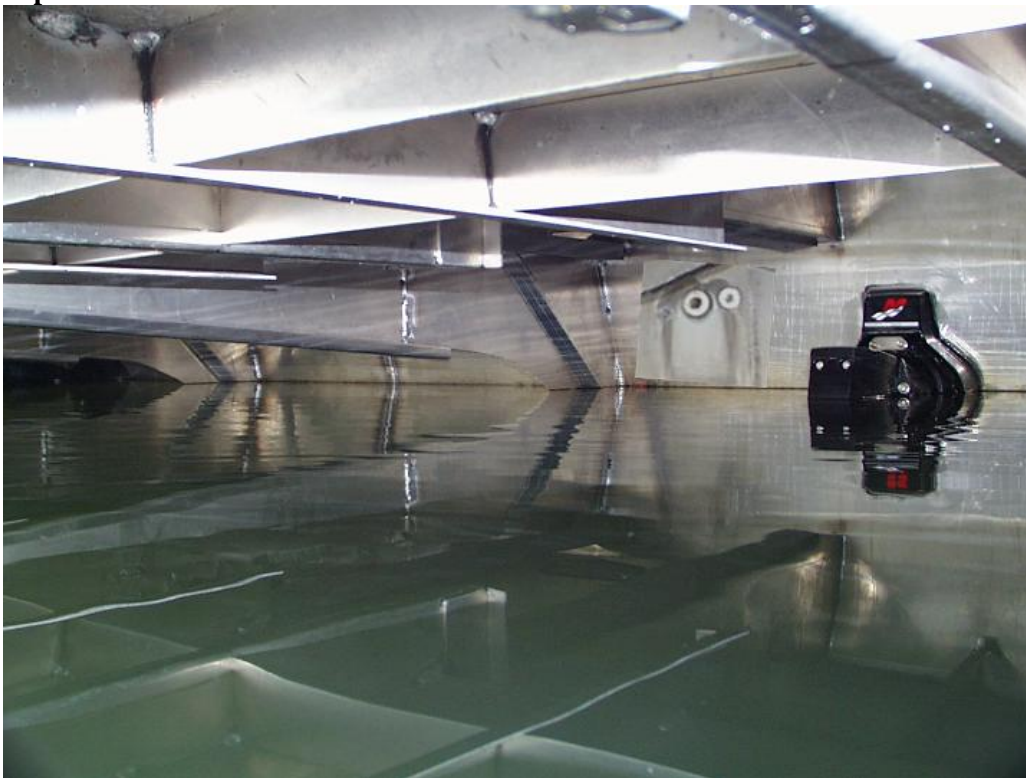
Without doubt, the cavity below the swim platform of houseboats with an extended rear deck presents a severe, sometimes fatal hazard that must be immediately addressed through design changes and public education. In all, we know of 21 people nationwide who have been poisoned by entering this airspace (14 on Lake Powell and 7 on other bodies of water), 13 of whom died (7 on Lake Powell, 6 on other bodies of water). This hazard is present during the operation of on-board generators housed in the engine compartment and exhausting into the cavity, as well during the operation of propulsion engines. Exhaust lingers in this airspace for an extended period following deactivation of either type of engine.

**Figure 2. Airspace Beneath the Houseboat Extended Rear Deck**

Initial recommendations contained in interim reports for this project were that the airspace beneath the extended rear deck of houseboats should never be entered for any reason. Unfortunately, the current design of this type of houseboat necessitates entry into the airspace to access the propulsion engine outdrives (to conduct maintenance and repair) or propellers that often get fouled by anchor ropes. CO concentrations measured in the airspace of these types of boats, and related fatalities associated with this airspace, confirmed the need: 1) for manufacturers to immediately address the placement of the generator exhaust terminus (get it out of that space and up to an location that is not accessible by swimmers or boat occupants); 2) for manufacturers to develop safe entry procedures for boaters until this space can be redesigned; and 3) to educate boaters about exercising extreme caution when entering this airspace.

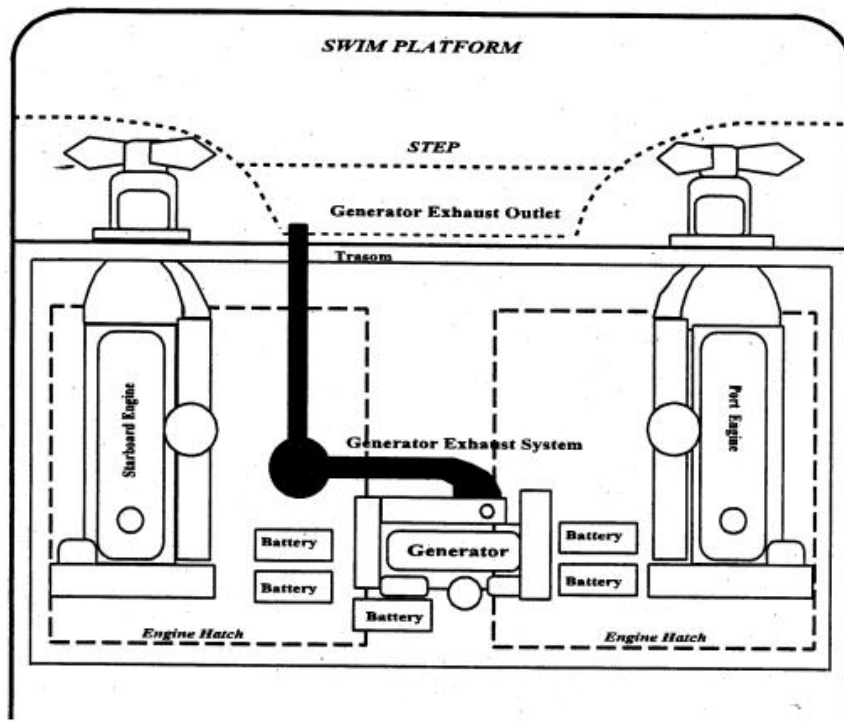
**Figure 3. Overhead Diagrammatic View Illustrating Generator and Generator Exhaust Terminus Location on Houseboats of the Design Associated with Seven GCNRA Deaths**
