# 5 Observations on Non-residential Property Protection

This section presents the BPAT's observations on non-residential property protection. The non-residential buildings were categorized into the various engineered types of construction focusing on the structural performance of each type of building. Important observations were also made concerning exterior architectural systems (e.g., roof and wall coverings, windows and doors).

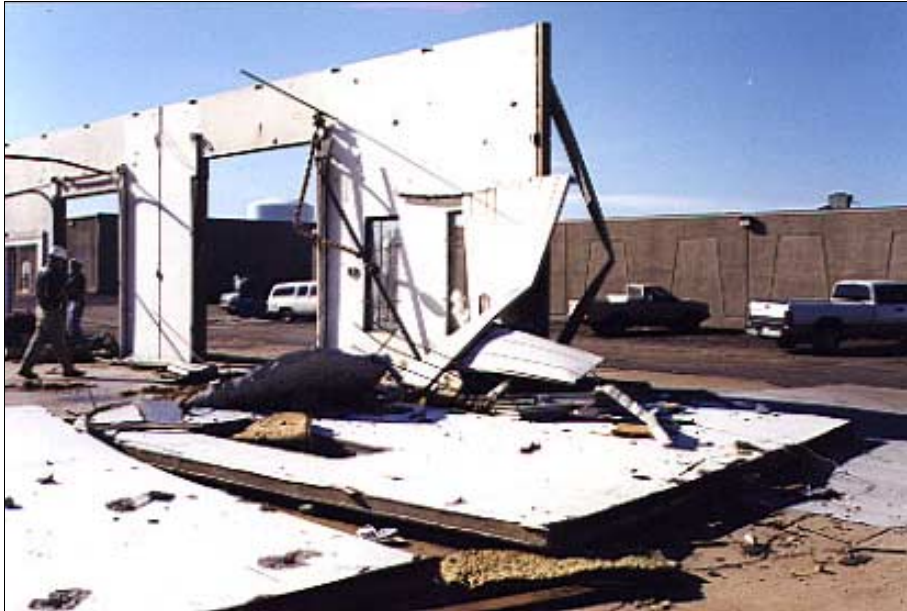
Inspection of a damaged tilt-up precast concrete wall building in Moore, Oklahoma, found no deficiencies with connections between the tilt-up walls and the foundation. However, connections between the roof systems and the tilt-up walls failed in some buildings. In a commercial building along Interstate I-35 outside Del City, Oklahoma, failure of these connections caused a loss of diaphragm action, which then led to collapse of the endwalls of this building and will be discussed further in Section 5.2.1. Figure 5-2 is a photograph of this building. The vortex of a violent tornado passed approximately 200 yards from this building, generating inflow winds that removed the roof of this structure. Once the roof of the building was removed and diaphragm action was lost, the endwall that was already being acted upon by outward (suction) wind forces failed.

**FIGURE 5-2:** *Tilt-up precast concrete walls at a storage building located outside Del City, Oklahoma. After the roof joists separated from the walls, this end wall became unable to withstand suction forces and failed.*

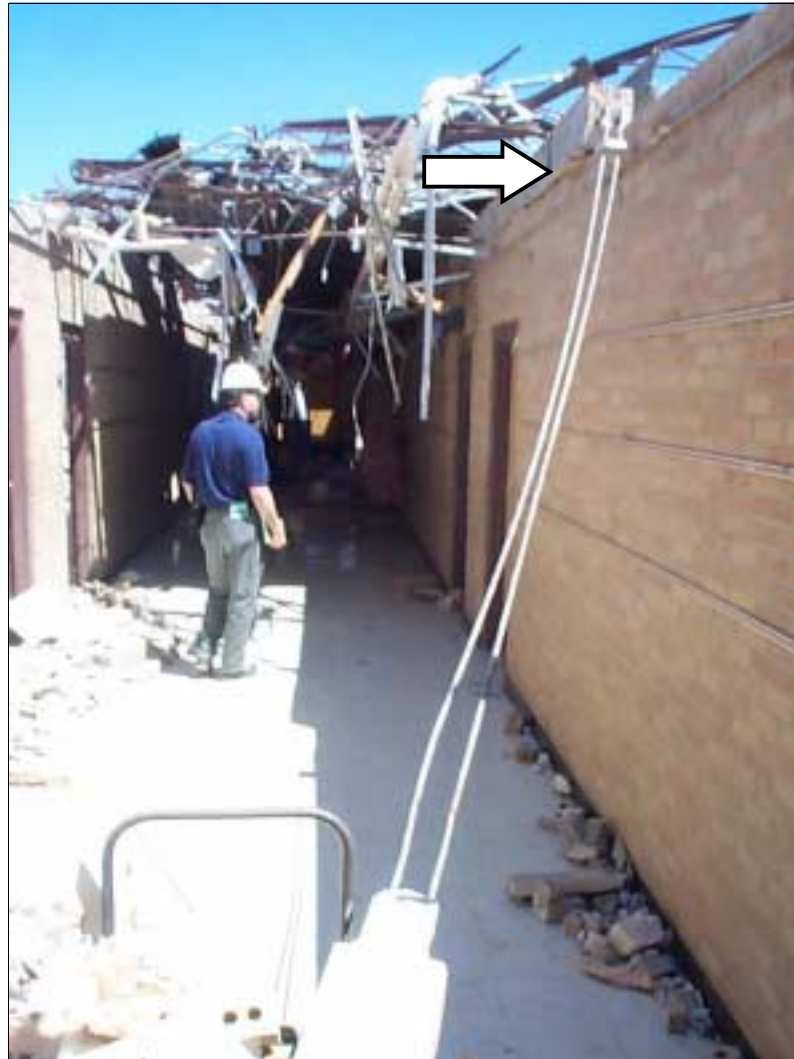
This section discusses the damage associated with the masonry wall section of the building; Section 5.1.3 will discuss the steel frame section of the school. Figure 5-3 shows damage to the Kelly Elementary School. Arrows show separation between the bond beam and its supporting wall and separation between the bond beam and roof bar joists. At both locations, connections between the bond beam, joists, and walls were adequate for gravity load, but could not carry the high uplift loads that were caused by winds associated with the violent tornado.

**FIGURE 5-3: Kelly Elementary School, in Moore, Oklahoma, hit by vortex of violent tornado. Damage to school displaying separation between the bond beam and supporting wall and separation between bond beam and roof bar joists.**

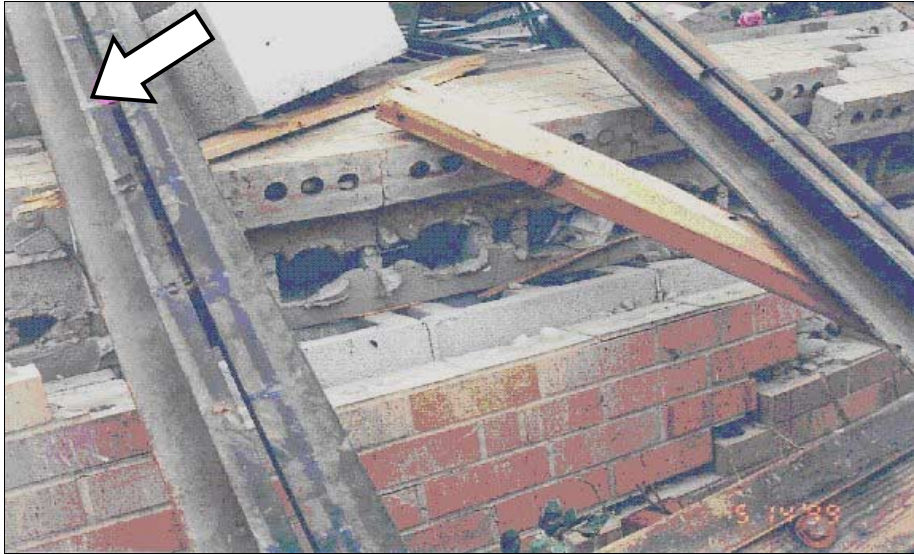
Figure 5-4 shows a close-up of a joist end over the old cafeteria. The arrow shows a location where the roof deck was supported for gravity load, but not welded for uplift. Below the arrow, broken welds can be seen. Also visible in Figure 5-4 is the lower portion of the external wall. As illustrated in the photograph, no effective vertical reinforcement was found in the wall. Consequently, the wall had low resistance to uplift in combination with high lateral wind loads.

**FIGURE 5-4:** Failed structure showing broken deck welds, and no effective vertical reinforcement. Kelly Elementary School, Moore, Oklahoma, hit by vortex of violent tornado.

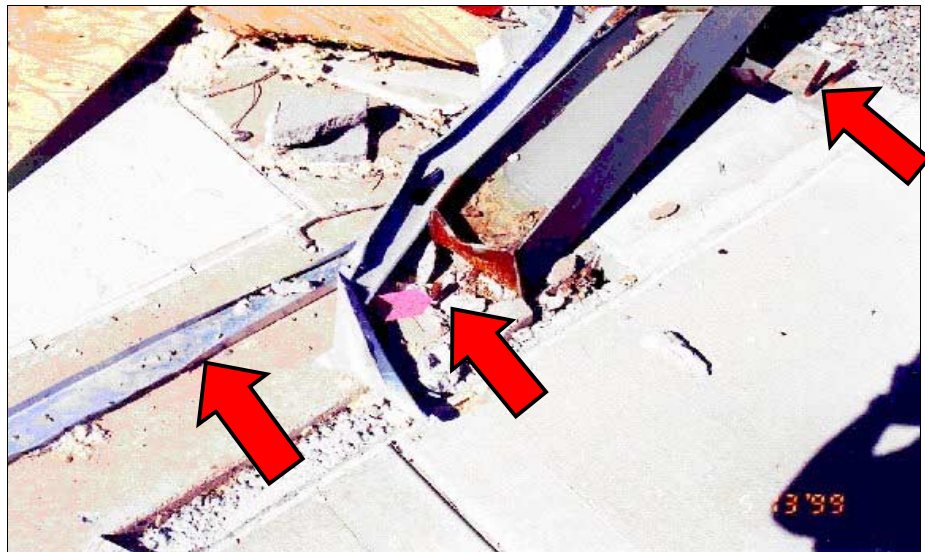
Figure 5-6 shows the attachment of columns to the foundation and attachment of the wall bottom plates to slab concrete. At the arrow on the right in Figure 5-6, anchor bolts were provided but the apparent lack of nuts on the anchor bolts permitted the column to lift off of the foundation. At the center arrow, anchor bolts with properly attached nuts provided a high level of restraint to column lift off. The arrow at the left of Figure 5-6 shows a wall bottom plate that was attached to the concrete slab by power driven nails. Although the plate held at this location, lack of penetration by the nails into the concrete permitted the plate to pull out at many other locations. Additional nail penetration would be needed to assure consistent attachment of wall bottom plates to the slab.

**FIGURE 5-6: Attachment of columns to foundation and attachment of wall bottom plates to concrete slab. Regional outlet mall, Stroud, Oklahoma, hit by moderate tornado vortex.**

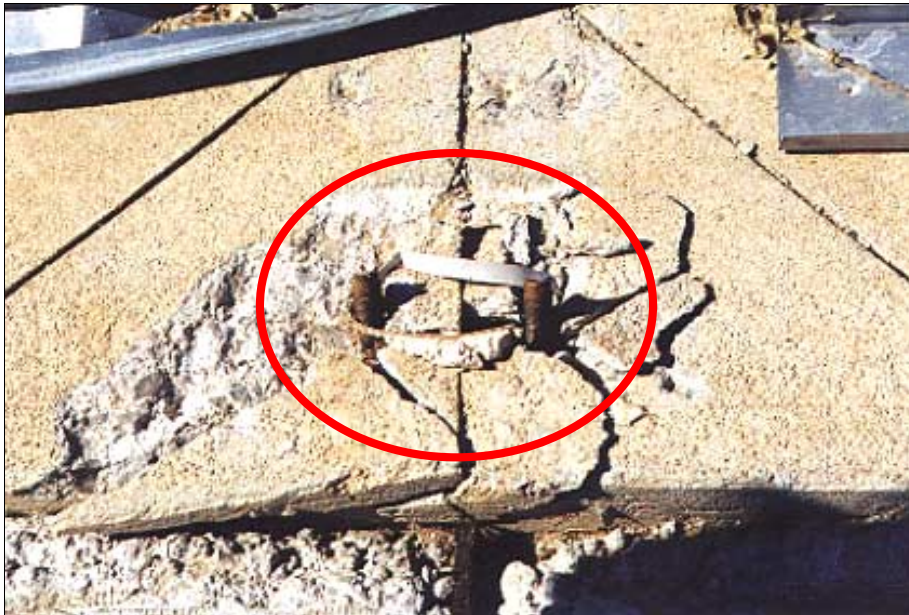
Most bolts with nuts exhibited a ductile steel failure as shown in figure 5-7. This was the failure mode observed in most cases. This was also the failure mode for the anchorages at the steel water tower in Mulhall, Oklahoma. However, some of the bolts observed at the mall did pull out of the concrete foundation, indicating a failure in the concrete bond (see Figure 5-8).

**FIGURE 5-7:** Column anchors that exhibited ductile failure at the regional outlet mall in Stroud, Oklahoma, hit by moderate tornado vortex.

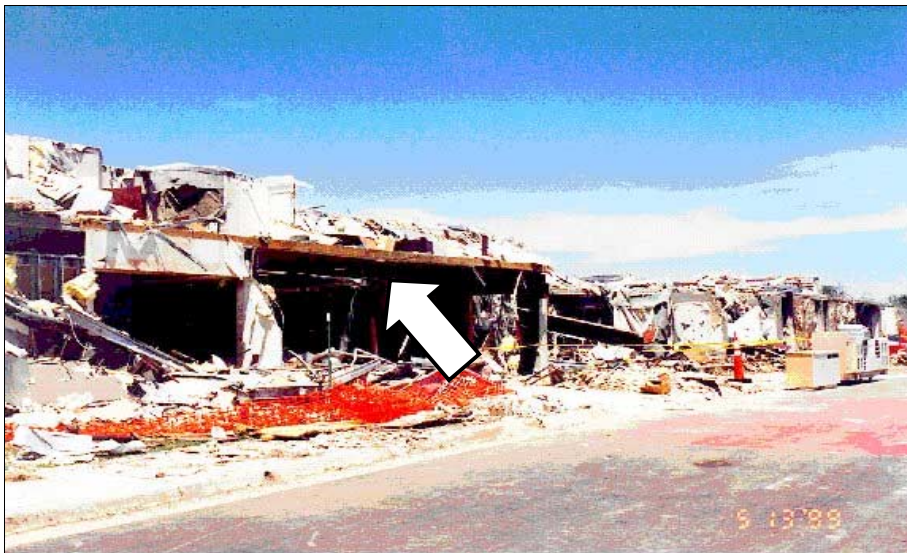
In several locations, combined effects of upward suction wind loads with horizontal wind loads caused unexpected damage to structures. When a continuous load path for uplift and lateral loads did not exist, roof failures and upper level floor failures were observed. Figure 5-11 shows the remains of a motel in Mid West City, Oklahoma, hit by a violent tornado vortex. The arrows show a steel beam that had been deflected inward significantly when the floor slab was lifted during the tornado. There was no positive connection between the steel beam and the floor above.

**FIGURE 5-11: Motel in Mid West City, Oklahoma that experienced major damage when struck by the vortex of a violent tornado.**

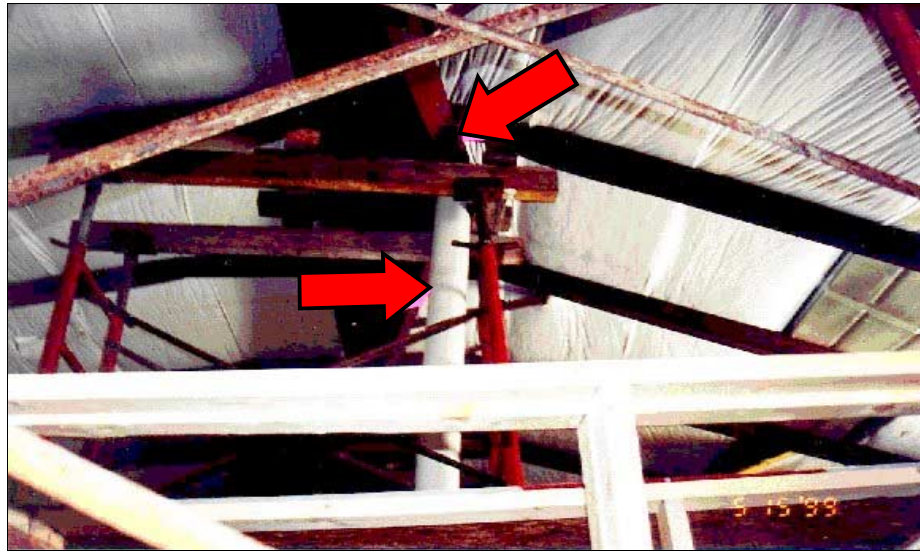
At a plastics manufacturing plant in Haysville, Kansas, a combination of upward and horizontal wind loads when the plant site was hit by a violent tornado caused out-of-plane buckling of the bottom flange of a main girder supporting the roof (Figure 5-12). One arrow shows the column that supports the girder, while the other arrow shows the bottom flange of the girder. It can be seen that the bottom flange has displaced significantly sideways in relation to the top flange of the girder. Inspection along the length of the girder indicated that the bottom flange was braced along its length at every purlin except at the location of the supporting column. This lack of bracing permitted buckling and out-of-plane displacement of the bottom flange. However, due to the light gravity loads left on the roof after the wind forces diminished, collapse did not occur.

**FIGURE 5-12:** Out-of-plane buckling of the main girder supporting the roof created by a combination of uplift and horizontal wind loads. Plastics plant, Haysville, KS hit by violent tornado. This building was in the inflow area of a severe tornado.

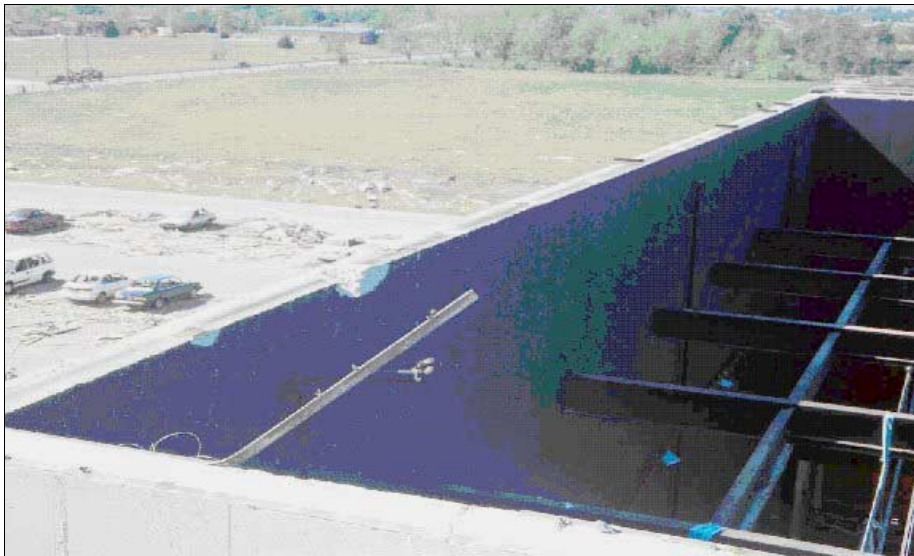
The Westmoore High School in Moore, Oklahoma, was a relatively new structure that was within 100 yards of the vortex of a violent tornado. Although most of the roofs stayed on this building, the roof over the auditorium stage was blown off. Figure 5-14 shows the walls where the bar joists had been attached prior to the tornado. In all cases, welds failed between bar joist ends and embedments in the walls in the auditorium stage roof. This loss of load path permitted the roof to be lifted up off of the reinforced concrete walls.

**FIGURE 5-14: Roof blown off over top of auditorium at Westmoore High School, Moore, Oklahoma hit by inflow winds of violent tornado.**

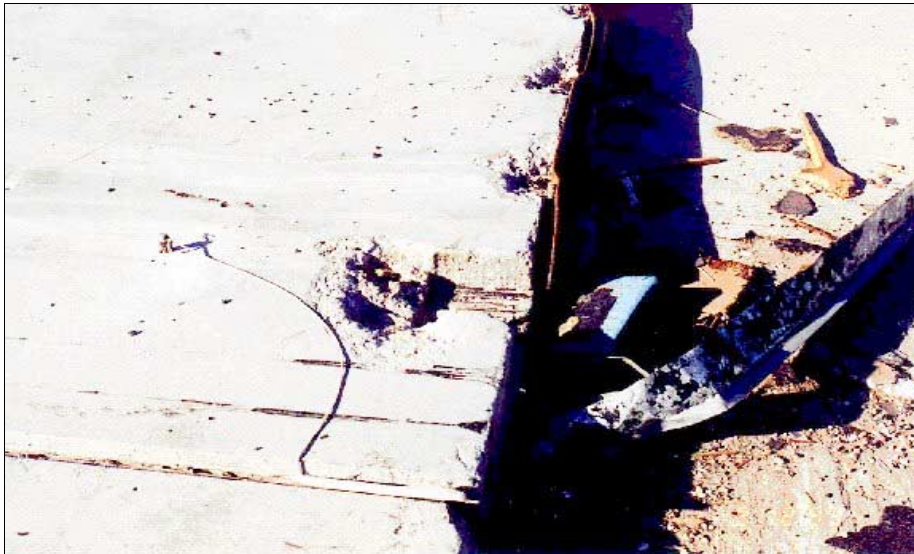
Figures 5-17 and 5-18 show the top of the tilt-up precast concrete wall that failed. Figure 5-17 shows that diaphragm action provided by a beam supported by the wall was lost when the beam pulled out of the wall pocket. Failed welds tying the roof into the top of the tilt-up wall can also be seen in Figure 5-18. Visual inspection showed that only one of the four walls of the building collapsed. The other walls had part of the diaphragm action provided by remaining portions of the roof.

**FIGURE 5-17: Top of failed tilt-up wall.**

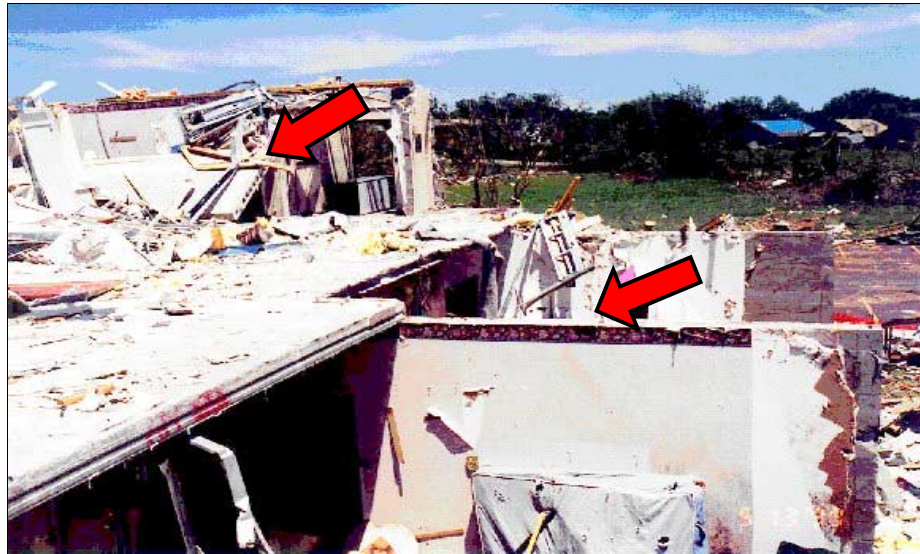
Figure 5-21 shows the location where hollow core plank had formed the second floor. The arrow at the right shows a dowel from the masonry wall into grout between the ends of two hollow core panels. One of the panels that had been at the edge of the building was found up on the second level and across on the far side of the building as shown by the arrow on the left of Figure 5-21. Apparently the uplift wind forces from the tornado were large enough to overcome the tie-down force provided by the very short dowels. The hollow core plank appears to have been lifted and blown across the width of the building.

**FIGURE 5-21:** *Hollow-core plank formed on second floor of a Midwest City, Oklahoma, hotel that was struck by the vortex of a moderate tornado.*

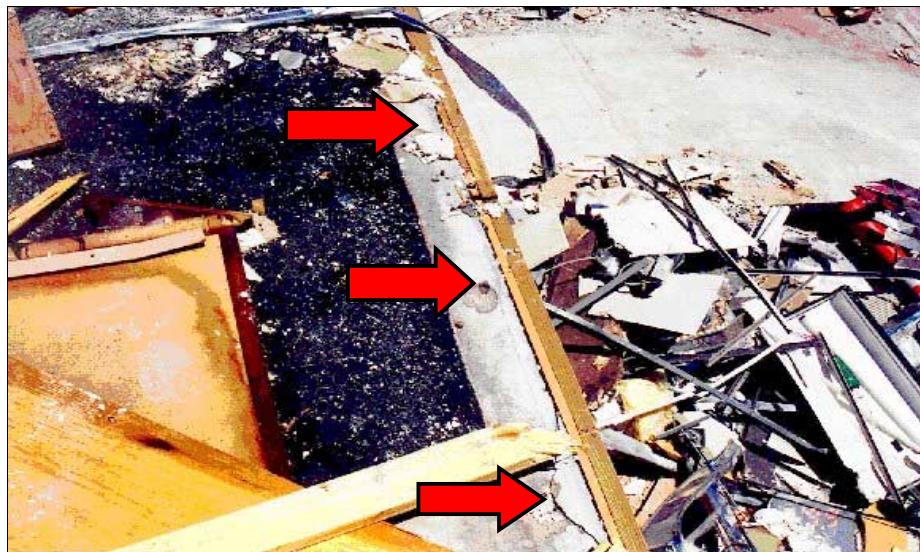
Elsewhere along the edge of the second floor of the motel, failure occurred between the hollow core planks and exterior walls of the building. As shown in Figure 5-22, lower plates for the walls had been attached to the hollow core planks using power driven anchors. As indicated by the arrows, the powder driven anchors pulled out during the tornado.

**FIGURE 5-22:** *Attachments of lower plates for wall to hollow core plank using power driven anchors failed when required to carry loads generated by the winds of a moderate tornado vortex. This motel was located in Midwest City, Oklahoma.*

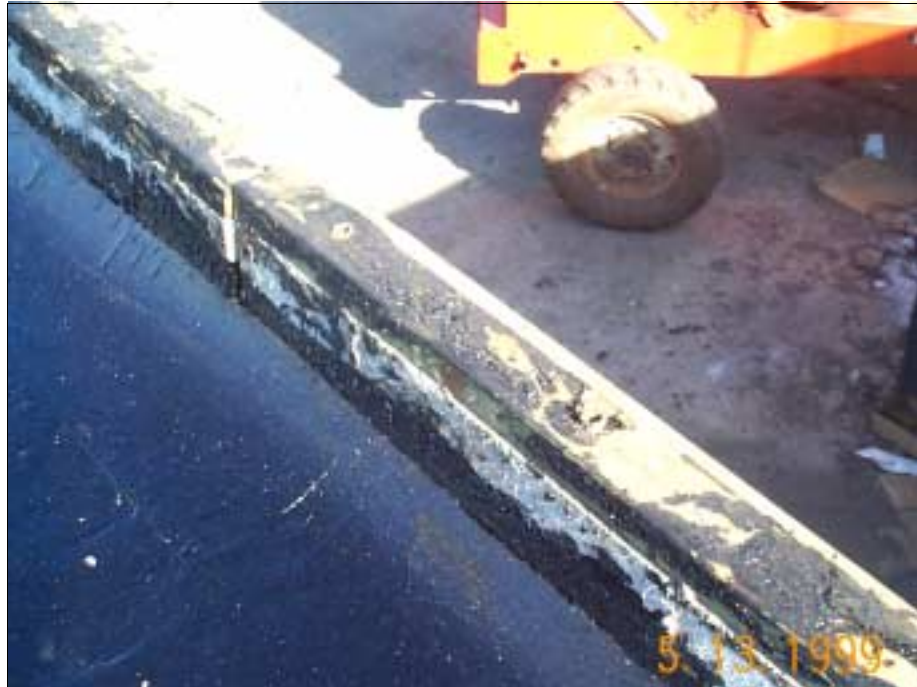
In one case, loss of a large portion of a built-up roof with aggregate ballast resulted in significant rainfall water infiltration into a hospital in Stroud, Oklahoma. After the storm, the hospital was closed and the patients moved to a facility about 30 miles away, which significantly reduced the availability of emergency medical services over this area of rural Oklahoma. The characteristics of the damage to the hospital were not indicative of tornado winds due to its distance from the tornado vortex. Rather, it is likely that the damage was caused by thunderstorm winds. The failure initiated when the coping lifted or with lifting of the nailer the to which the coping was attached (Figure 5-22). The nailer was poorly attached to a 4-in CMU that formed the parapet wall. In some areas, the CMU block parapet lifted slightly.

**Figure 5.23:** Nailer at the roof of the hospital in Stroud, Oklahoma. The roof surface in this photo was replaced prior to this photo, but the same nailer was used again.

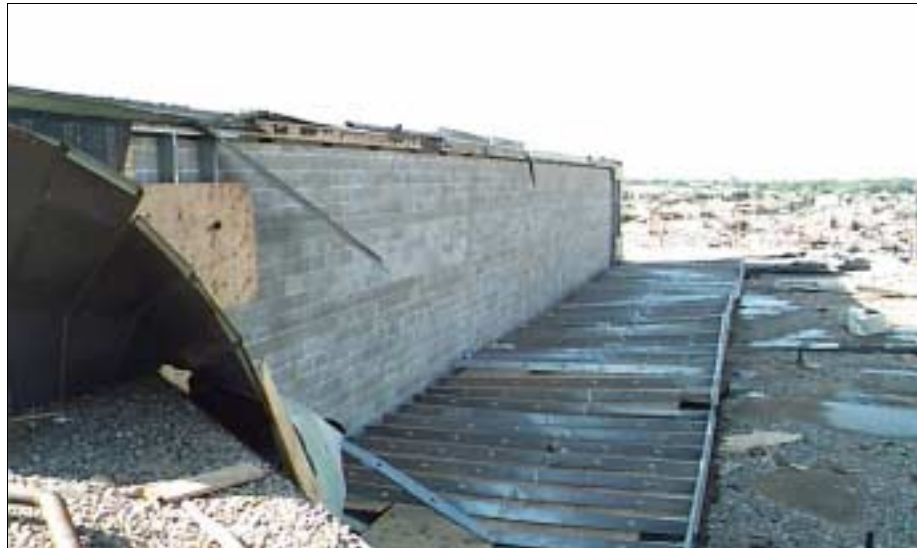
Brick veneer is discussed in Section 4.1.3.2. Some metal wall coverings over steel studs collapsed (Figure 5-24). Some Exterior Insulating Finishing System (EIFS) failures were observed.

**FIGURE 5-24:** This metal-clad wall covering collapsed and in other areas it was blown completely away.

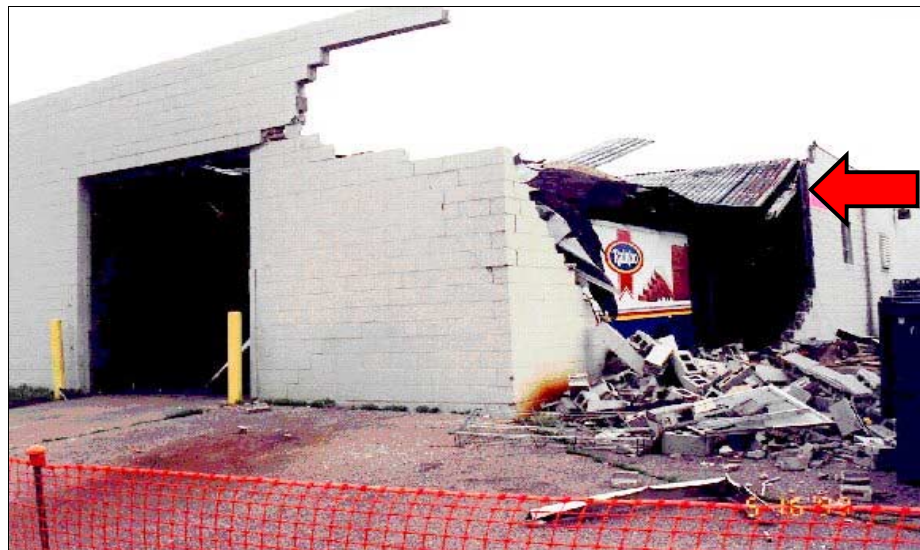
The breach of overhead commercial doors caused internal pressurization of the structure leading to significant load increases. Not unlike the residential case, a breach in the building envelope was observed, in some cases, to initiate a partial or total failure of primary structural systems. This was particularly true for pre-engineered buildings, which typically had little redundancy in load transfer of their structural systems. Figure 5-26 shows a breached commercial overhead door belonging to a bread manufacturing and

distribution center in Wichita, KS. The building exterior walls were constructed using both concrete masonry block and tilt-up concrete panels. The roof deck was standing seam metal on a Z purlin system. The door failure appears to be a result of positive (inward) pressure. The breach may have caused a sufficient enough rapid increase in load to produce failure of the URM block wall. It is worth noting the location of the failed door is near a corner where high negative suction or (outward) pressure is likely to occur on the adjacent wall. As a result of the exterior wall collapse, severe damage to the roof system occurred due to the loss of the load bearing exterior support wall. However, notice that the roof collapsed to the interior of the building, which may indicate that uplift loads acting on the roof were insufficient to cause progressive peeling failure of the roof system.

**FIGURE 5-26: Failure of roof and walls on structure due to increased loads caused by initial failure of garage door, Wichita, Kansas.**

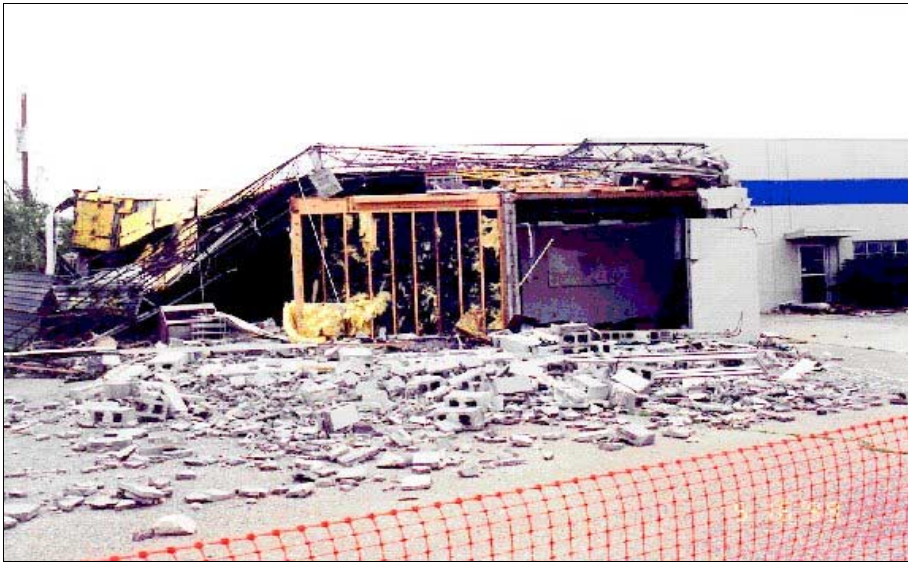
Figure 5-27 illustrates another condition in Wichita, KS where breach of the building envelope contributed to additional structural damage. In this case, loss of showroom windows and an overhead door greatly increased loads in the showroom and on the wall at the left of the photograph. These increased loads caused the walls to fail and the roof to partially collapse, thereby greatly increasing structural damage in the building.

**FIGURE 5-27: Additional structural damage caused by breach of envelope in Wichita, Kansas.**

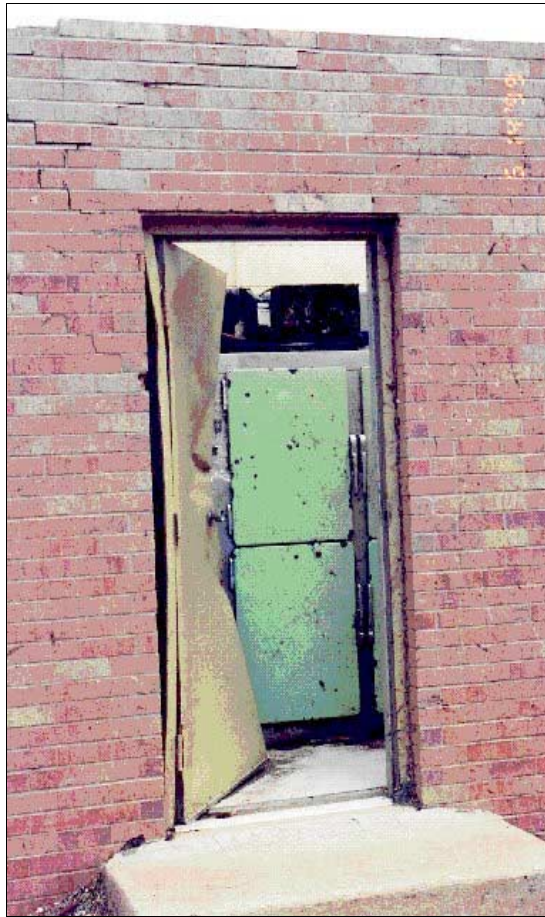
Figure 5-28 shows a steel door that appears to have been opened by impact of a heavy object. This door at Kelly Elementary School in Moore, Oklahoma, led into an area where the roof was completely missing. The breached door may have caused an increase in load that propagated damage to that part of the building envelope. A nearby door, which was also heavily impacted, but did not open, was located in an area of the school that saw less damage to the wall and roof of the building.

***FIGURE 5-28: Damaged door most likely opened by impact with heavy object. Kelly Elementary School, Moore, Oklahoma.***
