MISHAP INVESTIGATION REPORT 01-07

- 1. THIS IS THE FINAL INVESTIGATION REPORT OF AN INCIDENT (WITH POTENTIAL).**
- 2. SUBJECT: MULTIPLE ENGINE FAILURES DUE TO SALT INGESTION AT LOW ALTITUDE OVER NORTH ATLANTIC AT NIGHT**
- 3. EQUIPMENT:**
 - a. Aircraft: Lockheed WP-3D
 - b. Registration: N42RF
- 4. PILOT-IN-COMMAND:**

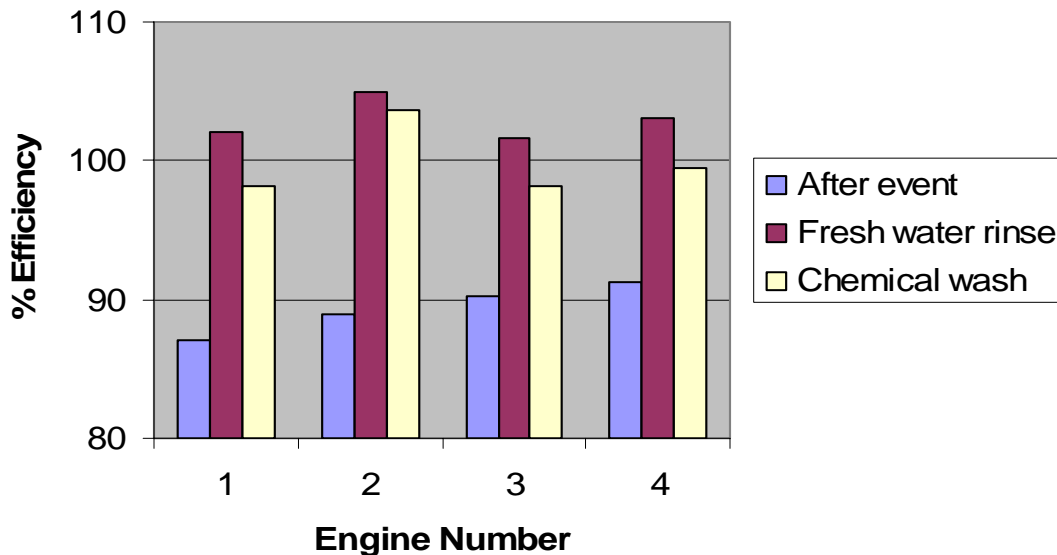
Engine Efficiency Run Results

These are slightly lower than they were in St. John's after the fresh water rinse but the difference can be attributed to the temperature and density difference between Jacksonville and St. John's. The various engine efficiency runs are depicted graphically below.
