Recent Electrical Events Highlight Equipment-Failure Hazards

February 14, 2007
 LANL 2007-0004

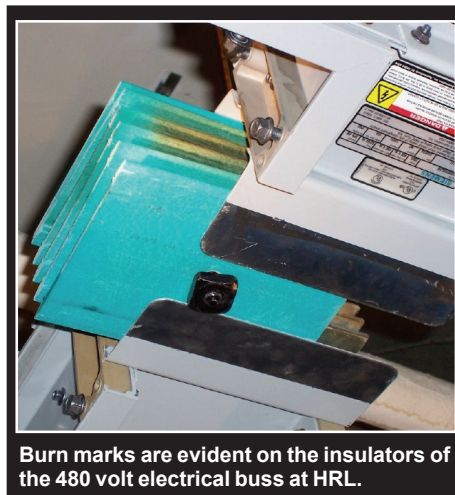
Burn marks are evident on the insulators of the 480 volt electrical buss at HRL.

NA-LASO-LANL-HRL-2007-0001
Evacuation Due to Electrical Upgrade Installation Flaw (Significance Category 3). On February 7, 2007, at TA-43-0001 (Health Research Laboratory), a facility technician on routine rounds noticed a burning smell in the basement equipment room and notified the operations manager and engineering lead. They detected unusual heat (235 degrees F) coming from an area around an elbow on the 480 V electrical buss entering the building. Portable generators were installed and power to the building was shut down. KSL electricians isolated the buss and found that the affected interface joint adjusting nuts had not been properly torqued and that one of the four stabs was not properly installed when the HRL's 480-V power was upgraded approximately two years ago. There was no exposure to hazards in this event, and all work was performed safely. The overheating of the facility power feed would not have resulted if the errors had been detected during construction upgrade inspection. Such problems can be addressed through full implementation of a new Project Management-Construction Management (PM-CM) process for inspecting and approving new and upgrade construction.

- Better processes for construction inspection through Project Manager Construction Manager and Industrial Hygiene and Safety (IHS) electrical inspectors will improve the inspection

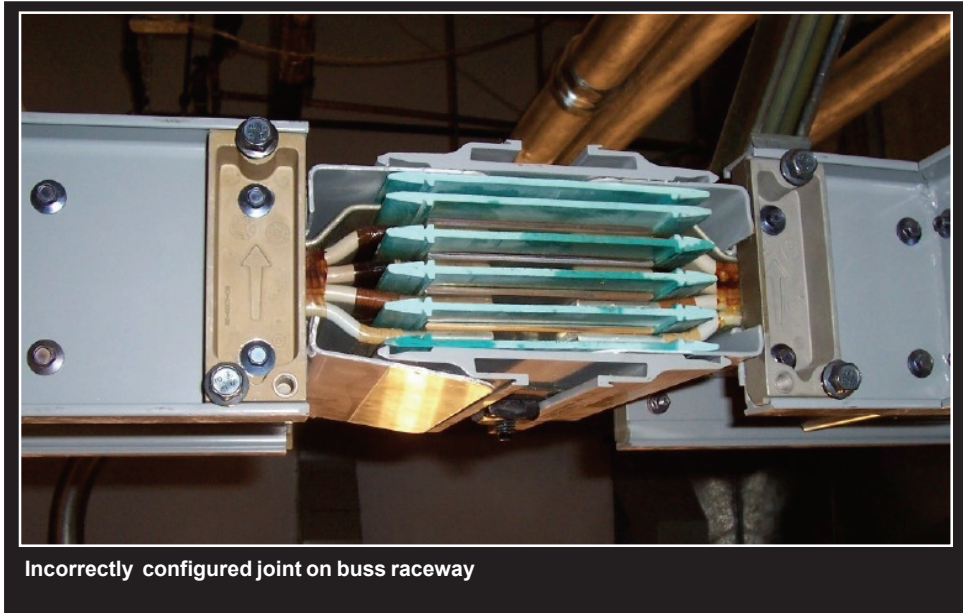
Incorrectly configured joint on buss raceway
