# Post Mortem Failure Assessment of MODUs During Hurricane Ivan

September 2004

**Minerals Management Service**

**Hurricane Ivan: MODU Investigation & Recommendations Sept 2004**

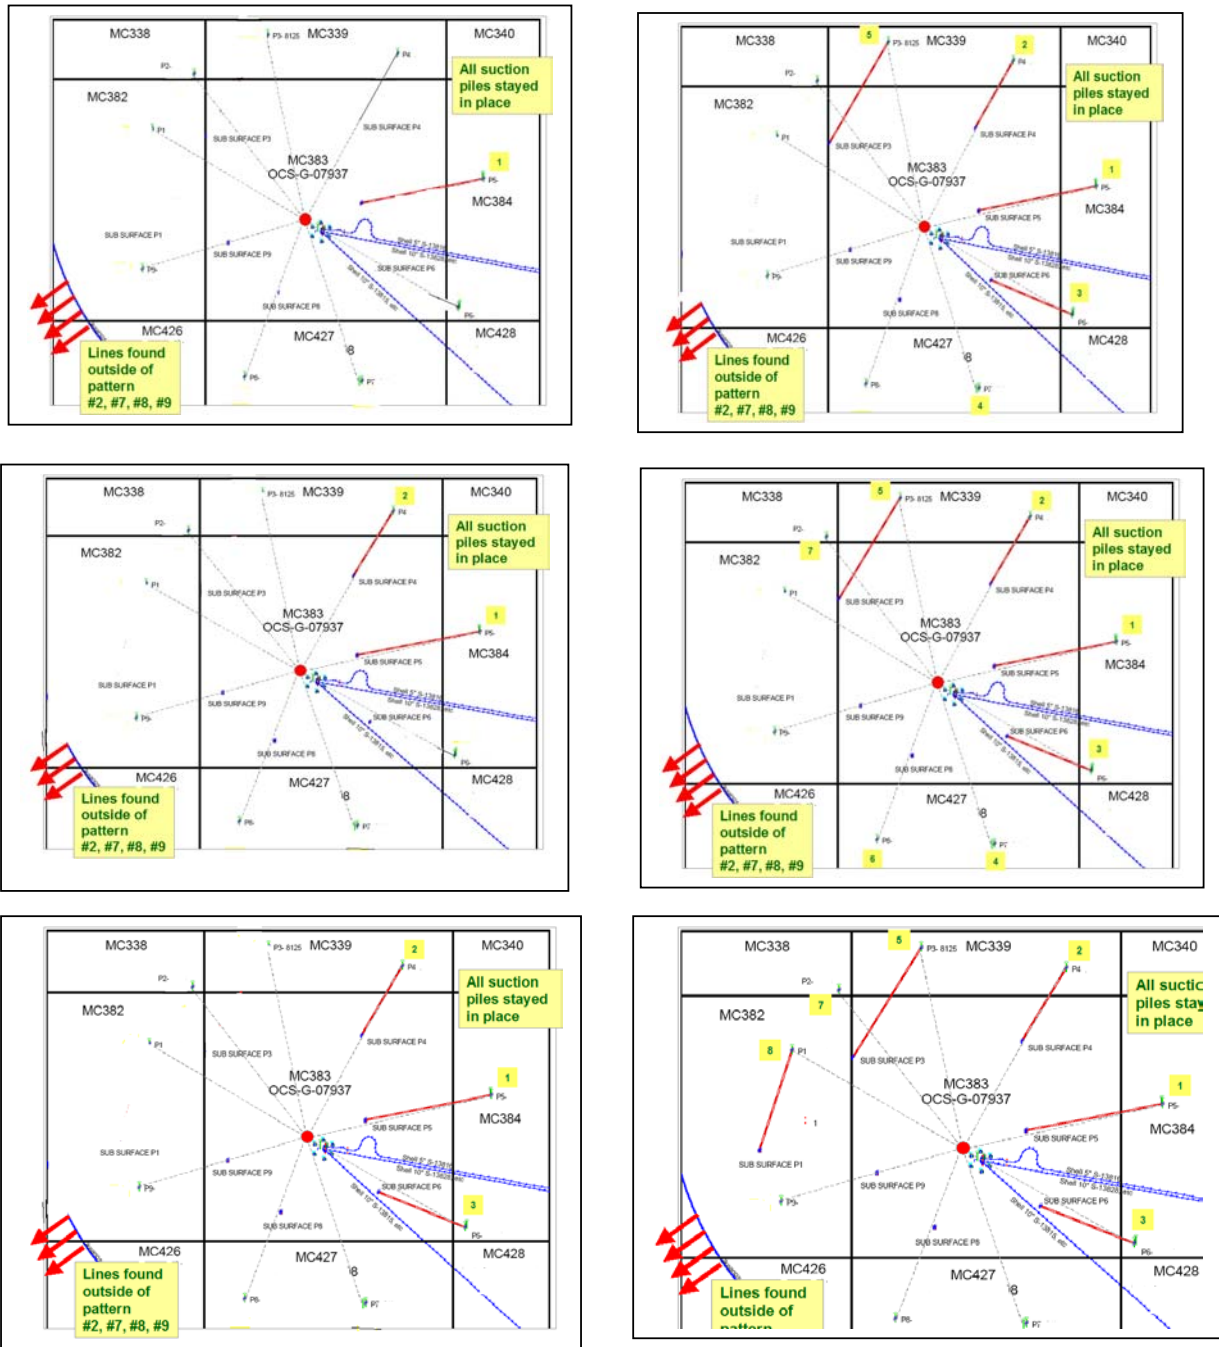
The sequence of failure as determined from the position of the equipment after the rig departed the site can be visualized by following the sequence of diagrams below in Figure 12 in order from view 1 through view 6. The sequence starts in view 1 with the 1<sup>st</sup> line breaking, line #5. The second view shows the 2<sup>nd</sup> line breaking is #4, and so on. The vessel moved off to the south-west based on the way the mooring lines on location were found and thus the moorings would most likely have broken with the wind to the west prior to the eye passing by the location.

Figure 12: Showing the Most probable Line Sequence of Failure: Views 1-6 (Ref (21)).

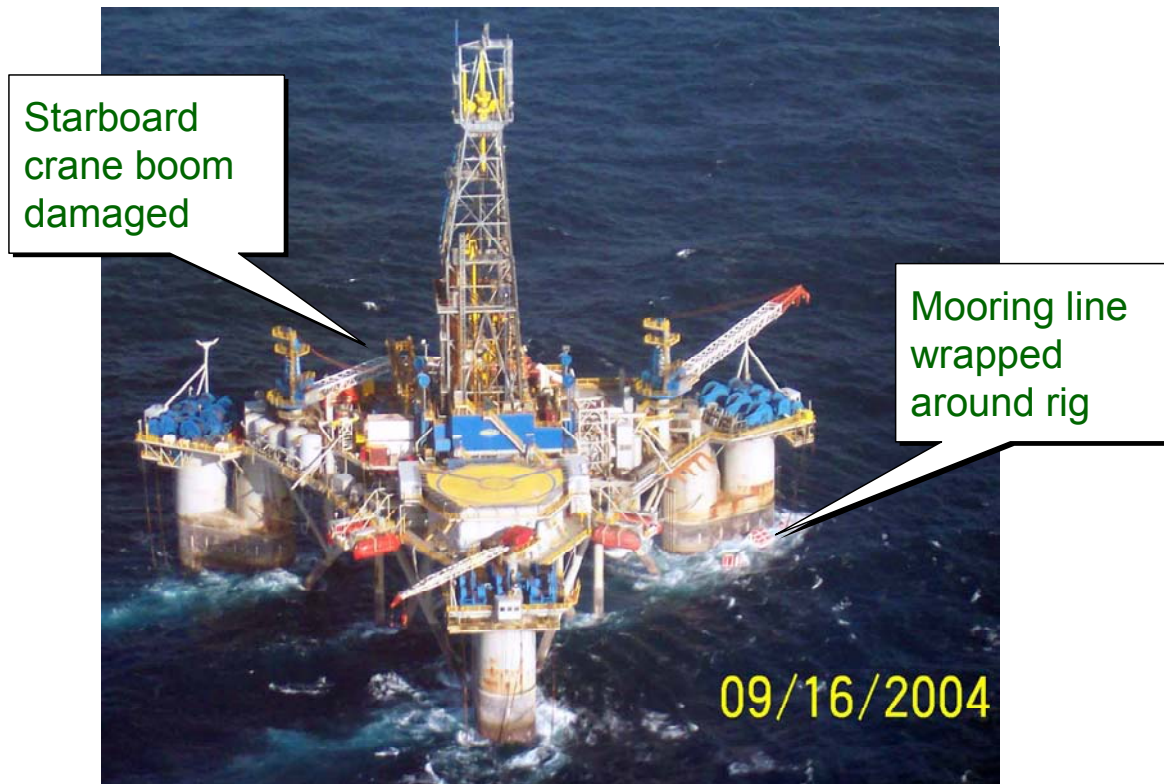
The damage to the rig was significant but it returned to work as soon as the repairs were complete and new mooring equipment procured. The damage can be summarized as follows:

Figure 14: Noble Jim Thompson with damages noted.

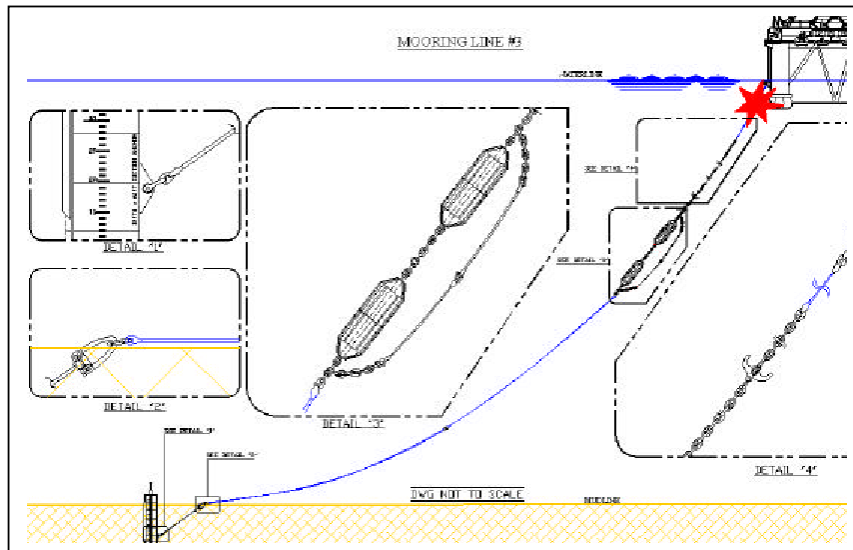
Figure 15  
Illustrating the break position for line #5 near to the fairleader

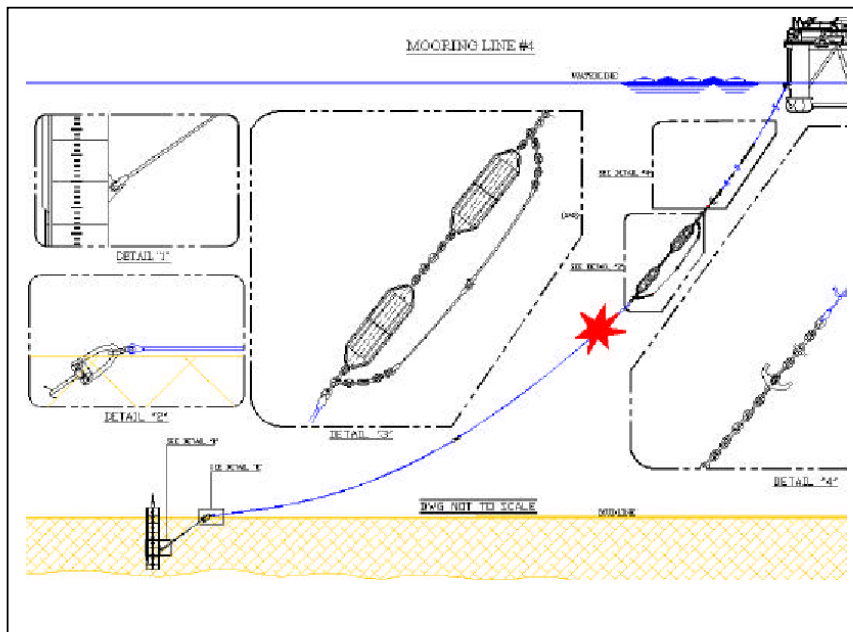
Figure 16  
Illustrating the line #4 the 2<sup>nd</sup> line to break in the wire below the buoys

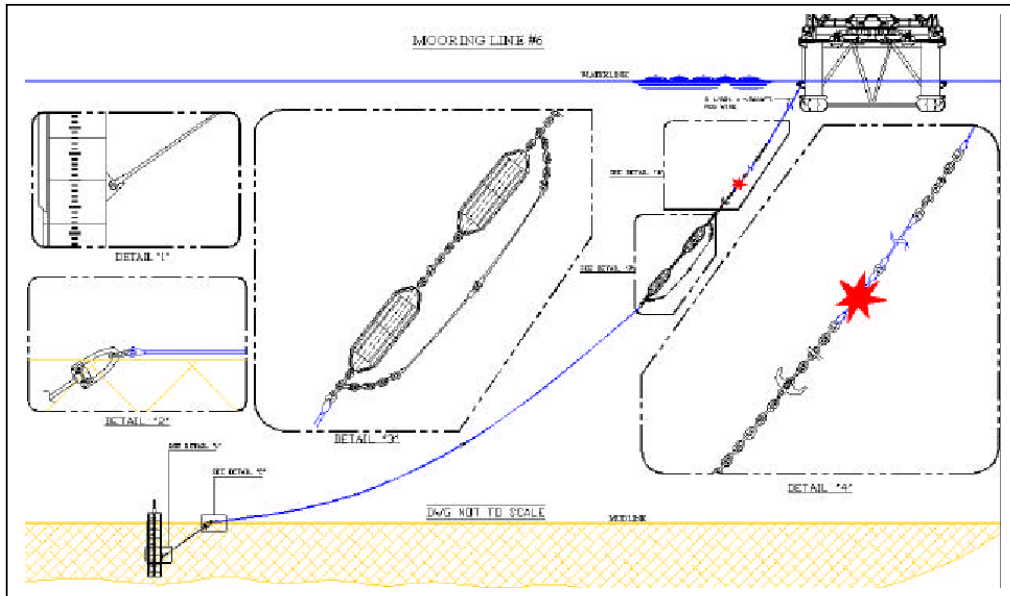
Figure 17 Illustrating the Break Point in 3-5/8" connecting wire Line #6

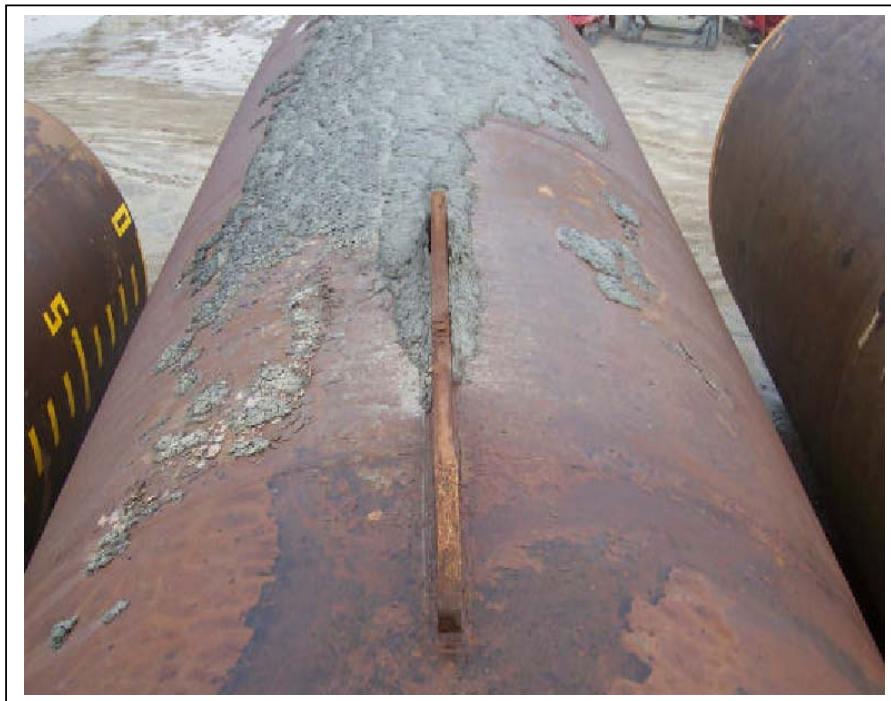
Figure 18: Shows the Damaged Padeye on the Suction Piles. The padeye angle was about 45° at the time of failure.

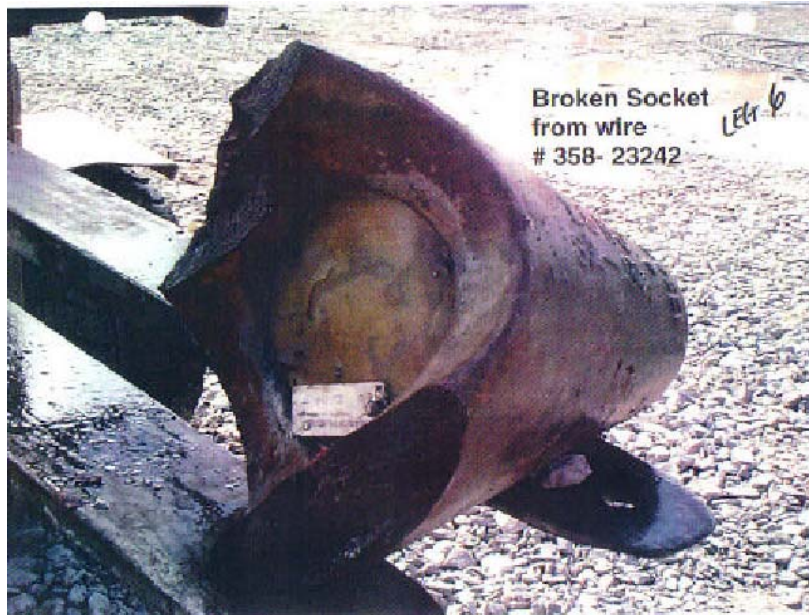
Figure 19: Broken socket from wire on Leg #6

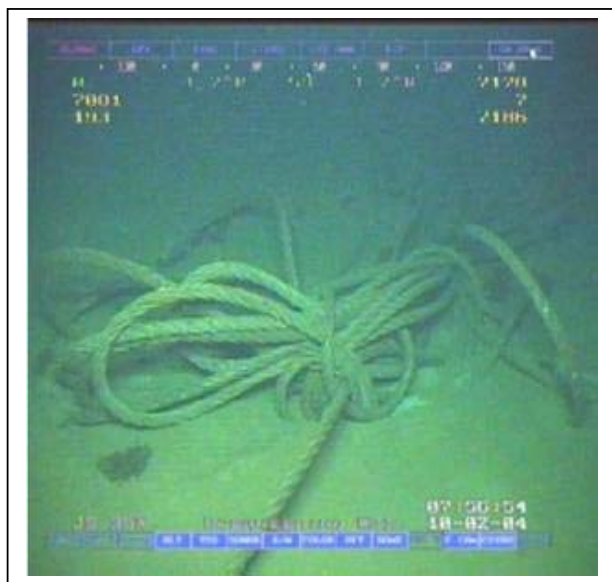
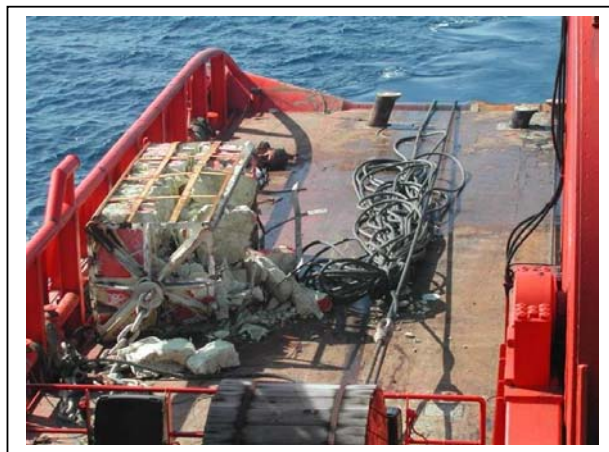
Figure 21: Photos taken during the recovery process of the wire.

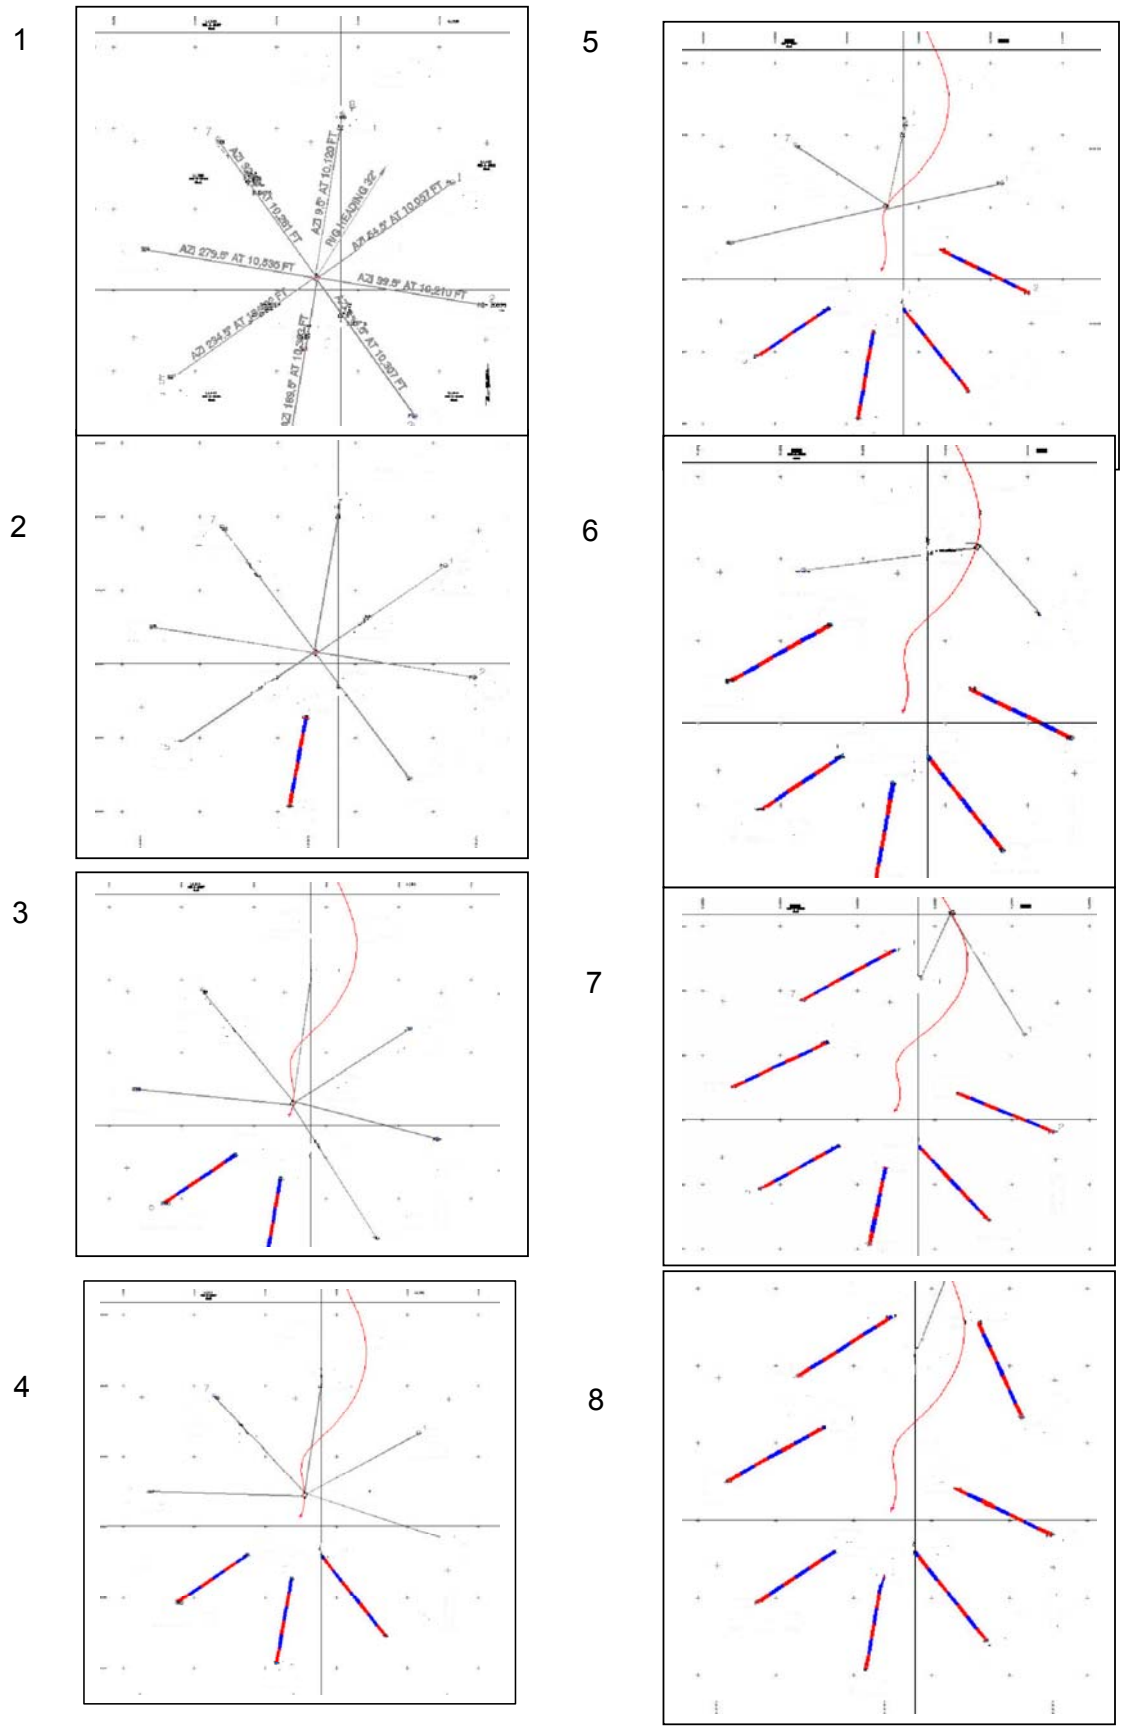
Based on the sequence of the breaks and the direction determined by the lines on the seafloor after the incident the break must have occurred close to the time the storm center was on the same latitude as the Nautilus. A break at this time would allow the unit to move north propelled by the northerly winds on the east side of the storm.

Figure 26: Sequence of Likely Mooring Line Failure – depicted as steps 1-8 (Ref 25)

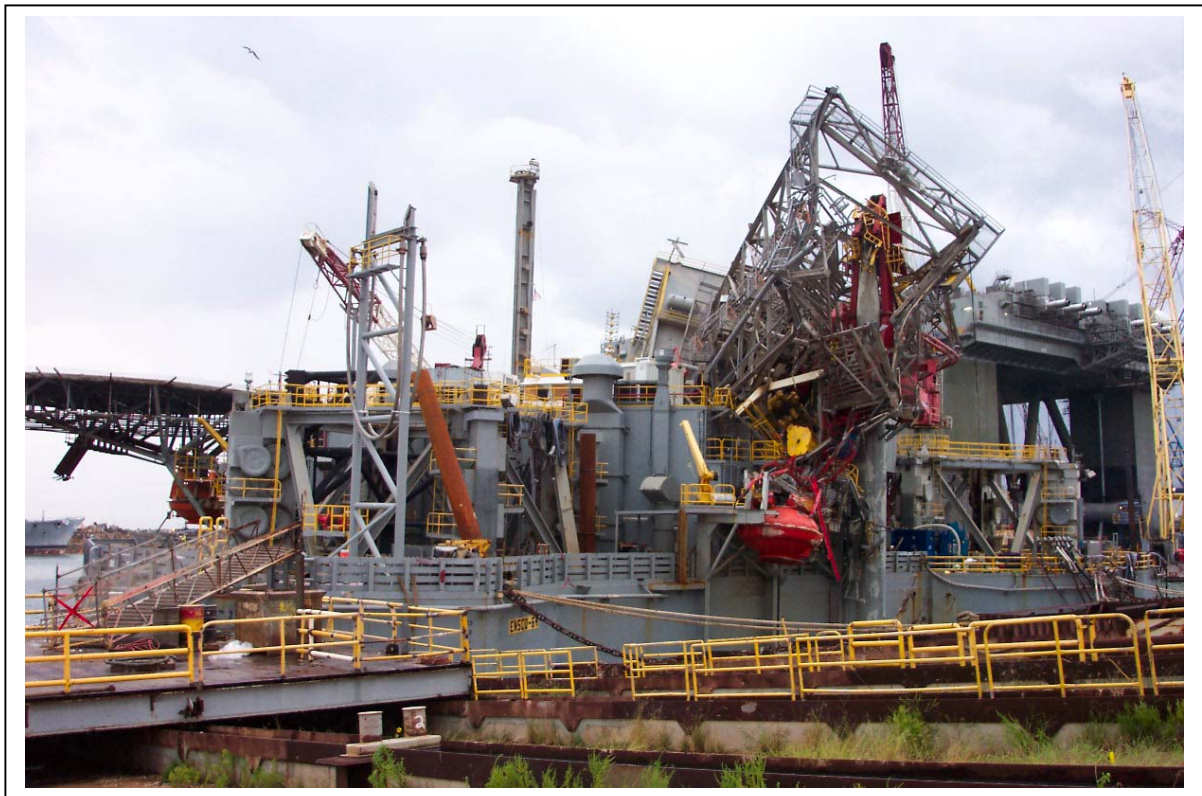
Figure 33: Photo showing the derrick collapsed.

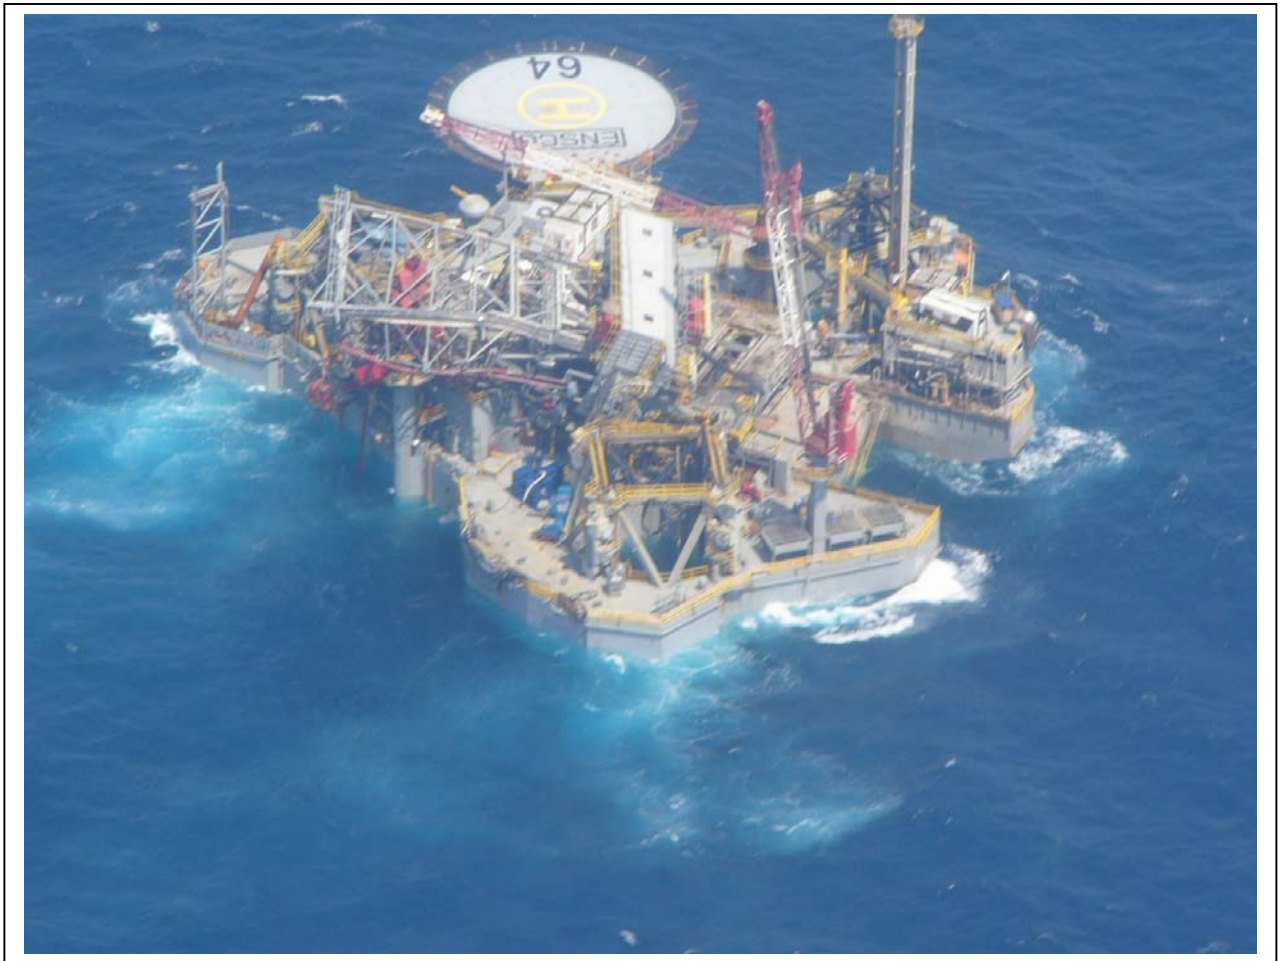
The hull drifted off location and Figure 34 shows a photo taken of the unit after it drifted 40 miles south of location. At Main Pass 280, the bottom of the legs were found laid over to the northwest. The legs had to be removed before a drilling rig could be mobilized to attempt well bore salvage. The well was leaning about 16 degrees toward the west from below the mudline for one full joint, which appeared to be straight. The pipe was cut to about 50 ft above the mudline. All casings were collapsed about 6' above a collar on the 2nd joint above the mudline with an angle greater than 90 degrees. The drive pipe deck and tensioner were laying in the mud at the base of the drive pipe.

The wave height as measured at a nearby buoy was originally reported to be 83 ft. The legs parted below the rig and did not penetrate the hull. Only one tank took on water.

Figure 34: Photo of EnscO 64, 40 miles south of location during recovery efforts.

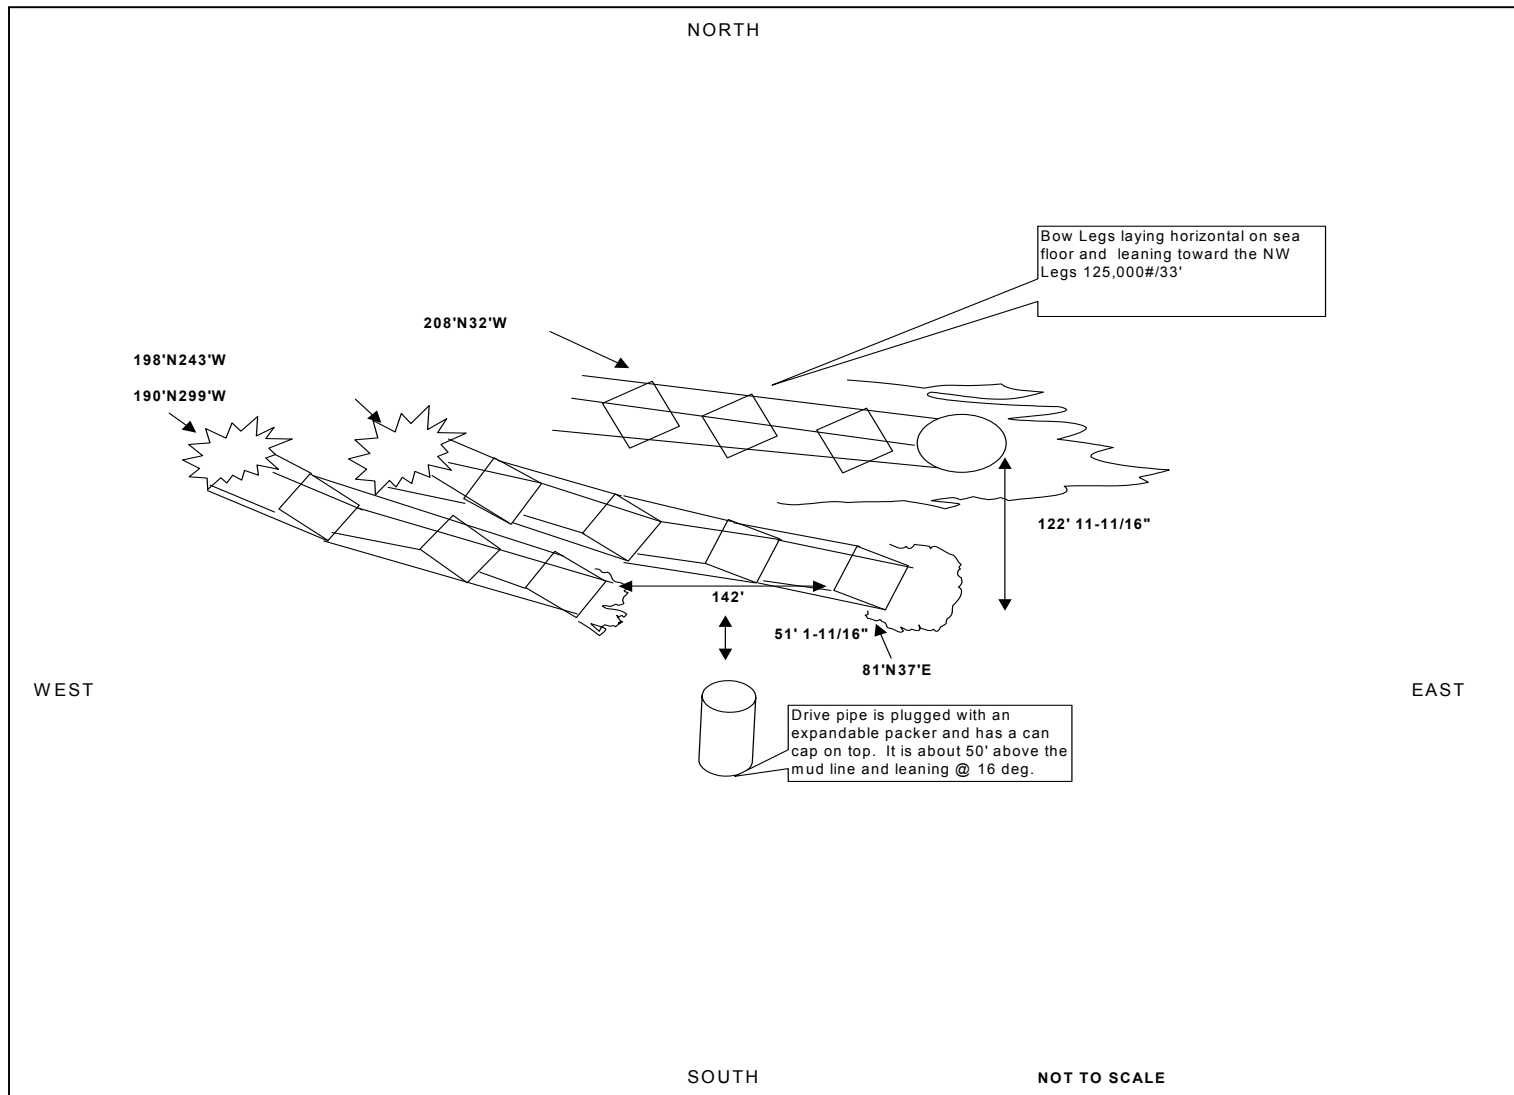
lengths is the H chord. It is the lowermost southern chord and it enters the seabed at the 150 ft mark .The K braces appear intact right up to the break.

Figure 35: 3 legs of Enscø 64 on the bottom, after Hurricane Ivan Port and starboard legs are laying on each other. Bow leg has been excavated and spud can and leg laying horizontal on the seafloor. All small debris was removed from the sea floor.

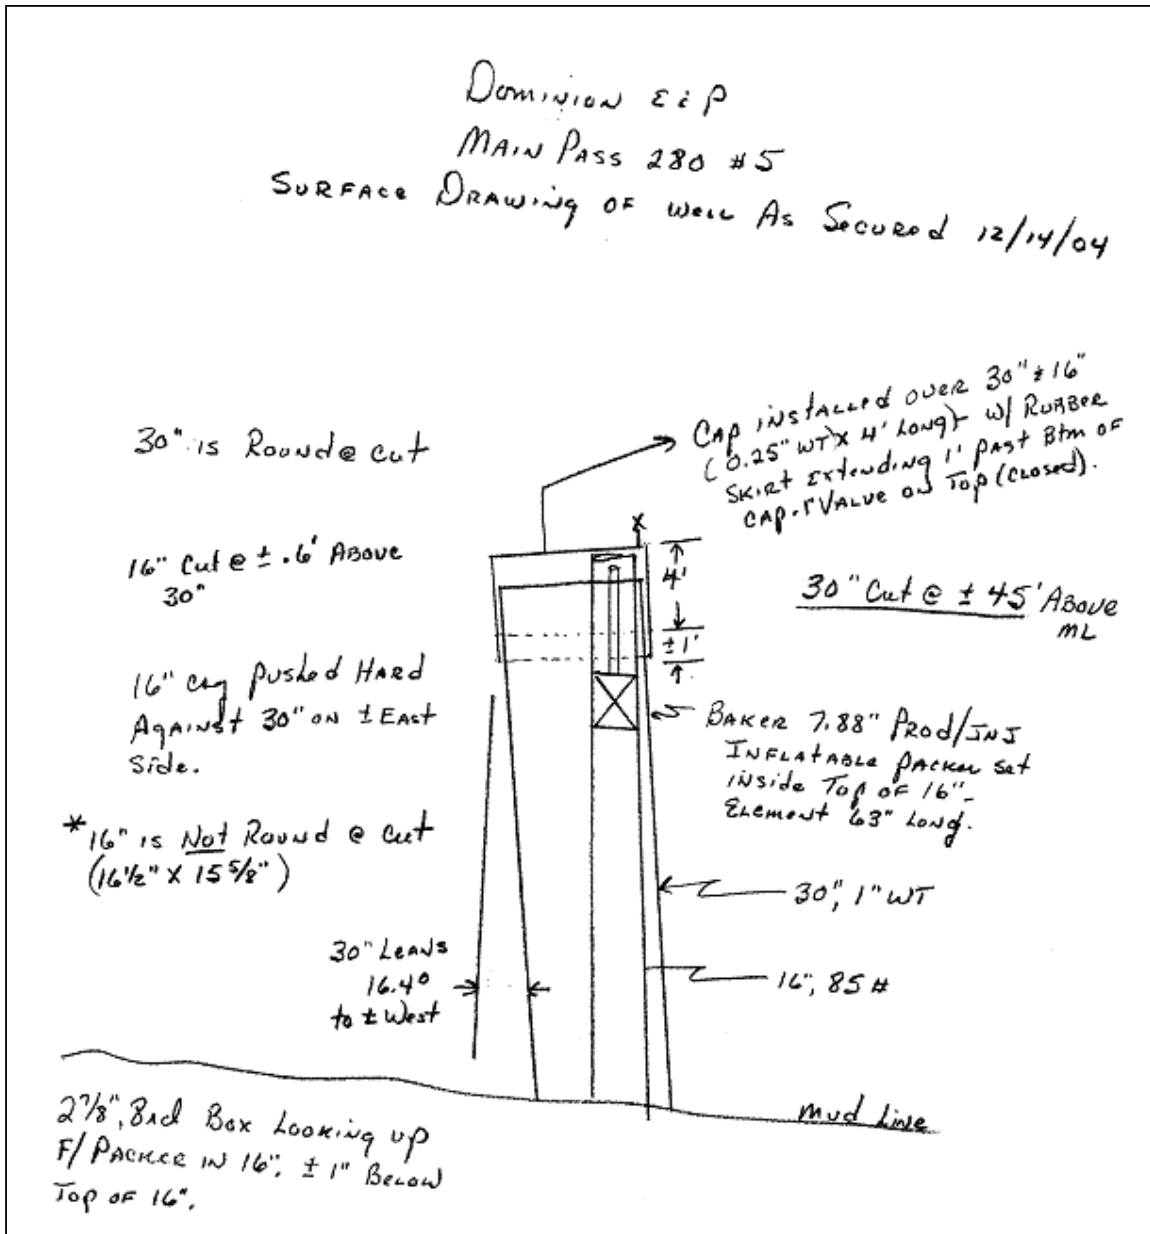
Figure 36: Well #5 after the incident.

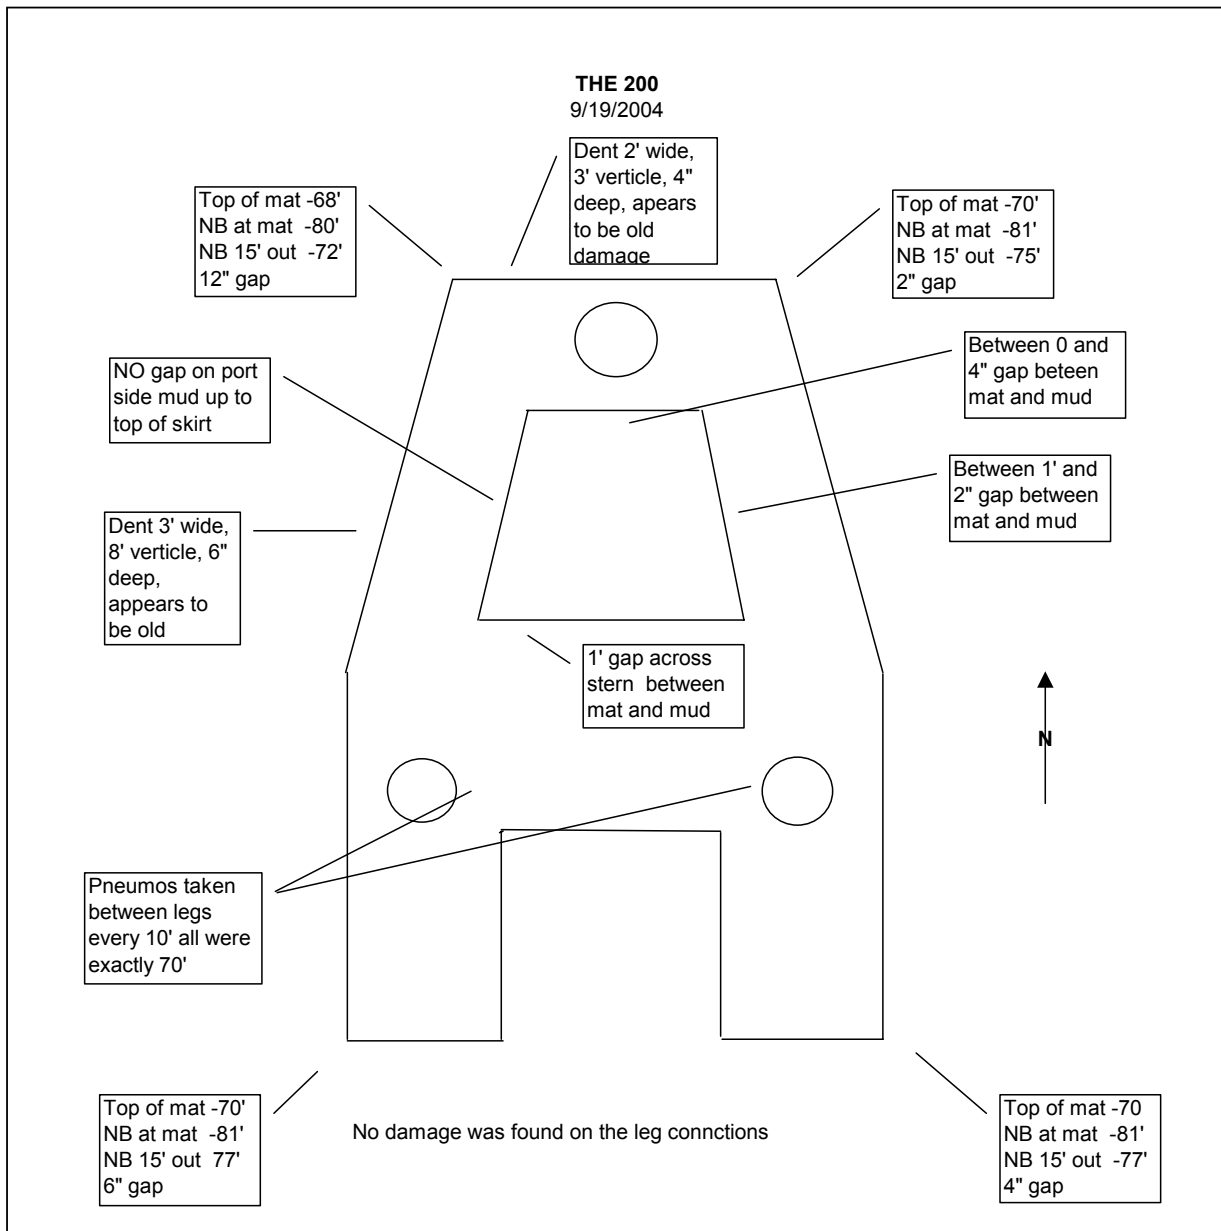
Figure 40: Sketch showing the situation at Location after Hurricane Ivan came through

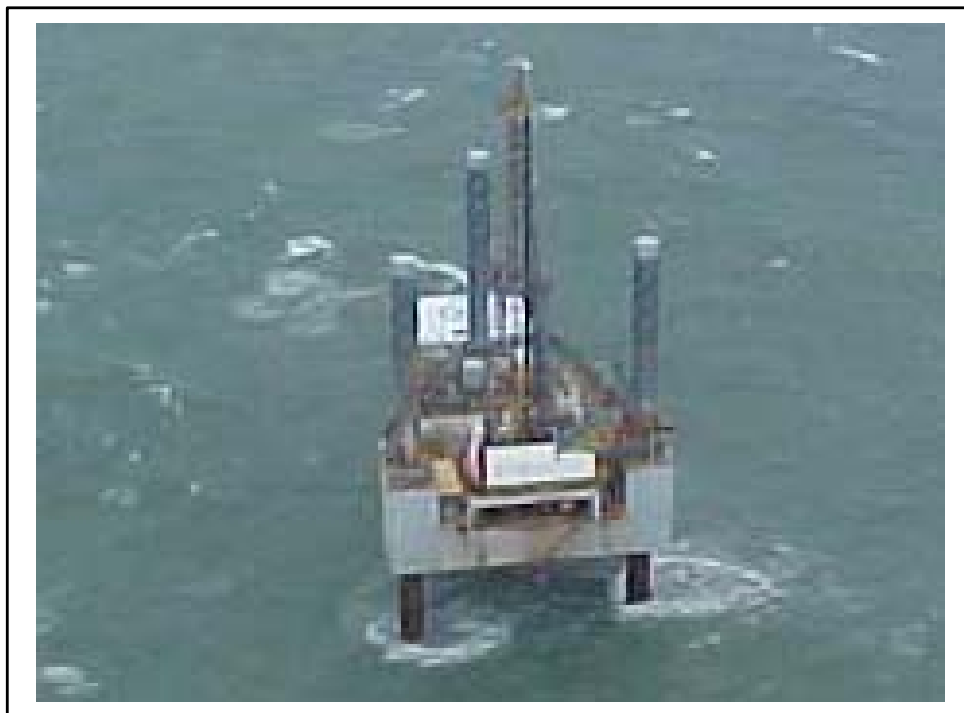
Figure 42: THE 200 Photo taken After the Storm (note effect of currents on the legs)
