# Post Mortem Failure Assessment of MODUs During Hurricane Lili

October 2002

**Minerals Management Service**

**MMS Order No.: 0103PO72450**

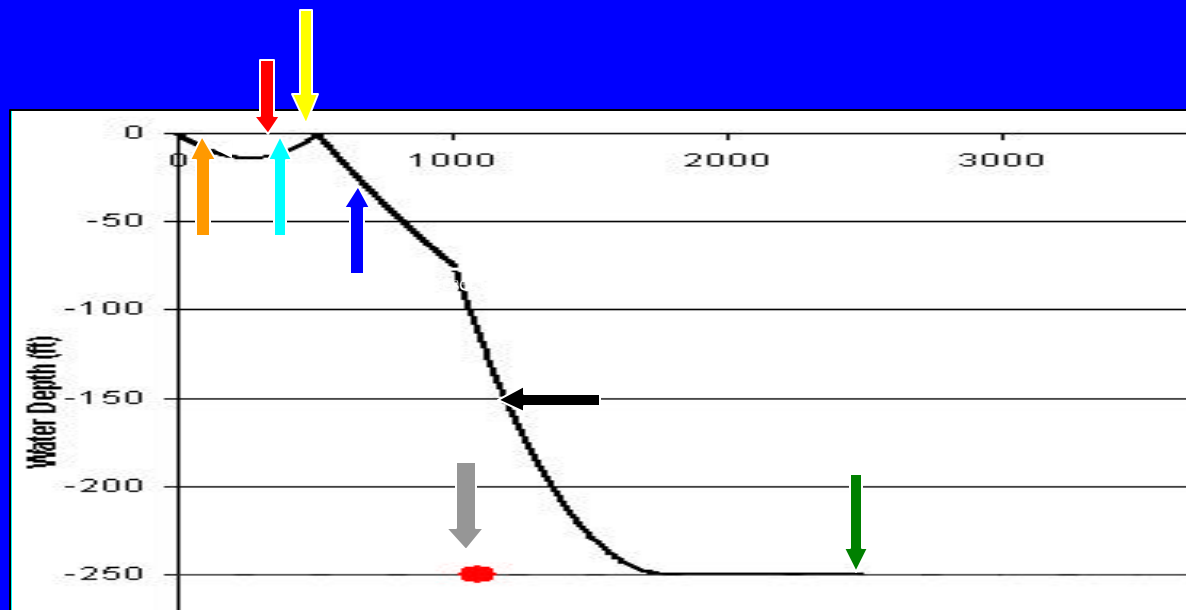
Figure 13: Showing location of Failure on Line #3.

No. 3 leg failed in the first section of rental wire between the rig chain and the buoy as shown on the Figure 13.

No. 3 Leg Catenary Over Pipeline

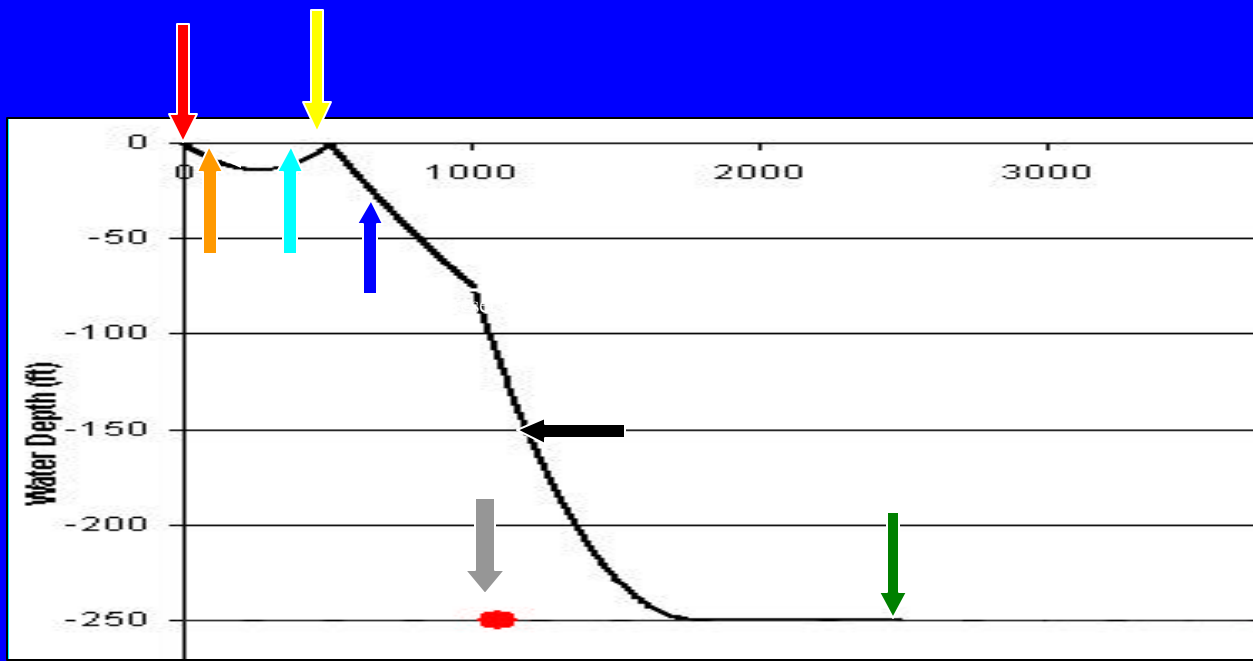
Figure 14: Showing location of Failure on Line #4

No. 4 leg failed at or near the fairlead on the rig chain as shown on the Figure 14.

No. 4 Leg Catenary Over Pipeline

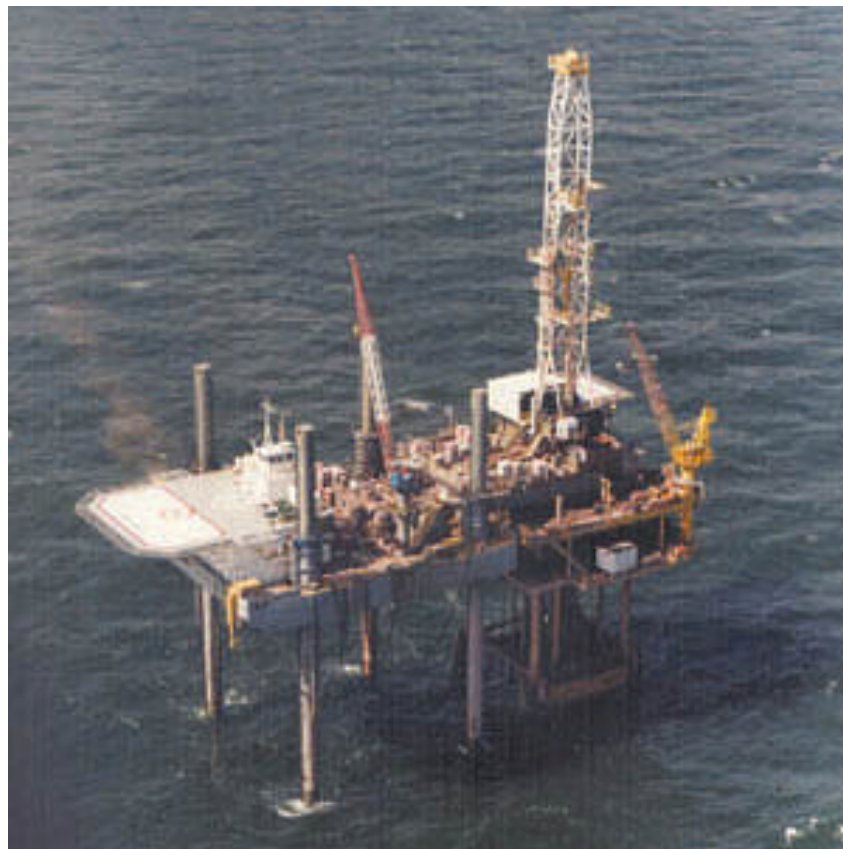
**Figure 17: Nabors Dolphin 105 on location working at a fixed platform.**

This mat supported 4-legged Penn Engineering designed rig was found with the mat floating upside down piercing the ocean surface and the hull sunk some distance from the location. There was not sufficient information to determine the sequence of events from observed logs. The rig was within 15 miles of the central path of the storm in the quadrant producing the worst waves and winds. The design conditions were for a 43 ft wave, 100 kt winds with a 1.5 kt surface current. Although the design would likely have been exceeded by some hindcast wind and wave, the location in Hurricane Lili was subject to breaking waves of 43.3 ft which would have vastly increased the expected loads. The combination of this together with a 4.3 kt current hindcast by Oceanweather would have caused the rig to be well beyond its design capability. Additionally the wave crest elevation would most likely have impacted the hull.

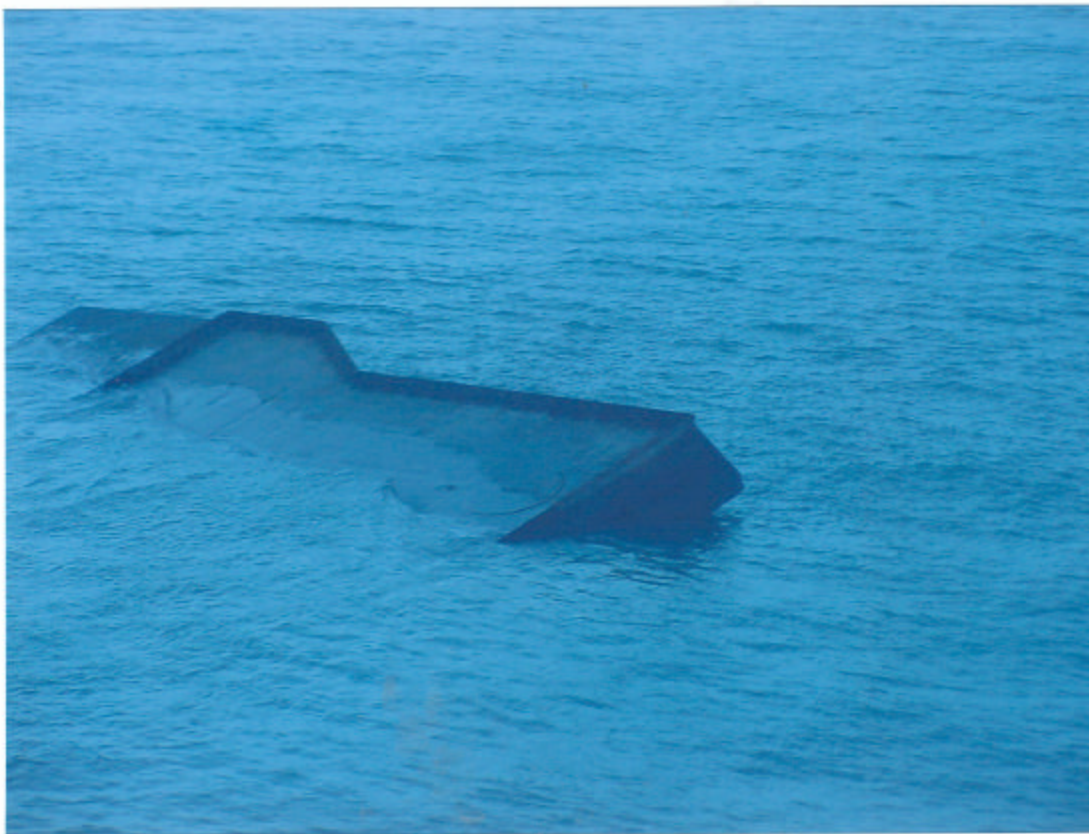
**Figure 19: Mat of Dolphin 105 showing skirts protruding upward: indicating mat is upside down**

The rig capsized in about 35 feet of water during Hurricane Lili on 2 October in Ship Shoal Block 126, south of Morgan City, Louisiana. All personnel had been evacuated ahead of the storm. The Dolphin 105 was under contract to BP at the time of the accident. Nabors Offshore awarded wreck removal to specialists Bisso Marine a salvage contractor to remove the rig.

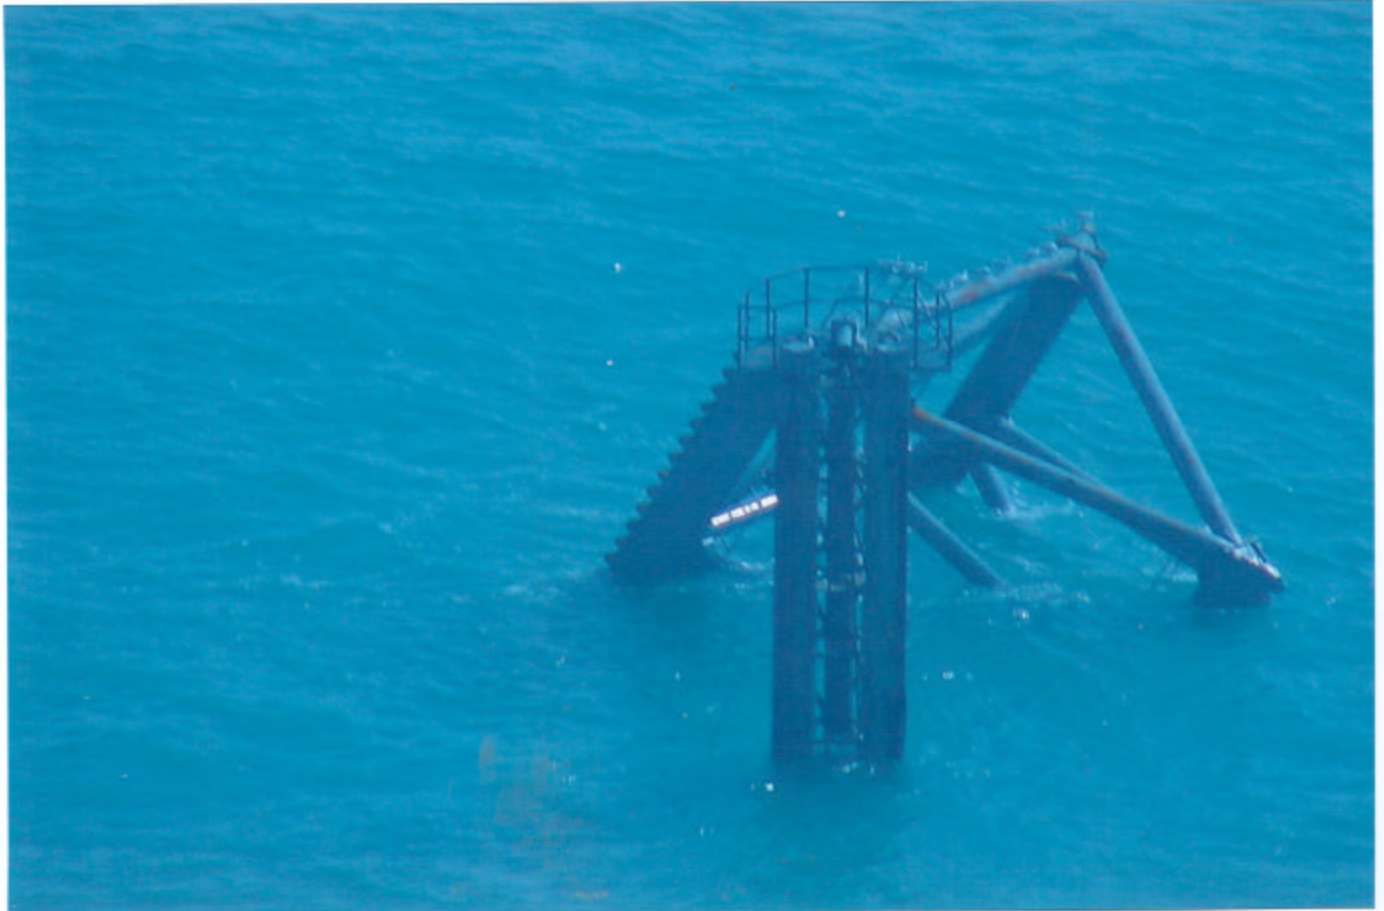
**Figure 25: Leg attached to hull of Rowan Houston at Sunk Location 1600+ft NW of original location**

The diagram above shows some of the debris path. The Hull was about 1600 ft off location to the NW. The legs had been severed and the bottom part remained on the original location. The crane boom is shown in relation to the rig about 365 ft from the platform. This view is very subjective and should only be relied upon for a general view of the area and situation.

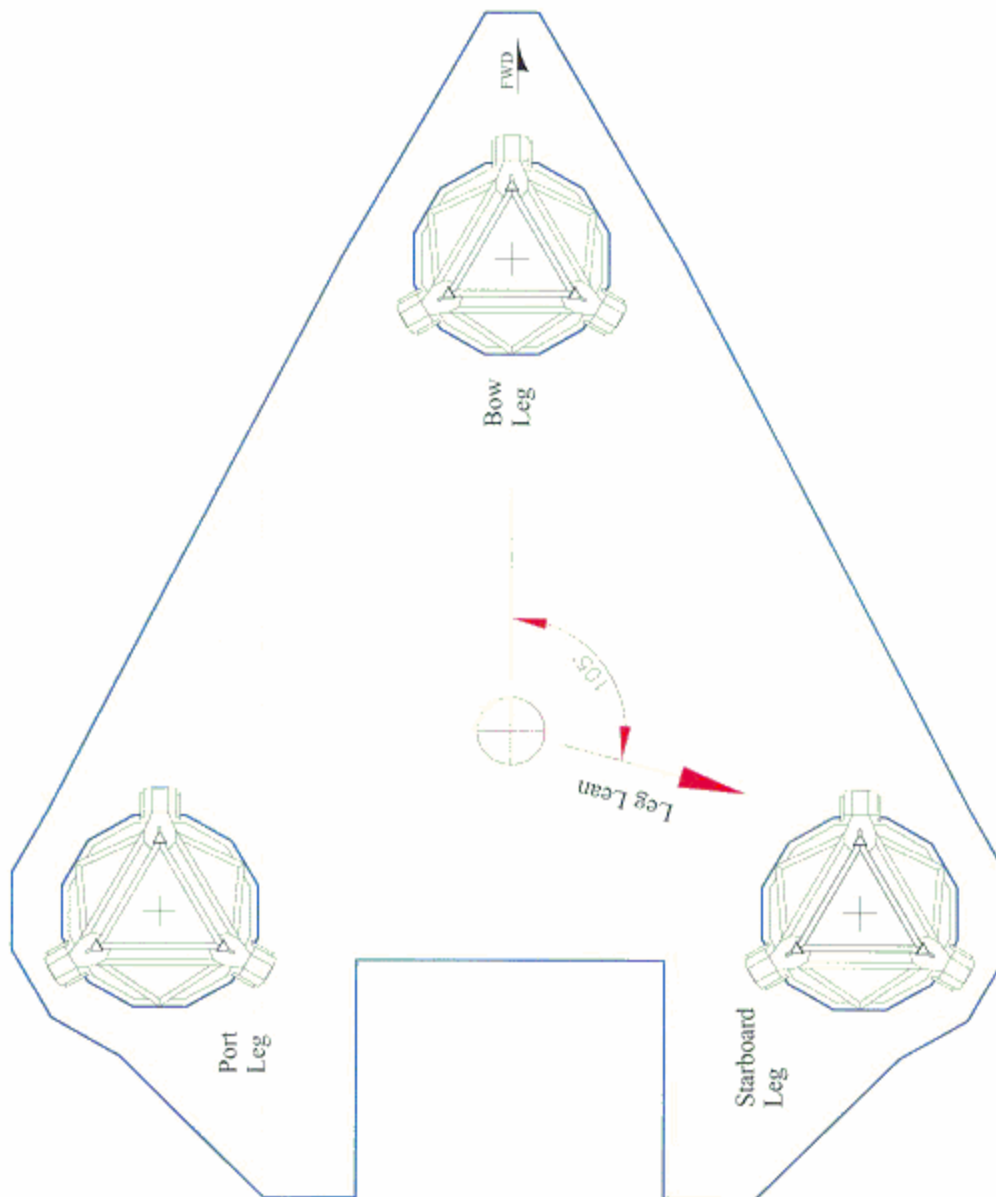
**Figure 31: Plan View of Rowan Houston showing direction of leg leaning prior to failure.**

The following diagram indicates the direction the legs were leaning:

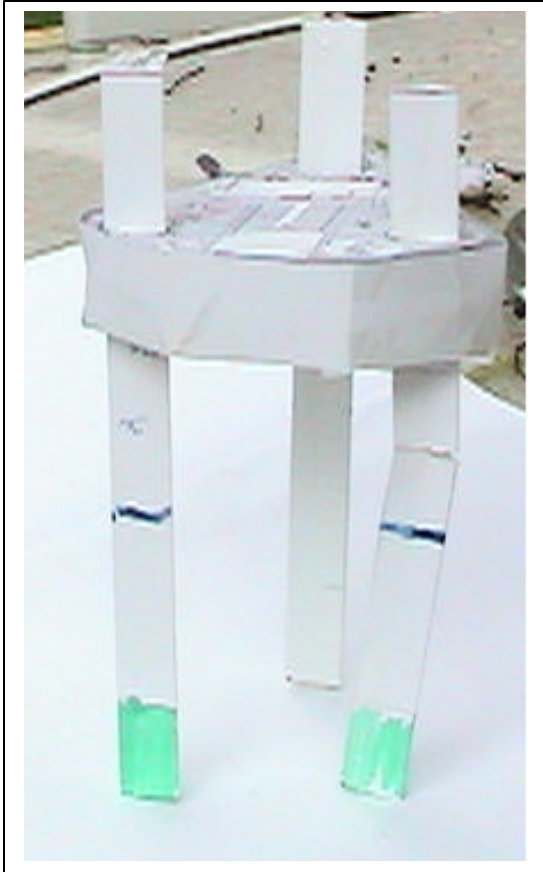
**Figure 32: Small Cardboard Replica of Rowan Houston**

The forces on location are greatest at the lower guide. The port side of the port leg was severed at (roughly) the 225 ft mark. The starboard chord of the port leg was torn above the 225 ft mark and parts of the chord extended to 260 ft., a distance well into the hull.

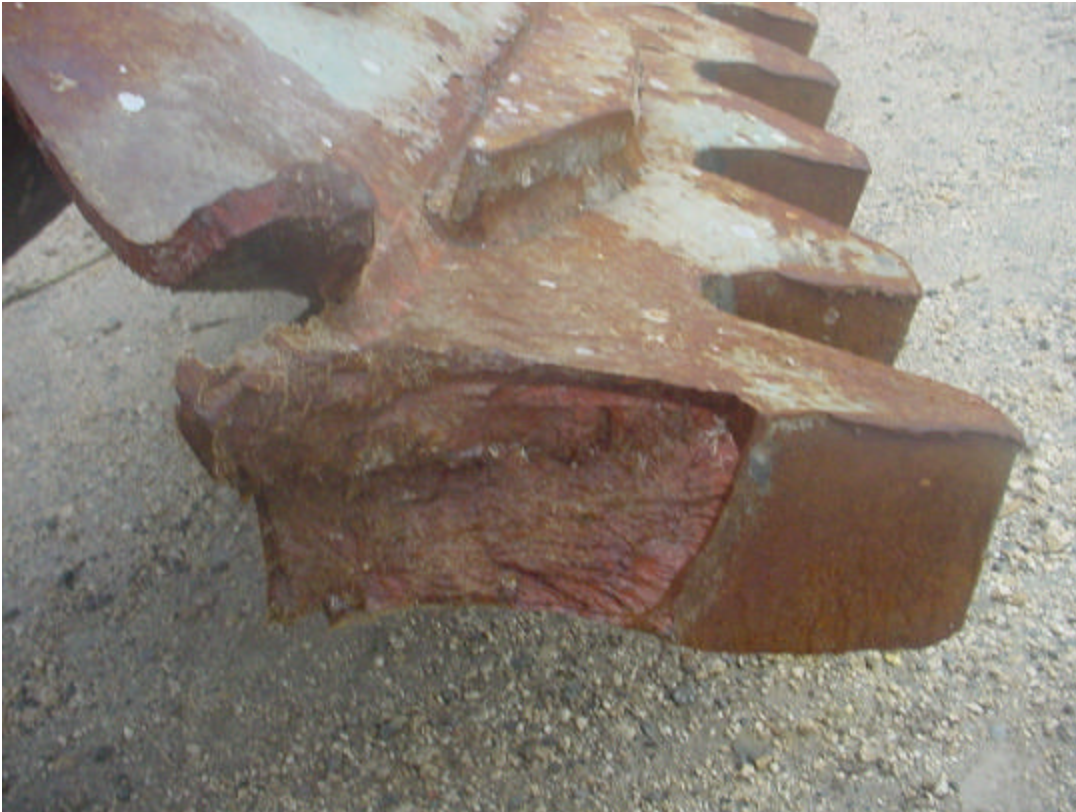
**Figure 33: Photo of bow chord of bow leg showing chord failed only after full capacity was reached.**

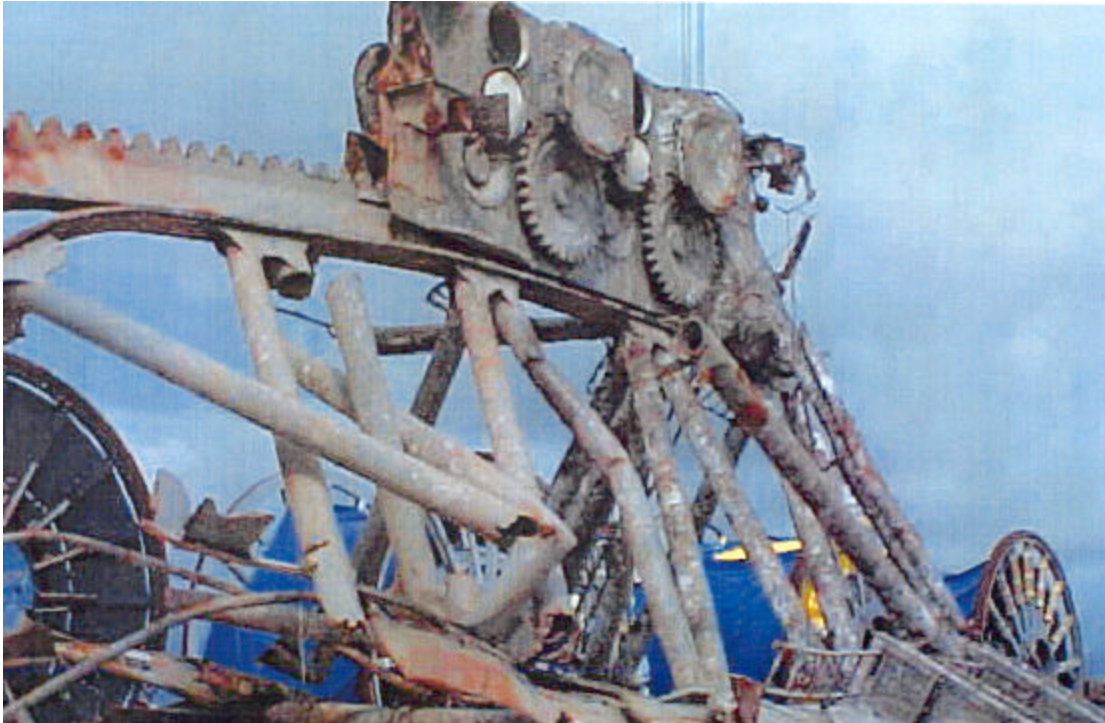
**Figure 34: Starboard leg recovered showing gear train still attached.**

Figure 34 shows the gear train directly attached to the starboard leg. It is clear that the gear train-deck connection failed during the process. The failure of the gear train to deck connection while not an unexpected failure possibility (and this connection is part of the rig design), it has been general experience that this area has not been the first to fail in other rig accidents. Since the Rowan Houston was overwhelmed with the storm to such a great extent, and would not have been expected to survive, when compared to the design event – the initiating event is important only as a means to provide further guidance on another location on the rig to be ever-diligent about, during the inspection process.

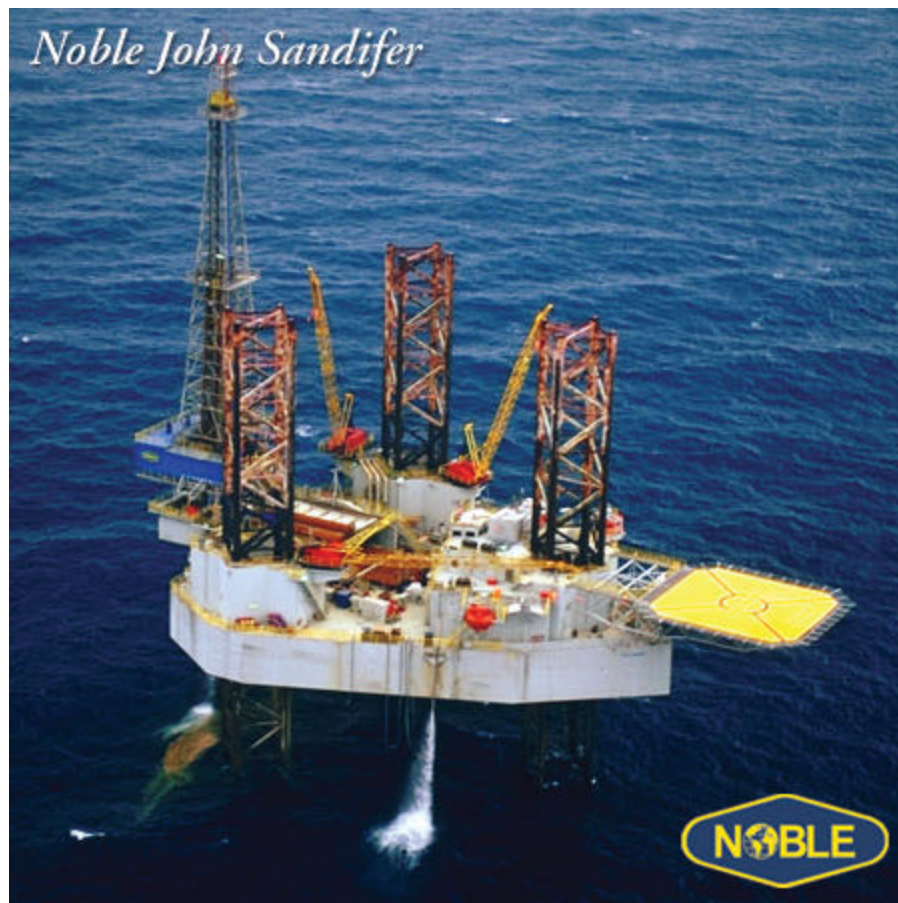
**Figure 35: Noble John Sandifer**

The Noble John Sandifer was 2.8 degrees down by the bow after the storm. Minor structural damage included cracked members and chord damage in the bow leg, port leg and slight damage in the starboard. There was some minor impact to the hull longitudinal bulkheads indicating some impact or possibly storm run-up on the legs. This hull type is particularly resilient to having the hull at an angle, but the loading was quite extreme.

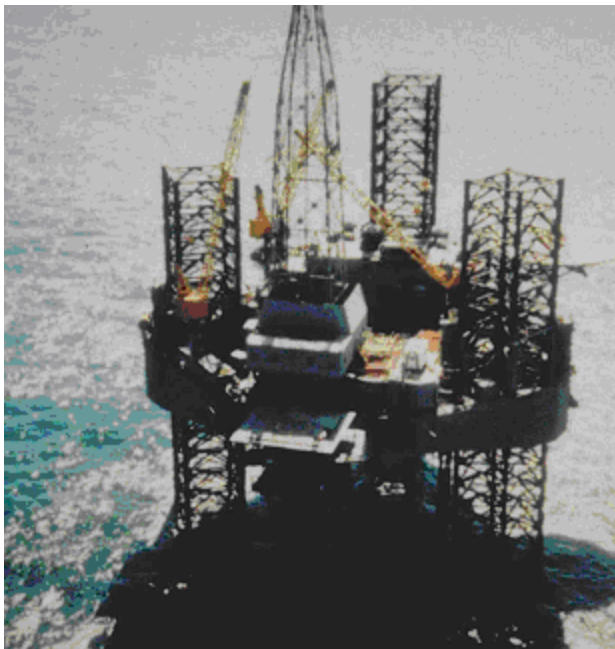
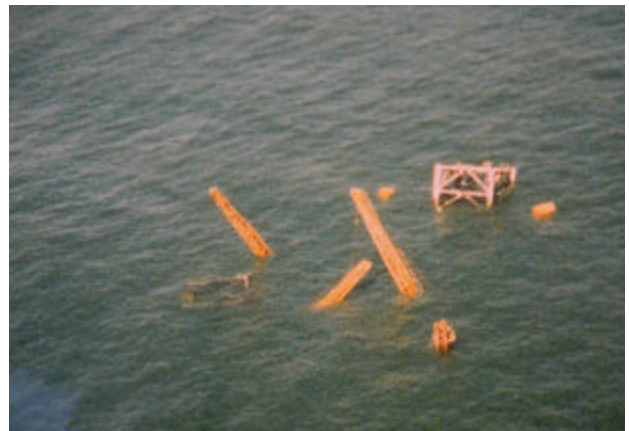
**Figure 43: Penrod 61 – “before” & “after” Hurricane Juan**

A recent incident involving preload limitations was the collapse of the Penrod 61 in Hurricane Juan. The bow leg had insufficient preload capability for the resulting storm, took on extra penetration, which was not responded to by personnel on board. The result was a continuing settlement until the rig collapsed.
