FY01 Mishaps

Fire Reconnaissance, Huron-Manistee NF July 20, 2001

Cessna U206G

Mission: Aerial Observation Damage: Substantial Injuries: 2 Minor Procurement: CWN NTSB ID: CHI01LA225

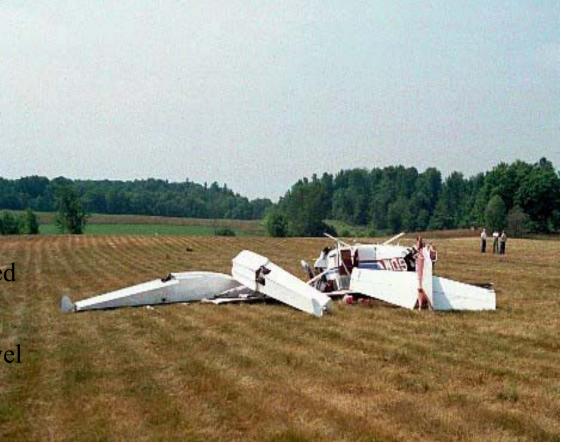
During an aerial observation mission the aircraft failed to respond to the pilots power application. The aircraft was not within gliding distance of an airfield or lake so the pilot maneuvered to land in a field.

The aircraft touched down in a level condition, bounced, then landed hard and flipped on its back.

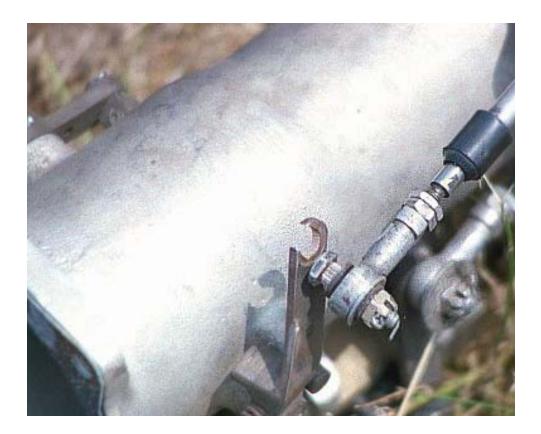
Throttle linkage failed in flight

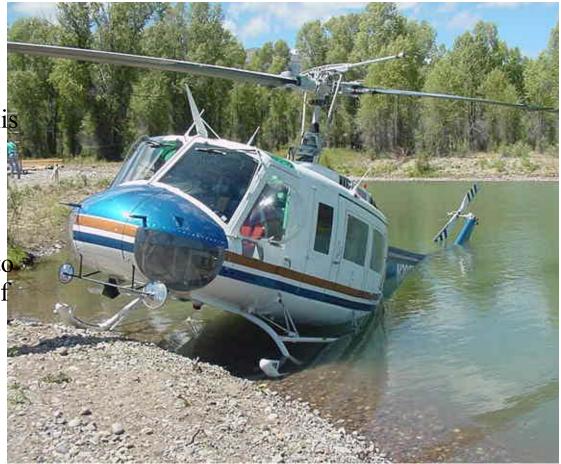
The Bell 205 was operating at a common dipsite when a Bell 212, operating in close proximity, got his long line and bucket tangled in the 205's rotor system.

The 205 pilot did a vertical autorotation to the water, coming to rest with the tail section and part of the fuselage in the pond. The Bell 212 was not damaged.

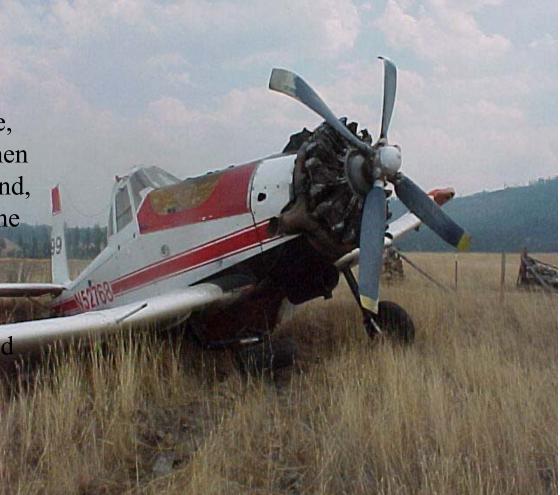
After touch down, witnesses observed the aircraft bouncing, leaving the runway on the east side, moving back across the runway, then spinning after contacting a fence and, coming to rest off the runway on the west side.

The pilot sustained only minor injuries. Assistance quickly arrived to prevent fire.

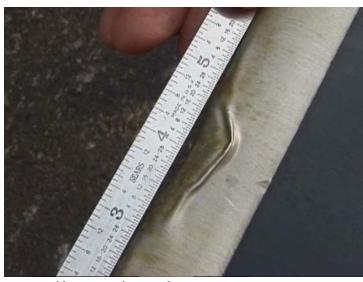
Leading edge damage

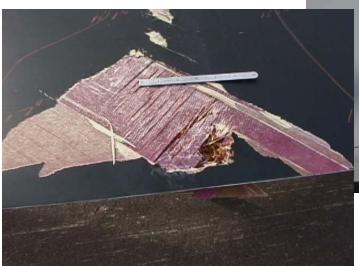
After making a precautionary landing, the pilot noted damage to one main rotor blade.

Main rotor blade damage
