FY02 Mishaps

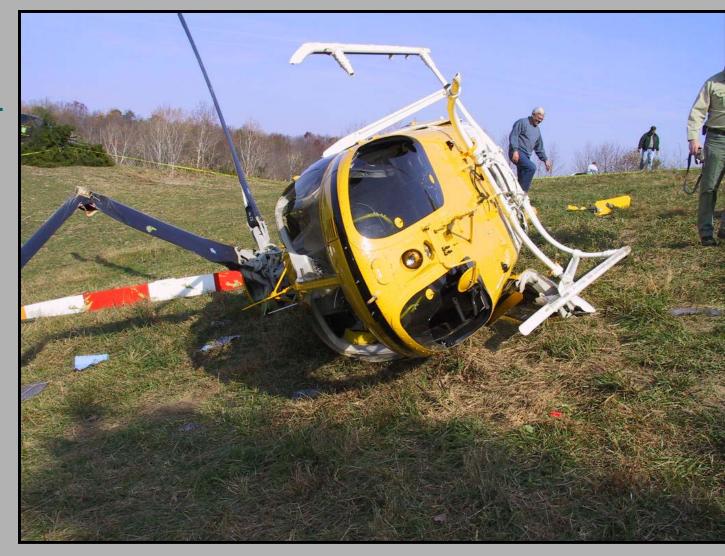
The helicopter was conducting bucket operations when the bucket, which was attached to the cargo hook of the aircraft with a short (approx. 11 ft) lead line, came into contact with the tail rotor of the aircraft.

The pilot received serious injuries and was airlifted to the hospital.

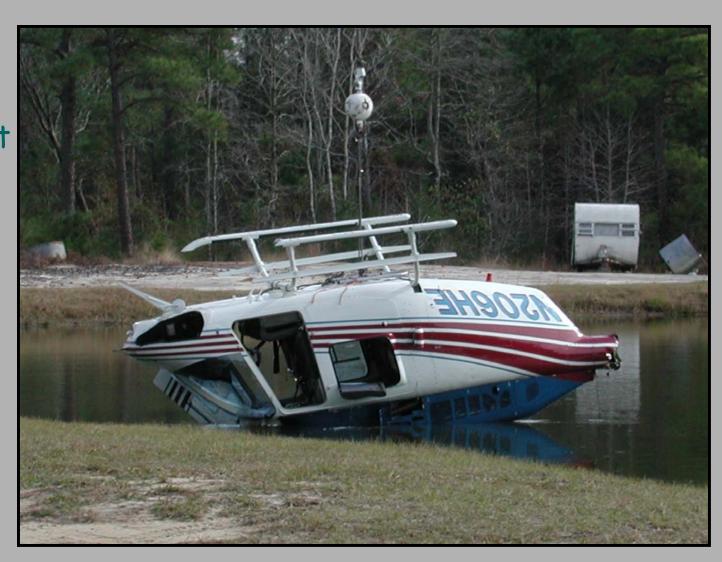
The aircraft crashed while dipping water from a pond.

The Pilot was wearing a PFD. He exited the aircraft from underwater and escaped without injury.

The aircraft sustained substantial damage including: severed main rotors, tail boom severed at attaching bulkhead and damage to the cyclic controls as a result of sudden stoppage.

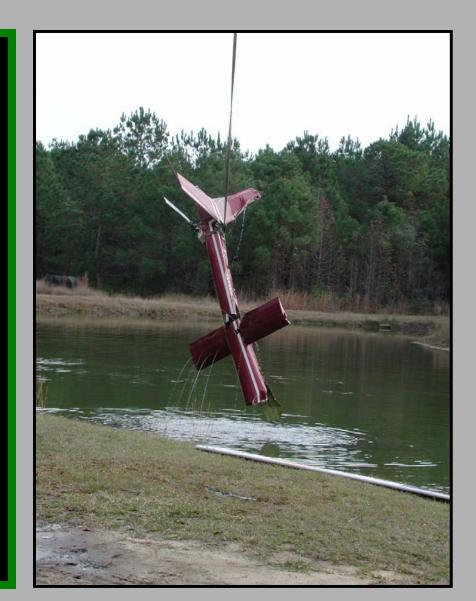
According to the operator, the pilot was attempting a water-dip when the cable slipped over the toe of the skid. As the pilot began a climb from the pond the helicopter rolled right and collided with the water.

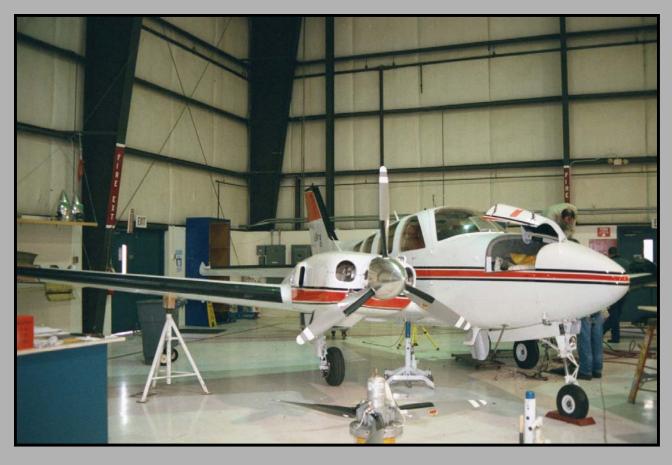
The pilot noticed flames from the engine nacelle just after liftoff, approx. 20 feet off the ground. He radioed the tower and notified them of the situation and that he was landing the aircraft on the departure runway. The aircraft sustained substantial damage to the section aft of the firewall.

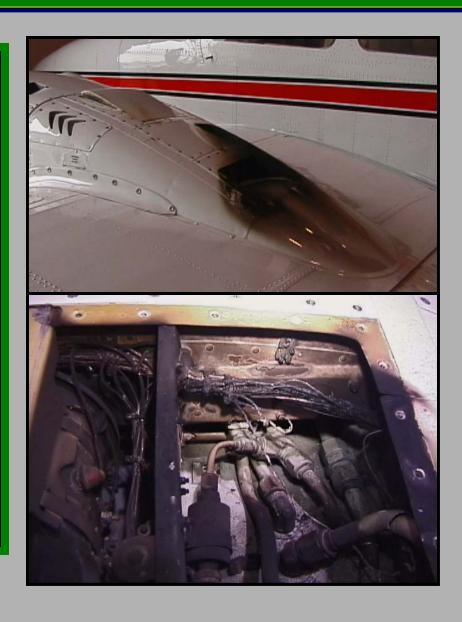
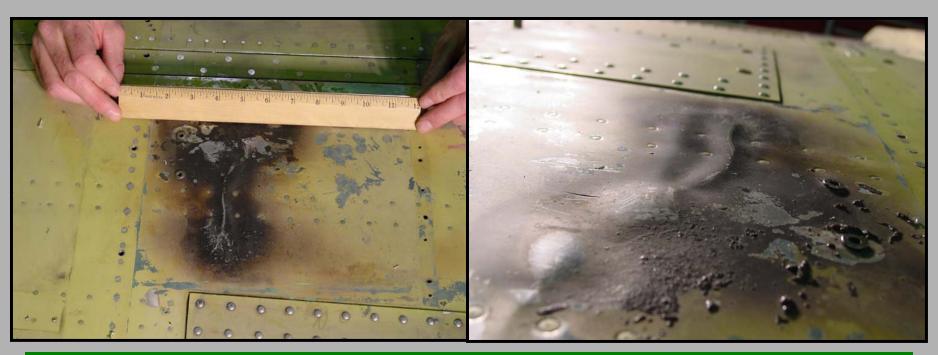
A NTSB Fire and Explosion Specialist inspected the aircraft's fire damaged structure and components and determined that accumulated fuel vapor from the fuel cell leak was most probable source of fuel while chafing alternator wires would have be the source of ignition.

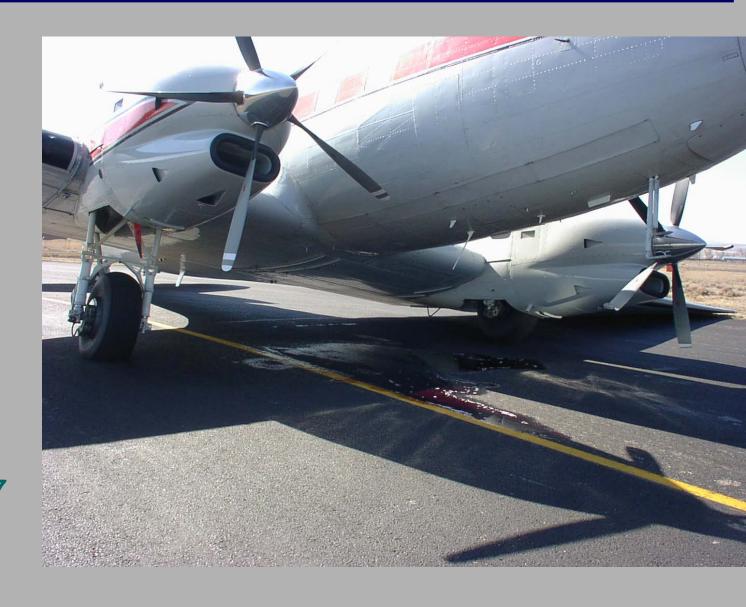
On April 5, 2002, at 0845 Mountain Standard Time, a Douglas DC-3C, N115Z, was substantially damaged when its left main landing gear collapsed while standing at Natrona County International Airport.

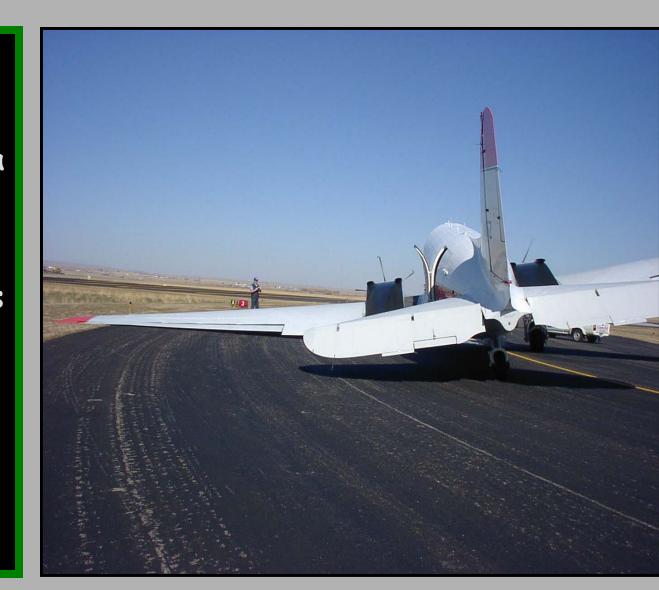
The landing gear hydraulic pressure was high. The pilot asked the copilot to cycle the landing gear handle to the down position in an attempt to lower the pressure. The copilot removed the landing gear safety, and inadvertently raised the landing gear. The left main landing gear collapsed before the pilot could intervene. The airplane settled onto its left wing bending several intercostal ribs.

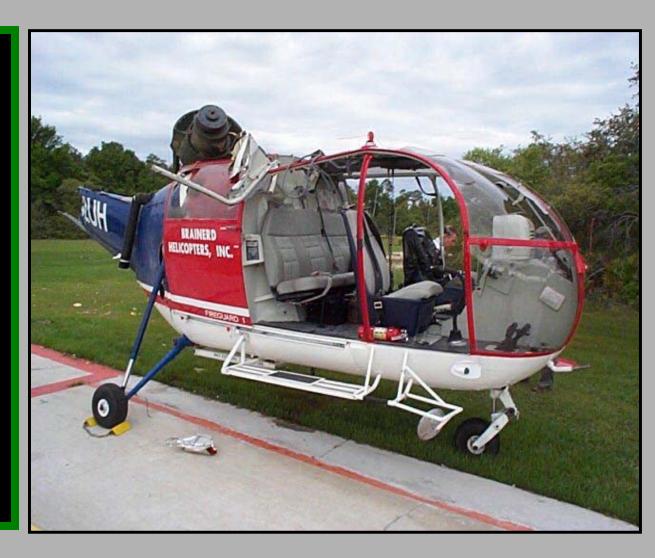
Upon landing at the Helibase, the aircraft began to roll forward on the ramp. The pilot attempted to gain control of the aircraft by lifting to a hover when the main rotor struck the tail boom. The aircraft was destroyed

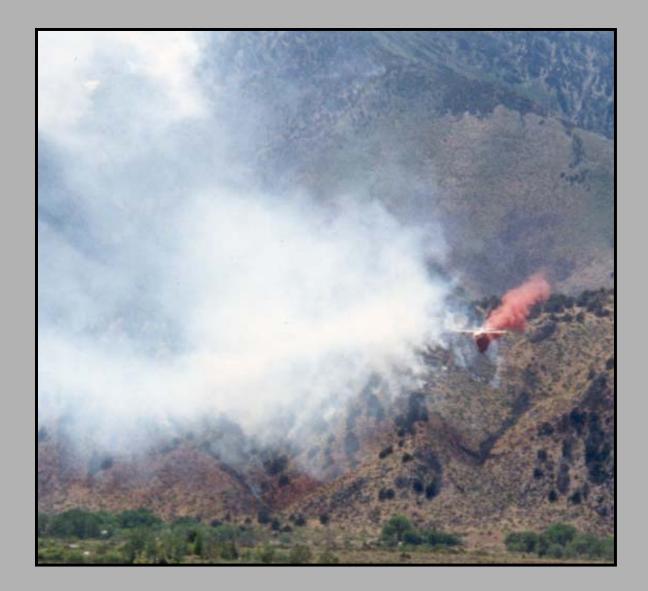
During the delivery, the wings separated from the fuselage near the wing roots. Subsequently, fire was ignited in the area of the separated wings

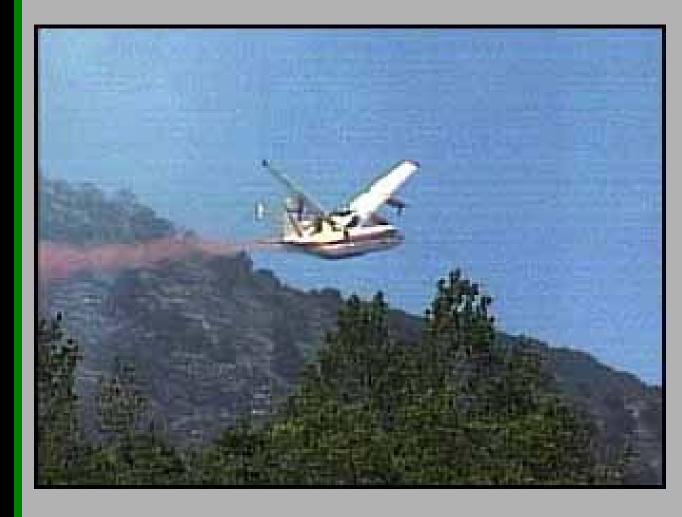
Preliminary findings have found several cracks in the C-130A center wing box lower skin. Specifically, the area of the wing that separated failed in fatigue as a result of the promulgation of the cracks.

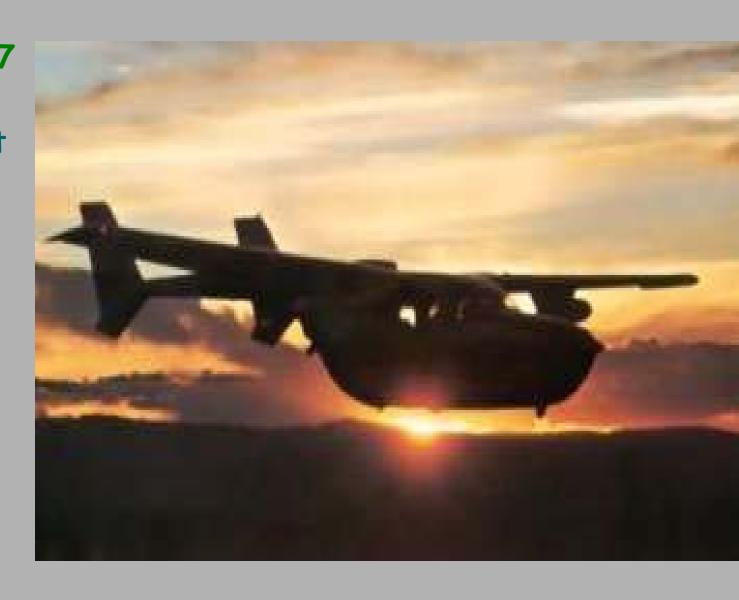
N26715, was destroyed by fire after a hard landing to a residential road following a loss of engine power to both engines while on approach to Big Bear City Airport

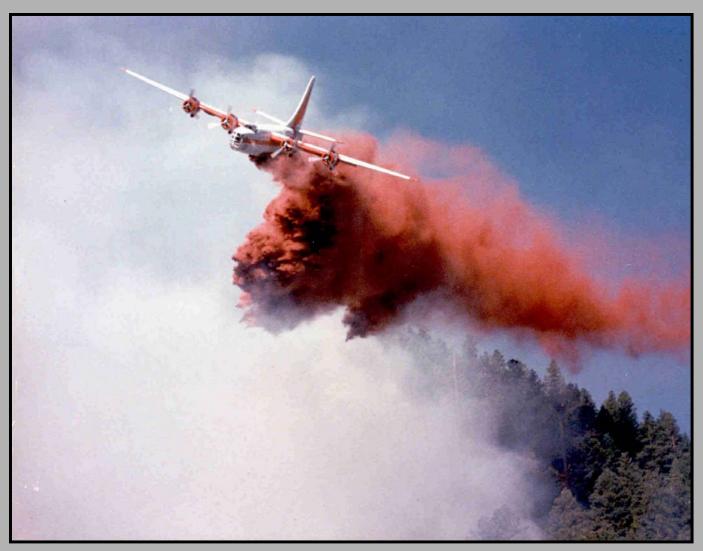
N7620C was destroyed when it impacted into mountainous terrain 6 miles southwest of Estes Park, Colorado. A post-crash fire ensued. Prior to the impact, the airplane's left wing separated and aircraft control was lost

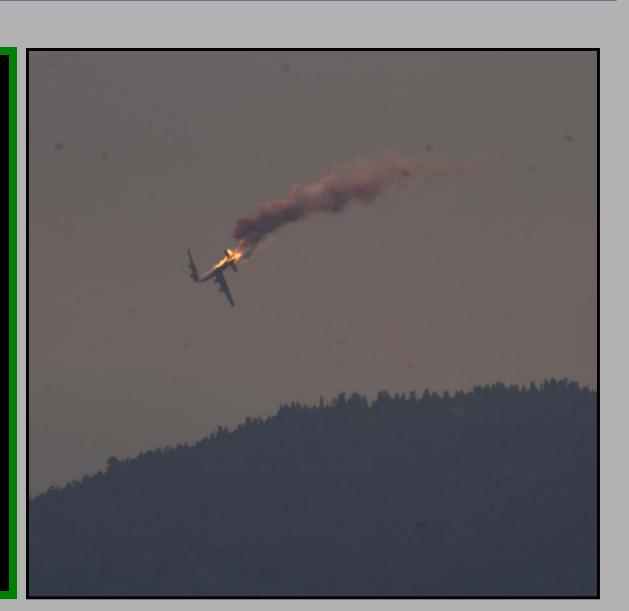
Preliminary findings of the wing indicated that the left wing, forward spar, lower spar cap assembly failed in fatigue.

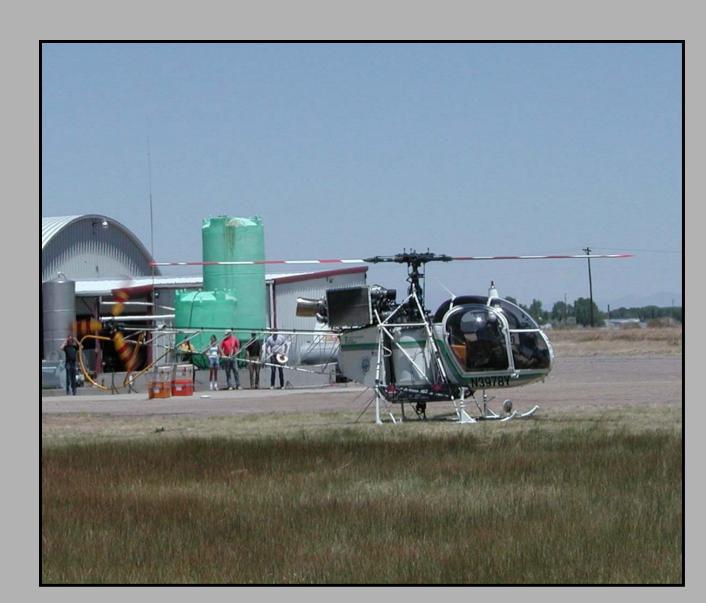
N3978Y was destroyed when it struck terrain The helicopter was engaged in fire suppression activities. It had been refueled and had taken off to apply water along the fire boundary.

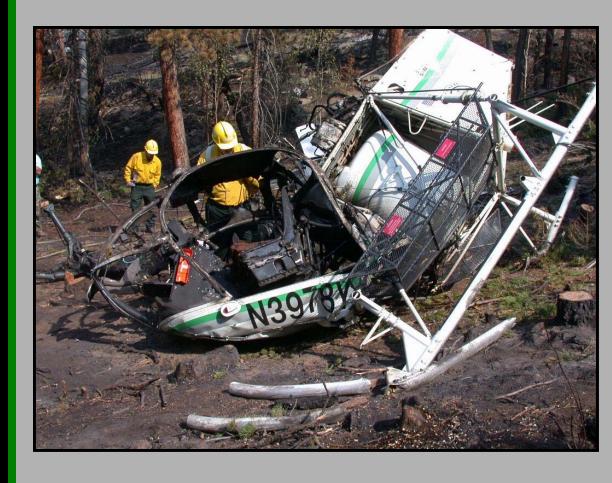
Preliminary findings indicate that an engine failure may have occurred prior to the crash. An Aviation Safety Alert was published as a result of this accident.

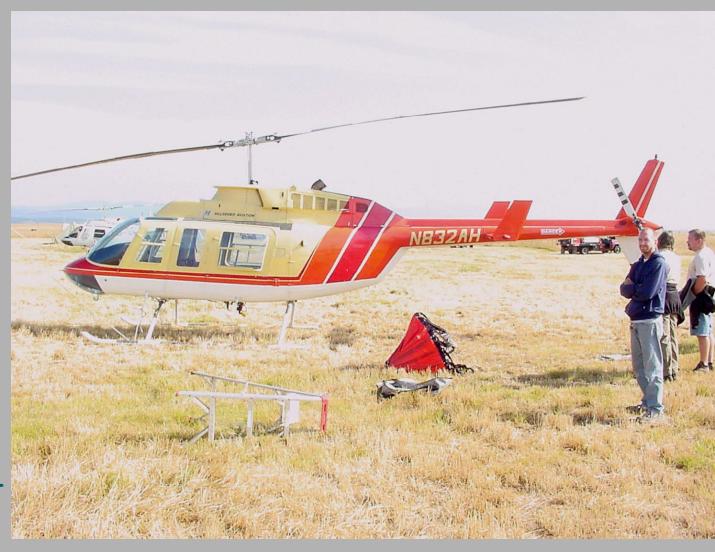
N832AH collided with trees, the helicopter was substantially damaged and the pilot, the sole occupant, was not injured. During a postflight walk around, the pilot noticed damage to both main rotor blades.

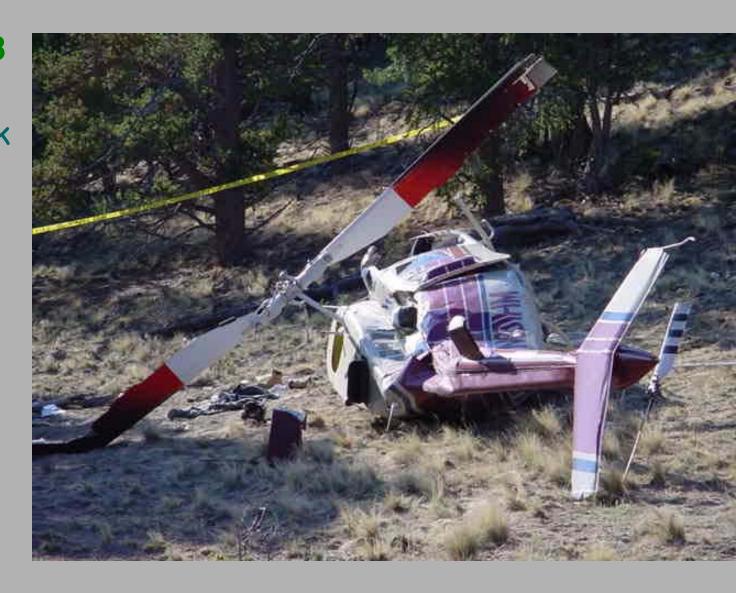
N801HM was substantially damaged when it collided with trees and impacted terrain during landing approach. The pilot was seriously injured and three passengers received minor injuries.

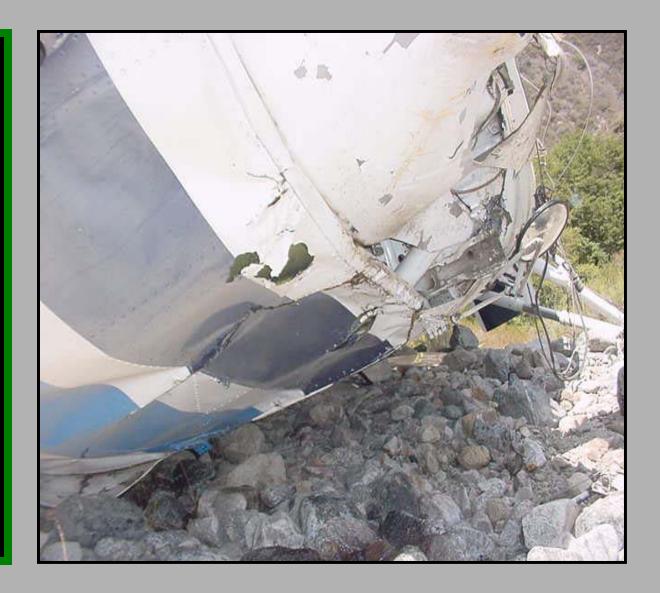
The pilot stated that a hydraulic warning light illuminated and the flight controls became stiff. He began an approach, about 10 feet above the ground, the cyclic moved "hard over" and the pilot was unable to regain control before the rotors made contact with a rocky shelf.

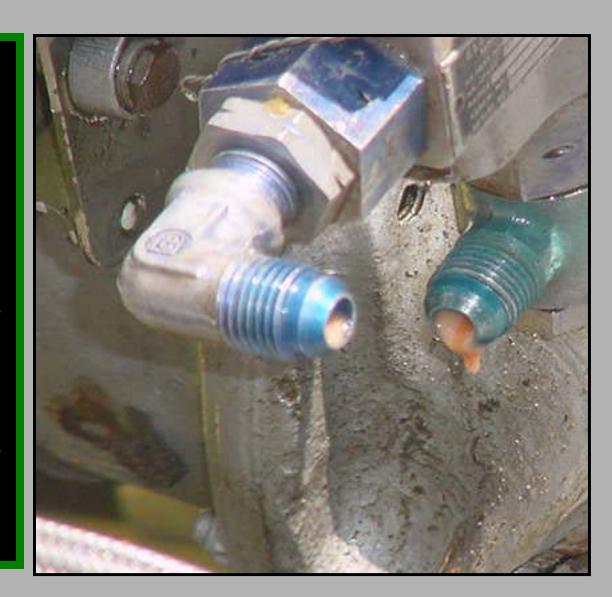
The Forest Service took a sample of hydraulic fluid from the reservoir and stated that it appeared to be severely contaminated. The fluid was sent to a laboratory for testing.

Sample was placed in graduated cylinder and allowed to separate. Two phases existed with top phase being 78% and bottom (water) phase being 22%. Karl Fischer water analysis was performed on the top phase (1.85%). Microbial Growth was detected in sample.

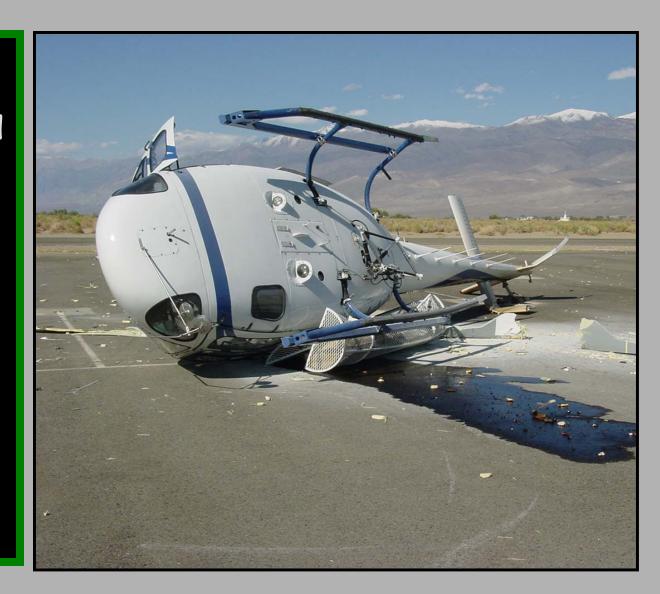
The collective's locking mechanism stud was worn and the collective came loose during movement of the cyclic.
