# *Aviation Accident Review*

**FY03**

## **USDA Forest Service Aviation Accident Review**

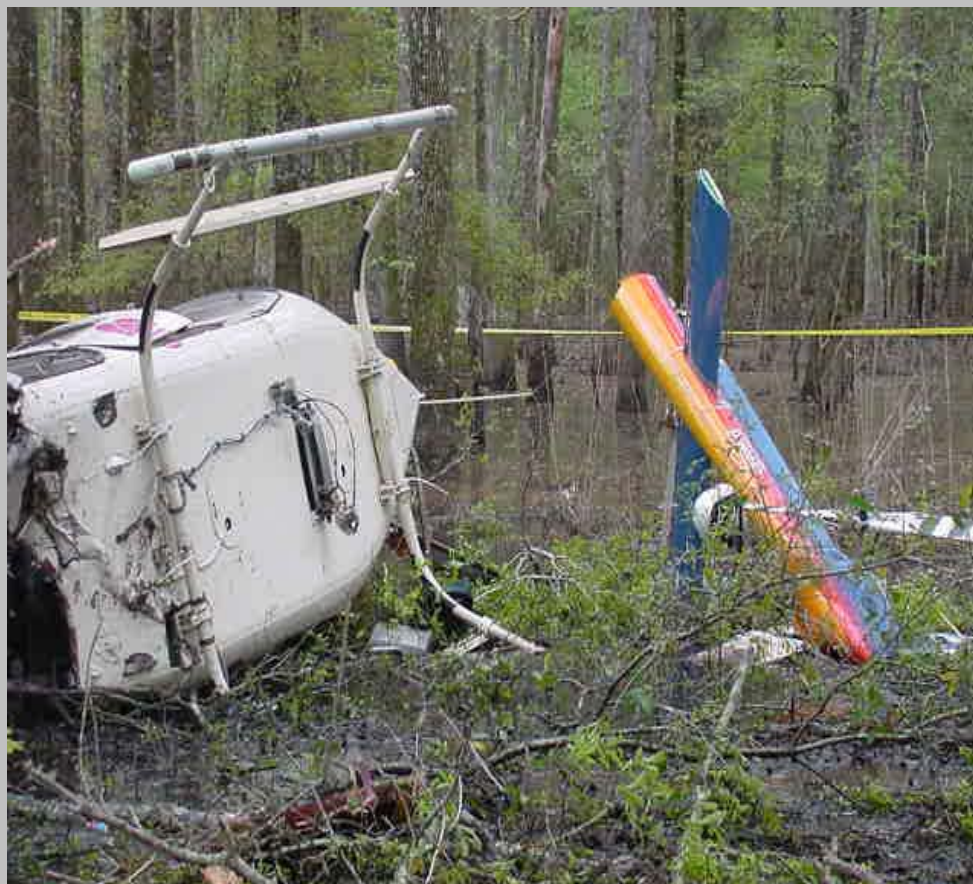
The surviving passengers reported that the helicopter lost power and descended rapidly into the 80-foot tall trees. The helicopter came to rest on its right side at the base of a 80-foot tree

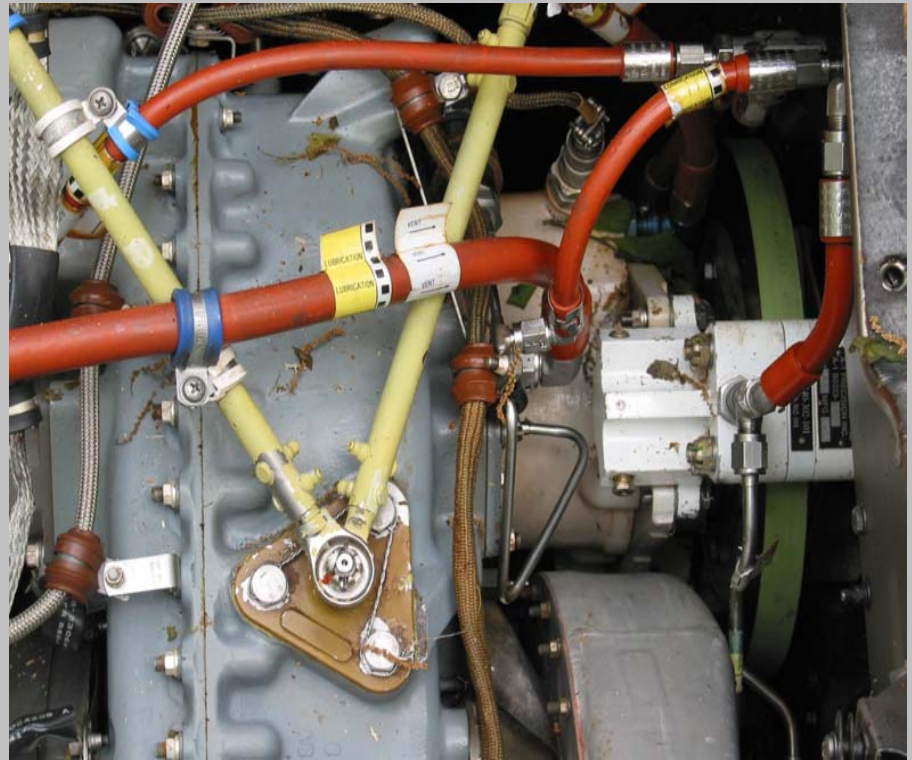
During the test cell run, it was discovered that the power lever angle (PLA) indicator on the Hydro Mechanical Unit (HMU) responded erratically to normal throttle inputs when the engine was operated in the electromechanical mode.

Further testing and evaluation of the HMU revealed anomalies with the potentiometer component of the system.

**Bell Helicopter Company has reported that since compliance with the Airworthiness Directives there has not been another Fully Automated Digital Electronic Control (FADEC) related accident in the world.**

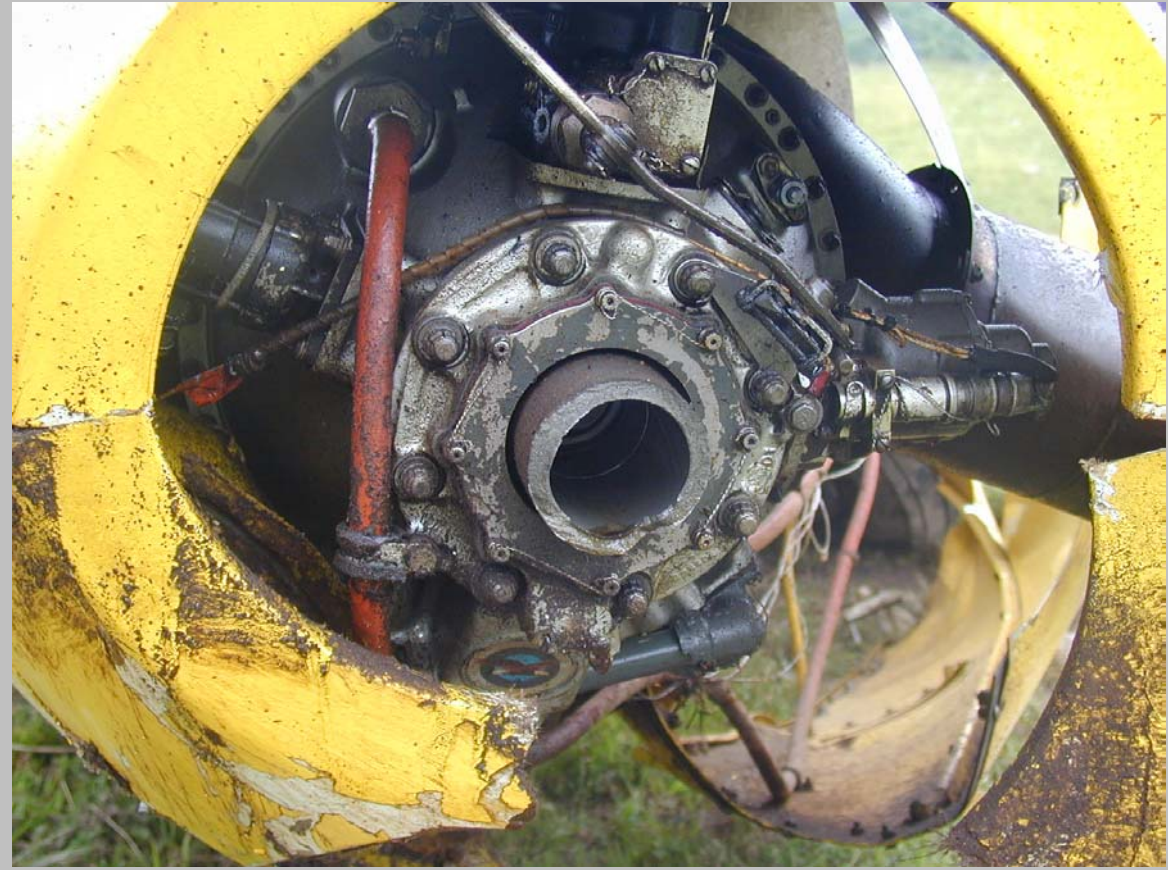
The Air Tractor  
under contract to  
the USDA  
Forest Service,  
was  
substantially  
damaged during  
the forced  
landing

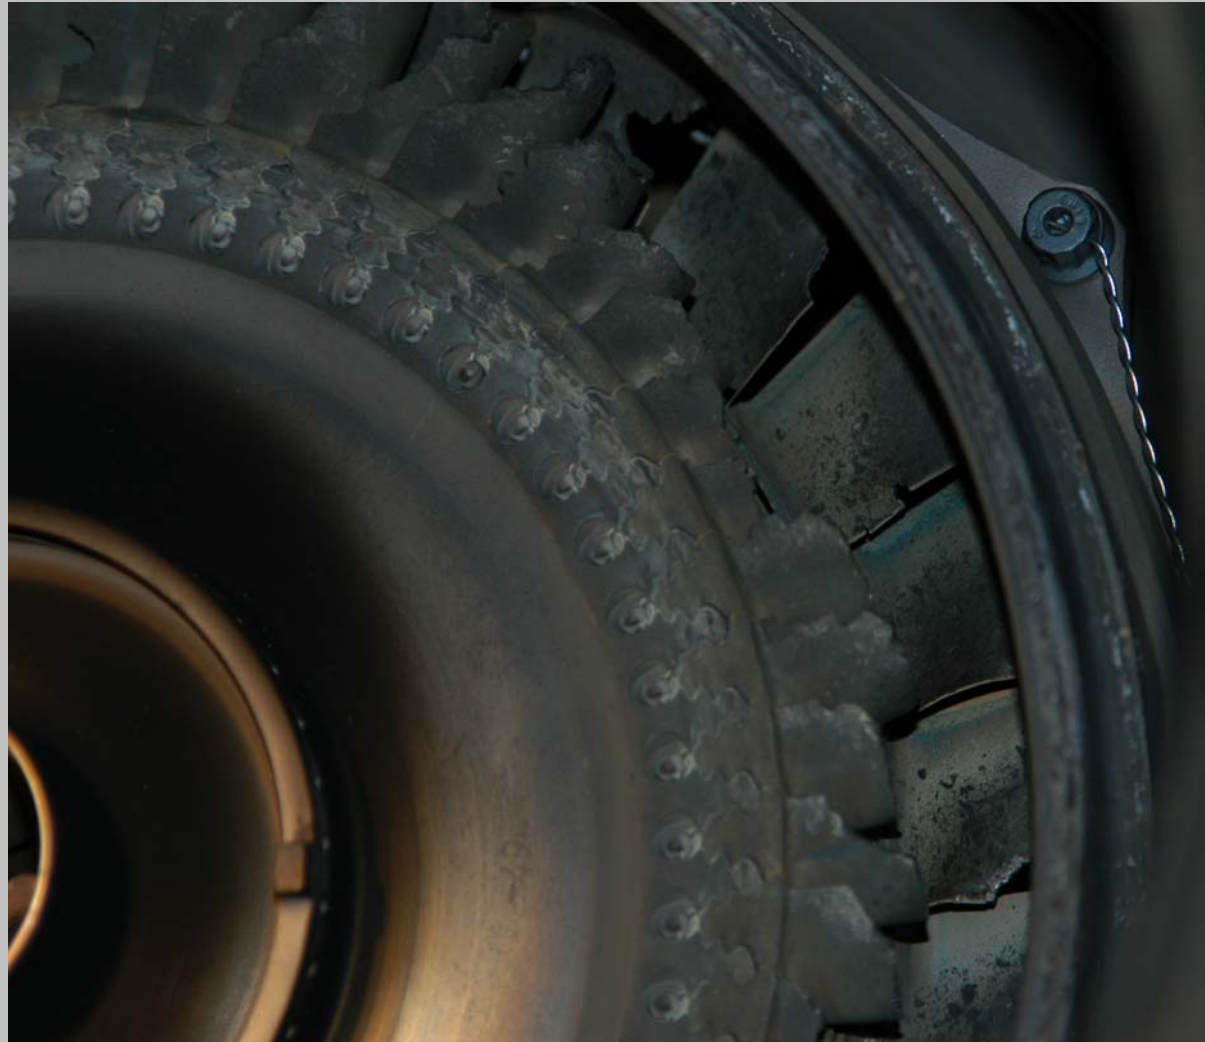
The tear down analysis revealed excessive damage to the compressor blades and other turbine components

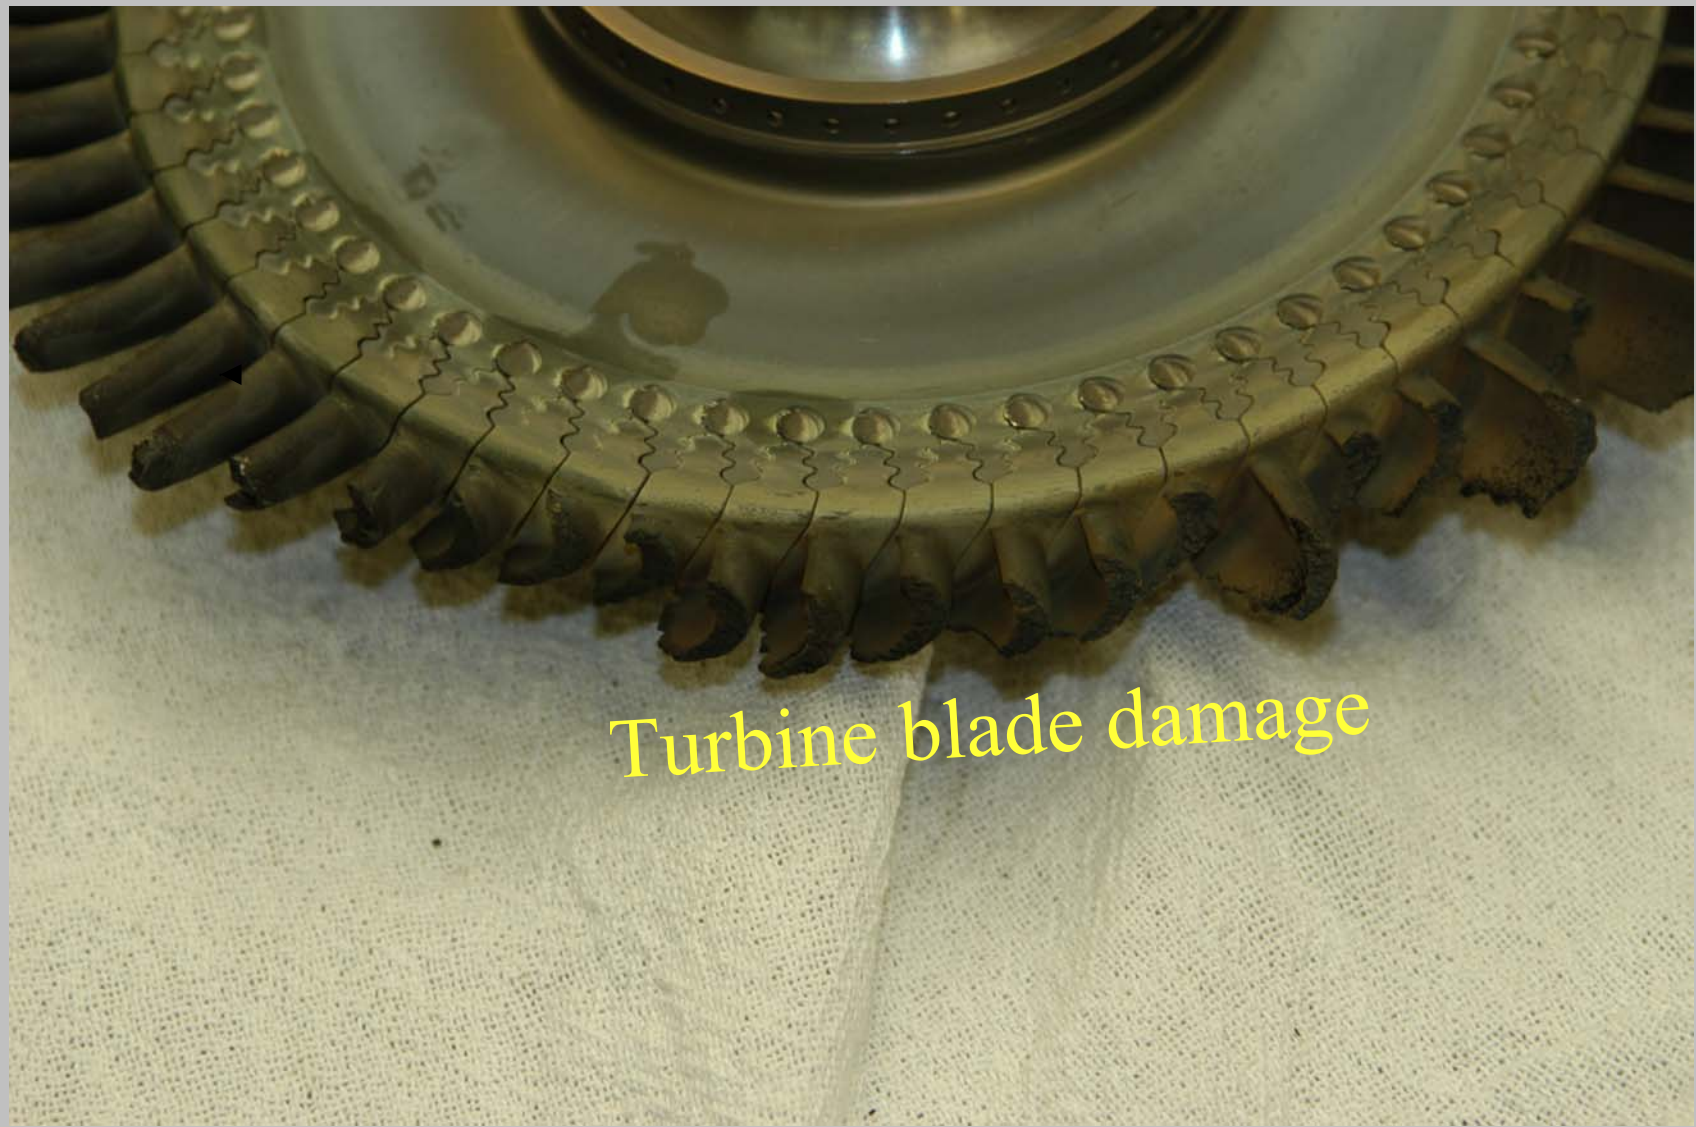
Turbine blade damage

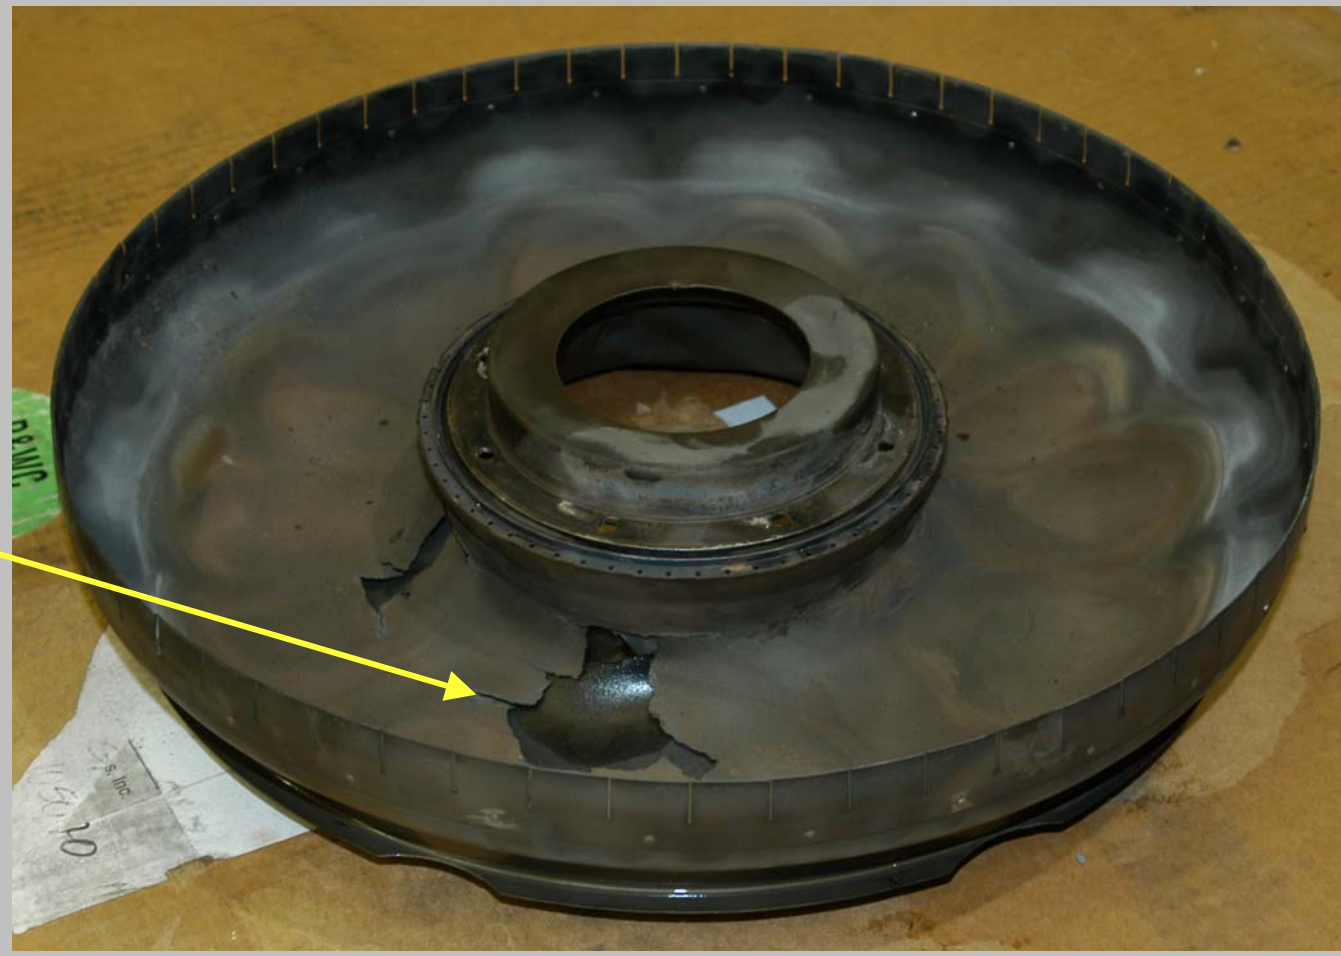
**Hole in  
Burn  
Can**

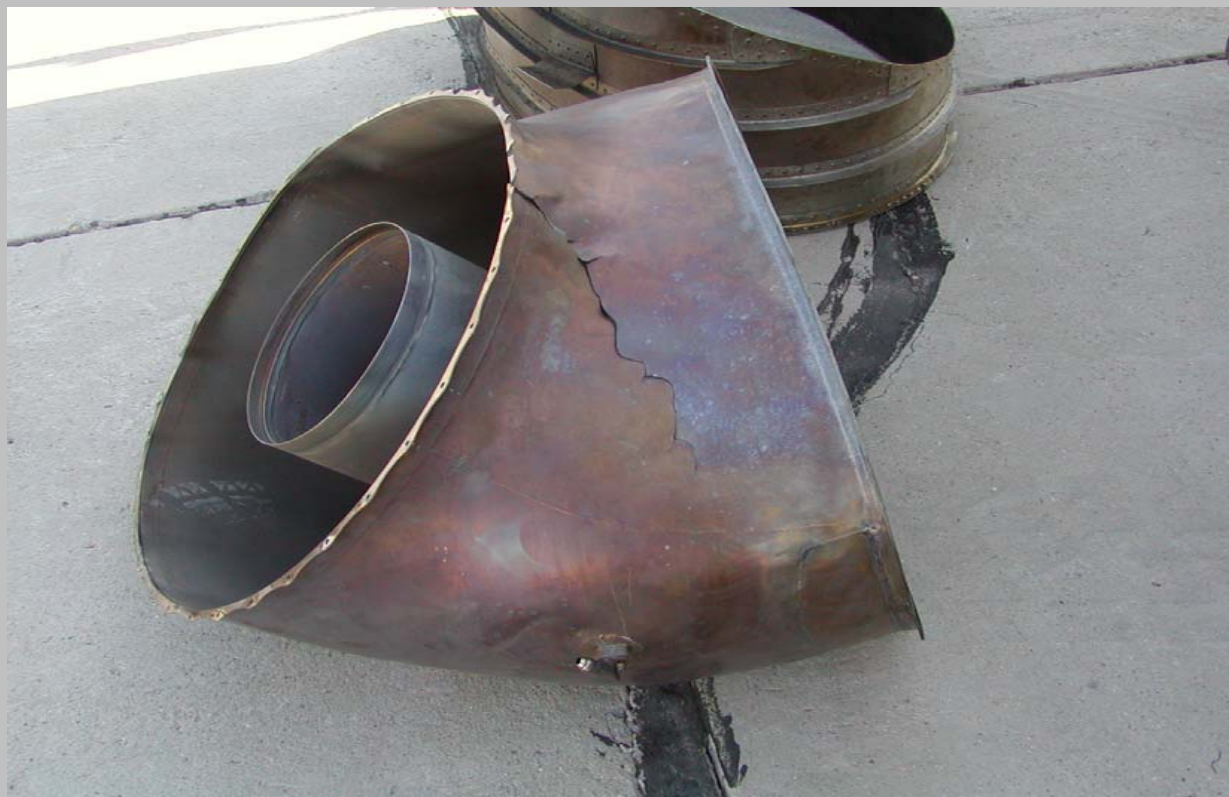
Maintenance personnel discovered the exhaust tube on the left engine was damaged. The helicopter was shutdown and examined

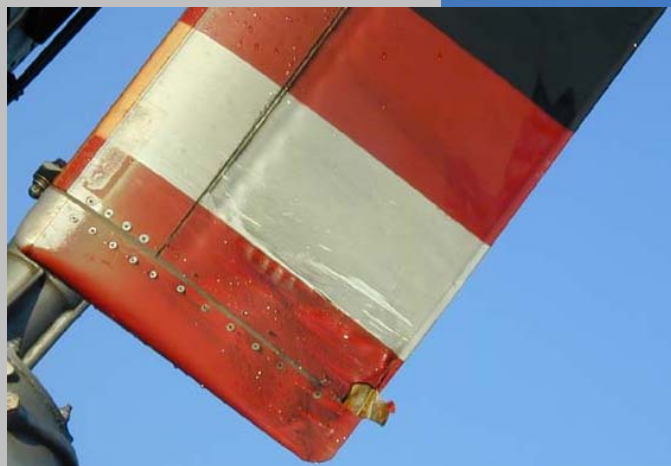
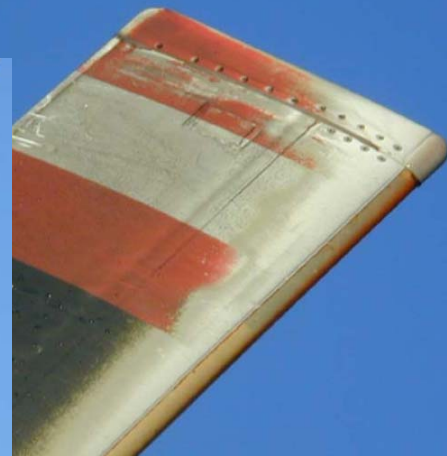
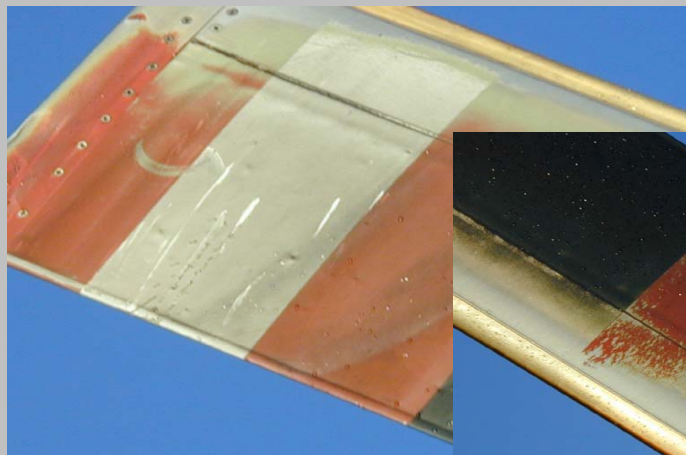
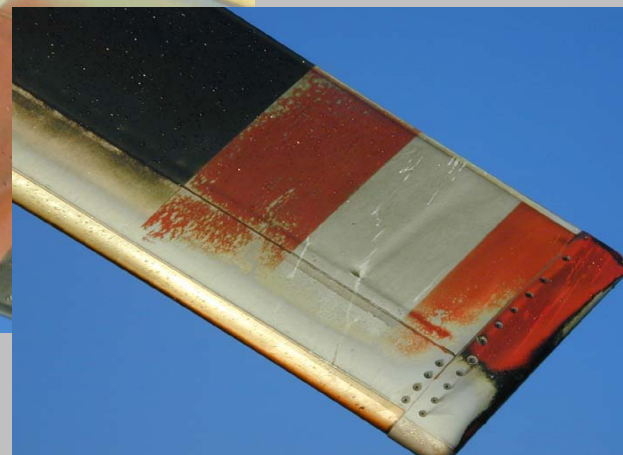
Upon closer inspection, it was determined that "all pieces were there." Other components of the helicopter were also examined. All 4 tail rotor blades sustained damage.

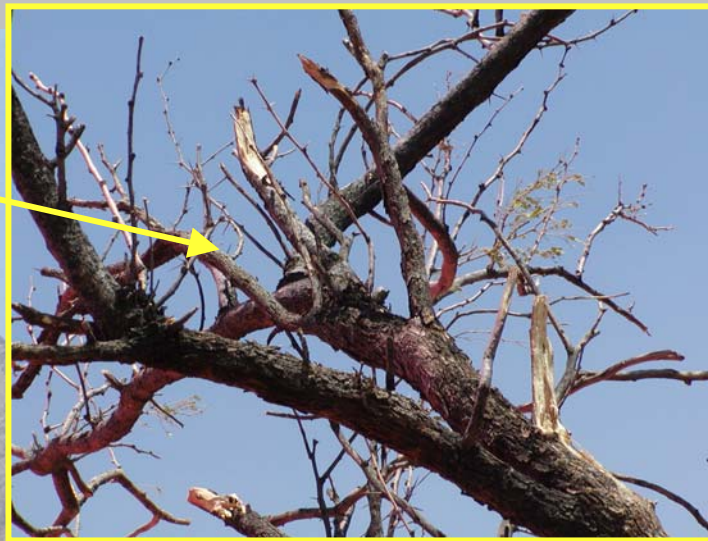
**Damaged mesquite branches- before trees were cut down**

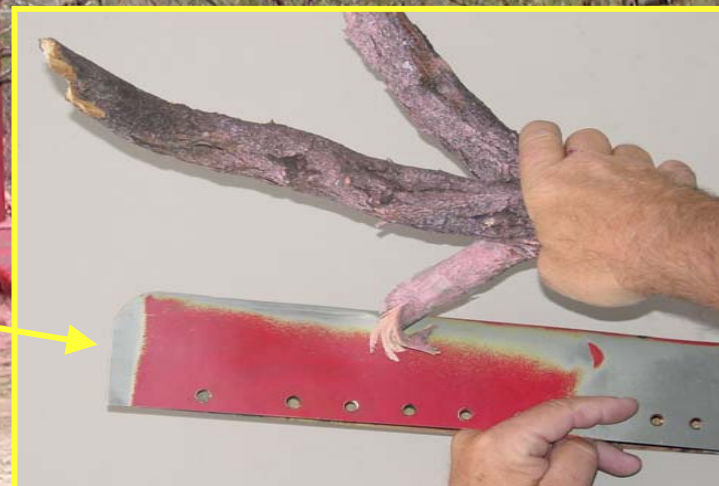
**Tail rotor blade #4 tip cap with damaged mesquite branch**

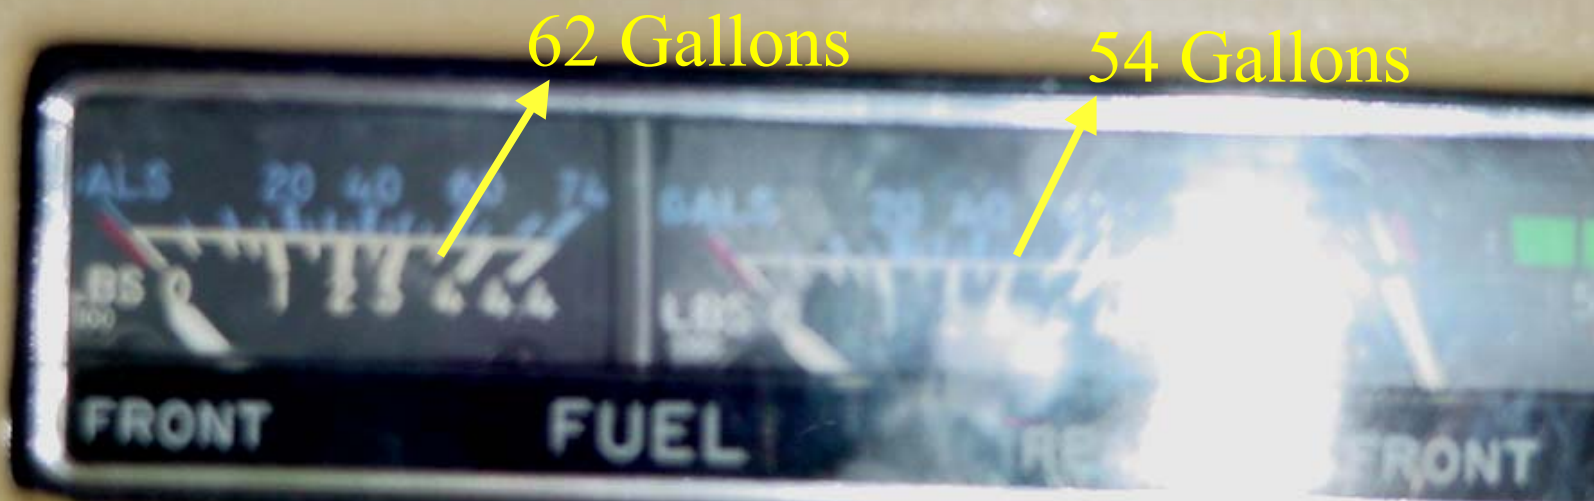
The pilot said he checked the fuel gauges before the flight and they were accurate, but upon inspection after the incident, the following condition was observed with full tanks. (74 Gallons)
