FY04 Forest Service Aviation Accident Review

NTSB Identification: **SEA04LA029.**

NTSB Identification: FTW04TA075.

NTSB Identification: SEA04TA147.

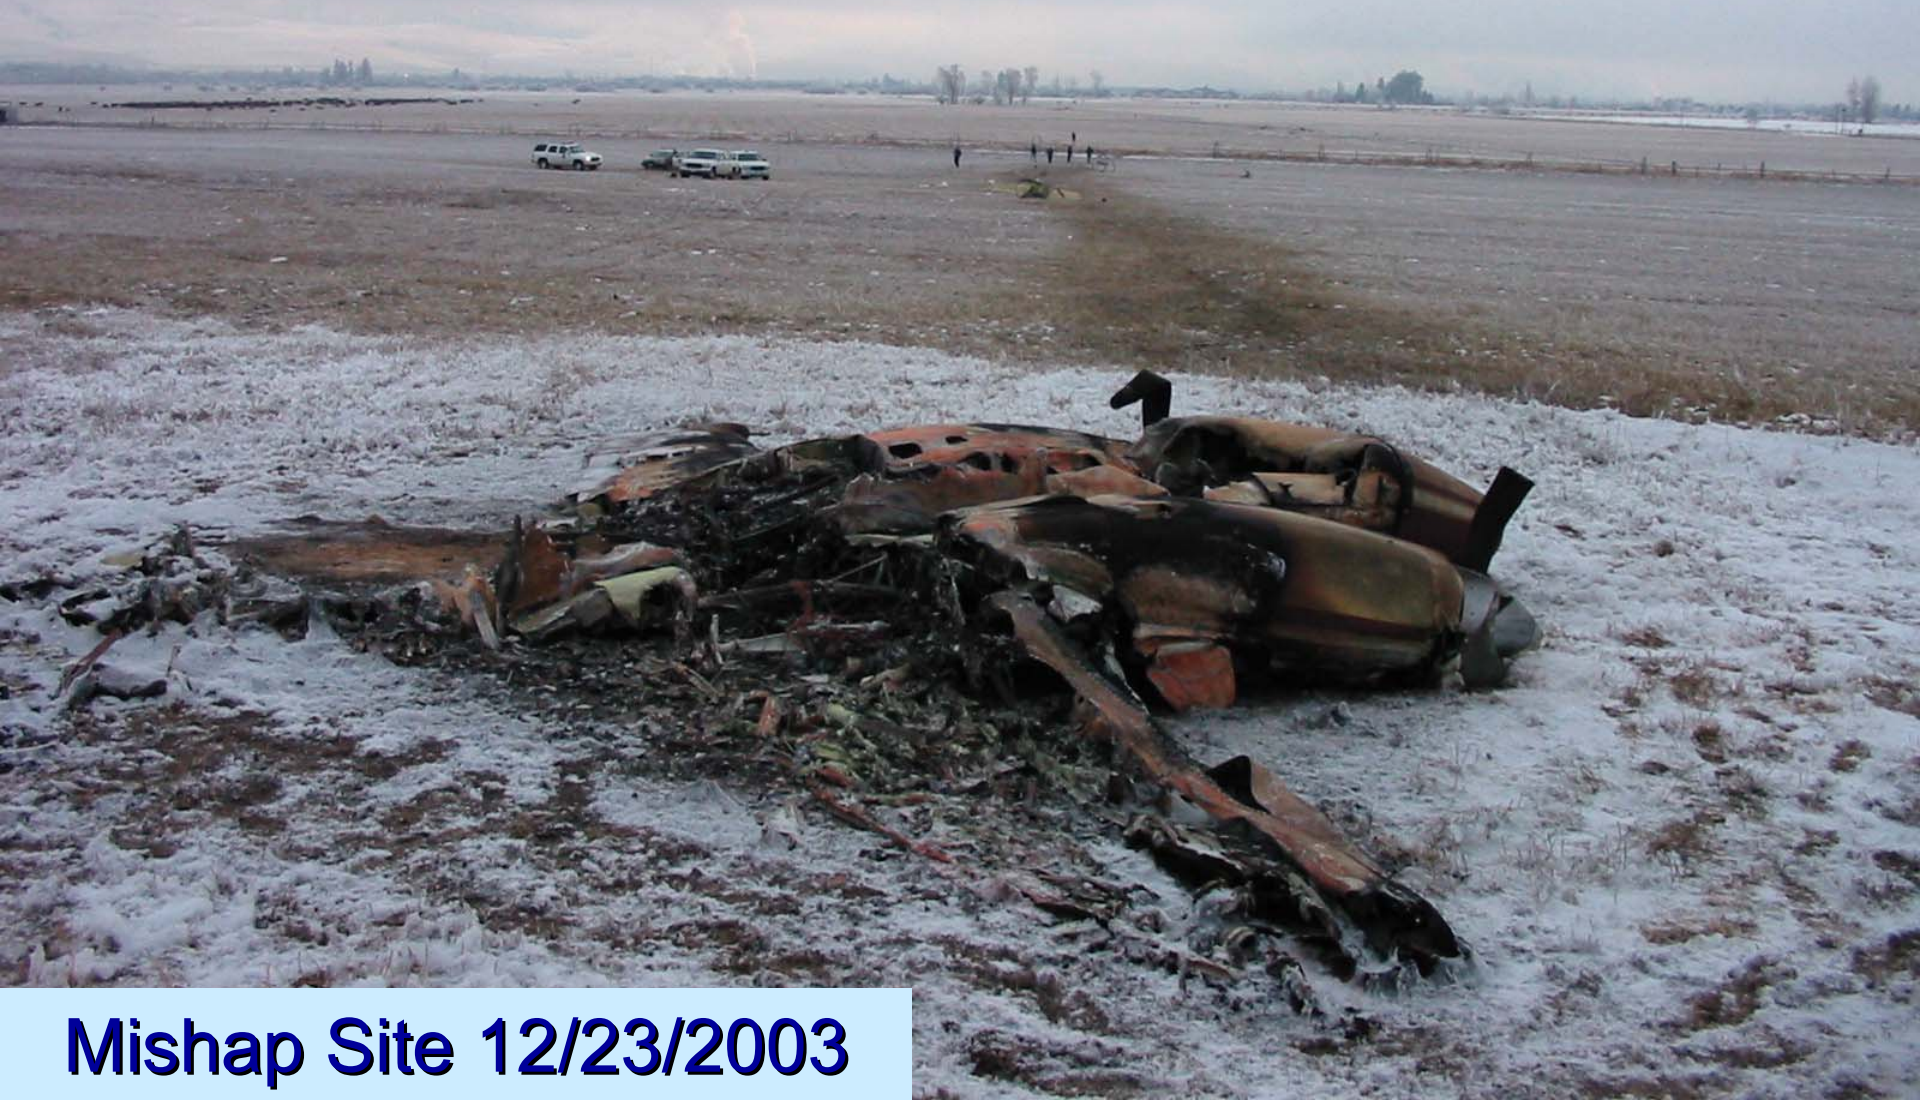
Mishap Site 12/23/2003

Just before ground impact to open terrain about one mile south of the runway, the pilot-in-command took control of the aircraft to level the wings.

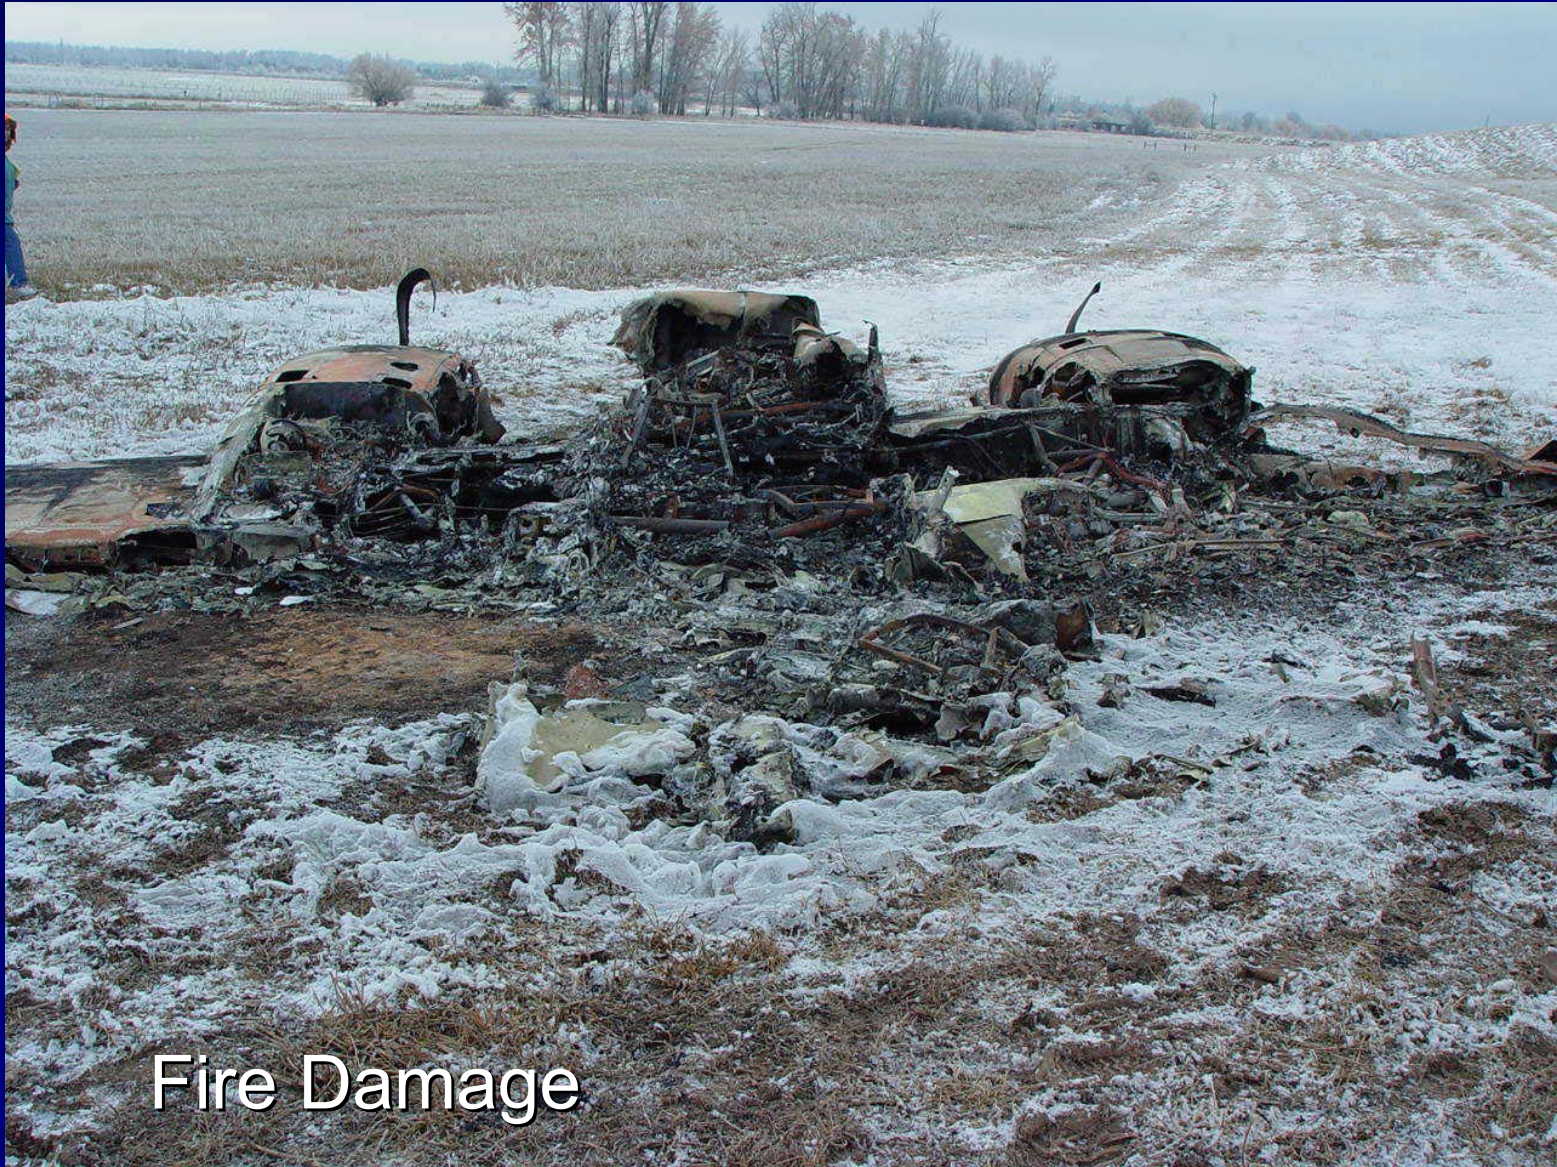
Fire Damage

The aircraft skipped across the open terrain for several hundred yards before coming to rest on its belly. The aircraft was consumed by fire shortly thereafter.

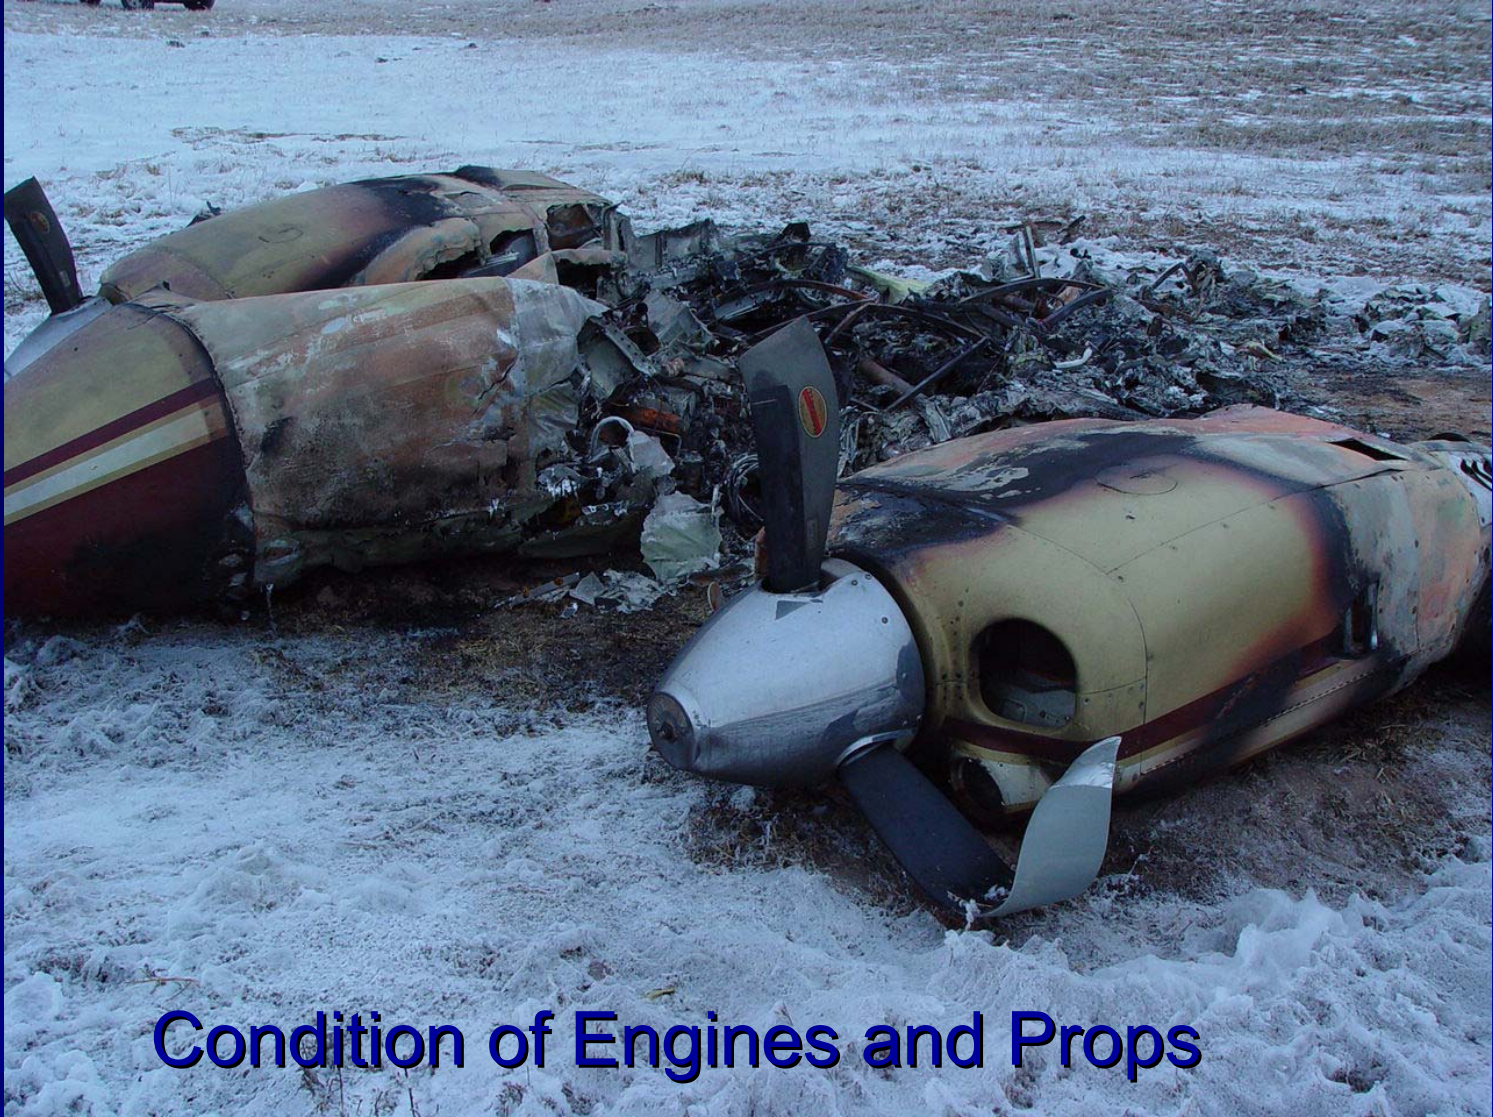
Condition of Engines and Props

During the post accident inspection of the aircraft, no evidence of a mechanical failure or malfunction was found and no evidence of an in flight collision with an object was noted. At the time of the accident, low freezing fog and visibility was reported.

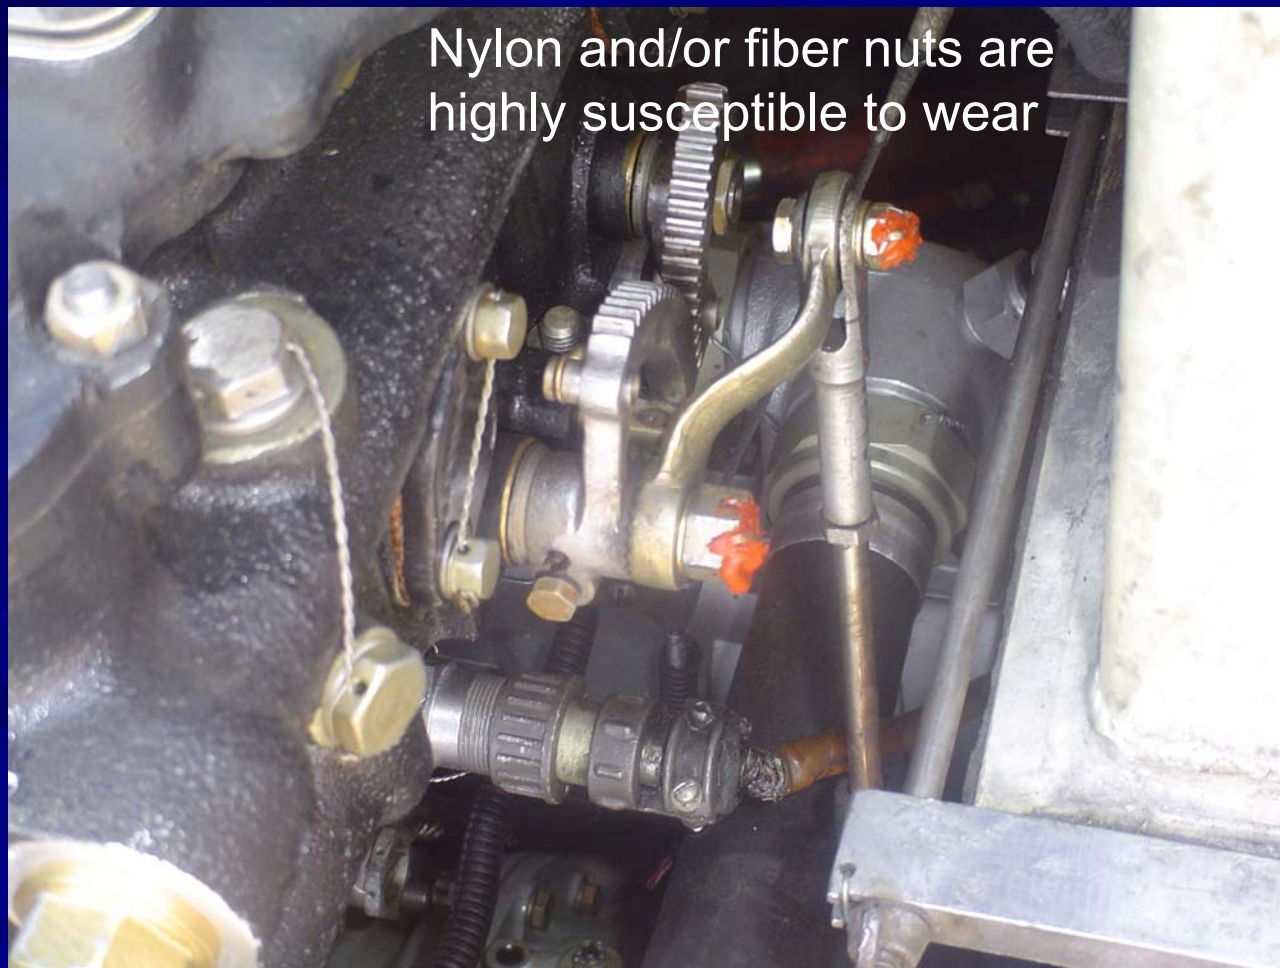
Post accident examination revealed that the bolt normally connecting the throttle linkage clevis to the throttle arm was missing. The investigating team examined a sister aircraft from the same provider. They found that a nylon lock nut had been installed on the clevis bolt, and it was loose enough to be removed without the aid of any tools.

The industry standard, found in FAA Advisory Circular AC43.13-1B, chapter 7, section 4, paragraph 7-64 states that nylon locking nuts should not be used with rotating components or assemblies. It further states that nylon and/or fiber nuts are highly susceptible to wear from repetitive use and from high heat

The improper installation of the throttle linkage clevis to the throttle control arm by unknown maintenance personnel. Contributing factors were the nylon lock nut separating from its' bolt, which permitted the throttle cable to disconnect from the throttle control arm, and the fence post.

- Re-inspect aircraft operated by vendor.
- Establish contractual requirements for maintenance of SEAT aircraft equivalent to other interagency fire aircraft.
- Conduct a risk analysis and develop mitigation measures for Forest Service use of SEAT's.
- Establish an interagency working group to conduct an operational analysis of SEAT's and develop use standards.
- Establish policy based on the risk and operational uses analyses.

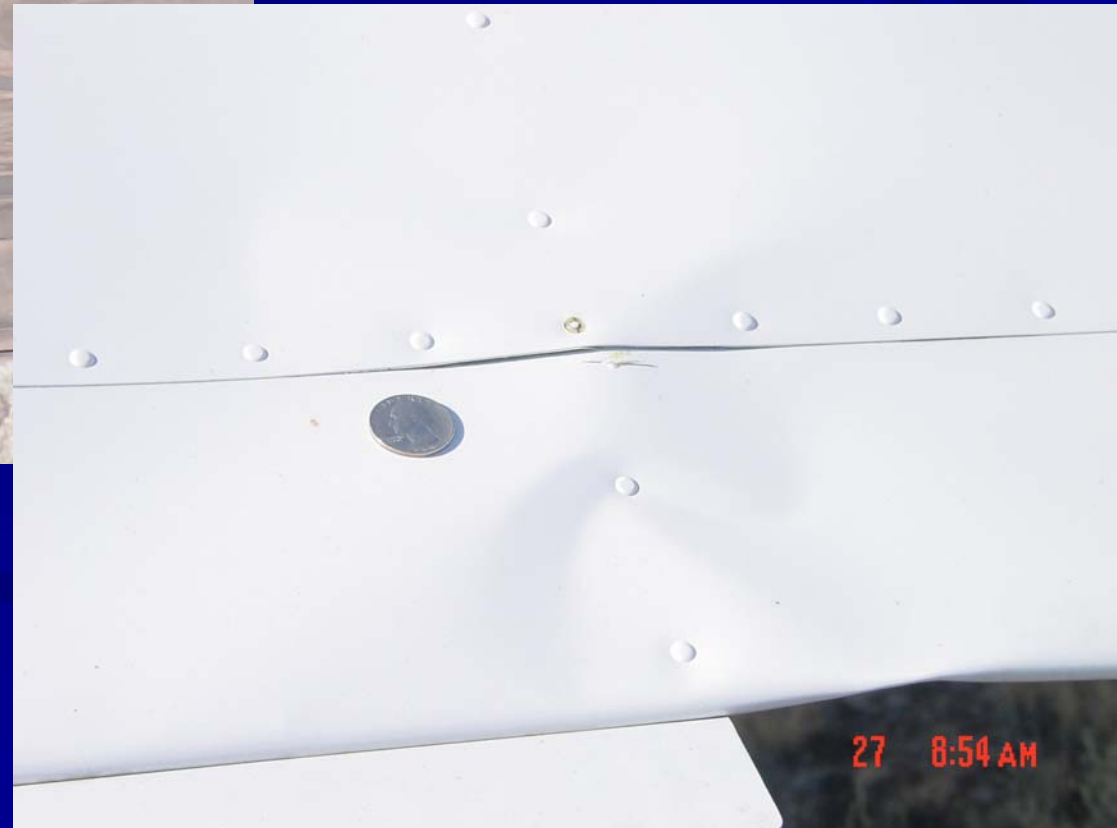
In order to land the airplane where he wanted to, he turned the fuel selector to the off position. During the landing roll, the left wing impacted a fence pole bending ribs and wrinkling the aileron.

Bent ribs and wrinkled aileron

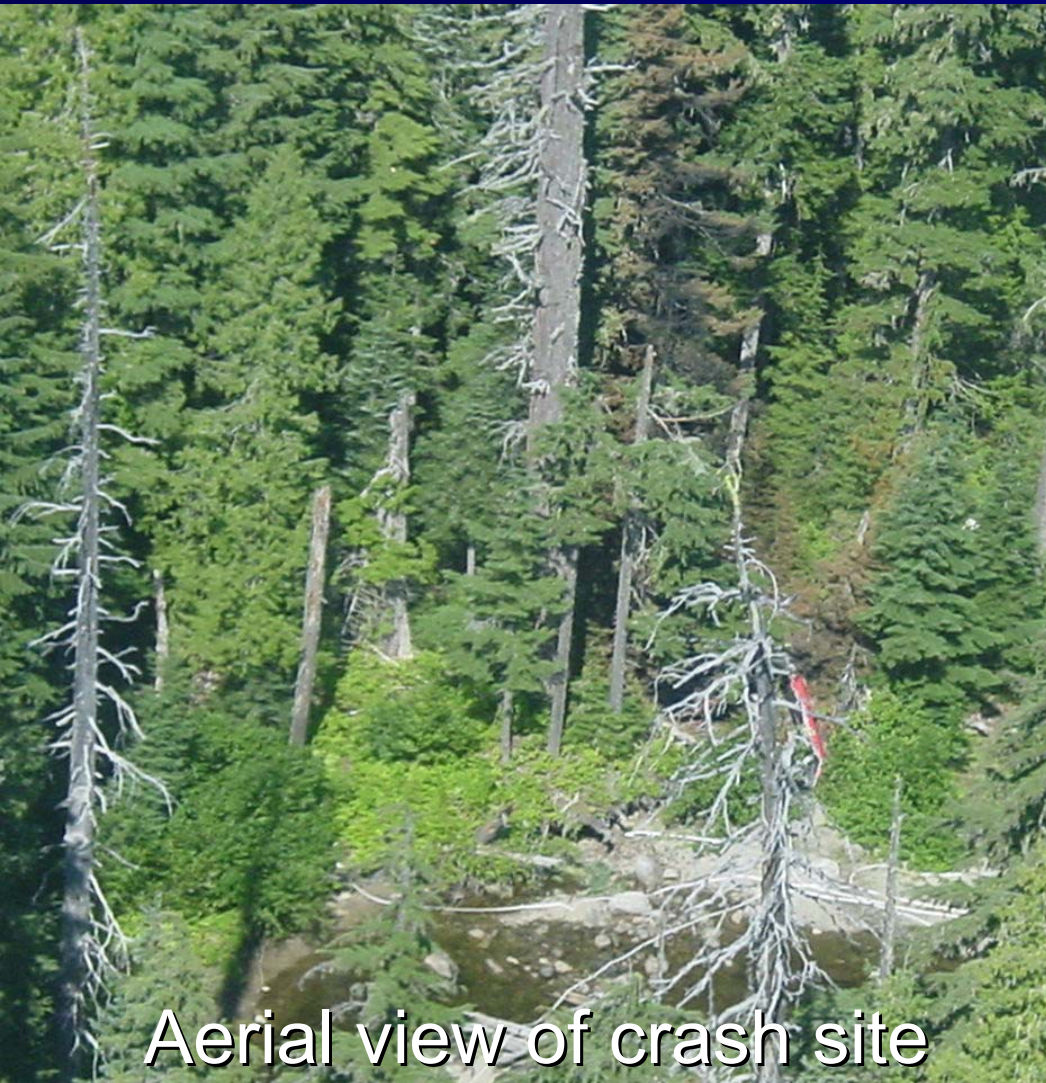
Aerial view of crash site

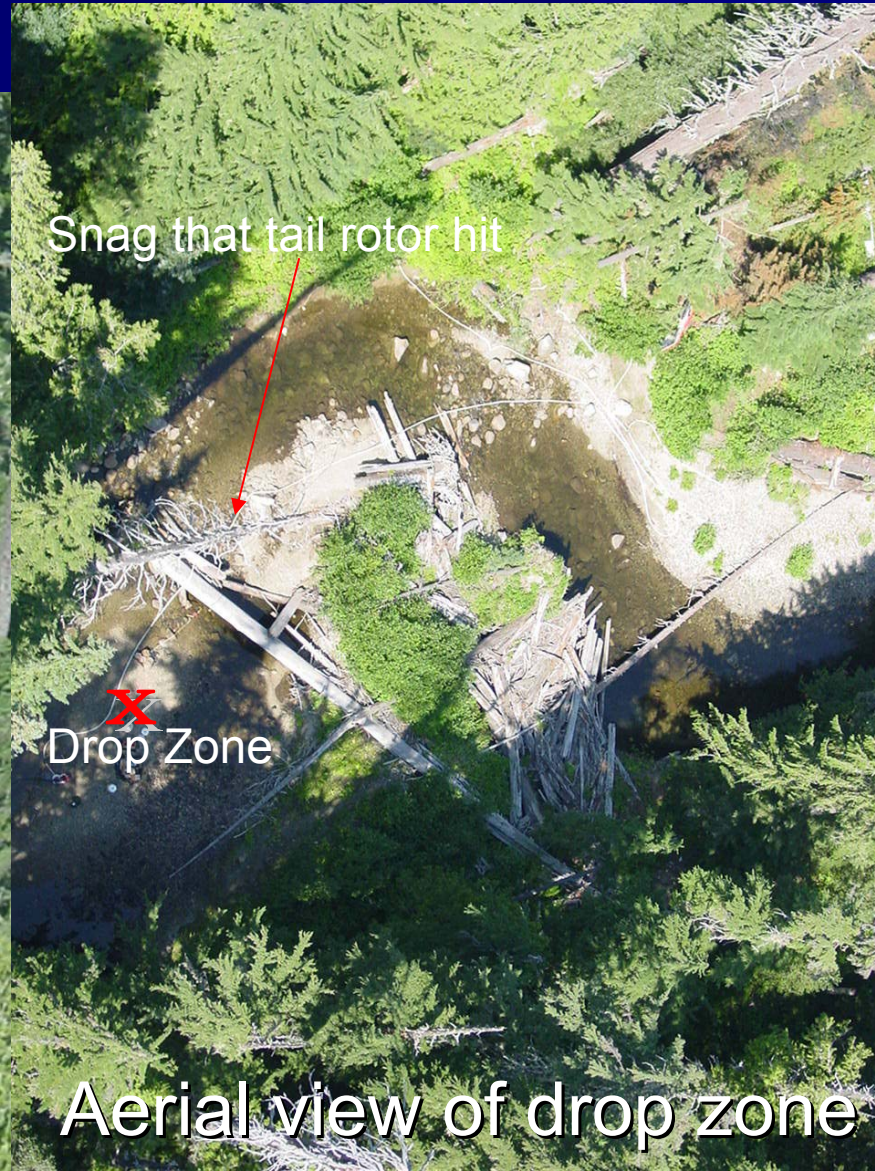
Aerial view of drop zone

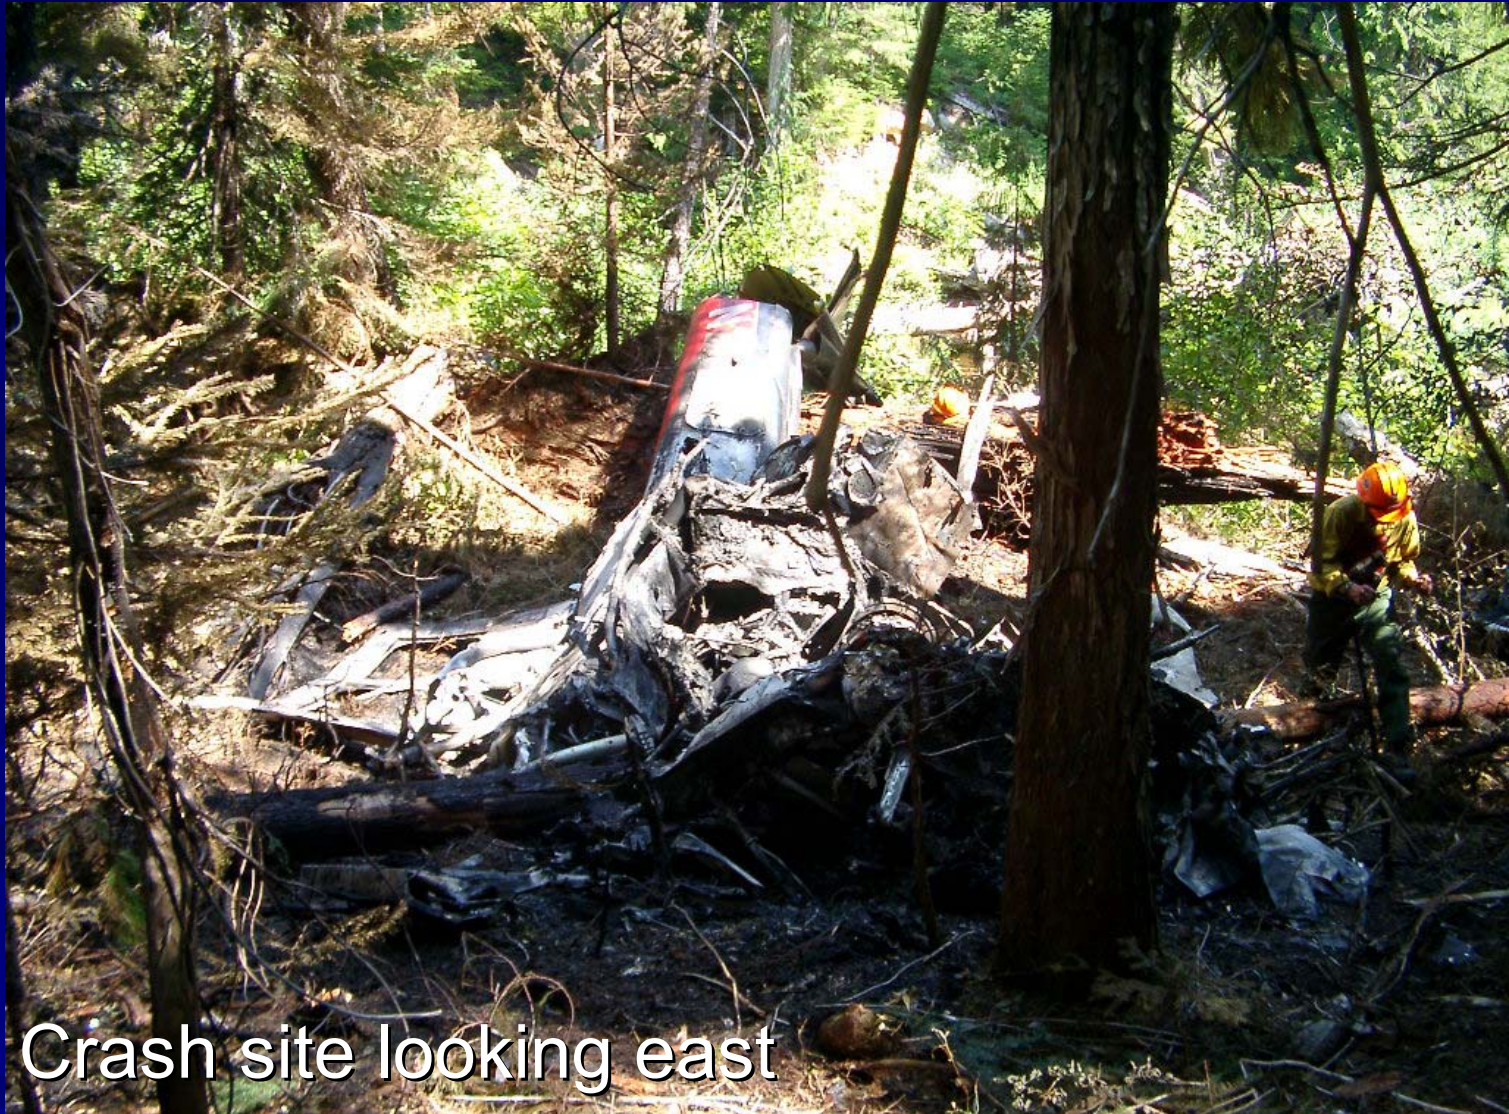
Crash site looking east

The helicopter then started to ascend, and at that time, the helicopter's tail rotor contacted a dead snag. When the tail rotor contacted the snag, the helicopter was about 100 feet above the ground.

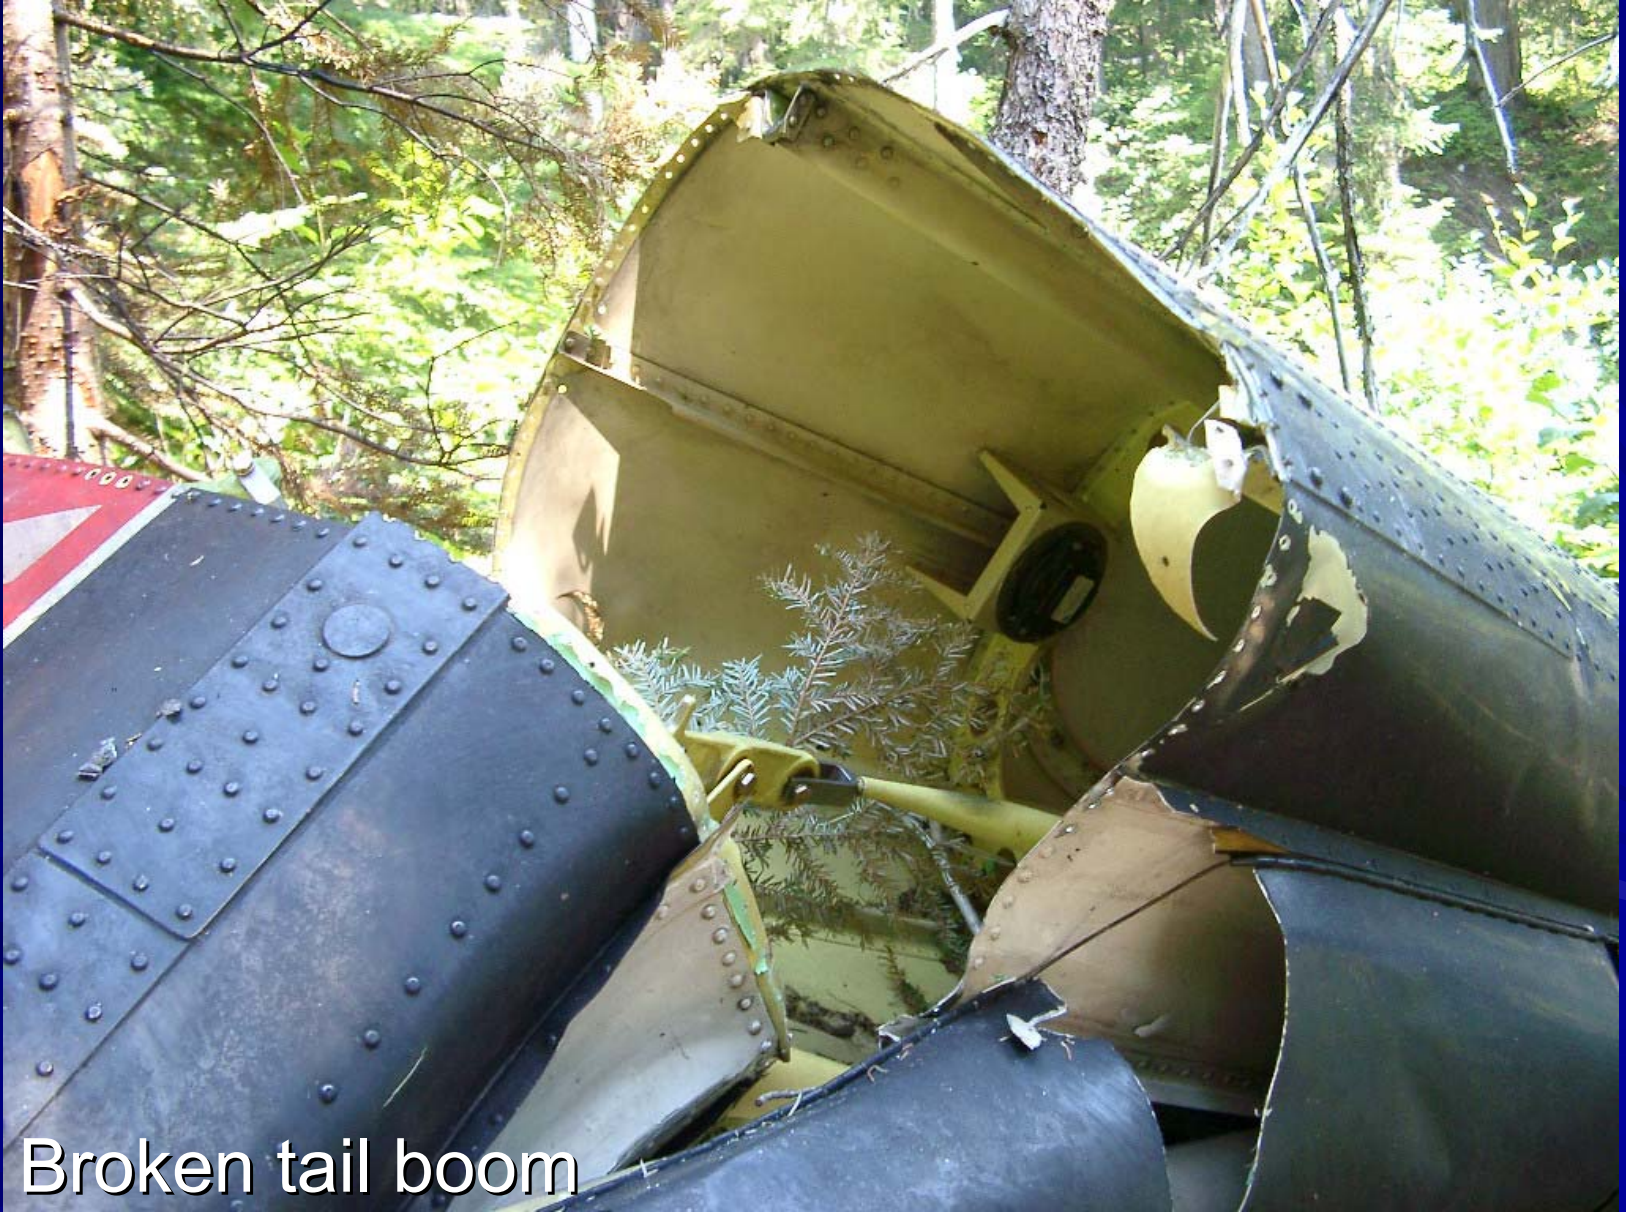
The helicopter began to spin, the main rotor blades struck other trees, and the helicopter fell to the ground. A post-crash fire erupted, which consumed the fuselage of the helicopter.

Broken tail boom

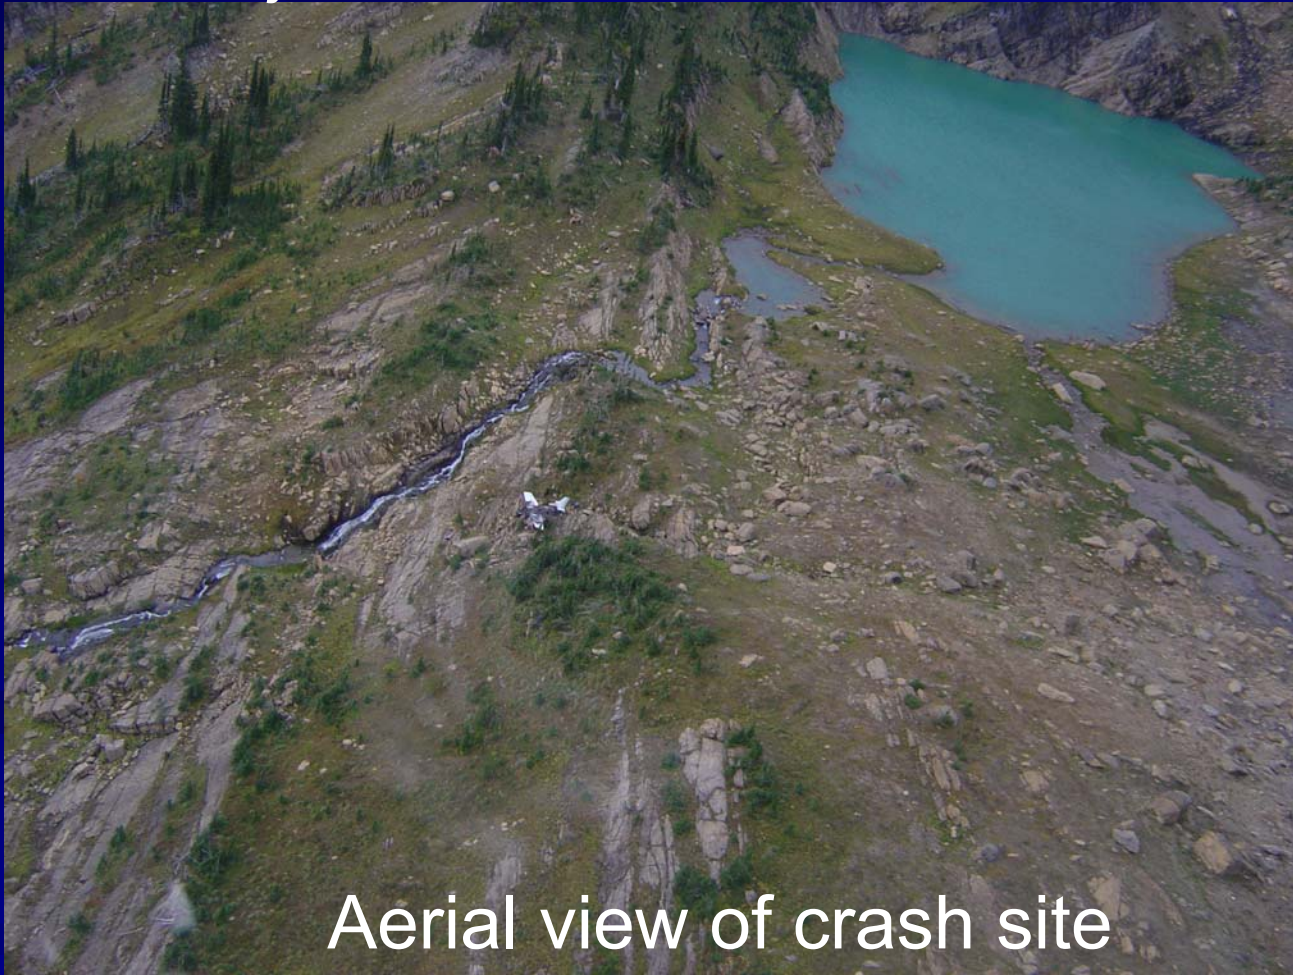
Aerial view of crash site

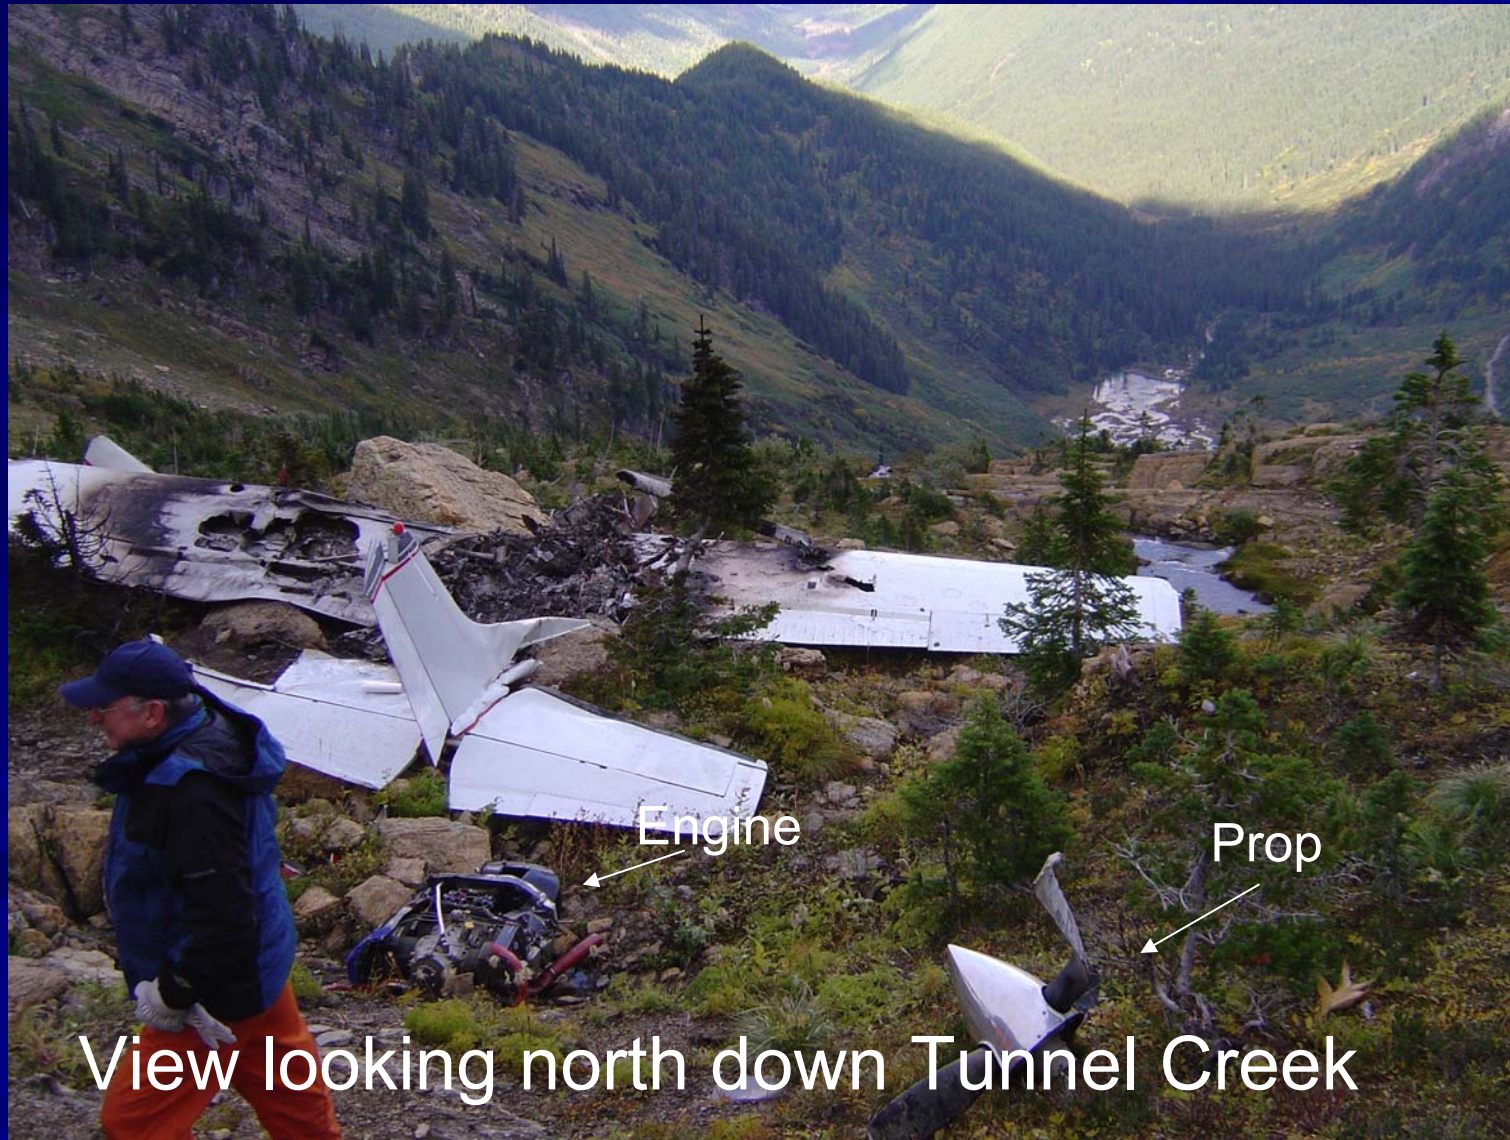
View looking north down Tunnel Creek

Approximate first ground contact

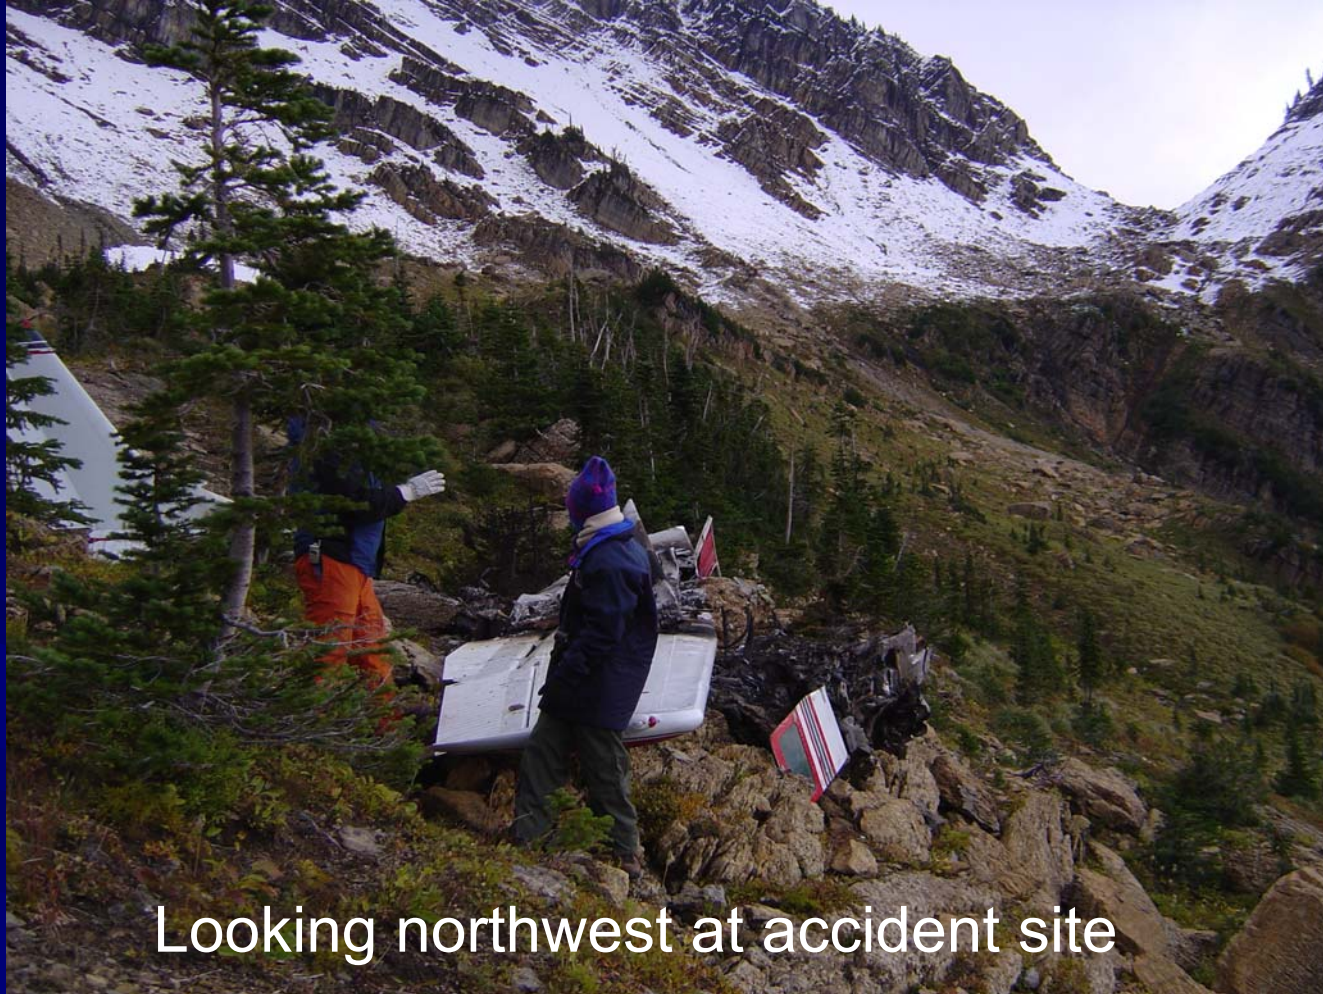
Looking northwest at accident site

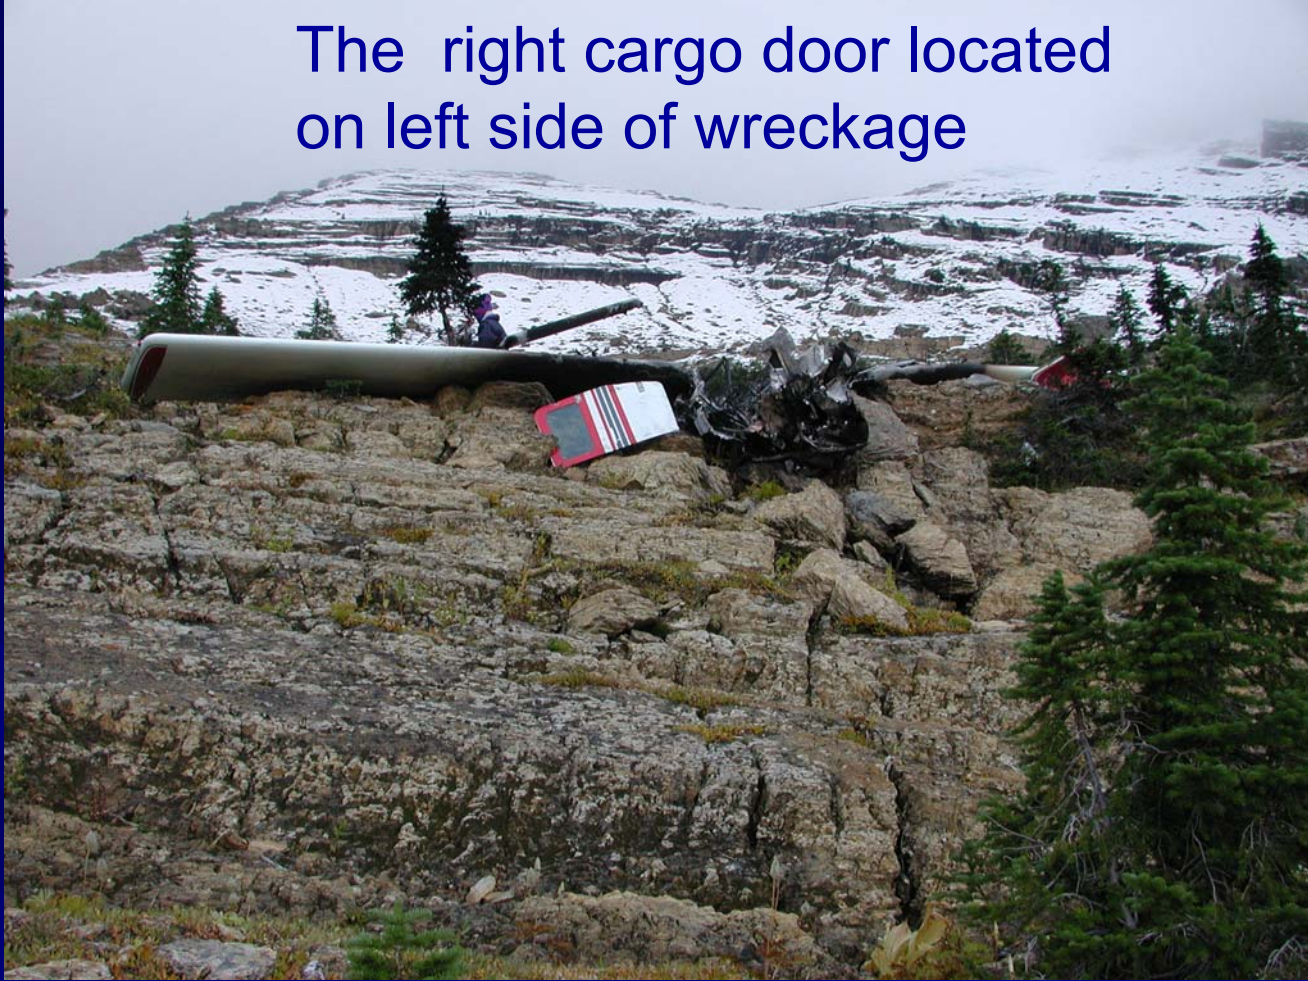
The right cargo door located on left side of wreckage

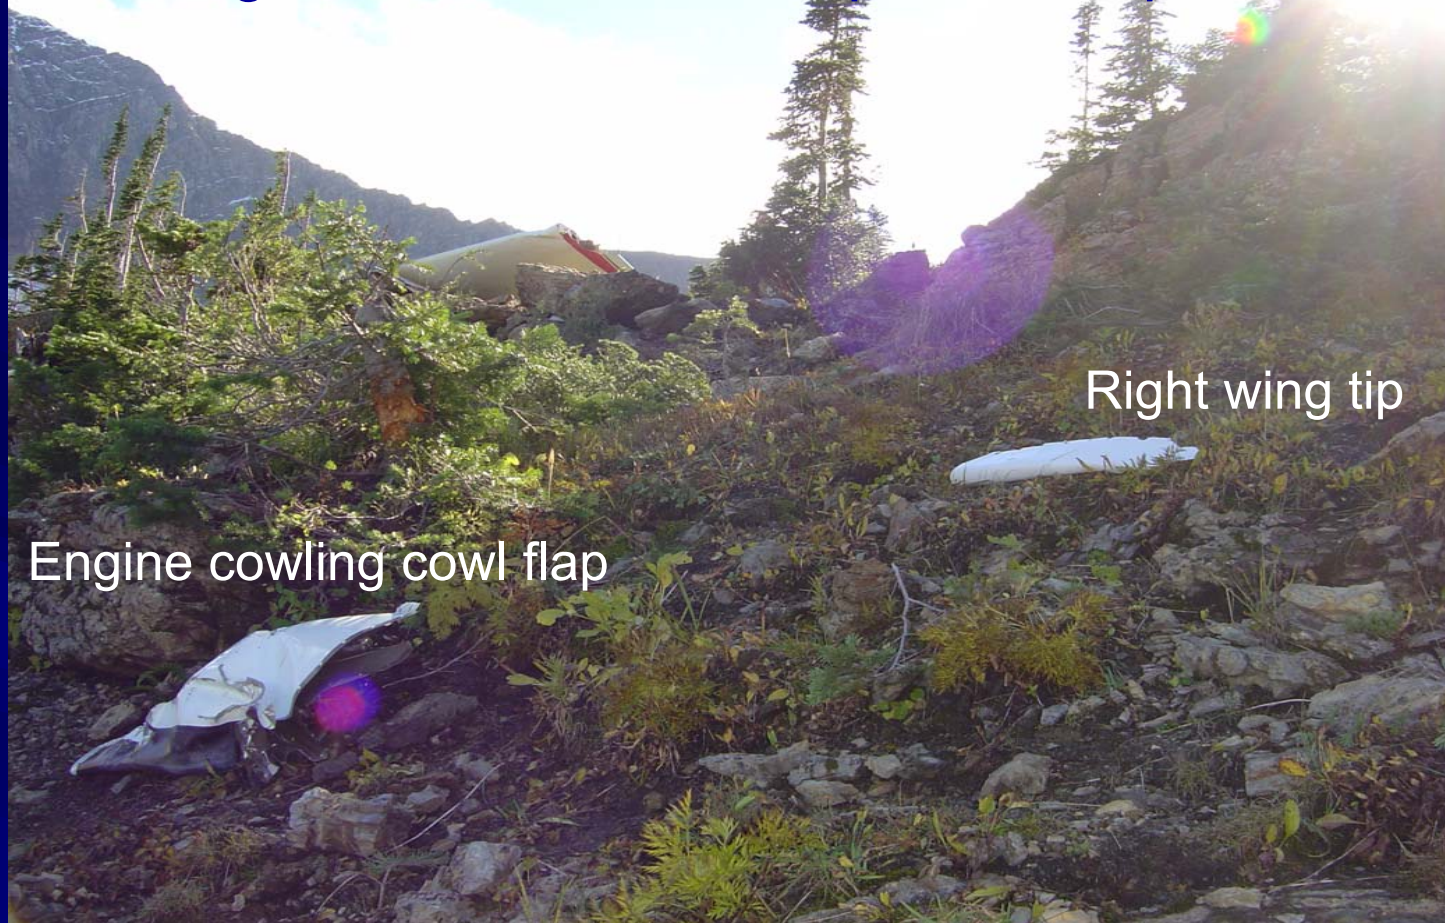
Looking southeast from first point of impact

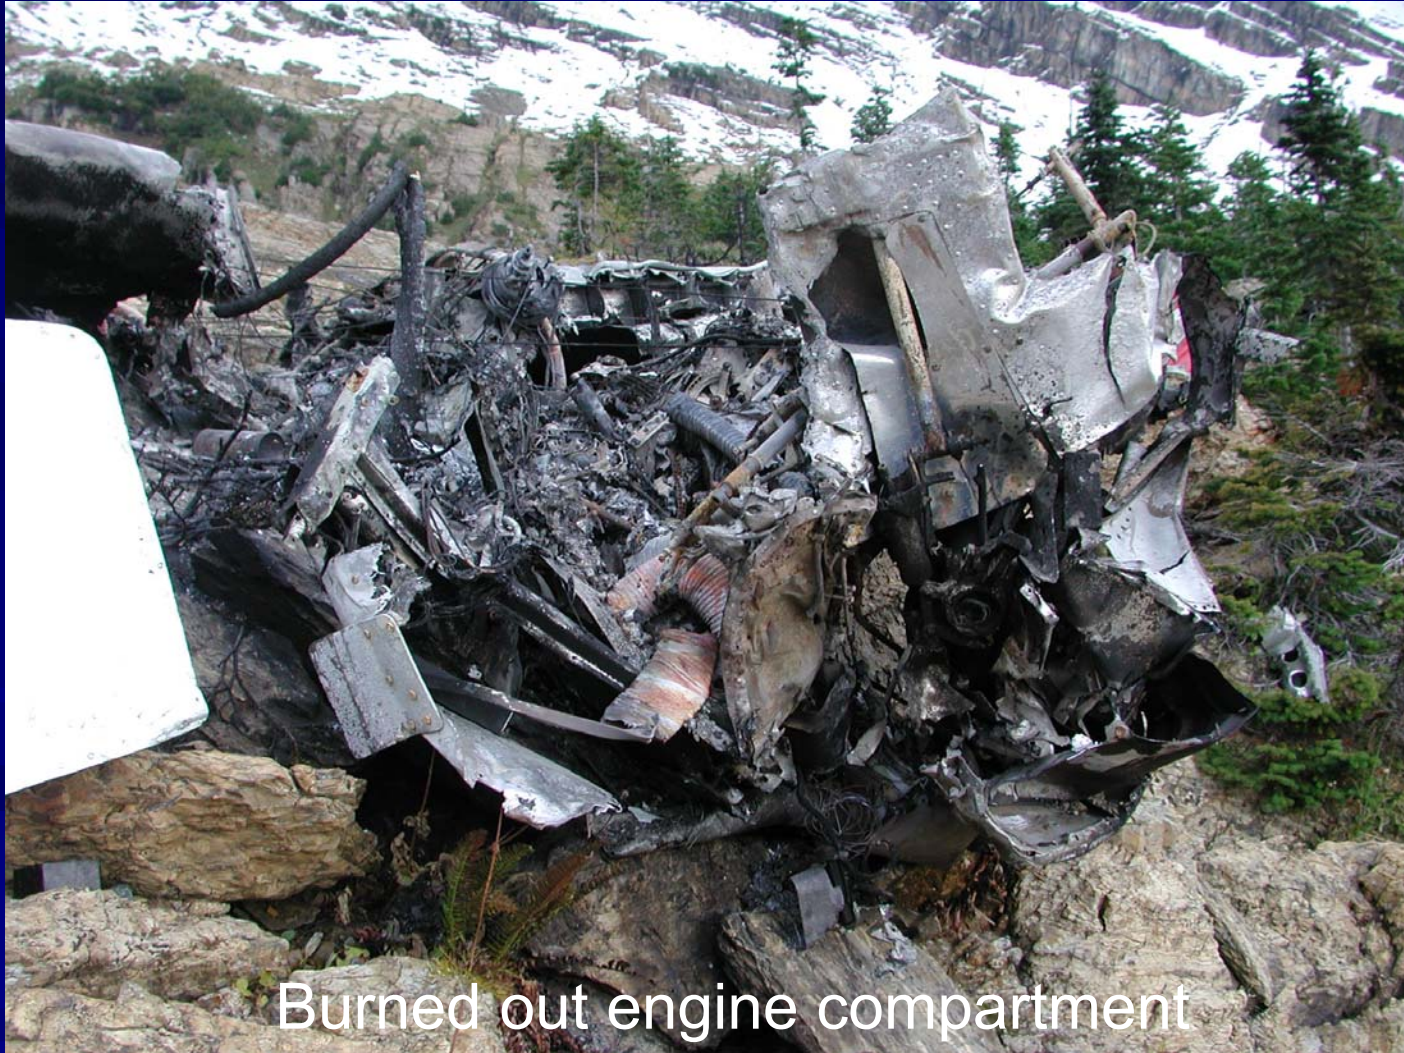
Burned out engine compartment
