# FY06 Forest Service Aviation Accident Review

NTSB Identification: **SEA06TA152**

NTSB Identification: **LAX06GA254**

NTSB Identification: **SEA06GA158**

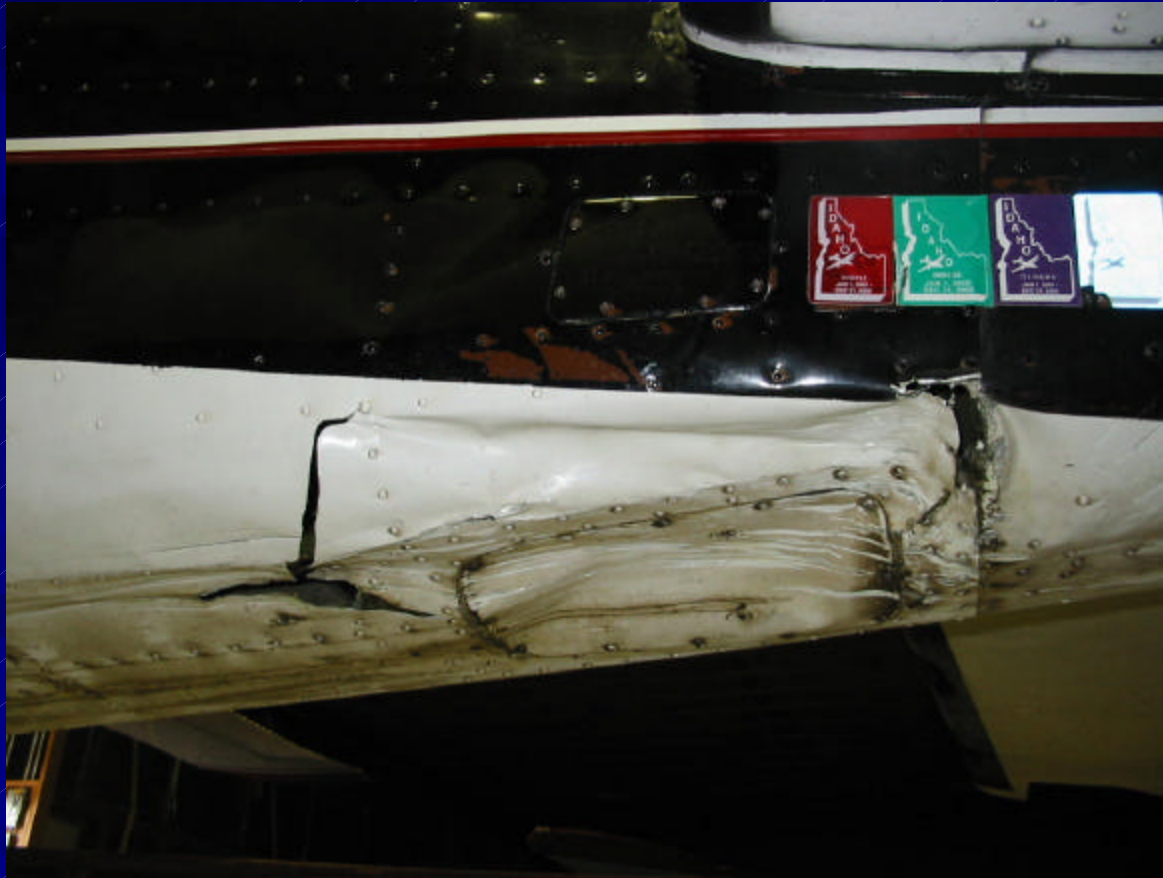
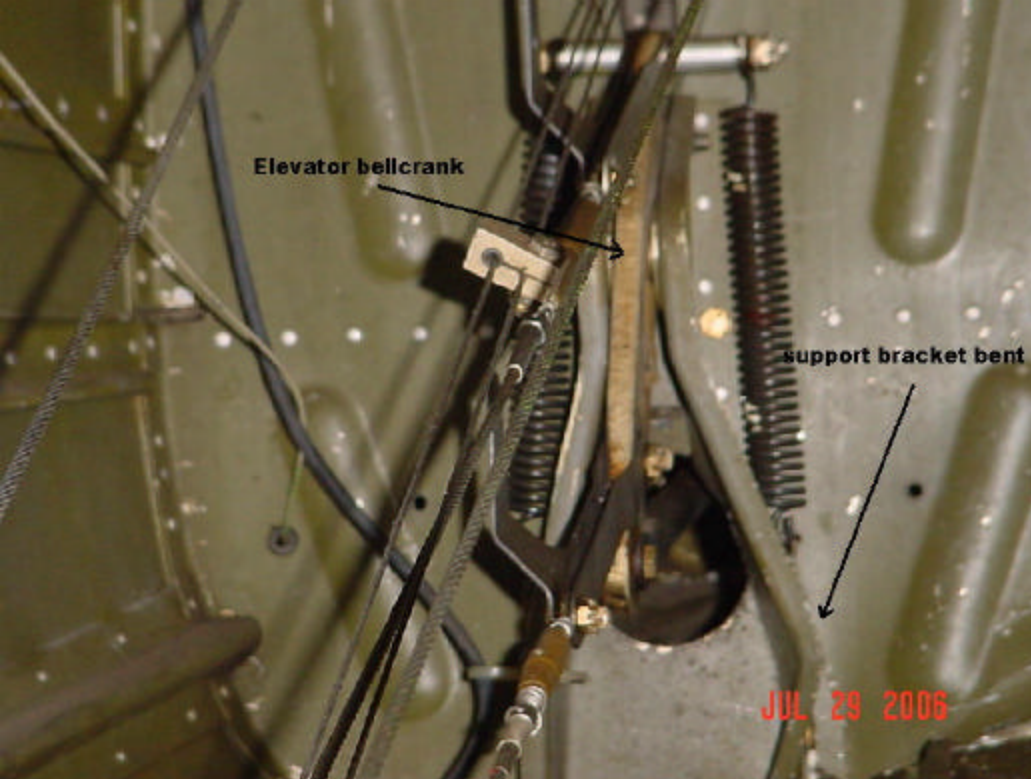
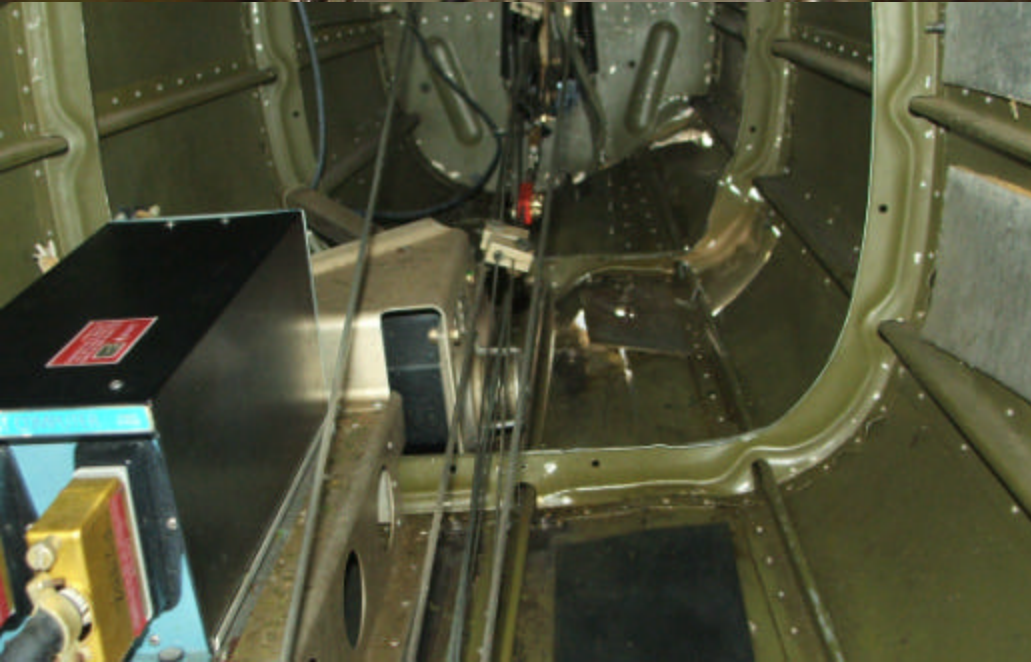
The aircraft hit hard enough to bounce the aircraft about 20 yards and right of the centerline of the airstrip and the right wheel went into a ditch. The Pilot applied left full rudder and left brake. The wheel came out of the ditch but the tail hit the ditch berm.

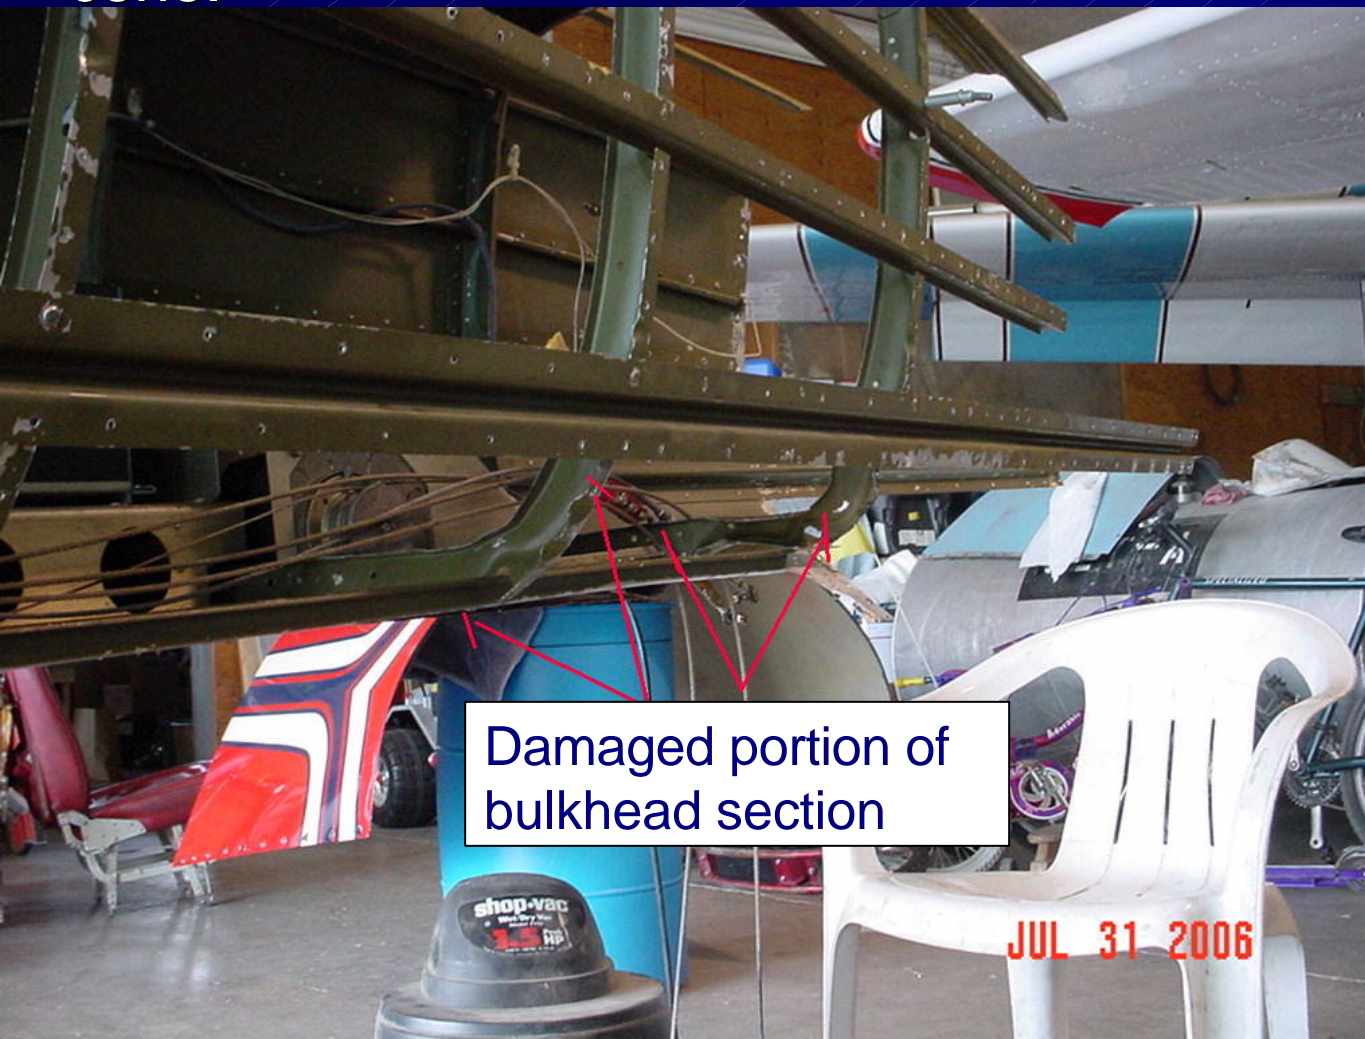
Damage was limited to the left side tail section below the level of the horizontal stab. Bulkhead frames and a few stringers were damaged and bent. The exterior skin in this area was also damaged as well as the skin on the underside of the tail cone.

Damaged portion of bulkhead section

There was no damage to any flight controls, cables, or wing surfaces. A bracket that holds a pulley for one of the elevator cables was deformed but did not displace the alignment of the cable travel.

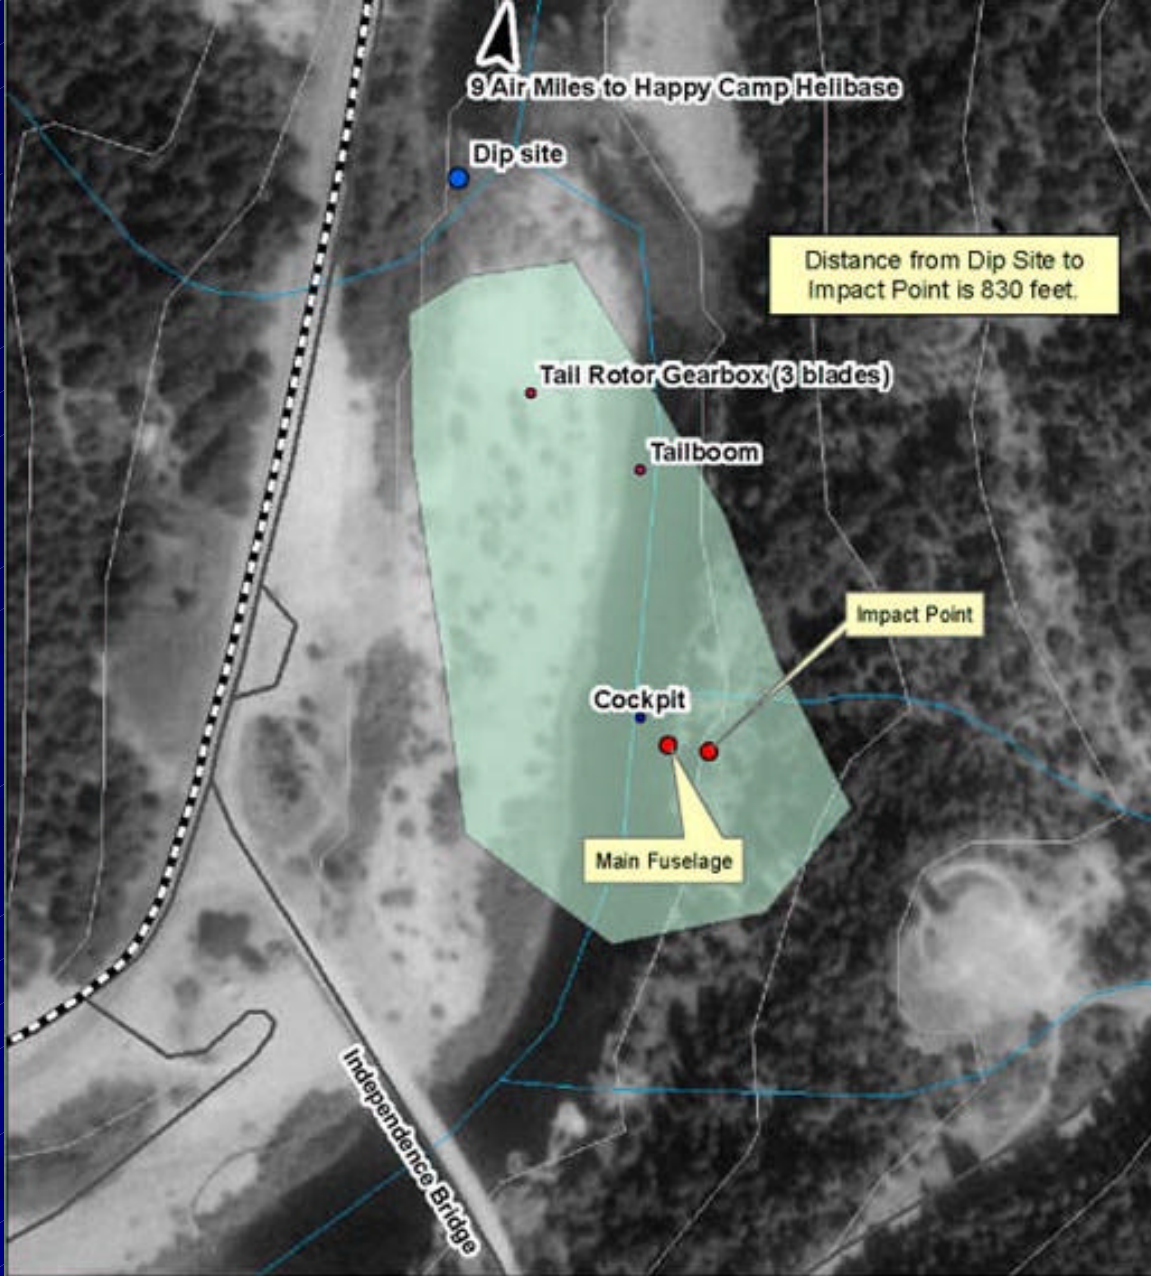
Distance from Dip Site to Impact Point is 830 feet.

Tall Rotor, Gearbox (3 blades)

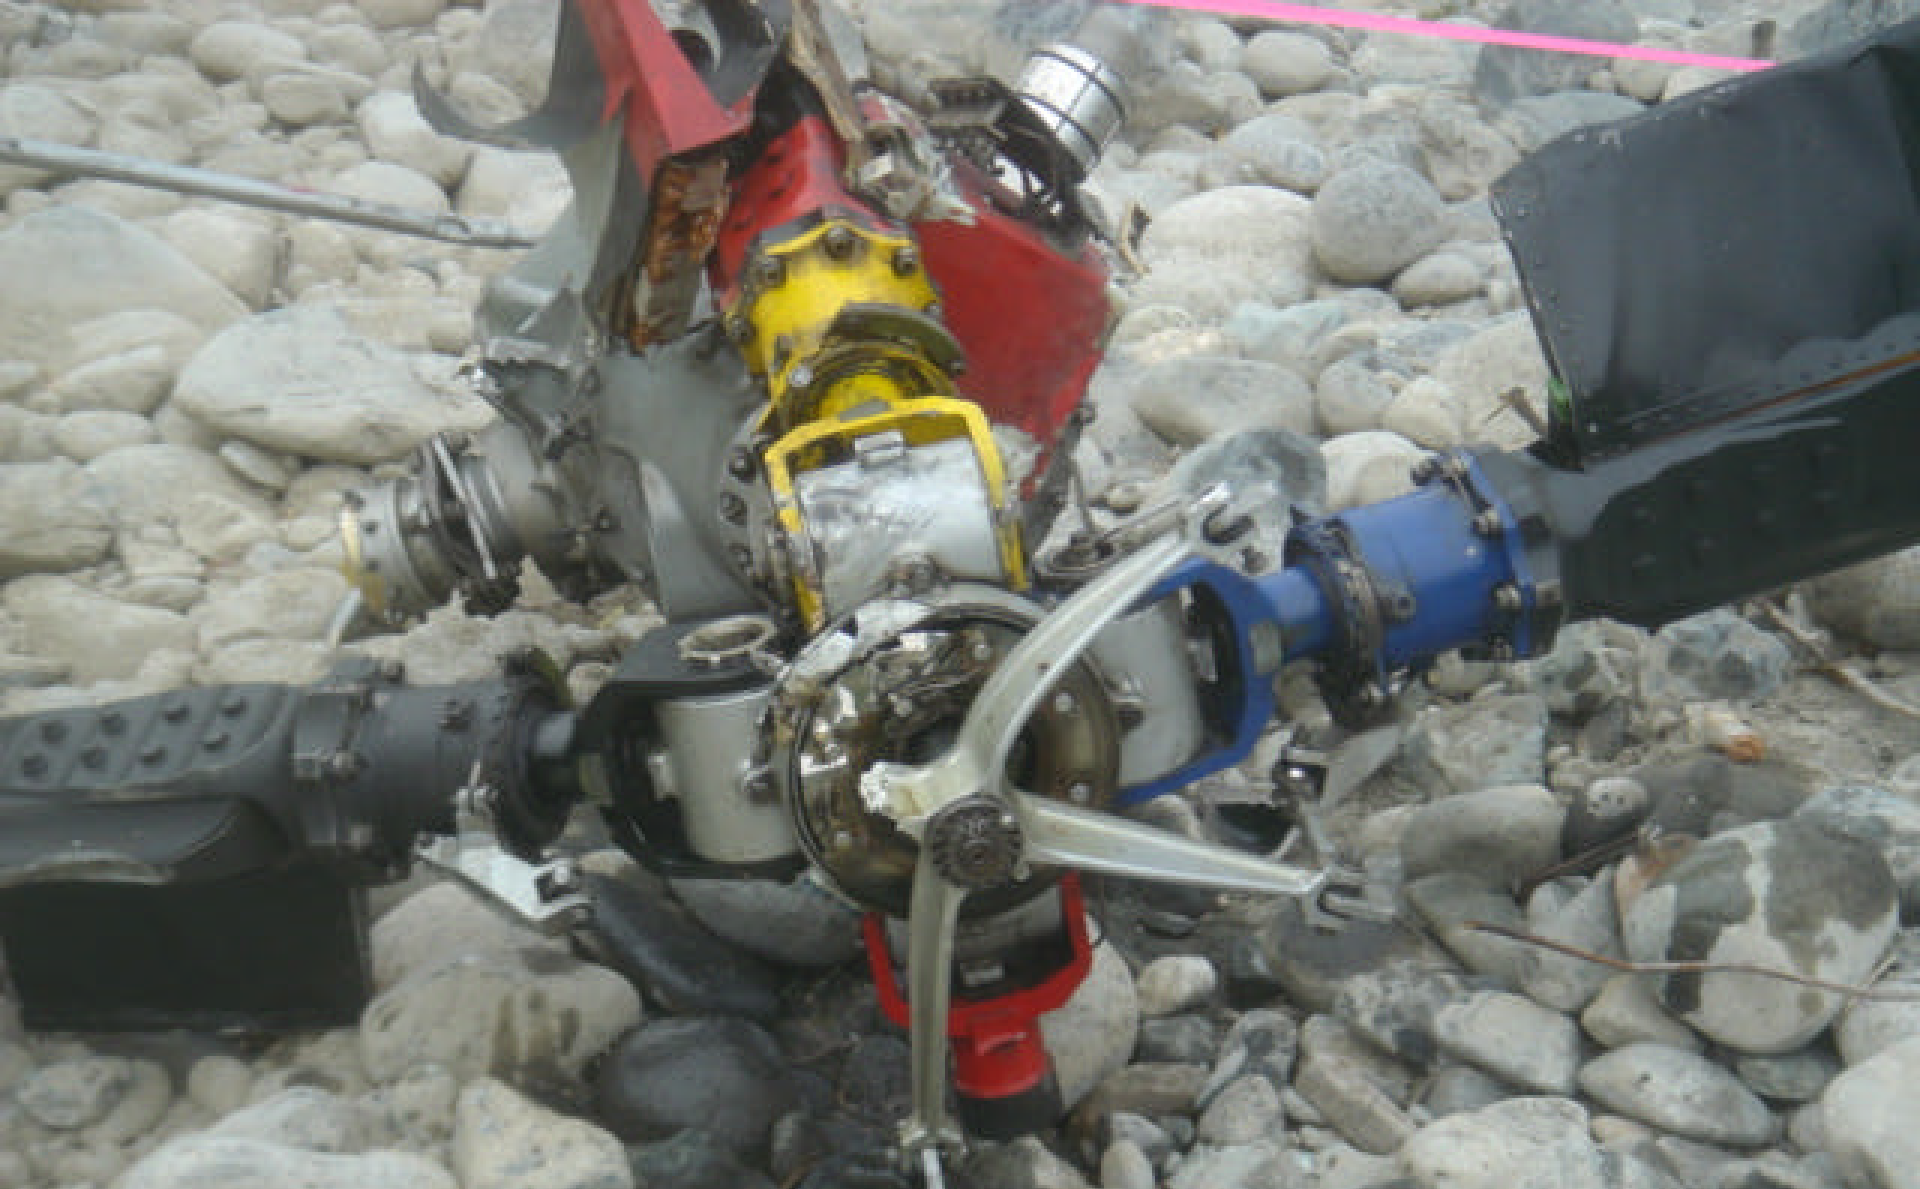
Examination of the tail rotor system revealed that the blade associated with the red collar/spindle was missing and has not been located. The spindle was fractured inboard of where the sleeve assembly would attach to the spindle. It was noted that the location of the fracture would not normally be visible in an assembled component.

The fractured spindle was removed from the tail rotor hub and shipped to the National Transportation Safety Board Materials Laboratory in Washington, D.C., for further examination.

- Review the maintenance performance of this contractor.
- Review our Forest Service procedures and our ability to follow through when concerns are identified.
- Assure the Region has action plans to implement findings of systems reviews and appropriate oversight to assure compliance with action items.

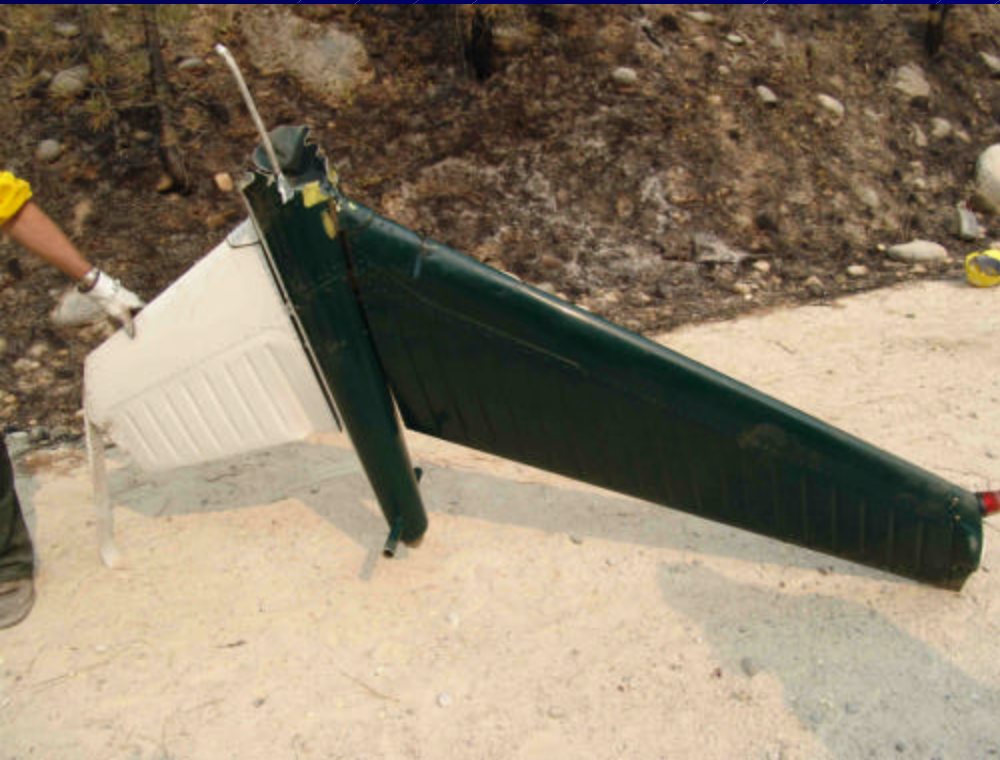
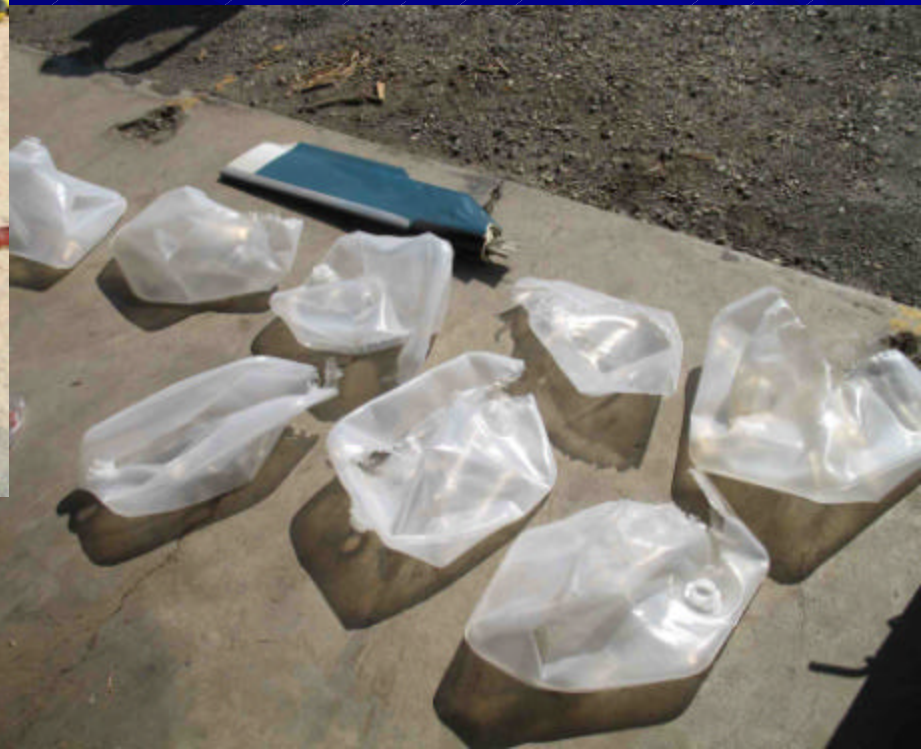
The debris included the tail-cone with its vertical and dorsal fins, the tail rotor gear box cover, one tail rotor blade, the top half of the upper wire cutter, and several five gallon potable water containers (cubies), and other miscellaneous refuse.

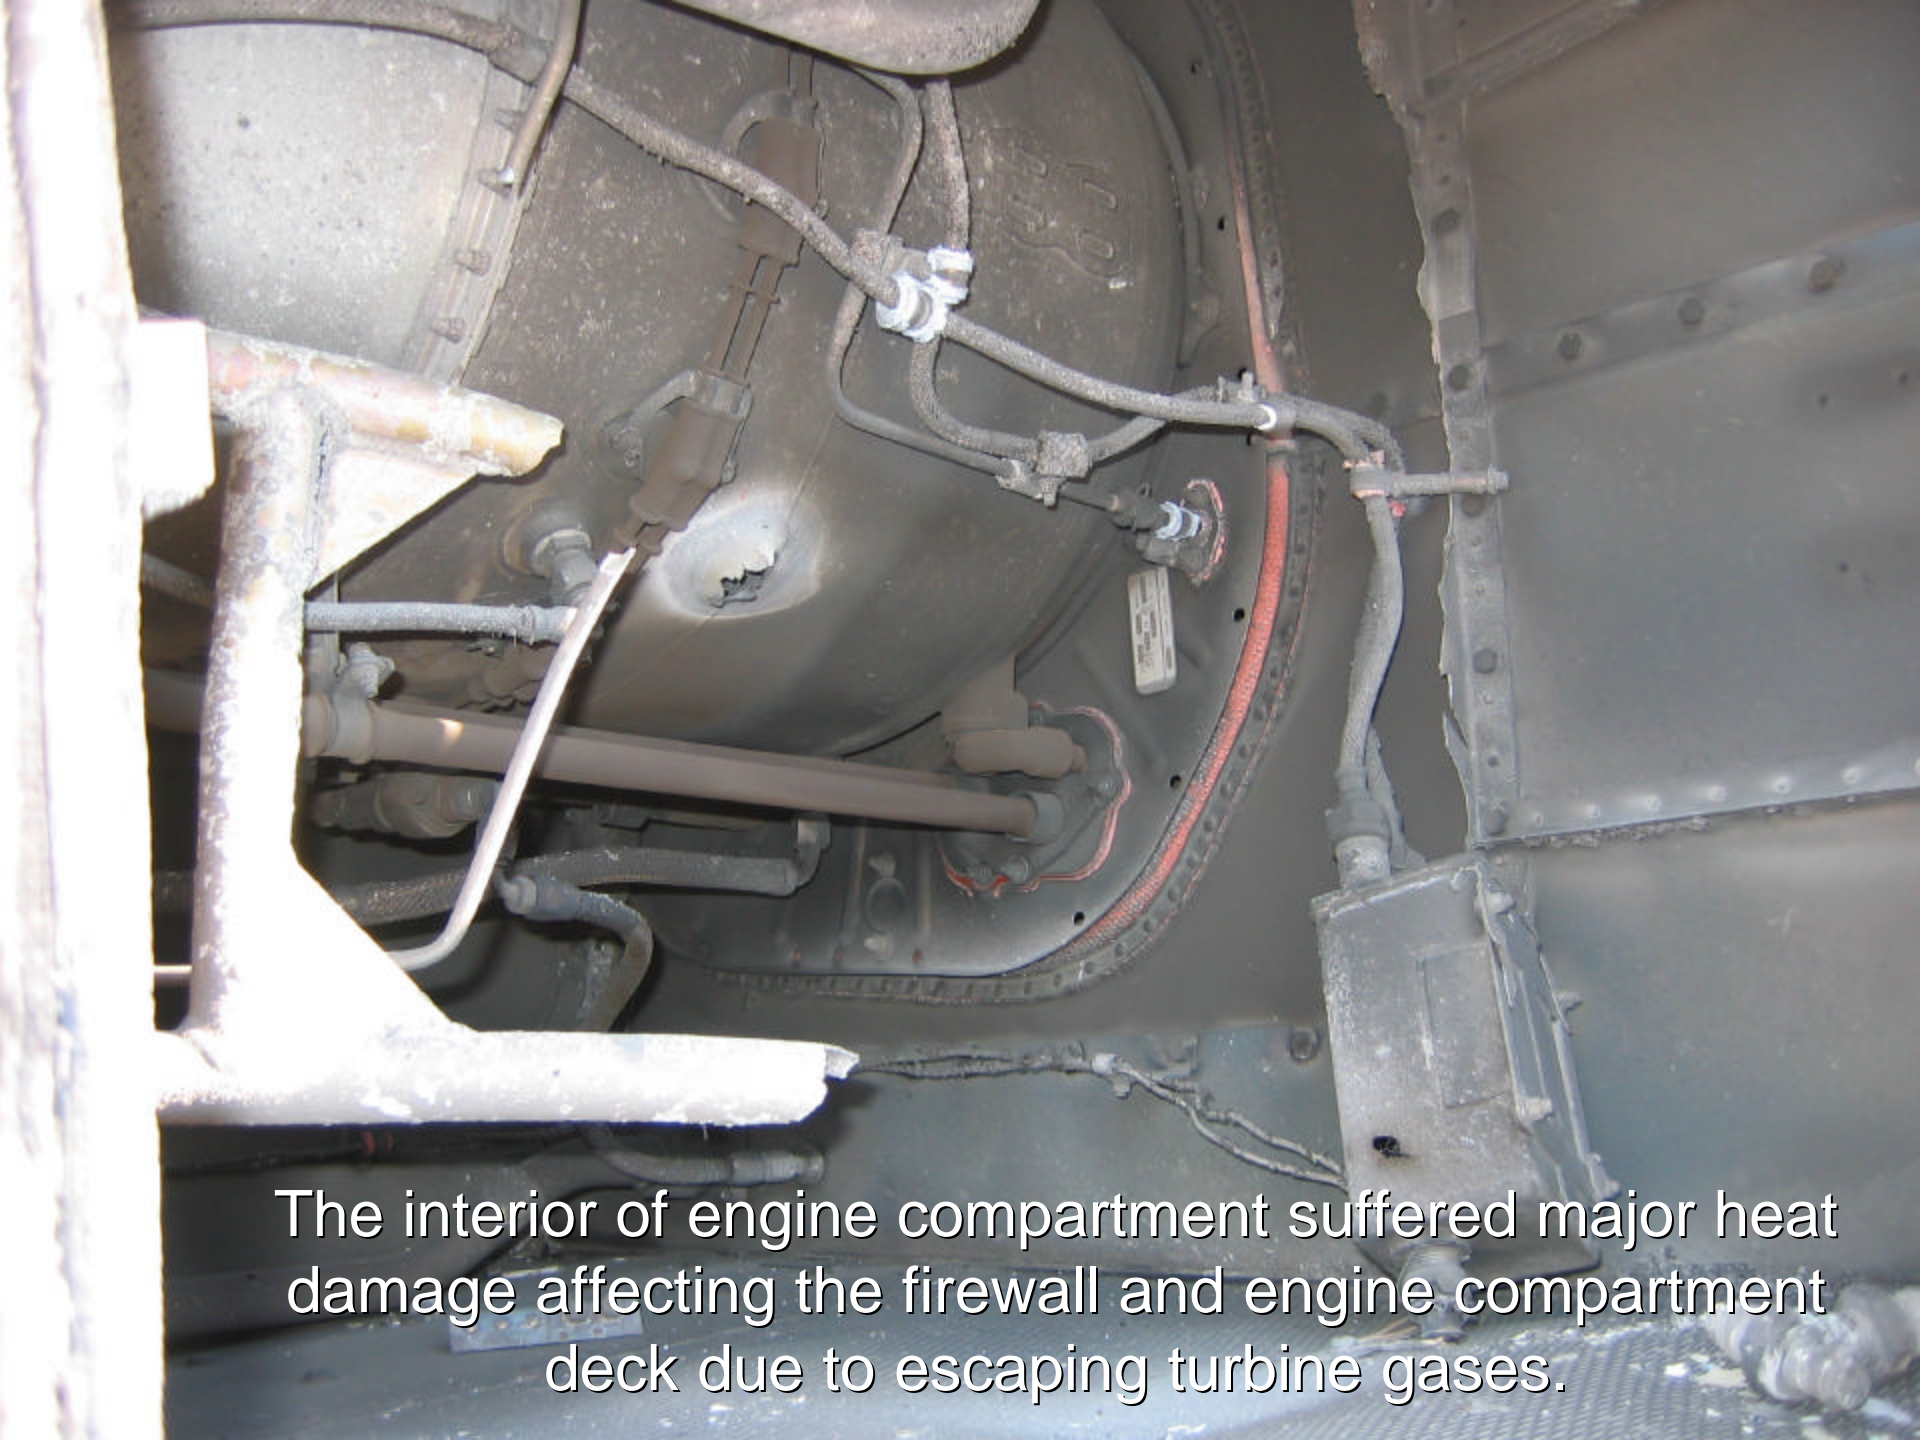
The interior of engine compartment suffered major heat damage affecting the firewall and engine compartment deck due to escaping turbine gases.

A post-landing examination of the helicopter revealed that a puncture from the inside out existed in the hot section of the right engine. The engine compartment, engine deck, firewall, cowling attachment point, and other accessories on the right side of the helicopter sustained damage.

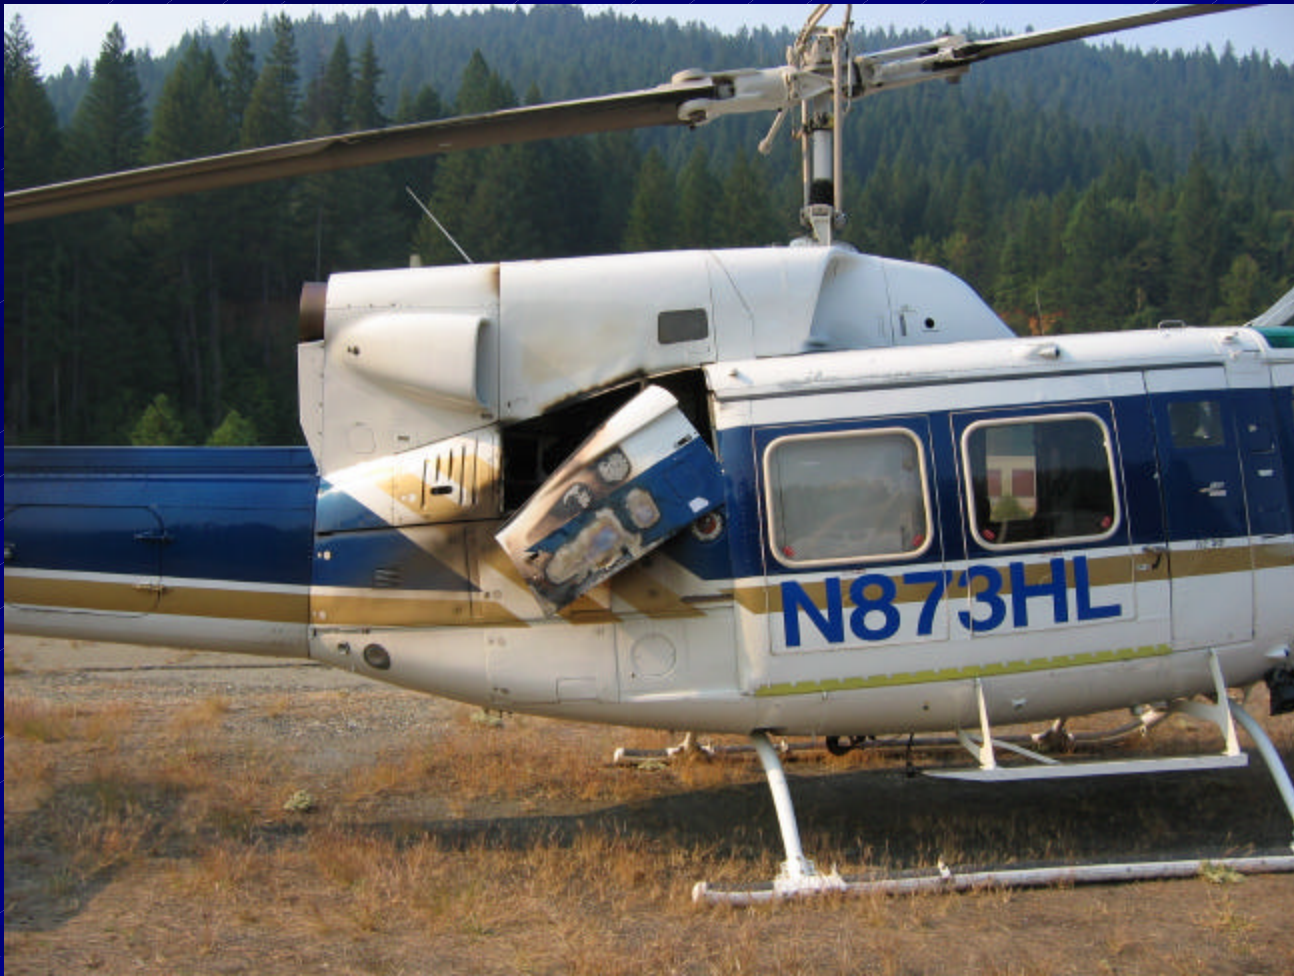
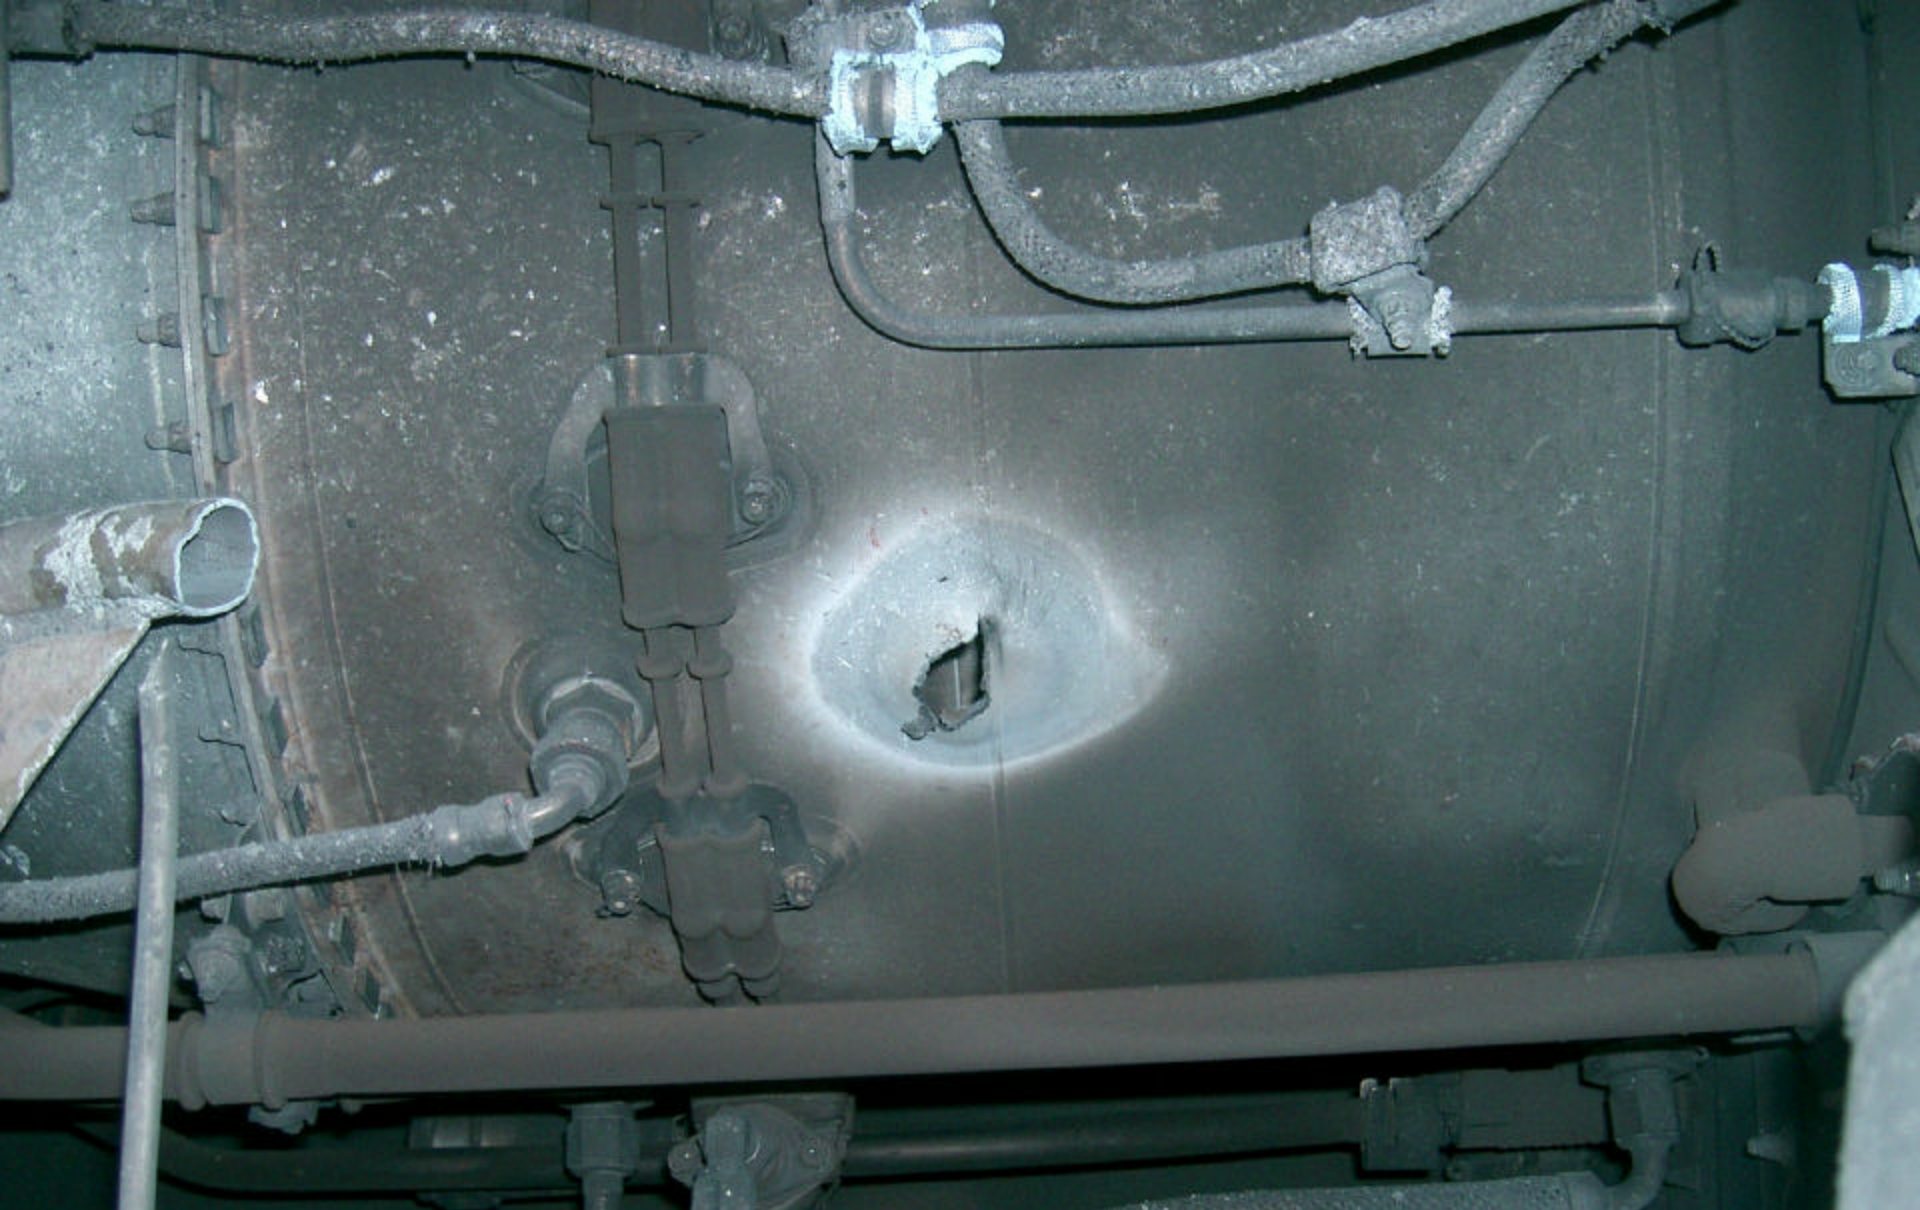
Initial engine teardown analysis determined an internal engine component failure. The engine manufacturer, FAA and NTSB are doing further analysis and metallurgy tests.

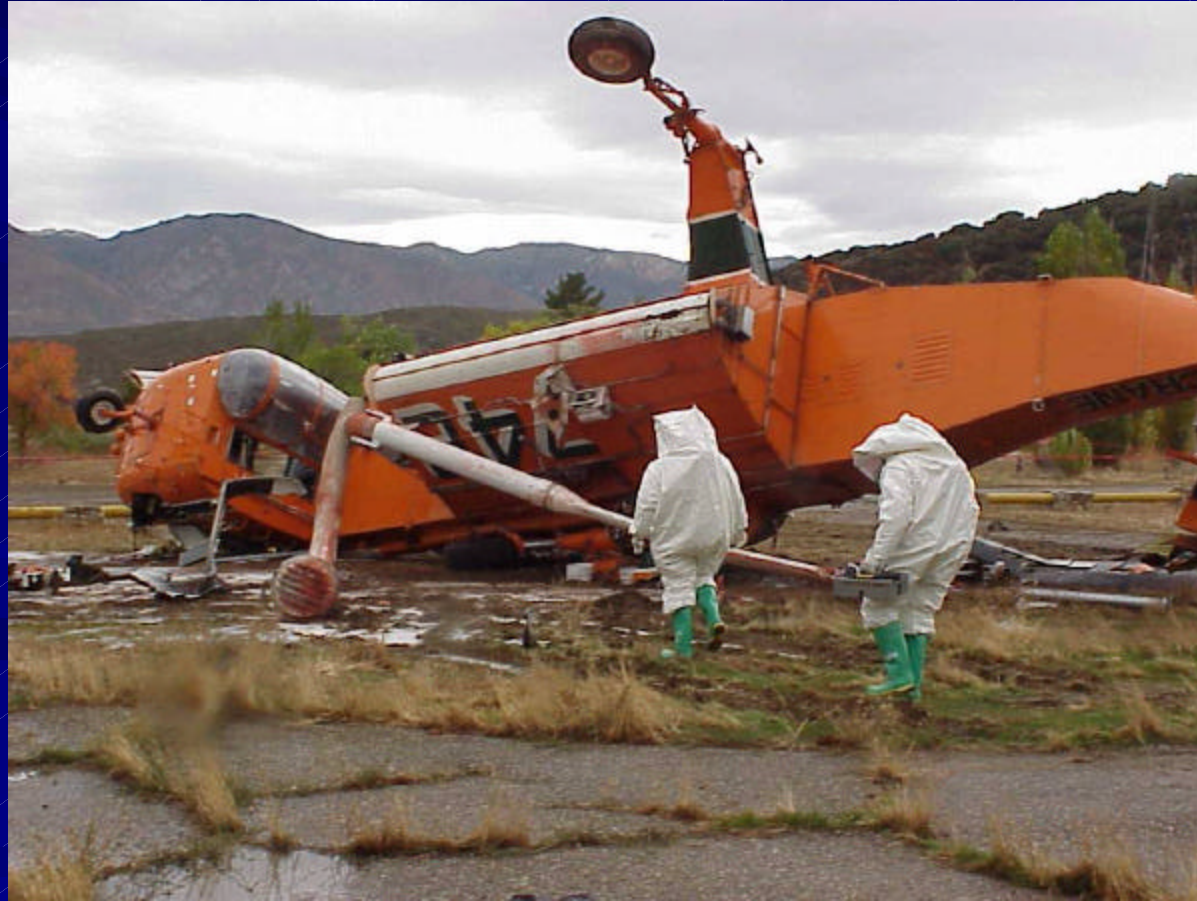
**The helitanker was picking up it's 6th load of retardant, it had drafted the last 200 gallons from the retardant tank and opted to top off the load with remaining water from the rinse tank. As the helitanker maneuvered from the retardant tank to the rinse tank the pilot misjudged the height of the snorkel, below the top of the tank.**

1. Request manufacturers of portable helicopter retardant/water tanks (PRT) to inspect and modify tanks that may have edges or protrusions.
2. Request the manufactures of “snorkels” to inspect and modify any snorkels to remove edges or protrusions that would catch a PRT.

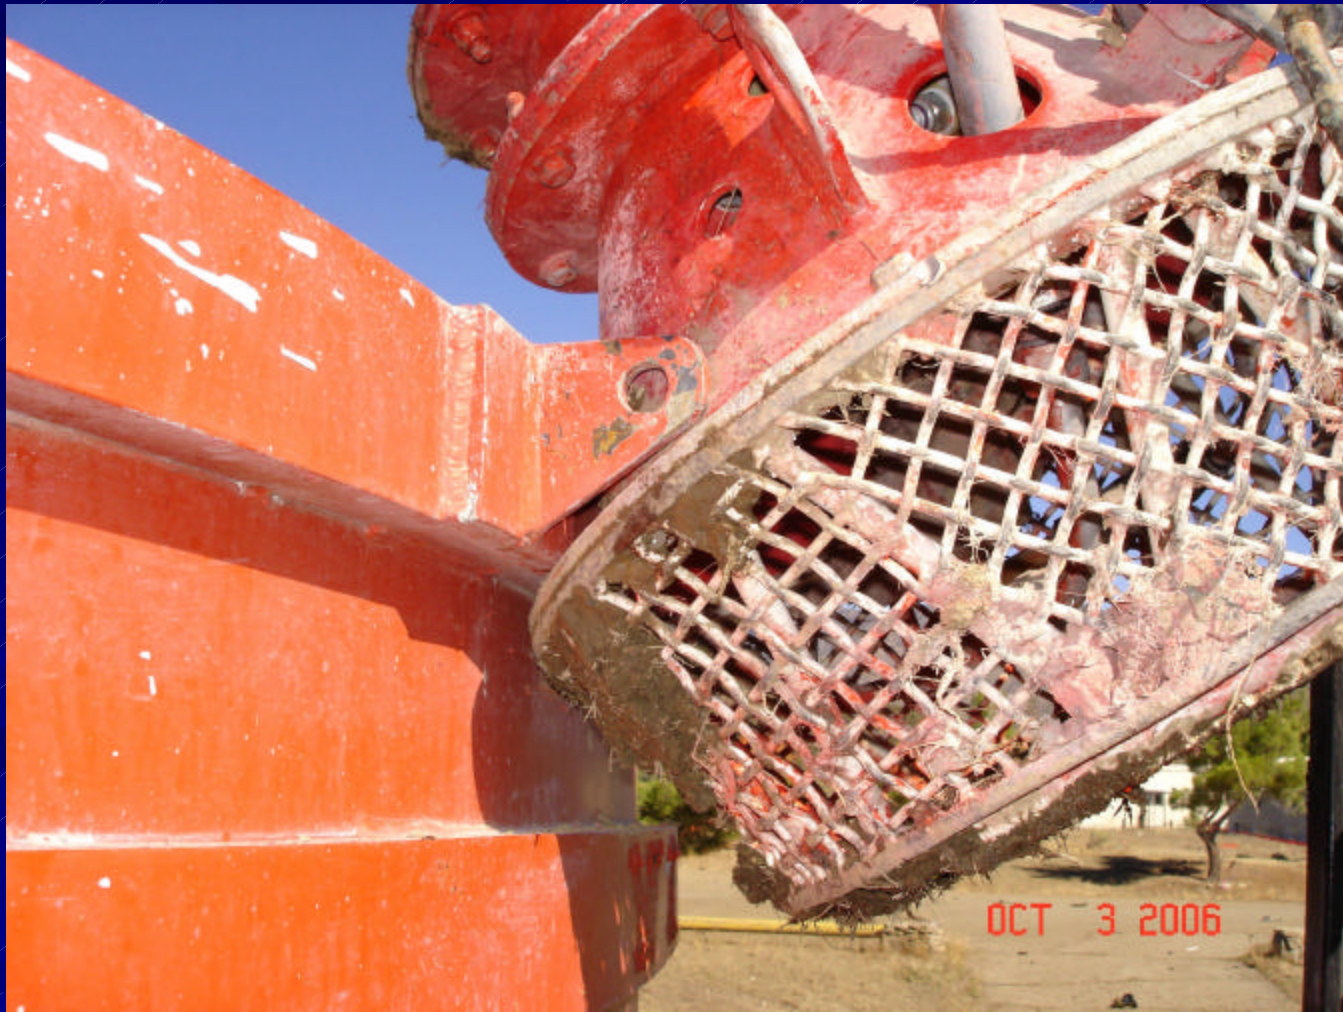
**The snorkel became lodged to the tank between the tank band and the lifting eye. The nose of the aircraft went down and the pilot pulled back on the cyclic and applied power**

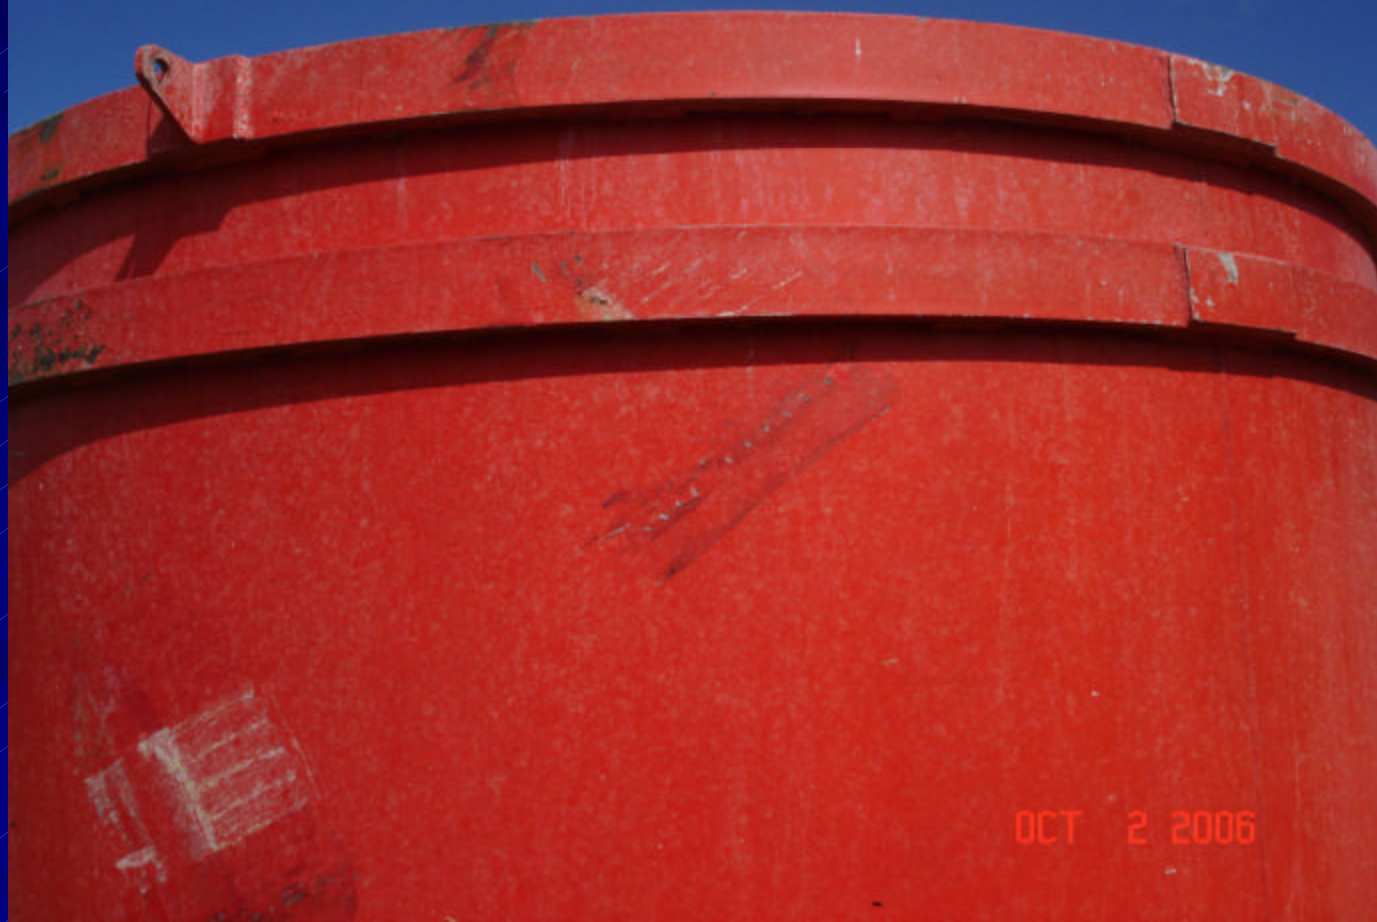
**The nose of the aircraft came up but was in a left bank with a high nose up attitude, the tail stinger contacted the ground and the aircraft spun around to the left. On this first rotation, the tail rotor blades contacted the retardant tank; two of the blades (symmetrically) depart the aircraft**

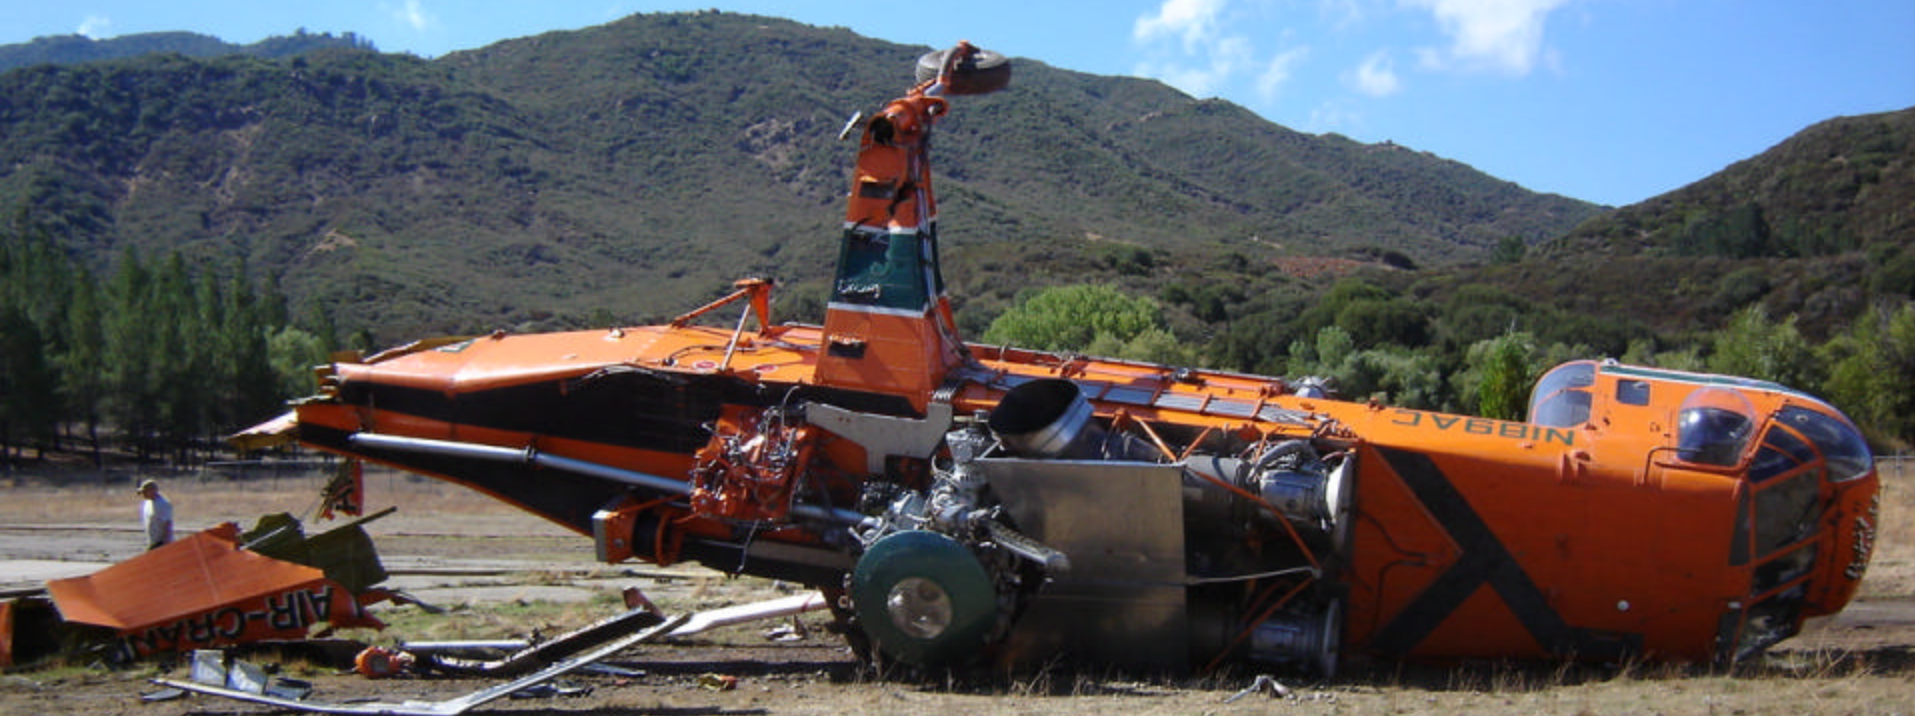
**The aircraft continued to spin (2nd rotation), the tail rotor head contacted the retardant tank a second time breaking off the 90 degree tail rotor gearbox, and also breaking off the last 1/3 of the tail boom.**

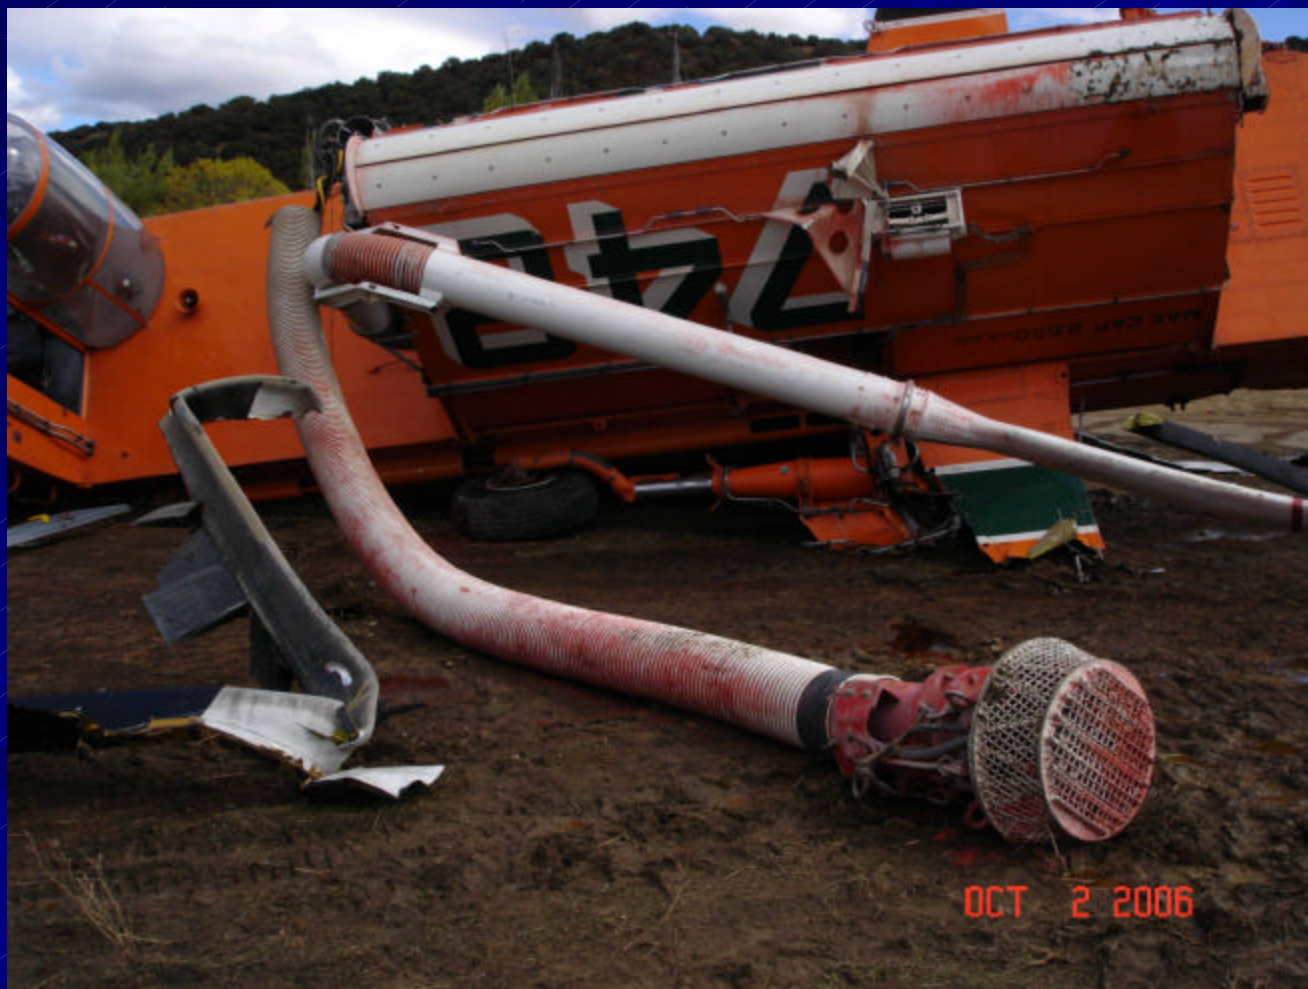
**The aircraft's right main gear contacted the ground hard enough to break it off. The aircraft rolled right striking the main rotor blades.**
