UNITED STATES
DEPARTMENT OF AGRICULTURE
FOREST SERVICE

FATAL AVIATION
ACCIDENT HISTORY

Compiled By: Candy S. Rock FitzPatrick

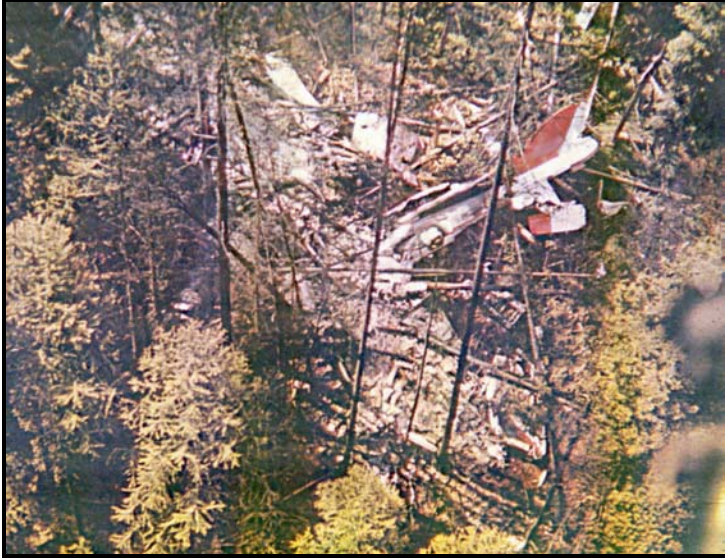
Boeing B-17G (B-17) wreckage location.

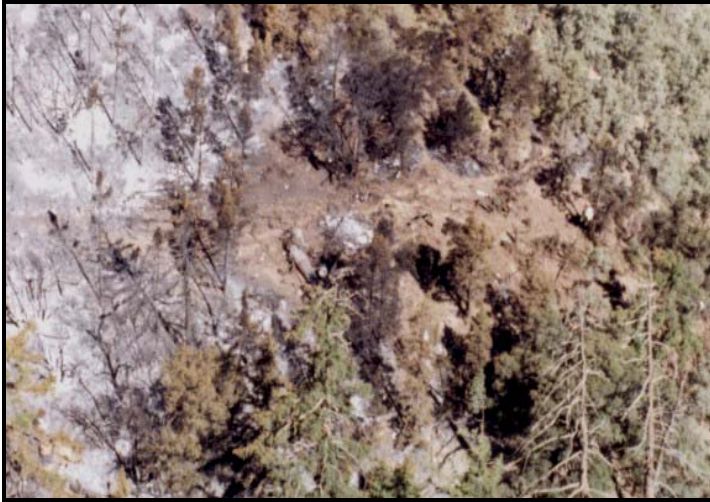
Investigation by the National Transportation Safety Board (NTSB) and Forest Service teams showed definite pre-mishap cracks in the inner left wing aileron bell crank control assembly. The possibility of a

bell crank failure could have induced aileron flutter, which in turn could have contributed to wing destruction causing the wing to separate from the airtanker.

Aerial view of Fairchild C-119 main wreckage.

After this mishap, all C119s under contract in this Region were grounded so airworthiness inspections could be conducted. Three aircraft were inspected and a total of 14 parts in aileron control systems were found cracked or to have had excessive wear. Three of five bell cranks were found to have cracks. An Airworthiness Directive (AD) was then issued by the FAA pertaining to prevention of possible wing failure due to loads induced by “free aileron” on this type of aircraft.

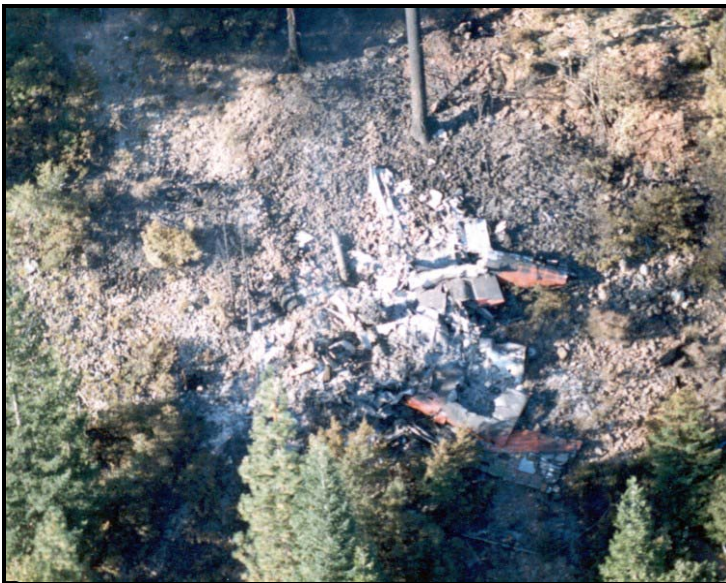
The mishap investigation team concluded that the airtanker was subjected to excessive aerodynamic loads, which led to a catastrophic structural failure of the wings due to excessive speed and probable excessive pitch-up at or immediately after dropping the retardant.

Fairchild C-119G (3E) main wreckage.

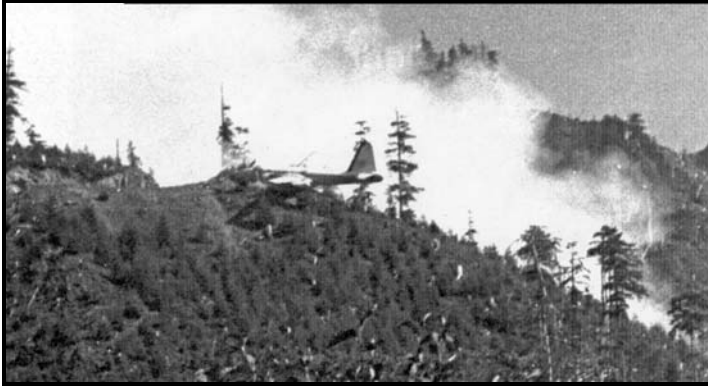
The probable cause of this mishap was that the pilot maneuvered the airtanker in a manner that he was extremely low and slow, with landing gear and flaps extended, and did not use additional jet engine thrust available to clear the ridge. The pilot had misjudged the short steep canyon and was not able to recover sufficient airspeed to exit the drop pattern safely. The pilot had dropped one half of their retardant on the target and did not jettison the other half of the load to avoid hitting the ridge.

Lockheed P2V-7 airtanker after impact and beginning to break up.

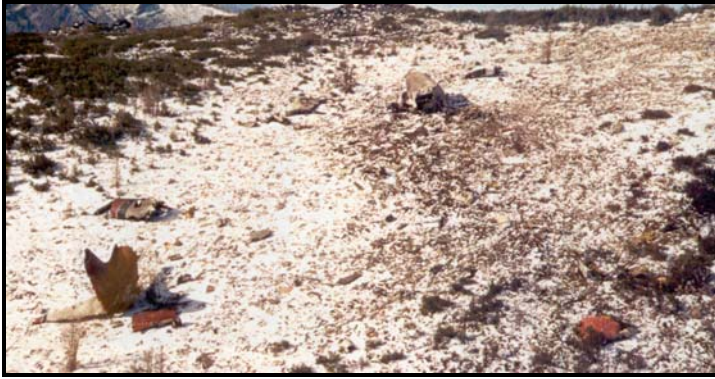
Lockheed P-3A Orion main wreckage site.

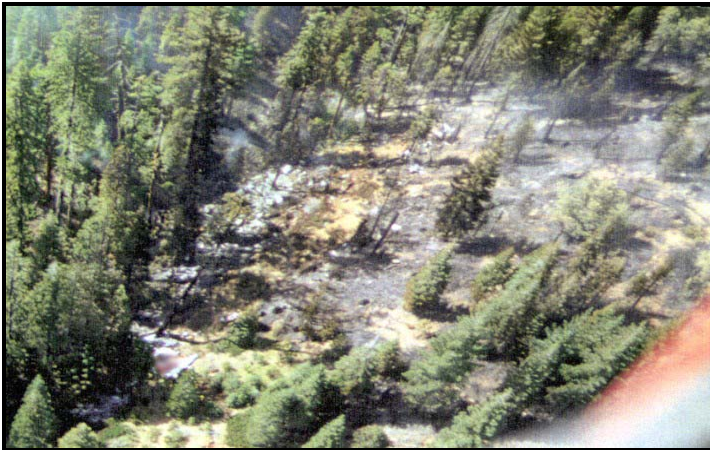
The causal factor of this mishap was the pilot's preoccupation, inattention, or possible distraction while operating the airtanker in close proximity to terrain. Contributing factors included: 1) Cockpit/Crew Management, 2) The pilots failed to recognize the severity of the situation and were reluctant to abort their retardant load, and 3) The fuselage struck vegetation.

Overview of main Douglas DC-7B mishap site.

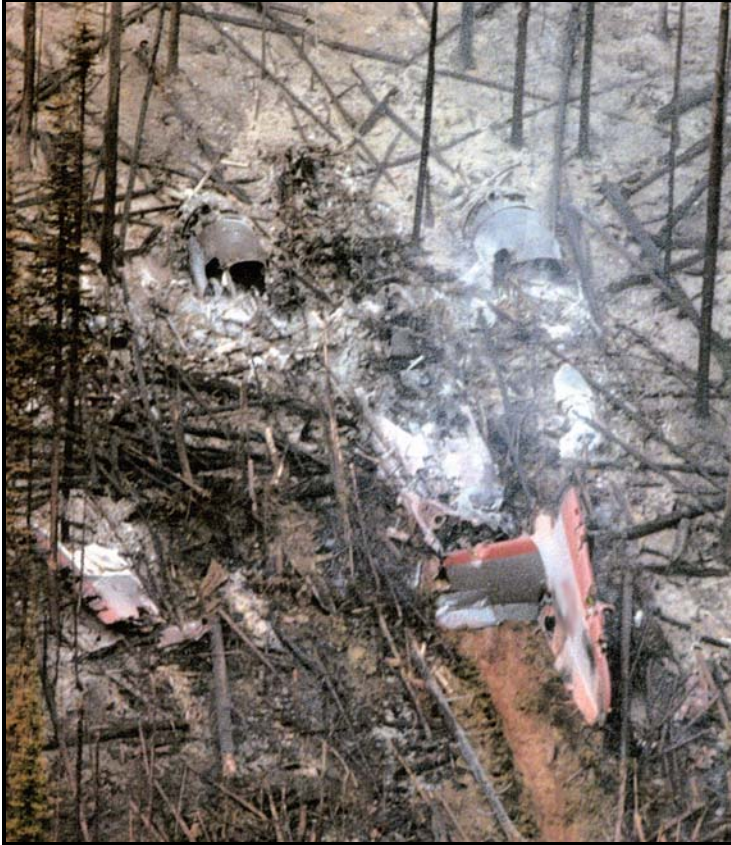
This photo of the Lockheed P2V-7 Neptune was taken the day after the mishap, July 30, 1994.

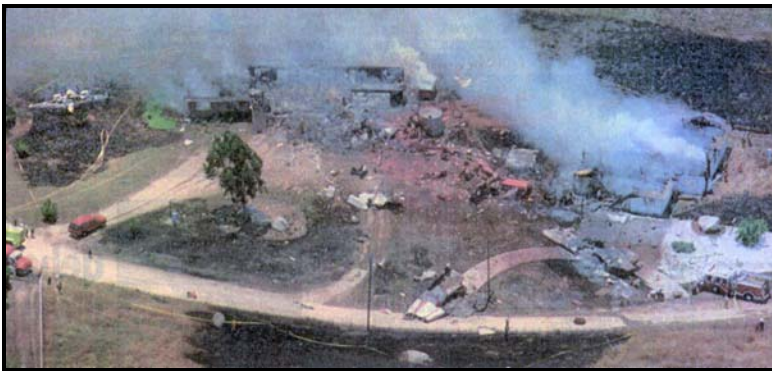
The wreckage of the leadplane is in the upper left hand corner of this photo, the airtanker near the center. Burning are the two residences. The tail sections of both aircraft are not pictured here.

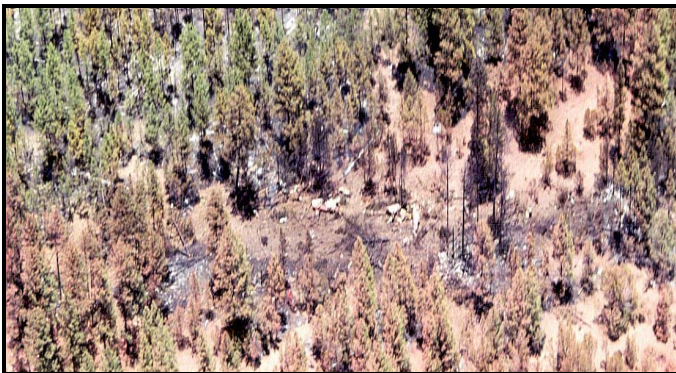
The probable cause of this mishap was stated as: While in a right bank descending turn, the right wing struck the top of a Ponderosa Pine tree. Contributing factors included: 1) The toxicological report for the pilot flying the airtanker revealed a presence of Brompheniramine and Chlorpheniramine, both antihistamines. At any detectable tissue level, the most common adverse reactions of these medications may include drowsiness, sedation, dizziness, faintness, and disturbed coordination, 2) The pilot flying was inexperienced in low level flight, and 3) The airtanker was in too steep of a turn and at too low of an airspeed to maintain altitude. The airtanker struck trees resulting in a loss of control of the airtanker.

Main wreckage location of the Neptune P2V-7, Navy version Lockheed SP-2H.

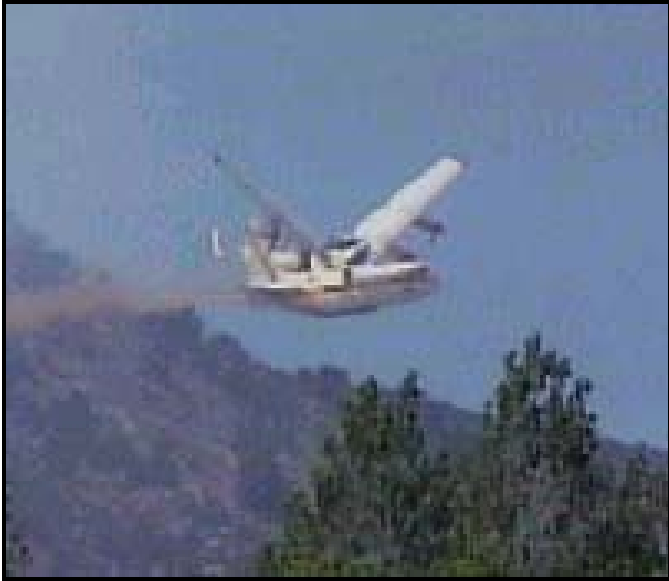
C-130A airtanker as its wings separated from the fuselage near the wing roots.

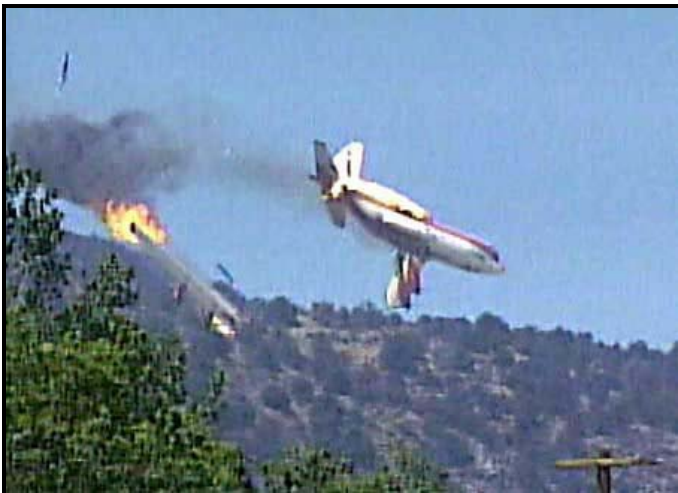
C-130A airtanker after its wings separated from the fuselage.

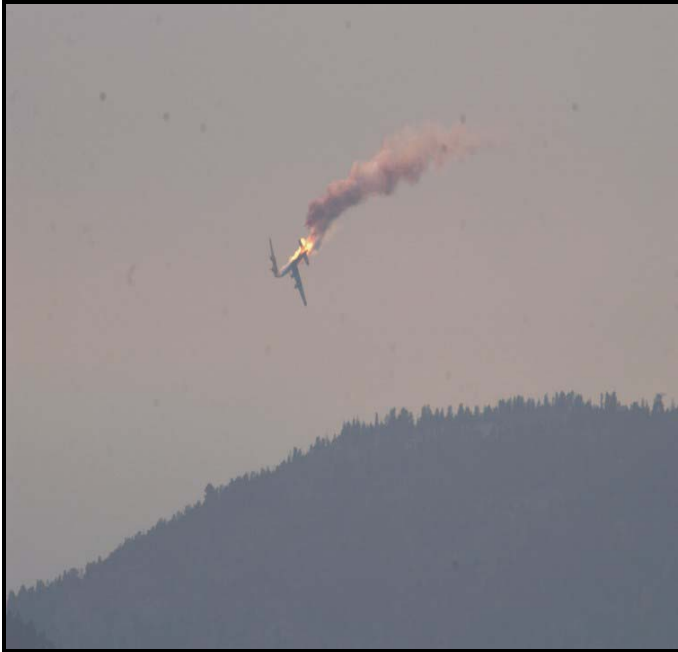
PB4Y-2 airtanker upon wing separation.

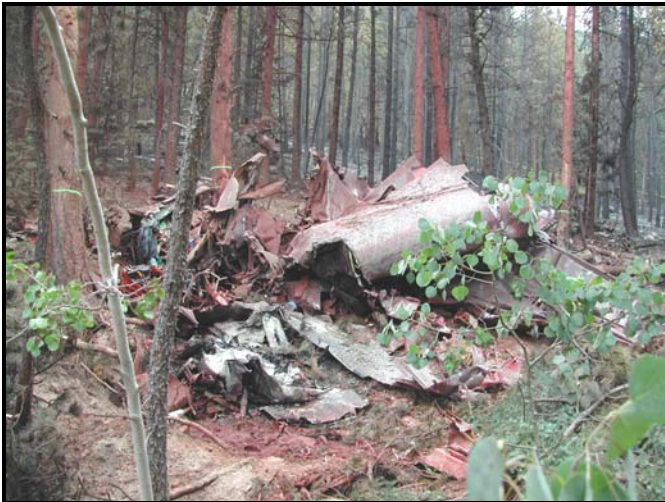
PB4Y-2 main wreckage.

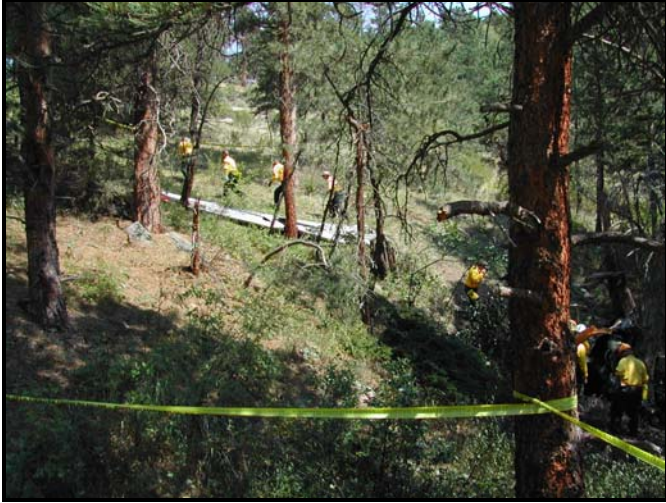
PB4Y-2 separated left wing.

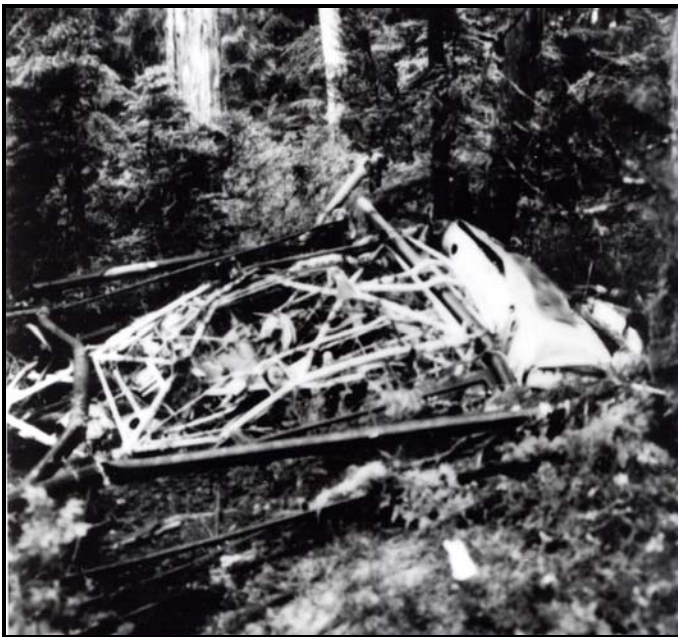
Further analysis of tail rotor blade Serial #A-376016 A-376008, which had been found 411 feet from the fuselage of the helicopter, revealed that this blade had a separation fracture at the grip area. Initial National Transportation Safety Board (NTSB) reports indicated that the separation was caused by fatigue failure of the tail rotor blade material. This caused severe vibration, separating the tail rotor gearbox and remaining blade from the helicopter. This then caused the loss of control of the helicopter, which resulted in the mishap.

Bell 47-G3B-1 wreckage.

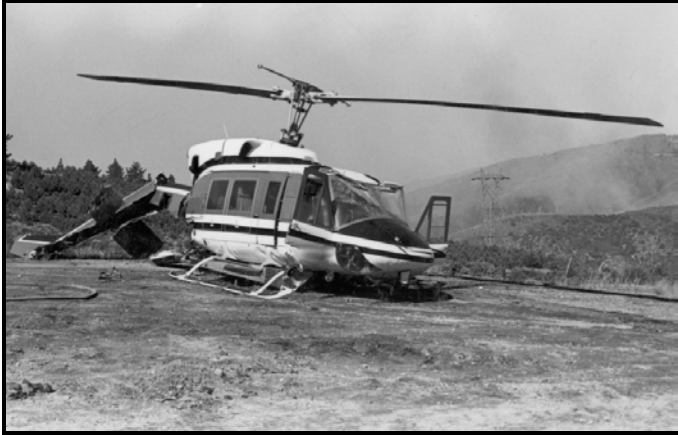
Forest Service contract helicopter on helibase, post-mishap.

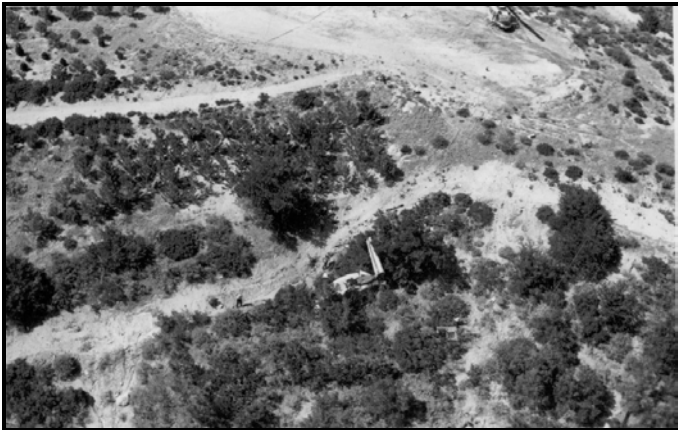
Final resting place of the County Fire Department helicopter (near center of photo) in relation to the helibase and to the Forest Service contract helicopter (in top right hand corner) post-mishap.

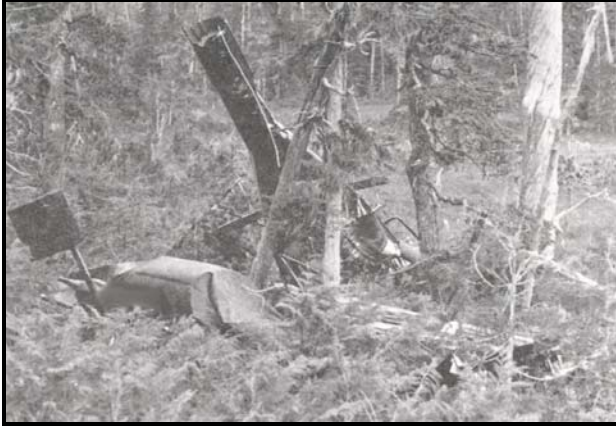
Hiller Model 12J3 wreckage.

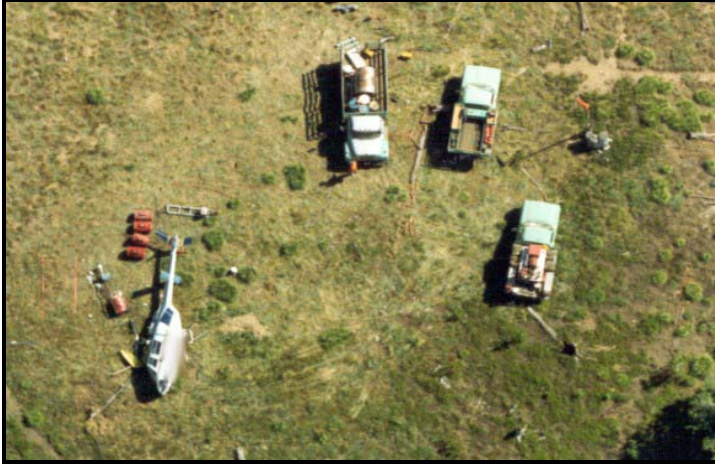
Bell 206BIII post-mishap photograph.

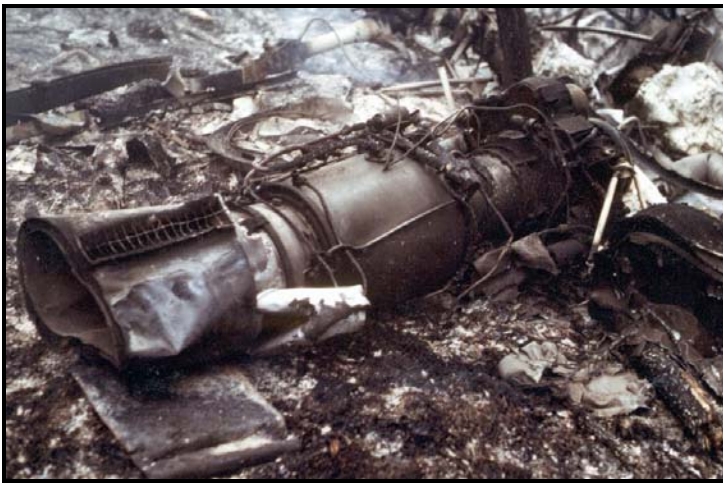
The investigation team believed the probable cause of this mishap was an engine failure. It was also deemed probable the pilot was flying too fast with an unweighted cable at the time of engine failure and the subsequent maneuvering caused the cable entanglement with the rotor systems. The loss of the tail rotor system may have contributed to the severity of the mishap.

SA316B engine wreckage.

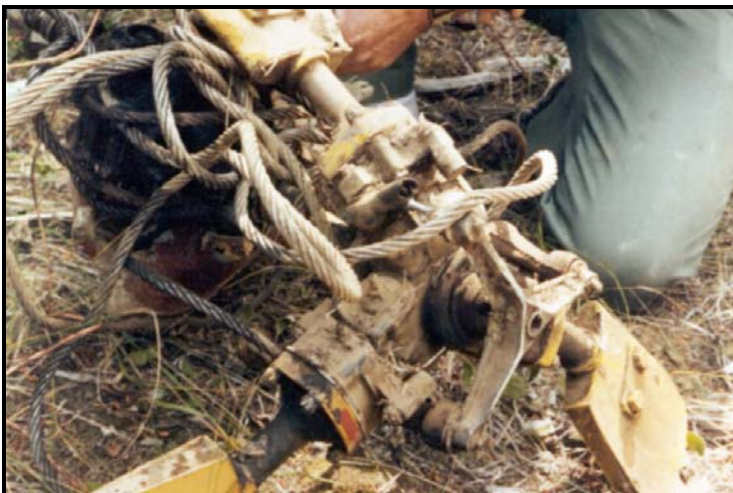
Tail rotor system with entangled cable was found 250 feet south of the main wreckage. All 100 feet of the cable was intact and found at this point.

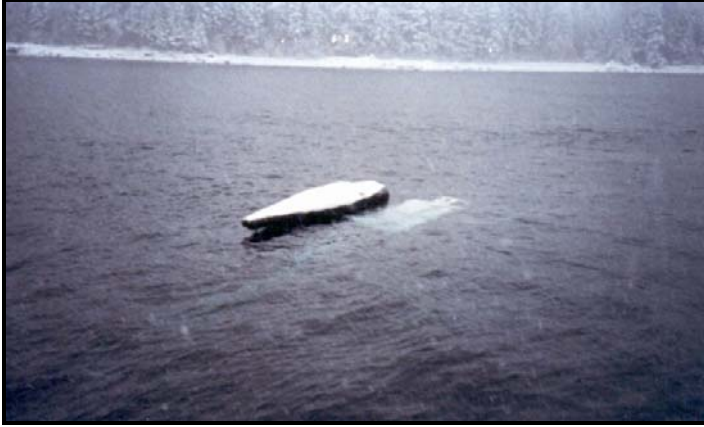
The wreckage discovered by the M/V Sitka Ranger boat.

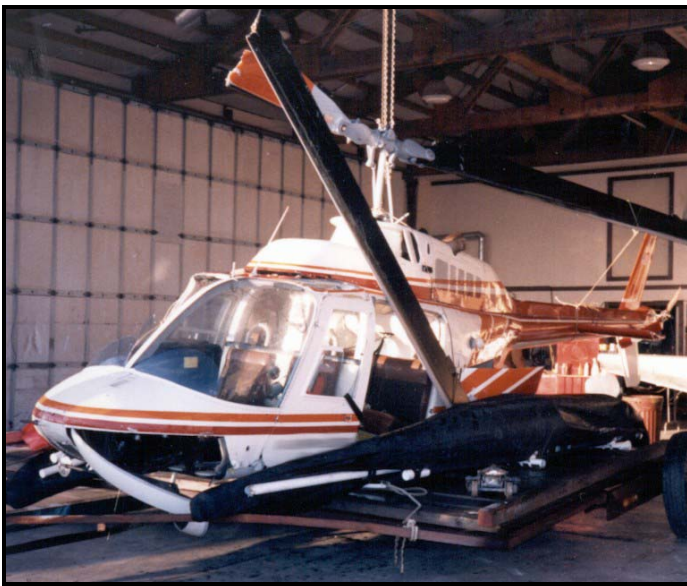
Post-mishap Bell 206BII Jet Ranger being moved into the hangar.

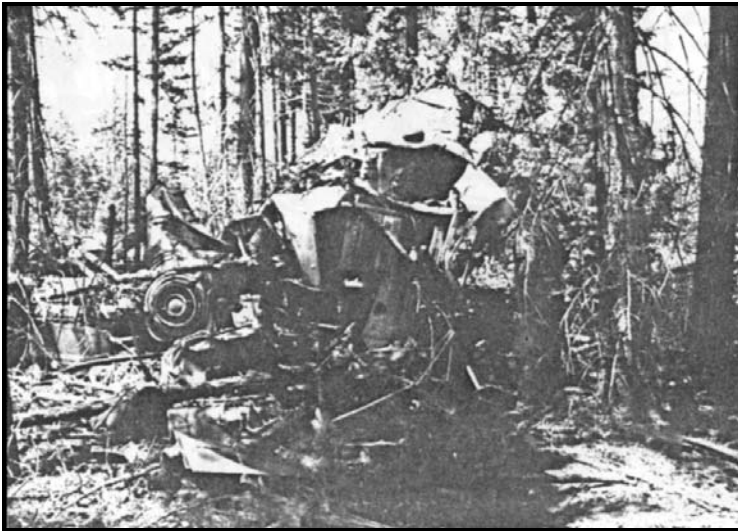
Wreckage of UH-1B as viewed opposite the direction of impact.
Black and white photocopy.

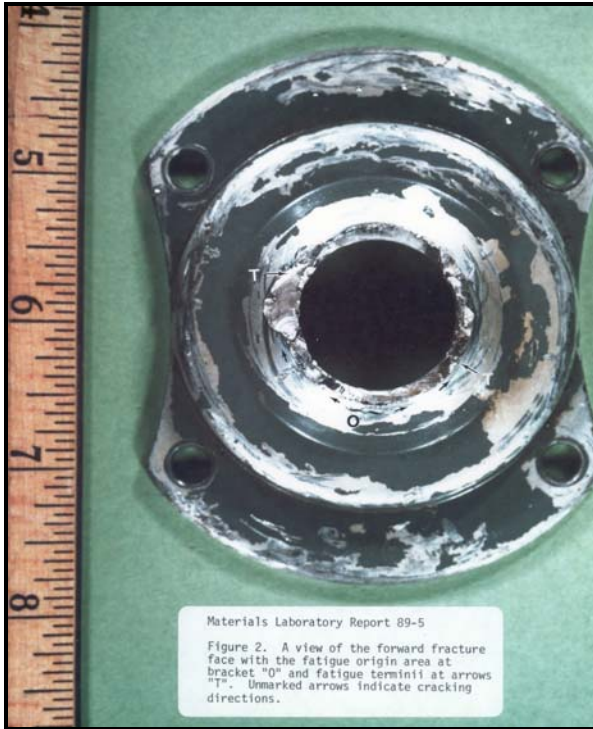
SA315B tail rotor failure was caused by the failure of the intermediate coupling shaft assembly, due to a fatigue crack at the coupling flange.

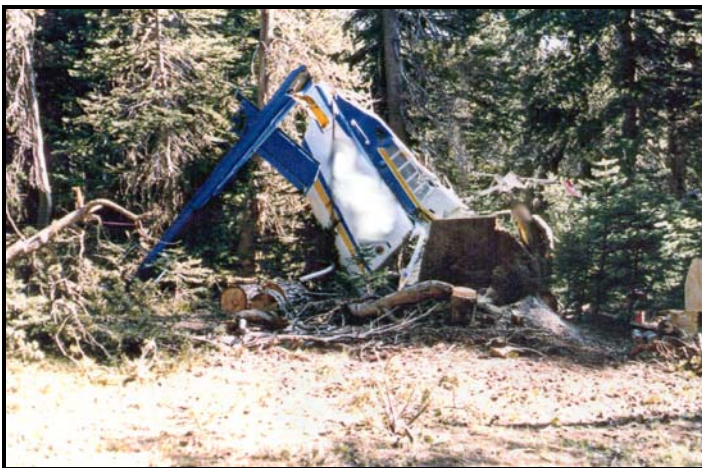
In developing a probable cause to this mishap, the investigation team stated that the flight profile of the final approach to land the load in the opening was conducive to the helicopter entering into a main rotor vortex ring state that was aggravated by a shift in direction or down draft in the wind. This could have caused a descent beyond the pilot's capability to arrest in the vertical space available to perform an escape maneuver. They deemed the mishap was caused by the strike of the main rotor blade near the top of a tree.

View of Bell 206LI from center of opening. Tree felled prior to mishap to enlarge opening.

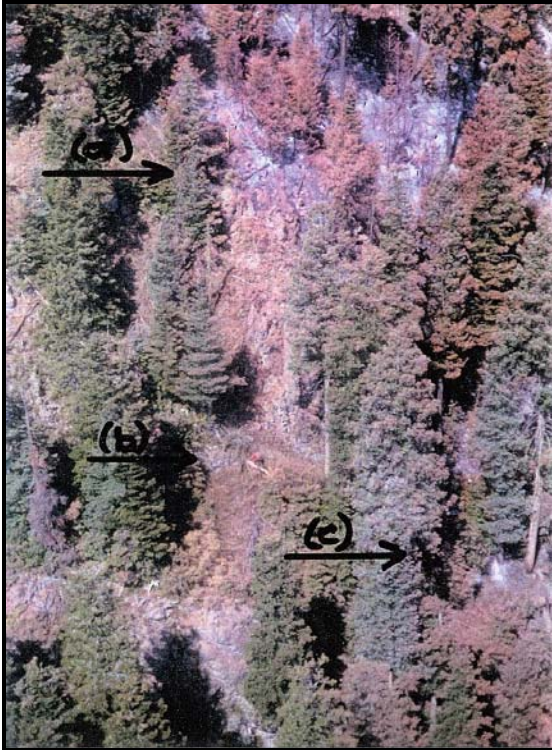
Wreckage distribution of Bell 206LIII.

**Arrow: (a) Slope below impact point (b) tail boom
(c) final resting point.**

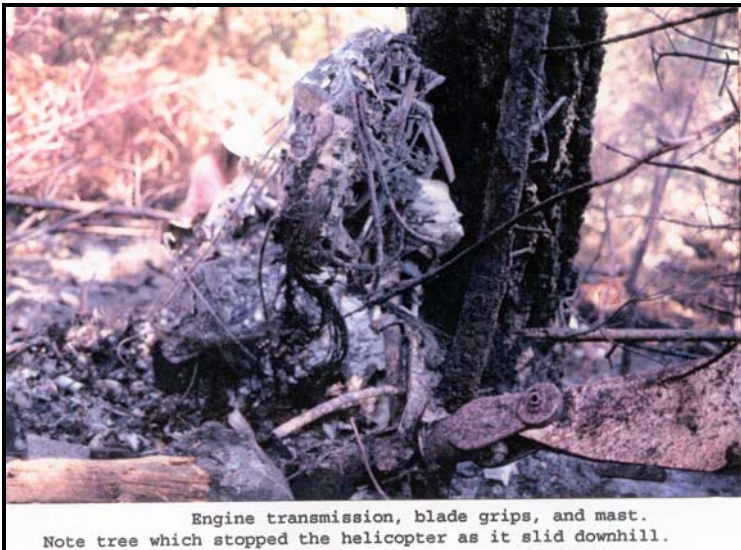
**Engine transmission, blade grips, and mast.
Note tree which stopped the helicopter as it slid downhill.**

Engine transmission, blade grips, and mast of Bell 206LIII.

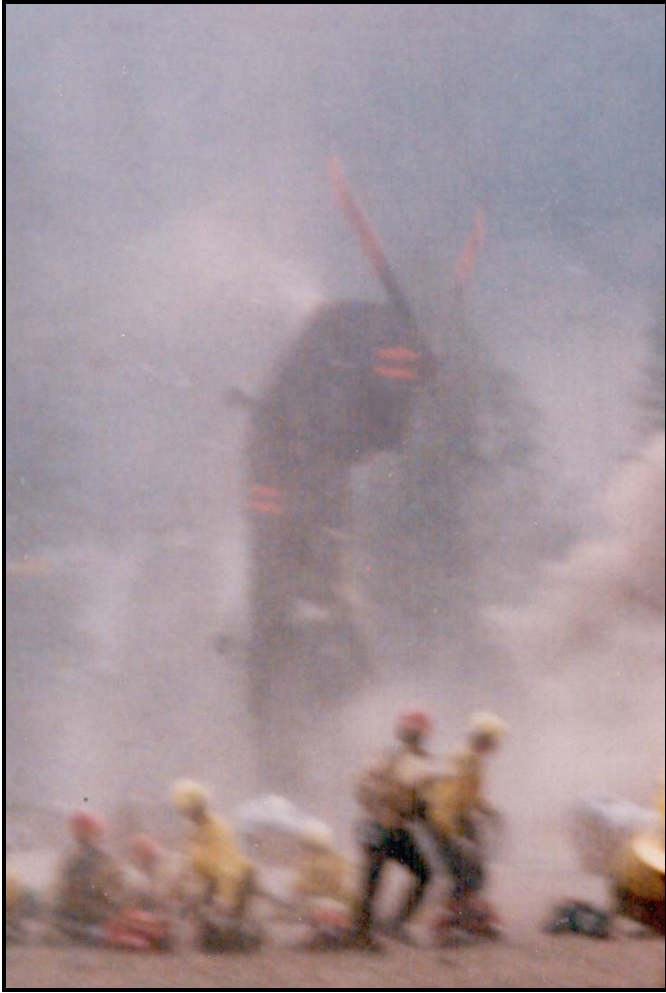
Chinook helicopter during mishap sequence.

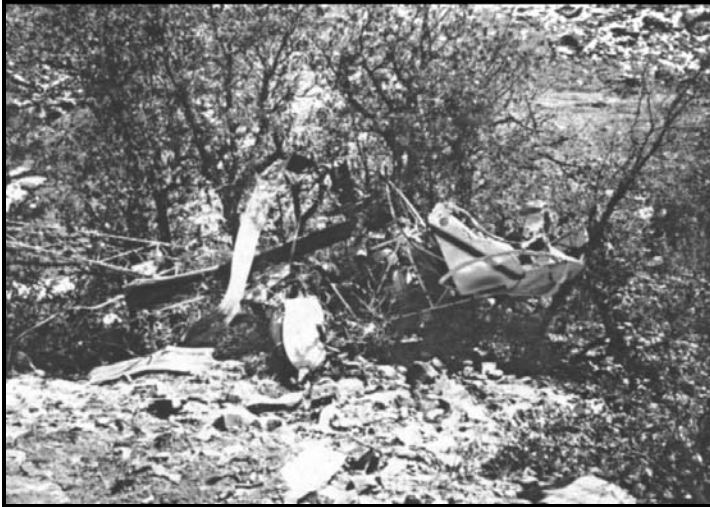
It was determined that the pilot was unable to control the helicopter and flew into ascending terrain. The helicopter had exceeded its lateral cg limitations due to the external load; the cable hooked over the landing skid. The contractor's procedures for loading and clearing the helicopter for departure were inadequate. Agency policy did not provide for aviation management or oversight of job contracts.

Bell 47 Soloy wreckage resting in oak brush.

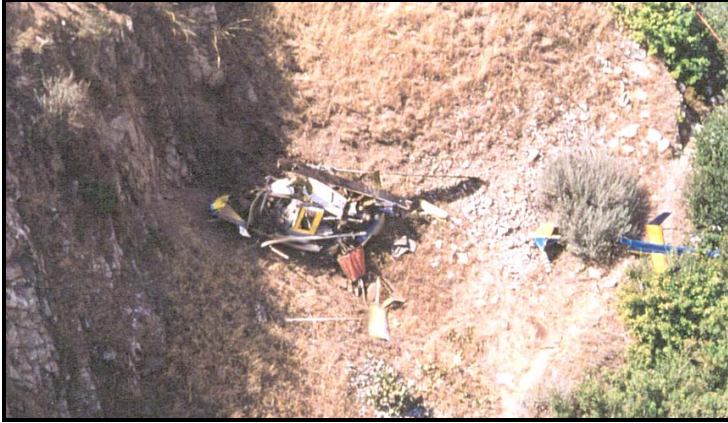
Close-up of Bell 206LI mishap site. Tail rotor actually found under nose and moved to permit access to cockpit.

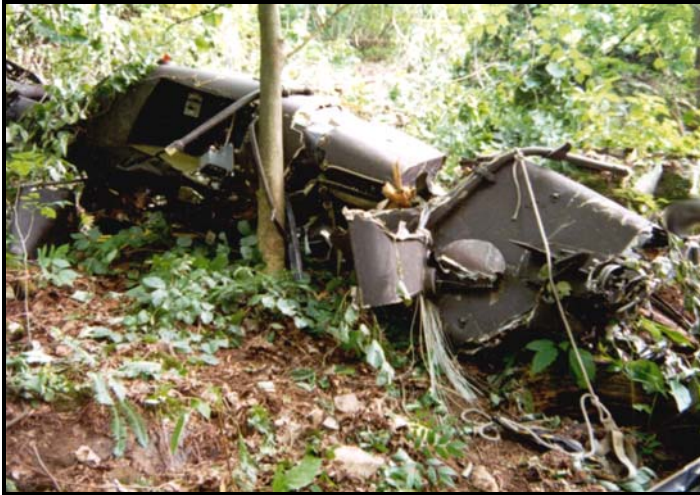
OH-58A Kiowa fuselage wreckage.

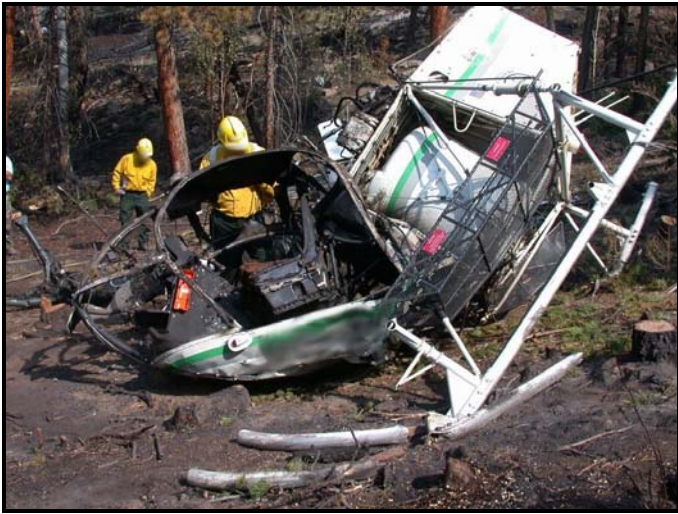
Aerospatiale AS315B wreckage.

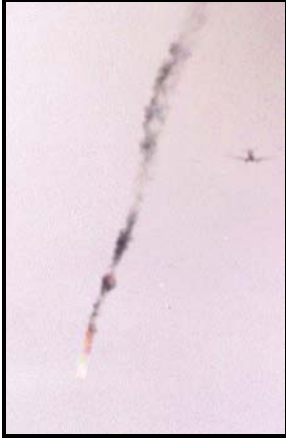
DC-3 RIGHT engine trailed about 100 feet of flame.

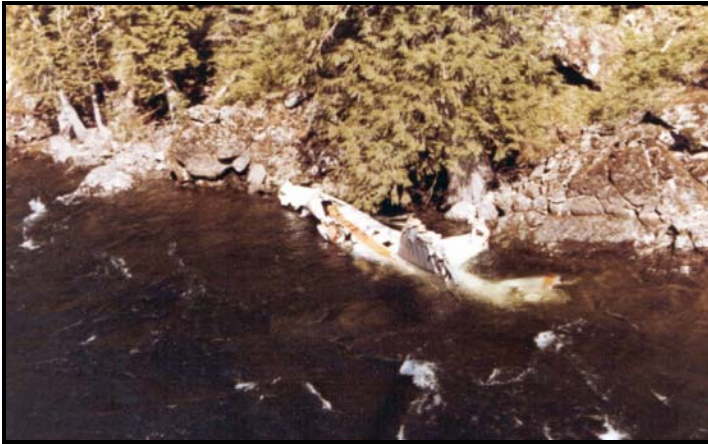
The tail section in the river where it had come to rest in slower water. This scene was downstream of the mishap site.

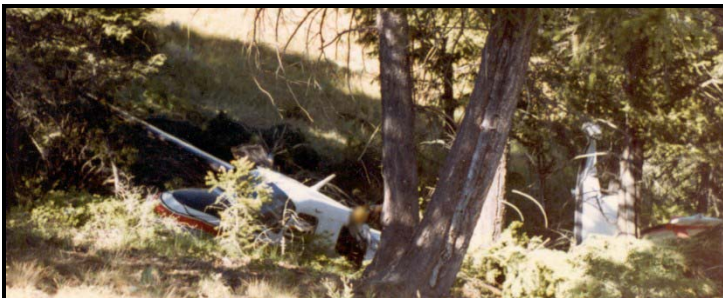
General view of Aero Commander wreckage.

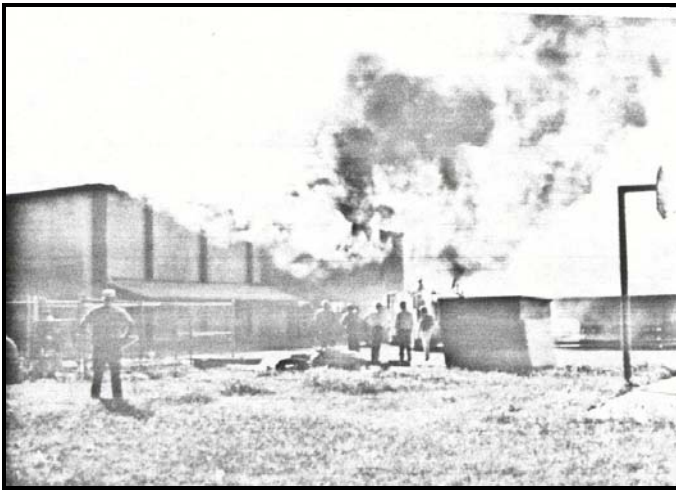
Southeast end of warehouse showing the initial post mishap fire.

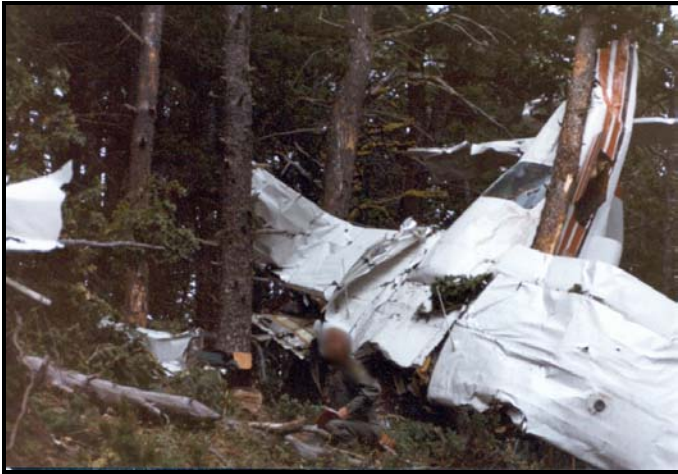
The probable cause of this mishap was the pilot failing to maintain altitude and airspeed, causing the airplane to stall and enter a spin. The pilot attempted to turn out of the canyon, which was too narrow to accommodate the required radius of turn without stalling the aircraft. The low cloud ceiling did not allow a climb out of the canyon under visual flight conditions. The pilot entered the canyon under conditions that made a safe exit difficult or impossible.

Cessna T210 main wreckage.

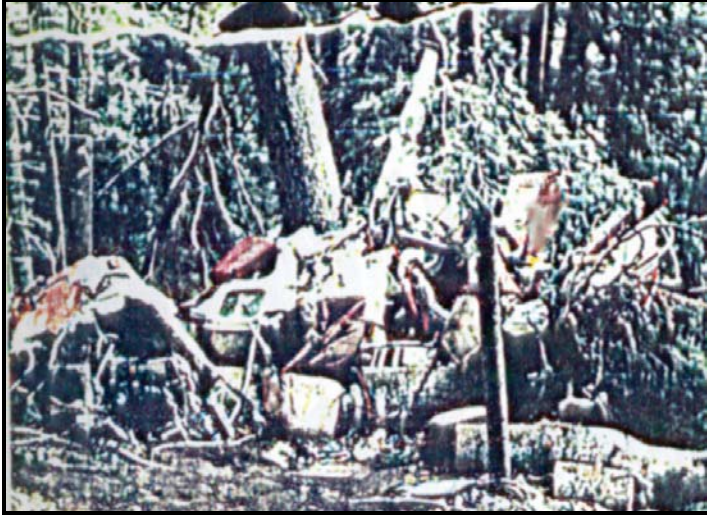
The cause of the mishap was undetermined. The nonfunctional front engine turbocharger diminished aircraft performance at the high-density altitude coupled with the pilot's limited experience with low-level flight in mountainous terrain was documented as contributing factors.

Cessna T337G main wreckage at impact point.

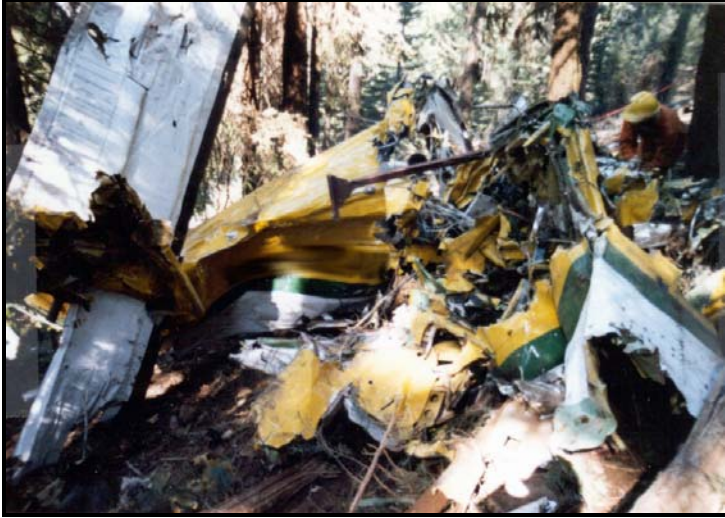
The most probable cause of this mishap was determined to be the pilot's acute in-flight incapacitation due to sleep.

DeHavilland DHC-6 300 (Twin Otter) final impact site.

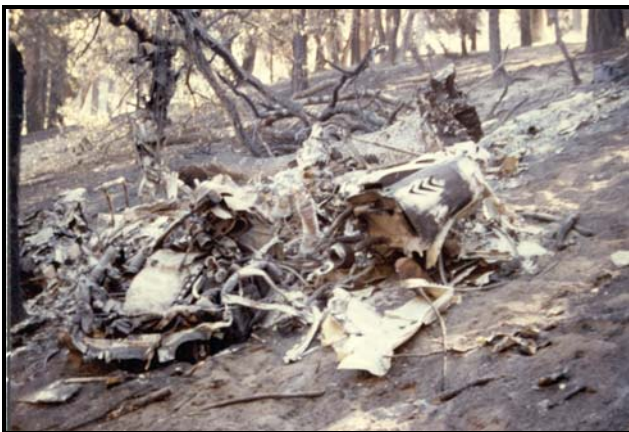
Baron wreckage looking southwest. On the left is the left engine, upside down. Right of the left engine is the nacelle (air scoop is open, in flight position) indicating the air conditioner was on. Tail section with cables hanging over tree limb.

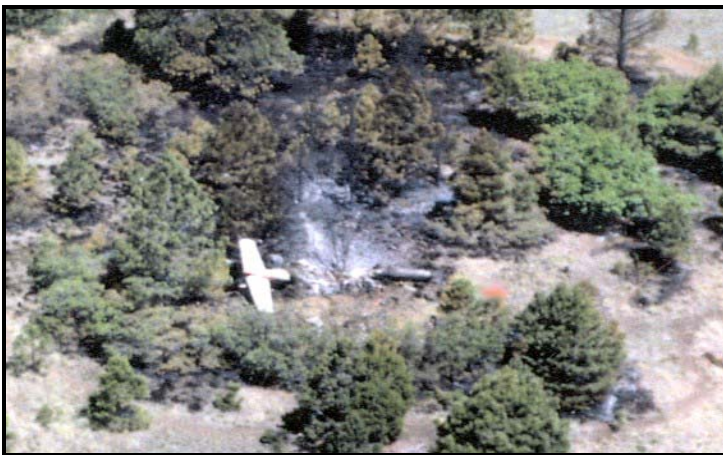
The Baron at the impact site. The Baron is inverted.

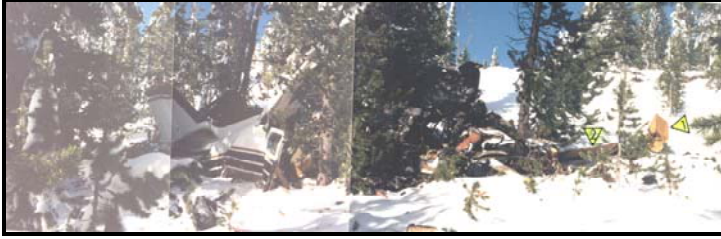
The Forest Service investigation report simply stated the causal factor of this mishap to be that the aircraft was flown into meteorological conditions that resulted in the loss of the aircraft's ability to climb and maintain a safe altitude and flying speed. Control of the aircraft was lost as a result of the effects of the adverse conditions.

Composite view of the ground impact site looking upslope 343-degree magnetic. Note the right wingtip (arrow 1) and right wing outboard (aileron) trailing edge (arrow 2).

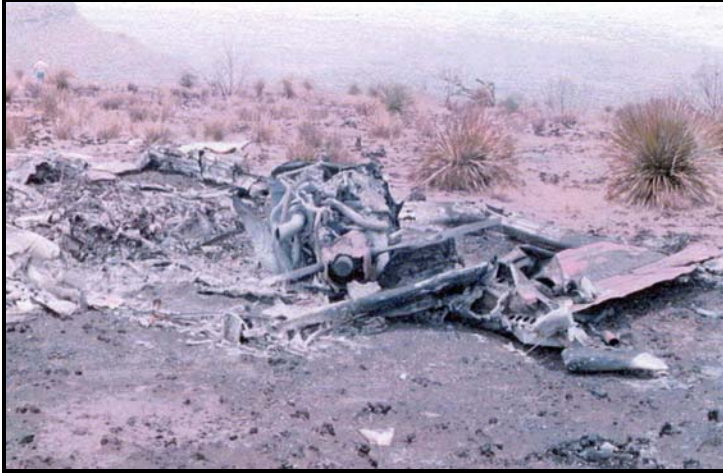
View of Cessna T337C, looking approximately southwest, towards Alamogordo-White Sands Regional Airport, New Mexico.

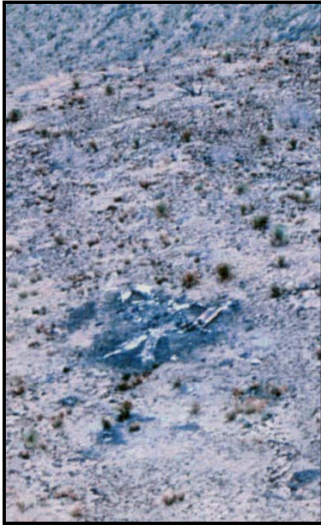
Overhead view of mishap site, approximate southwest heading.
