**United States Department of Agriculture
Forest Service**

FY 2005

Aviation Safety Summary

Prepared by the
National Aviation Safety Center
Boise, ID

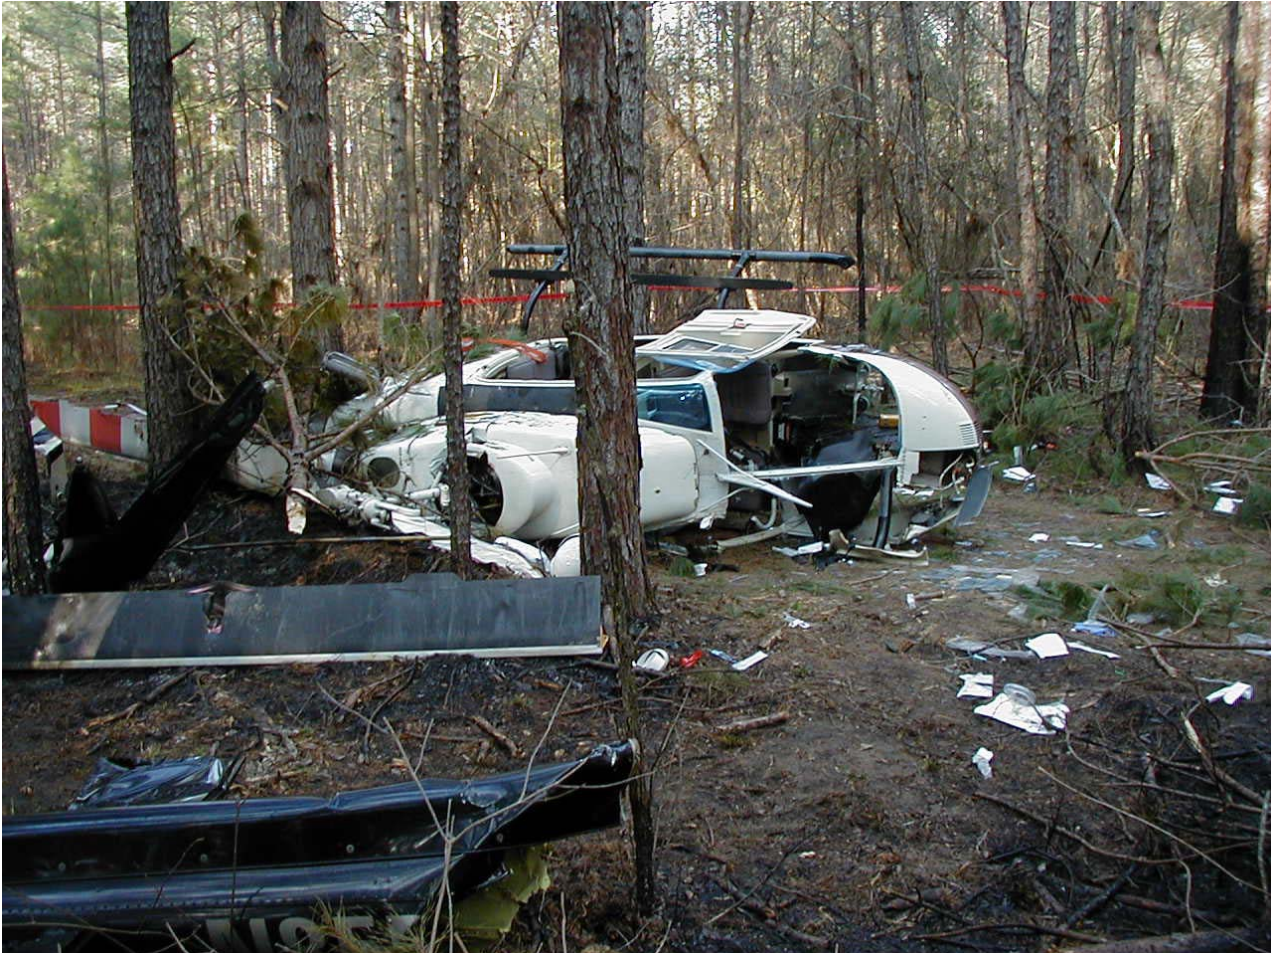
NTSB Identification: DFW05FA086
Accident occurred March 10, 2005 in Shelbyville, TX
Aircraft: Bell 206 BIII
Fatalities: 3
Operational Control Region 8, Sabine NF

On March 10, 2005, approximately 1354 central standard time, a Bell 206B-III helicopter, N85BH, registered to Brainerd Helicopter Service, Inc, sustained substantial damage when it impacted heavily wooded terrain in the Sabine National Forest near Shelbyville, Texas. The airline transport rated pilot and two USDA Forest Service crewmembers sustained fatal injuries. Visual meteorological conditions prevailed, and the flight/mission was being monitored and conducted in accordance with USFS aviation policies for public use aircraft in fire management operations. The flight departed at 1347 from a field helicopter pad (H1), located approximately 7 miles southeast of the accident site.

On the morning of the accident, the helicopter was assigned to support a prescribed fire within heavily wooded terrain with 50-60 foot high trees near Shelbyville, TX. The prescribed fire was supported by the application of aerial ignition spheres utilizing a cabin mounted plastic sphere dispenser (PSD) machine. PSD missions are typically flown at 50-150 feet above the top of vegetation at airspeeds from 20-40 knots. The helicopter was pre-positioned and a mission brief was conducted at Angelina County Airport, Lufkin, Texas. At 0900, after the mission brief, the helicopter and re-fueling truck re-positioned to H1 (coordinates North 31 degrees 42.110 minutes West 93 degrees 52.540 minutes) and were met by support equipment and personnel from the Sabine National Forest to conduct a prescribed fire mission.

At 1417, the helicopter wreckage was found at coordinates North 31 degrees 45.425 minutes West 94 degrees 00.244 minutes. Immediate rescue operations commenced.

The NTSB has not determined probable cause at this time.

Recommendation 1: Include in FS agency policy, relative to pilot approval (carding), a requirement that agency pilot inspectors review/verify pilot time for those pilots that have never been approved by the agency (Initial approvals). Subsequent approvals would not require this review for total time.

- C. Modify FSM 5700 and FSH 5709.16 to require pilot inspectors to verify pilot time for all initial pilot cards, utilizing verification records provided by contractor.
- D. Ensure all pilot inspectors are briefed regarding the changes at annual pilot inspector workshops.
- E. Make recommendation to DOI, Aviation Mgmt Directorate regarding above changes to incorporate into OPM 21.

Recommendation 2: Recommend to Interagency committee to include a requirement in the Interagency Aerial Ignition Guide pre-mission briefing that addresses PSD flight profile “watch out” situations including but not limited to loss of tail rotor effectiveness (LTE), Settling with Power, etc.

Recommendation 3: Require pilots being evaluated for an Initial pilot approval (carding) demonstrate to the Inspector Pilot their skill in low level, low airspeed maneuvering in a PSD flight profile during flight evaluation.

- A. Modify Interagency Helicopter Practical Test Standards document to incorporate requirement.
- B. Ensure all pilot inspectors are briefed regarding the changes at annual pilot inspector workshops.

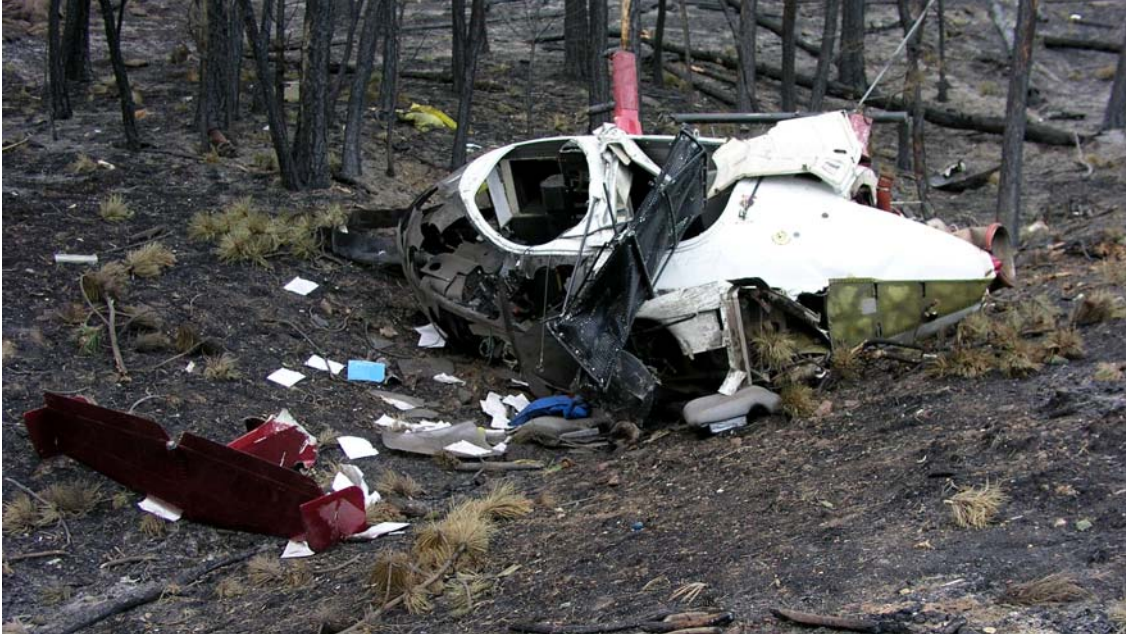
NTSB Identification: **DN05TA113**
Accident occurred July 19, 2005 in Loveland, CO
Aircraft: Hughes 369FF, registration: N530TJ
Injuries: 1 Minor.
Operational Control: Arapaho-Roosevelt NF

On July 19, 2005, approximately 1515 mountain daylight time, a Hughes 369FF single-engine helicopter, N530TJ, was destroyed when it impacted trees and terrain following a loss of control while hovering approximately 20 miles west of Loveland, Colorado. The commercial pilot, who was the sole occupant, sustained minor injuries. The helicopter was operated by the United States Department of Agriculture (USDA) Forest Service Rocky Mountain Region (Region 2) for public use firefighting missions, and registered to Utility Aviation Inc., Fort Collins, Colorado. Visual meteorological conditions prevailed, and a flight plan was not filed. The flight originated from a staging area west of Loveland at 1504.

The helicopter was being used to support firefighting operations in the area and was attempting to deliver supplies via external load. The helicopter was equipped with a 100-foot long line and a 20-foot choker, the external load weighed 615 pounds, and the helicopter weighed a total of 3,000 pounds.

According to a witness, who was assisting near the LZ, the surface winds were light at the time; however, it had been a "pretty windy day." As the helicopter approached the LZ, "everything was normal when he did a 180-degree turn. The load was fairly stable below him and the ship did a quick 180. Paused briefly, did another (180), completed to the 360, and then kept slowly spinning...The flight pattern started getting a little more erratic, as far as the load of his, the sling was kind of penduluming...swinging." The witness then observed the helicopter release the external load. The witness lost sight of the helicopter behind a tree and heard the impact. The witness responded to the accident site and the engine was still running. Shortly after that, "the engine cut."

On August 16, 2005, the NTSB investigator-in-charge, a representative of Boeing, and a representative of the USFS examined the helicopter. Examination of the airframe revealed the fuselage was crushed and deformed. The tail boom was fractured into several fragments. Damage to the tail boom was consistent with impact forces and main rotor blade strikes. The main rotor hub assembly and components were destroyed and consistent with sudden stoppage. All five main rotor blades were separated from the rotor head and exhibited fractured and bent spars, skin delamination, cuts and gouges.

The main transmission rotated when the main rotor system was turned by hand. Continuity was established to the tail rotor output pinion and the engine input quill when the transmission was rotated. The tail rotor drive shaft was fractured into multiple segments which corresponded to the fractures in the tail boom structure. The tail rotor gearbox was fractured across the case elbow. The tail rotor gearbox output quill rotated when turned by hand. One tail rotor blade was fractured into three sections with one fracture at the pitch change arm, one at the root fitting, and one approximately 10 inches from the blade end. The other tail rotor blade was fractured at a point just past the blade doubler.

The longitudinal and lateral cyclic flight controls and collective flight controls exhibited continuity from the controls to the upper flight controls. The upper flight controls were damaged; however, movement of the controls operated the flight control links. Anti-torque flight control continuity was established from the foot pedals to the separated control rod located at the aft fuselage station 100. The tail rotor control rods and bell cranks were bent and fractured in numerous locations.

Examination of the engine revealed damage consistent with the impact to the exhaust and combustion sections. Continuity was established to N1 and N2 control linkage from the throttle and collective to the fuel control and power governor. No anomalies that would have precluded operation were noted with the airframe systems and engine.

On the day of the accident, the pilot completed another Interagency Load Calculation form based on the following: departure pressure altitude 9,500 feet, departure temperature 35 degrees Celsius; and helicopter operating weight of 2,454 lbs. A review of that form revealed the pilot incorrectly completed the form in several areas; adjusted weight, selected weight, and allowable payload. Based on the conditions listed by the pilot, the pilot's calculated jettisonable OGE allowable payload was 646 lbs. The improperly completed form was signed off by the pilot and the USFS Helicopter Manager. According to the USFS Helicopter Inspector Pilot who reviewed the form after the accident, the allowable payload calculations could not be performed because the pressure altitude and temperature values exceeded the manufacturer's performance limitations for the helicopter.

According to the USFS, at the time of the accident, the gross weight of the helicopter was 3,072 lbs, based on an aircraft weight of 1,860 lbs; pilot 200 lbs; fuel 280 lbs; and an external load of 732 lbs. The reported actual environmental conditions were pressure altitude 8,000 feet, and temperature 32 degrees Celsius. In accordance with the Rotorcraft Flight Manual, CSP-FF-1, dated August 14, 1998, with revision 5, dated October 3, 2003, Page 8-4, Figure 8-3, Hover Ceiling, Out of Ground Effect, Engine Air Particle Separator Inlet with Mist Eliminator, indicated that the maximum gross weight for OGE was 2,940 pounds.

According to the Federal Aviation Administration's Rotorcraft Flying Handbook, FAA-H-8083-21, Chapter 11, LTE at Altitude, "At higher altitudes, where the air is thinner, tail rotor thrust and efficiency is reduced. When operating at high altitudes and high gross weight, especially while hovering, the tail rotor thrust may not be sufficient to maintain directional control and LTE can occur. In this case, the hovering ceiling is limited by tail rotor thrust and not necessarily power available. In these conditions gross weights need to be reduced and/or operations need to be limited to lower density altitudes."

The pilot's failure to maintain aircraft control due to delayed remedial action during the encounter with the loss of tail rotor effectiveness. Contributing factors were the pilot's inadequate preflight performance planning, and the inadequate supervision by the US Forest Service personnel.

Action Item #4: Work with cooperating agencies in developing policy and procedures for Dispatch Centers to ensure that radio communication transmissions generated during incidents and accidents are recorded and retained.

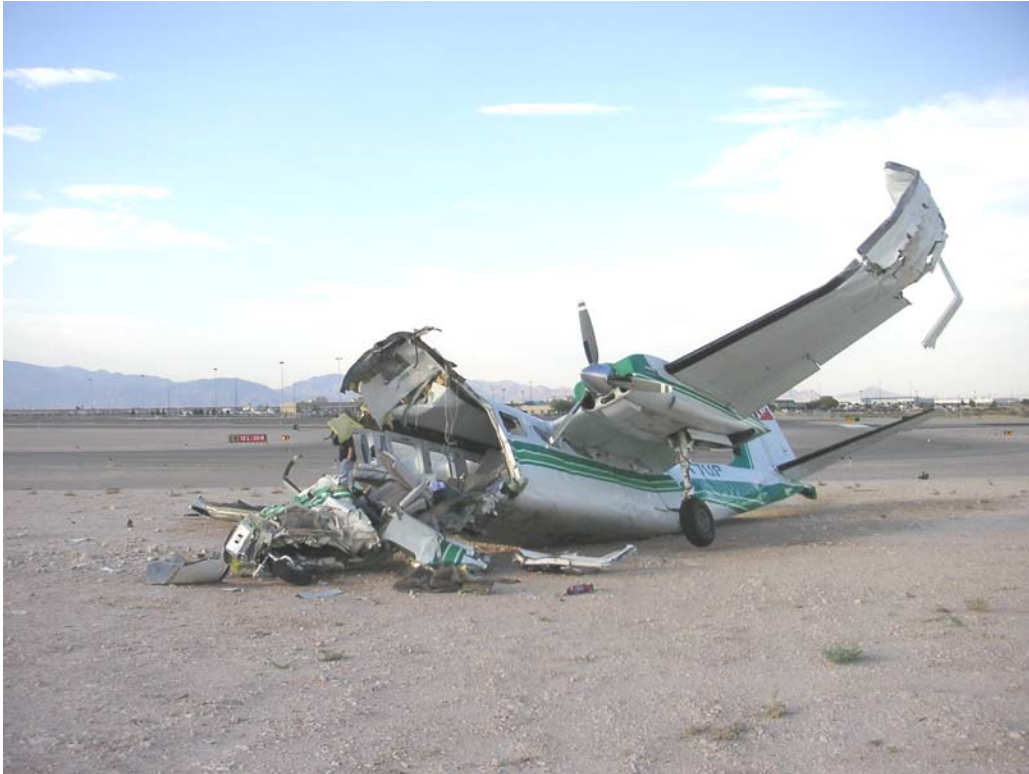
NTSB Identification: LAX05GA243
Accident occurred July 21, 2005 in Las Vegas, NV
Aircraft: Aero Commander 680 FL, registration: N7UP
Injuries: 2 Serious, 1 Minor.
Operational Control: R-4 Humboldt-Toiyabe NF

On July 21, 2005, about 1707 Pacific daylight time, an Aero Commander 680 FL, N7UP, impacted terrain during takeoff at North Las Vegas Airport (VGT), Las Vegas, Nevada. Commander Northwest LTD was operating the airplane under contract for the US Forest Service under the provisions of 14 CFR Part 91 as a public-use aircraft. The airline transport pilot and one passenger sustained serious injuries; the second passenger sustained minor injuries. The airplane was destroyed. The local fire reconnaissance flight departed VGT at 1707. Visual meteorological conditions prevailed, and a company flight plan had been filed. The primary wreckage was at 36 degrees 12.233 minutes north latitude by 115 degrees 11.289 minutes west longitude.

During takeoff from runway 12R witnesses reported seeing the airplane airborne but not climbing. The airplane continued down the runway in a nose up attitude and remained in ground effect until impacting terrain about 600 feet southeast from the departure end of runway 12R. The airplane impacted in a 30-degree nose down attitude. During the accident sequence the airplane rotated about 270 degrees around the vertical axis. The cockpit section of the airplane was destroyed during the accident sequence.

The representative from Aero Commander identified the airplane wreckage at the beginning of the debris field as forward fuselage and cockpit structure components. Pieces of the left wing tip were found in the middle of the debris field.

The flaps were measured in the 30-degree position; the flap actuator was measured at 1 15/16 inches, which the manufacturer stated corresponded to a 30-degree position. The flap indicator was damaged in the impact sequence but indicated the flaps were in the 30-degree position.

The NTSB has not determined probable cause at this time.

1. Follow-up on a study on fixed-wing performance charts that was started by the National Fixed-Wing Specialist.
2. Review the recommendation in the Interagency Standards for Fire and Fire Aviation Operations (Red Book) for Personnel Protective Equipment (PPE) for special mission use.

The Accident Investigation Team recommended that the federal agencies that utilize the North Las Vegas airport meet with airport officials and be actively involved in the development of a new/updated emergency response plan and considerations when staging aircraft at the airport. The agencies were actively pursuing this shortly after the accident.

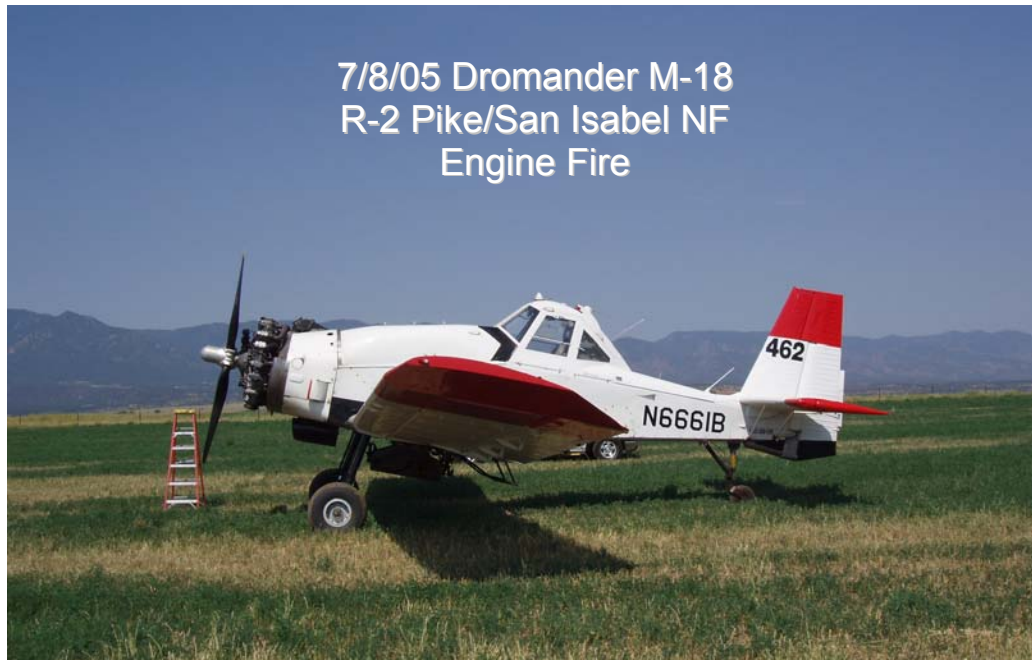
T462 departed Canon City, CO for the Mason Fire with 400 gals of water and foam. While enroute to the fire the pilot noticed the engine running rough, it would loose then gain power. The pilot added carb heat with no change to engine. The pilot contacted the leadplane on the fire and informed him that he was returning to the airport due to engine problems. He punched off the load over farmland and turned towards Canon City. The pilot then noticed flames coming from engine and determined he needed to land the aircraft immediately. He successfully landed the aircraft in a field and extinguished fire. The investigation team found a safety wire that had completely worn through the bolt allowing fuel to leak into the engine, which caught fire.

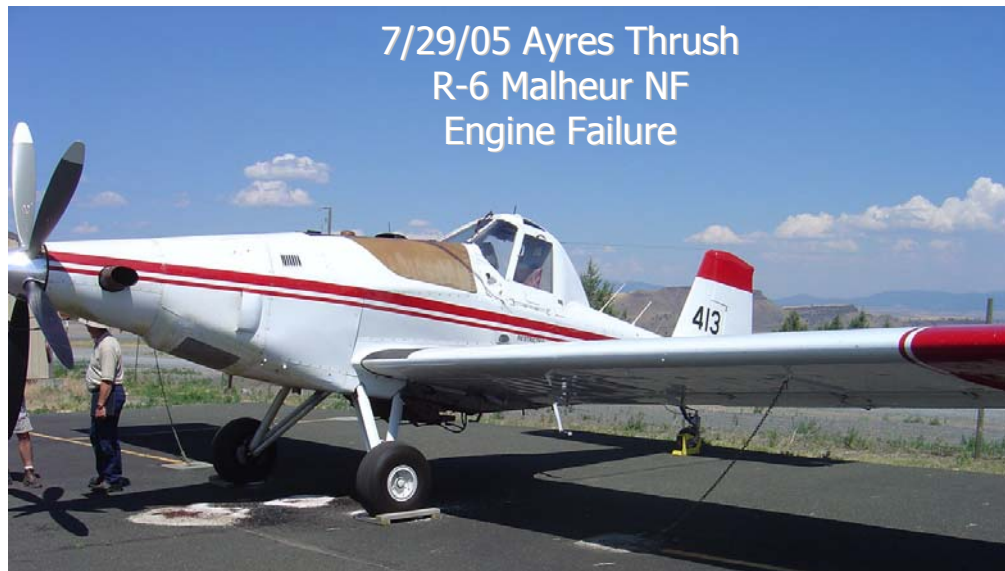
The aircraft was dispatched to fire #060 for retardant drops. On the third drop of the morning, the pilot powers up the aircraft to start his drop run. According to the pilot, the drop run is normal and nothing out of the ordinary. Upon completing his third drop and starting to climb out he scanned his instruments and saw the low oil pressure light come on. He immediately notified the ATGS and keeps climbing towards the middle of the valley and headed for John Day airport. His instruments were showing normal readings at this time except for the low oil pressure and engine torque had dropped to 10%. He noticed a vibration in the engine and felt a slight power drop followed quickly by an engine chip light. He knows he only has a few seconds before the engine would probably quit and reacts immediately to feather the propeller, shut off the fuel and set up for the proper glide profile to get back to the airport. The airtanker is approximately 5 miles from the airport and the pilot has been able to gain enough altitude prior to the engine stopping to complete a successful "dead stick" landing to the airport. The investigation team found that the aircraft had a catastrophic engine failure 38.2 hours after it had been overhauled.

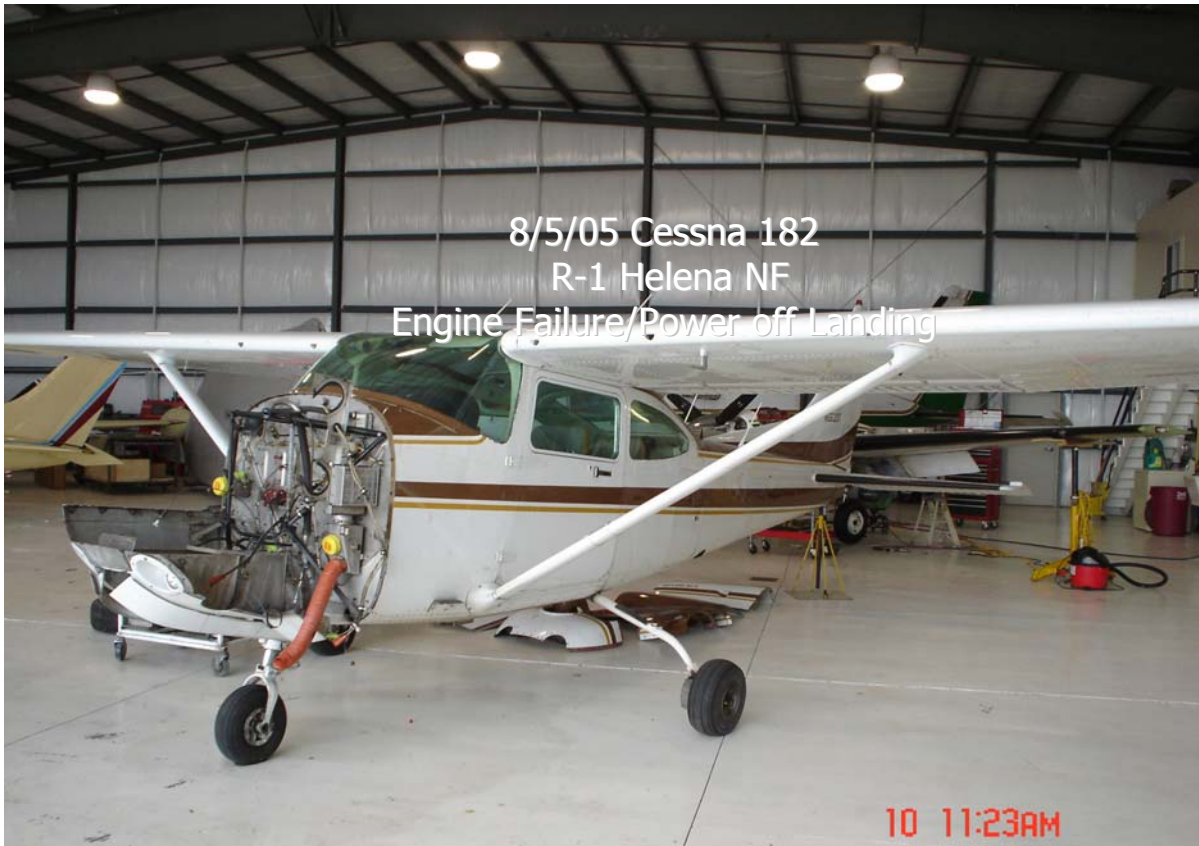
The aircraft was on an insect and disease flight with one USFS aircrew member mapping an area east of the Helena. At approximately 11:45 the pilot noticed a sudden drop of oil pressure and immediately turned the plane toward the airport, they were about 20 mi from the airfield at this point at 10,000 MSL. Within 1 minute the oil pressure dropped below the green and continued to drop toward zero, however, the engine appeared to be running normal. As they continued toward the airport the oil temp gauge began to slightly decrease and the cylinder head temp gauge indicated a slight increase in temperature. At approximately 10 miles the oil pressure indicated zero and the engine rpm began to fluctuate, probably due to a loss of oil pressure in the prop. The pilot kept the altitude high to increase the glide distance, and looked over the emergency checklist cards. At about 5 miles they were losing RPM and the landing gear alarm began to sound since the gear was still retracted. At about 1 mile the pilot lowered the gear, simultaneously the engine began to vibrate violently and the pilot officially declared an emergency with the tower. The tower did an outstanding job of keeping traffic clear and making sure they could make a straight in landing. At about ¼ mile or less, on final, the pilot shut off the fuel and pulled back on the mixture to shut down the engine in case of fire. He landed with the power off and coasted off the active runway onto runway 34 where we met the fire truck. The pilot remained calm and performed all the steps methodically throughout the incident.
