WORKER DEATHS IN CONFINED SPACES

A Summary of NIOSH Surveillance and Investigative Findings

U.S. DEPARTMENT OF HEALTH AND HUMAN SERVICES
Public Health Service
Centers for Disease Control and Prevention
National Institute for Occupational Safety and Health

January 1994

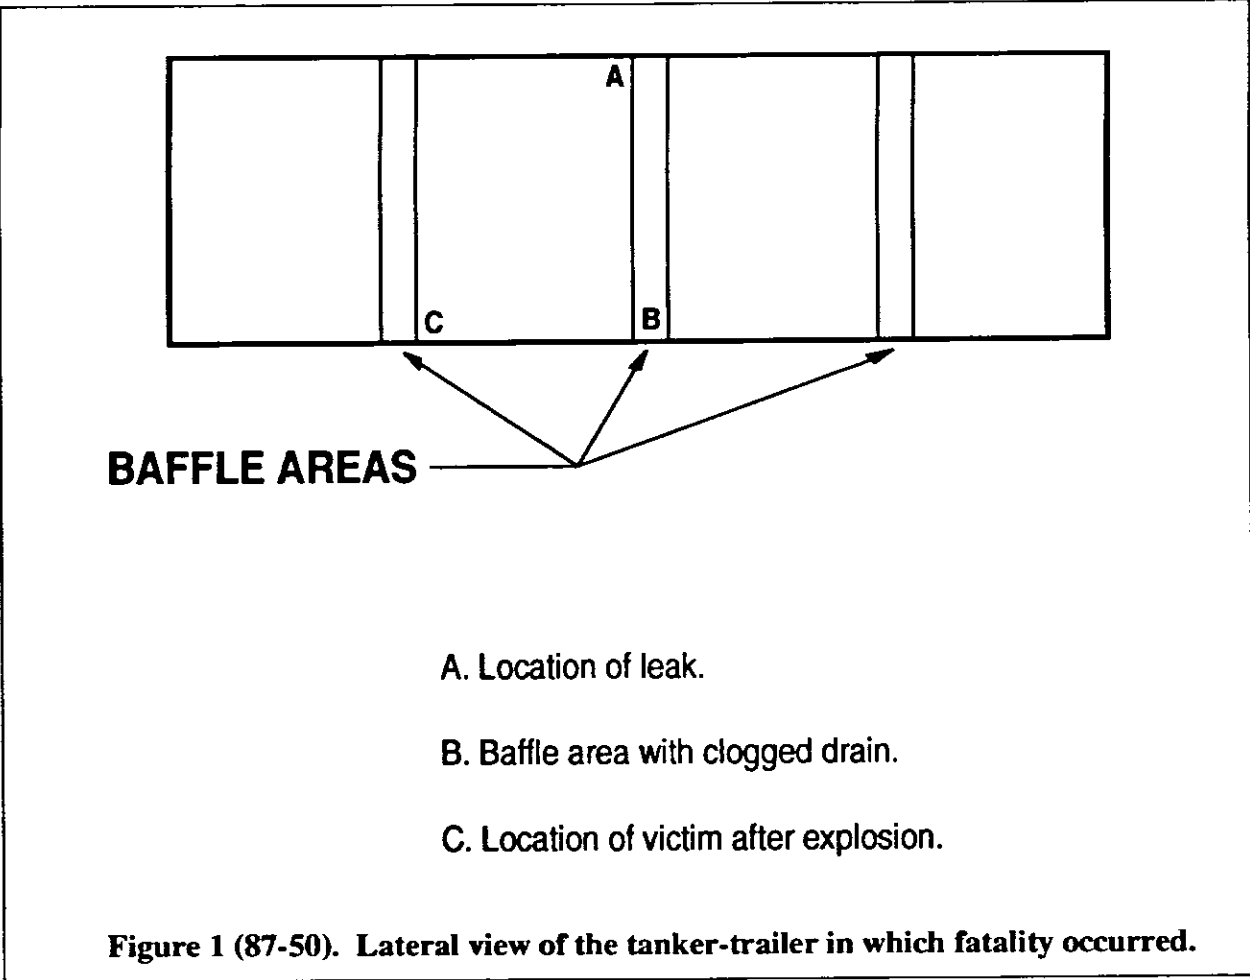
Figure 1 (87-50). Lateral view of the tanker-trailer in which fatality occurred.

Discussion: This incident emphasized the need to address all of the potential hazards in confined spaces. Locating the clogged baffle drain before entering the tanker compartment allowed the baffle to be drained of trapped chemicals. However, if the clogged drain had not been located, the concentration of chemical vapors in the tanker compartment may have been sufficient to place both the victim and the assistant in an oxygen deficient or toxic environment. The need to inform employees about the hazards of confined spaces in all respects should be a priority of the employer. Information concerning confined space entry procedures is available from various NIOSH documents including:

1. “Criteria for a Recommended Standard...Working in Confined Spaces” - DHEW (NIOSH) Publication No. 80-106
2. “A Guide to Safety in Confined Spaces” - DHHS (NIOSH) Publication No. 87-113.

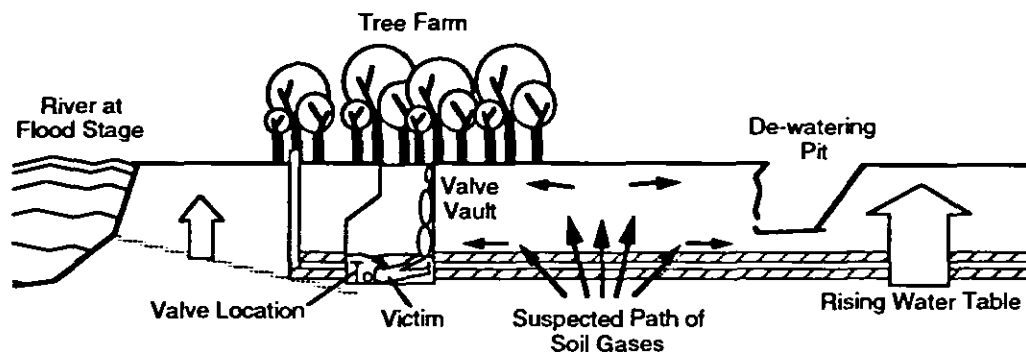
(Figure, FACE 91-17)

- c. the rising water table forced gases and liquids normally trapped deep within the surrounding soils toward the surface;
- d. the clay soils and sands used by the municipality for the surface of the valve vault field inadvertently formed a seal, or cap, forcing the gases and liquids to flow into the only two openings into the ground, the valve vault and a sewage dewatering pit (Figure);

- e. the soil gases (carbon dioxide, methane, and hydrogen sulfide) entered the valve vault through the drain hole in the center of the concrete floor and possibly through the joints between the sections of preformed concrete pipe forming the walls of the valve vault; as gases filled the valve vault, they displaced oxygen to below the minimal level to support human life; the victim lost consciousness upon entering the oxygen-deficient environment.

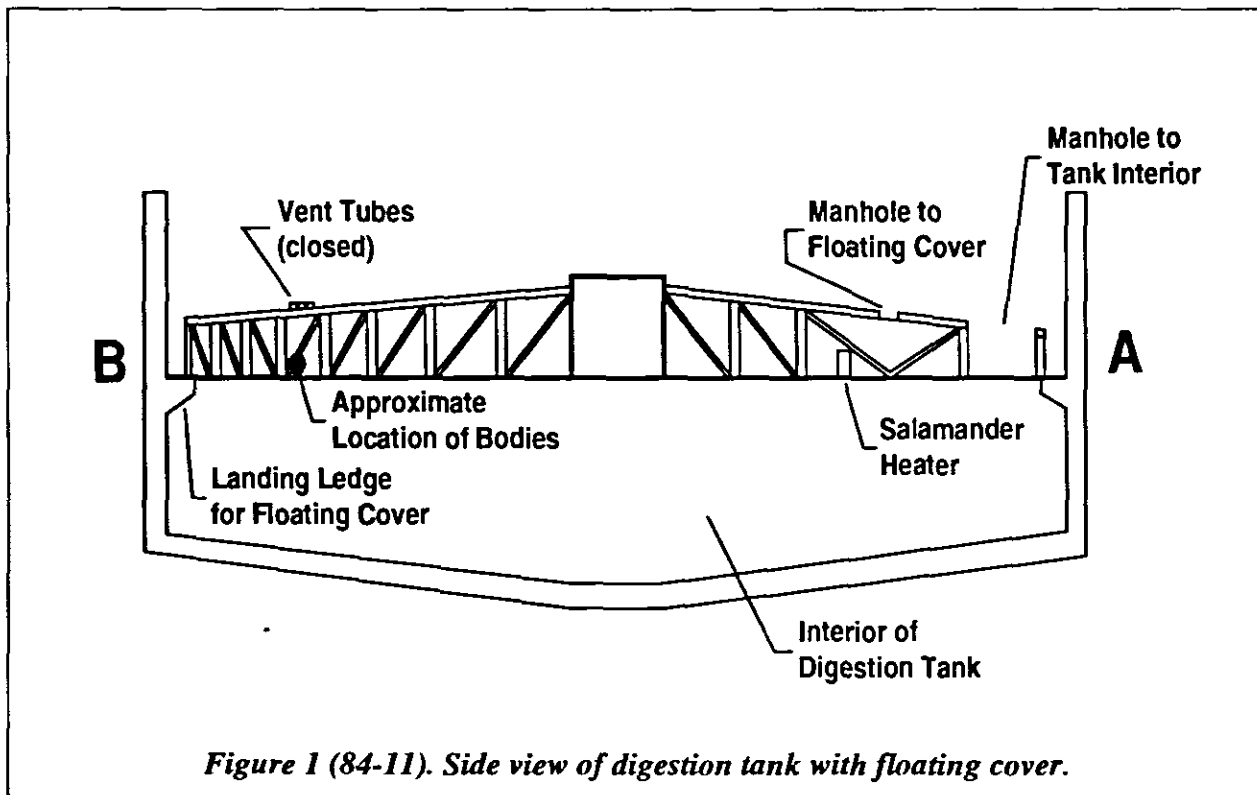
Figure 1 (84-11). Side view of digestion tank with floating cover.

Future efforts should evaluate the feasibility of designing and/or providing automatic pilot valves whose reset buttons cannot be intentionally or unintentionally made inoperative.

Finally, victims of confined space incidents are often rescuers who attempt to save a worker(s). In this case, there was a near-miss with one carpenter. Also, the possibility exists that the younger victim could have died as the result of a rescue attempt. All organizations that have employees who work in confined spaces should increase educational efforts dealing with entry and proper rescue responses.
