Wind Turbine Lightning Protection Project

1999—2001

Brian McNiff
McNiff Light Industry
Harborside, Maine

NREL Technical Monitor: Eduard Muljadi

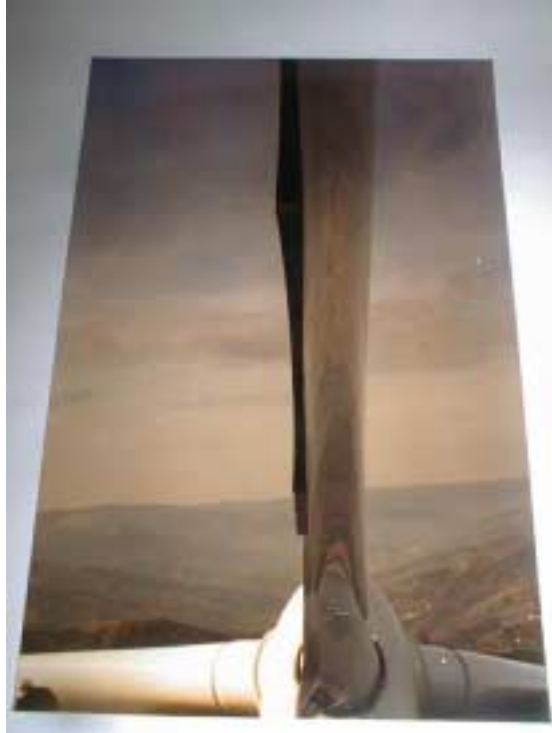
Figure 7. IVPC/Vestas blade damage

The lion's share of damage occurred on blades that have had to be replaced or repaired in the field. An example of typical blade damage is shown in Figure 7. Events that did not result in blade damage usually had some amount of downtime until the turbine could be inspected and the controller reset. In some such cases, sensors may have taken damage, but the repair cost was usually low compared to events with blade damage. It is interesting to note that as the population of turbines increased, the frequency of events experienced (per turbine) stayed in the same range of 6–8%.

IVPC estimated that *in situ* blade repair costs were about \$1900 including boom truck and labor. When a damaged blade was replaced, the cost was about \$45,000, and this included a new blade, half a day for a significant crane, and personnel time. Note that downtime is not included in these estimates.
