## **Section 5    Instrumentation and Controls**

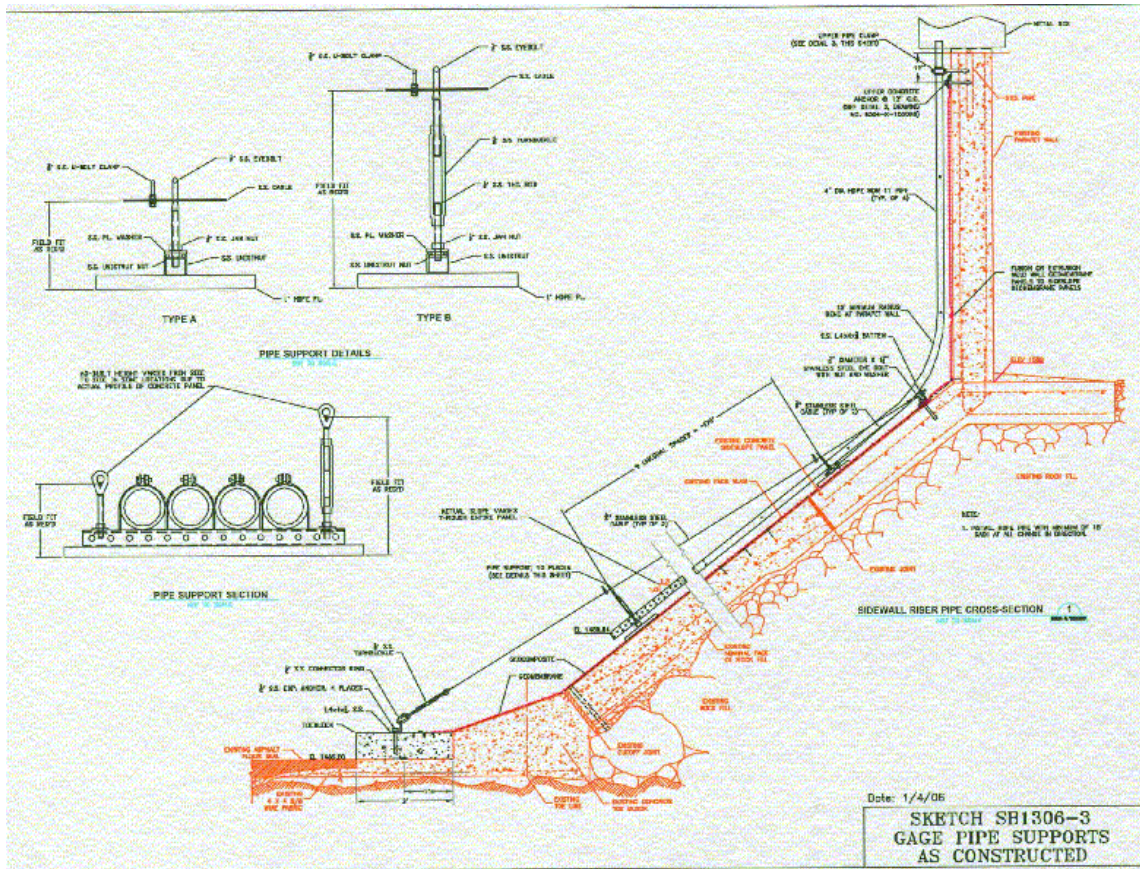
**Figure 5.1 - Structural Design of the Upper Reservoir Control System  
December 2004**

The HDPE pipes were tied to 1 inch by 48 inch by 12 inch HDPE flat stock which was set on, but not connected to a HDPE rub pad which was glued to the geomembrane liner. These pipes were not firmly attached to the face of the dam. Instead, stability was intended to be provided by a configuration of stainless steel unistrut section, steel bolts, turnbuckles, jam nuts, eyebolts and U-shaped cable lock bolts tied to two stainless steel cables. The cables were anchored only at the toe block at the base of the slope and at the interior base of the parapet wall (Figure 5.1). Down slope movement of the HDPE pipe assembly was limited by clamps placed on the cabled just down slope of the eyebolt connection to the pipe assembly. A similar restriction to movement upslope was not included.

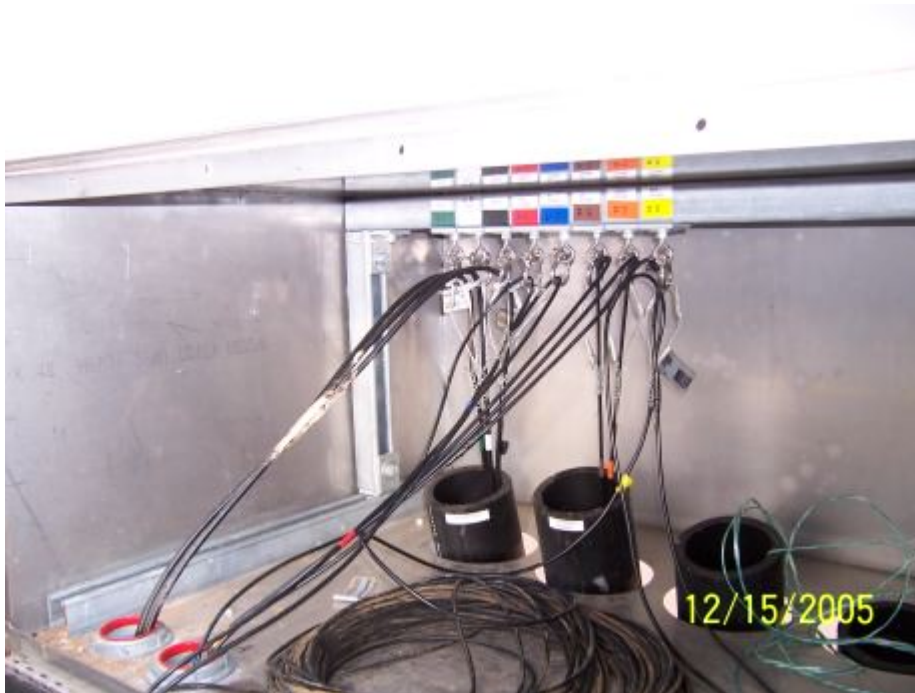
**Figure 5.2 - Cabinet containing the Druck pressure transducer and Warrick conductivity sensor wiring**

Figures 5.2 show the configuration of the sensors within the instrument cabinet. The cabinet is located on the dam crest at the southwest end of the reservoir. Figure 5.3 shows distances from the Warrick Conductivity sensor tips to reference tapes placed on the wiring by AmerenUE staff. The tapes were used to place the sensors at the original design elevation (November 2004) and the as-found elevation on December 14, 2005.

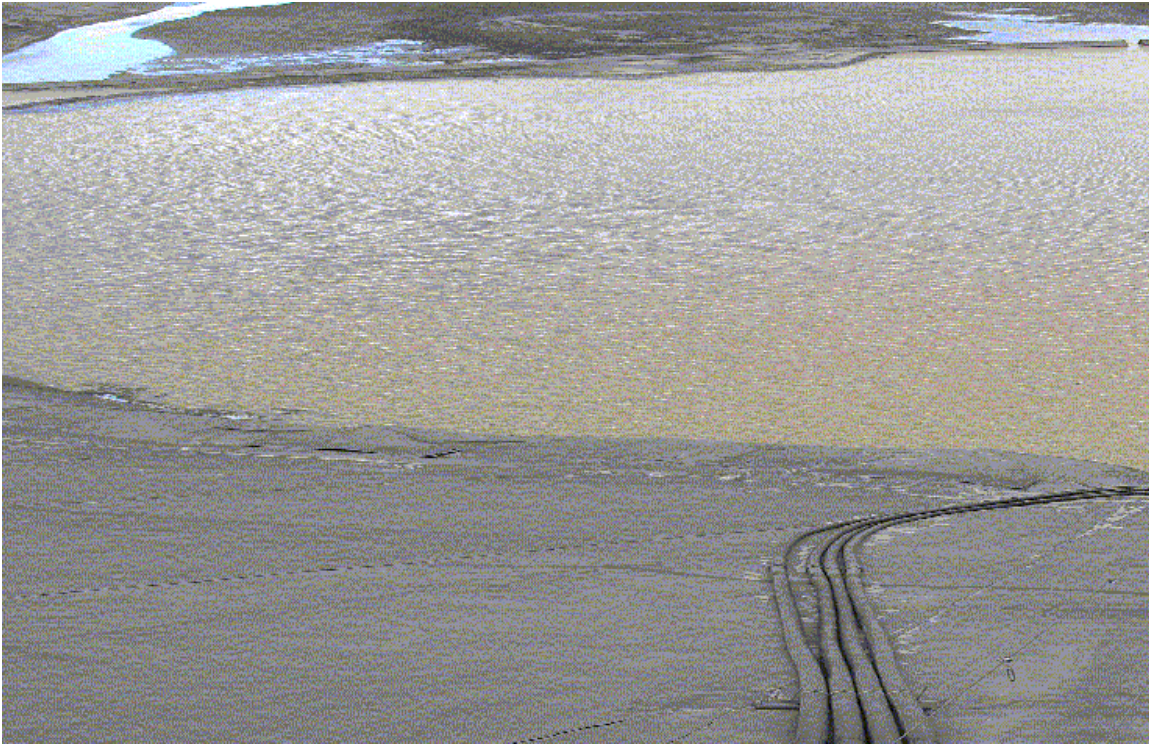
**Figure 5.4 - Bowing of HDPE Tube position on December 15, 2005  
(Courtesy of Missouri DNR)**

An October 3, 2005 inspection by AmerenUE of the reservoir monitoring system revealed the HDPE pipes were bowed out to one side an estimated 3 feet. (Figure 5.4 shows bowing after the breach) The bowing of the instrumentation pipes coincided with the failure of the fasteners holding the pipes to the stainless steel cables. The intake in the upper reservoir is about 125 ft from the location of the HDPE pipe and instrumentation.

The effect of the pipes bowing out to the side was to raise the elevation of the Druck pressure transducers. The pressure transducers were no longer at a known elevation to accurately report the water surface elevation of the reservoir. On October 7, 2005, the system was adjusted by resetting the stop pumping operations to elevations 1591.6 for the first unit and 1594.0 for the second unit. AmerenUE believed the adjustment was sufficient to prevent overtopping. Following this adjustment, the operating staff visually monitored the reservoir elevation with the staff gage, but only once a week. AmerenUE employees used check marks on their inspection sheets to verify the monitoring was performing properly.

The licensee reported that the offset and length of the arc of the HDPE pipes measured after the breach were 14 ft and 119 ft, respectively (see Figure 5.4). This was estimated to raise the reservoir control sensors approximately 2.5 feet. Due to the fact that the pipes have a tendency to straighten after the water is drawn down, it is not known what the maximum deflection was at the time of the breach. The estimate of peak pool level of about 1597.7 ft verses the Druck pressure transducer reading of 1593.72 indicates the transducers were about 4 feet higher in elevation than the original design. The following table presents the results of a geometric analysis of the bowing in the HDPE pipes showing several variations of offset and arc lengths and the resulting increase in elevation. Chord lengths were limited due to a cut in the rock outcrop where the pipes tended not to move laterally (see Figure 5.5).

Per AmerenUE staff, the design for a stiffer mounting system was completed October 25, 2005. Scheduling of the diver and a low water period for installation was not finalized with the last schedule for work being set for a spring 2006 drawdown.

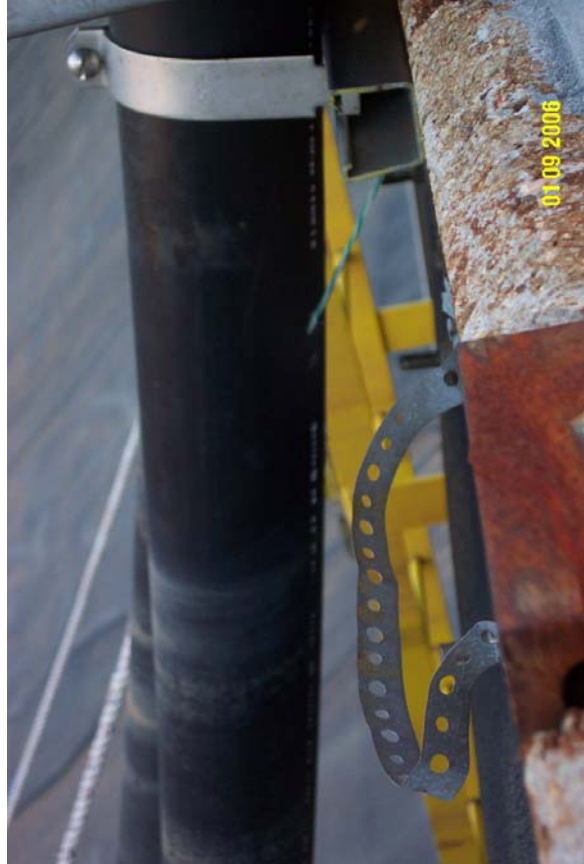
**Figure 5.6 - High Water marks on HDPE Tubes**

Evidence of the monitoring system not operating as designed was found at the gage house with water marks noted on the HDPE pipes. The elevation of the watermarks indicates the peak reservoir level may have been routinely above elevation 1596 ft. Figures 5.6 and 5.7 are a photograph and schematic of the high water marks, respectively.

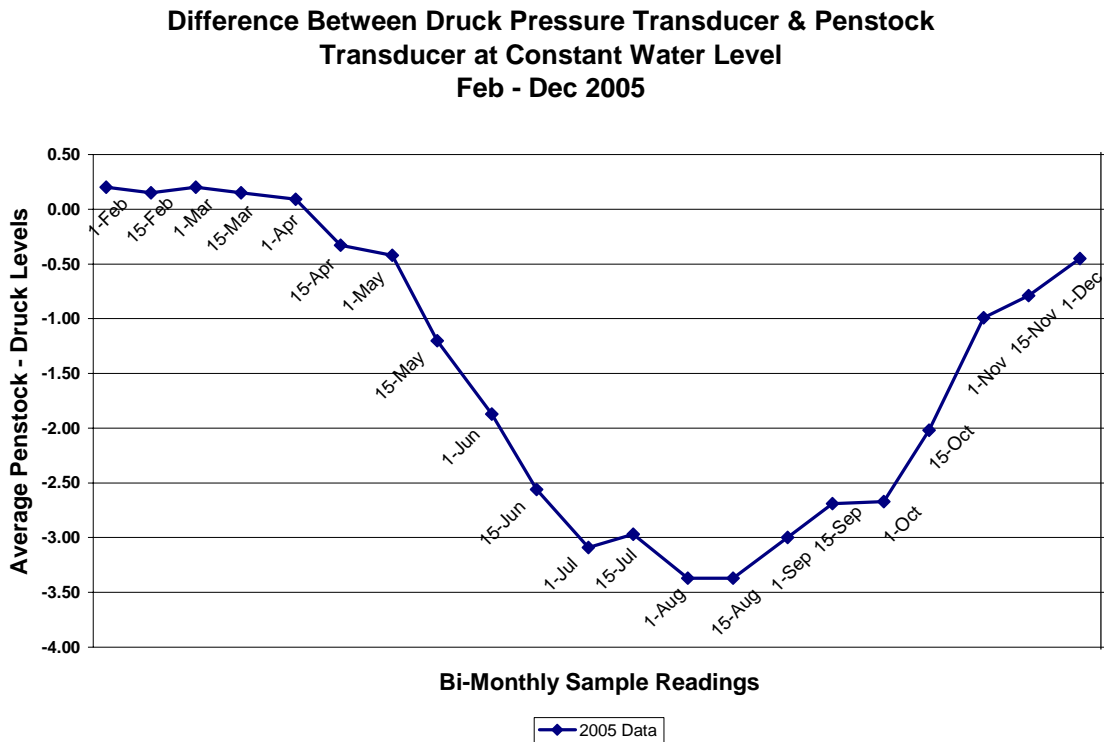
**Figure 5.8**

Figure 5.8 plots the average difference between the penstock transducer and druck pressure transducer readings as provided by AmerenUE's letters dated December 27, 2005 and February 7, 2006. The chart plots the daily average differences on the first and fifteenth of each month from February 1 to December 1, 2005

The bi-monthly plots show a sharp negative trend in the differences of the readings between April and August, reaching a low point in August. The differences then have a positive trend from August to December, approaching the readings experienced the previous winter. AmerenUE's February 7, 2006 submittal notes that the trend between the difference of readings correlates with the trend in water temperature. That is, the difference of readings became larger as water temperatures increased during the spring and summer and the difference became smaller as water temperatures decreased in the late summer and autumn.

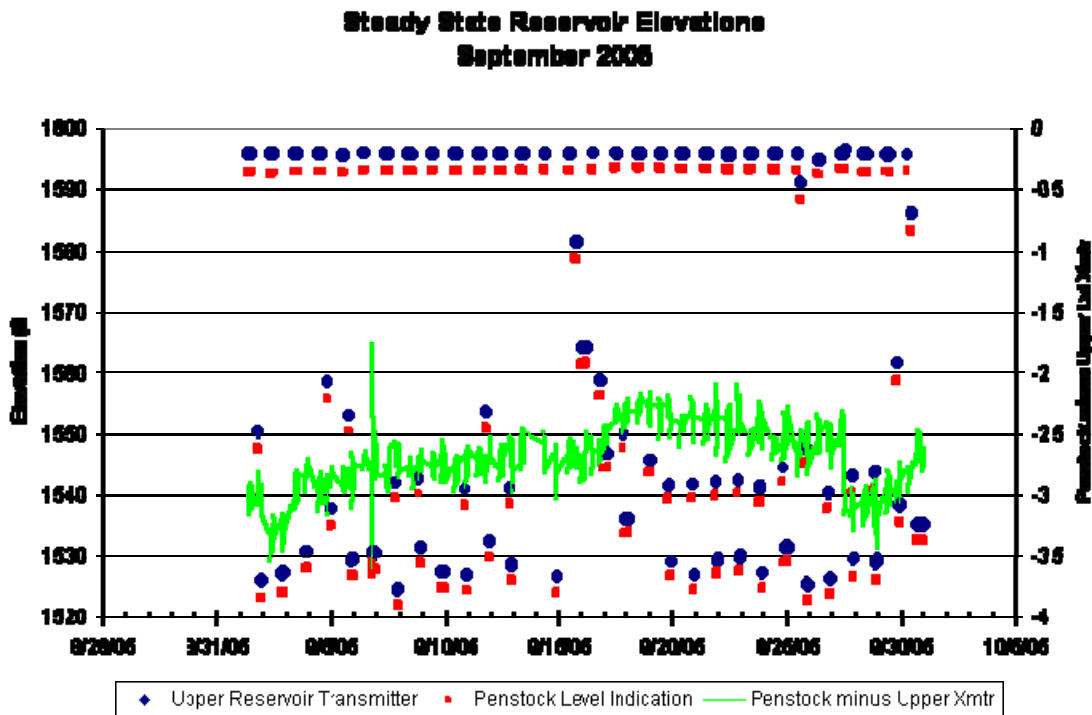
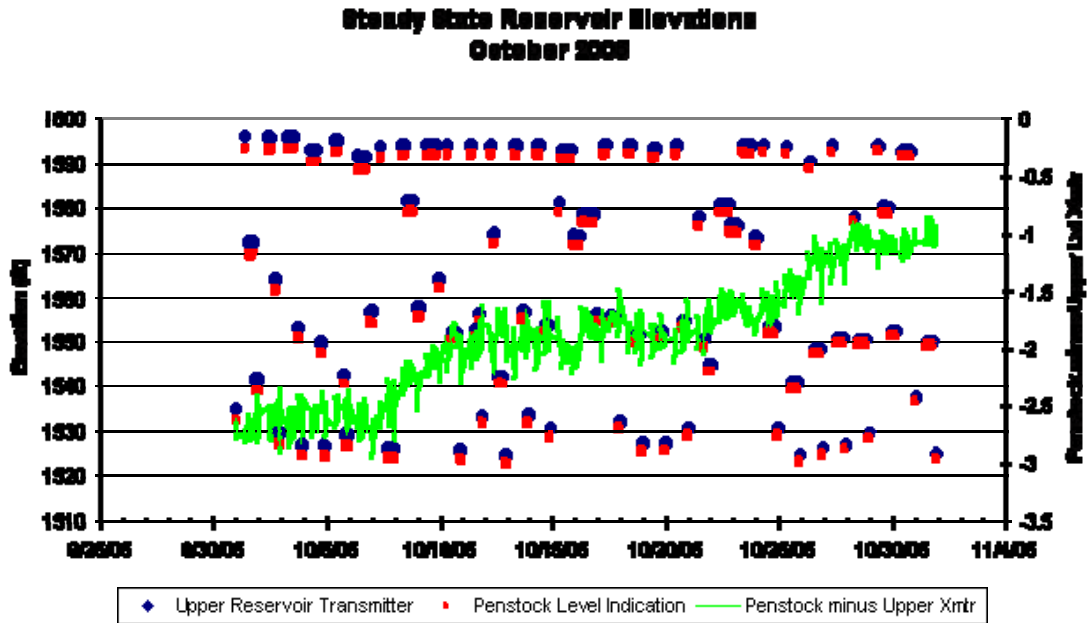
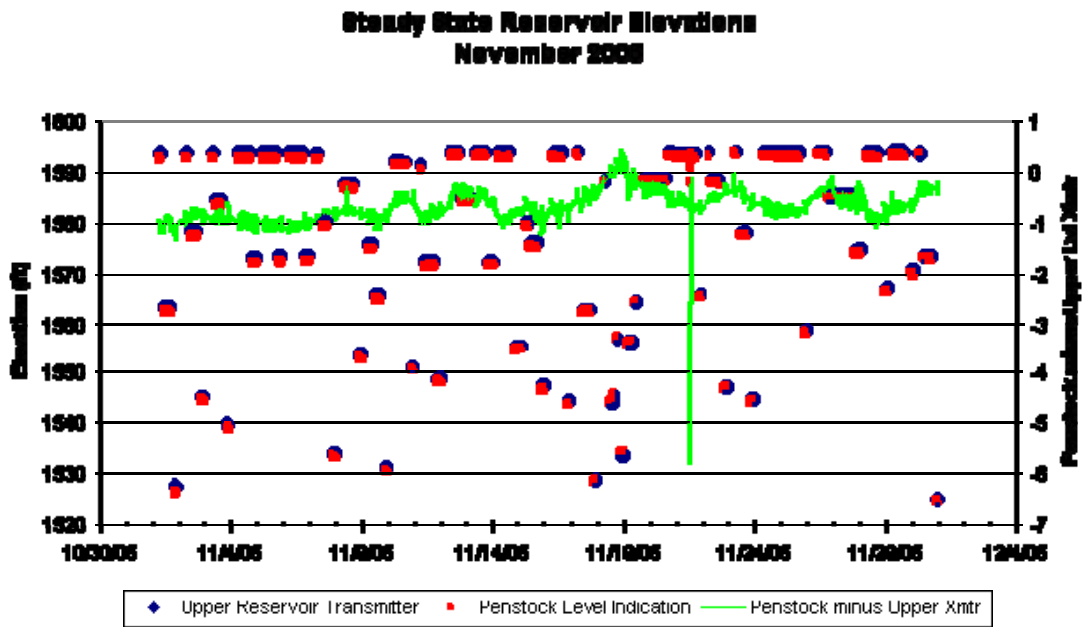
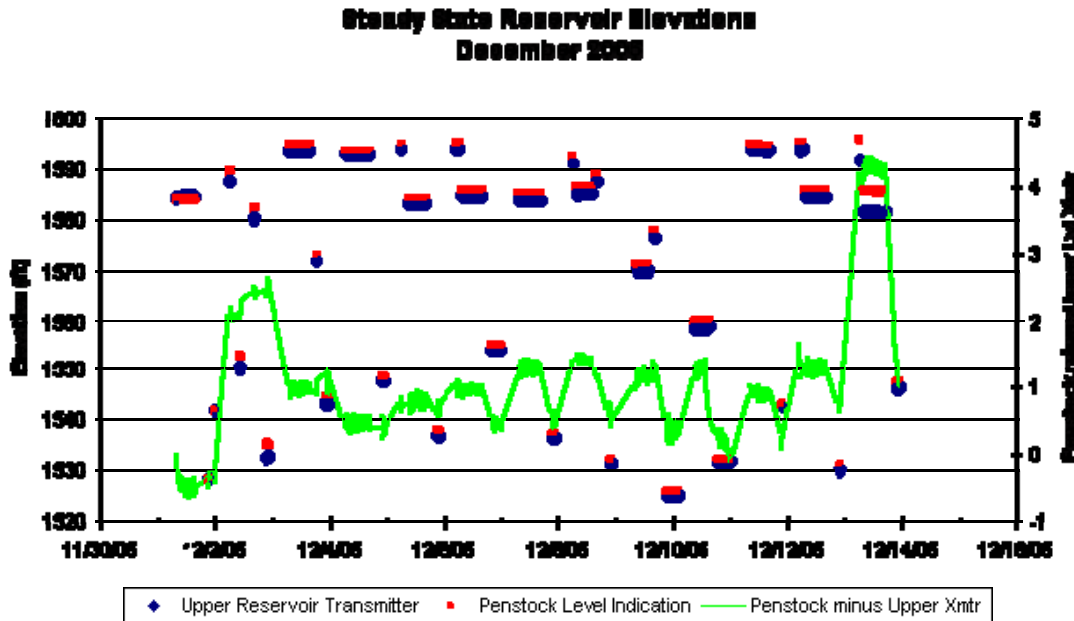
AmerenUE's February 7, 2006 filing also provides charts comparing the Druck pressure transducer (referred to as transmitter) readings and the penstock transducer readings, to determine if movement of the Upper Reservoir transducers could be detected. These charts give more specific information for each day in 2005 until December 14. Figures 5.9-5.12 show the graphs provided by AmerenUE for September through December 2005. September 27 shows a significant movement which coincides with the date one Druck pressure transducer was removed from averaging and a 0.4 foot correction was made in the PLC to the Druck pressure transducer readings. Significant and larger movements appear in December 2005, with increases in the differences on December 2 and December 13.

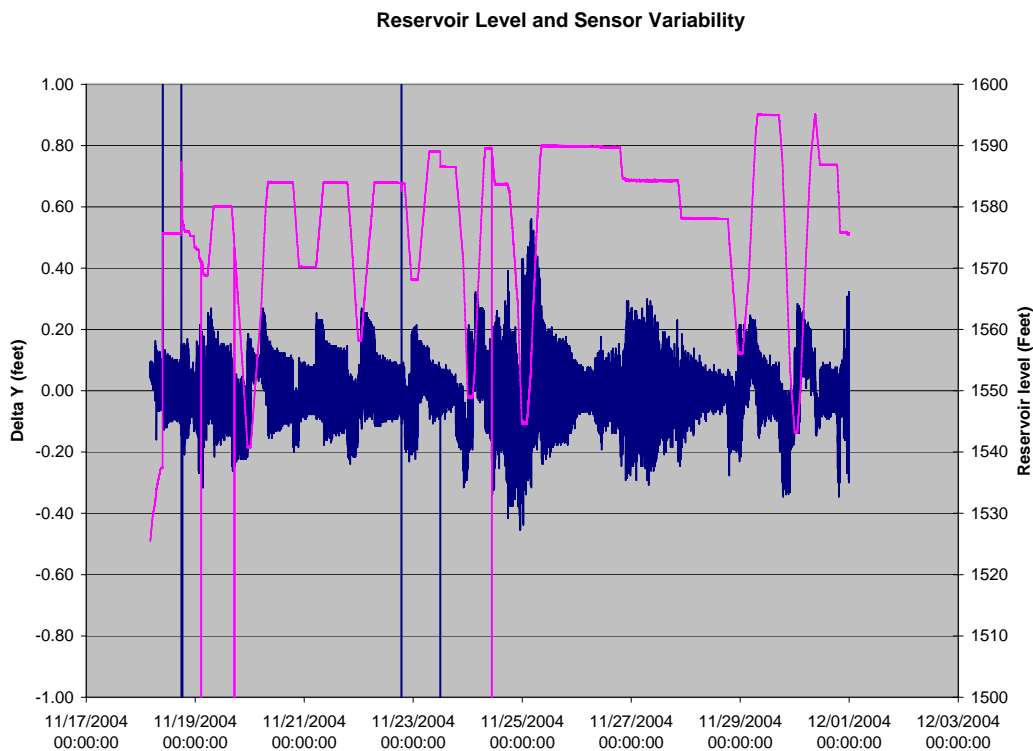
**Figure 5.12 - System Variability November 2004 - After Installation**

1. The variability in the system output when the reservoir was in pump mode appeared to be within the specification after initial installation.
2. Increases in variability of the Druck pressure transducer signals and output appear to increase from September 2005 through December 2005.
3. Variability appears to be greater than the sum of the electronic error and the rate of reservoir rise. Variability up to +/- 1.75 feet occurred December 13, 2005.
4. The greatest fluctuation in the output occurs during the pump cycle when the reservoir elevation is between 1545 ft and 1565 ft.
5. It is possible there is a relationship between the movement of the instrumentation pipes and the turbulence caused by the pumping cycle (Figure 5.16 – shows turbulence on first filling. Figure 5.5 shows proximity of pipes to the intake shaft.)

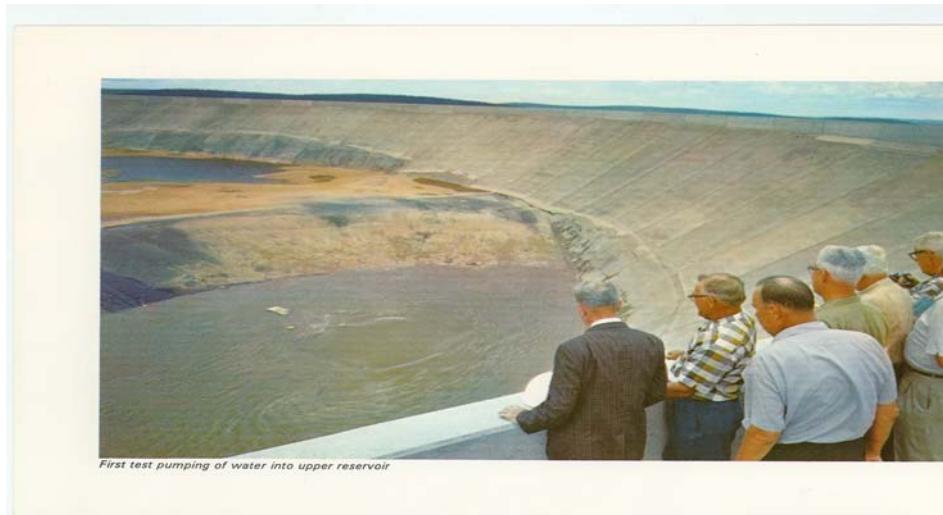
**Figure 5.16 - Turbulence on first filling (from AmerenUE)**
