GAO

OVERSEAS PRESENCE

Conditions of Overseas
Diplomatic Facilities

Statement of Jess T. Ford
Director, International Affairs and Trade

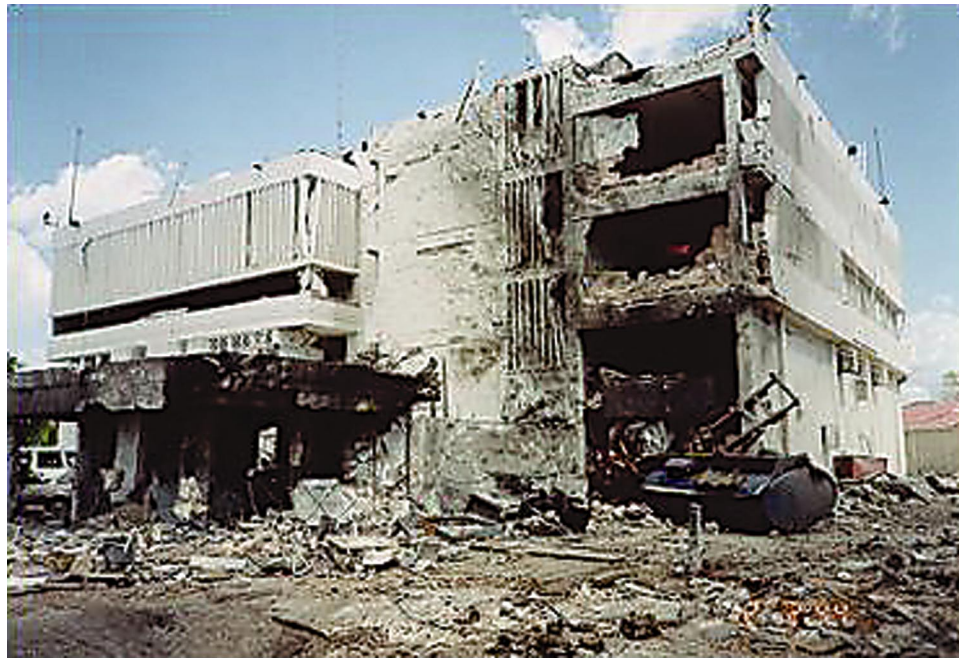
Figure 2: U.S. Embassy in Tanzania, after the August 7, 1998, Terrorist Attack

In the 1998 bombings, terrorists attacked the U.S. embassies in Nairobi, Kenya, and Dar es Salaam, Tanzania. These large-scale truck bombings killed more than 220 people, including 12 American U.S. government employees and family members, 32 Kenyan national U.S. government employees, and 8 Tanzanian national U.S. government employees. In addition, the bombings injured more than 4,000 Kenyans, Tanzanians, and Americans.⁵ Figures 1 and 2 show pictures of the embassy in Tanzania before and after the bombings.

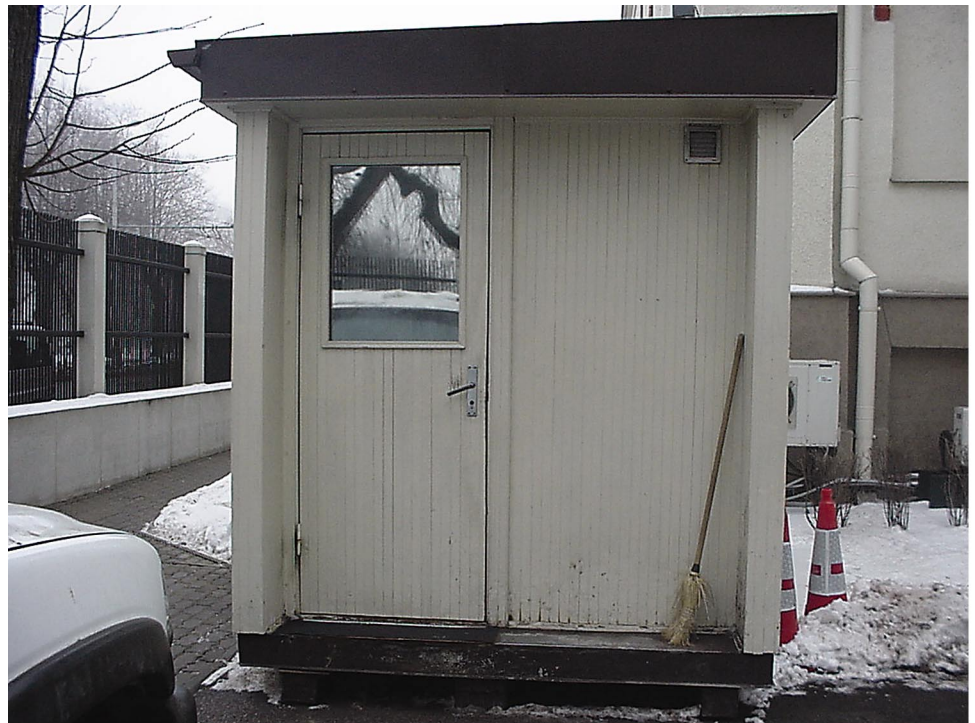
Figure 9: Inadequate Compound Access Control Booth

We also found that 108 posts either lack or have inadequate compound access control, a system of gates, barriers, and guard booths that is used to pre-screen personnel and vehicles before entering the embassy grounds. At one embassy we visited, visa applicants could gain access to the embassy building prior to undergoing proper screening, which would be a serious concern in the case of a terrorist action. Figure 9 depicts an inadequate compound access control booth, which is located within the embassy compound. The Security Officer acknowledged that this was a serious weakness and that visitors were not screened adequately before entering the embassy building. Construction of a new compound access control system is scheduled to begin in May 2003. Figure 10 depicts a
