Appendix A

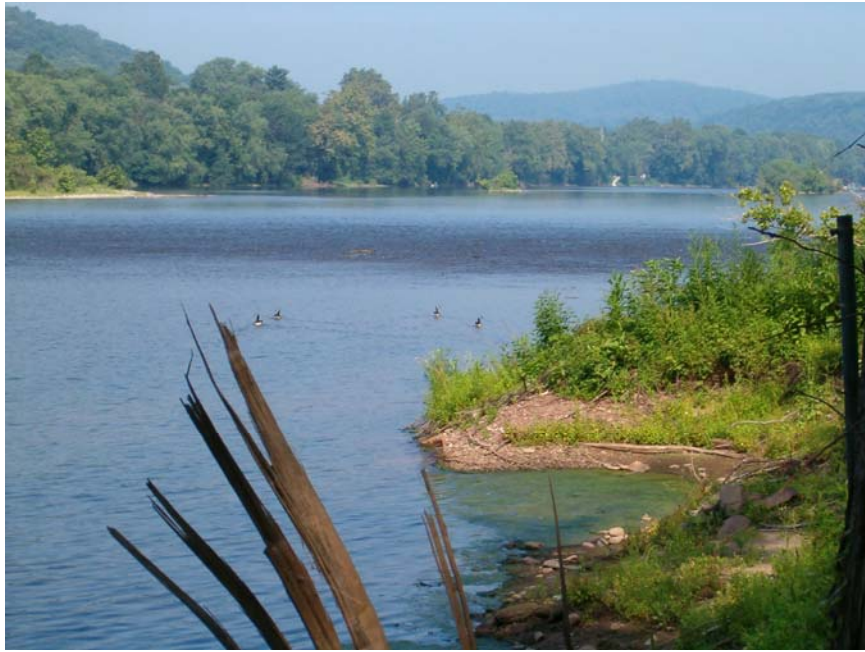
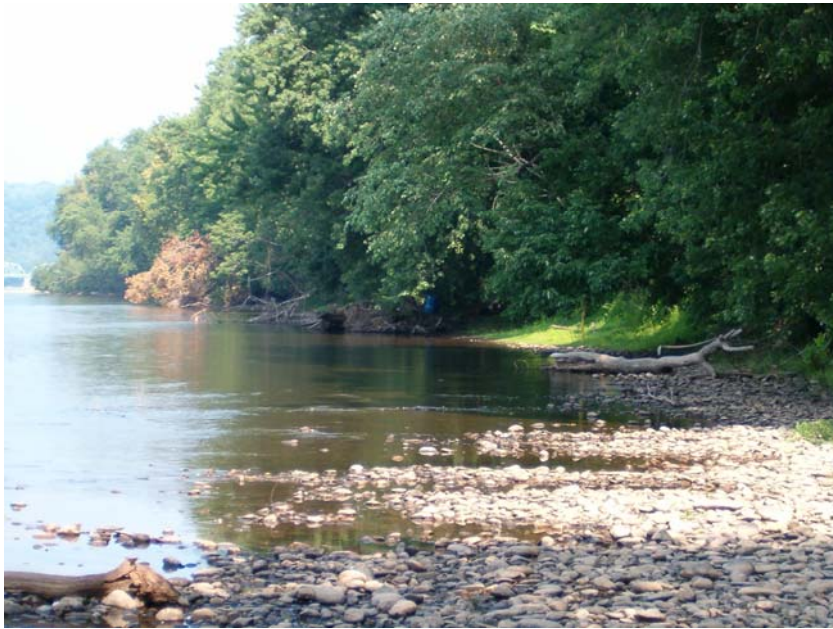
Photographs 1 and 2: View of the Delaware River along the western portion of the Crown Vantage Landfill site, August 11, 2005

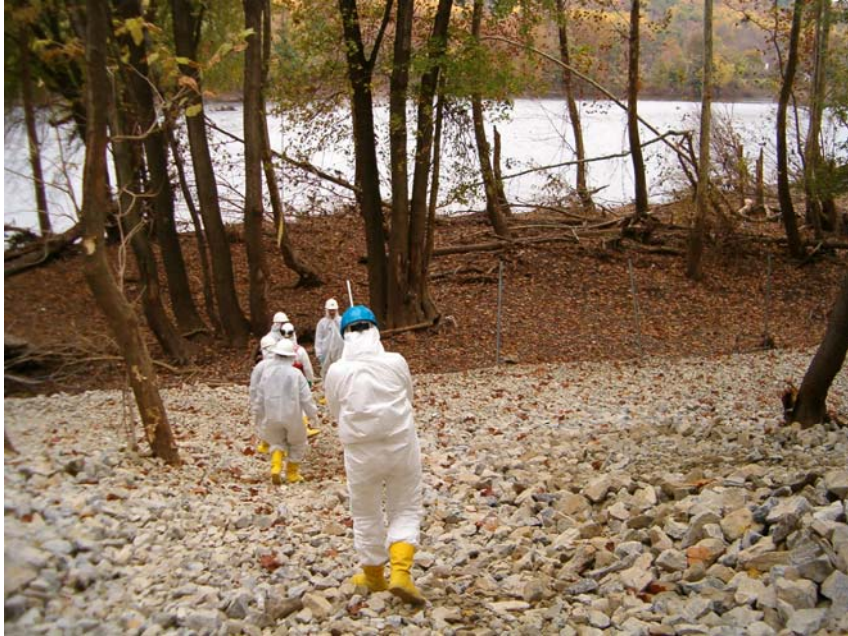
Photograph 3: Riprap on the western portion of the Crown Vantage Landfill site, October 26, 2004

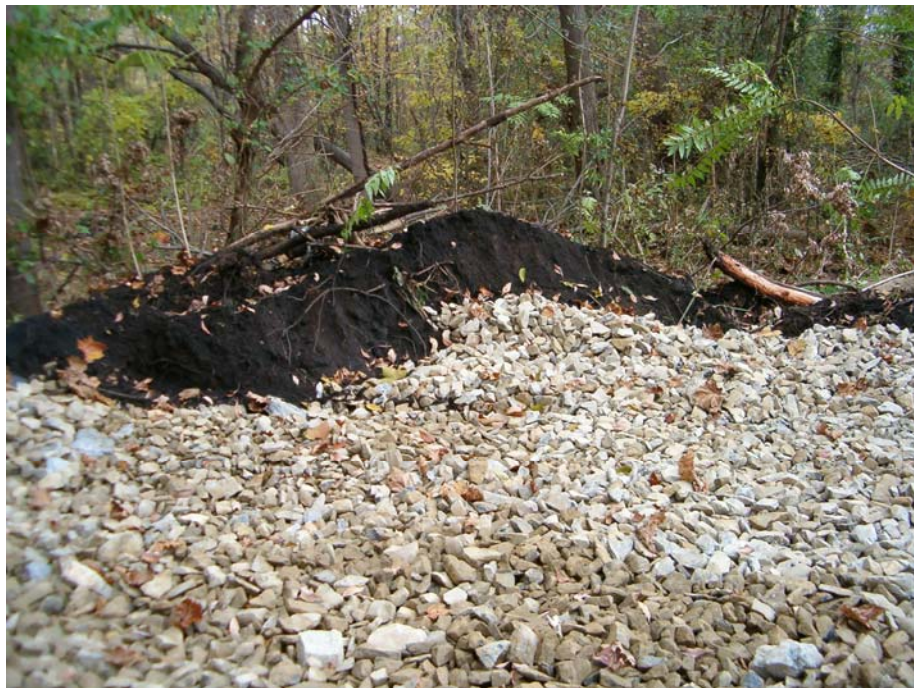
Photograph 4: Flyash on the Crown Vantage Landfill site, October 26, 2004

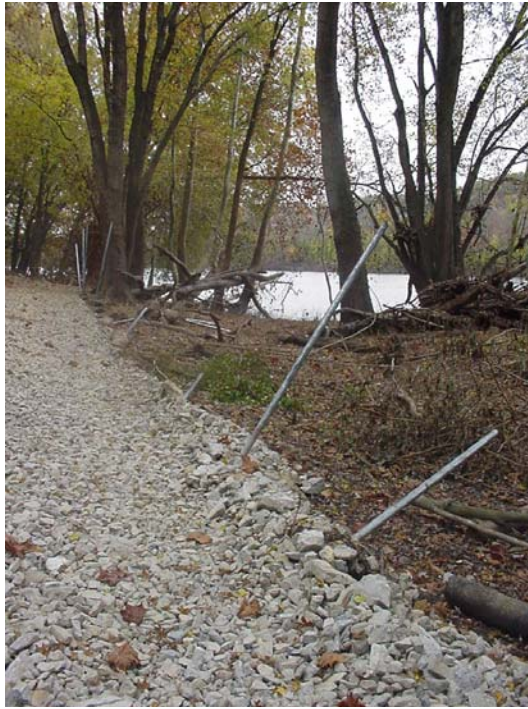
Photograph 5: View of fallen fence posts on the western portion of the Crown Vantage Landfill site, August 11, 2005

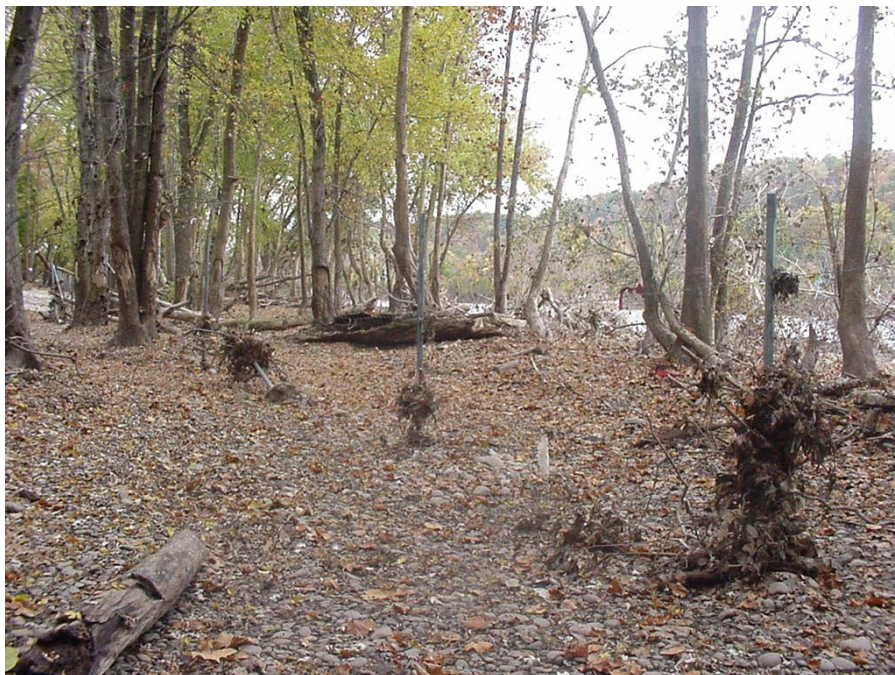
Photograph 6: Fence with flood debris on the western portion of the Crown Vantage Landfill site, August 11, 2005

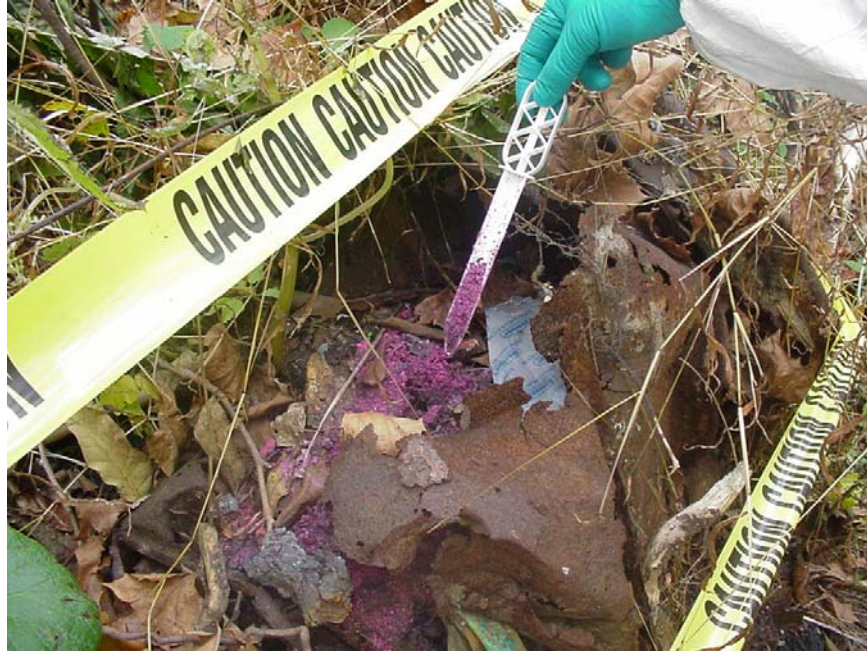
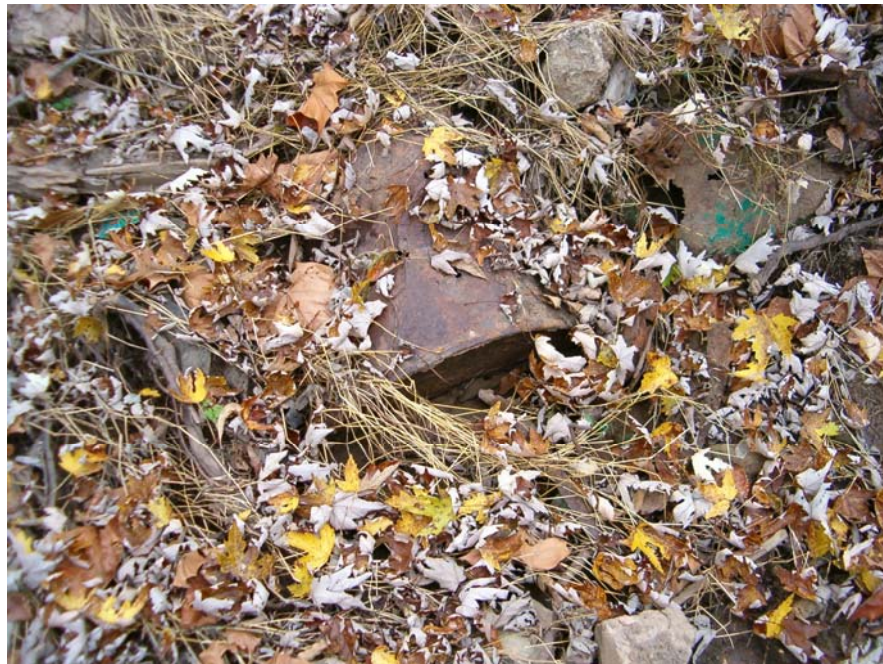
Photographs 7 and 8: Half-buried disintegrated drums on the Crown Vantage Landfill site, October 26, 2005

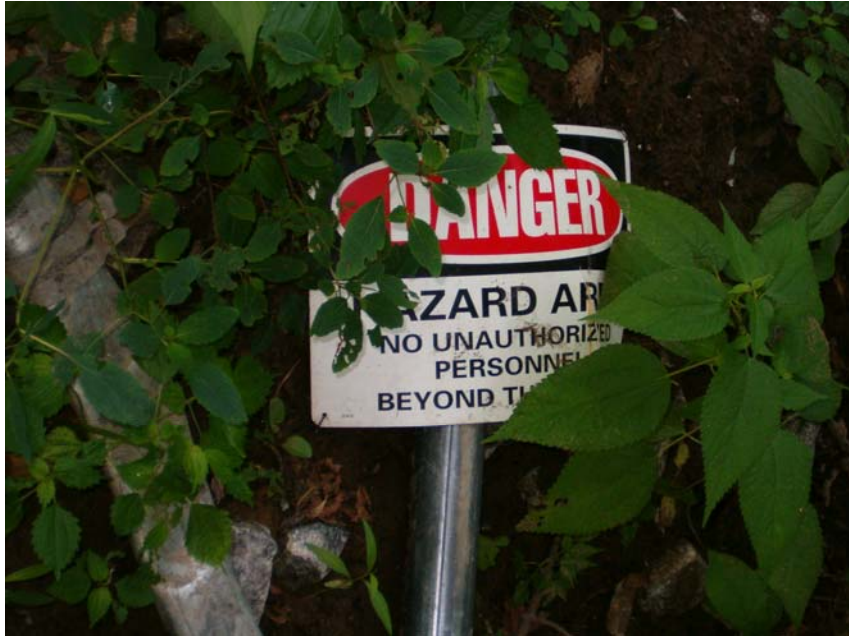
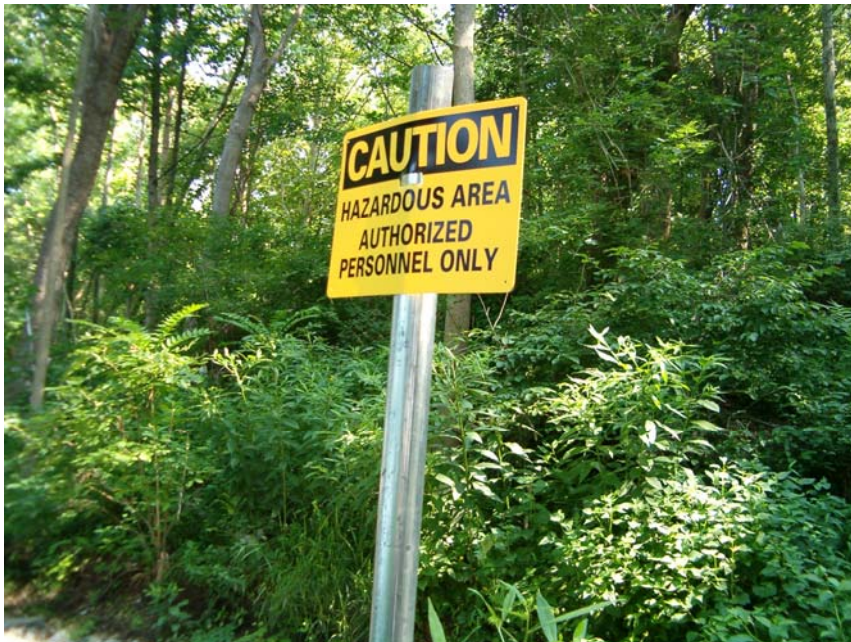
Photographs 9 and 10: Warning signs posted along the western portion of the Crown Vantage Landfill site, August 11, 2005

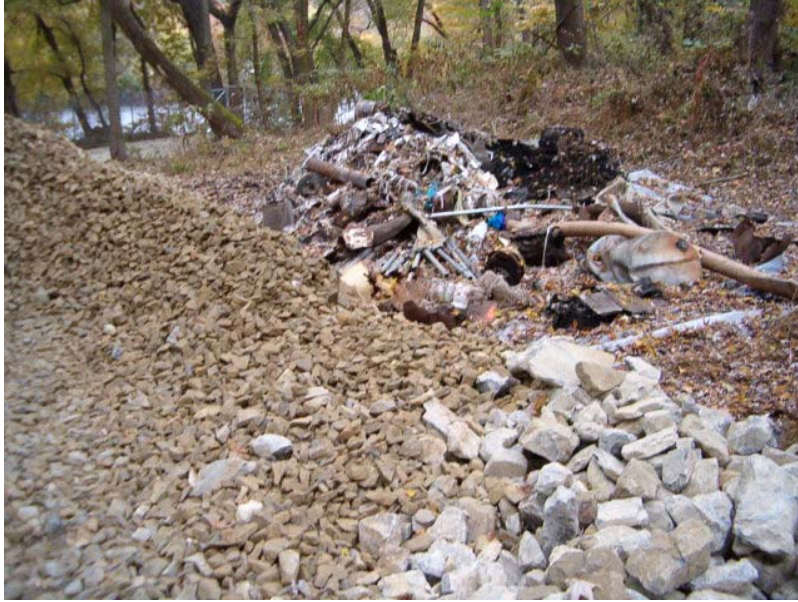
Photograph 11: Flood debris on the Crown Vantage Landfill site, October 26, 2004

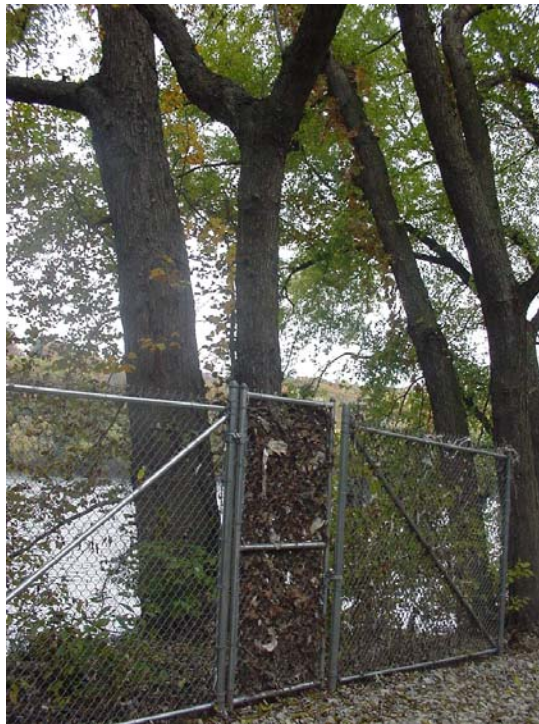
Photograph 12: Fence with flood debris on the western portion of the Crown Vantage Landfill site, August 11, 2005

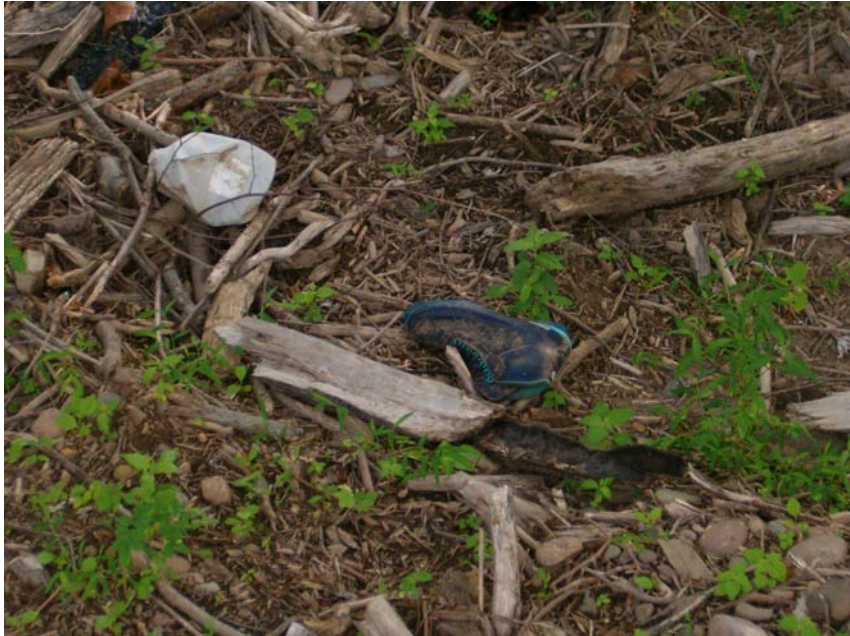
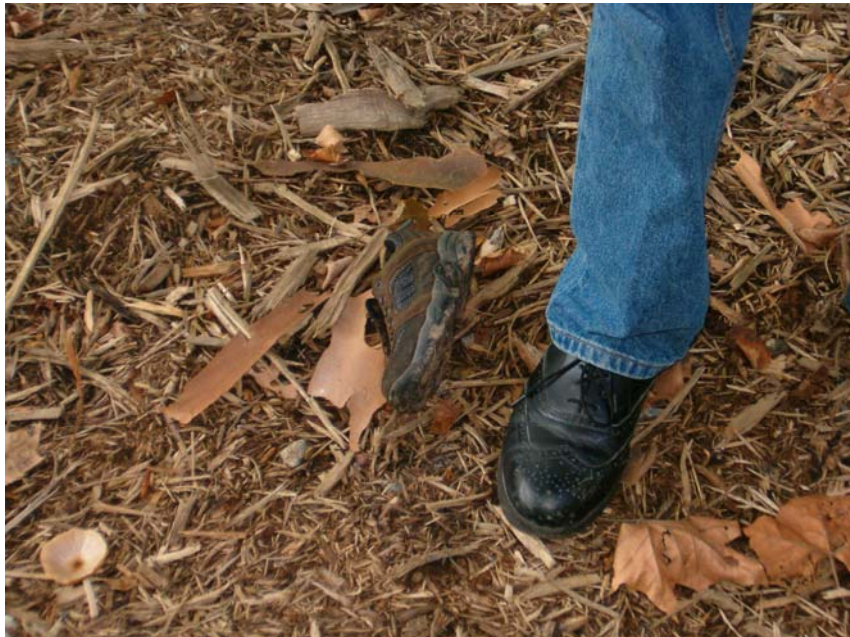
Photographs 13 and 14: Evidence of adult and child shoe washed ashore on the Crown Vantage Landfill site, August 11, 2005

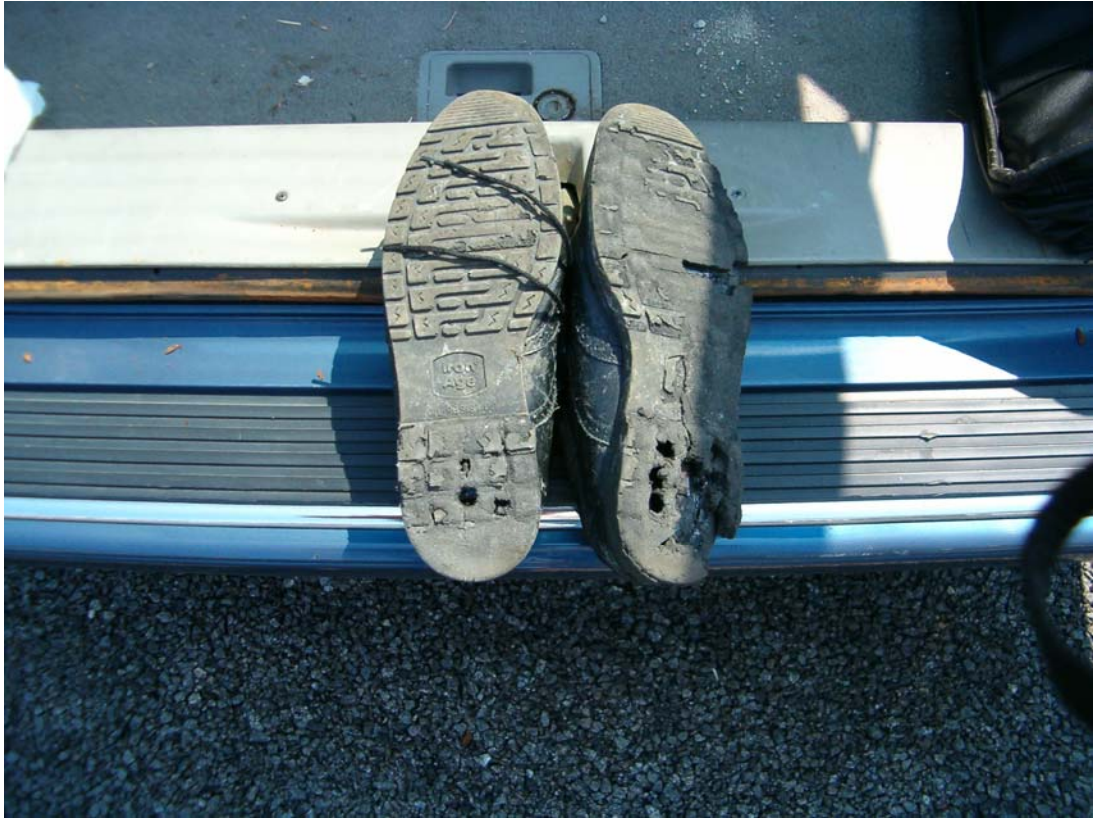
Photograph 15: NJDHSS staff member's steel-toed safety shoes following the site visit to the Crown Vantage Landfill, August 11, 2005
