September 26, 2007

RE: BLM Little Hyatt Dam – Structural Evaluation
Work Order No. HAD 075M09

KPFF visited the site of the Little Hyatt Dam near Ashland, Oregon on September 18, 2007 to review the structural condition of the dam. A geotechnical engineer from Ash Creek Associates accompanied us on this visit to review the foundation conditions. This visit was requested by the BLM to provide a report on the state of the structure and its foundation that identifies structural problems and necessary repairs.

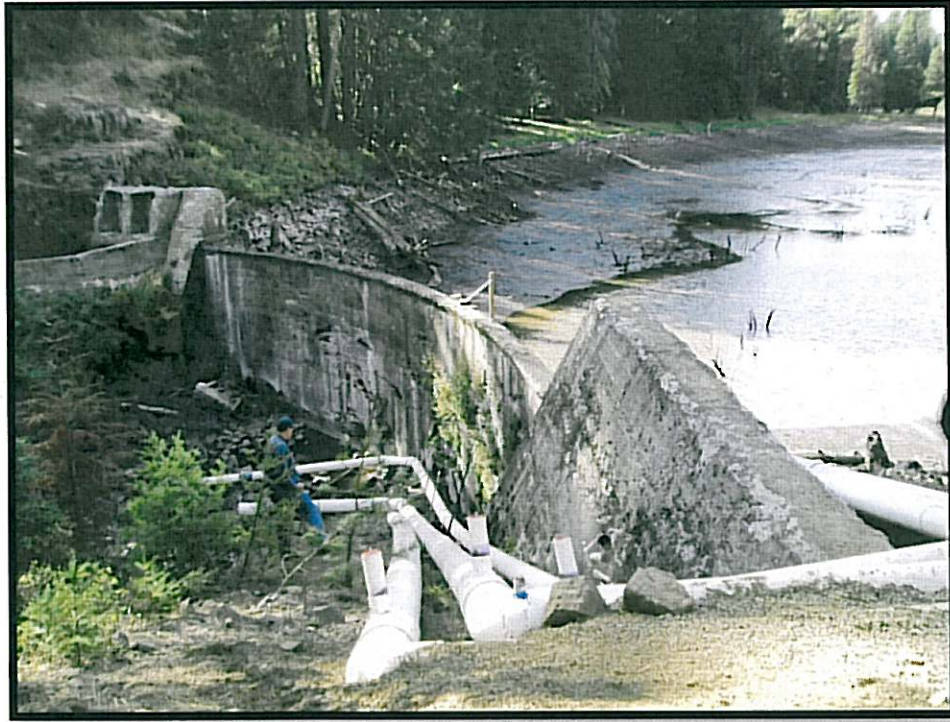
PHOTO 1 - DOWNSTREAM FACE OF DAM

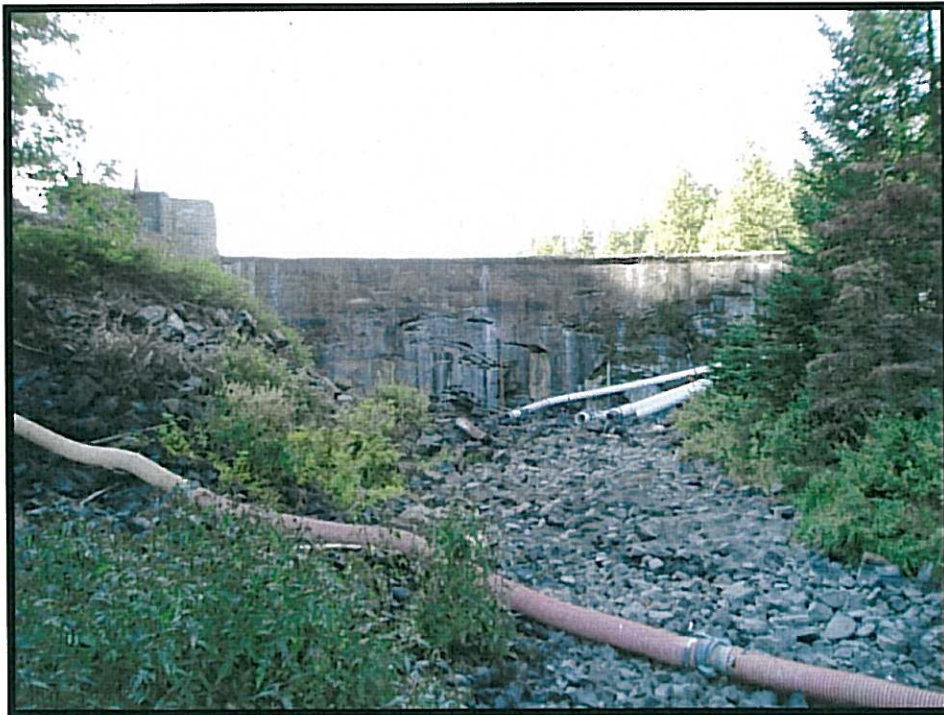
PHOTO 2 - DOWNSTREAM FACE OF DAM

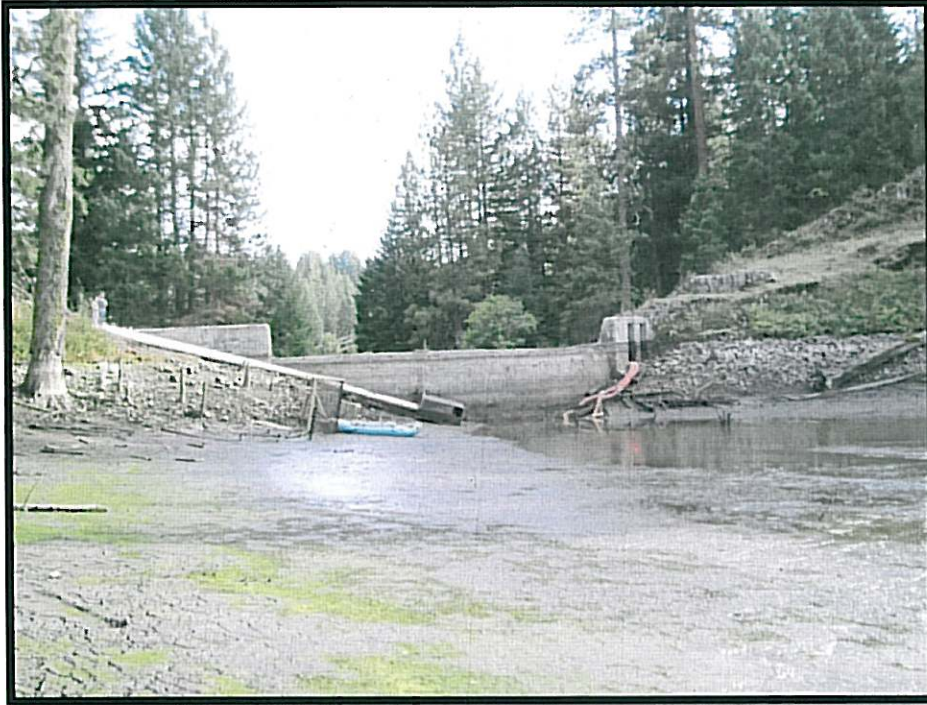
PHOTO 3 – UPSTREAM FACE OF DAM

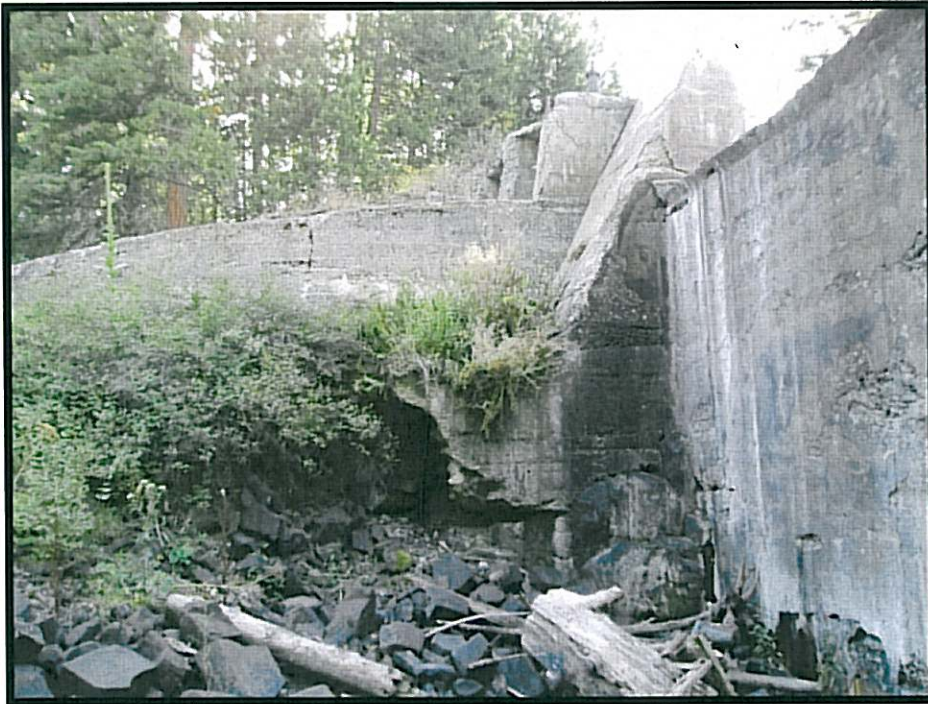
The void behind the right abutment was discussed in detail in the previous study and continues to be a concern. This void has altered the load path for the support of this abutment which now relies on the support of the concrete canal wall to prevent it from overturning. If the concrete canal wall deteriorates to the point that it is no longer providing support for the right abutment, the abutment would fail in overturning which would result in sudden failure of the entire dam. We therefore continue to recommend that this void be repaired as soon as possible, restoring the original support load path for the abutment.

PHOTO 4 – EROSION BEHIND RIGHT ABUTMENT

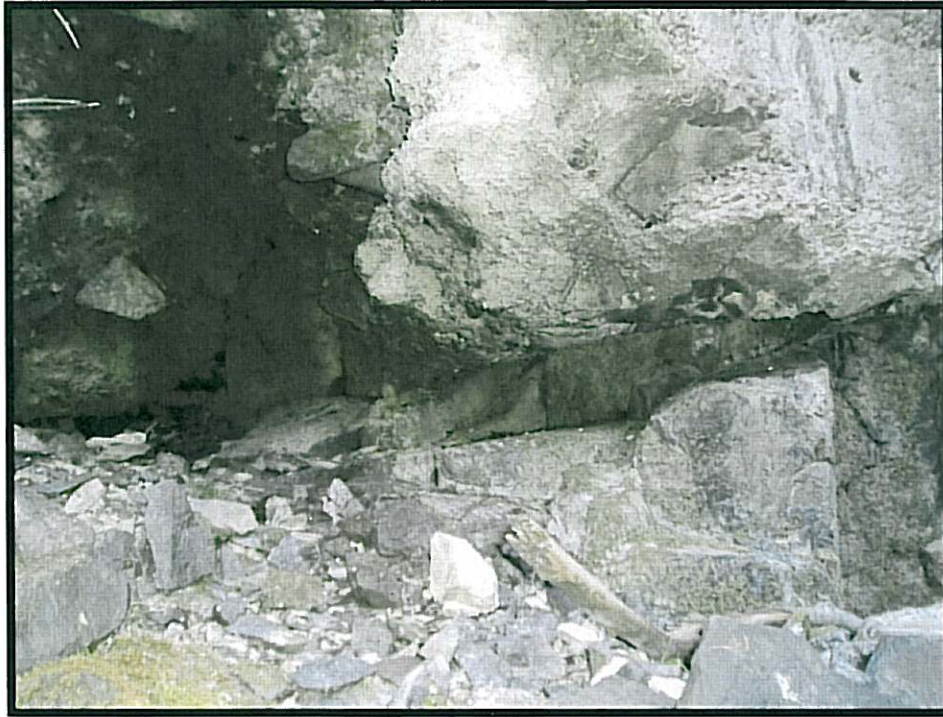
PHOTO 5 – EROSION BEHIND RIGHT ABUTMENT

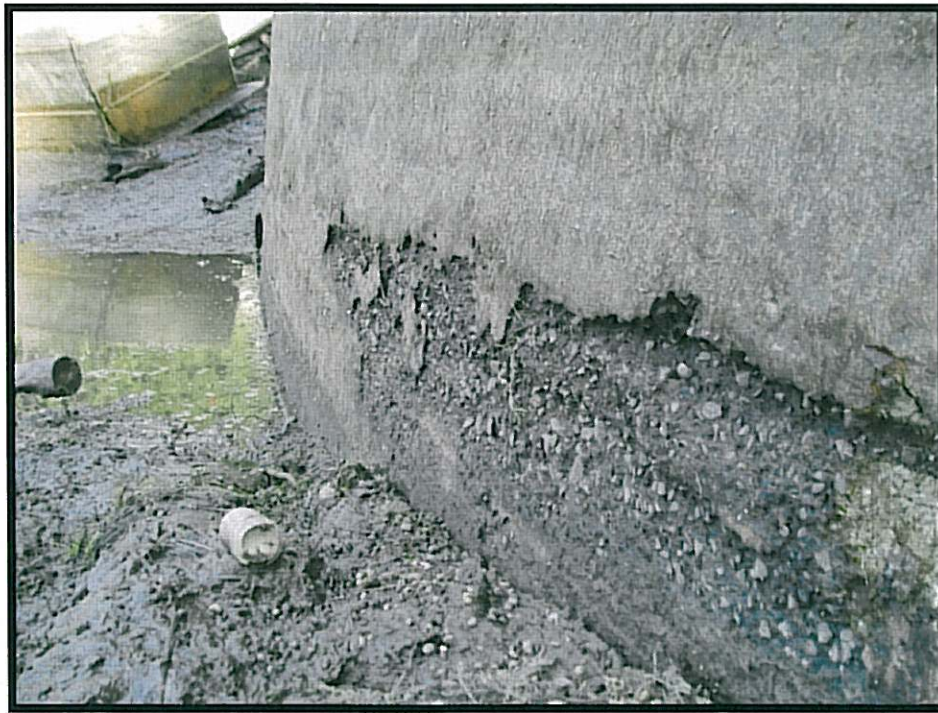
2. Areas of concrete deterioration on both faces of the dam will continue to increase in size and depth until they connect to form holes through the dam. As water passes through these holes their size will quickly increase reducing the storage capacity of the reservoir or potentially rendering it useless if the holes occur low enough on the face of the dam. The variation in the condition and quality of the concrete throughout the dam make it impossible to predict when these hole will occur. However, we believe that the rate of deterioration is accelerating and that the current rate is significantly above the lifetime average for the dam. Failure could occur within a few days of refilling of the reservoir or it may take several years. However, it should be noted this mode of failure is unlikely to cause a catastrophic collapse of the dam, it is more likely that the localized deterioration will cause the dam to drain, relieving the stress on the overall dam structure.

PHOTO 6 – CONCRETE DETERIORATION ON UPSTREAM FACE

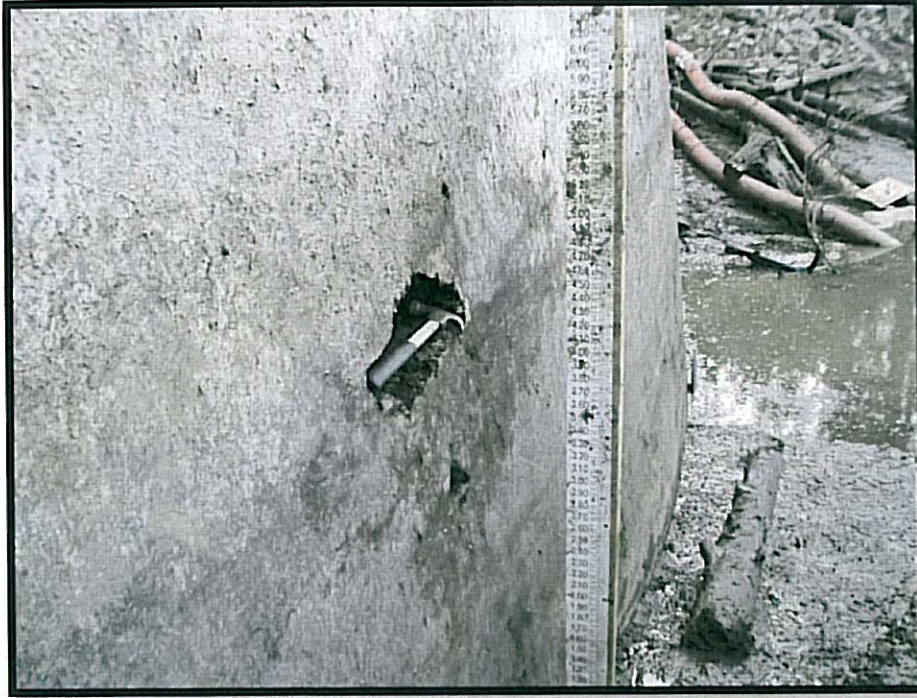
PHOTO 7 – HOLE IN UPSTREAM FACE OF DAM

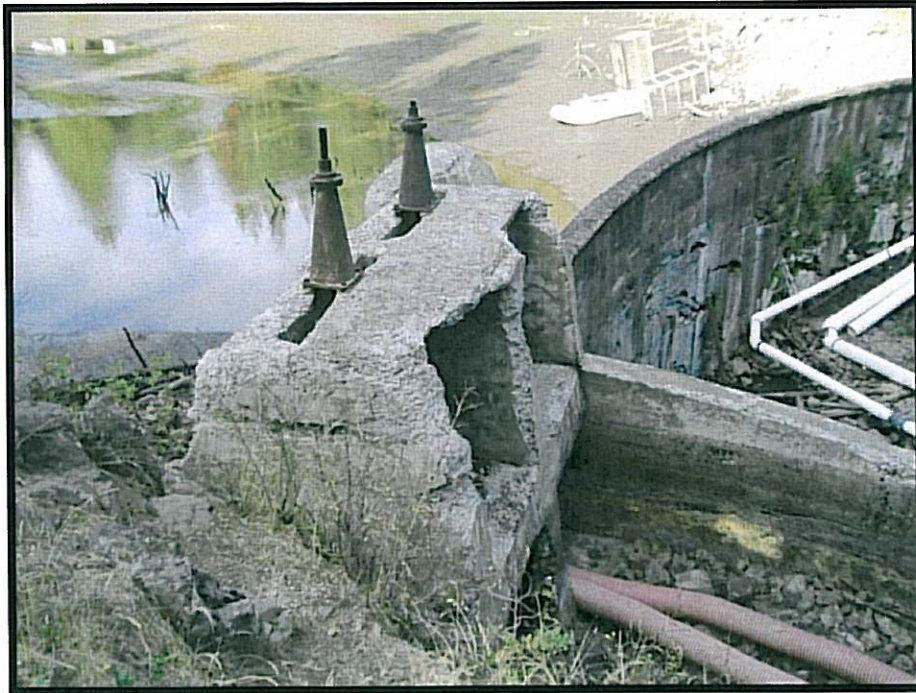
PHOTO 8 – SLUICE GATES

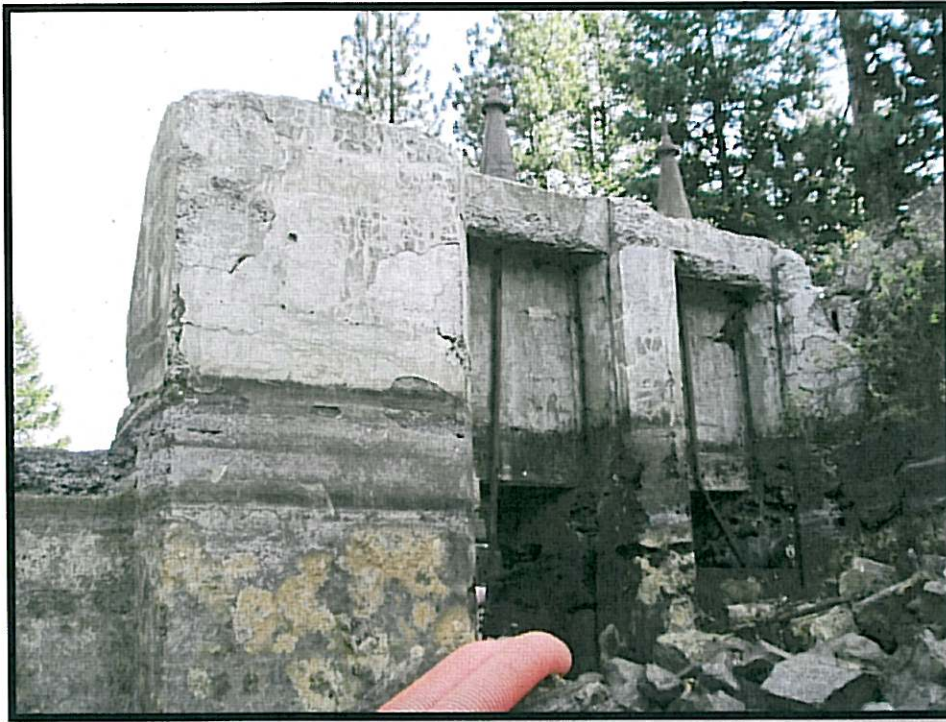
PHOTO 9 – SLUICE GATES

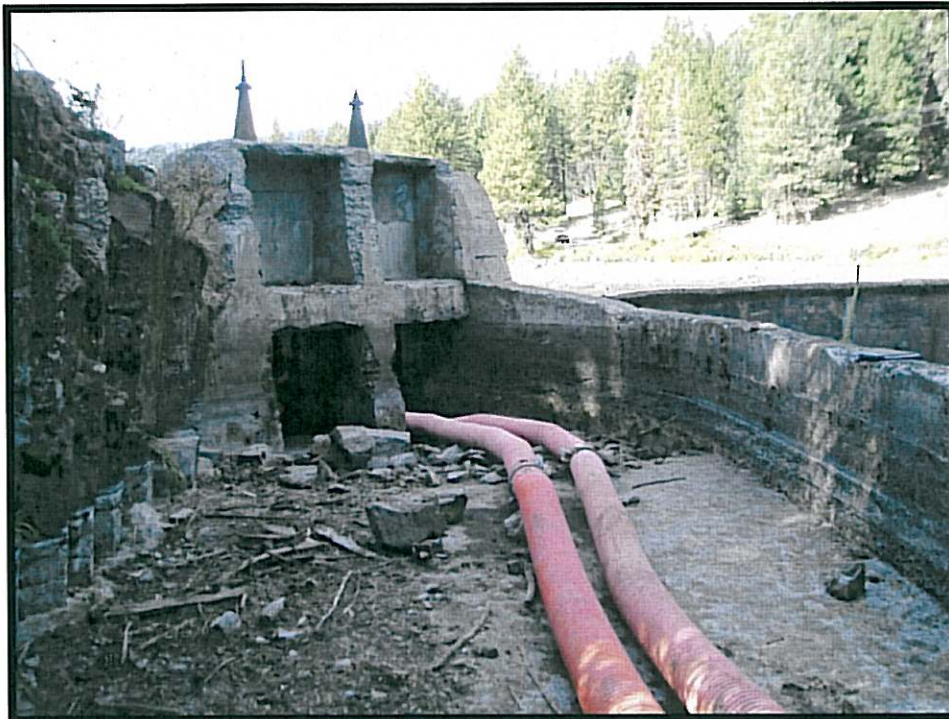
PHOTO 10 – SLUICE GATES

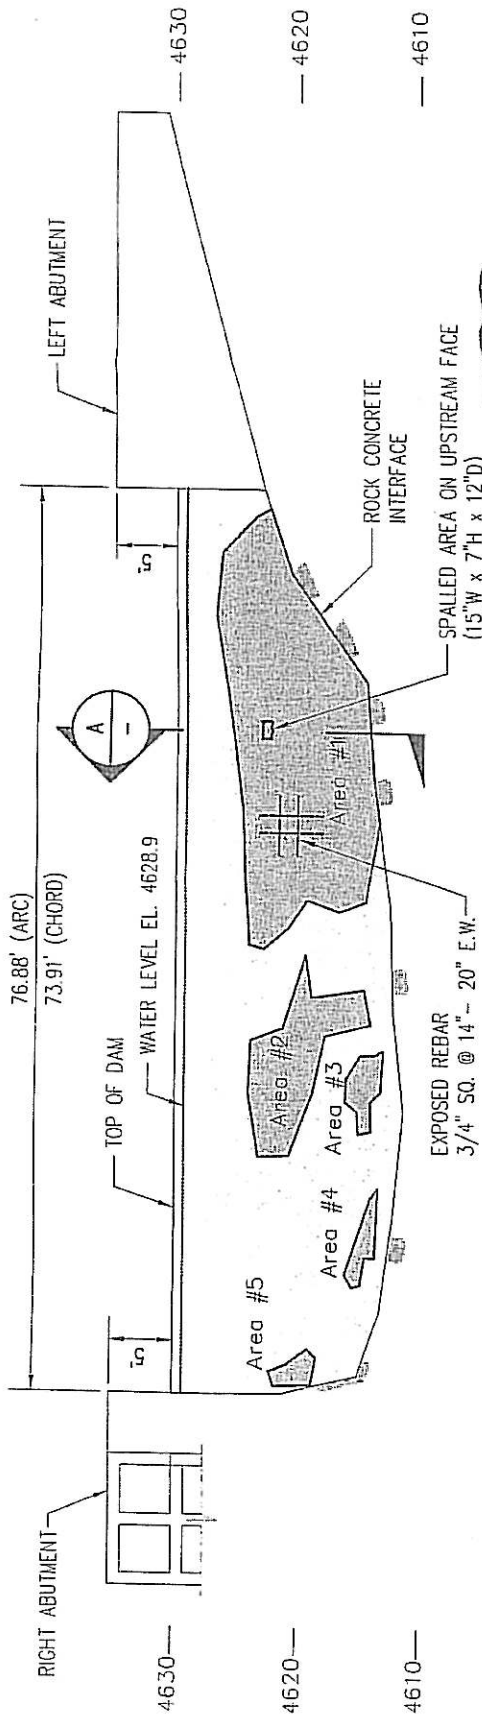
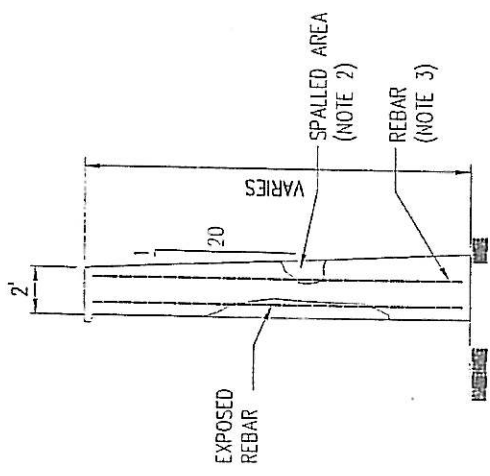
FIGURE 1
ALWAYS THINK SAFETY

Where possible, depths of concrete deterioration that were listed in Figure 11 of the 1999 study were measured using a steel tape. Generally the depths of deterioration were found to have increased since the previous investigation. This is consistent with the findings of the 1999 study which predicted that the depths of deterioration would continue to increase due to seepage flows and freeze/thaw cycles. (See attached for a copy of Figure 11 from the previous study with current measured depths of deterioration marked-up.)

15" DEEP 9/18/07

ERODED AREAS ON DOWNSTREAM FACE OF DAM		
LOCATION	AREA (SQ. FT.)	DEPTH OF EROSION (FEET)
AREA #1	315	0.7
AREA #2	71	0.7
AREA #3	13	1.6
AREA #4	10	0.3
AREA #5	8	0.45
TOTAL ERODED AREA	417 SQ. FT.

9/18/07 Depth of Erosion (FT)	
1.2	
NOT ACCESSIBLE	
1.8	
0.5	
0.5
