Two Volunteer Fire Fighters Die Fighting a Basement Fire - Illinois

Fatality Assessment and Control Evaluation Investigative Report #F2001-08

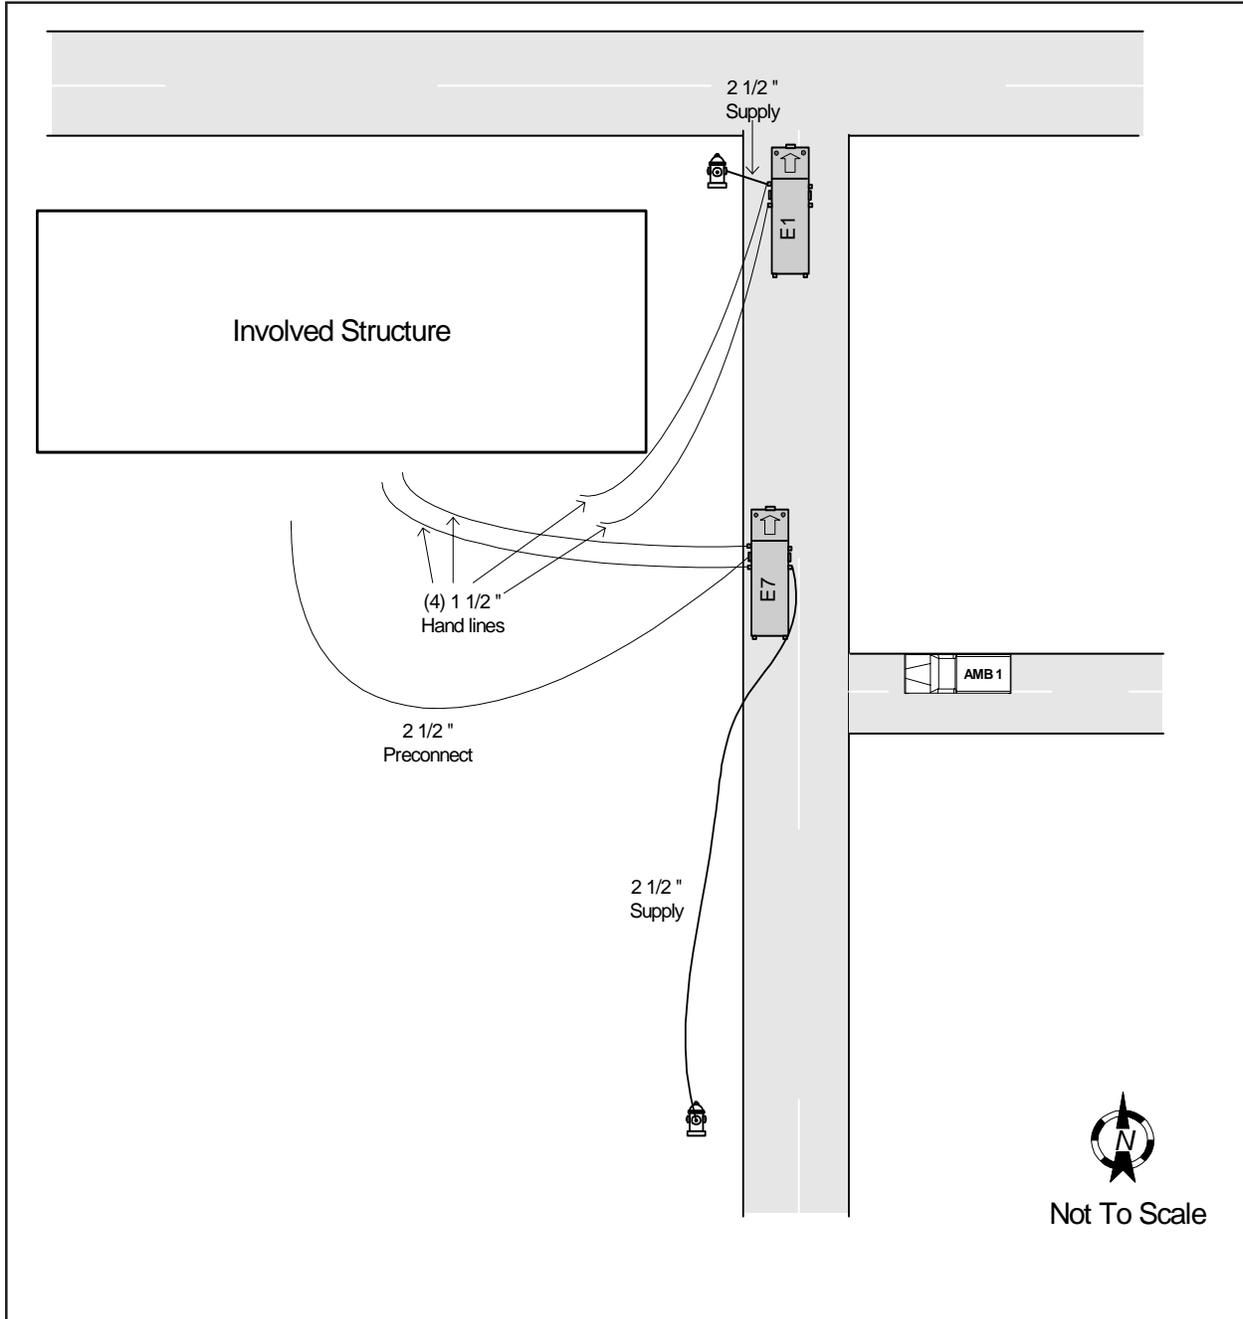
Diagram 1. Apparatus Layout

At 0823 hours, Engine 1 and Ambulance 15 were the first to arrive on the scene. When approaching the scene, the crew noticed a small amount of white smoke emitting from the house. Fire fighters from Engine 1 pulled two 1 ½-inch preconnects and stretched both lines to the south door of the structure (Diagram 1). The Chief assumed Incident Command (IC) and was informed by a relative of the resident that no one was inside the structure and that the resident had noticed smoke in the bathroom on the first floor (Diagram 2). Engine 7 and Ambulance 23 arrived on the scene at 0824 hours. While Engine 7 connected their supply line to a hydrant and pulled a 1 ½-inch preconnect to the south side of the structure, the Assistant Chief conducted a scene size-up while walking around the structure. He noticed light gray smoke emitting from the eaves and around the chimney with no visible flames. The Chief informed the Assistant Chief they had two 1 ½-inch lines pulled to the south (rear) door.

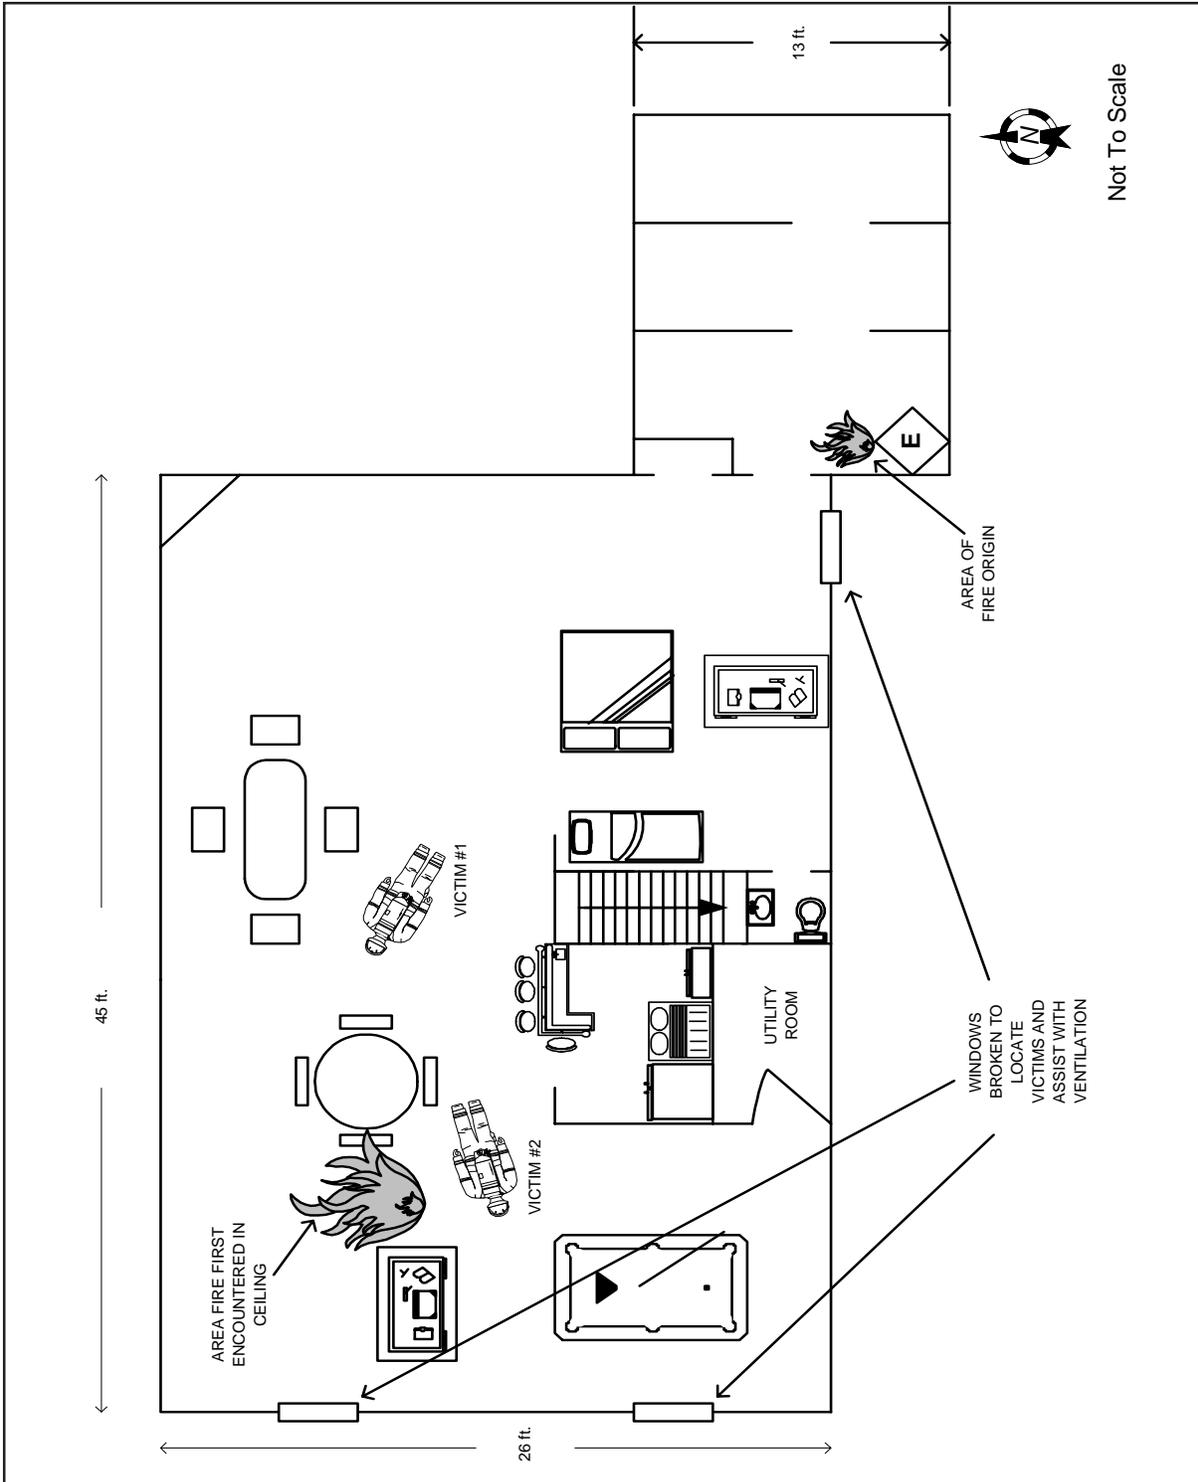
Diagram 3. Basement

Victim #1 and two other fire fighters entered the south-side door to make the first entry into the basement. The crew took a 1 ½-inch hoseline with them. At the foot of the stairs, they saw fire on the ceiling to the west (Diagram 3). The crew opened the nozzle and pushed the fire back. One of the fire fighters left the basement to retrieve halogen lights and flashlights and to inform the Assistant Chief that they had a working basement fire. With one low air alarm sounding, the crew exited the basement after
