A summary of a NIOSH fire fighter fatality investigation

January 27, 2006

Career Battalion Chief and Career Master Fire Fighter Die and Twenty-Nine Career Fire Fighters are Injured during a Five Alarm Church Fire - Pennsylvania

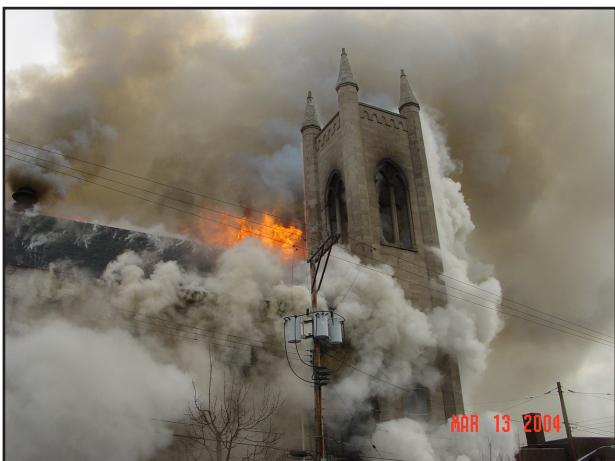
Church involved in the incident

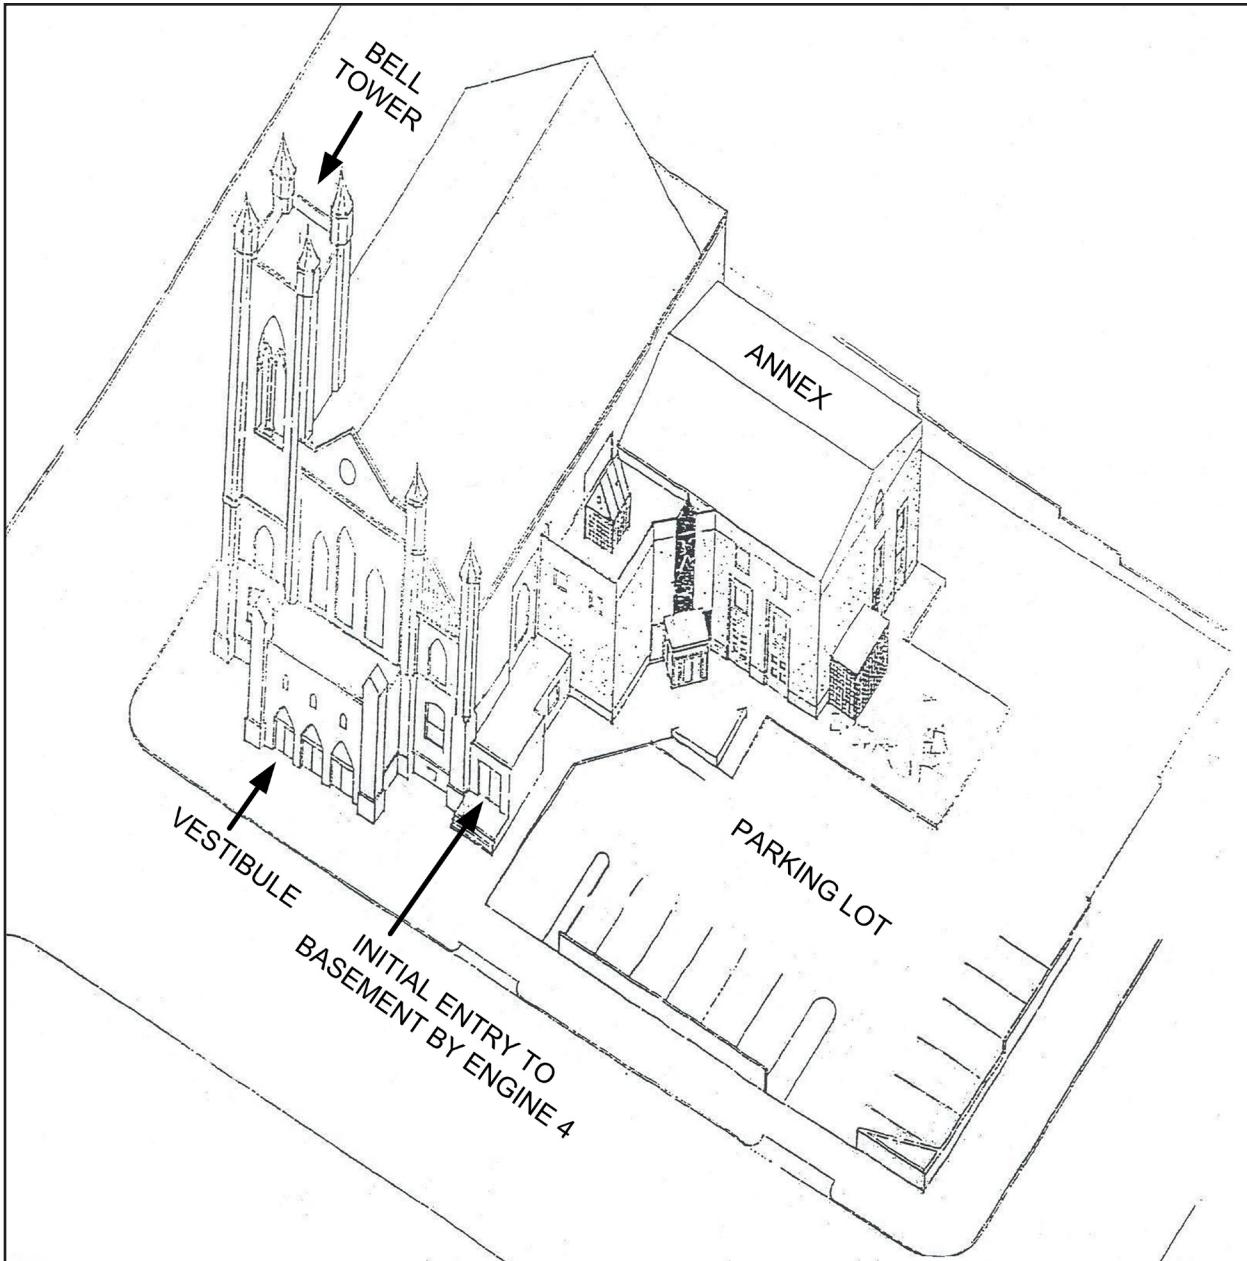
Diagram 1. Church involved in incident

The church was a National Historic Landmark that was built in 1875 (Diagram 1). The building was still in use as a house of worship and school at the time of this incident. The exterior construction was masonry with several courses of red brick covered with stone. The building foundation was approximately 120 x 70 feet and approximately 50 feet to the roof line. The pitched roof was covered with asphalt shingles and supported by heavy timber roof trusses. The stone façade exterior of the structure was added during a renovation in the 1930s. This renovation also included the addition of a 115 foot bell tower capped with four spires. The bell tower was not a stand-alone structure, but was supported by steel I-beams with a brick and stone façade that was connected into the southwest corner of the original church.

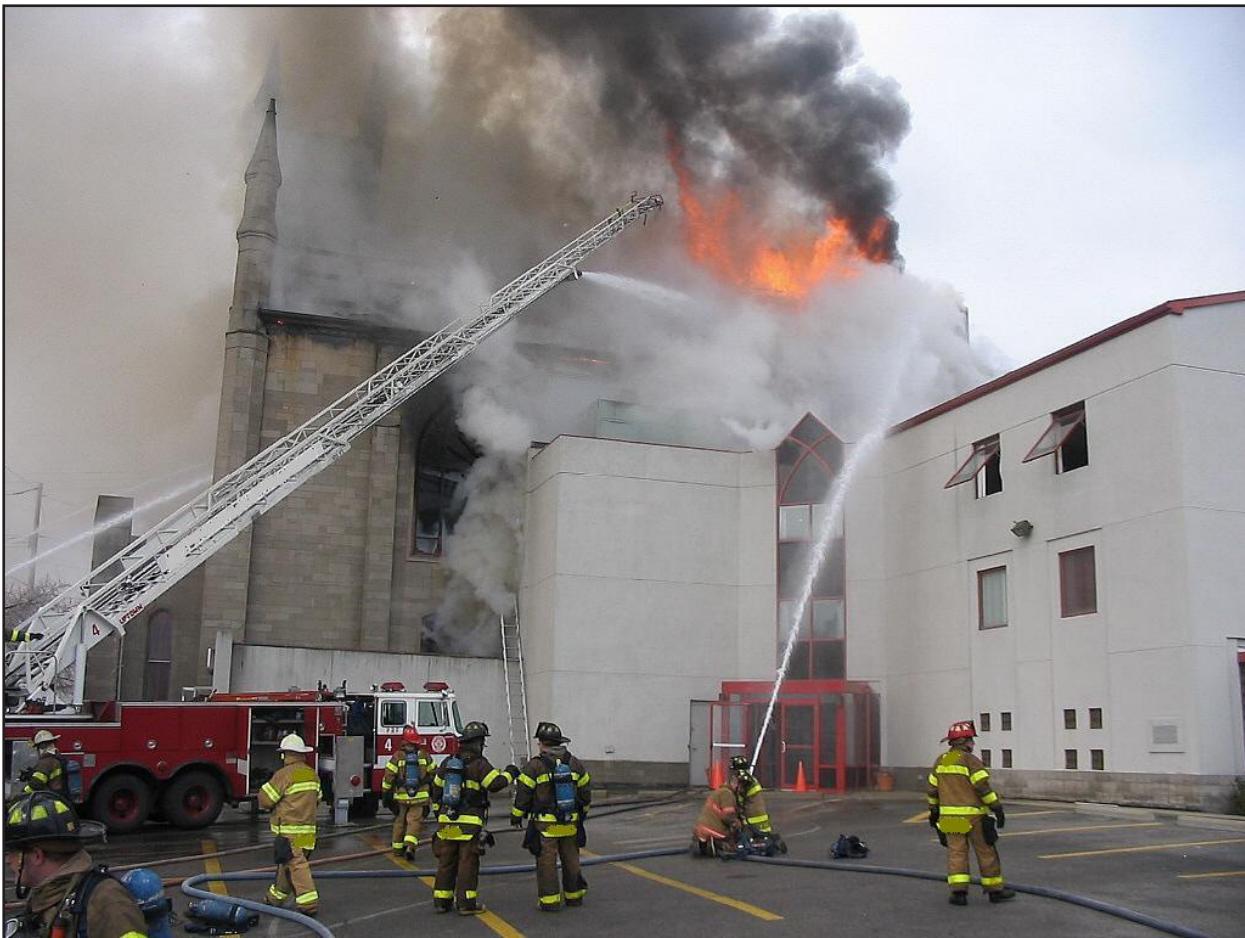
At 0949 hours, fire was present throughout the western side of the church. At 1007 hours, heavy black smoke was observed in the eastern side and at 1009 hours, fire was breaking through the roof (Photo 1). At 1031 hours, there was heavy fire throughout the church and at 1048 hours (approximately 2 hours into the incident), the roof was completely burnt away and companies were continuing with "surround and drown" operations (Photo 2).

Photo 1. Fire breaking through roof of incident structure

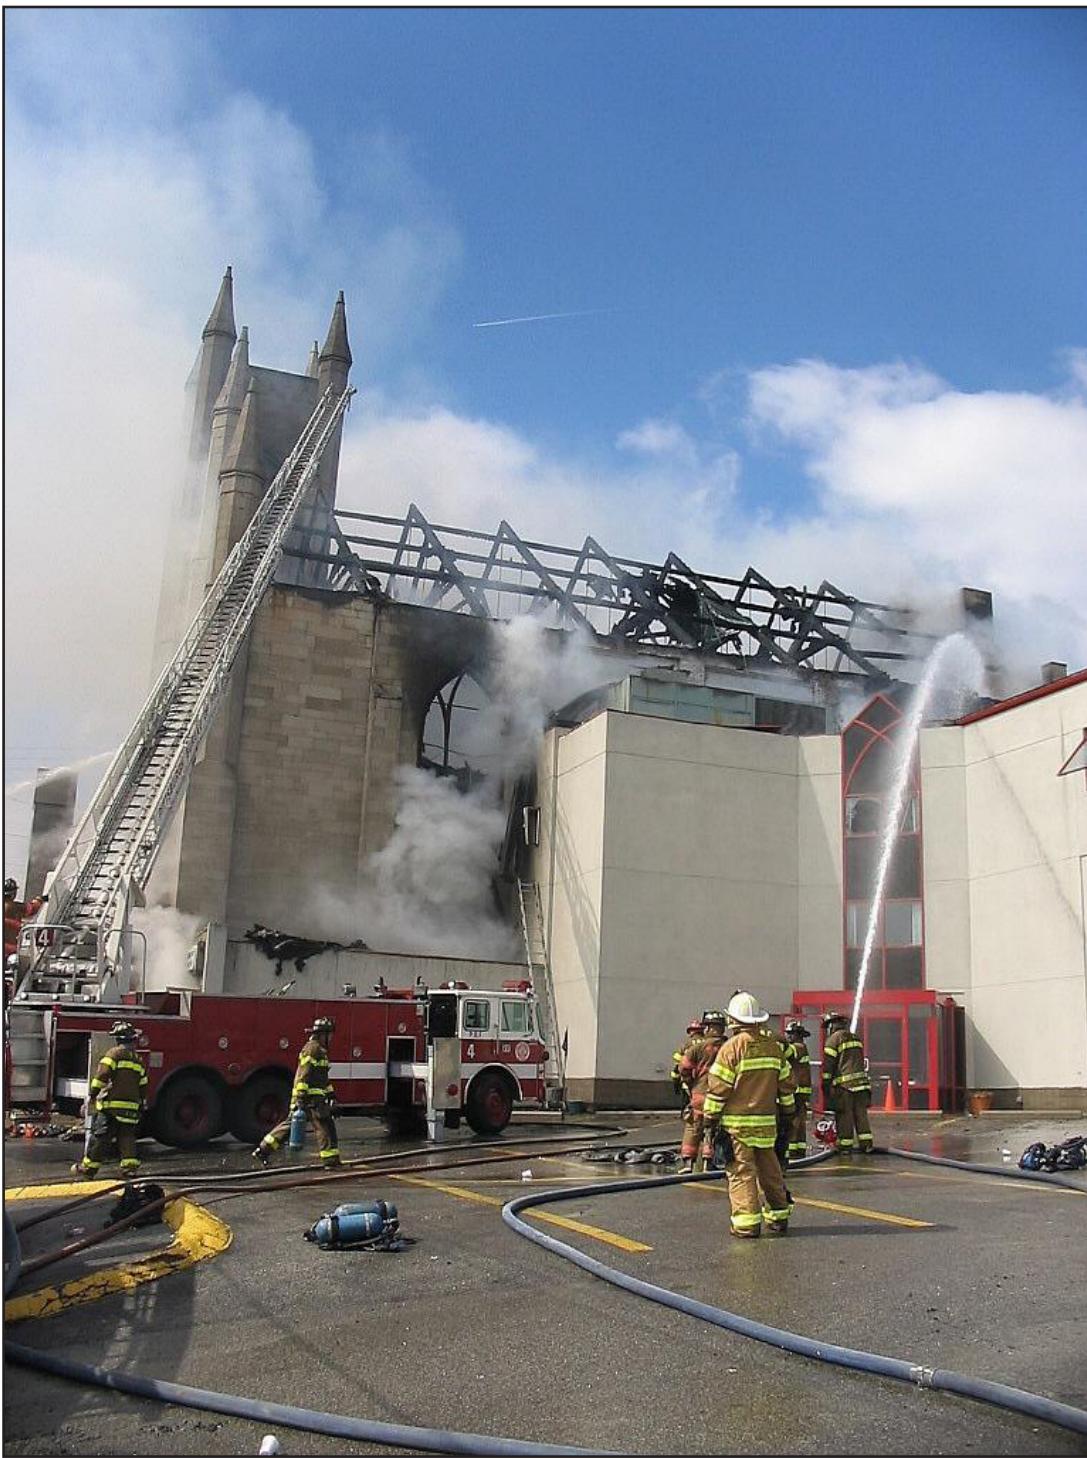
Photo 2. Incident structure prior to overhaul

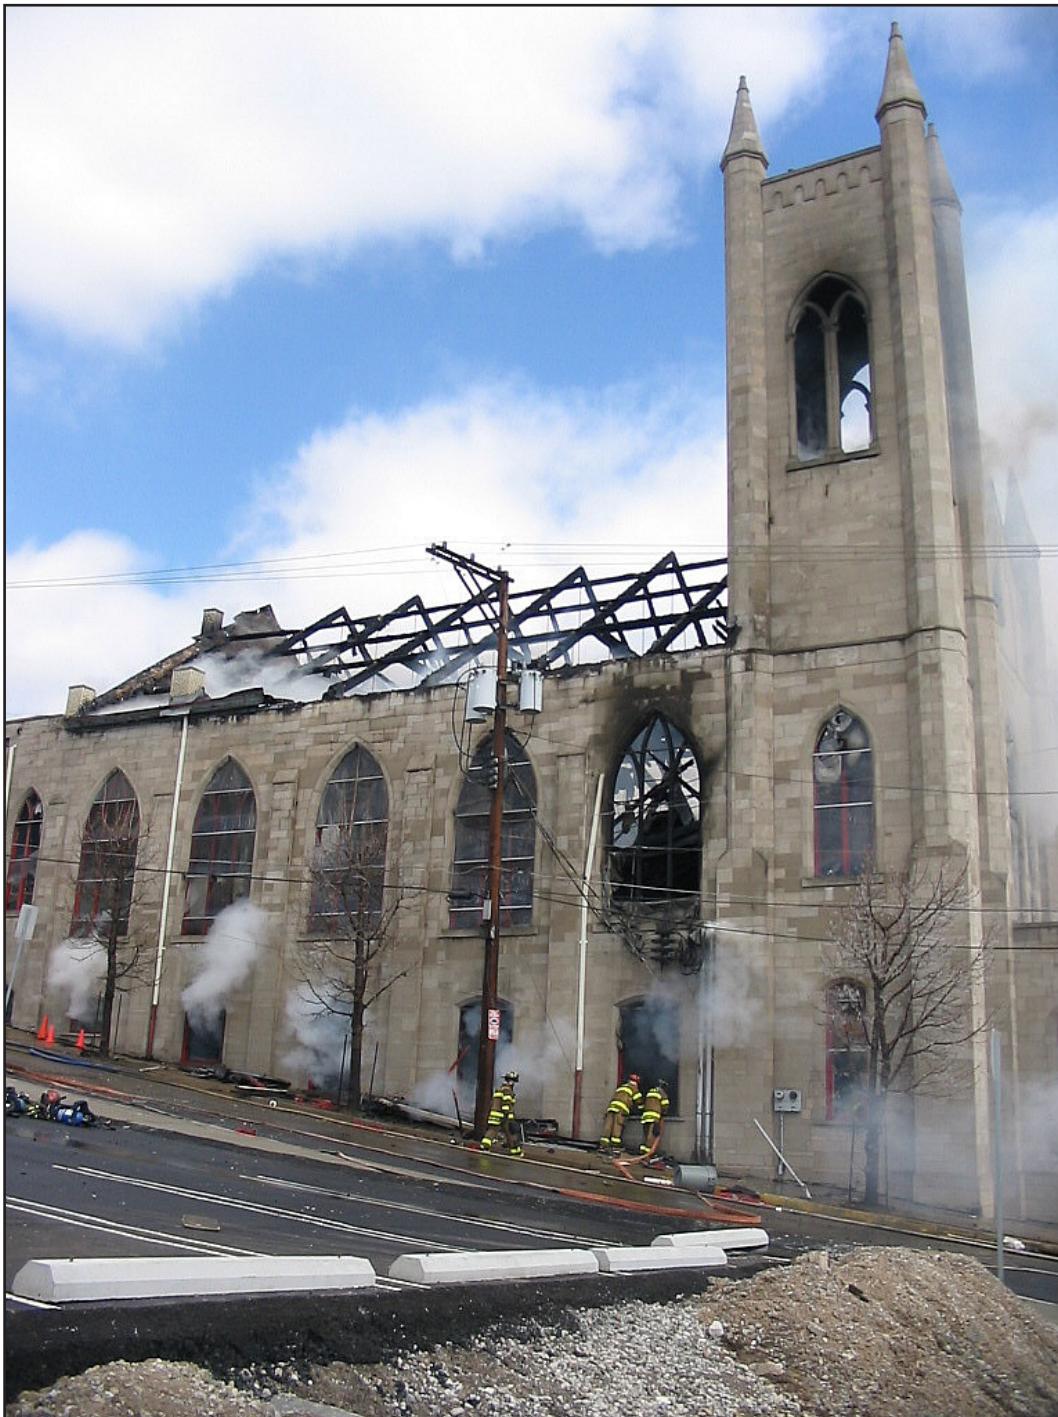
At 1148 hours, the IC ordered all exterior hose streams shut down (Photo 3). One ISO left the

Photo 3. Incident structure prior to collapse

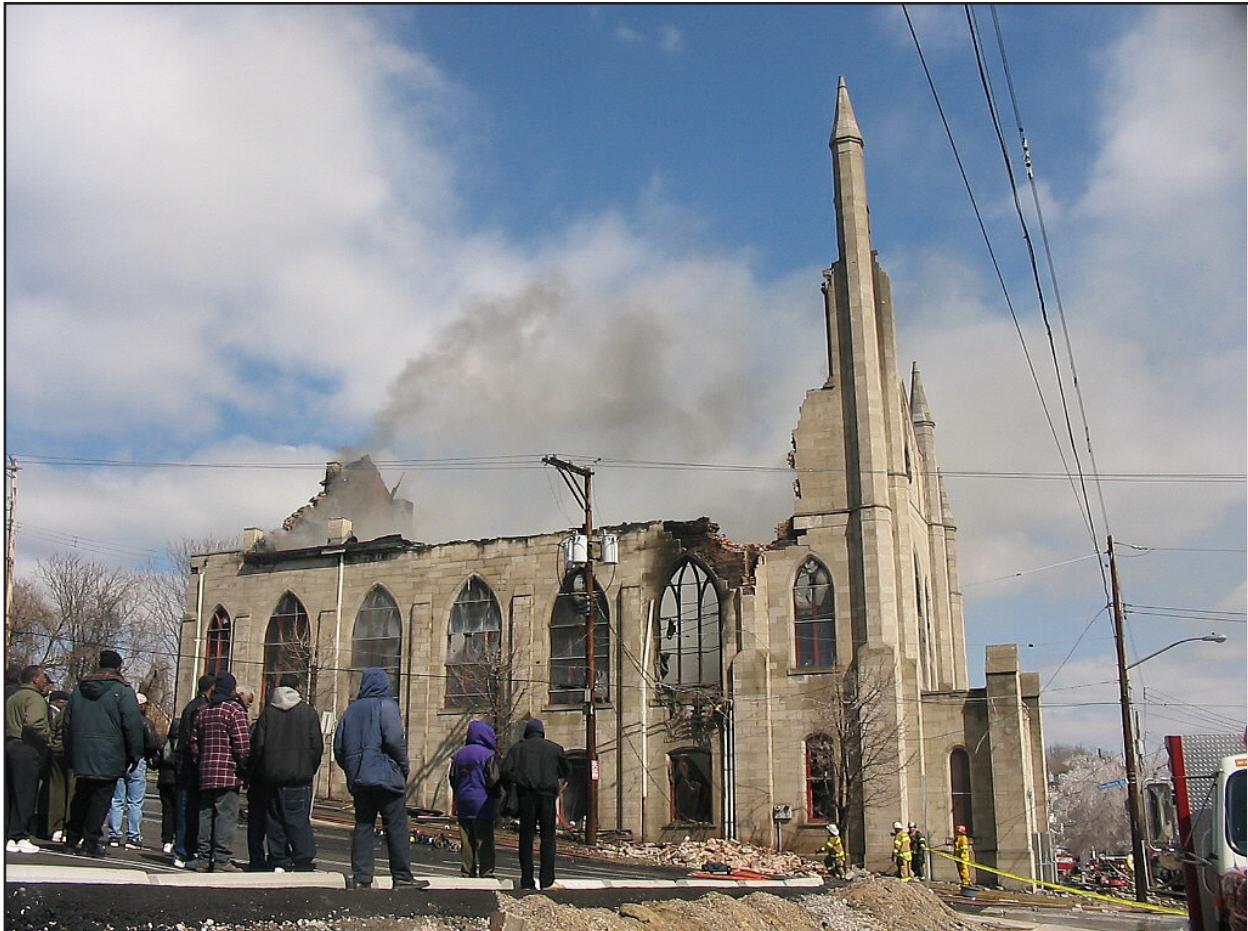
At 1213 hours (approximately 3½ hours into the incident), the church bell tower collapsed sending large chunks of stone, brick, heavy wooden timbers, and other debris crashing through the vestibule trapping both victims under debris. (*Note: At the time of the collapse Victim #1 was not wearing a SCBA and therefore did not have an activated PASS device.*) Other fire fighters operating in the vestibule recall that heavy timbers and wood boards broke through the ceiling and then the entire ceiling came down. Several fire fighters reported narrowly escaping from the collapse.

Photo 4. Incident structure after collapse
