Career Engineer Dies and Fire Fighter Injured After Falling Through Floor While Conducting a Primary Search at a Residential Structure Fire – Wisconsin

SUMMARY

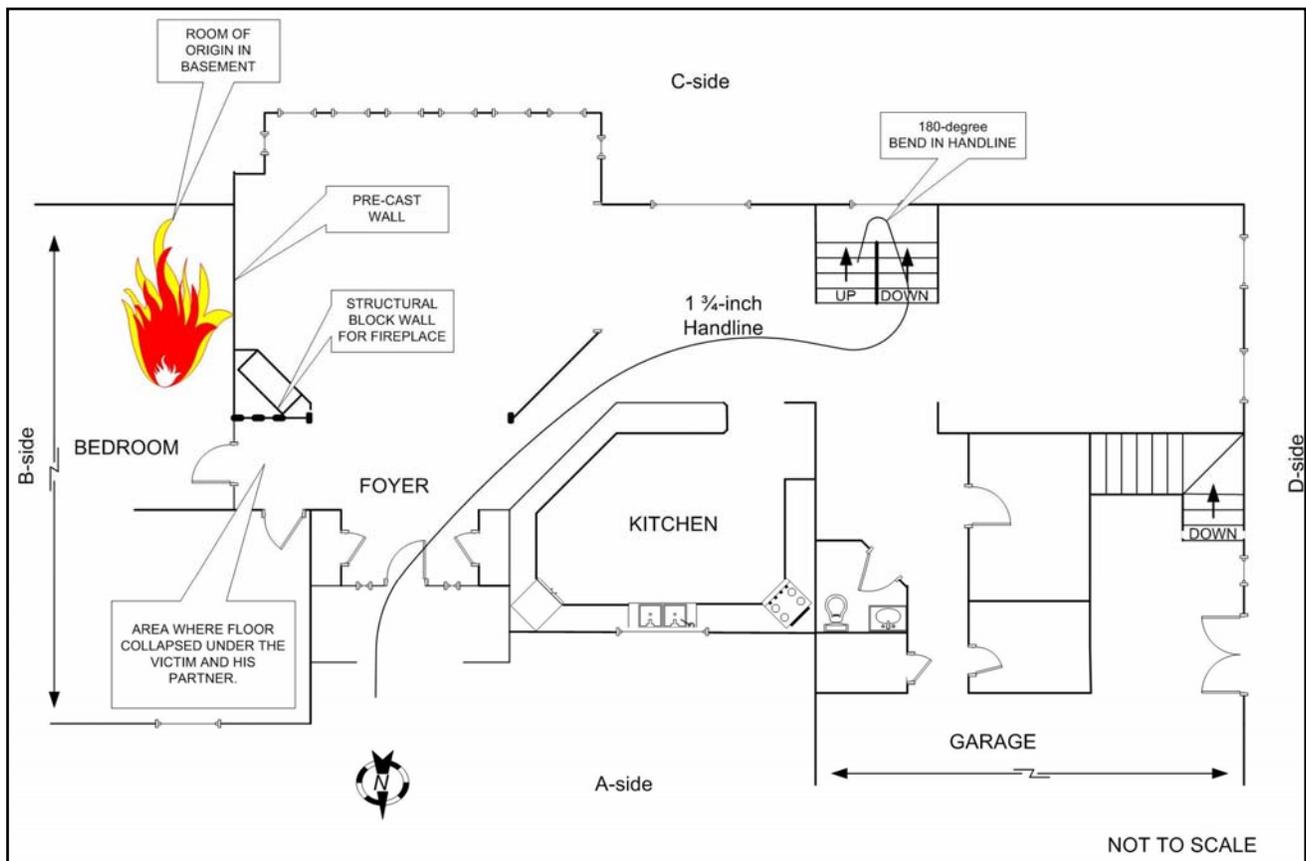
Battalion Chief 411 arrived on the scene and took over command from L451 at approximately 1232 hours. Ladder 451 set up and started the PPV fan at the front door and proceeded to the C-side of the structure to conduct horizontal ventilation at approximately 1233 hours. A451 finished making connections to the hydrant and were making their way up the driveway as a crew from E451 prepared to enter the structure. Upon entry, the officer and two fire fighters from E451 encountered yellow/brown smoke that filled the entire first floor of the structure. Visibility was near zero with minimal heat conditions. The crew entered the foyer and conducted a right hand search for an entry into the basement. They were unsuccessful and changed directions. The officer from E451 heard L451 tell command they vented the basement windows. He called command and requested that the first floor windows be vented. Within minutes visibility improved and they could see across the kitchen area to the stairway which led to the basement (Diagram).

The crew from E451 walked over to the stairs and started to stretch the hose down the stairway into the basement which had a landing that was mid-way down the stairs. The officer put a fire fighter on the landing which made a 180-degree turn to flake out the hoseline (Diagram). The nozzleman made his way down the stairs and opened the door into the basement which was full of thick black smoke. He stepped and immediately fell down because of an extremely slippery floor. He made several attempts to stand up when his Lieutenant stepped and slipped onto the floor knocking him further into the room. He then could feel intense heat coming from the B-side of the basement. Visibility was zero.

Diagram. Partial first floor layout aerial view relevant sections only.

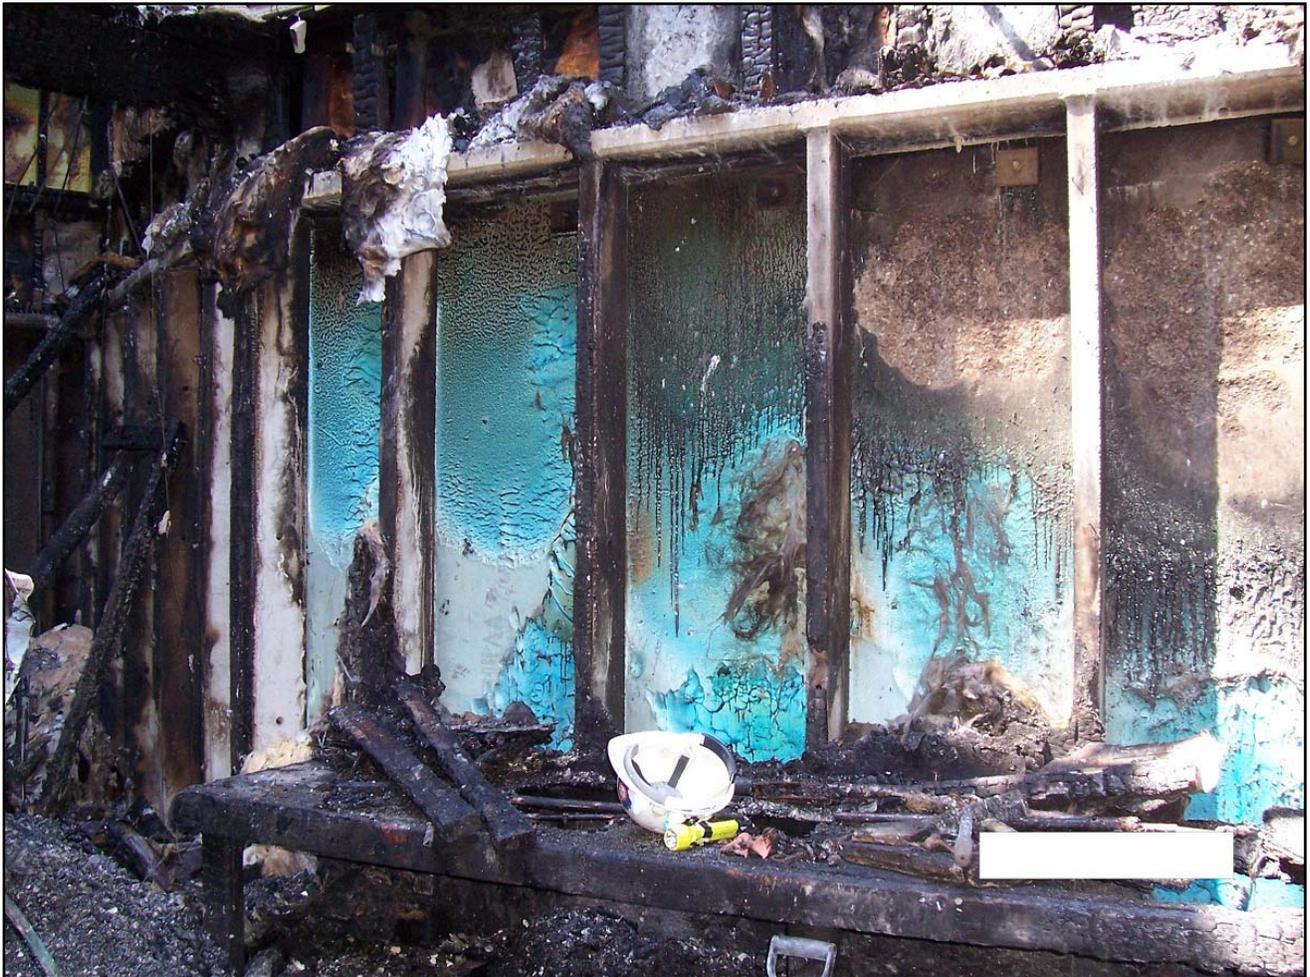
The origin of the fire was located in a section of unfinished basement that was approximately 750 square feet. The pre-cast basement walls in the room of fire origin were framed and insulated with foam sheets (Photo #1). The ceiling in the room consisted of exposed floor trusses that were supported with wooden beams and metal post jacks (Photos #2 and #3).

Photo1. Framed pre-cast walls with sheets of foam insulation

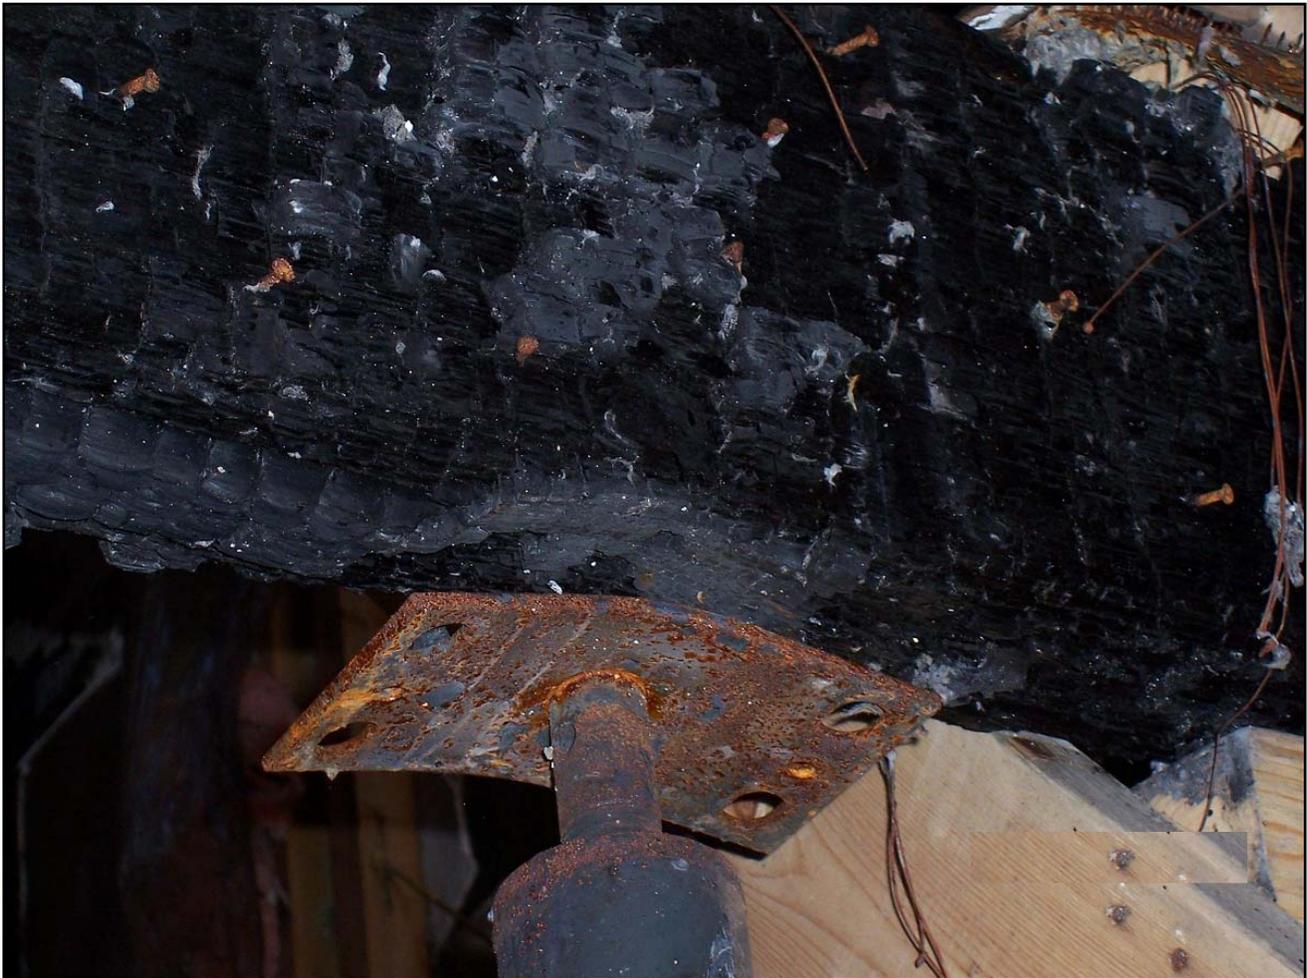
Photo2. Wooden beam and metal post jack

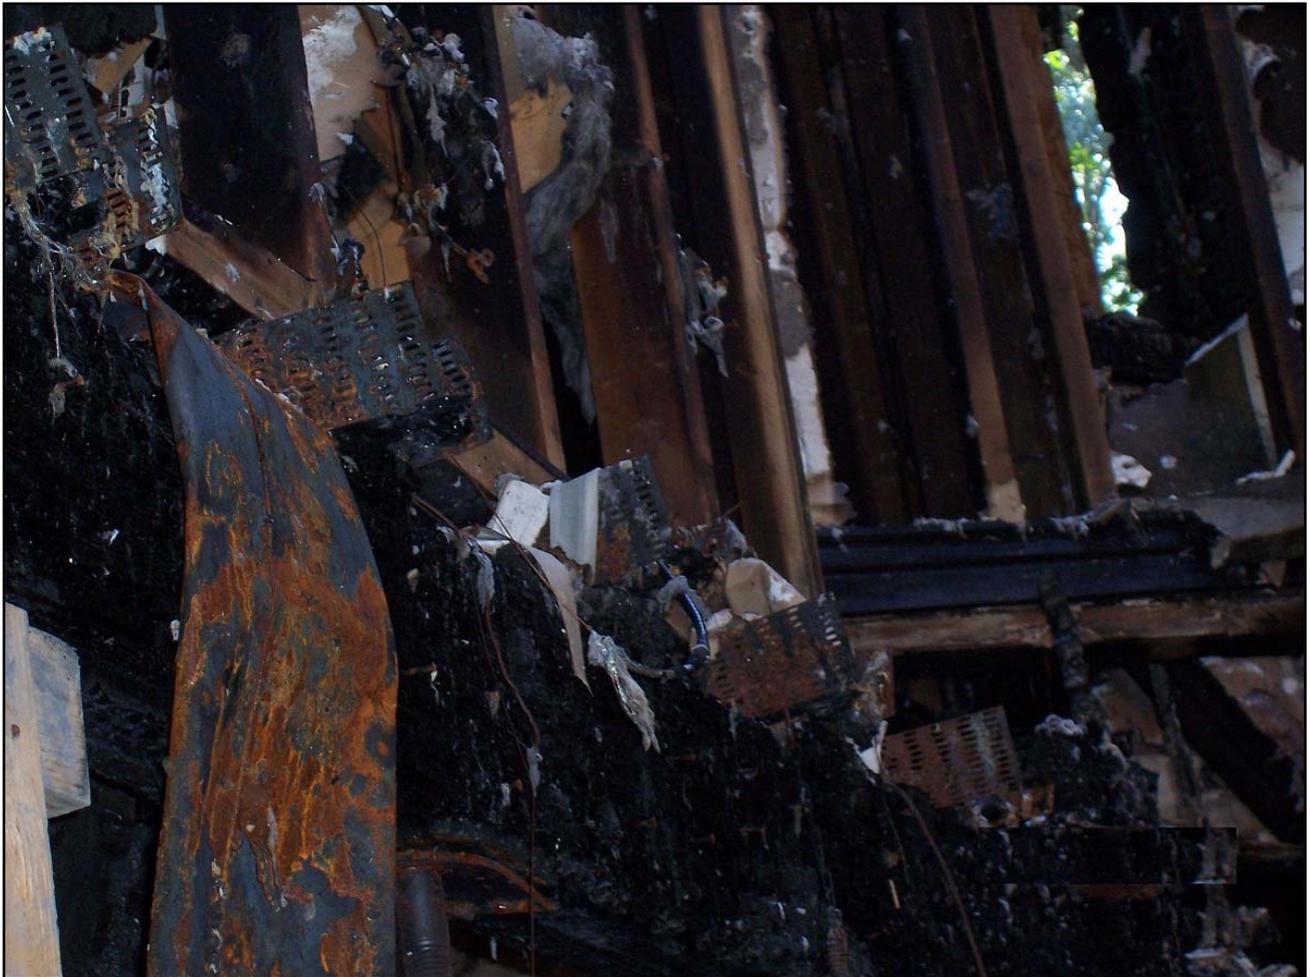
In this incident, the floor trusses for the first floor did not have any protection on the bottom cord, which immediately exposed the trusses to fire in the basement. Unfinished basements are very common throughout the country. It is critical for trusses that are used in a load-bearing assembly be protected with a thermal barrier such as gypsum wallboard. The function of the thermal barrier is the critical factor in the fire performance of the assembly. Municipalities, Building Code Officials, and Local Authorities having jurisdiction should also include experienced fire personnel throughout any developmental review process concerning life safety to the public and fire department members.

Photo 3. Wooden beam and metal post jacks with bottom gusset plates from floor joists pinned to beam by first floor framing after entire floor joist consumed by fire.

Recommendation #4: Additionally, Municipalities, Building Code Officials and Local Authorities having jurisdiction should consider modifying the current codes to require that lightweight trusses are protected with a fire barrier on both the top and bottom.

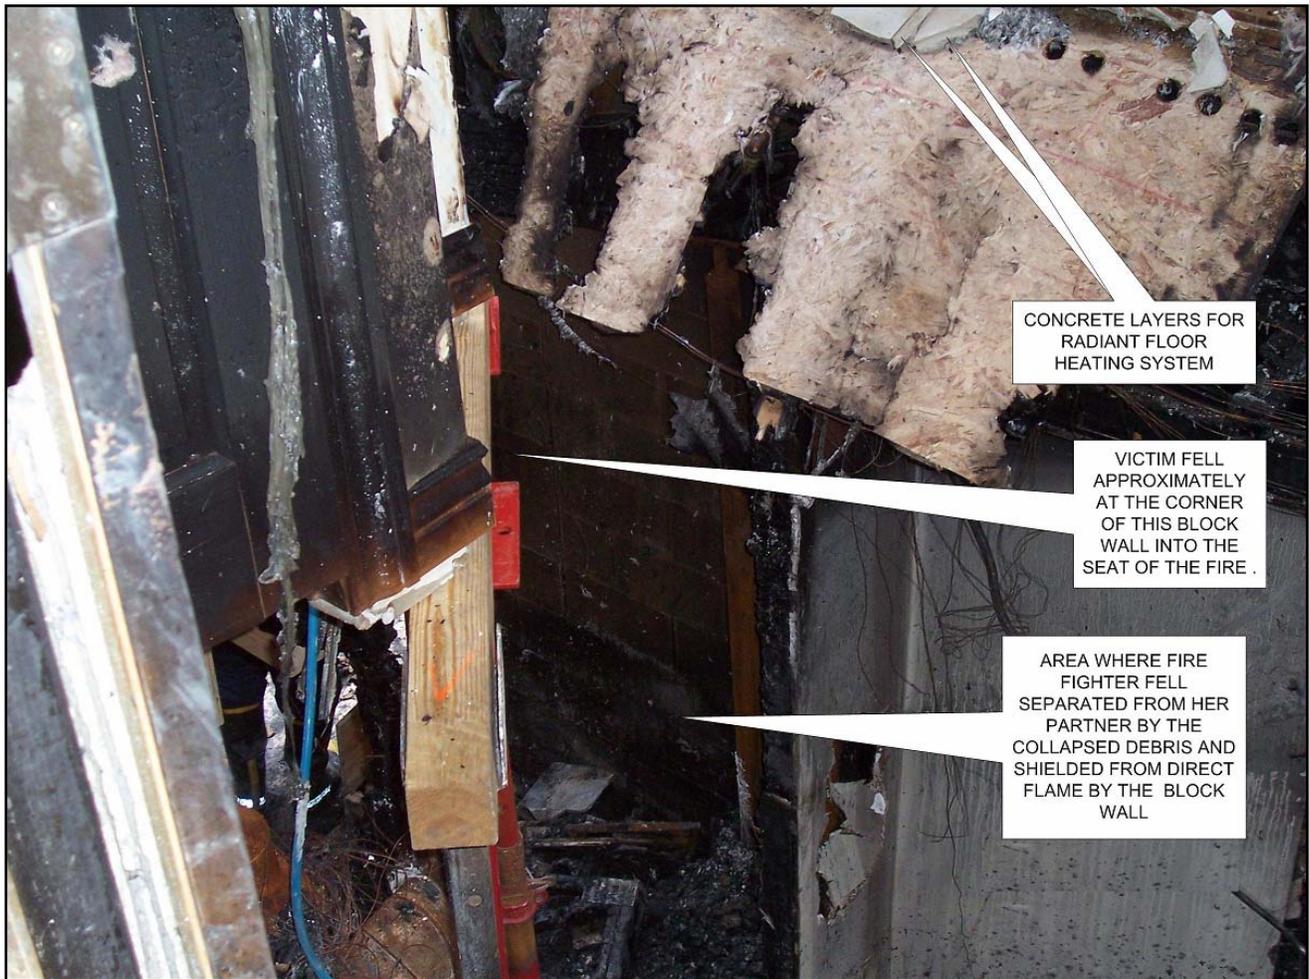
The hallway which separated the unfinished from the finished basement had a concrete block wall for the structural support of the chimney to the south, and a framed wall possibly with drywall to the north. *Note: This is the area where the victim and fire fighter fell into when the floor collapsed.*

The first floor had a radiant floor heating system installed on top of the sub-floor. This system consisted of a flexible hose that circulated hot water and was layered in concrete approximately 3 inches thick (Photo #4).

Photo 4. Transition between foyer and hallway where floor collapsed

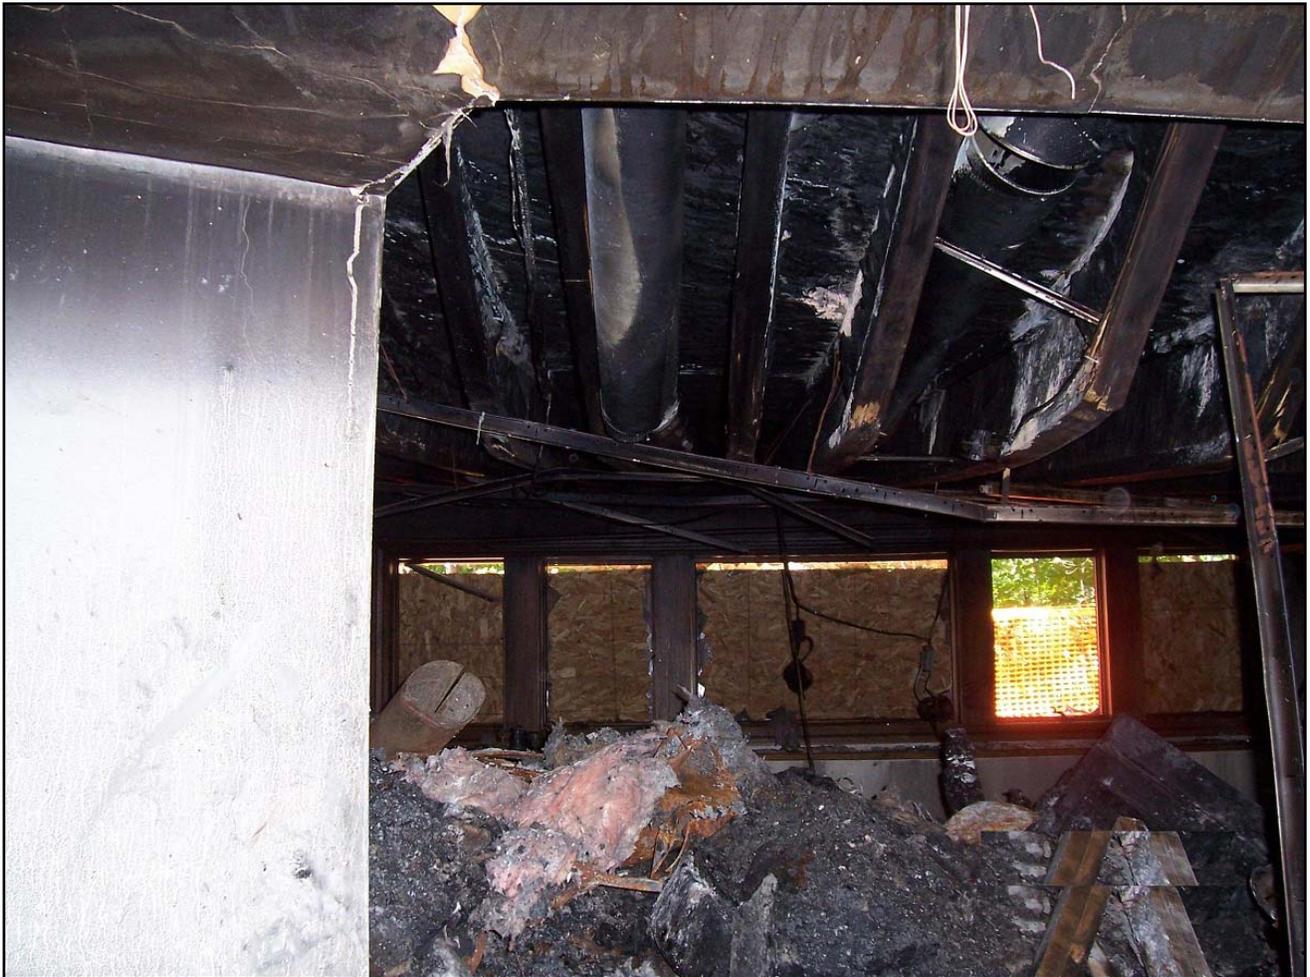
At the same time, the crew from E451 made their way back up the stairs from the basement to the front door. The entire foyer area was engulfed in flames at this time. Another crew was spraying water through the front door which allowed the crew from E451 to jump through the flames and out the front door. The injured fire fighter who fell into the basement felt the water and saw the fire darken down. She stood up and once again encountered extreme heat conditions which immediately melted her facepiece. She turned away from the fire and pushed her way through debris created from the collapse and made it into the next room of the basement. She saw a window and could hear crews operating at the rear of the structure. She was able to make her way to the rear of the structure where the crews assisted her out through the windows (Photo #5).

Photo 5. Windows on C-Side of structure where fire fighter exited basement.
