Four Career Fire Fighters Injured While Providing Interior Exposure Protection at a Row House Fire – District of Columbia

Fatality Assessment and Control Evaluation Investigation Report # F2007-35

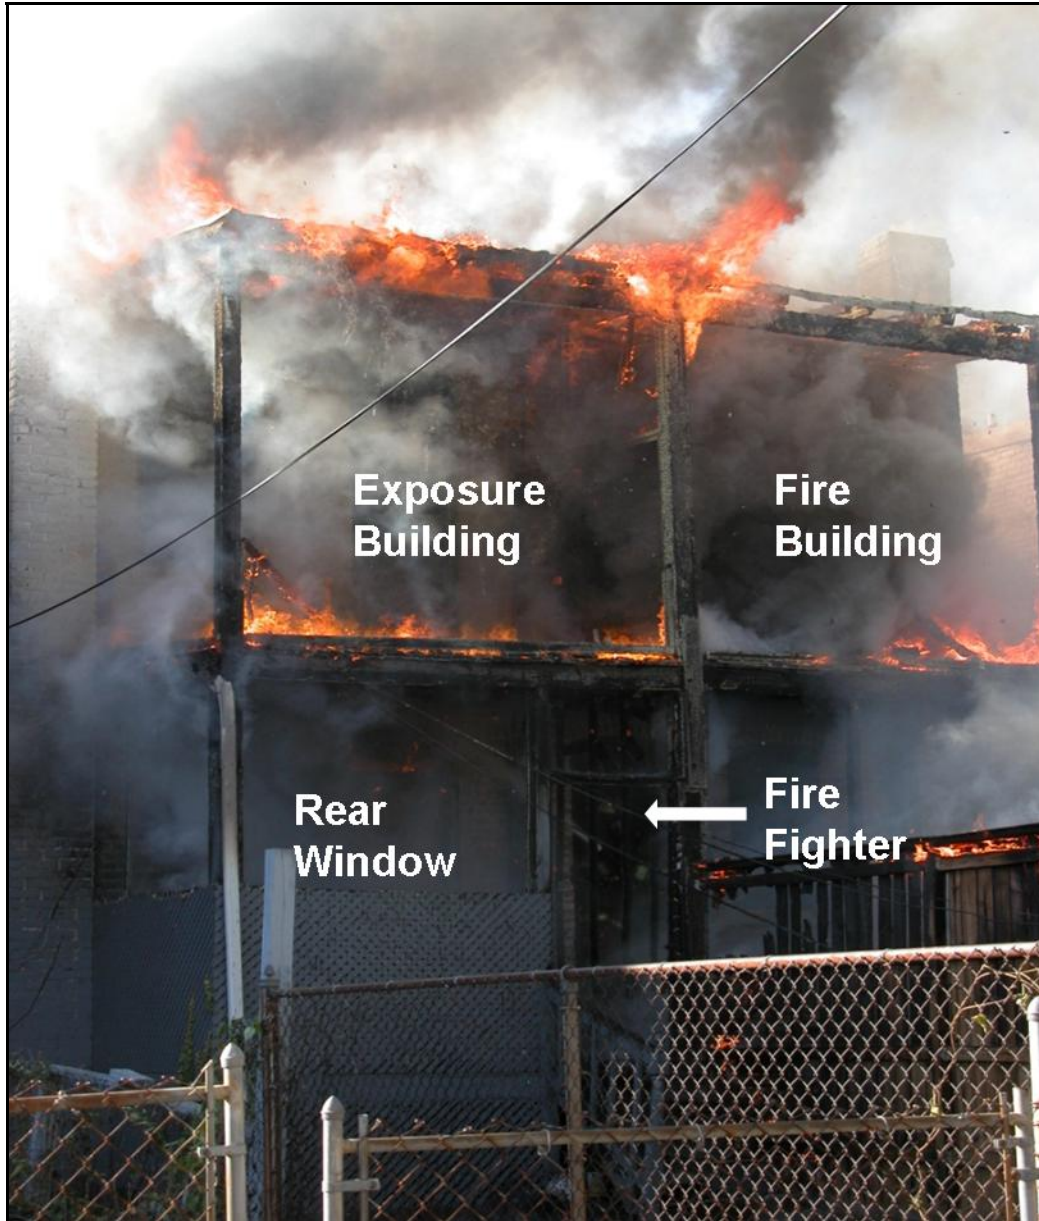
Photo 1. Fire fighter attacking fire through a rear window from the back porch area on side-C of exposure building at approximately 1528 hours; illustrates fire extending inward.
(*Photograph courtesy of the fire department.*)

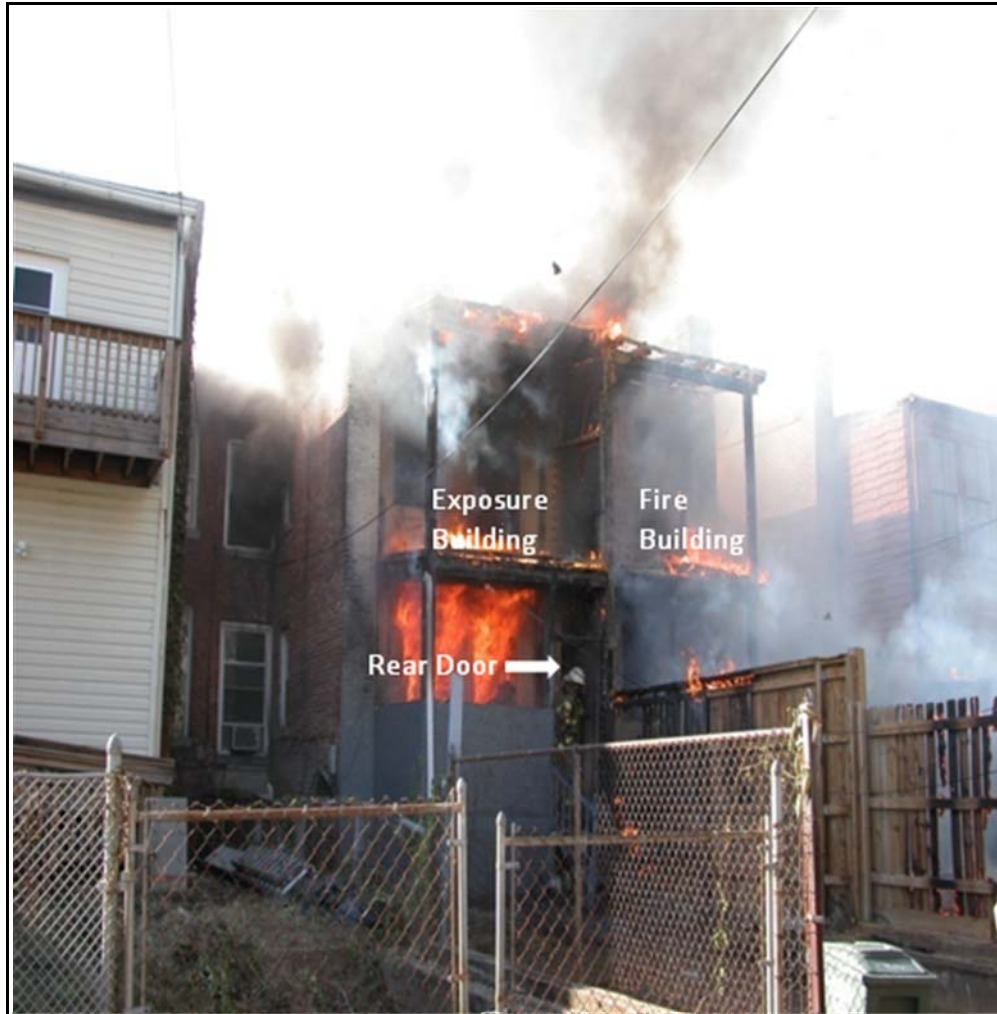
At 1525 hours, E6's crew continued the fire attack, T15's crew continued ventilating the fire building, and E4's crew (victims 1, 2, 3, and 4) made preparations to enter into the front of the exposure building. At 1526 hours victim #1 (Officer/Sergeant) entered the front door of the exposure building and walked halfway through the first floor, checking fire conditions (see Diagram 2). He encountered light smoke and no fire, and at that point, turned back to the stairwell and went upstairs. Victim #4 (lineman/nozzle man) had entered the front of the building with the 1 ½-inch line and saw light to moderate smoke on the 1st floor with about 8-foot visibility. He proceeded up the stairwell to the top of the stairwell landing with victim # 2 backing him up on the hose line. Victim #3 had also advanced up the stairwell to the second floor where he and the other victims observed fire in the back of the building on side-C. At 1527 hours, victim #1 reached the second floor, joined the other fire fighters, and began directing fire fighting operations and pulling ceiling. The hose line was advanced down the hallway toward the back of the building (see Diagram 3), and at 1528 hours, victim #4 hit the fire in the back room and knocked it down. Visibility improved to the point where the victims could see to the rear porch on the exterior of the building on side-C. During this time, a fire fighter from E10 was hitting the fire through the window of the exposure building on the 1st floor of side-C. Shortly thereafter, the rear door on side-C of the 1st floor of the exposure building was kicked open by an Officer (see photographs 1, 2, and 3), and the fire grew in intensity.

Photo 2. Rear door of exposure building (side-C) is opened at approximately 1529 hours and conditions on first floor and second floors deteriorate.
(Photograph courtesy of the fire department.)

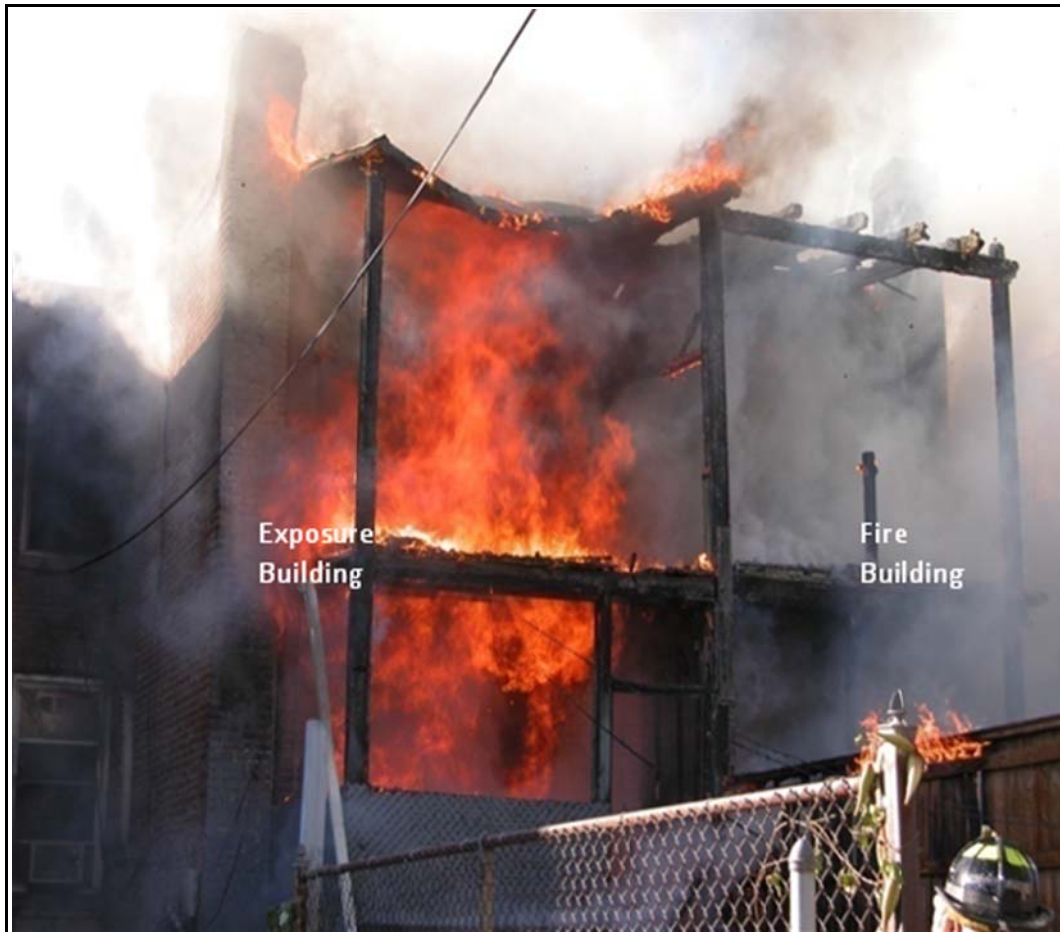
3. *Sizing up the stairway design.* The type of stairway leading to the floor above must also be evaluated by the fire fighter. An open stairway, such as the one found in this structure, is the most dangerous stairway a fire fighter can climb when operating above a fire. It becomes a chimney flue, allowing the flame, heat, smoke, and toxic gases generated by the fire below to flow up the open stairway leading to the second-floor rooms.

Photo 3. Fire travels up interior stairwell and up exterior back wall to second floor of exposure building at approximately 1530 hours and fire fighters are burned.
(Photograph courtesy of the fire department.)

Recommendation #1: Fire departments should ensure adequate size-up, including in exposure buildings, to reduce the risk of fire fighters being trapped.
