Revised January 8, 2009

## **Volunteer Fire Chief Dies from Injuries Received when Privately Owned Vehicle Crashes into Bay Door Pinning him Against Fire Tanker – Wisconsin**

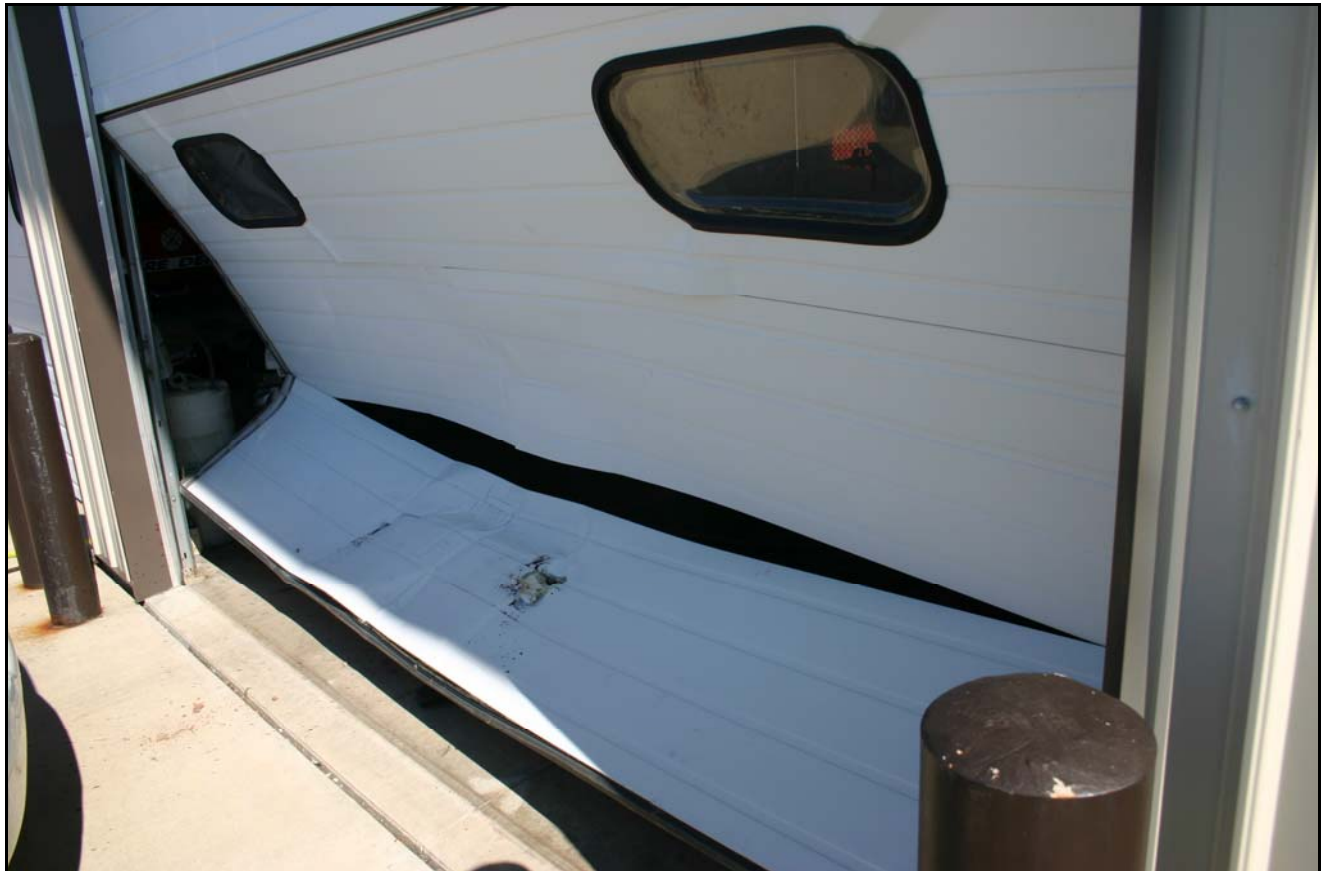
The fire station had five front bay doors and five rear bay doors. The incident occurred at the rear of the station. The automatic roll-up bay doors consisted of six panels made from steel with a polyurethane insulated center. Each panel measured 134 inches in length, 24 inches in height, and 1 ¾ inches thick. The third panel from the ground contained three rectangular windows with rounded corners. The windows measured 24 inches in length and 11 inches in height, with 59 inches between each window. Each bay door was separated by 24 inches of metal siding and metal studs, which were protected by two 48 inch tall, 7 inch diameter concrete pylons on the exterior. After the impact, the bottom three bay door panels had to be replaced (see Photo 1).

Photo 1. Damage to bay door.  
*(Photo courtesy of Sheriff's Office)*

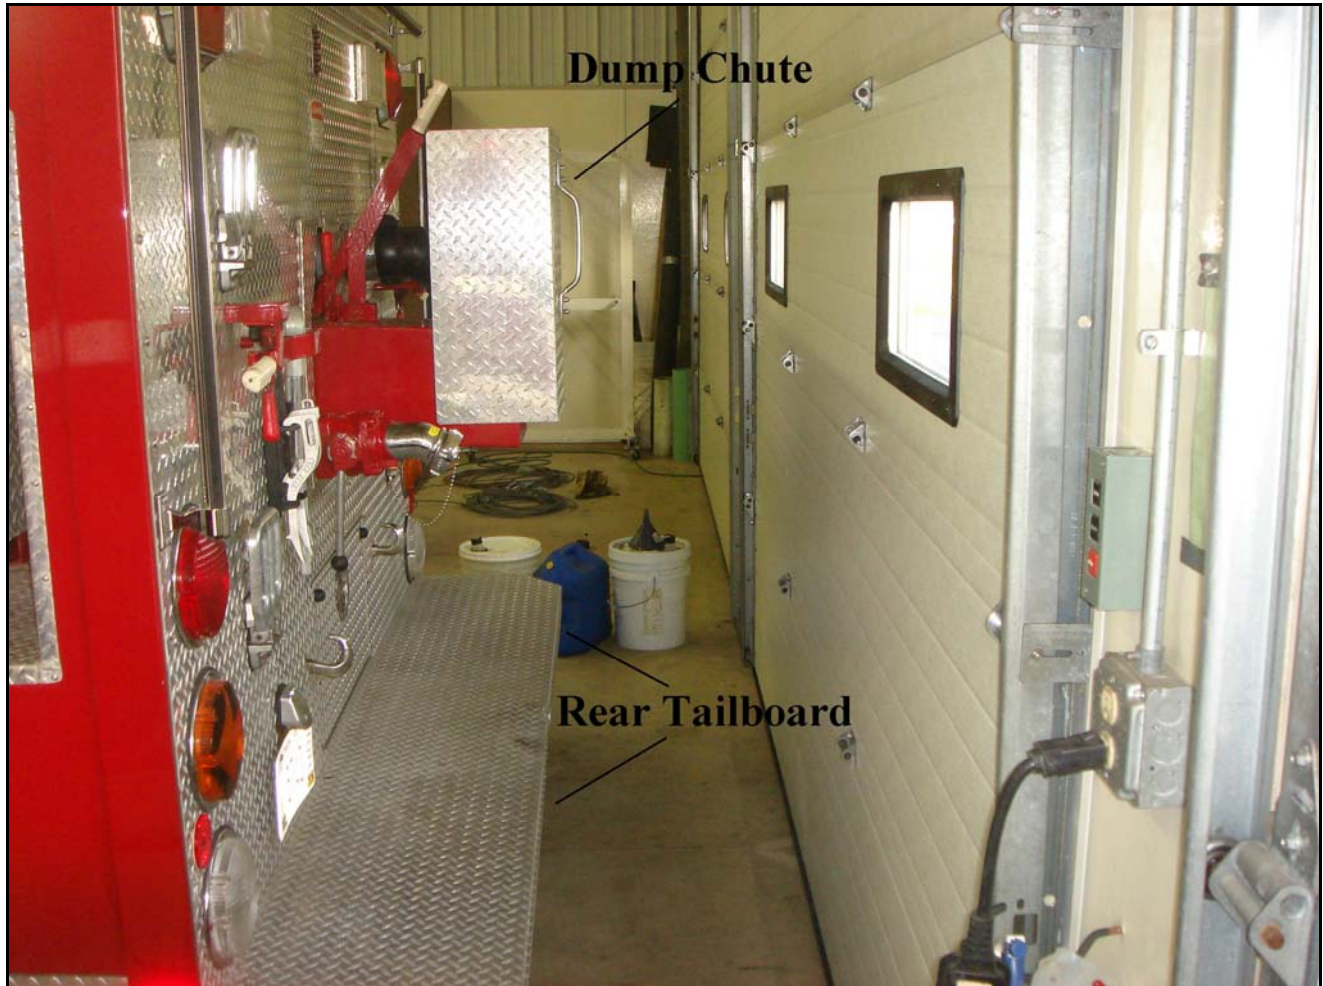
There was approximately 24 inches between the closed bay door and the tanker's diamond plated tailboard (see Photo 2). The tailboard was approximately 18 1/2 inches from the bay floor, and measured 102 inches in length, 18 ½ inches in width, and was 2 inches thick. The diamond plated dump chute<sup>a</sup> was approximately 48 inches from the bay floor. It measured 10 ½ inches in length, 24 inches in height, and 20 inches out (front of the chute to the rear of the truck). The tanker was moved approximately 67 inches to release the victim from between the bay door and tailboard.

Photo 2. Tanker's position in relation to the bay door.  
(NIOSH photo)

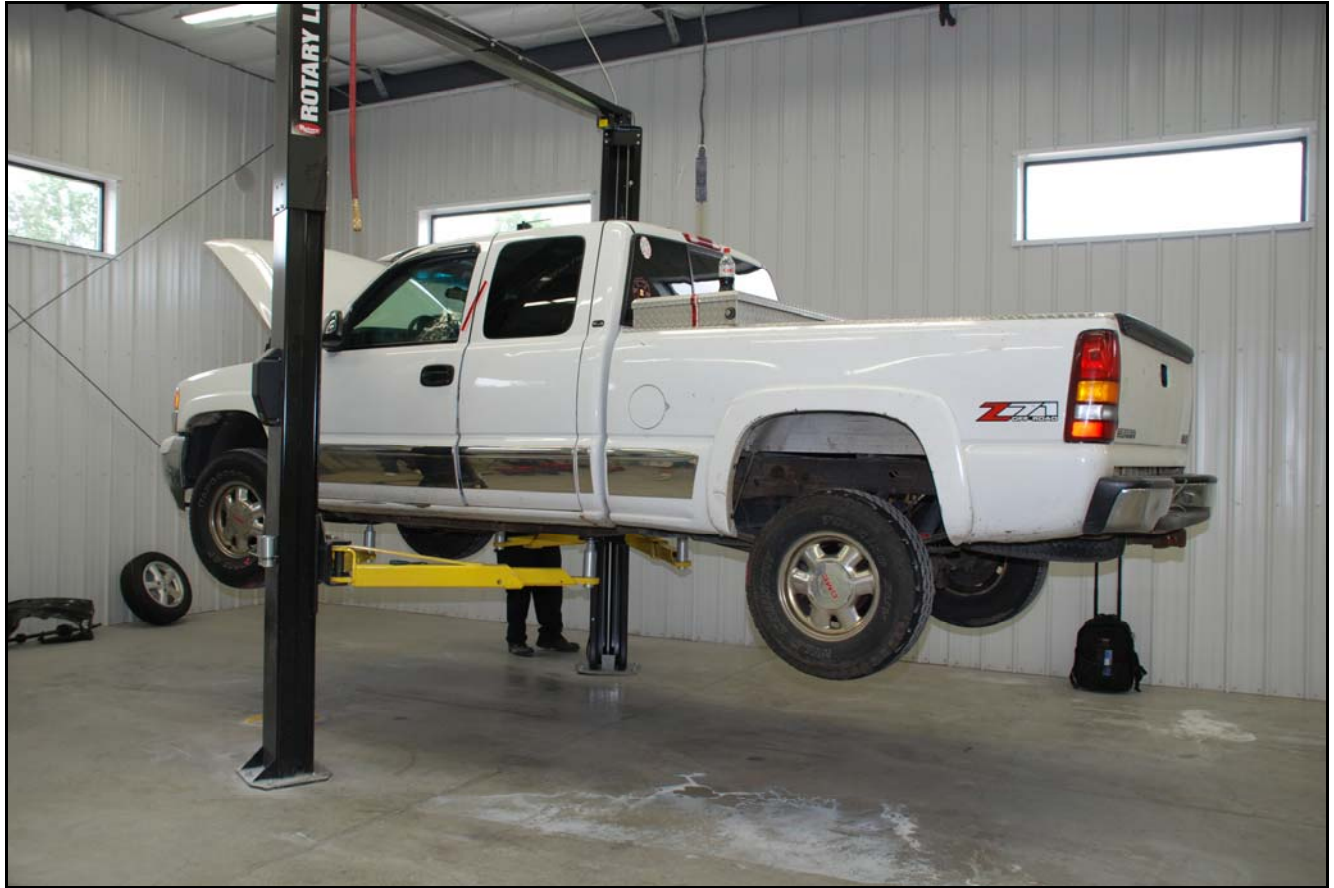
The vehicle involved in this incident was a 2001 4-wheel drive pickup truck with a gross vehicle weight of 6,400 pounds (see Photo 3). The pickup truck had approximately 300,000 miles on it with a recently rebuilt automatic transmission with 4,500 miles. The pickup truck had been purchased by an Assistant Chief in 2003 from a private party. Upon titling the pickup truck in his name, he had discovered it was a rebuilt salvaged vehicle. The State Department of Motor Vehicles advised him it had passed a salvage inspection conducted by a certified state salvage title inspector prior to his purchase. Passing this inspection allowed the pickup truck to be reintroduced as a registered vehicle within the state. The pickup truck had not been state inspected since the salvage inspection, nor was an annual inspection required by the state. The First Assistant Chief stated he had experienced no operational issues since its purchase.

Photo 3. Pickup truck involved in incident.  
(Photo courtesy of Sheriff's Office)

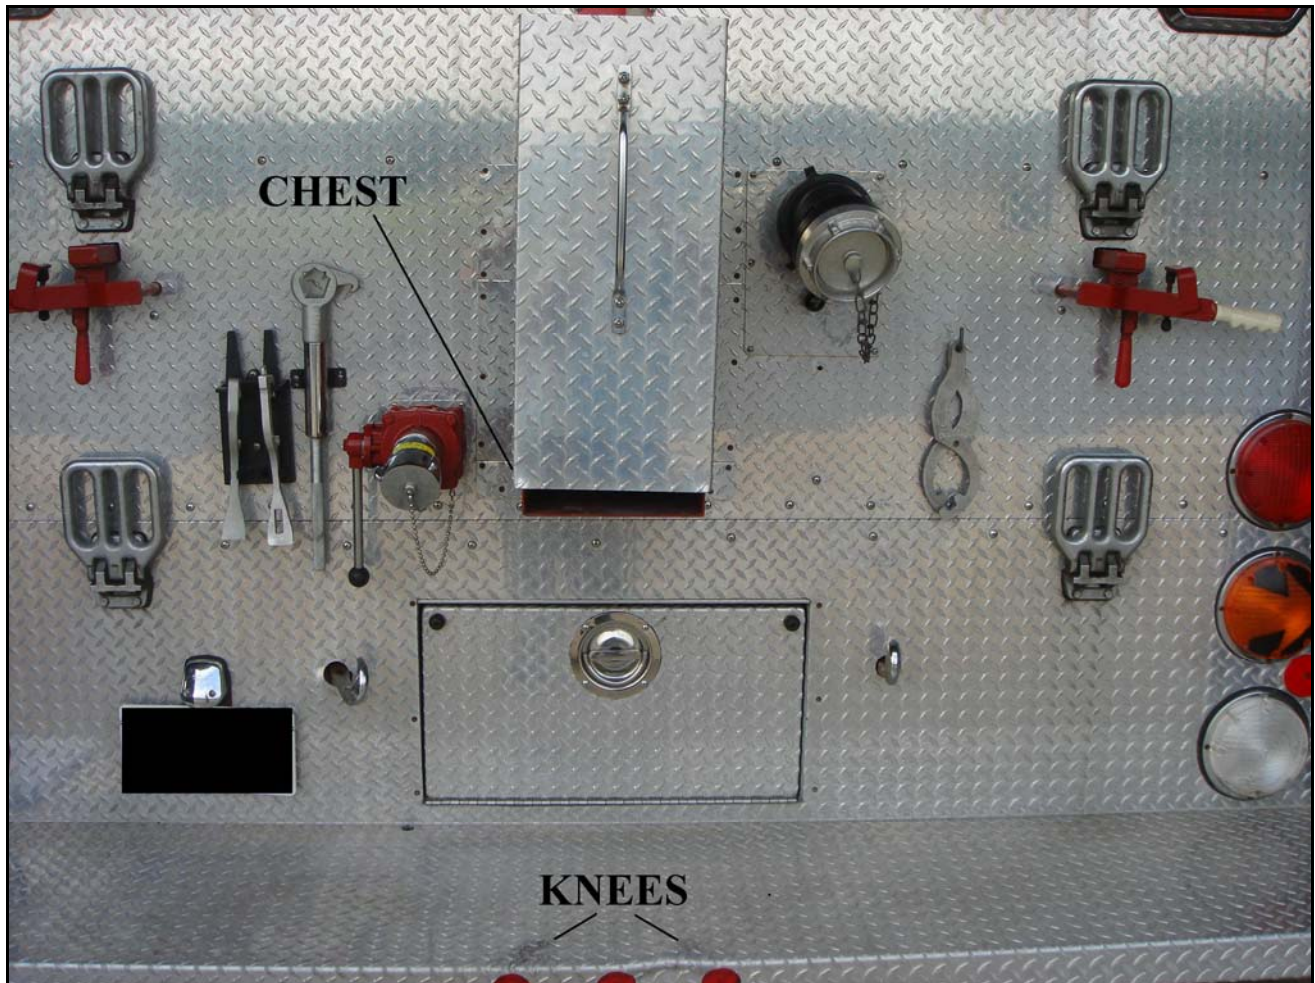
truck crashed into the closed bay door (see Diagram). The bottom two panels of the door caved inward onto the victim pinning his knees to the tailboard of the tanker. The force from the impact pushed him forward causing him to strike his chest and head against the diamond plated corner of the dump chute (see Photo 4). Fire fighters immediately moved the tanker forward to release the pressure exerted on him from the bay door. Emergency care was then given to him by trained fire fighters until EMS arrived. The victim was transported to a local hospital where he was pronounced dead.

Photo 4. Victim's impact points on dump chute and tailboard.  
(NIOSH photo)

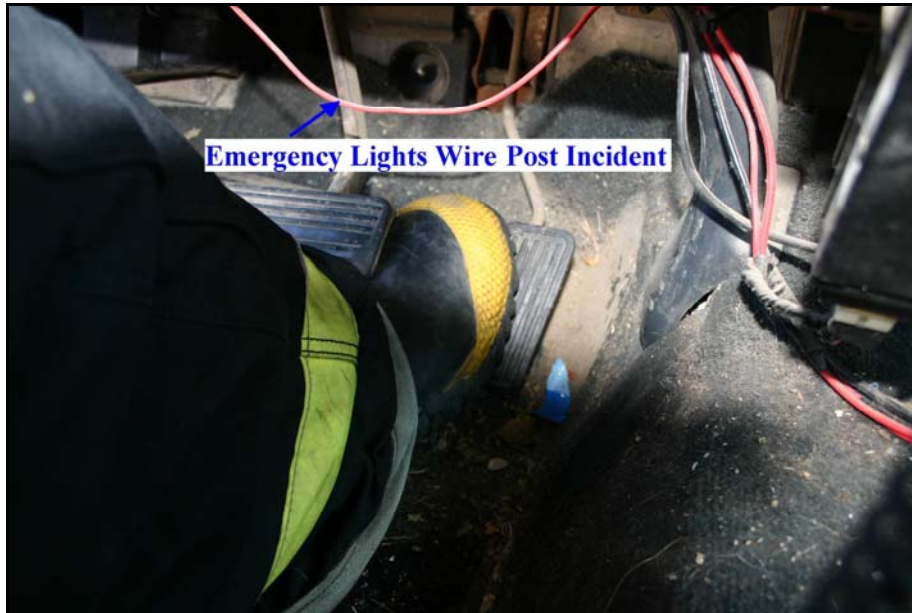
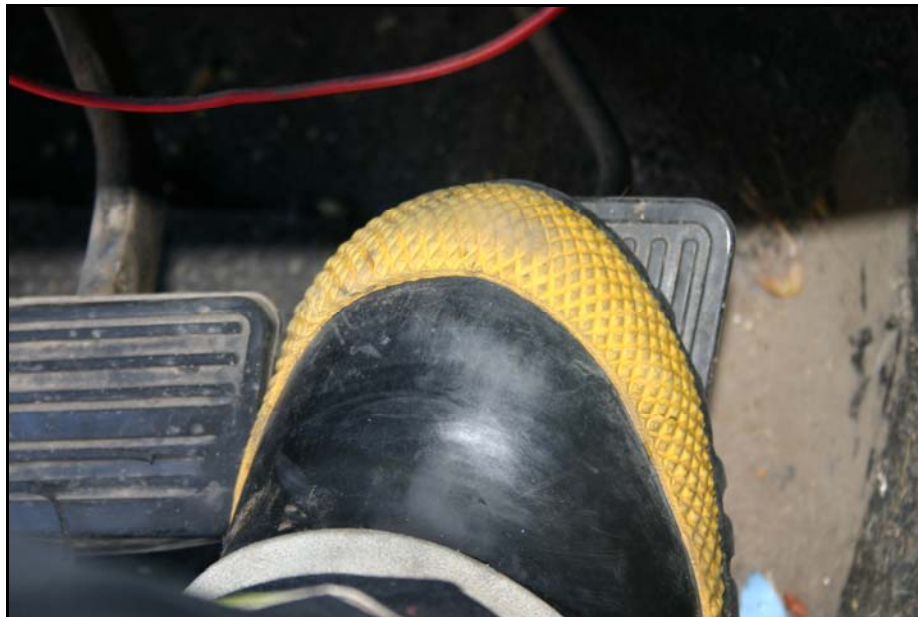
accidental depression of both pedals at the same time (see Photo 5). This theory aligns with the unexplained and sudden acceleration of the pickup truck from the crash data retrieved from the Event Data Recorder (EDR)<sup>b</sup> from within the pickup truck's airbag control module. The airbag did not deploy, but the EDR recorded an event that appeared to be consistent with witness statements. The data showed the brake switch being applied and then releasing with the speed climbing, then the throttle going from 0-100% just before the incident.

- Wearing wet, rubber fire boots while driving. The accident reconstruction report showed that the fire boots were large enough to cover the brake pedal and the accelerator pedal, and significantly touch or cover both pedals at the same time. The boots could also easily get stuck between the pedals. The boots were also wet which could have caused the boot to slip.
- Parking a vehicle in a non-designated parking spot.
- Lack of administrative program oversight and maintenance procedures. The privately owned vehicle was used as an emergency response vehicle but was not inspected and maintained by the fire department, and was found by law enforcement investigators to be in poor mechanical condition.

Photo 5. Rubber fire boot caught between pedals and comparison of boot size to pickup truck's pedals.

***Recommendation #1: Fire departments should consider developing and implementing a policy prohibiting the wearing of rubber fire boots while operating a vehicle***

Discussion: The use of proper footwear while driving is important for safe vehicle operation. Wearing shoes not suitable for driving, especially shoes that are thick-soled and irregularly-shaped can impact a driver's ability to safely operate vehicle braking and acceleration pedals and may lead to vehicle crashes. Shoe characteristics that should be avoided include soles thicker than 10cm, worn sole treads, and heaviness.<sup>5</sup> During the accident reconstruction study, it was determined that the wet, rubber boot likely slipped off the brake pedal and onto the accelerator pedal, then stuck underneath the brake pedal, pinning the accelerator down and causing the prolonged 100% acceleration recorded by the EDR. The pickup truck owner stated that he had previously experienced trouble negotiating the pedals in his pickup truck when wearing his rubber fire boots during operation.

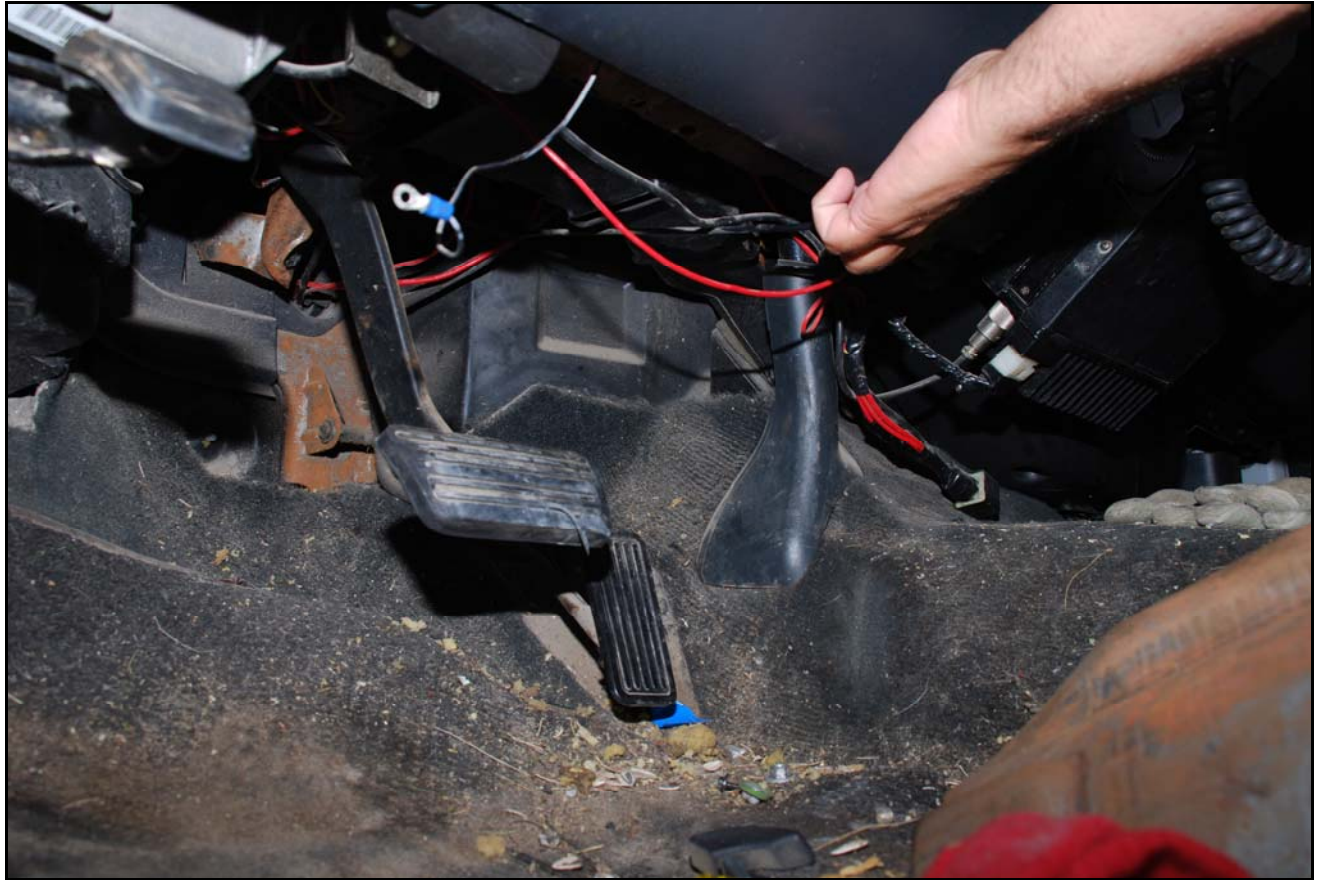
The mechanical inspection conducted after the incident discovered two serious items; poor and unsafe installation of emergency warning devices, and control and operational issues in the steering column shift lever. The crash reconstruction report stated that hand pressure applied to the siren cable was enough to cause the throttle cable to depress the accelerator pedal to the floorboard. These cables were hanging down after the incident, but were found to be above the normal foot operations for the pedals. Only a drastic foot motion could have caught these cables causing the 100% acceleration into the bay door. Although unlikely, this could not be ruled out by the crash reconstruction investigator. The crash reconstruction report also indicated the inability at times of the shift lever to successfully take the vehicle out of gear. It is reasonable to conclude that this was a mitigating factor when trying to move the pickup truck from the bay door after the initial impact. These mechanical defects were not caused by the crash, and may have been found earlier by a vehicle inspection.

Photo 6. Hand pressure being applied to exposed siren cable causing accelerator pedal to go to floor.  
*(Photo courtesy of Sheriff's Office)*

***Recommendation #3: Fire departments and municipalities should establish program oversight and vehicle inspection procedures for privately owned vehicles used in emergency response***

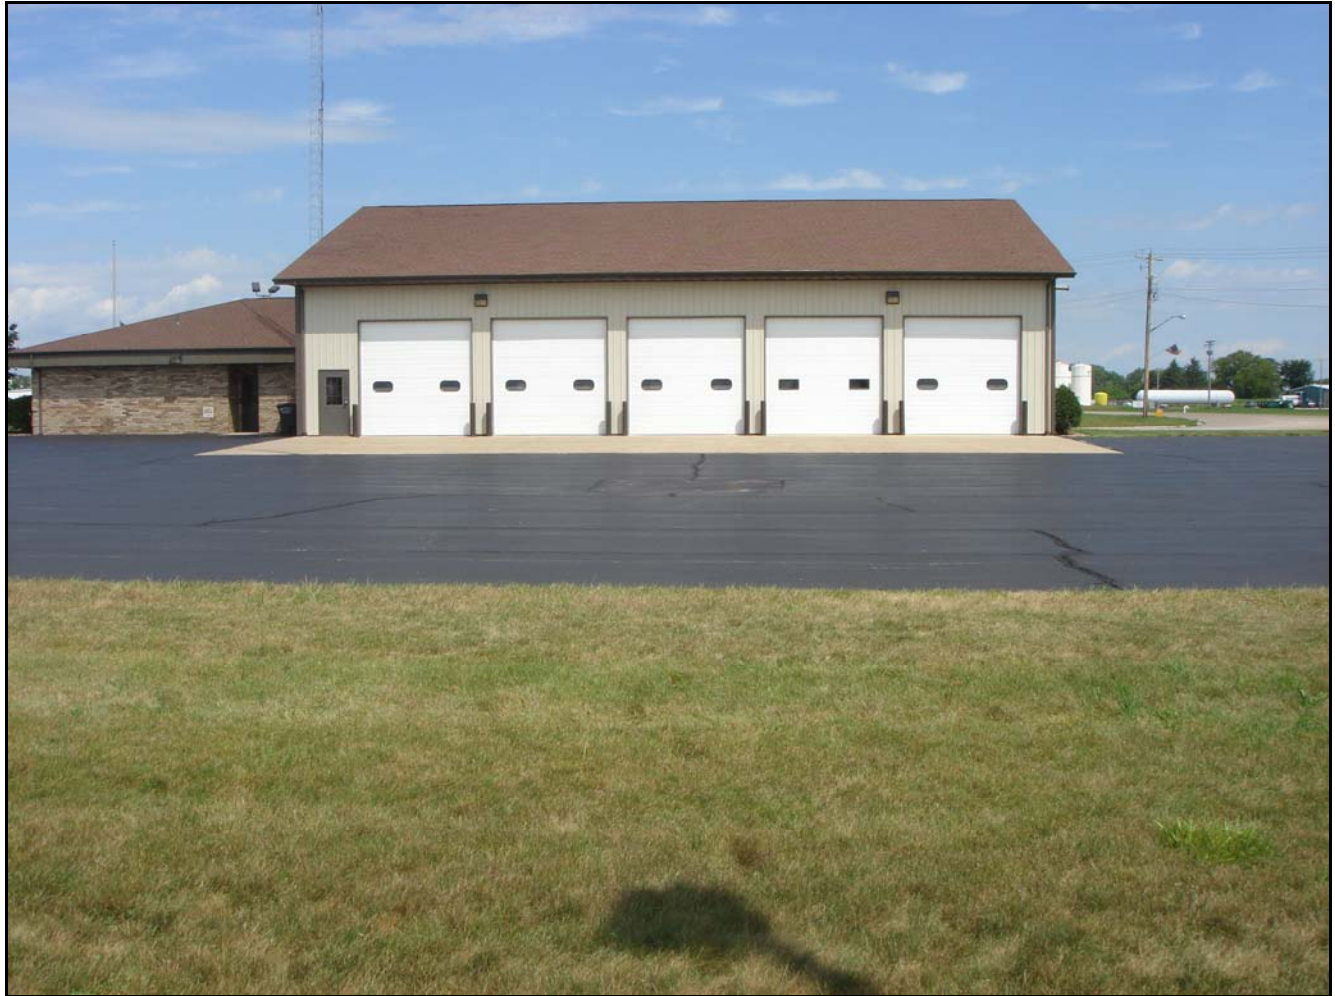
Photo 7. Parking available at rear of station where incident occurred.  
(NIOSH Photo)

***Recommendation #2: Fire departments should consider designating parking areas for privately owned vehicles***

Discussion: Fire fighters interviewed stated that there was a verbal policy prohibiting privately owned vehicles from parking on the aprons in a manner that would block the entry or exit of fire apparatus. It is not known why the pickup truck was parked on the apron before the structure fire call, or why it was repositioned in front of another bay instead of parking it in the parking lot off the apron. At the time of the investigation, there were no signs posted on the station indicating that parking was prohibited on the apron. The rear parking lot where the incident occurred had recently been resurfaced with asphalt pavement, and fire fighters interviewed stated that this area provided ample parking for private vehicles and fire apparatus (see Photo 7). The use of designated parking areas and "no parking" signs help ensure that fire apparatus and emergency response vehicles can rapidly respond to emergency incidents by negating the need to move vehicles that might block their travel routes, and eliminates injury hazards associated with moving such vehicles.
