Volunteer Fire Chief Dies From Injuries Sustained During a Tanker Rollover - Utah

SUMMARY

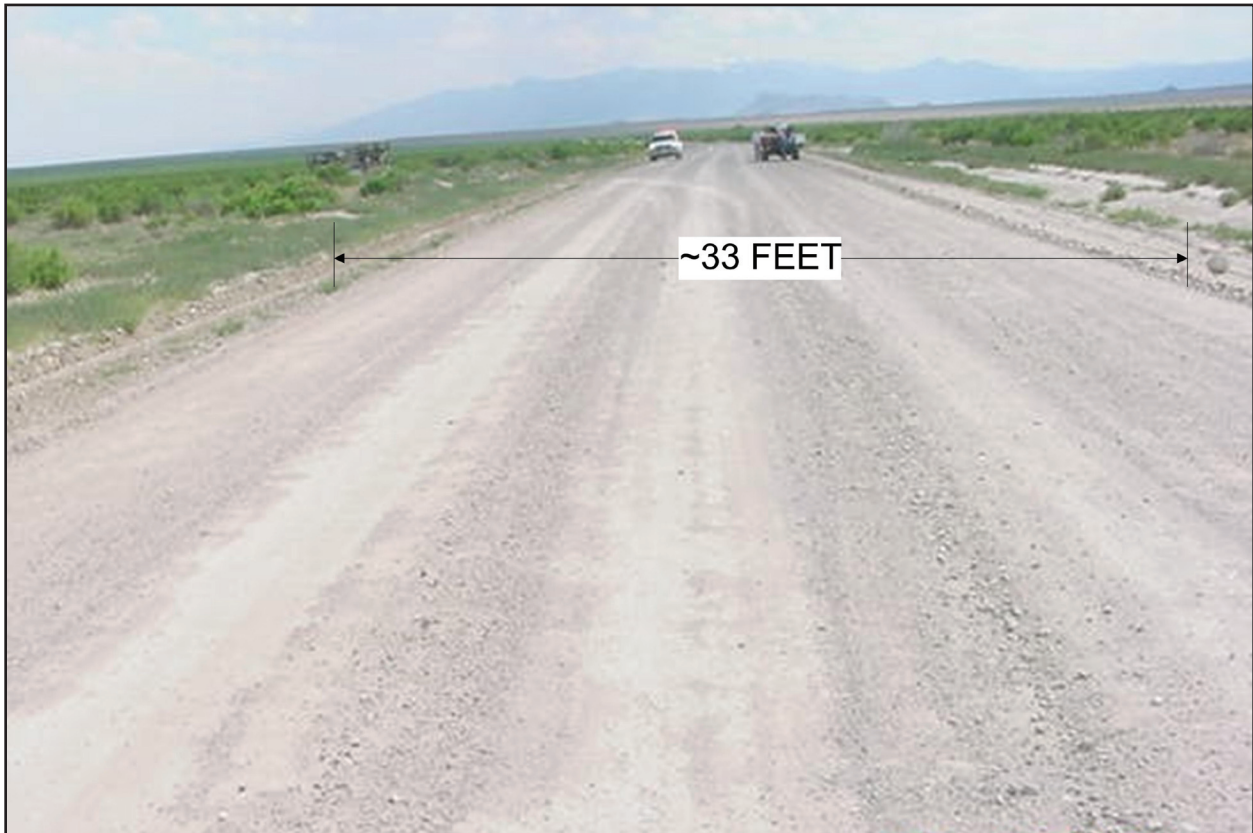
The county gravel road is approximately 33 feet wide with the aggregate averaging 1-1/2-inches or smaller. The incident site was a level straightaway that had no obstructions (see Photo #1). A ditch ran parallel on both sides of the roadway, and was approximately 6-foot wide and 1-foot deep.

*Photo 1. Incident Site
Photo courtesy of State forestry department*

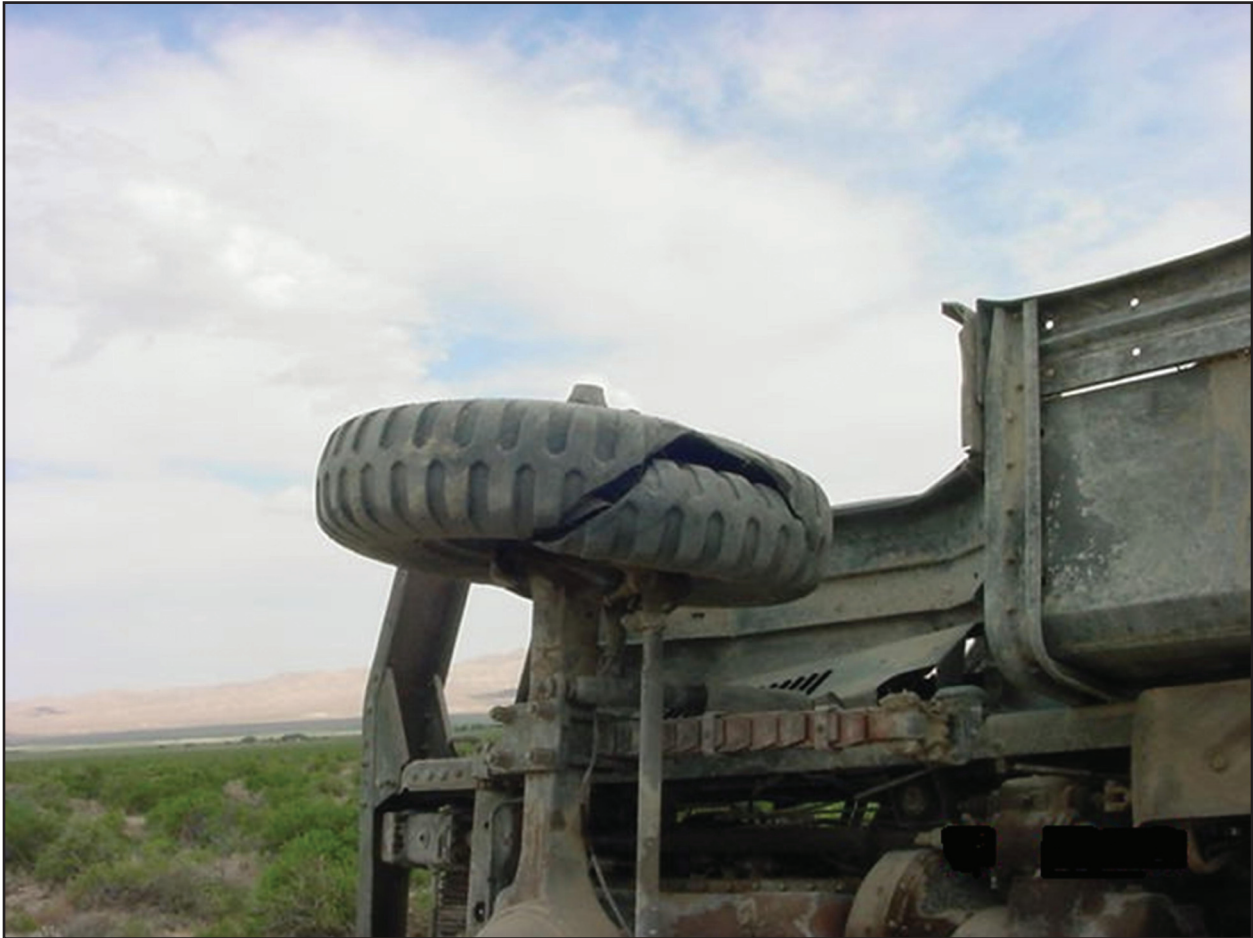
On June 21, 2005, a 52-year-old male volunteer Fire Chief was driving a military surplus truck that had been converted into a tanker to a nearby town to obtain a yearly State vehicle inspection. While driving on the gravel road at approximately 40 miles per hour, the left front tire ruptured (see Photo #2) causing the Chief to lose control of the vehicle. The Chief was able to keep the vehicle on the road for approximately 100 feet before it struck the ditch along the east side of the road and rolled more than 3 times (Photo #3). *Note: The two rear interior tires on both of the back axles of the passenger's side were ruptured. It is believed that these tires ruptured after entering the ditch and possibly contributed to the rollover (see Photos #4 and #5).* The apparatus traveled approximately 137 feet while rolling over and came to rest on its passenger side (see Photo #6). The Chief was ejected during the rollover and died at the scene from his injuries.

*Photo 2. Driver's side front tire
Photo courtesy of State forestry department*

States should verify that the tires, wheels, and axles of the modified vehicle meet all gross vehicle weight requirements. If the surplus vehicle tires have defects (e.g., wear, punctures, cuts to the cord, dry rotting, or sidewall splitting) then the tires should be replaced by States prior to being put into service. Split rims typically accompany the original bias tires that are found on government surplus vehicles. They should be replaced due to their inherent hazard of exploding or coming apart during removal or inflation/deflation.^{5,6}

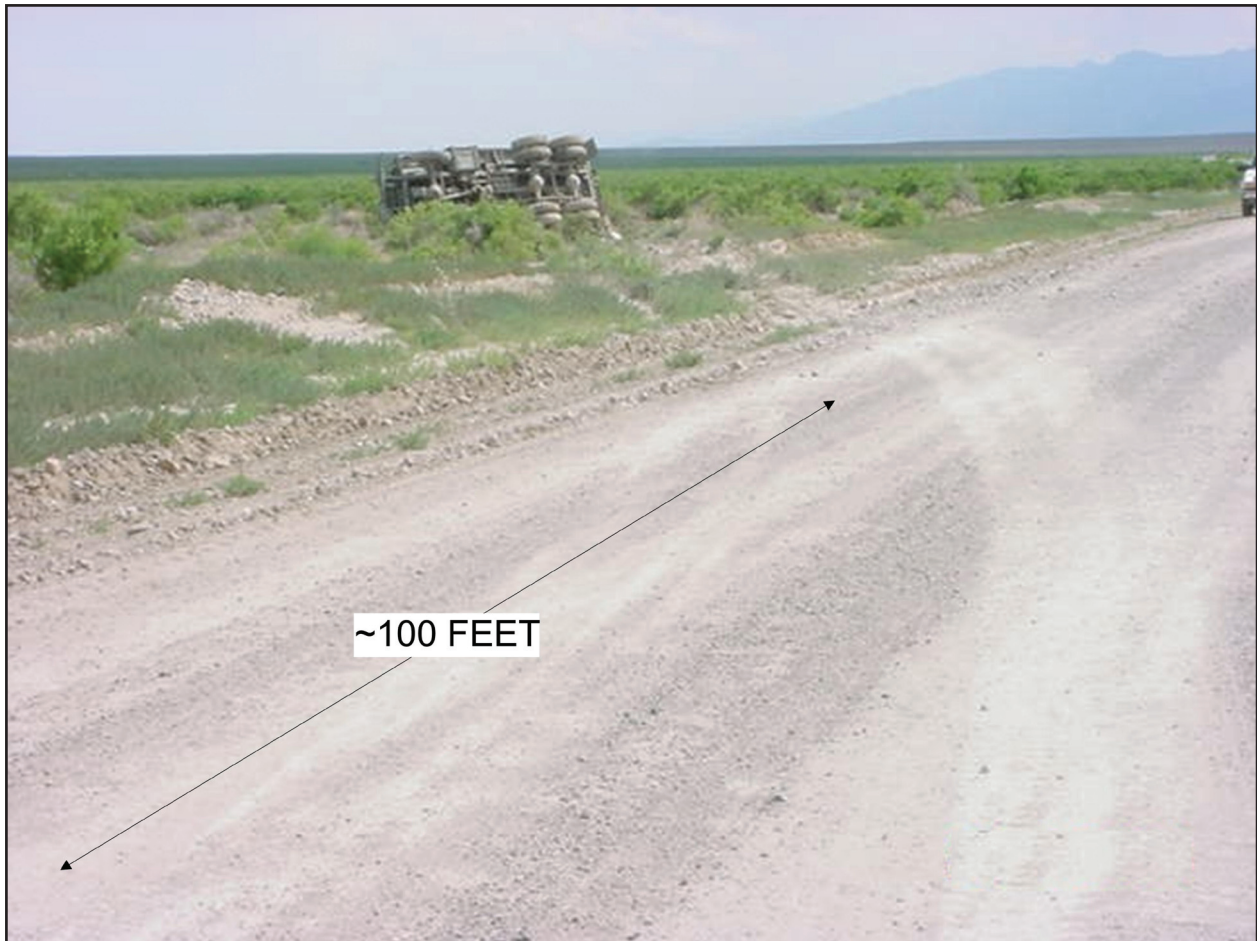
*Photo 3. Approximate distance victim was able to keep the vehicle on the road following the front tire rupture
Photo courtesy of State forestry department*

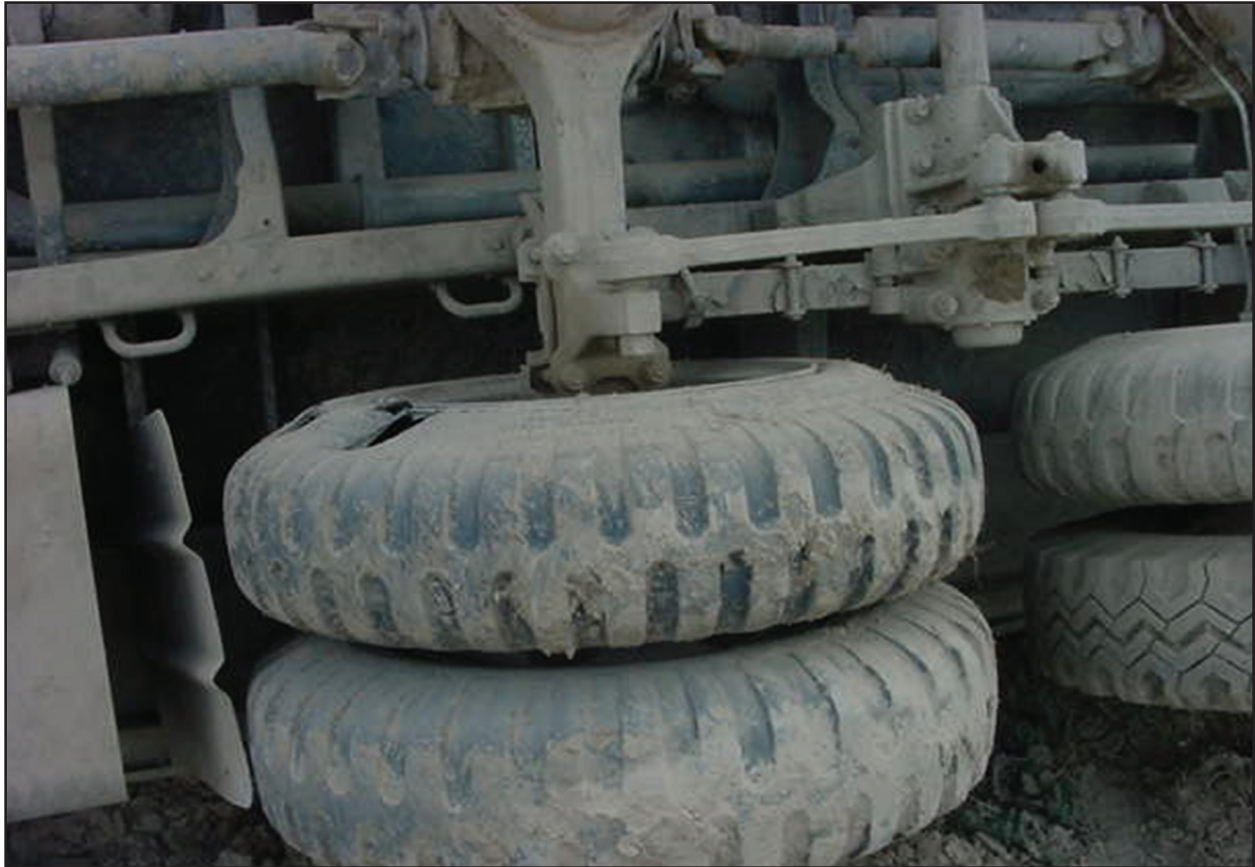
*Photo 4. Interior tire on the front rear axle of the passenger's side
Photo courtesy of State forestry department*

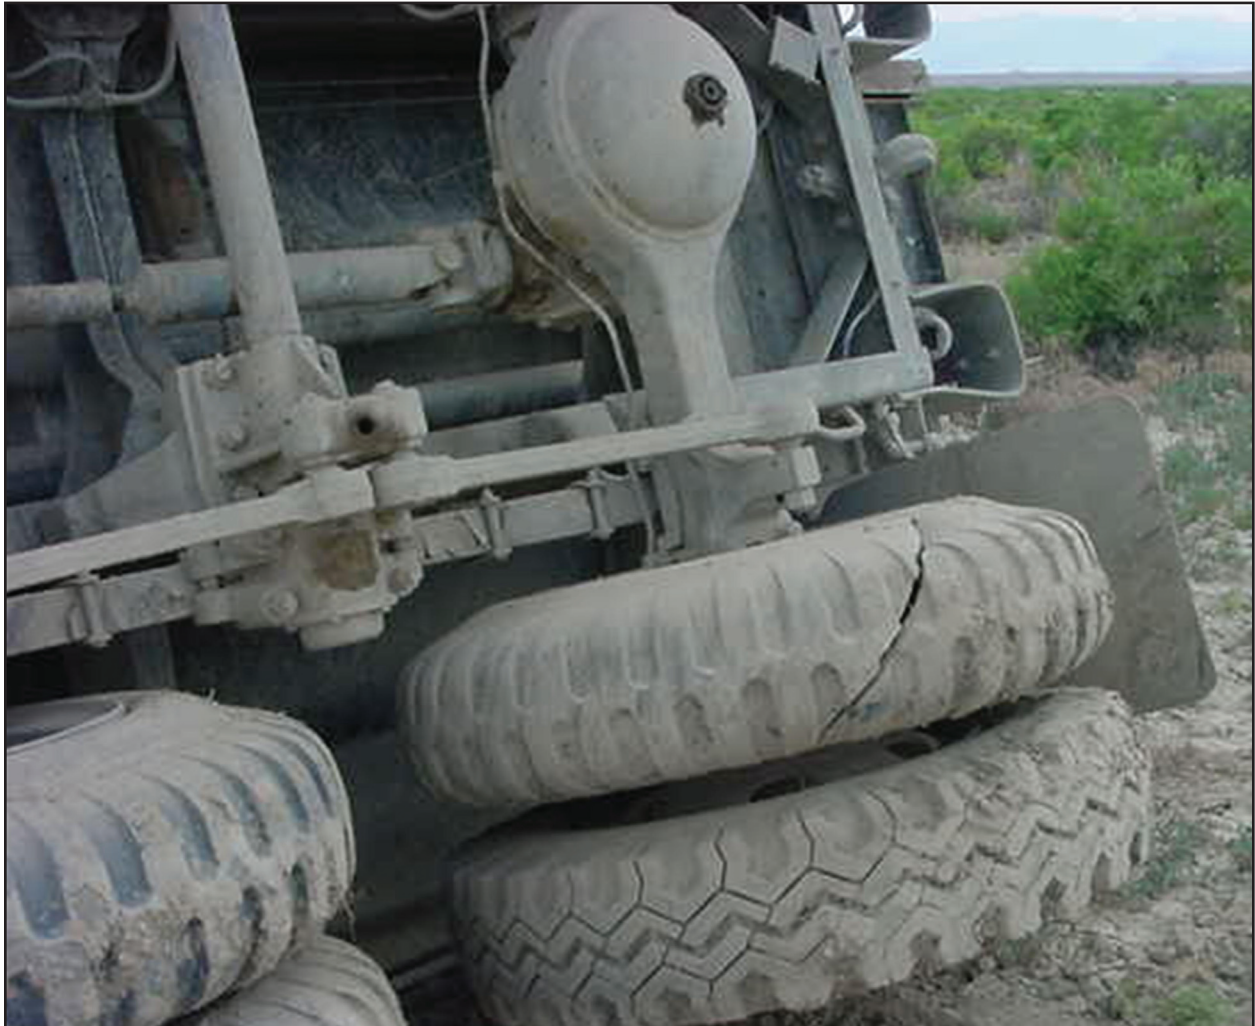
*Photo 5. Interior tire on the back rear axle of the passenger's side
Photo courtesy of the State forestry department*

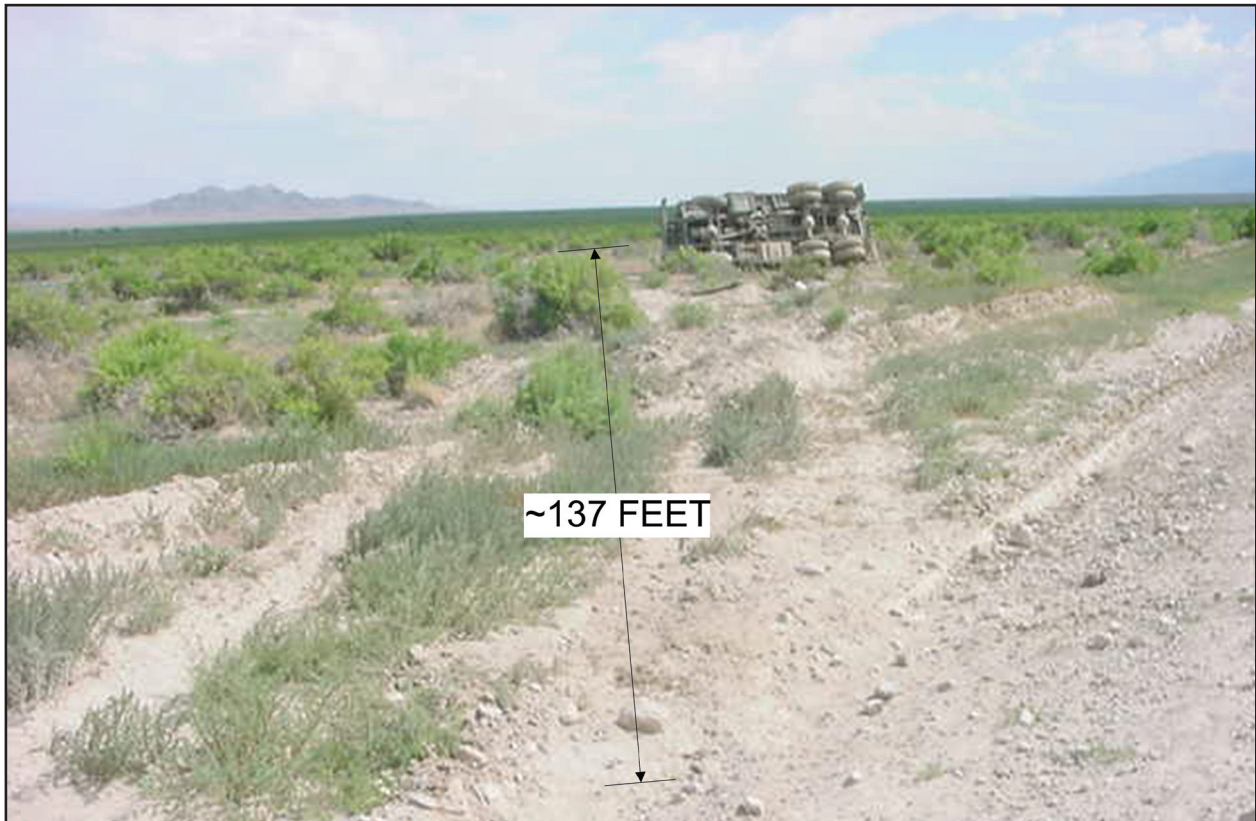
Photo 6. Distance from ditch to final resting place of vehicle which rolled more than 3 times
