# Death in the line of duty...

A summary of a NIOSH fire fighter fatality investigation

December 17, 2007

Career Captain Dies from Complications of a Drowning Incident due to a Combination of Exhaustion, Hypothermia and Carbon Monoxide Poisoning During Surf Rescue Training – Washington

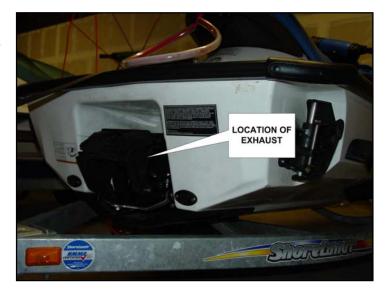
The PWC used by the instructor was a 2000, class A inboard boat with jet propulsion. It was 124 inches in length and weighed 605 pounds. It was a 2-stroke gasoline engine with 718cc displacement. The exhaust fumes exited near the water line at the rear of the craft (Photo 1). The PWC had an 18 inch towing strap looped off the back seat (Photo 2).

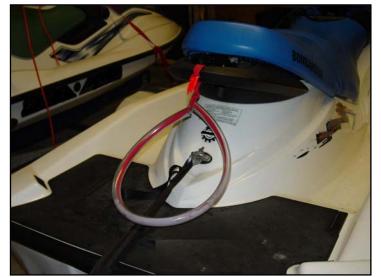
Photo 2. Towing Strap

Due to his exhausted state and the force of the jet propulsion hitting his upper body, the victim had difficulty holding onto the strap. The instructor had to circle around several times to reattach the victim to the strap. Approximately 100 yards from shore the victim became detached from the strap for the last time, remained face down, and was lost in the surf for a few minutes. The instructor found him and swam him into shallow water where he was assisted by the Safety Officer who was positioned on the shore.

(ppm) with peaks of 15-17 ppm.<sup>30</sup> The NIOSH recommended exposure limit for occupational exposures to CO gas in air is 35 ppm for a full shift time-weighted average exposure, and a ceiling limit of 200 ppm, which should never be exceeded.<sup>31</sup> Additional study is needed to determine CO levels at various PWC locations for the driver, passengers, and during use of the towing strap and the rescue board under various environmental conditions.

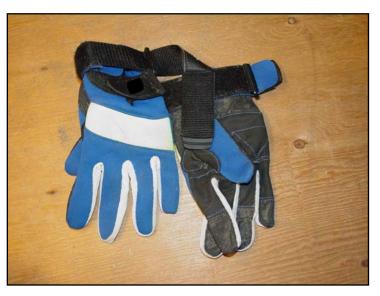
Photo 3. Gloves worn by victim during incident

The victim was wearing a full body dry-suit with a poly-propolyene jump suit underneath, a polyolefin and Lycra® combination hood, a helmet, a strobe, a mask, a snorkel, a personal flotation device, and a pair of thin non-insulated gloves that he reportedly purchased to improve dexterity (Photo 3). The dry-suit provided a protective and abrasion resistant shell while the undergarment provided thermal protection. These garments were part of a system that provides substantial protection against the elements as long as it is not compromised. The hood and gloves that the victim

was wearing were not waterproof and would have provided minimal thermal protection in this windy environment on the ocean, and possibly none once they became wet.

Prior to this incident the Fire department issued the trainees a neoprene body suit including gloves to provide protection from the cold water. The gloves issued by the fire department were three millimeters thick which reduced hand and finger dexterity. To overcome this dexterity problem, the victim used other gloves he had purchased that provided limited thermal protection. After falling from the craft into the cold water, the victim's hands would have become very cold. His cold hands probably impaired his ability to board the PWC, hold on to his training partner, clip himself onto the buoyancy ring, and hold onto the PWC's towing strap. In addition, the victim's face was also exposed to the cold water without insulation. These two sources, hands and face, immersed in cold water were likely responsible for the victim's mild hypothermia.

In this incident the fire fighters who were taking the training were wearing gloves that were not issued to them. The gloves that were issued to them were made from neoprene that was 3mm thick to provide protection from the cold (Photo 5). The gloves that the fire fighters were wearing to increase

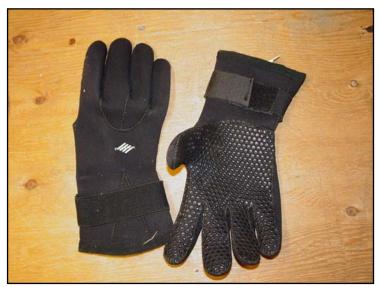
Photo 5. Gloves issued to surf rescue members

dexterity, provided limited thermal protection. Also, the hood that was issued to the surf rescue team provided little thermal protection once it became wet. After falling from the craft and being exposed to the cold water, the victim's ability to board, operate, and hold on to a partner while attempting the exercises could have been restricted. Reduced thermal protection could have also affected the victim's ability to attach a personal flotation device or hold on to the towing strap. A clear and effective policy addressing the use of issued PPE and protective clothing is the cornerstone to ensure that fire fighters will understand the importance of using this vital

Recommendation #3: Fire departments, police departments, and/or agencies with surf rescue teams should enhance current standard operating procedures to include requirements for issued personal protective equipment (PPE).
