# BUILDING PERFORMANCE ASSESSMENT REPORT

PRELIMINARY REPORT

## *Midwest Tornadoes of May 3, 1999*

FEDERAL EMERGENCY MANAGEMENT AGENCY  
Mitigation Directorate, Washington DC and Region VI, Denton, TX  
and Region VII, Kansas City, MO

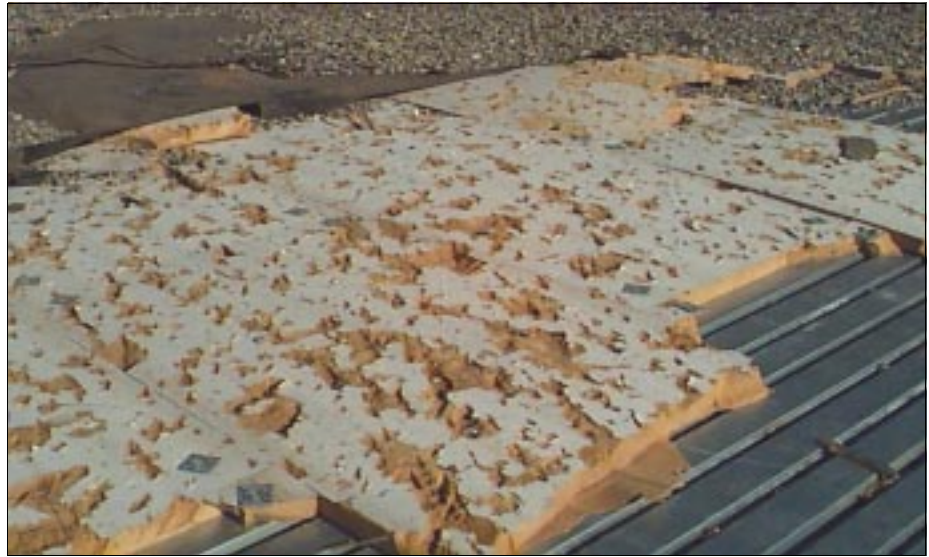
**FIGURE 3-26:** This house was on the periphery of a violent tornado damage area in Moore, Oklahoma. Two large missiles struck this area of the roof.

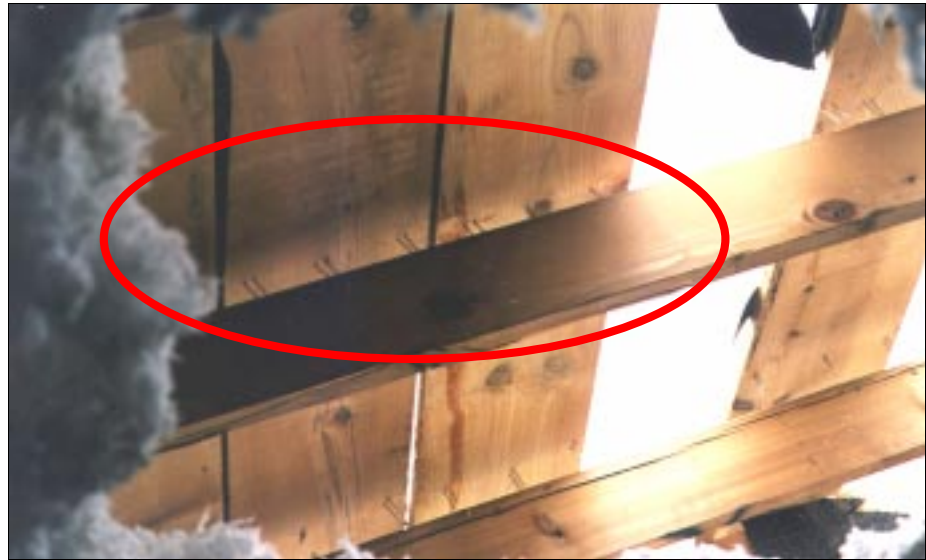
**FIGURE 4-4: Although roof sheathing was lost at this Wichita, Kansas, home code requirements of staggering joints in sheathing applications was observed. This house experienced inflow winds from a severe tornado.**

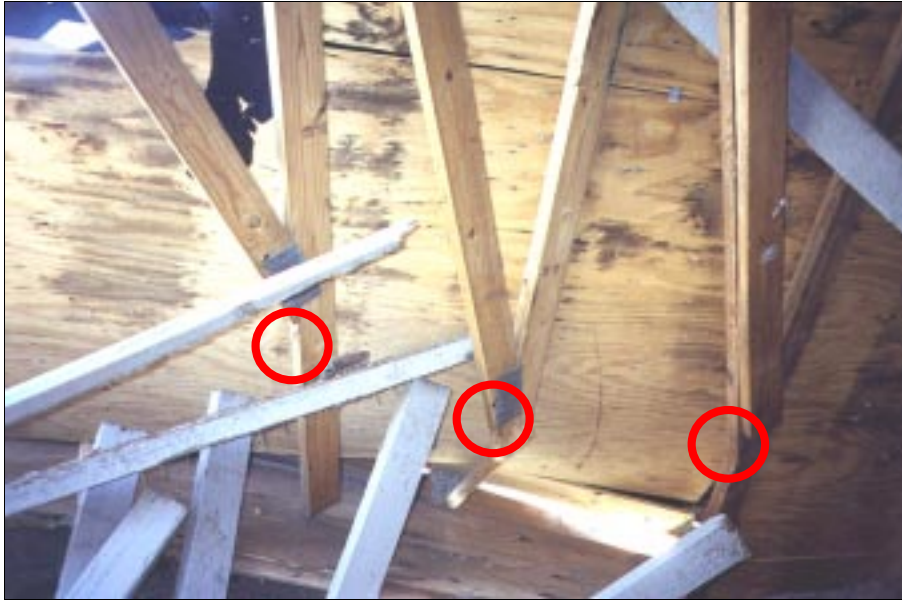
**FIGURE 4-7: Roof truss failure. A single nail (circled) was used to connect each truss to the top plate. This house was in Midwest City, Oklahoma and experienced inflow winds from a violent tornado.**

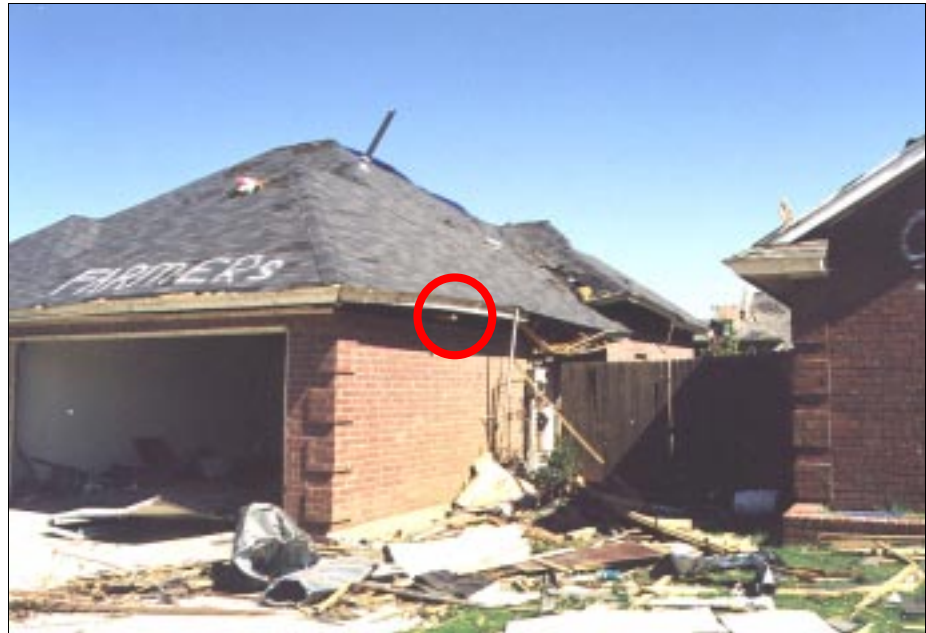
**FIGURE 4-22:** Garage door failure possibly resulting in the localized partial roof failure on the left side of this home located in Moore, Oklahoma.

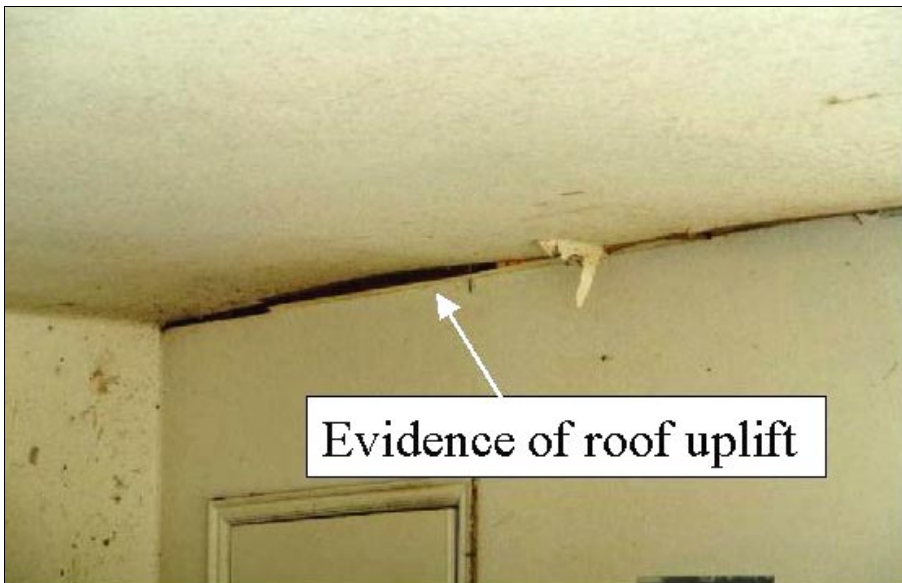
**FIGURE 4-24:** Roof uplift between garage roof and exterior wall at home G.

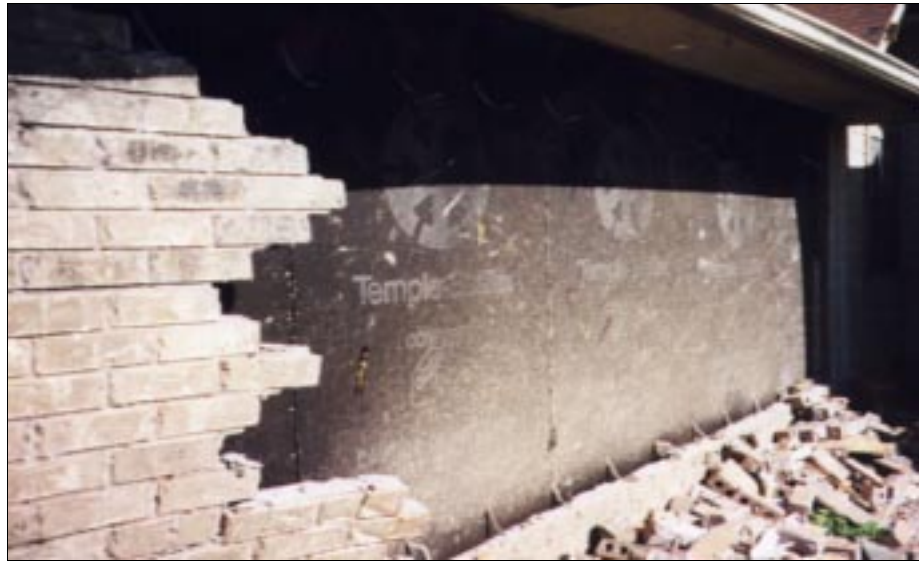
**FIGURE 4-33: Failure of masonry veneer wall, close-up view, Moore, Oklahoma. This home was located along the periphery of a violent tornado.**

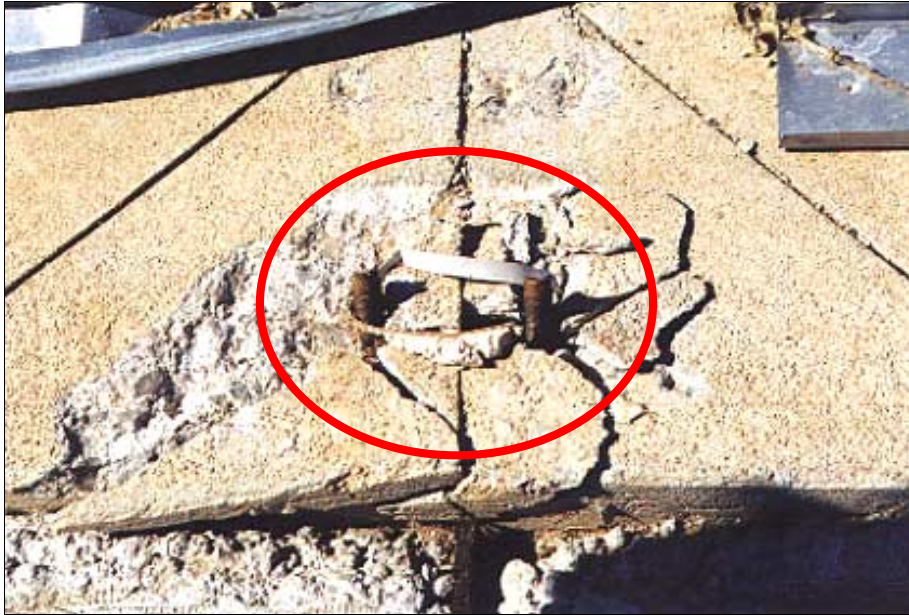
**FIGURE 5-7:** Column anchors that exhibited ductile failure at the regional outlet mall in Stroud, Oklahoma, hit by moderate tornado vortex.

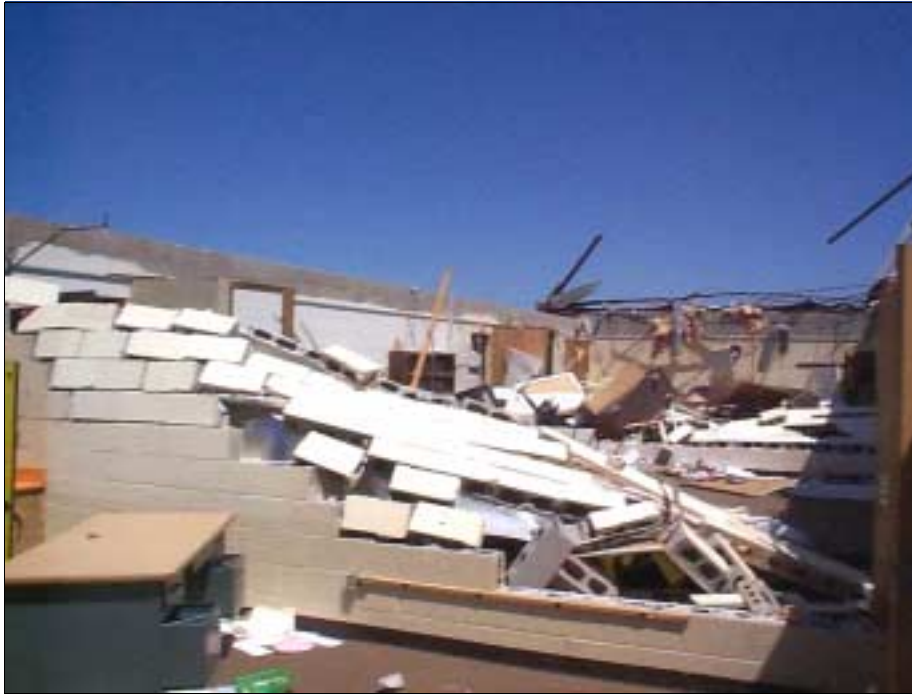
**Figure 5-20: Damage to interior and exterior unreinforced masonry walls when bond beam failed at Kelly Elementary School in Moore, Oklahoma. The school was struck by the vortex of a violent tornado.**

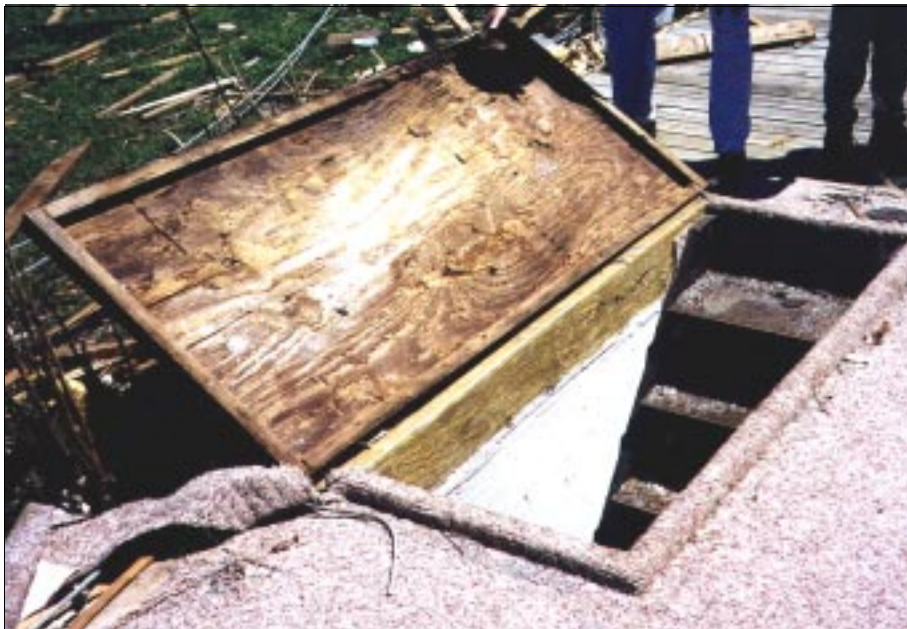
**FIGURE 6-12: Door to underground shelter with rotting wood and corroded hinges.**

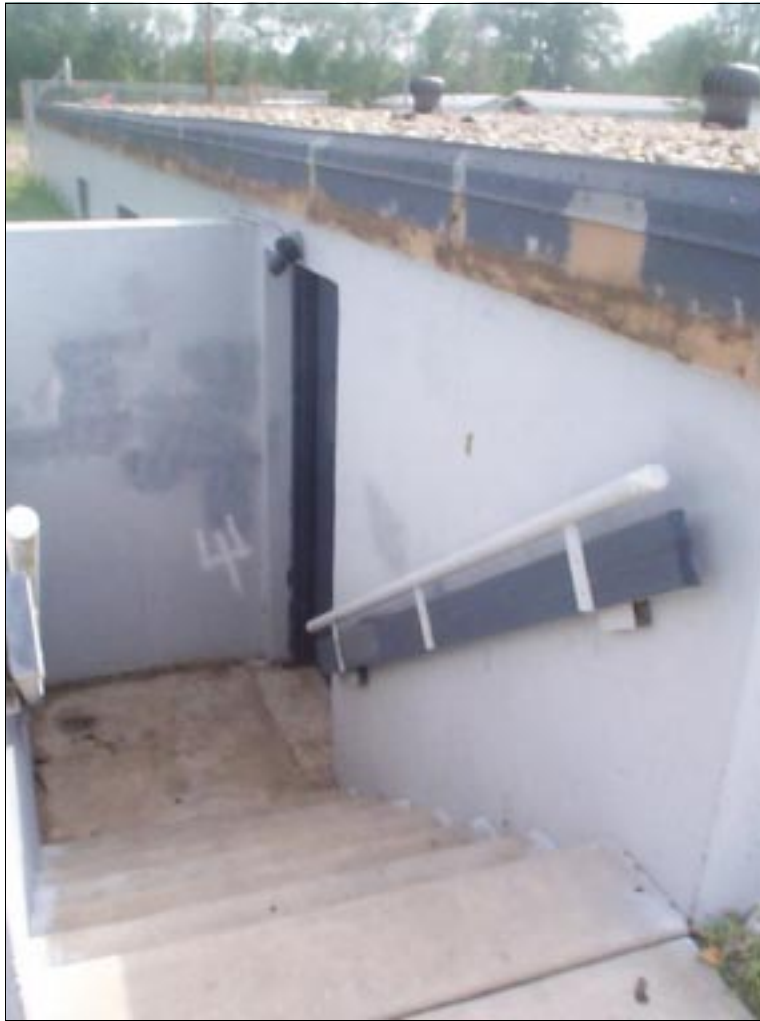
**FIGURE 6-16:** *Stairway leading to entrance of manufactured home community shelter, Wichita, Kansas. The only means of accessing this structure were this stairway and an identical one at the other side of the shelter.*

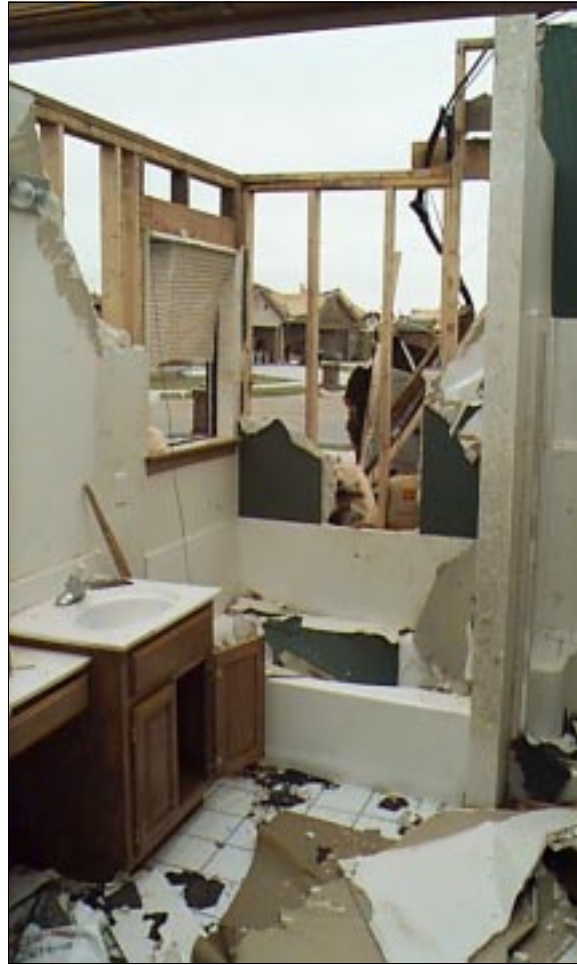
**FIGURE 6-26:** *This bathroom was on an exterior wall and had a window. It was not a safe refuge.*

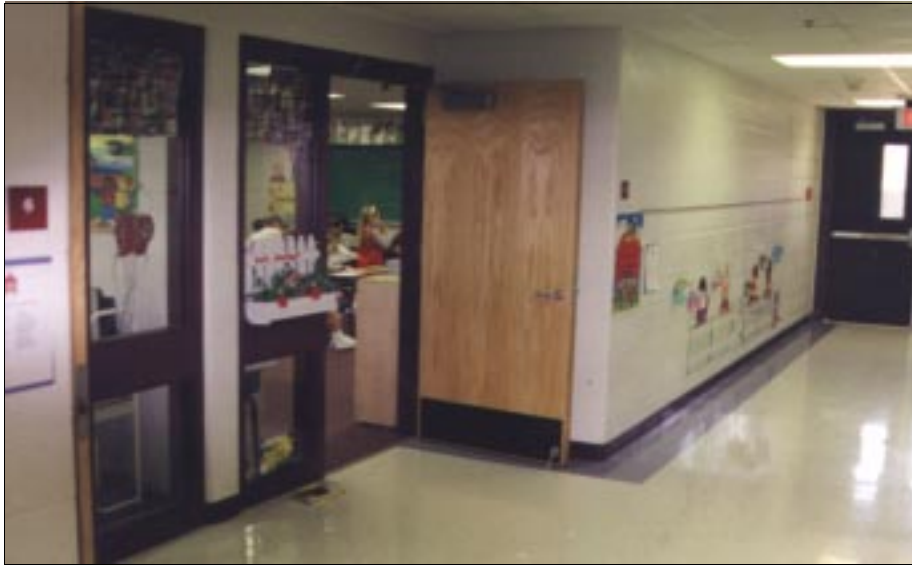
**FIGURE 6-30: Eastlake Elementary, Moore, Oklahoma, glazed sidelight at classroom entrance.**
