Research
Paper
FPL-RP-560

Field Performance of Timber Bridges

12. Christian Hollow Stress-Laminated Box-Beam Bridge

January 1998

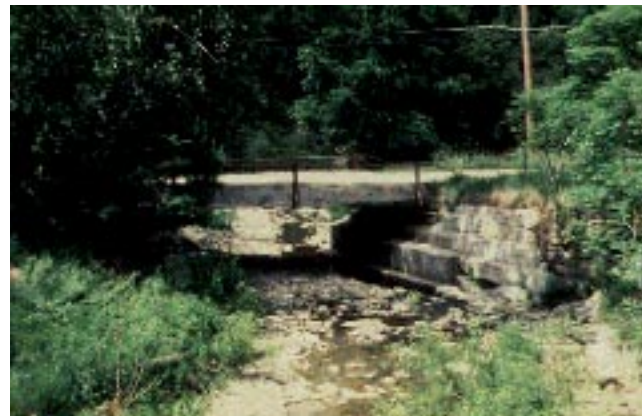
Figure 2—Original bridge constructed in the 1950s.

The original Christian Hollow bridge, constructed in the 1950s, consisted of steel stringers supporting a concrete slab deck with tubular steel guardrails (Fig. 2). The girders and deck were in poor condition, and the steel tubing guardrails were inadequate and posed significant safety hazards to motorists. Because of an interest by the Steuben County staff to use innovative timber bridge designs, a decision was made to replace the existing structure with the newly developed stress-laminated box-beam timber superstructure.

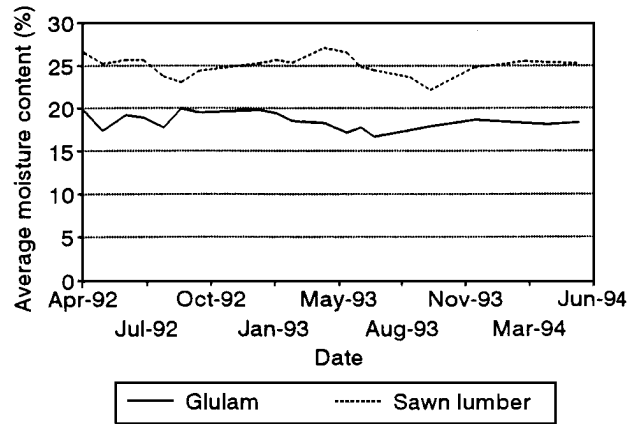
The average trend in moisture content is presented in Figure 13. At the initiation of monitoring, the average moisture content was approximately 20 percent for the glulam webs and 26 percent for the sawn lumber flange laminations. Minor fluctuations within the range of ± 3 percent occurred during the monitoring period, but the moisture content remained relatively stable. At the conclusion of monitoring, the moisture content of both the glulam beams and the sawn lumber flange laminations had decreased slightly.

The average trend indicates that no significant changes in moisture content occurred during the monitoring period. The glulam web moisture content is near the anticipated equilibrium level for this site. Although installed slightly greater than the specified maximum of 19 percent, the sawn lumber moisture content did not decrease in service as typically observed for most timber structures installed near fiber saturation. However, it is anticipated that the moisture content of the sawn lumber will gradually decrease and equilibrate with its surrounding environment during the next several years.

Figure 13—Average trend in moisture content.

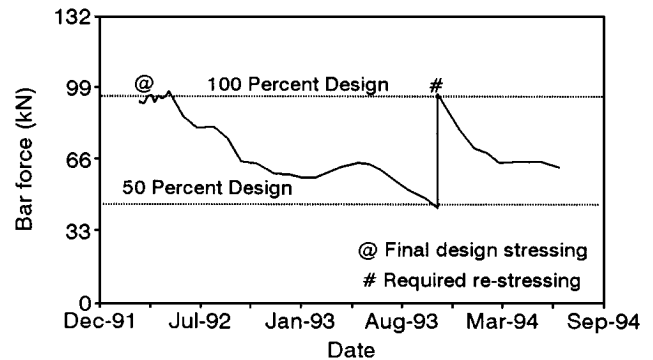
The average trend in stressing bar force is presented in Figure 14. From the final design stressing in March 1992 through March 1993, the average bar force decreased from the design level of 96 kN (21,600 lb) to approximately 58 kN (13,000 lb), or approximately 414 kPa (60 lb/in²) interlaminar compression. During the subsequent 6 months ending October 1993, the average bar force slightly increased but then decreased to 49 kN (11,000 lb), or approximately 345 kPa (50 lb/in²) interlaminar compression. In October 1993, the bridge was restressed to the full design level of

96 kN (21,600 lb), because the potential for interlaminar slip between the web and flange increases as the interlaminar compression decreases below 345 kPa (50 lb/in²). Between October 1993 and March 1994, the bar force decreased to 67 kN (15,000 lb), or approximately 483 kPa (70 lb/in²) interlaminar compression, and became somewhat stabilized for the remainder of the monitoring period. Additional measurements taken in August 1995, 14 months after completion of monitoring, indicated an average bar force of 58 kN (13,000 lb), or approximately 414 kPa (60 lb/in²) interlaminar compression.

Bar forces remained greater than 48 kN (10,800 lb), or 345 kPa (50 lb/in²) interlaminar compressive stress, throughout the monitoring period, although one restressing was required in October 1993. The moisture content of the web and flange laminations was essentially constant during the monitoring period; therefore, lamination shrinkage resulting from decreasing moisture content did not substantially affect bar force. A large majority of bar force loss can be attributed to stress relaxation in the web and flange laminations. As observed in previous field evaluations (Ritter and others 1995), bar force losses as a result of stress relaxation may have been accelerated by the relatively high moisture content (24 to 26 percent) of the sawn lumber flange laminations. Future inspections of the Christian Hollow bridge should include hydraulic bar force measurements to ensure that the forces remain greater than approximately 48 kN (10,800 lb), or 345 kPa (50 lb/in²) interlaminar compressive stress.

Figure 14—Average trend in stressing bar force.

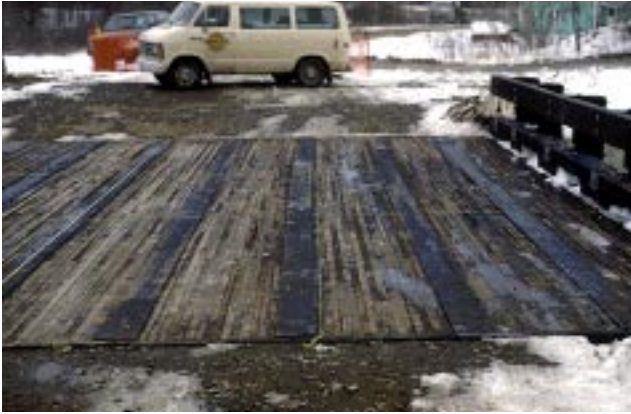
surface (Fig. 20). Width measurements indicated that the cross section of the centerspan was 102 mm (4 in.) narrower than the ends of the bridge. This was probably due to the sequential bar tensioning with a single hydraulic jack. This slight distortion has not increased in magnitude and should not affect overall bridge performance.

Figure 20—Slight hourglass shape was noticeable soon after initial stressing. Note stringline aligned with web member in middle of photograph.

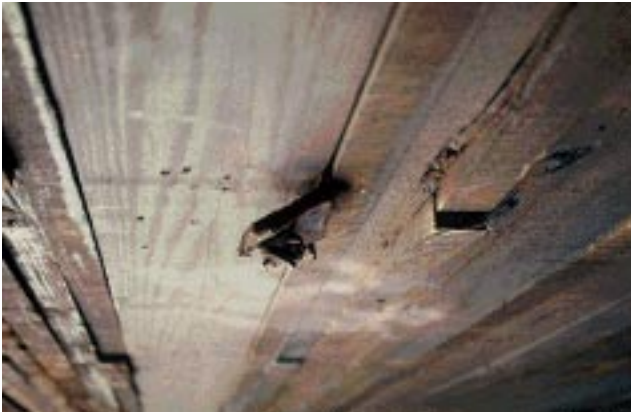
Figure 21—Cardboard corner strapping protector was not removed at installation and caused a visible separation between lower flange laminations.

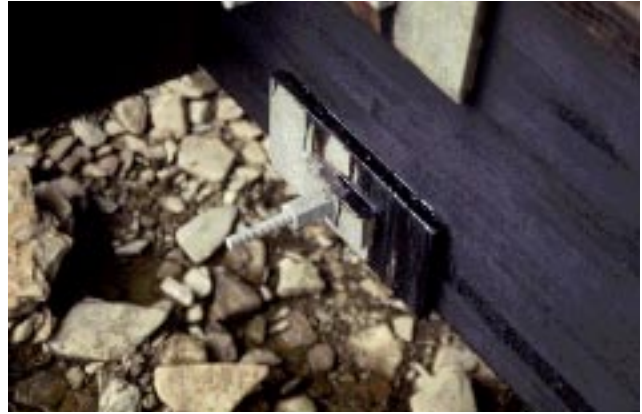
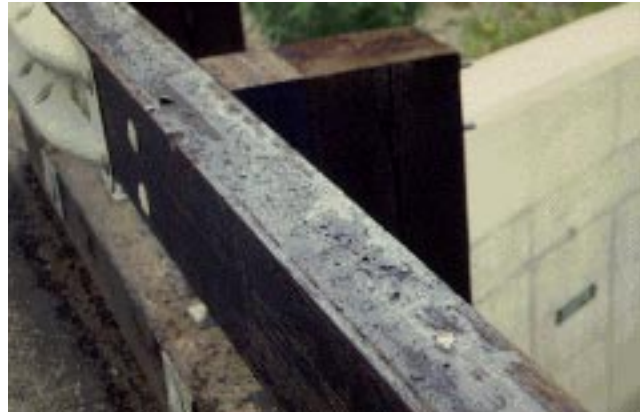
Excess creosote preservative was bleeding from members with a southern exposure and stained several steel bearing plates (Fig. 22, top). In addition, the side and top surfaces of the rail members had a visible layer of residue (Fig. 22, bottom) that was leaching from the glulam members. Proper treatment procedures, including a post-treatment vacuum or steam process, could have alleviated this problem.

Figure 22—Excess creosote preservative was noticeable at several steel bearing plates (top) and along the top surface of the glulam timber rail (bottom).
