# Field Investigations of Stress-Laminated T-Beam and Box-Beam Timber Bridges

*S. E. Taylor, M. H. Triche, L. E. Hislop, and P.A. Morgan*

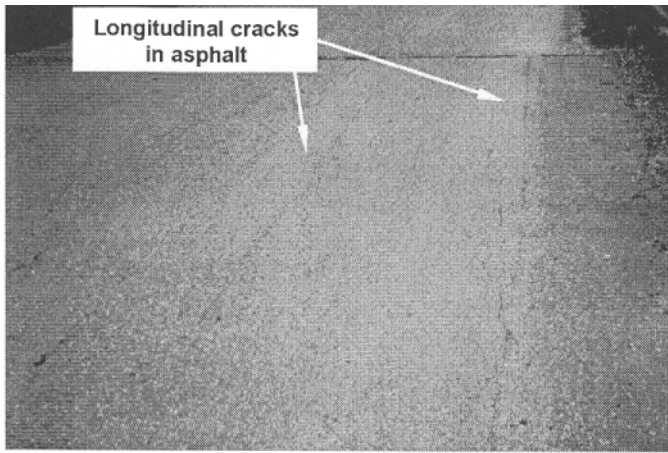
**Figure 3.**—Example of longitudinal cracks in the asphalt wearing surface of the Six Mile Creek bridge. Location of cracks corresponded to location of webs.

Perhaps the most immediate feature noted on many of the bridges was longitudinal cracks in the asphalt wearing surfaces as shown in Figure 3. Cracks were observed at locations that were immediately above the webs, in both T-beam and box-beam bridges. This feature was observed in seven T-beam bridges and five box-beam bridges. Most cracks were longitudinal; however, on two bridges, smaller transverse cracks in the asphalt were also observed. While these cracks could have resulted from reflective cracking due to fluctuations in wood moisture content, much of the cracking is believed to be due to slip between webs and flanges. The presence of longitudinal cracks in wearing surfaces has not been noted in previous performance reports on T-beam or box-beam bridges (Wacker *et al.* 1998, Kainz 1998). On four of the bridges that did not have cracks in their asphalt (Upper Five Mile No. 1 and No. 2, Steeles, and Little Huff), new asphalt had been applied to the bridges, so it is very possible that the original wearing surface may have had similar cracks before repaving.

12 out of 18 bridges that exhibited cracks in their wearing surfaces. In addition, there were nine bridges that had what should be considered low bar forces; i.e., at least one bar out of those checked was below the allowable level of bar force as described previously. Of these nine bridges with “loose” bars, seven bridges had problems with asphalt cracking, one had problems with asphalt rutting, and one had been recently repaved. Therefore, there appears to be a strong relationship between low bar forces and cracked asphalt wearing surfaces.

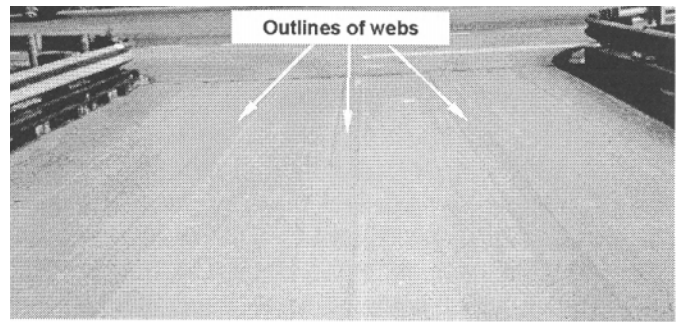
**Figure 4.**—Examples of web outlines that were visible in the asphalt wearing surface of the Hope Station bridge.

Outlines of webs were visible in the asphalt wearing surface on several bridges, which may indicate that the flanges had slipped since the wearing surface was paved. Figure 4 is a photograph showing outlines of webs on the Hope Station bridge. In the case of one box-beam bridge (Six Mile Creek), visible slip between the web and top flange of the bridge was observed when a heavy truck passed over the bridge. Several bridges had butt joints in the flanges that were misaligned in the horizontal plane. These misaligned joints could have been the result of slip between laminations. On one T-beam bridge (Nebo), the bottom of the flange was in contact with the top of one of the diaphragms, while a 50 to 100 mm (2 to 4 in.) gap between the flange and diaphragm occurred at other diaphragms. This was further indication of possible slip in the flange. Since asphalt cracking and lamination slip has not been addressed in the literature, it may be a feature that has appeared in bridges that were not in the USDA Forest Service monitoring program, and it may

also be a feature that does not manifest itself until later in bridge life. At any rate, the possibility of slip between webs and flange laminations is an indication that complete composite behavior is not occurring in the bridges. This would indicate that bridges do not have the levels of stiffness or strength for which they were originally designed.

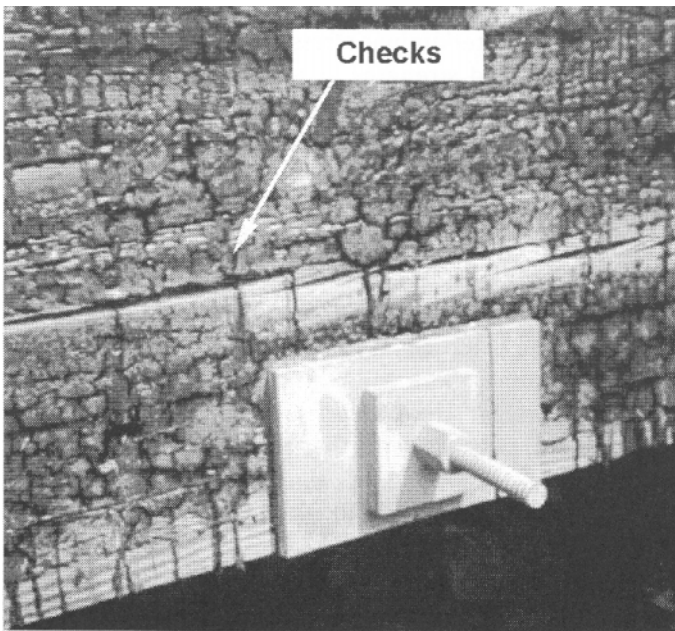
Figure 5.—Example of large horizontal checks in an exterior web of the Bonds Creek box-beam bridge.

Checking was observed on the outside face of exterior webs of many box-beam bridges and on some of the T-beam bridges near abutments. Figure 5 shows examples of these checks in a box-beam bridge. These checks were typically below upper bearing plates and above lower bearing plates. In the most extreme case, the check was 13 mm (0.5 in.) wide and 25 mm (1 in.) deep. Dickson (1995) reported that these checks may be related to problems with unsquare box-beam modules. However, field performance results for bridges in other regions of the United States have not mentioned this problem (Wacker *et al.* 1998, Kainz 1998). This situation, which developed during the stressing process, resulted in uneven compression of the box-beam modules. Uneven compression led to transverse bending and tension perpendicular-to-grain stresses in the webs. If webs experienced tension perpendicular to grain stress (with stressing bars applying lateral loads near the top and bottom of the web), this stress may have been a contributing cause of large checks in the outside faces of webs.

- The presence of checks in exterior webs of many bridges was cause for concern and may have been indicative of excessive levels of transverse bending stresses in the glulam beams. Since many of these checks have appeared during the years since the bridges were erected, cracks may continue to grow. This issue warrants further monitoring to determine if checks are changing in size with length of bridge service.
