Frank Preusser & Associates, Inc.

Deterioration and Preservation of Porous Stone Royal Presidio Chapel, Monterey, California

Final Report to NPS/NCPTT

February 1996

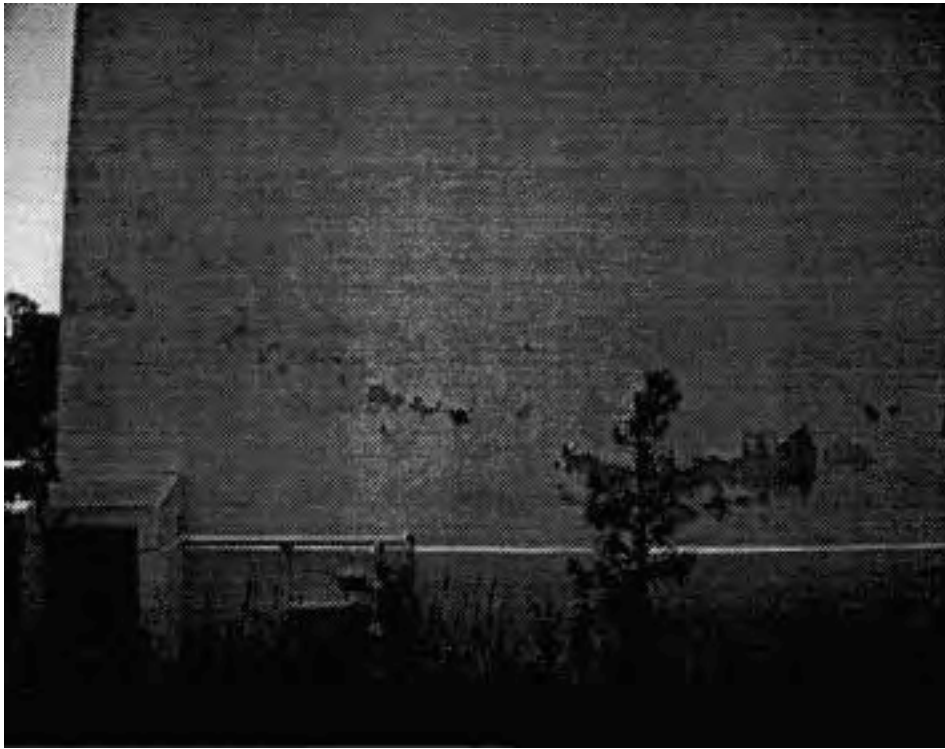
Tidelines³ on all walls of the Chapel indicate the presence of rising damp (see figures 2 and 3). The concrete apron, installed in the nineteenth century, was probably meant to mitigate the problem, but most likely only increased the height of the zone of evaporation. This is not a new problem, since similar tidelines can already be seen on historic photographs dating from 1934. No signs of rising damp are visible in the interior of the church, except on the west wall of the transept, where the confessionals had to be removed due to the moisture problem. At this point the terrain slopes towards the church and the concrete apron and walkway are cracked, allowing surface water to gain access to the base of the wall. It is also suspected that a similar problem exists along the east wall of the transept⁴.

Figure 2: Tideline on West Wall

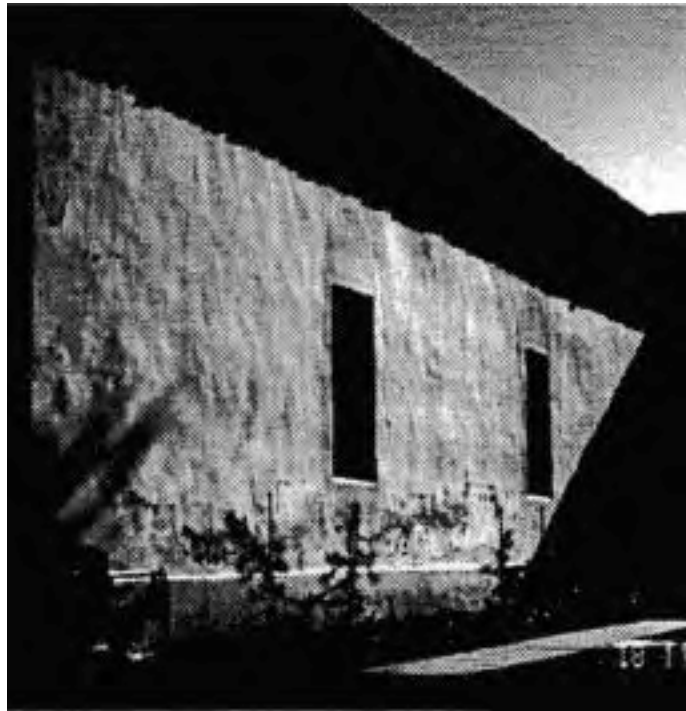
Figure 3: Water Damage (runoff, wind driven rain, and rising damp)

Damage patterns at higher elevations of the building can be associated with water run-off from the roof (see figure 3)⁵, caused by the removal of the rain gutters sometime after 1934, and wind driven rain.

Patchlike deterioration at higher elevations (above tideline) indicate water penetration from wind driven rain, and salt damage.

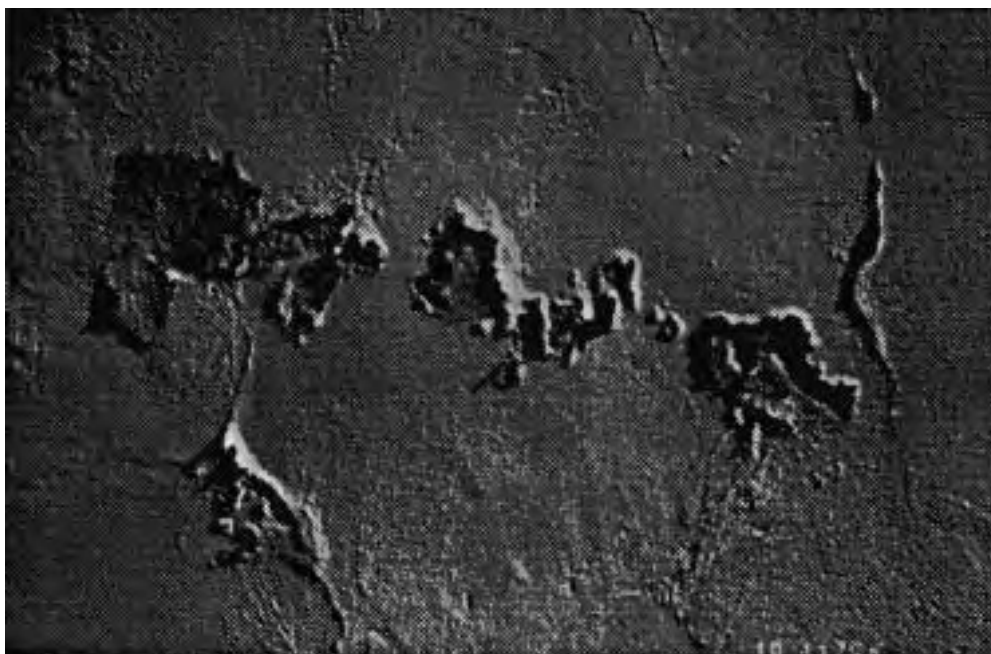
In some areas of exposed stone salt efflorescence could be observed and the overall damage patterns indicate the action of salts.

Figure 4: Peeling Paint Due to Salt Pockets in Rendering

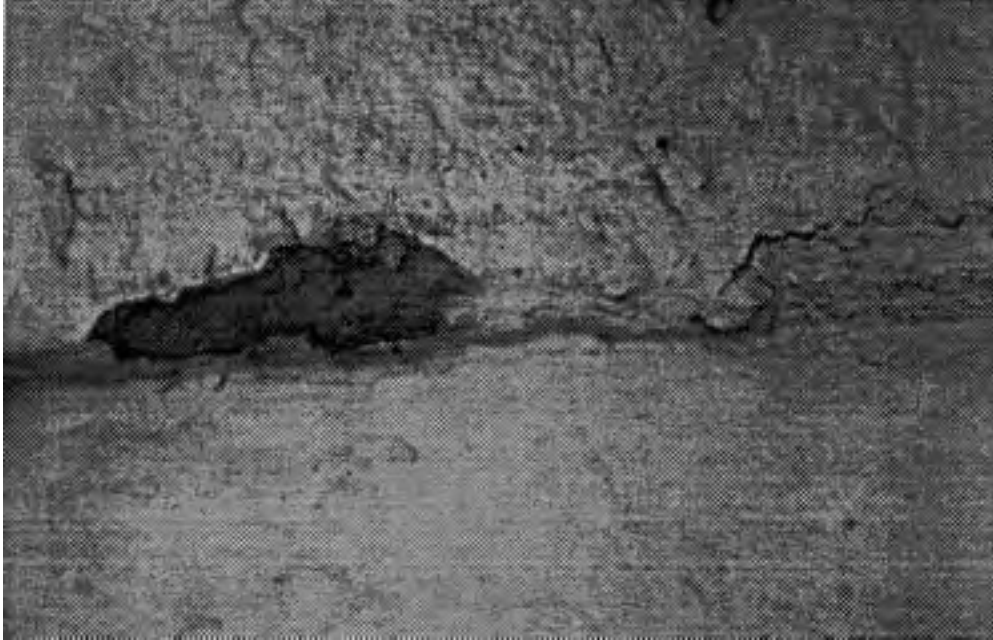
Extensive repairs have been made in the past to the rendering and sculpted parts of the facade. Most of these have been done with cement based or other extremely hard materials. Due to the different hardness, water permeability, and thermal expansion coefficients, many of these areas show delamination (from the stone or underlying rendering) and spalling (see figures 5 and 6).

Figure 5: Spalling of Cement Patch adjacent to Lime Based Rendering

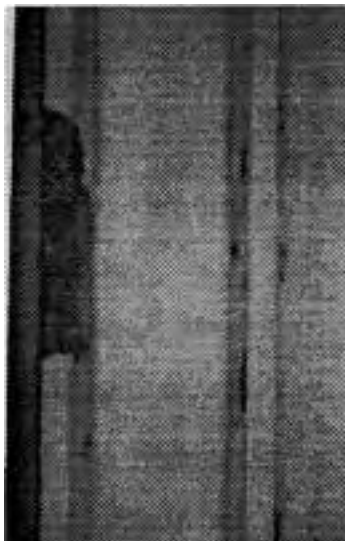
Figure 6: Spalling of Cement Repair

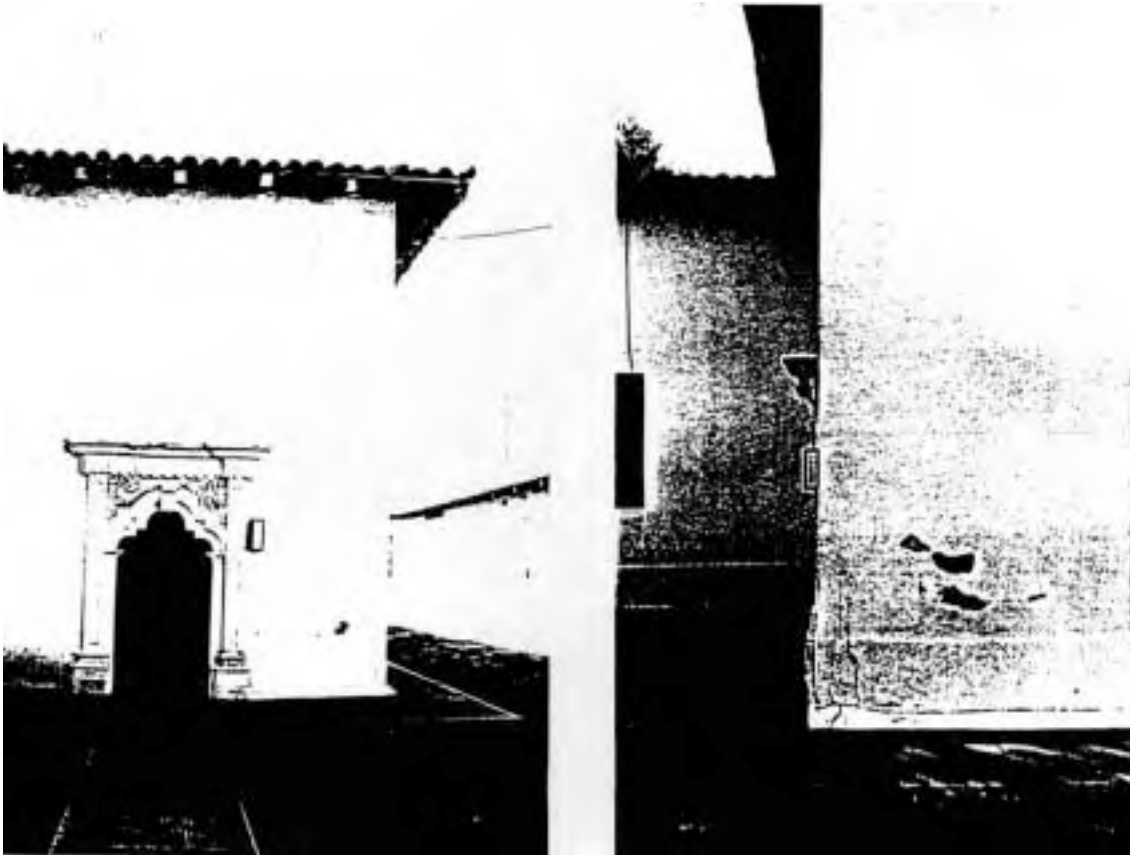
the transept. The sidewalk immediately adjacent to the building exacerbates the moisture problems. The concrete walk is relatively impervious and prevents normal evaporation from the soil. The moisture is then forced up into the masonry wall. As the hard parging on the lower portion of the exterior surface restricts evaporation, the primary damage from the evaporating moisture is on the interior wall surface and above the parging. The effect of the sidewalk can also be seen on the greater deterioration of the left side of the transept door pilaster (Figure 5).

Figure 4a and b: Views of the northwest corner of the west transept showing the sidewalk, the ground slope, and some of the decay.

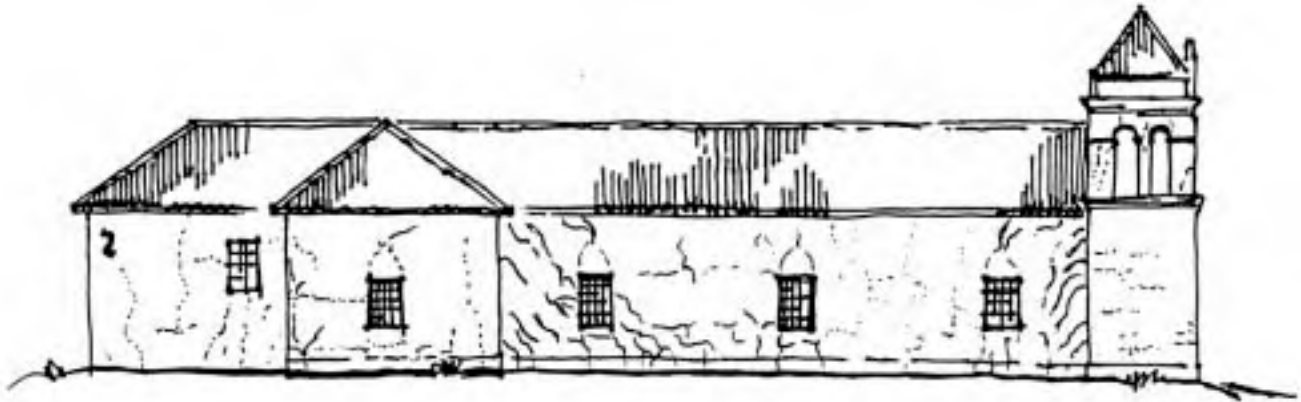
Figure 6a: East wall elevations showing existing crack patterns. The pattern at either end of the east wall are consistent with structural movement.

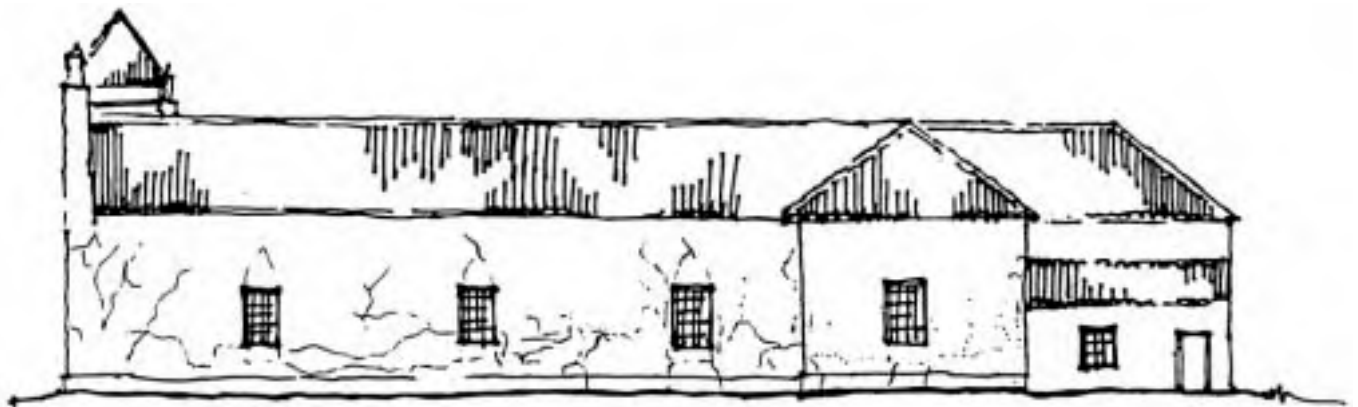
Figure 6b: West wall elevation showing existing crack patterns. The pattern does not appear to reflect structural movement

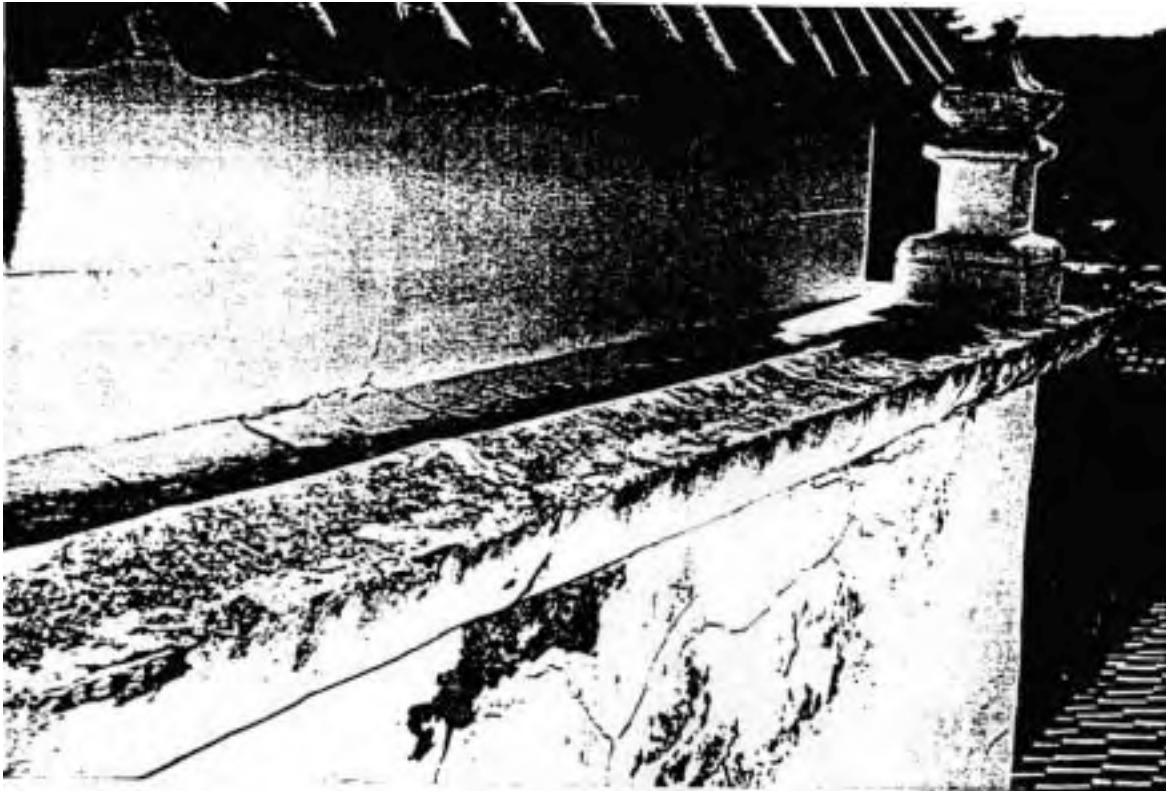
The other portion of the Chapel where structural cracks, opposed to surface cracks, were observed is along the upper portions of the bell tower at the cornice immediately below the pyramidal tile roof (Figure 7). These cracks could be caused by a number of things such as thermal expansion, the differential loading from the bells, mechanical system, or roof, but further analysis is necessary here as well.

Figure 7: Oblique view of the west cornice of the bell tower. The cracks occur at approximate third points.

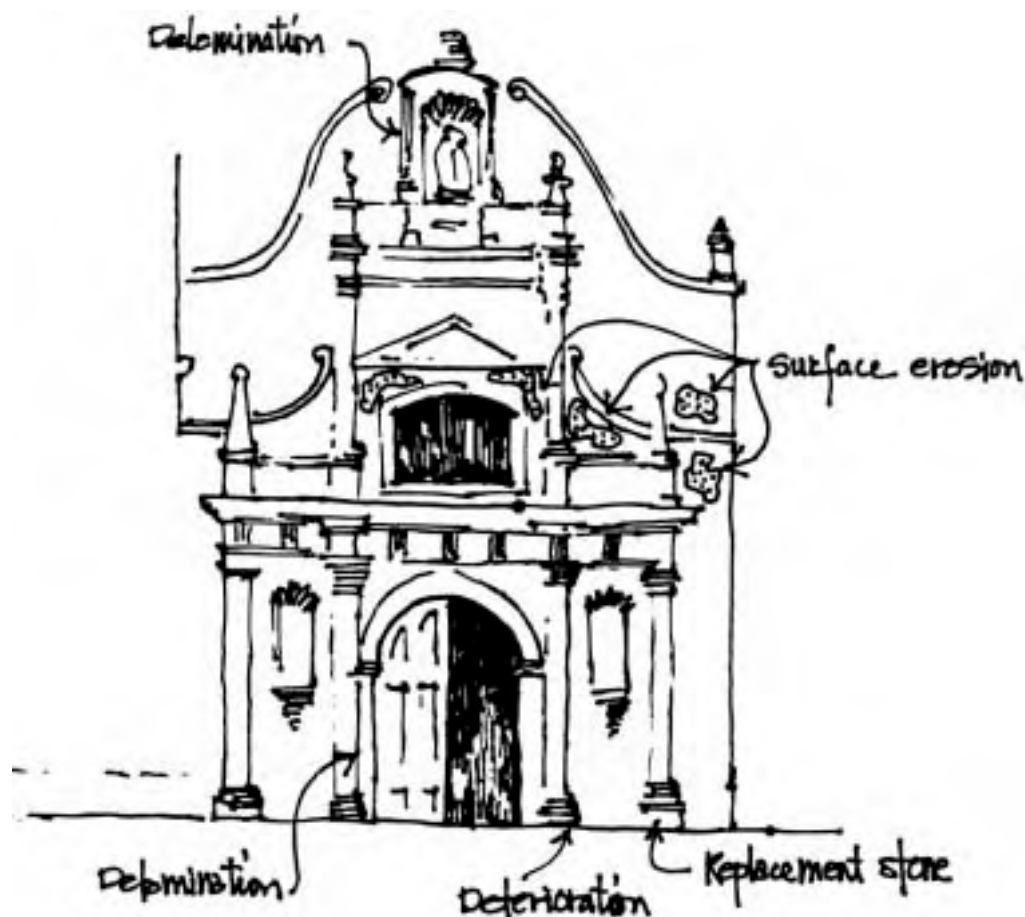
area is to the left of this center piece, under the engaged “C” scroll. Figure 12 is a sketch of the facade with these areas identified. A strong raking light across the entire facade will probably reveal other similar areas.

Figure 12: Sketch of the front facade showing the locations of various conditions observed during the inspection.

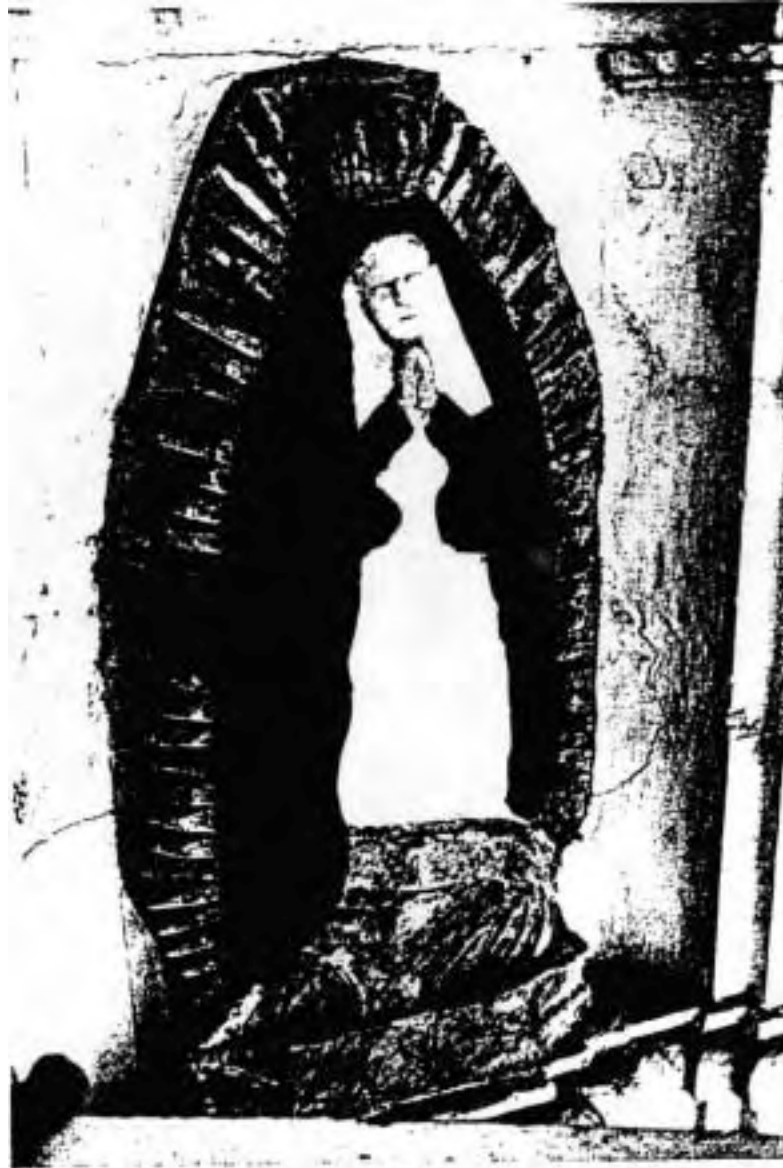
Figure 13: An overall view of the Virgin of Guadalupe. The amount and the extend of erosion is obvious.

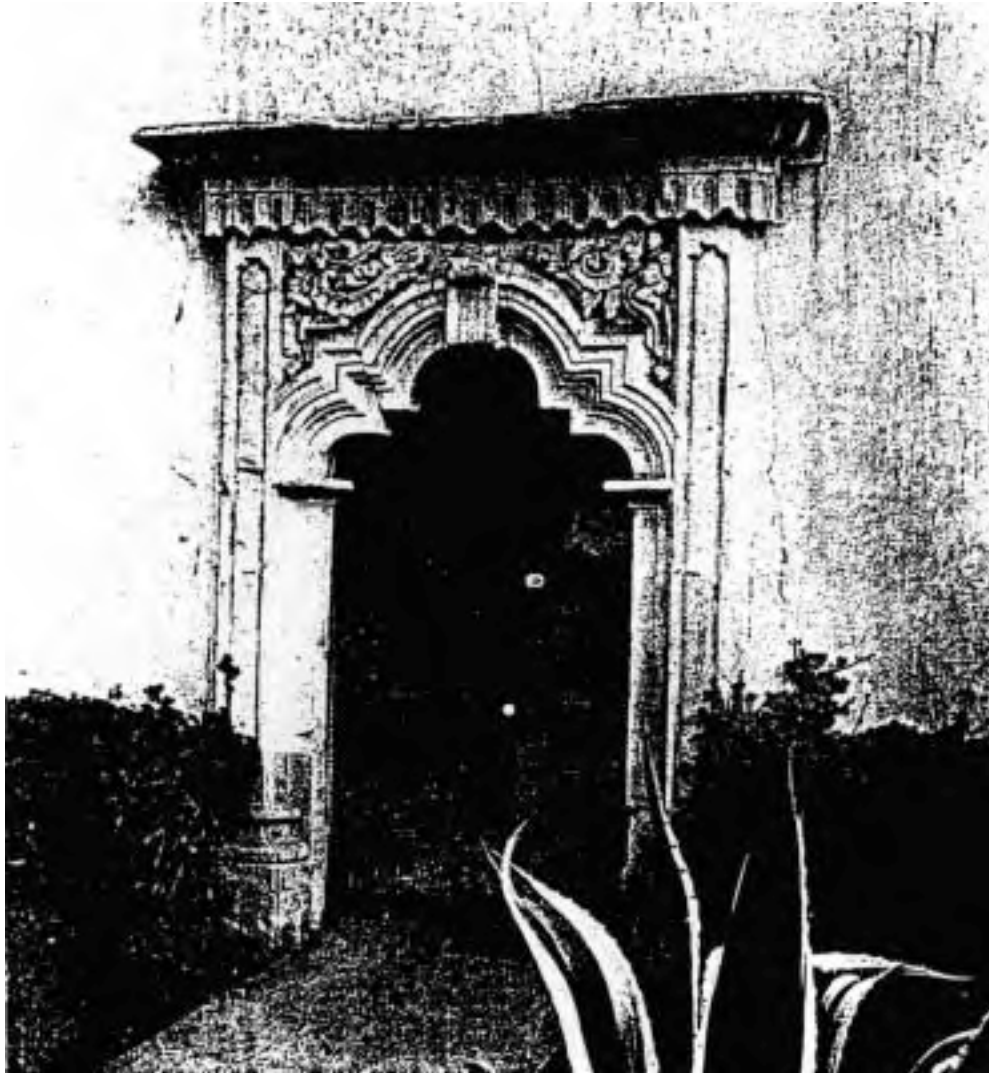
Figure 15: A copy of a 1934 HABS photograph of the west transept doorway shows some areas of decay that have subsequently been repaired.

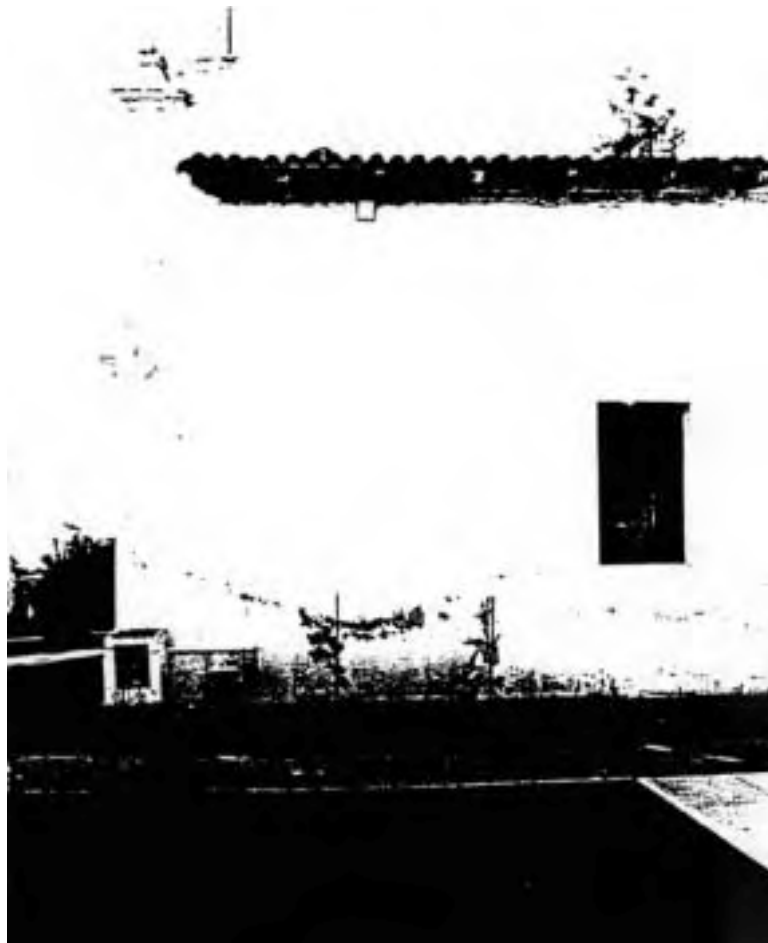
then has evaporated above a more impervious layer of exterior parging. Through cycles of wetting and drying and the deterioration of the plaster substrate by the deposition of soluble salts, the paint has either flaked off, or simply deteriorated in place.

Figure 16: A partial view of the north end of the west nave wall showing flaking paint along the north edge of the wall and above the base of the wall.
