NATIONAL GALLERY OF ART

**FINAL REPORT  
TO THE  
NATIONAL CENTER FOR PRESERVATION TECHNOLOGY AND TRAINING  
1997 GRANT PROGRAM**

2. Project title: RESEARCH INTO PROTECTIVE COATING SYSTEMS FOR OUTDOOR  
BRONZE SCULPTURE AND ORNAMENTATION. PHASE II.

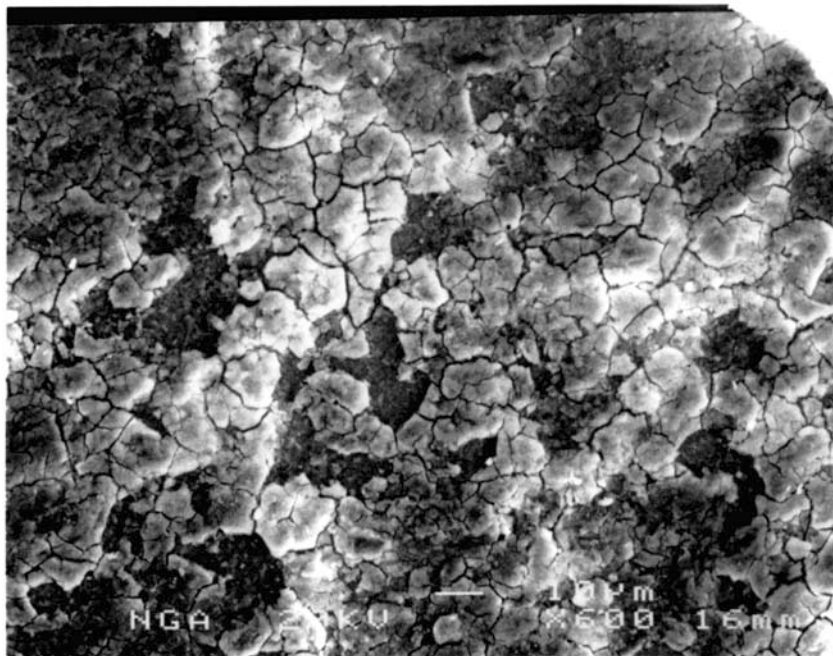
B

SEM of the artificial patina on bronze samples (Figure 1b) reveals a patchy, finely cracked mineral layer. This fissuring is finer in some areas than in others. EDS analysis of the artificial patina showed the presence of iron spread unevenly across the surface. No chloride or potassium was detected. The presence of sulfur could not be determined due to overlap with metal peaks. Aluminum and silicon were also detected; these are common contaminants, most likely found in the foundry environment. The average thickness of the patina was 0.2 mils (5 microns), which is less than experimental error using this method of measurement.

Figure 1: SEM photographs normal image of a) cast bronze (500x) and b) patinated bronze (600x).

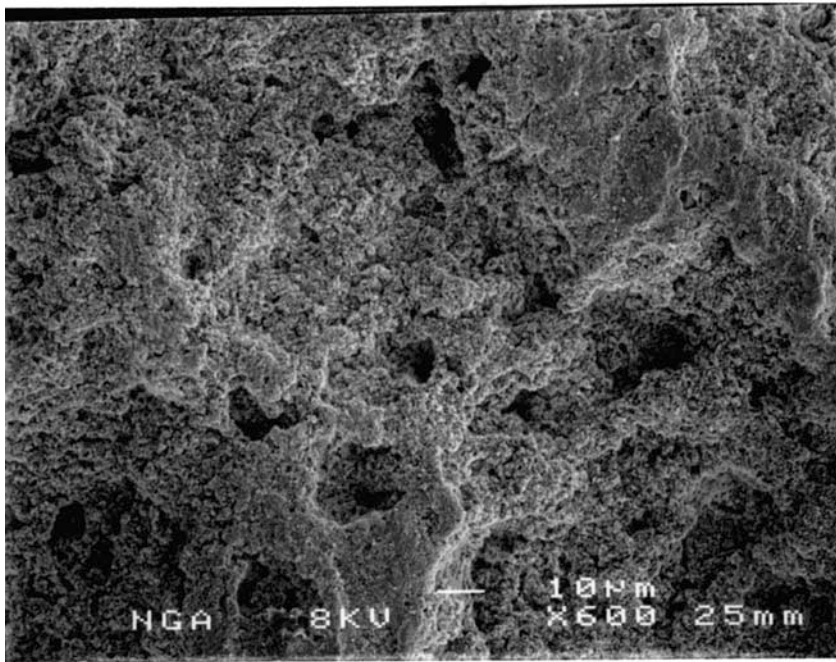
A

As described in the "Final Report to the NCPTT 1996 Grant Program," SEM imaging of the copper roof patina (Figure 2a) shows a very rough, but finely textured and porous morphology. EDS analysis of the green patina revealed the presence of aluminum, silicon, iron, and phosphorous contaminants in addition to copper, sulfur, and oxygen. The presence of phosphorous in outdoor bronze and copper patinas has been sporadically noted, particularly in connection with black spots on copper patinas, and has been variously attributed to airborne fertilizer-containing particles or pigeon droppings.<sup>12</sup> The other contaminants are commonly found in airborne dirt particles. No carbon was detected. (Nitrogen cannot be detected from this detector array.) It is interesting that SEM/EDS analysis of black spots in the patina revealed the presence of chlorine, calcium, and vanadium, the latter for which we can offer no explanation. The presence of silicon as well as aluminum also appeared relatively higher in this spot.

Figure 2: SEM photographs normal image of a) 50-year-old copper roof (600x) and b) 50-year-old copper roof, walnutshell-blasted (300x).

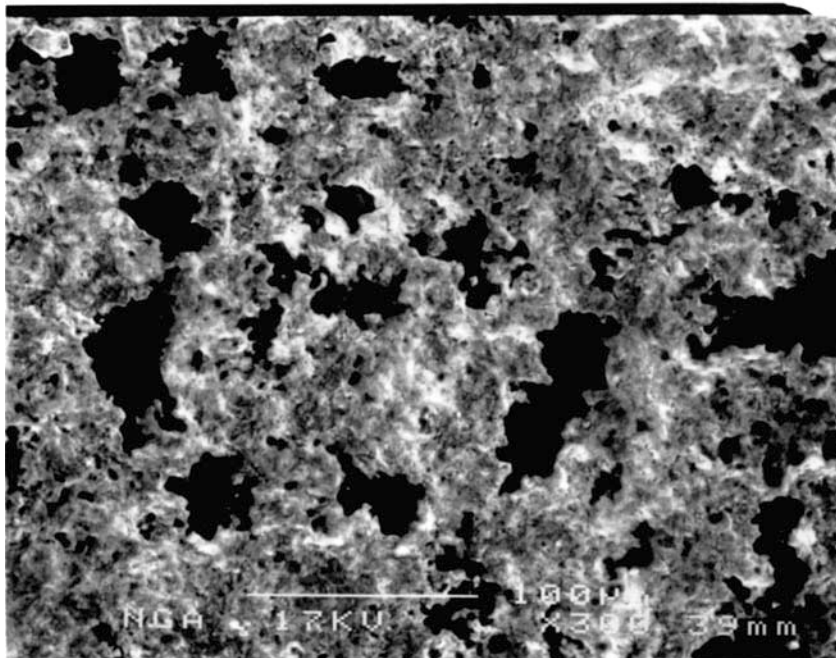
B

SEM of the walnut shell-blasted copper roof, shown at half the magnification of the unblasted roof surface (Figure 2b) shows a surface in which the voids in the top mineral layer appear greatly exaggerated. The mineral layer also appears denser and more compact or matted down, with fine cracking visible in spots. EDS results for blasted copper roof coupons, both with and without subsequent solvent cleaning, matched those for the unblasted surface with the notable exception of a carbon peak in both spectra. This evidence appears to confirm suspicions that walnut shell blasting leaves oily deposits which are not easily removed from the surface of treated metals. FTIR of the blasted patina was ambiguous regarding the presence of oil, however.

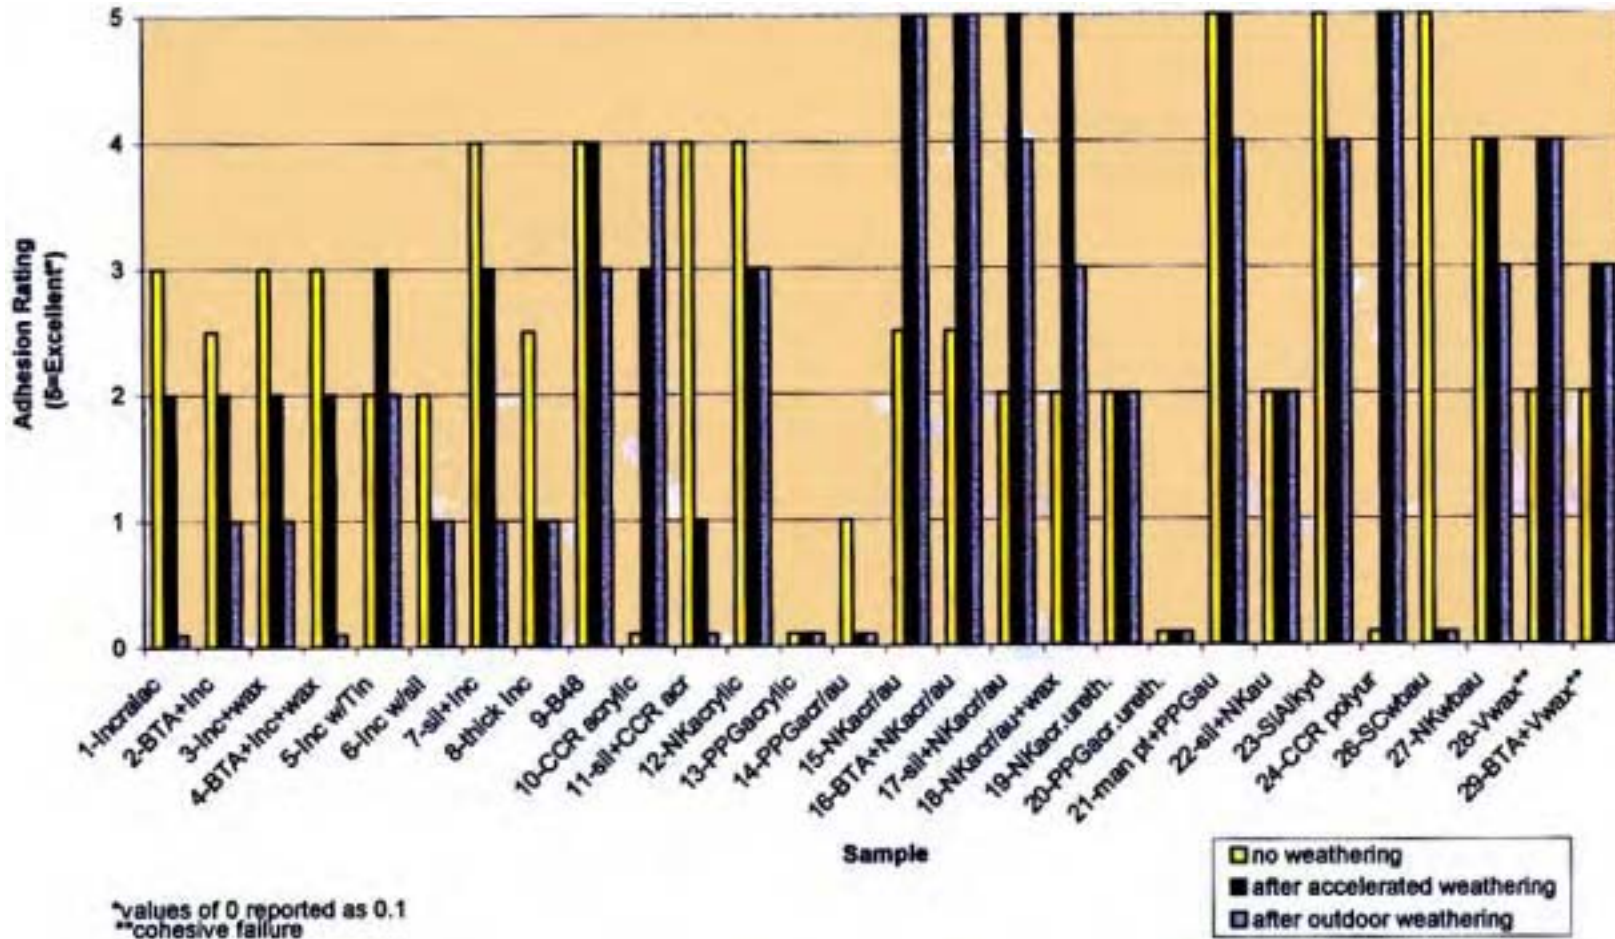
**Figure 6**

Cross-cut and X-cut adhesion tests for Phase I samples were re-evaluated in order to increase consistency of results between different operators. Results are shown in Figures 5,6. Slight adjustments were made in some cases; however, an error was found in the case of adhesion of StanChem waterborne acrylic urethane before weathering on polished, cast bronze. The initial adhesion rating for this coating was a four, not a zero (where 5 optimal adhesion), as previously reported. It was confirmed, however, that adhesion of this coating after accelerated and outdoor weathering fell- to zero. Adhesion rating checks also uncovered that the CCR waterborne polyurethane on polished, cast bronze has undergone aging in the laboratory/storage. The adhesion in this case was reported correctly initially as zero, but changed over time, without exposure to weathering tests, to a rating of five. Adhesion of the polyurethane to polished bronze also changed to a five after accelerated and outdoor weathering. It was observed that the polyurethane films have become extremely tough, so that it is hard to cut through with a scalpel.

**X-Cut Adhesion Ratings of Coatings on 50-Year-Old Copper Roof, Phase I, Before and After Weathering**

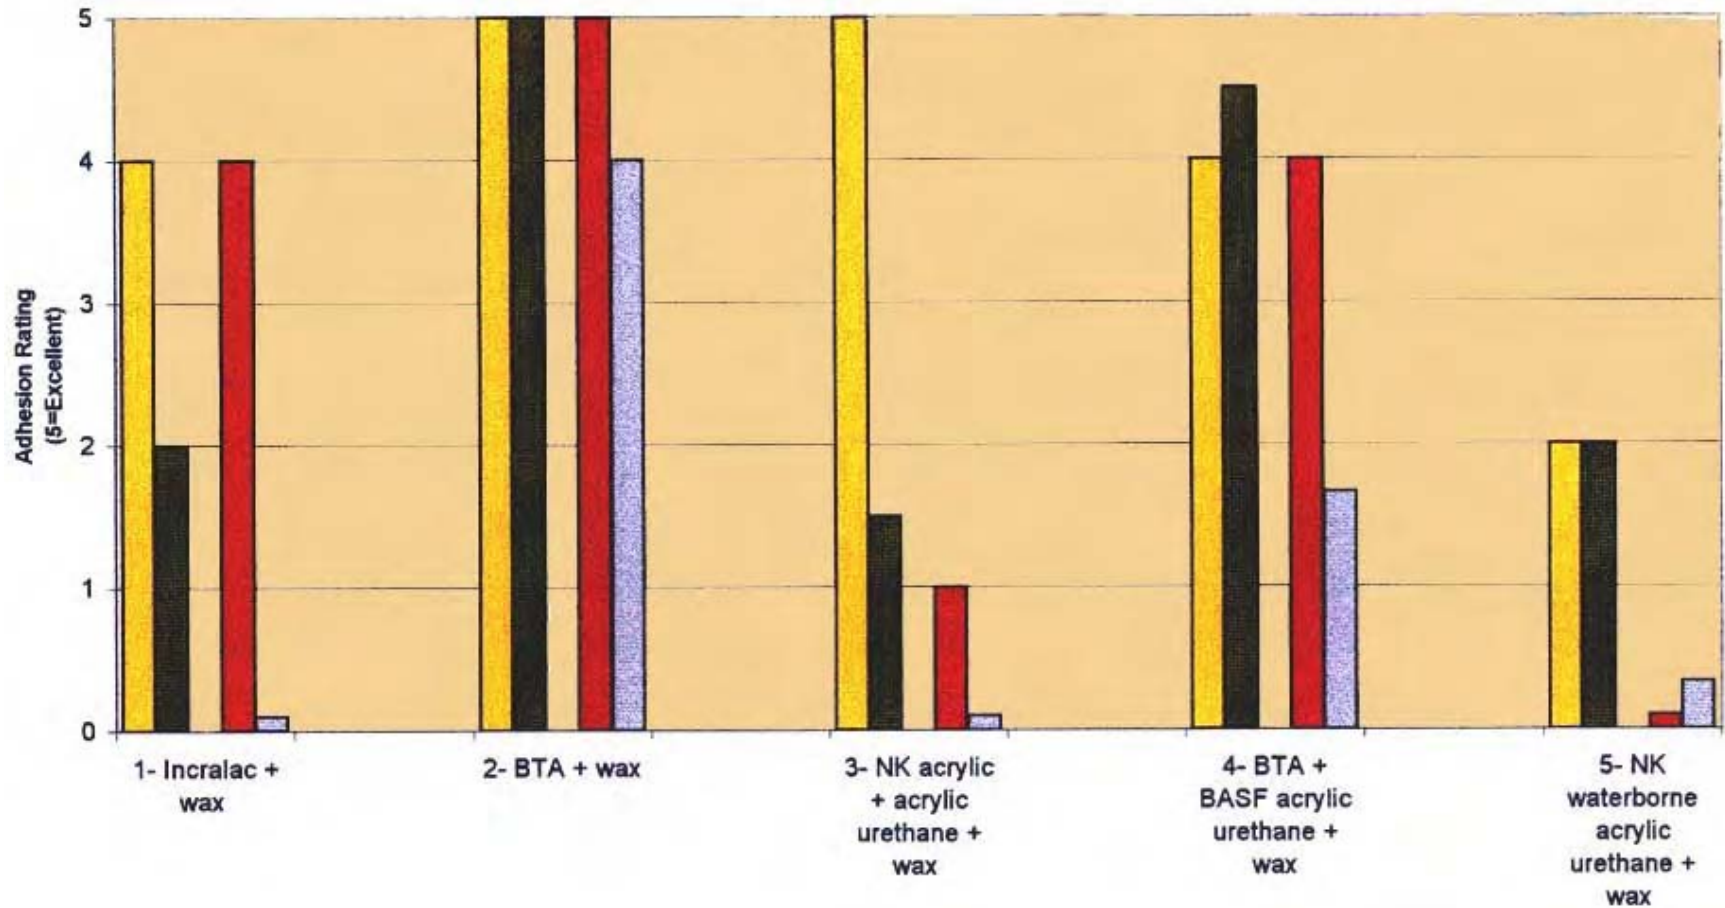
**Figure 8**

Results of cross-cut and X-cut adhesion tests for Phase II samples, before and after accelerated weathering, are shown in Figures 7,8. Results first of all show deceptively high ratings for the wax coating on all substrates both before and after weathering. This may be explained as difficulty in observing cohesive failure in the very thin wax coatings applied to Phase II samples, although this type of failure was observed in the thicker wax coatings of Phase I and most likely predominates in wax coatings. The remaining coatings on polished bronze show fairly good to excellent initial adhesion both before and after weathering, with the exception of the Nikolas waterborne acrylic urethane. In the case of Inralac and the Nikolas acrylic/acrylic urethane coatings, initial adhesion values before weathering are higher than in Phase I. This may be attributed to the slightly rougher polish finish on samples in Phase II, and the use of water polishing to produce cleaner surfaces. Both of these coatings also show a decrease in adhesion after weathering. This effect was observed only for the Inralac series coatings on bronze in Phase I, and cannot be explained for the Nikolas coating at this time other than possible differences in surface and coating preparation, or internal stresses resulting from application. Results also clearly indicate that adhesive failure was generally more prevalent in coatings on the artificially patinated bronze surface.

**X-Cut Adhesion Ratings of Coatings on 50-Year Old Copper Roof, Phase II,  
Before and After Accelerated Weathering**

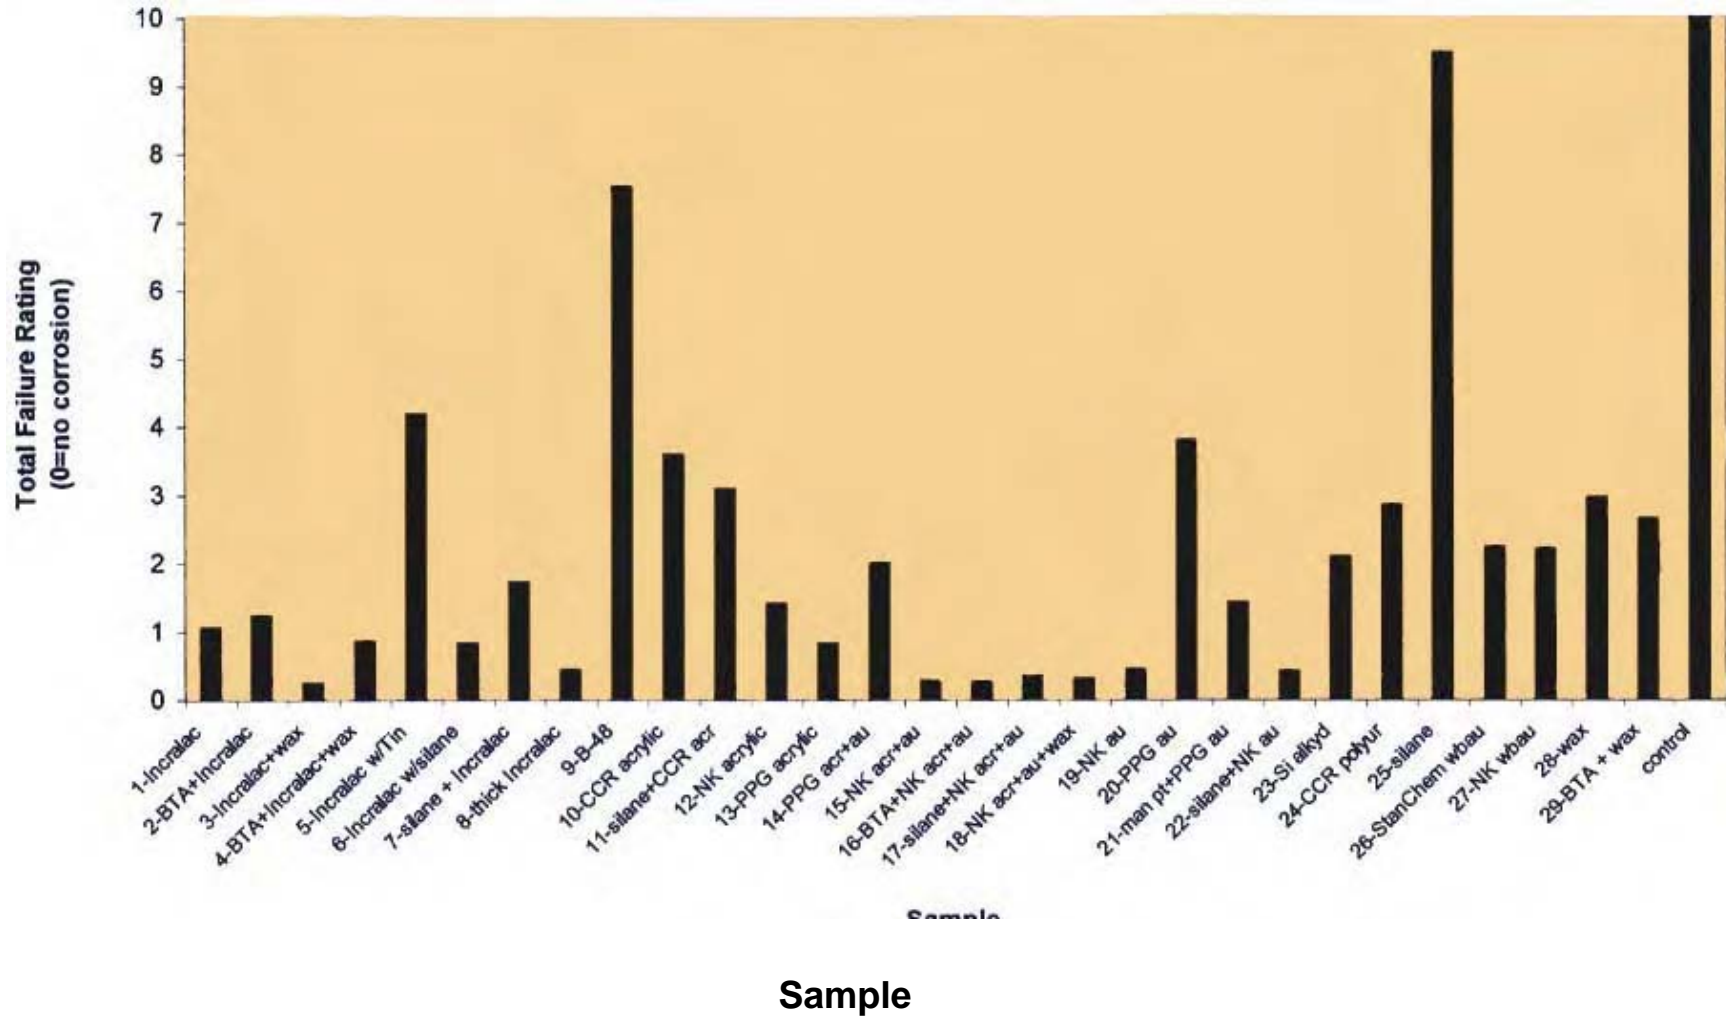
**Figure 11**

Failure ratings were recalculated for results obtained after both 1200 hours and 6 months total accelerated weathering according to methods described in “Experimental Methods” and are shown in Figures 10, 11. The new rankings do not markedly differ from those previously reported, but are believed to be more precise. Comparison of Figures 10 and 11 is especially interesting in respect to apparent differences in rates of failure. For example, after 1200 hours of weathering, most of the coatings in the Incralac series were performing only slightly worse than the Nikolas acrylic/acrylic urethane or single acrylic urethane coatings. But after 6 months of weathering, performance of the Incralac coatings was clearly lagging behind the others. This was also true for thick Incralac, showing that coating thickness was not the overriding factor in performance. However, two of the Incralac coatings, BTA pretreatment + Incralac + wax, and Incralac with silane, were doing somewhat better after 6 months, although still not as well as the Nikolas series. These results indicate a definite benefit from the coupling of BTA pretreatment and a wax topcoat. The addition of silane to the incralac may have caused some crosslinking in the coating, although this was not confirmed. This could have boosted performance, although crosslinking may not be desirable from the standpoint of removability.

**Failure Rating of Coatings on Polished, Cast Bronze, Phase I,  
After 6 Mo. Accelerated Weathering Based on Visual Evaluation of Coating Appearance,  
Overall Corrosion, and Corrosion at Scribemark  
Sample**

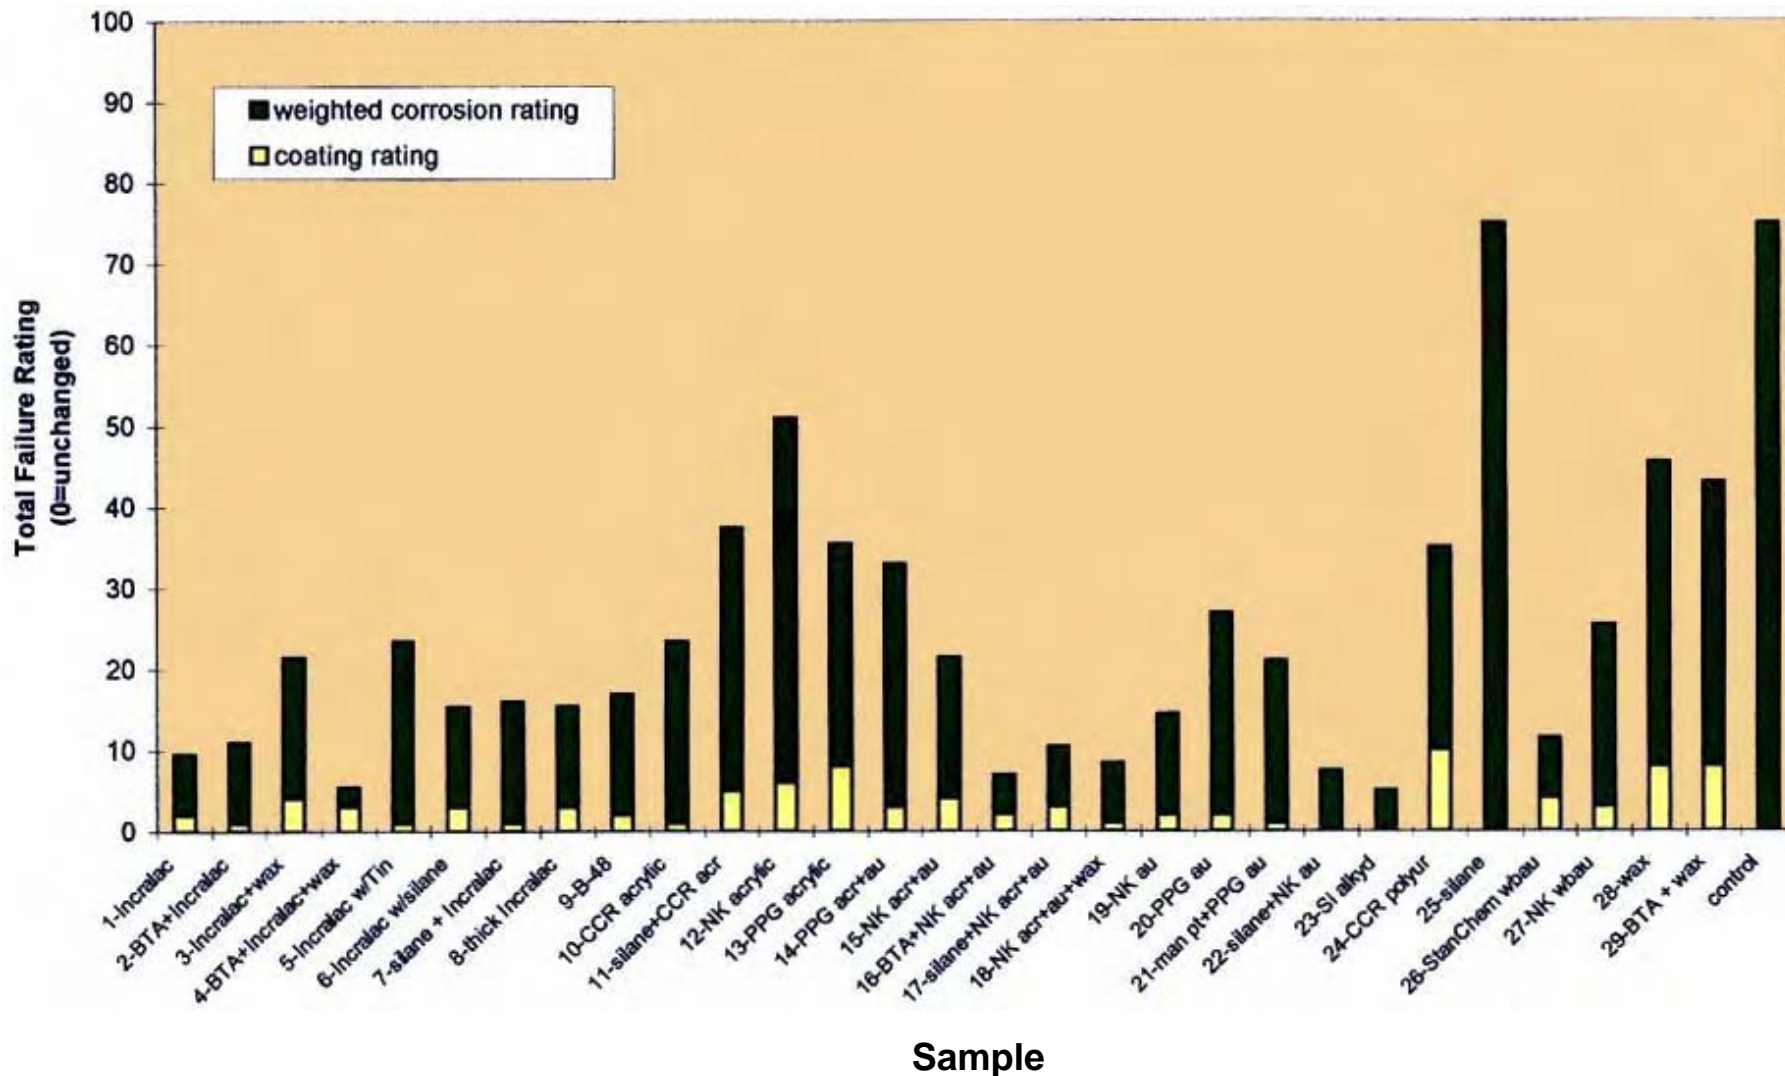
**Figure 13**

Failure ratings for coatings on copper roof substrates after 6 months of accelerated weathering are shown in Figure 13. Little or no light green pitting corrosion was produced on the substrates in this weathering regime, and new, dark green or red corrosion was difficult to judge from the top surface. For these reasons, failure ratings were more difficult to obtain than on bronze. It should be noted that corrosion rates on a fresh metal surface are expected to be higher than on an already oxidized/corroded metal, and thus show greater initial change in appearance.

**Failure Ratings of Coatings on 50-Year-Old Copper Roof, Phase I, After 6 Mo. Accelerated Weathering, Based on Visual Evaluation of Coating Appearance, Overall Corrosion, and Corrosion at a Scribemark**
