# SCIENCE OF TSUNAMI HAZARDS

Volume 23 Number 2

# **EFFECTS OF MEDU AND COASTAL TOPOGRAPHY ON THE DAMAGE PATTERN DURING THE RECENT INDIAN OCEAN TSUNAMI ALONG THE COAST OF TAMILNADU**

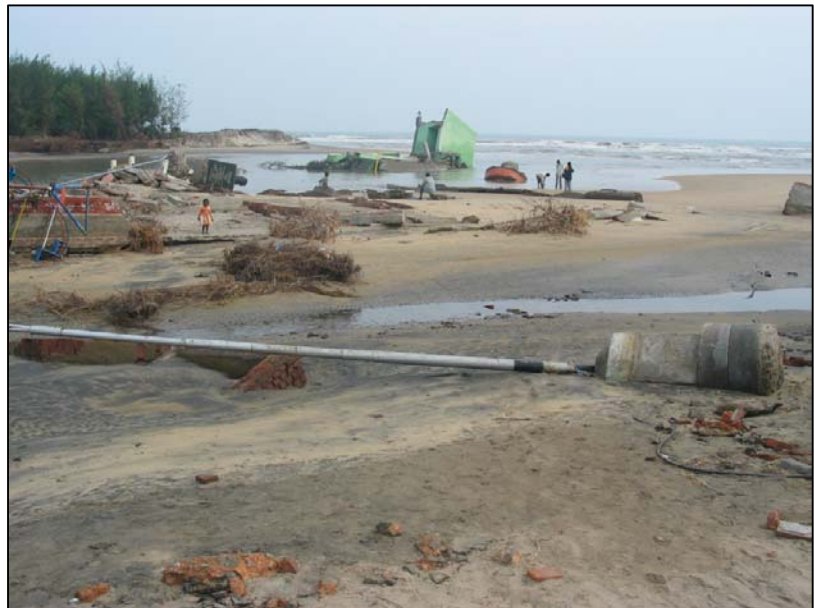
**Figure 3:** Depicts the damaged children’s park, uprooted electric pole, damaged SINGNADH and the collapsed auditorium on Nagapattinam Beach.

Nagapattinam beach, a newly constructed tourist spot was completely destroyed (Fig. 3). Extensive ground erosion and uprooting of trees was observed every where (Fig. 4 & 5). Many structures suffered damage of grade G4 and some destroyed. Severe damage to lifelines (road, bridges, telephone and electric poles and railway line), port and harbors took place (Fig. 5). Many big boats/vessels were thrown violently towards the coast (Fig. 6). It seems that lesser width of continental shelf near the coast of Nagapattinam district and the interference of the direct waves and the reflected waves from Sri Lanka developed largest tsunami run-up (10-12 m) in Nagapattinam district (Fig. 2). On the other hand, much lesser damage occurred along the coast of Kanchipuram district due to some what wider continental shelf (Besana et al, 2004).

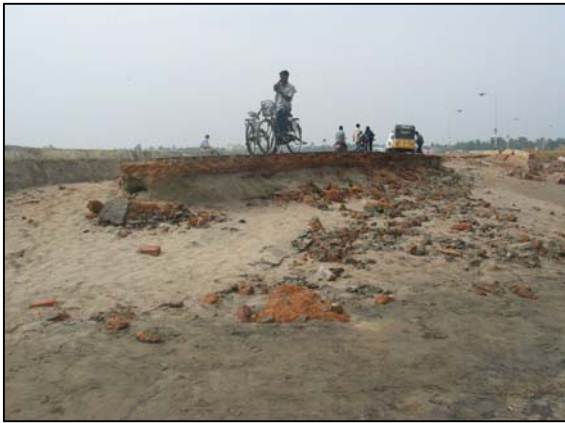
**Figure 4:** Intense erosion of front portion of beach road, facing to the sea coast at Nagapattinam beach.

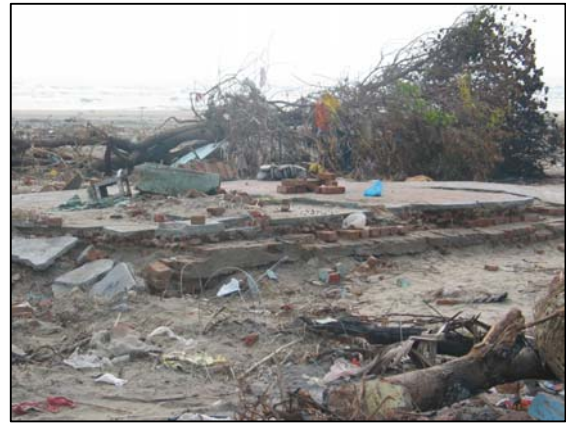
**Figure 5:** Uprooting of the trees and washing away of destroyed building materials in Vellaipallyam village

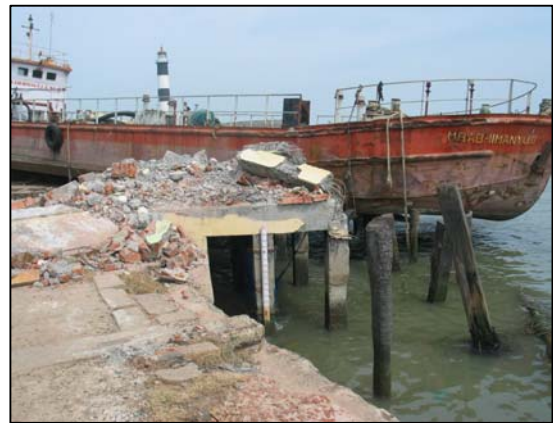
**Figure 6:** Damaged structure on the Nagapattinam Port due to the collision of a boat thrown by tsunami.

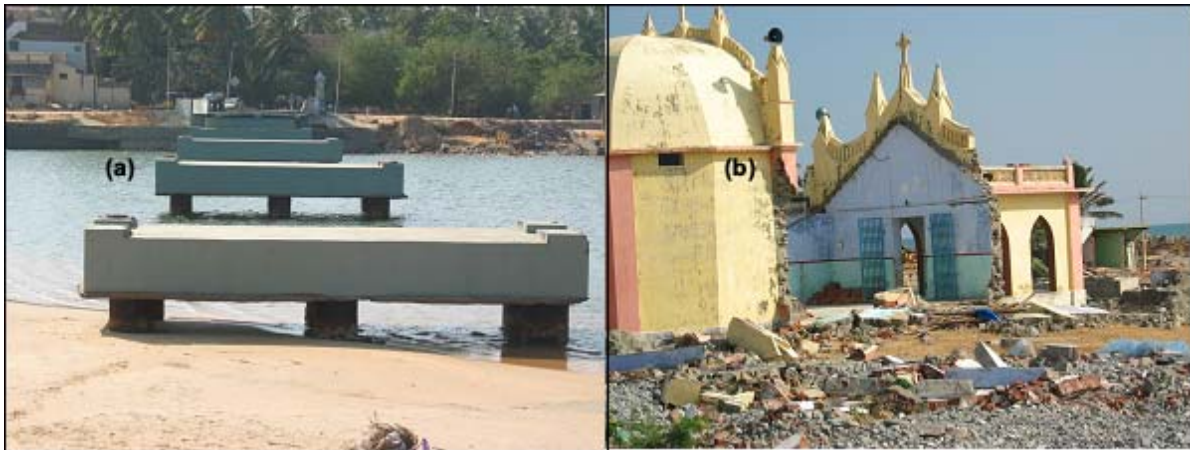
**Figure 7:** Damaged bridge on the Palyar River, whose spans of the deck were washed away (left), and partially collapsed Church of Keelmanakudy Village (right).

All the four spans of the deck were washed away by the tsunami and two were missing. Almost every building of good quality along the seashore suffered heavy damage (Fig. 7b). Damage to masonry buildings was quite intense; few of them not only collapsed but were completely flattened. There was intense erosion to a road linking the village to the bridge. Variation in tsunami run-up/damage along the west coast of Tamilnadu can be explained considering the interference of first receded waves with the reflected waves from Maldives Islands and the lesser width of continental shelf (Fig. 2). It has also been reported in the literature that some times the later arrivals cause more severe damage (Bryant, 2001).

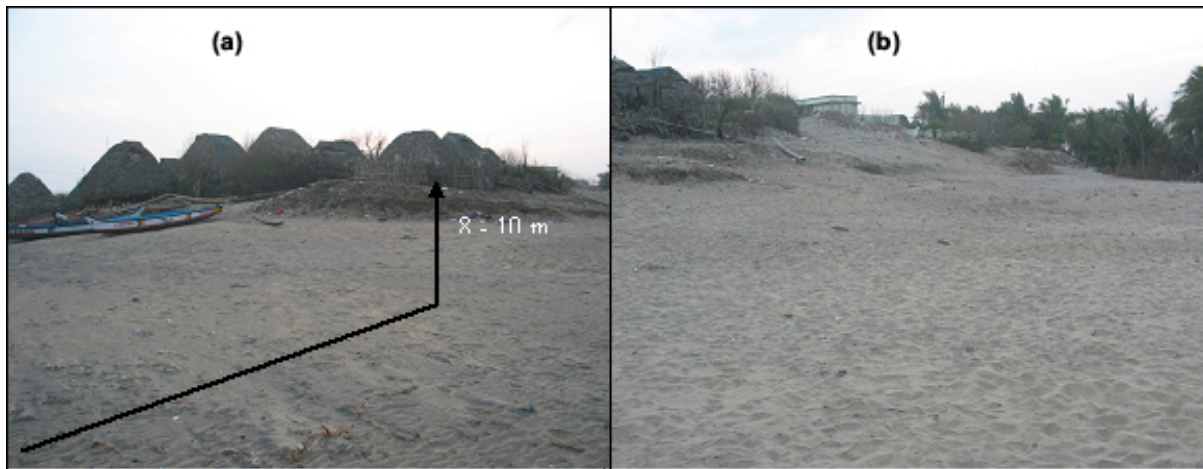
**Figure 8:** Illustrates the different views of the Killinjal Medu and the little damaged house/huts on the Medu.

Figure 8 depicts houses and the Kilinjal Medu from different locations. We observed that there was no damage to even huts built on the Medu (Fig. 8a). The presence of Medu prevented damage of many huts/houses behind it and finally the loss of human life also. Figure 9a shows a hut, which suffered almost no damage since it was behind the Medu. Severe damage to collapse of houses occurred to the north and south of Medu. Figure 9b depicts damaged houses, which were situated to the north side of the Medu. It was general feeling of the residents of this village that Medu has saved much loss of human life and houses.

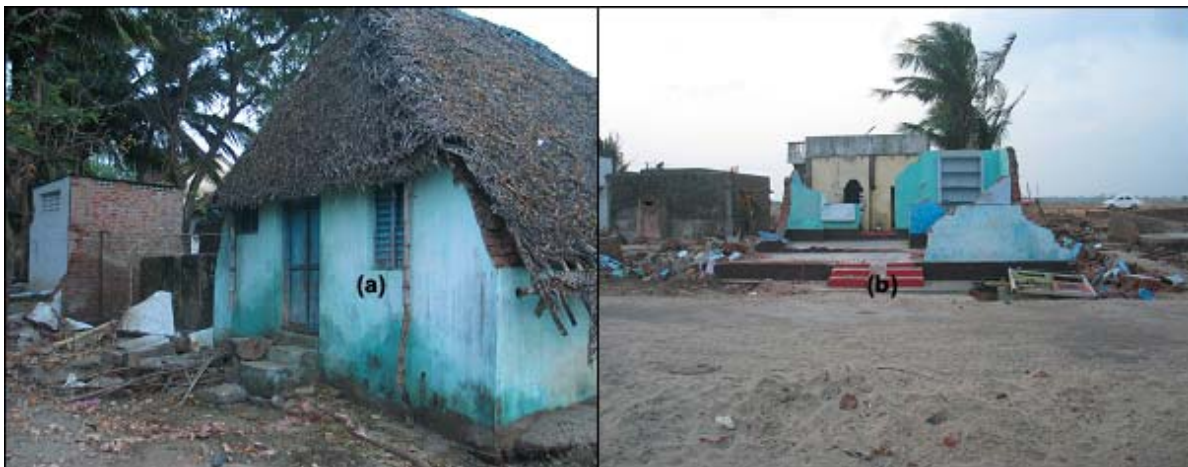
**Figure 9:** Depicts lightly damaged houses behind the Kilinjal Medu (left), and destroyed structures north of the same (right).

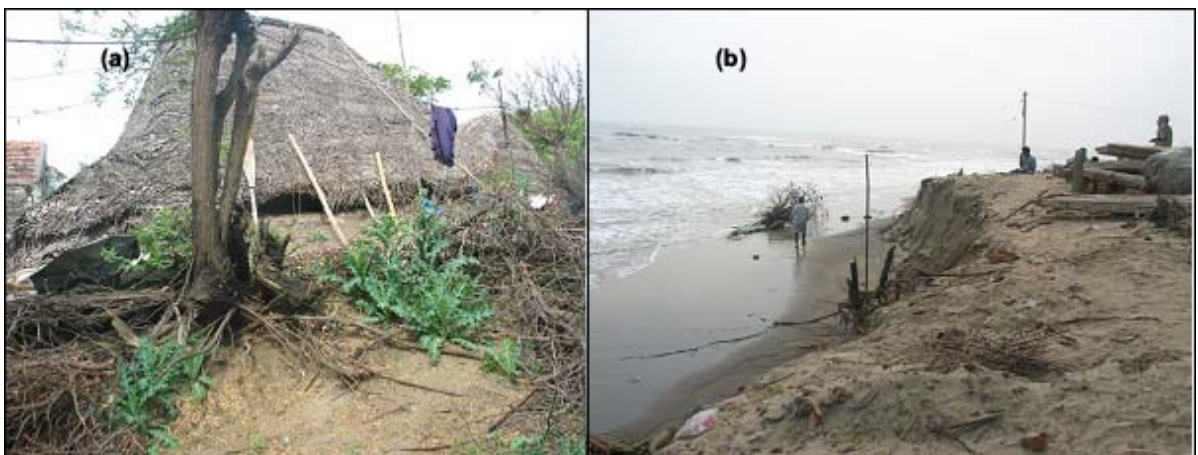
Very less damage was observed to the buildings behind the Medu. The huts on the Medu suffered no damage, since tsunami waves were unable to cross the Medu. The height of the Medu was around 14 m. It has steep slope towards north and sea but has gentle slope towards south and behind. Some huts were also washed away which were in front of Medu and at lower elevation. It was reported that coastline has come near to the Medu by 50 m. On the south side of Medu where elevation was lesser houses suffered severe damage. Intense erosion towards north of Medu was observed (Fig. 11b).

**Figure 11:** Lightly damaged hut on the front portion of the Nabiyarnagar Medu (left), and intense erosion of coastal land, north of the Medu (right).

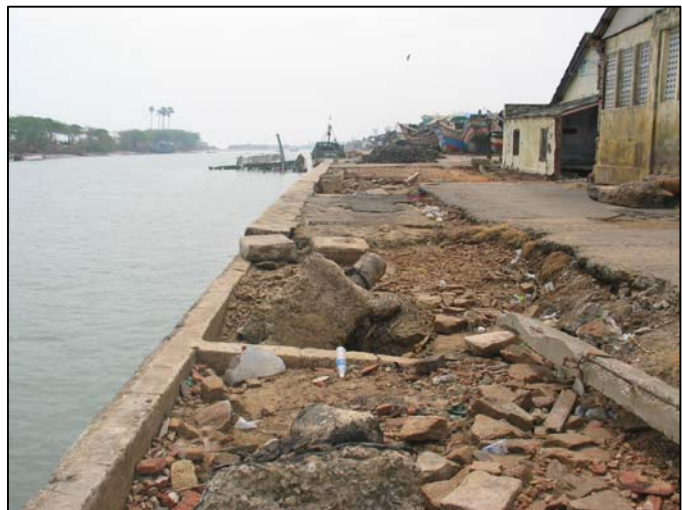
Lesser damage occurred just behind the Medu, as can be inferred from the figure 13 in which there is lesser damage to wharf in its upper and left corner. Same was the feeling of employees of this port that Medu in front of the port reduced the damage to some extent, particularly to the structures and boats in the Kaduvaiyar River, as reported by Mr. Shajath Ali (Assistant Engineer, Mechanical). On the other hand, Nagapattinam Port suffered heavy damage and it was not in operation for 15 days. Tsunami caused heavy damage to wharfs (Fig. 13), boats (Fig. 6), compound wall and an old jetty constructed in 1972.

**Figure 13:** damaged wharf of the Nagapattinam Port.

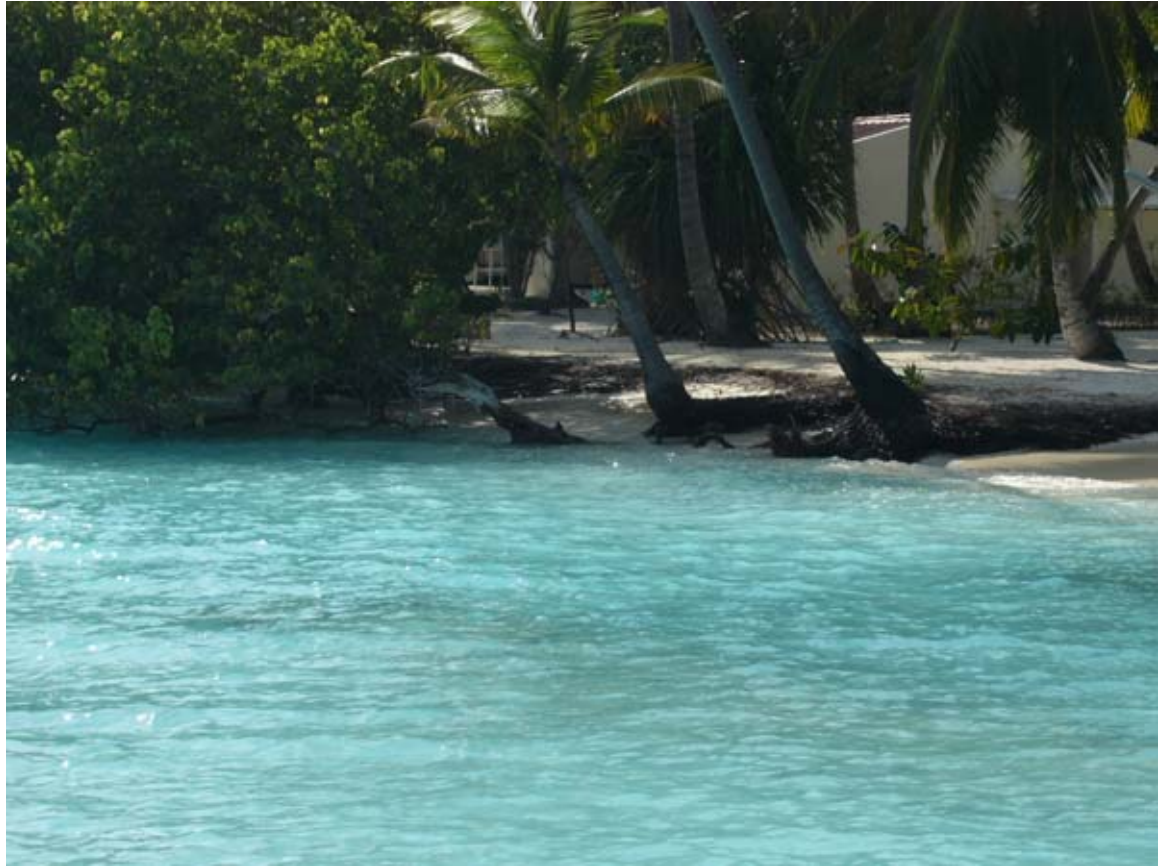
**Figure 2. Photograph of Villivaru. These resort room units were flooded due to their proximity to the coast and the fact that this is a very low-lying islands (roughly 0.5 m above sea level).**

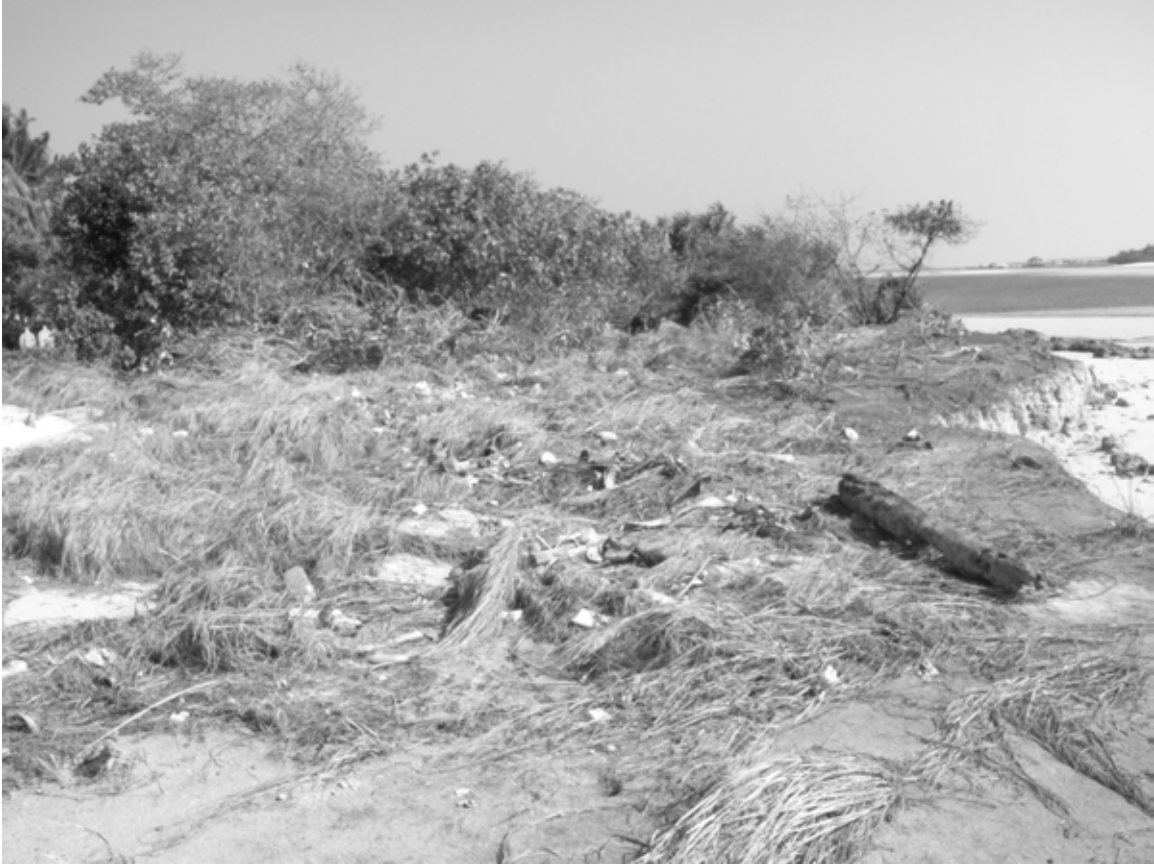
**Figure 3. Photograph of the vegetation that was laid back onto Guraidhoo Island by the tsunami inundation. This shoreline is situated between Guraidhoo and Lhosfusfi Islands. A log (at right) and corals (5-8 cm across) have been thrown up on the island surface.**

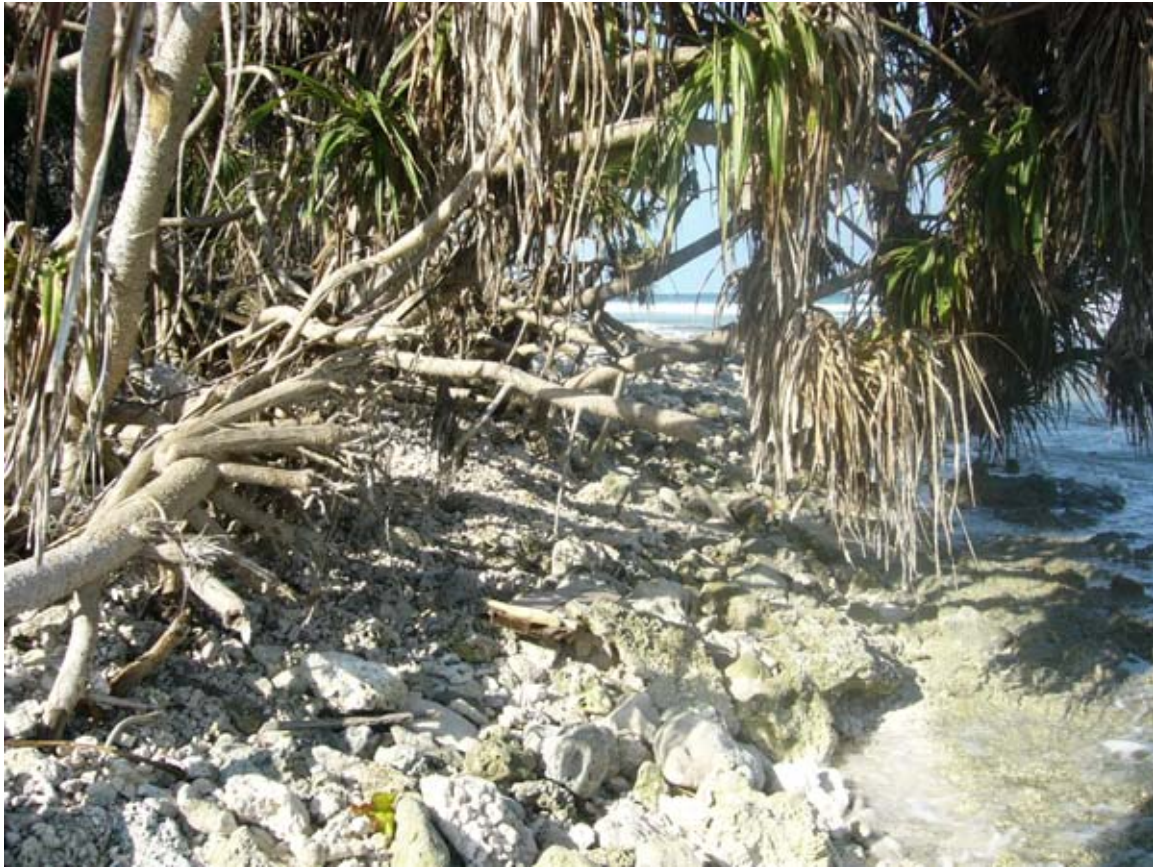
**Figure 4.** This tree is the *Pandanus* tree. Because the tree proves a broad cross-section to the sea, it stopped corals from being transported onto the surface of the island. These trees were buried in several cms of coral clasts.

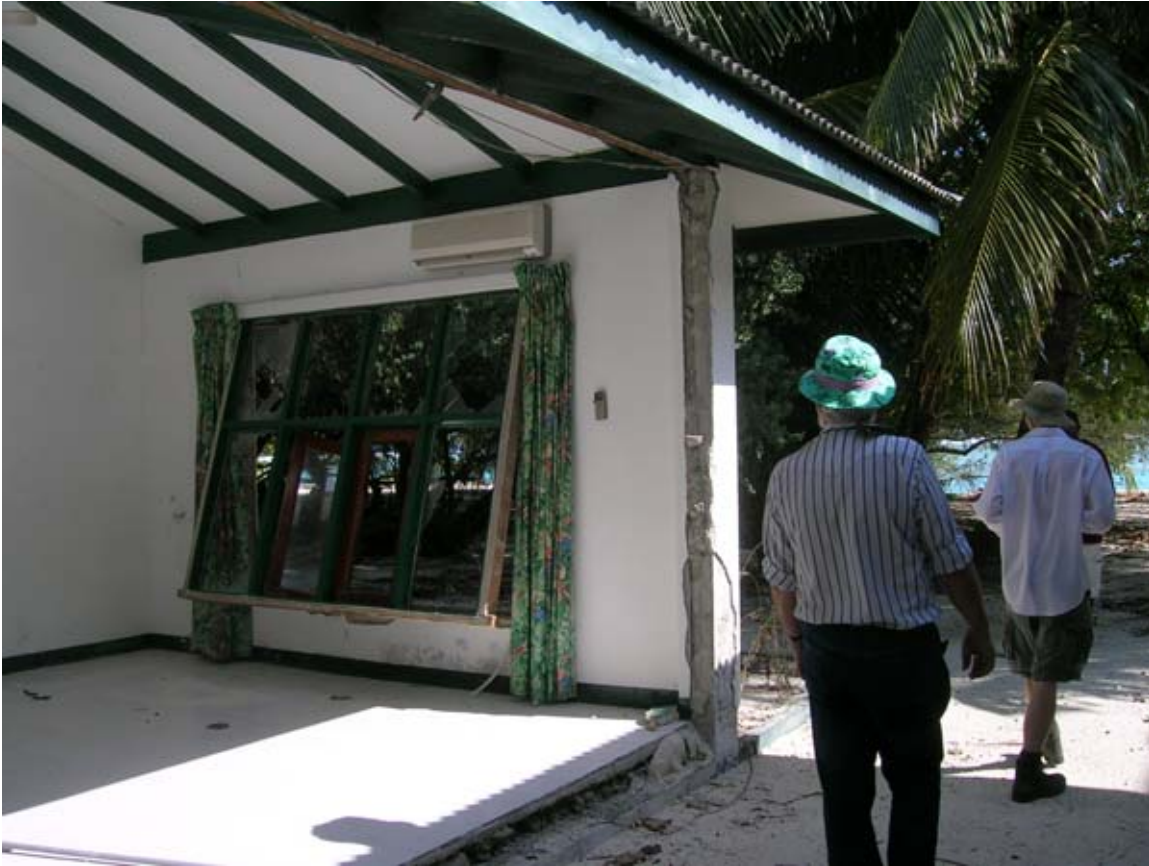
**Figure 5. The interior of this resort room unit on Kandooma was destroyed by the tsunami. The building lost the sidewall; and the window units were forced in by the force of the tsunami. The air conditioning units above the windows, and the lighting and electrical fixtures were filled with seawater. The contents of the room were spread over the island. The exterior doors (front and back) on many units were torn away or damaged.**

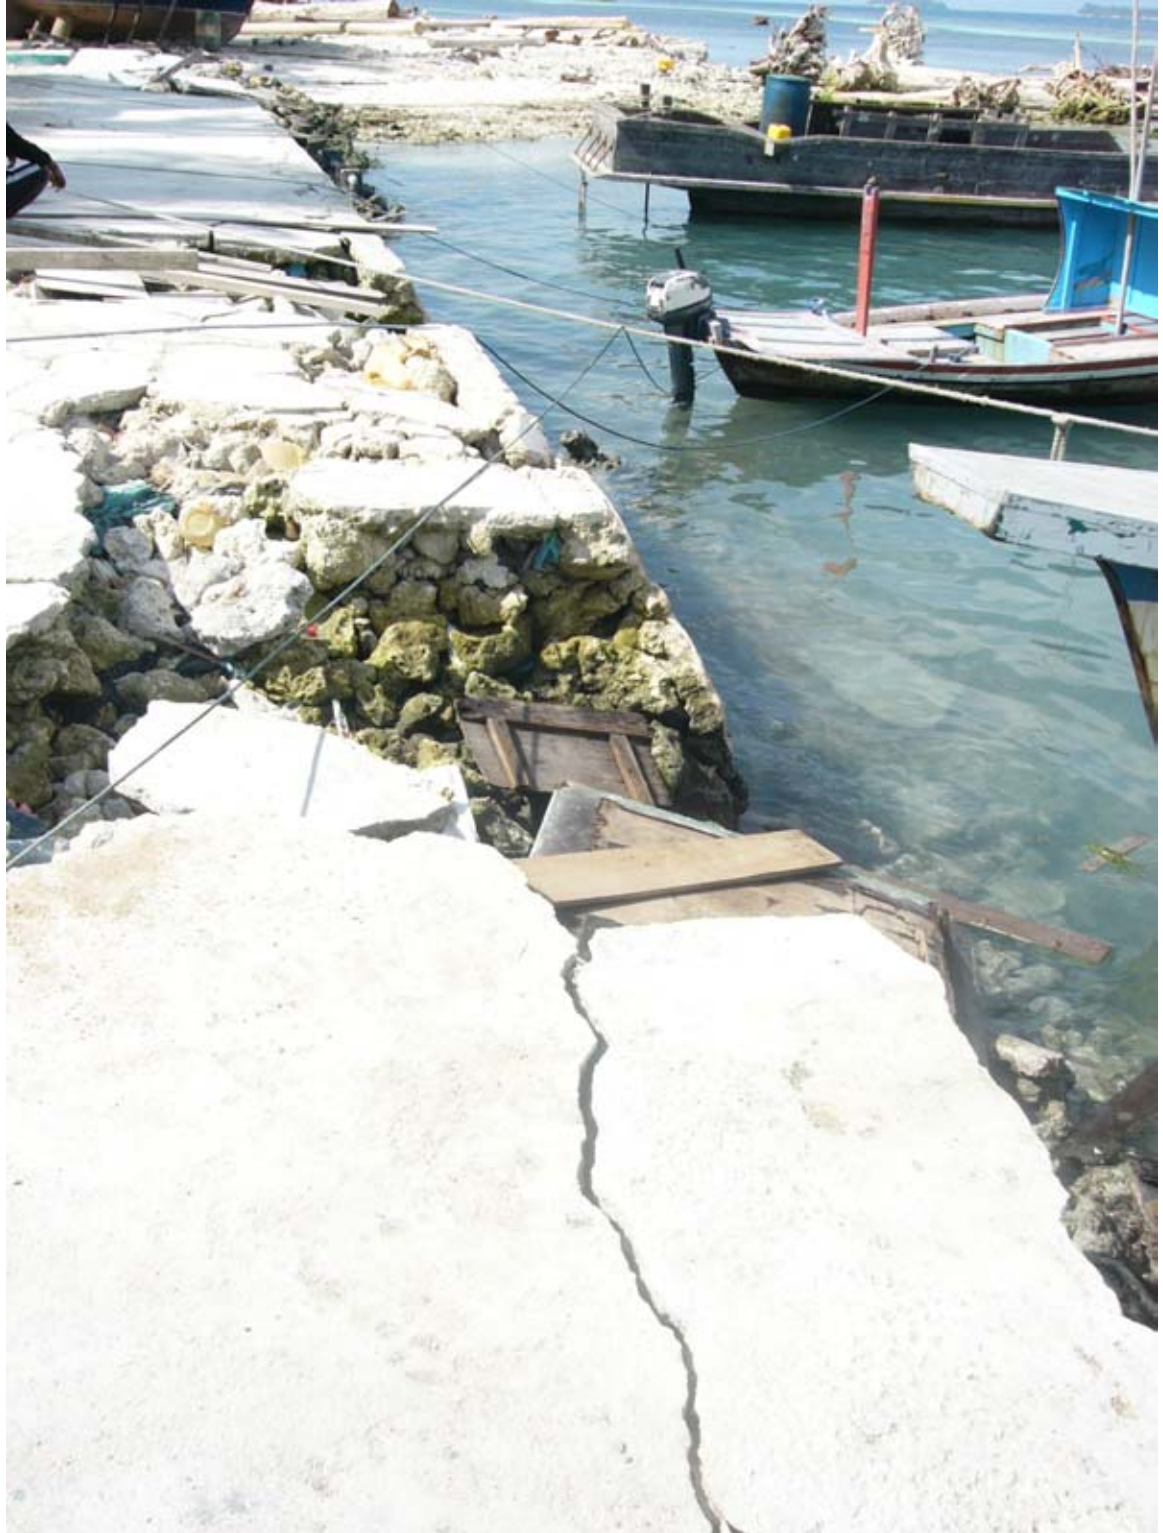
**Figure 6. It was common to see piers like this one damaged or toppled by the drawdown. The waters draining from the islands eroded behind the piers and the concrete structures were heavily damaged or destroyed. This photograph shows the damaged pier at Maafushi.**

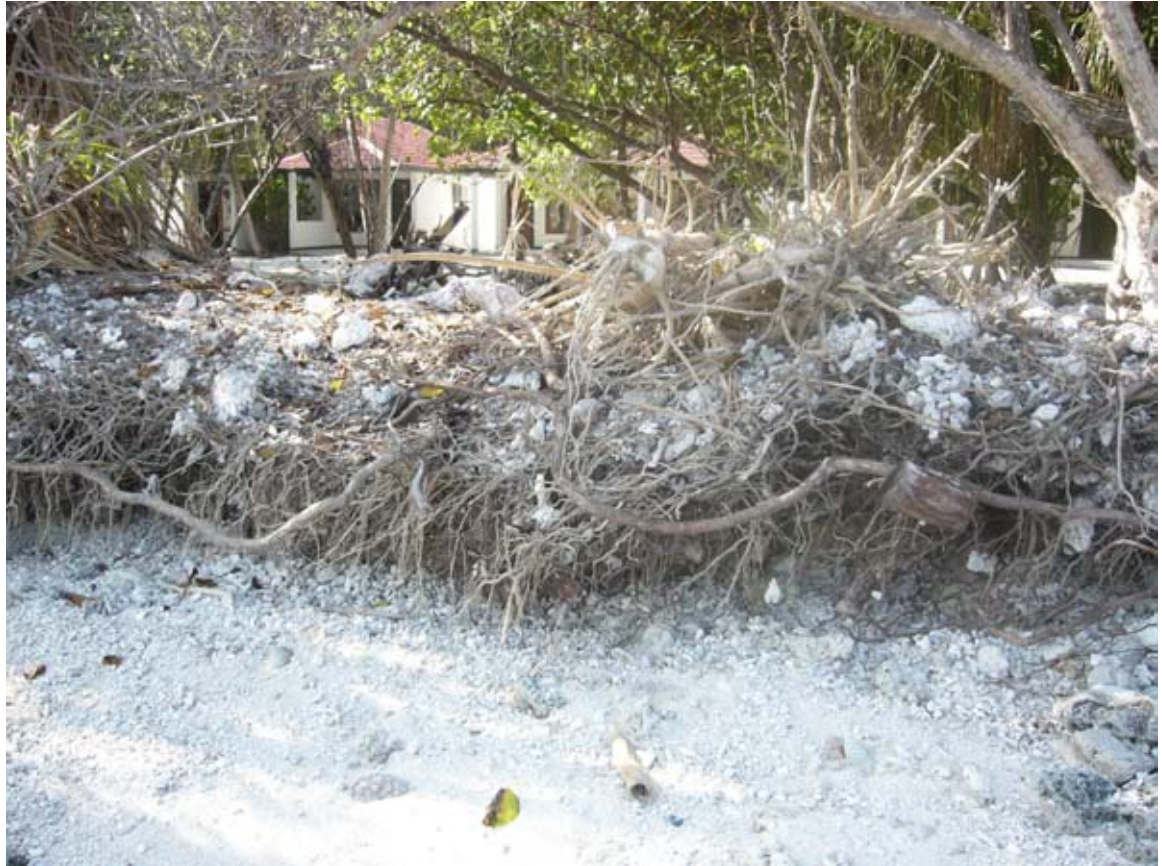
**Figure 7. The vegetation was heavily damaged by the tsunami. At right a shrub has been toppled and laid back onto the surface of the island. The thick root mat of the trees has been undermined by sand erosion and blocks of coral were caught in the vegetation. In the background is one of the room units on Kandooma Island, where doors and windows were removed by the tsunami flooding.**

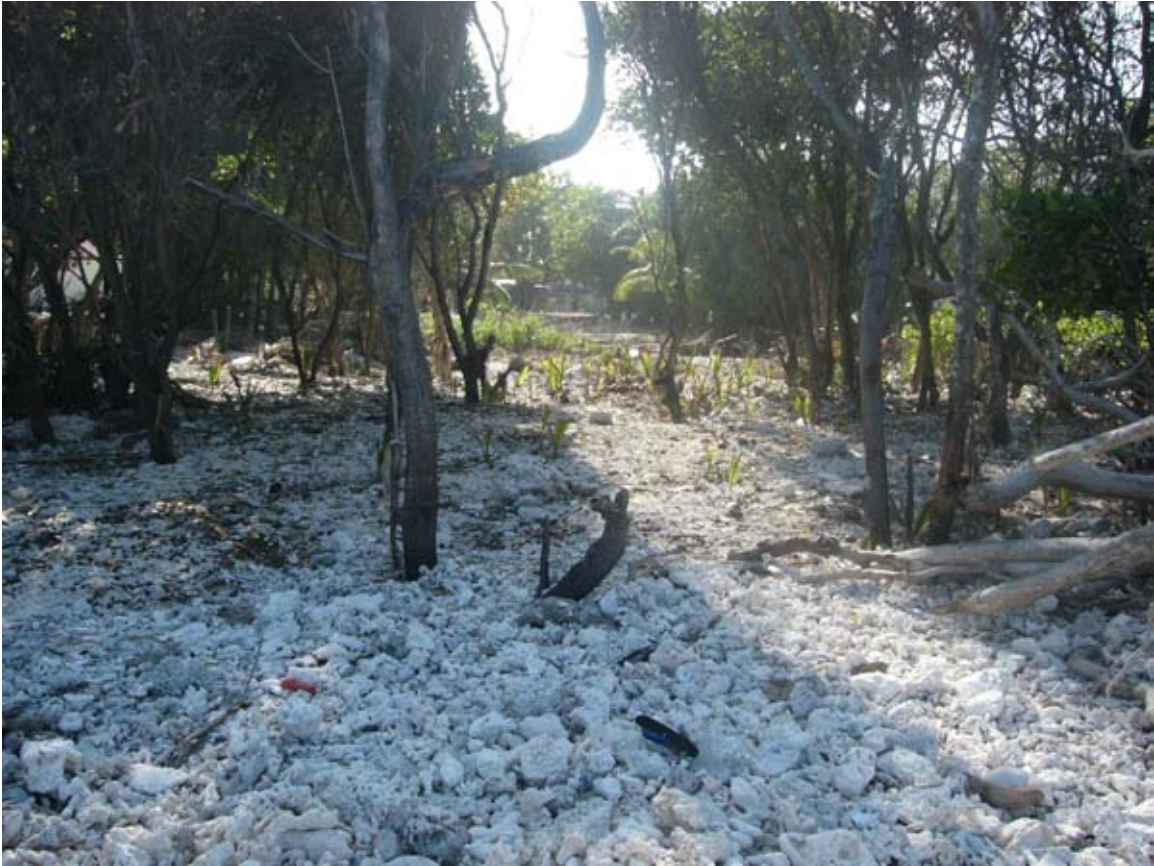
**Figure 8. On the east side of Kandooma Island, coral clasts were washed over a berm and onto the surface of the island. The trees are buried in corals about 20 cm in depth. The coral rubble extends about 20 m inland from the sea. Broken trees can be seen to the right.**

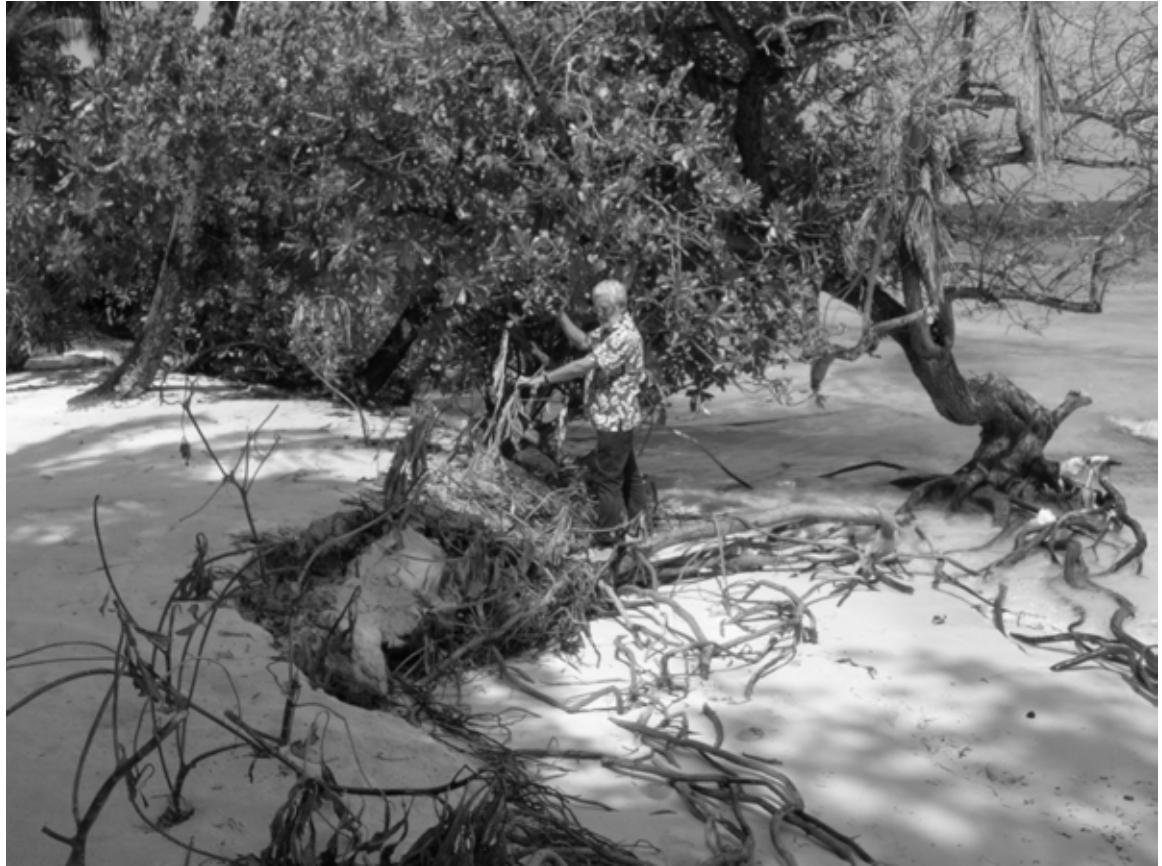
**Figure 9. The most obvious tsunami damage was to the vegetation. This photograph demonstrates the extent of erosion and under-mining of the vegetation. The tree in the photograph is now standing in the sea. The roots of the trees are now exposed above sea level. Many trees were killed, undermined, damaged by salt, and their leaves stripped.**

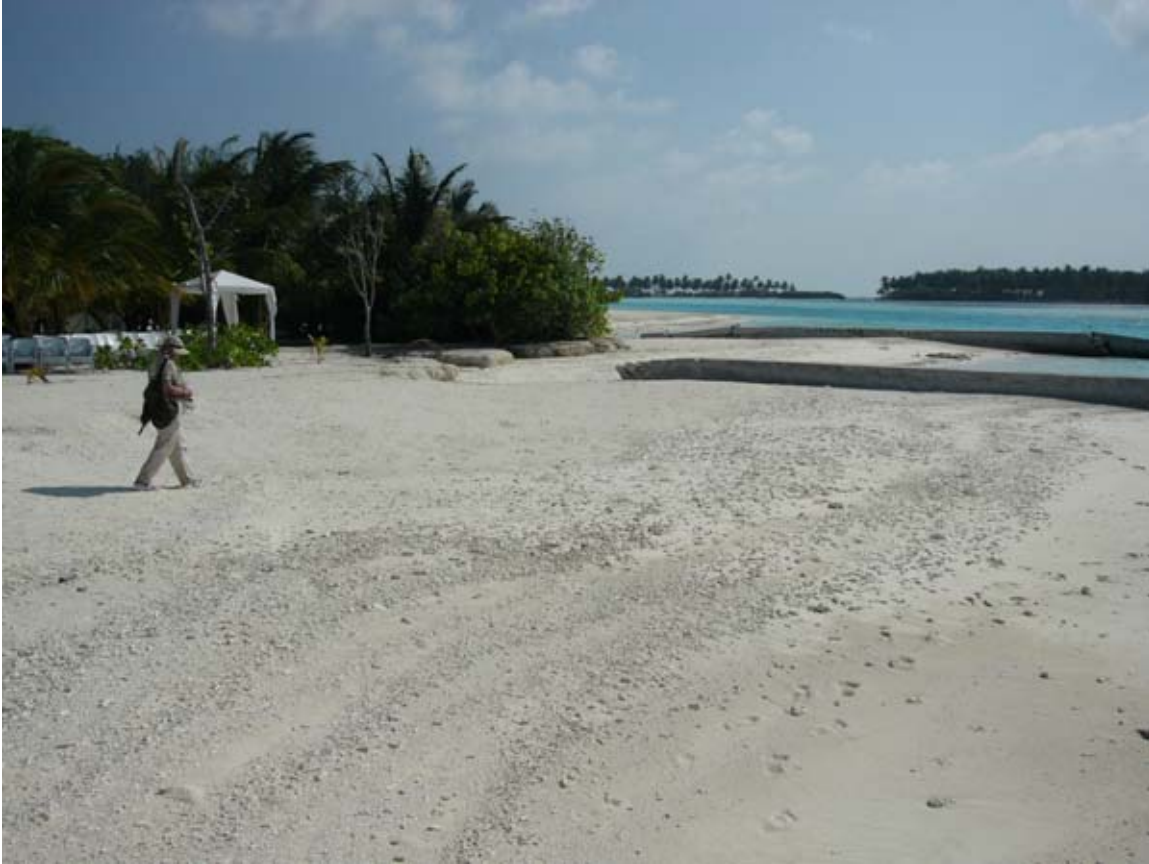
**Figure 10. The reclaimed beach on the east side of Kandooma Island was heavily eroded, with incised gullies (shown at center of the photograph) removing a meter of sediments. The erosion undermined the two concrete jetties so that the inland portions of the structures are entirely missing. A plastic lawn chair was wedged underneath the closer jetty. A great deal of beach and lawn furniture was permanently lost during the tsunami.**

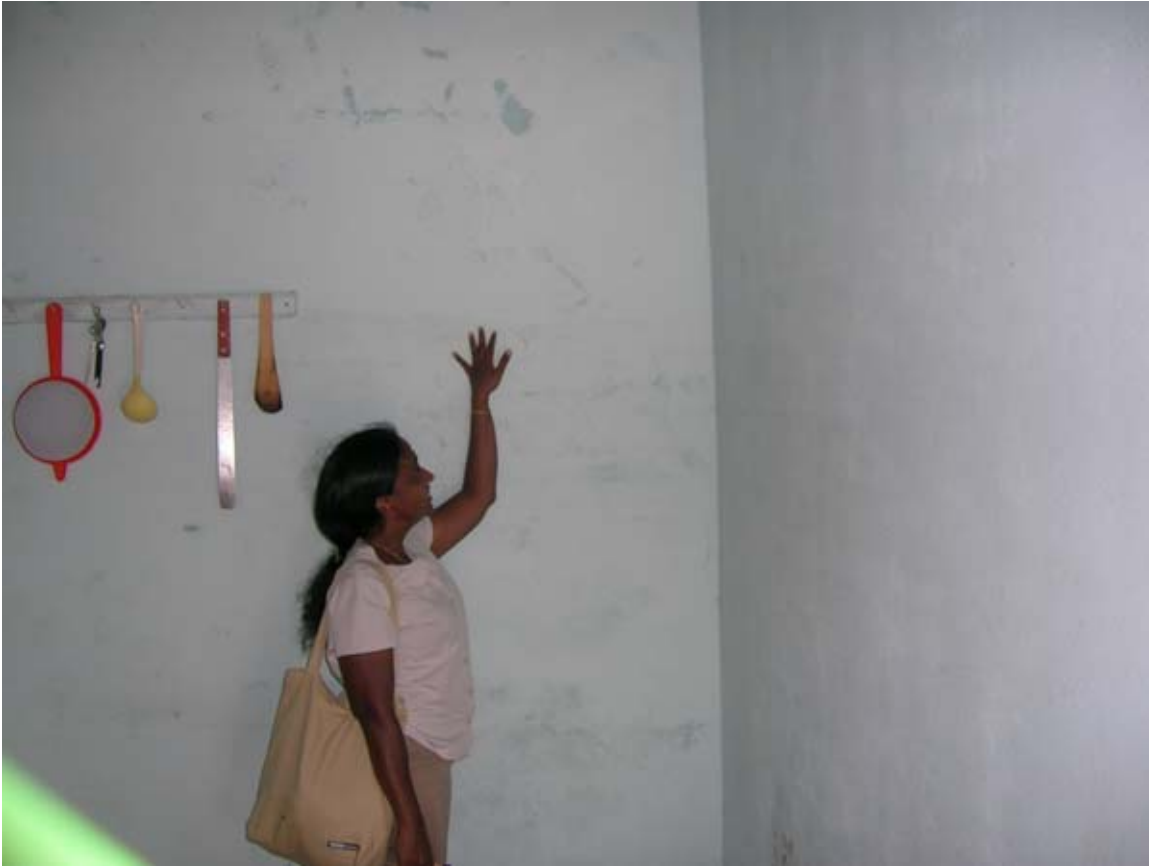
**Figure 11. This photograph illustrates the flood lines preserved on the interior walls of a partially destroyed residence on Maafushi. The waters flooded this home to roughly 1.5 m. The occupants were forced to swim in order to survive the tsunami.**

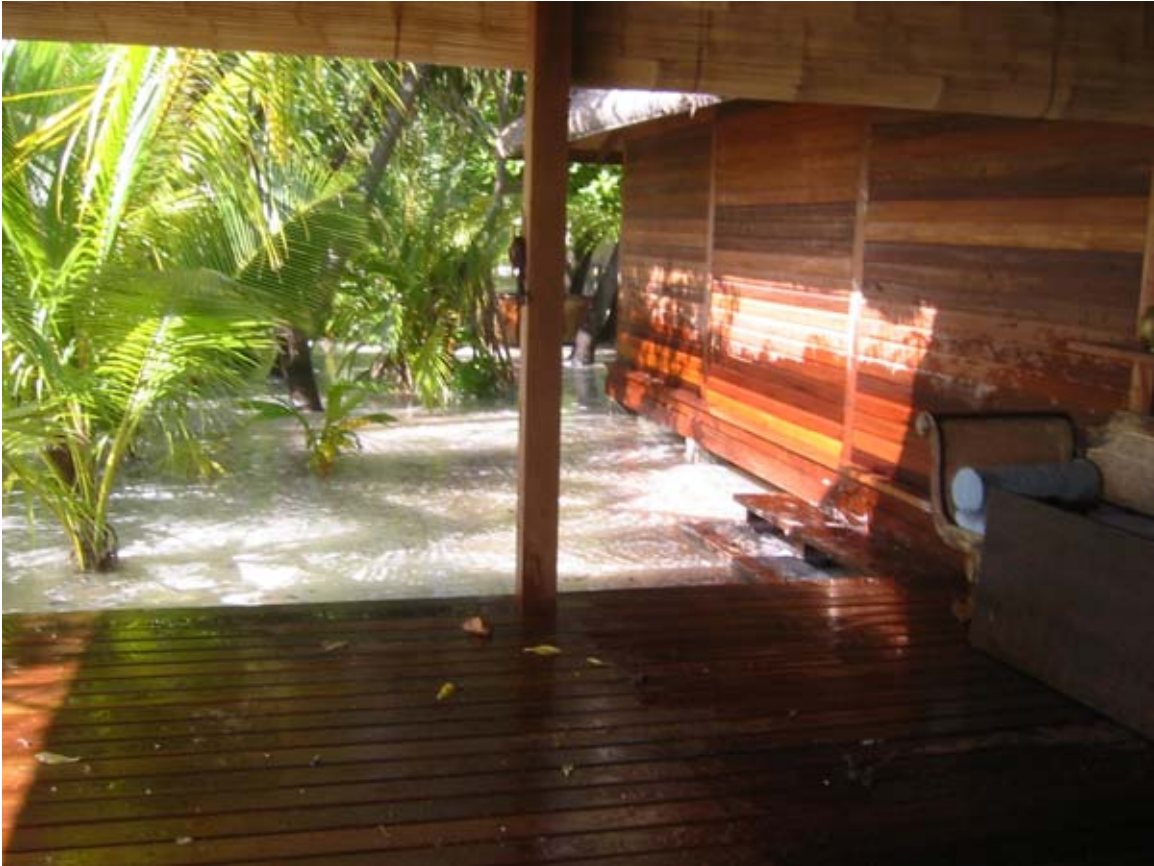
**Figure 12. Employees of the Cocoa Island Resort, in the Maldives Islands, took this photograph of the tsunami flooding. The tsunami flooding at the time of this photograph is roughly 20 cm deep. The seawater is laden with sand, resulting in a milky appearance. The wall at right has been wet by the tsunami inundation. The splashy or turbulent nature of the inundation is evident from the uneven splash lines on the wall. The splash is roughly 1 m above the island surface. The buildings on the island were inundated by water. The flooding damaged computer equipment, bedding, and furnishing but very little structural damage occurred.**

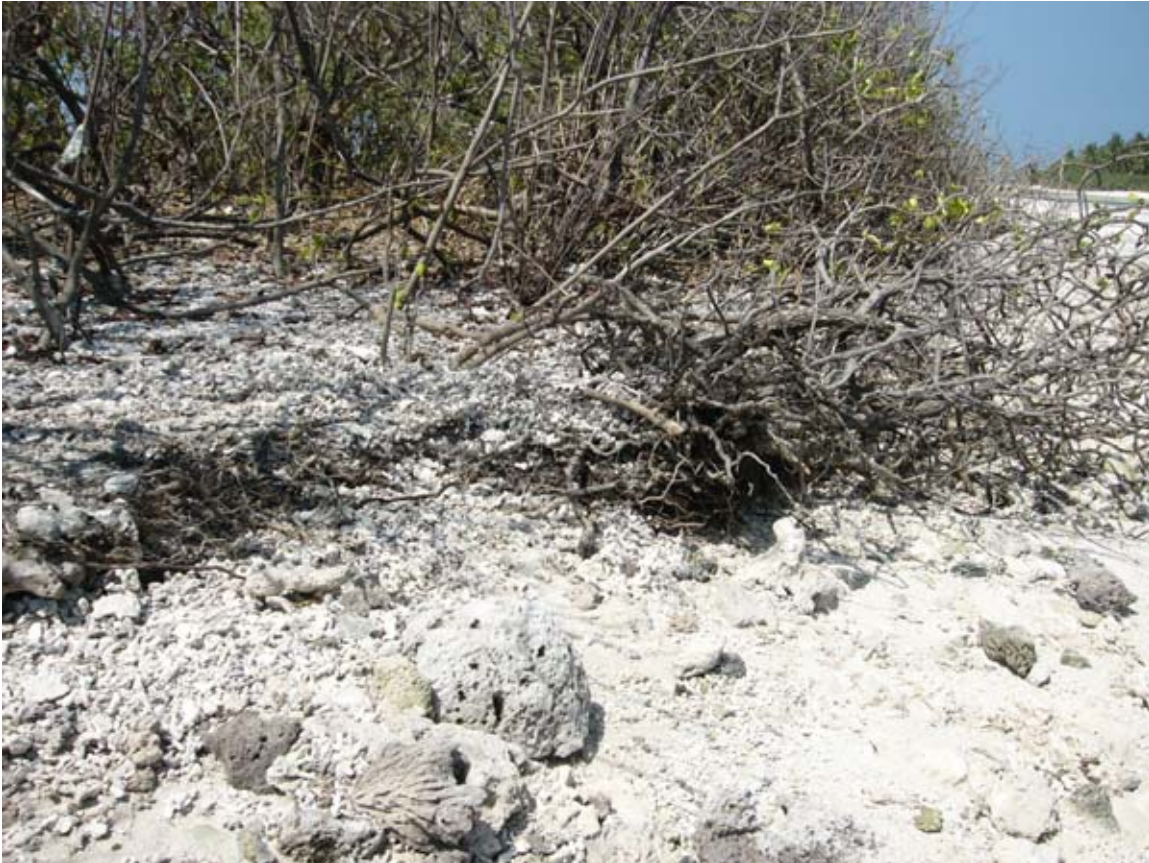
**Figure 13.** The thick vegetation along the shore at Lhosfushi Islet trapped much of the coral at the back of the beach and in around brush. Much of the brush on the island was killed by salt water or torn away by the tsunami. The shallows bank east of the island was stripped of coral and sand, and exposed well-cemented beach rock in the surf.

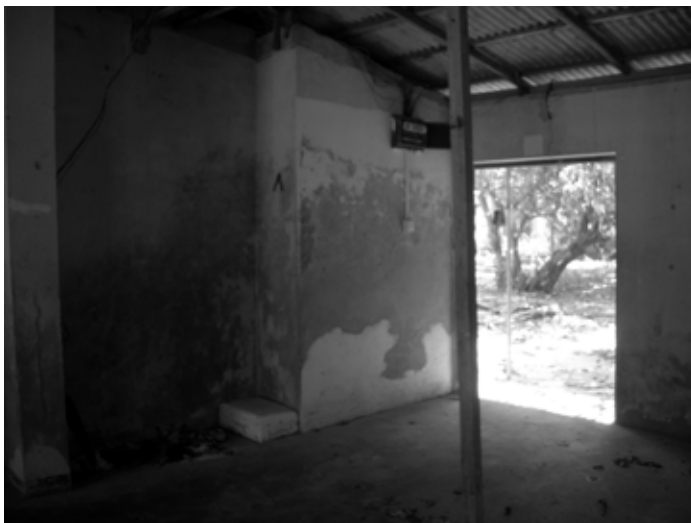
**Figure 2. The interior of the employee quarters is shown in this photograph taken after the 2004 tsunami. The building was flooded to about 3 m depth and the**

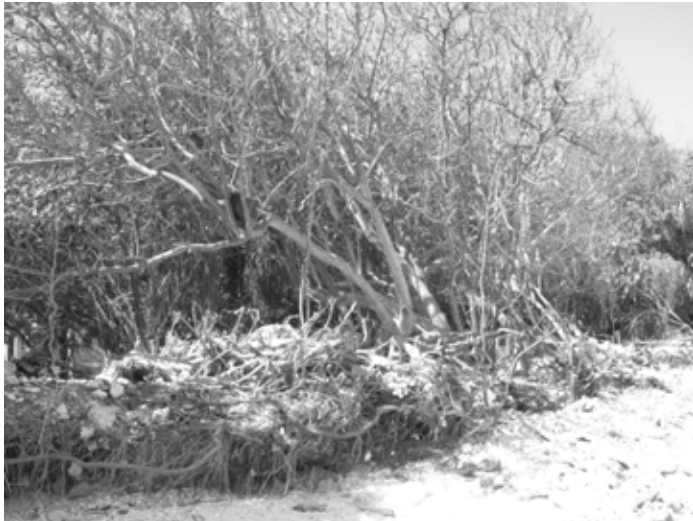
**Figure 3. The vegetation on the east side of Kandooma was crushed by the tsunami and laid backyards toward the center of the island. The leaves were stripped from the trees. The roots of the vegetation were undermined and the coral from the littoral zone was trapped within the vegetation. But, the vegetation provided important protection to the buildings nearby.**

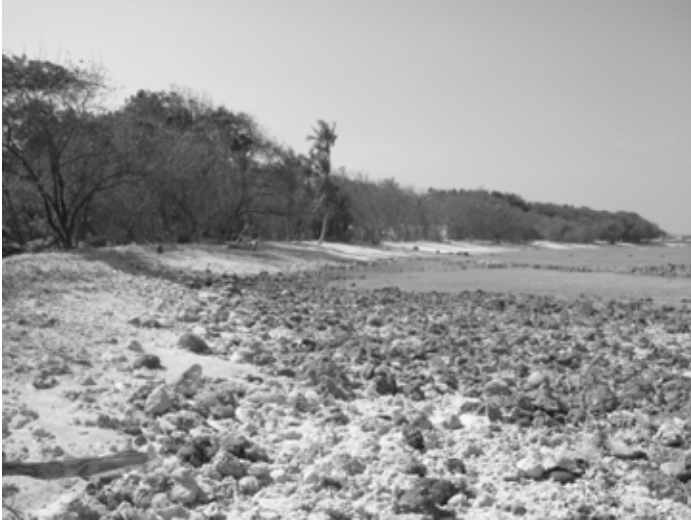
**Figure 4.** The manager of the resort reported that 15 m of sand (horizontally) was stripped from this beach. A beach ridge or berm can be seen at the back of the beach, where the vegetation is seen.

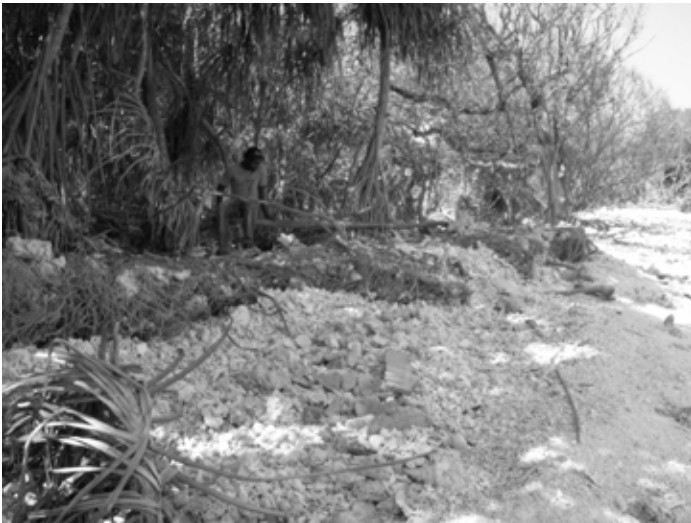
**Figure 5.** On the eastern side of Kandooma Island, coral clasts were left along the back of the beach by the tsunami. The maximum coral clast size is roughly 10 cm across. The clasts bury the roots of some trees along the coast. These trees are roughly 5 m inland from the ocean.

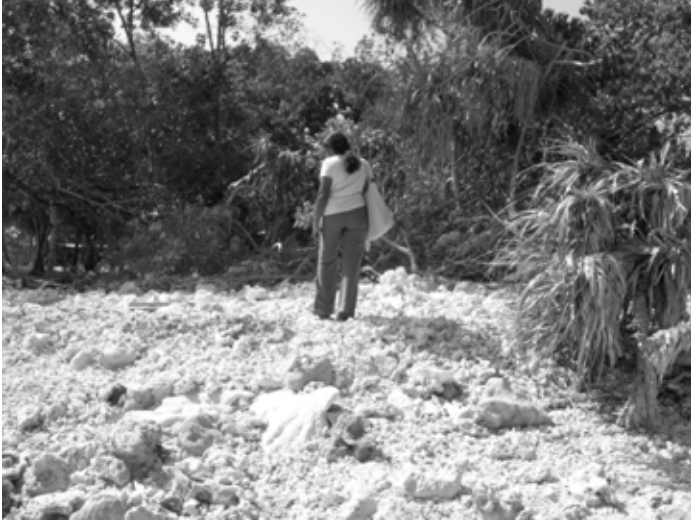
**Figure 6. On the eastern side of the Kandooma Island, coral clasts were carried up onto the island surface in one area, by the tsunami. The typical coral clast size was roughly 10 cm across. The clasts bury the base of the trees along the coast up to roughly 20 cm.**

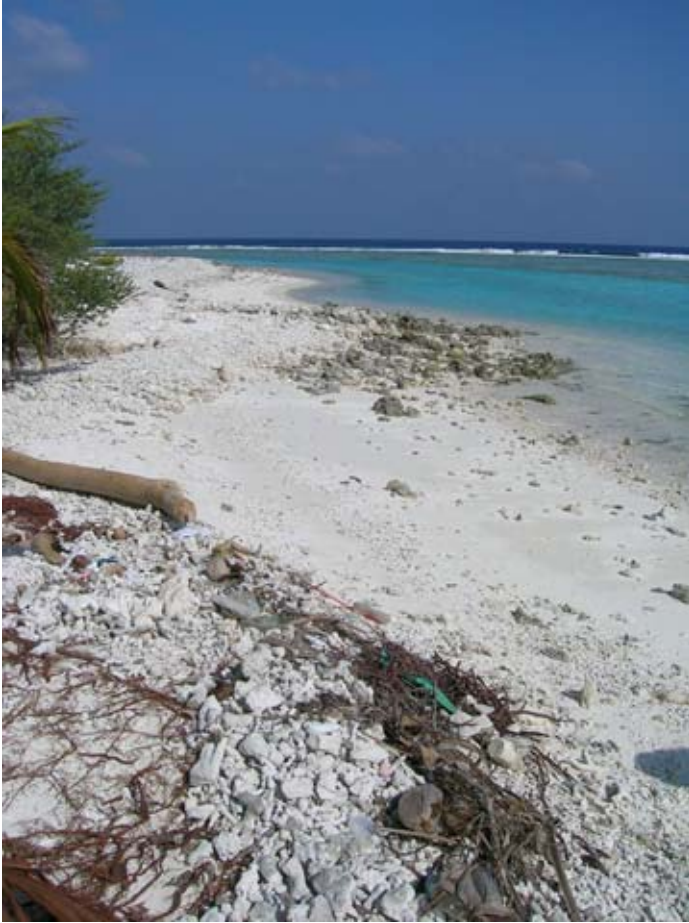
**Figure 7. The leeward side of the Kandooma resort island experienced significant erosion. The roots of coconut trees are exposed to the air. A comparison of satellite pictures taken before and after the tsunami shows that a large number of coconut trees were missing after the tsunami and 5-15 m of beach sand had been removed.**

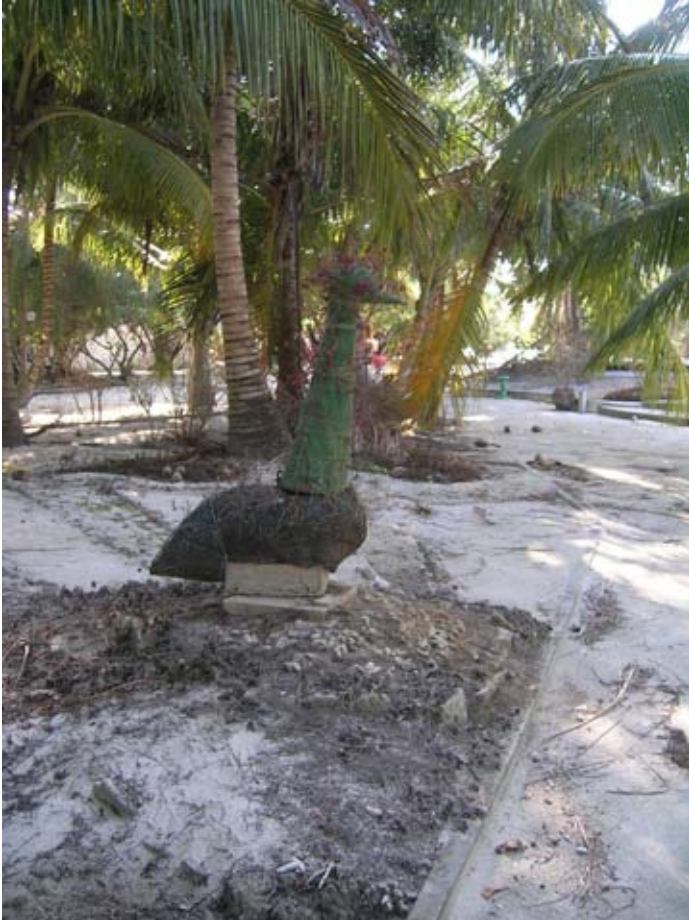
**Figure 8. The island of Kandooma was completely flooded by the tsunami. The tsunami arrived from the east and wrapped around the island and flooded inland from the west, meeting near the center of the island. The resort manager reported that he broke out a window in order to escape from the flooding in the employees housing on the east side of the island, where the waters were neck-deep. The entire surface of the island was covered by sand, forming a sheet. In many places the sand sheet does not completely bury the grass. The tsunami flooding abraded paint from the concrete walkways and buildings and the salt water killed the vegetation in the foreground. This topiary form (shape of a peacock) was part of a luxuriant garden that was completely stripped of vegetation.**
