# SCIENCE OF TSUNAMI HAZARDS

Volume 23 Number 2

# **EFFECTS OF MEDU AND COASTAL TOPOGRAPHY ON THE DAMAGE PATTERN DURING THE RECENT INDIAN OCEAN TSUNAMI ALONG THE COAST OF TAMILNADU**

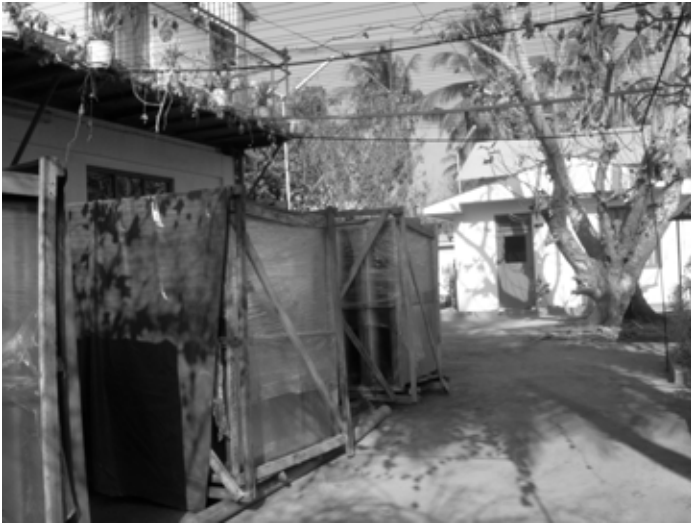
**Figure 9. These wooden crates of equipment for the Guraidhoo Island Power Plant had been delivered and placed in side the concrete garden wall surrounding the power plant. The tsunami flood picked up and moved the heavy equipment and crates inside the 1.5 m high concrete block garden walls.**

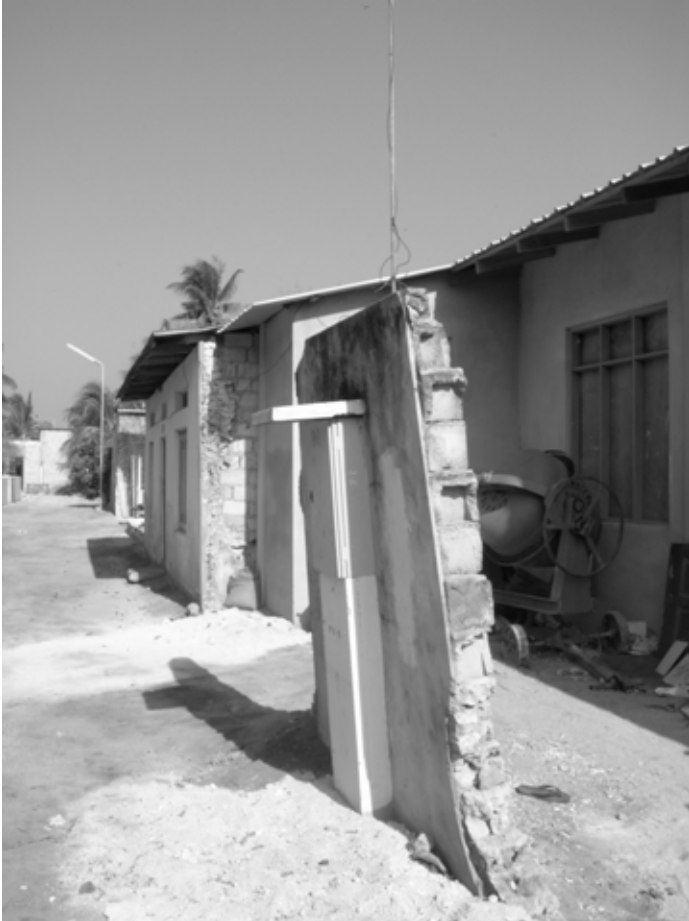
**Figure 10. This wall is what remains of a building damaged by the tsunami on Guraidhoo Island. It shows the typical construction of blocks without reinforcing rods, and without interior fillings of concrete.**

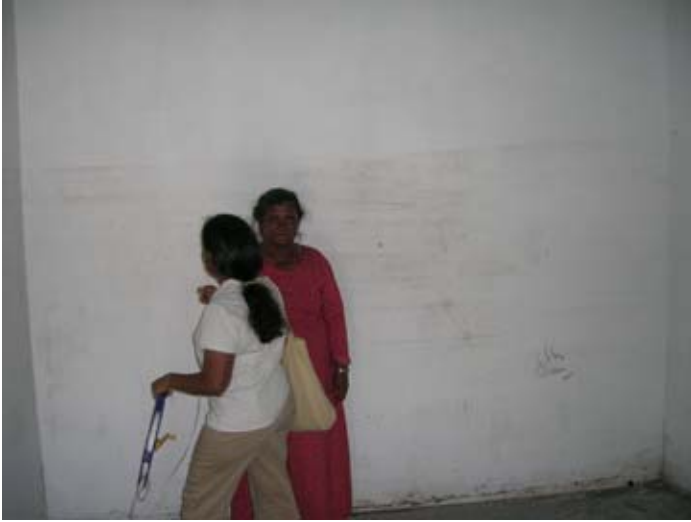
**Figure 11. Residents of the Guraidhoo Island assisted us during our surveys and allowed us to enter their homes and measure the flood lines left on the interior walls. The flood lines can be seen on this wall, as dark horizontal lines on the white paint. The tsunami flooding exceeded the height of most residents.**

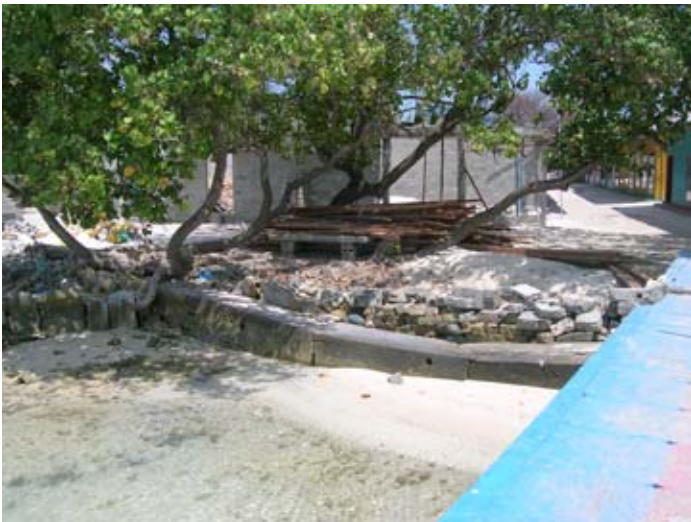
**Figure 12. Guraidhoo islanders set up a tent city on one end of the island and have remained there during the reconstruction and our survey (six weeks after the tsunami). The large blue garden wall (at the lower right in this picture) was undermined by the tsunami flood and toppled.**

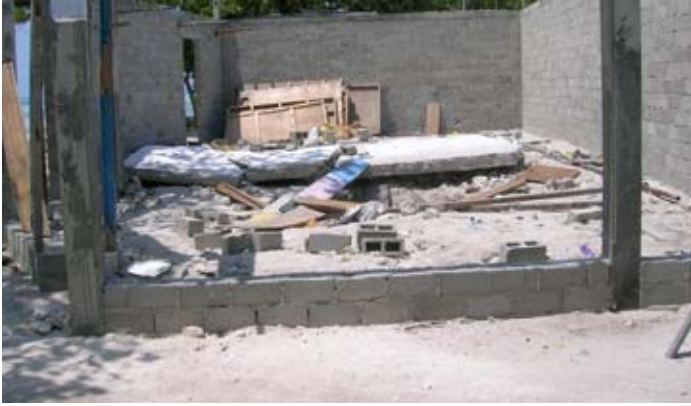
**Figure 13. At the center of this picture is a toppled hollow block wall. Reconstruction of new walls appears to enclose the old wall.**

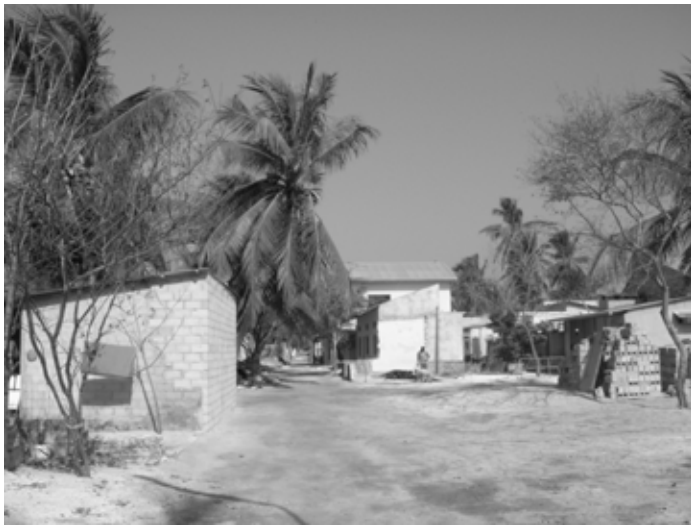
**Figure 14. The hollow blocks used for construction in Guraidhoo are about 12 cm wide. This photograph above shows the construction blocks at right and a newly repaired building at left. The small building has new construction on the right side where the wall was lost during the tsunami, but the remainder of the structure pre-dates the tsunami. The roof is corrugated metal. The buildings are being constructed in the pre-tsunami manner and still lack reinforcing and foundations.**

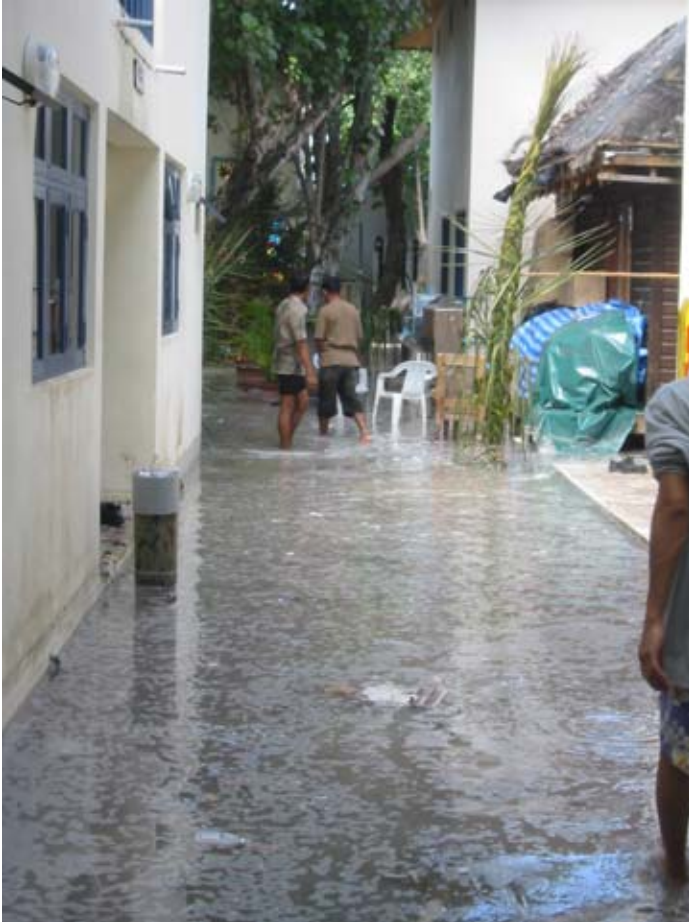
**Figure 15. An employee on Cocoa Island took this photograph during the tsunami. It shows that tsunami flooding inundated buildings, and damaged the interior furnishings but did little harm to the building structures. Note that more than one flood line was left on the walls of the building at left.**

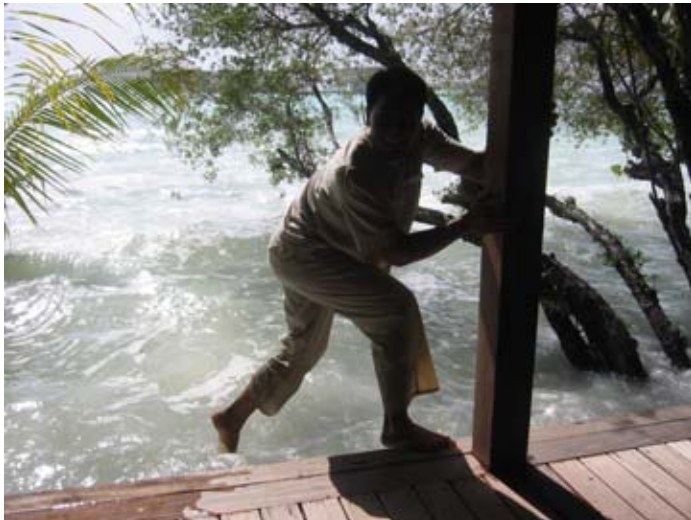
**Figure 16. In another photograph taken by a resort employee, a person can be jumping out of the tsunami flood waters on to a porch of one of the Cocoa Island Resort buildings during the tsunami. In the background the bungalows lining the lagoon can be seen in the distance. During the tsunami, the water rose to the floor of the bungalows without damaging the building structures significantly or the raised walkways. The bungalows were designed to sit above sea level.**

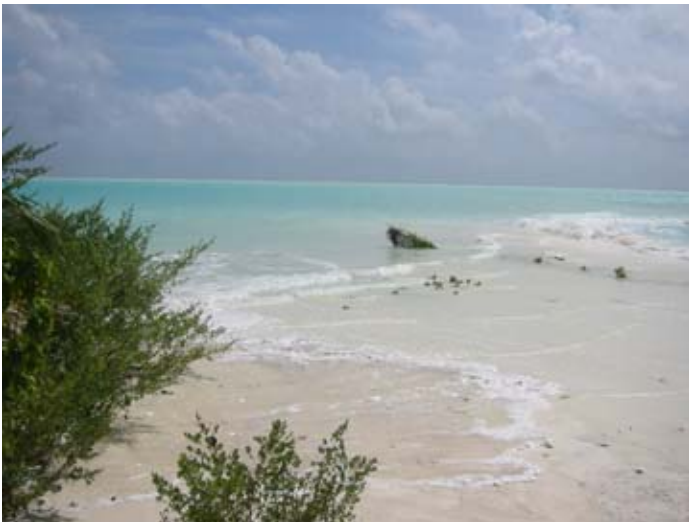
**Figure 17. The Cocoa island resort is situated on a small island that is connected to extensive sand bars. A large segment of the sand bar was removed from the north side of the island by the tsunami. The bungalows situated over the lagoon fared extremely well. The bottoms of the bungalows were about 3 m above the floor of the lagoon. The buildings on the island were flooded with about 30 cm of water. Scour pits were cut as deep as 1.5 m around the corners of the reception building. Extensive erosion was reported to have occurred in the lagoon below the bungalows, without damaging the building structures.**

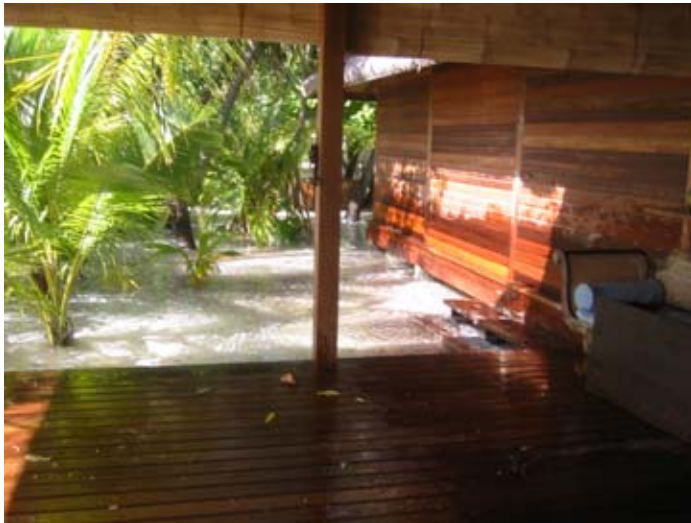
**Figure 18. This picture was taken during the 2004 Tsunami on Cocoa Island. The tsunami flooded the island as can be seen in this picture (provided by a resort employee). The water was milky in color due to the suspended sand in the water. No flood line was preserved on the building's exterior wall. The waters rose over a meter above the ground but the flood was turbulent enough that the trace left by the water appears irregular. Episodic draining of tsunami flood waters from the islands left the flood lines, according to the survivors.**

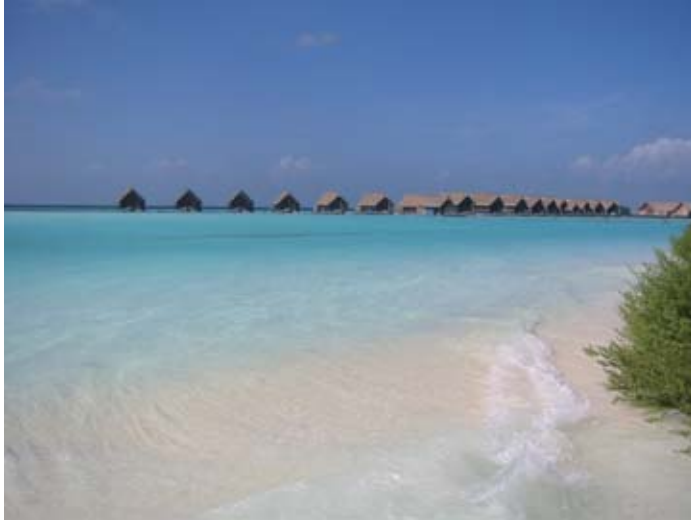
**Figure 19. These are the bungalows built on concrete poles within the Cocoa Island resort lagoon. The walkways and the bungalows survived with very little damage. Fortunately the tsunami only reached the base boards of the bungalows, leaving the structures intact.**
