**An Assessment of the Impact of Social Trails Use  
on Cultural Resources in Technical Area 71,  
Los Alamos National Laboratory, New Mexico**

Cultural Resources Report No. 252  
Survey No. 697

**U.S. Department of Energy  
National Nuclear Security Administration  
Los Alamos Site Office**

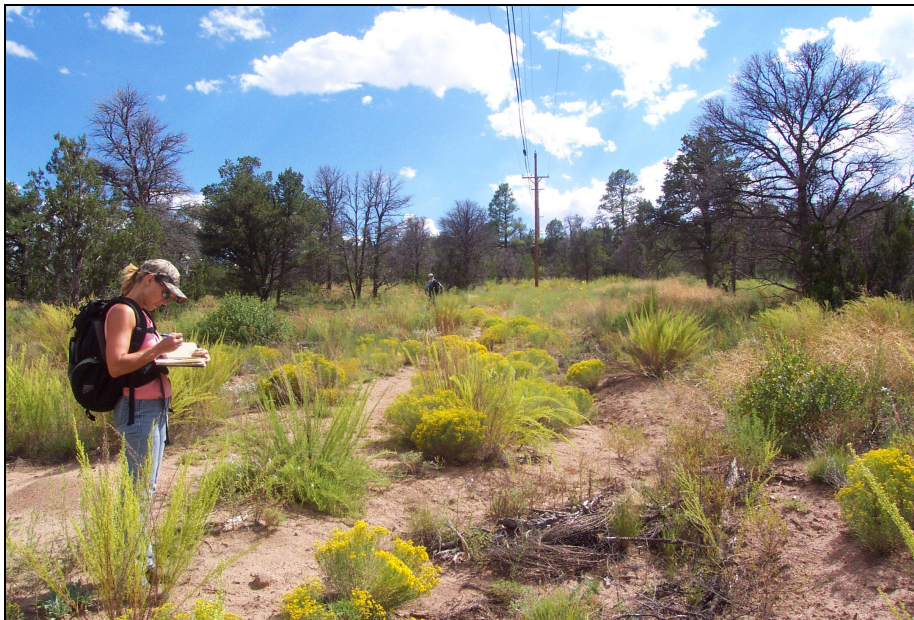
The three primary impacts related to cultural resources, including Ancestral Pueblo trails, because of recreational trails use on LANL lands are erosion (Figure 3), site looting (Figure 4), and vandalism and/or modern disturbances (Figure 5). Natural erosion, primarily from wind and water, accounts for the majority of site and trail impacts. In some cases, recreational, grazing, and LANL mission activities, including the use and construction of two-track roads, fire roads, and new trail segments, exacerbate the impacts of natural erosion (Figures 3 and 5). Figure 3 illustrates damage to a trail segment and an artifact scatter resulting from construction of a power line in TA-71. The affects of erosion on trail segments and cultural resources can be mitigated to some degree with better land management methods (e.g., tree and grass planting as well as other erosion controls included in LANL projects).

**Figure 3. Erosion impacts to trail segment 1-C, a power line corridor, and LA 139576, a Coalition period artifact scatter.**

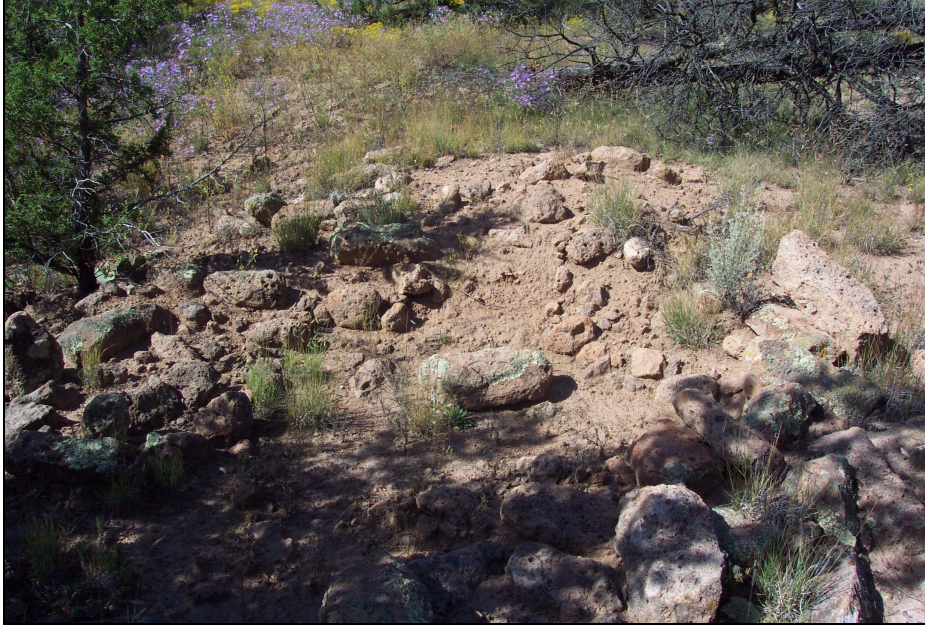
**Figure 4. LA 139477, evidence of looting at an Ancestral Pueblo site adjacent to trail segment 16-D.**

Looting of archaeological sites (Figure 4) has also been an issue at TA-71 as recreational trail segments sometimes cross through these sites. In most cases, looting activities include manual excavation of Ancestral Pueblo sites resulting in depressions in the centers of masonry rooms and the pushing aside of masonry blocks in an attempt to retrieve artifacts. Disturbance of cultural resources ultimately results in their destruction,

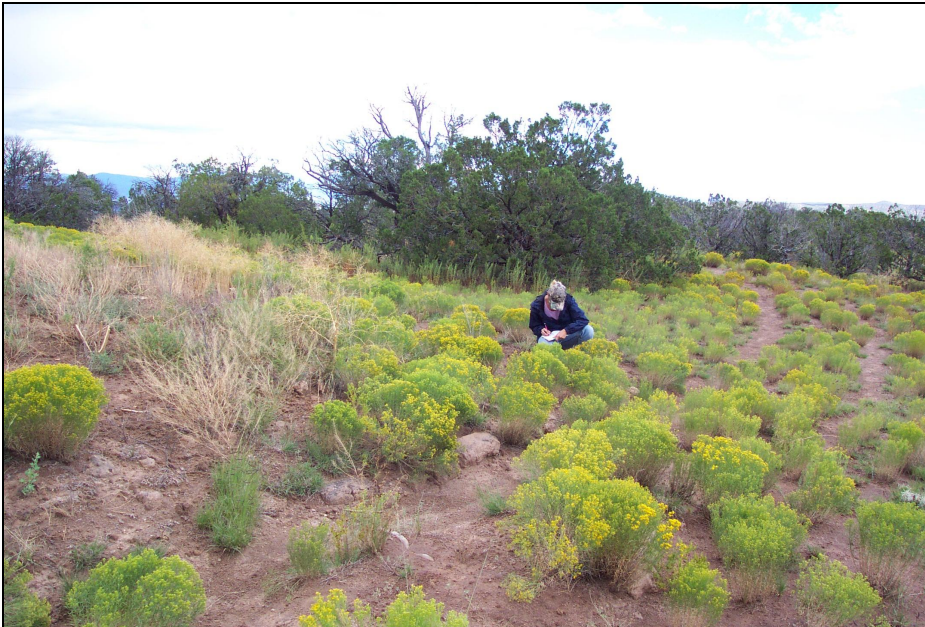
**Figure 5. LA 6787A, a two-track road runs through the site, shaped tuff blocks line the side of the road.**

as stratigraphic and contextual information is lost when the contents of these sites are ransacked. Recreational trails users and LANL personnel sometimes impact archaeological resources unintentionally; however, results of these activities are also detrimental to these resources (Figure 5).

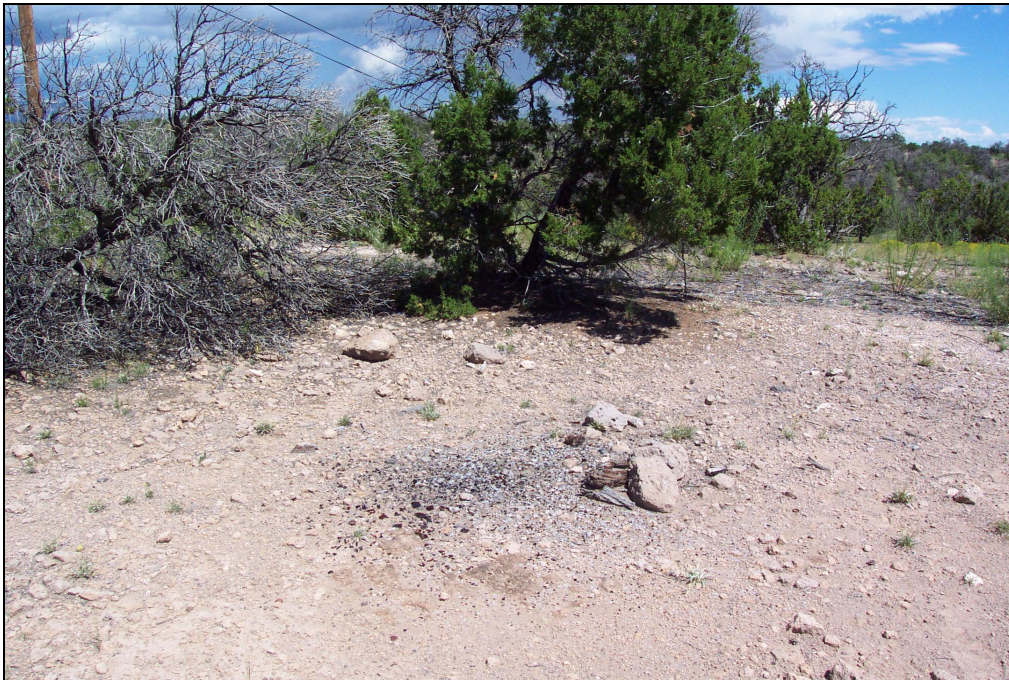
**Figure 6. Trail segment 1-F and LA 139571 with evidence of a modern campfire within the site boundaries.**

*Trail segment 1-F and LA 139571.* Assessors recommend monitoring for trail segment 1-F and LA 139571. The site consists of an Ancestral Pueblo period artifact scatter within two meters of the trail segment. Impacts to the site include scattered modern trash, a recent campfire, a road that cuts through a portion of the site, and low-level erosion (Figure 6). Erosion has resulted in areas of exposed bedrock. Because the site is a relatively dispersed artifact scatter, assessors recommend future site monitoring. Monitoring will help keep a record of further impacts and will allow assessors to alter their recommendations if additional treatment becomes necessary.

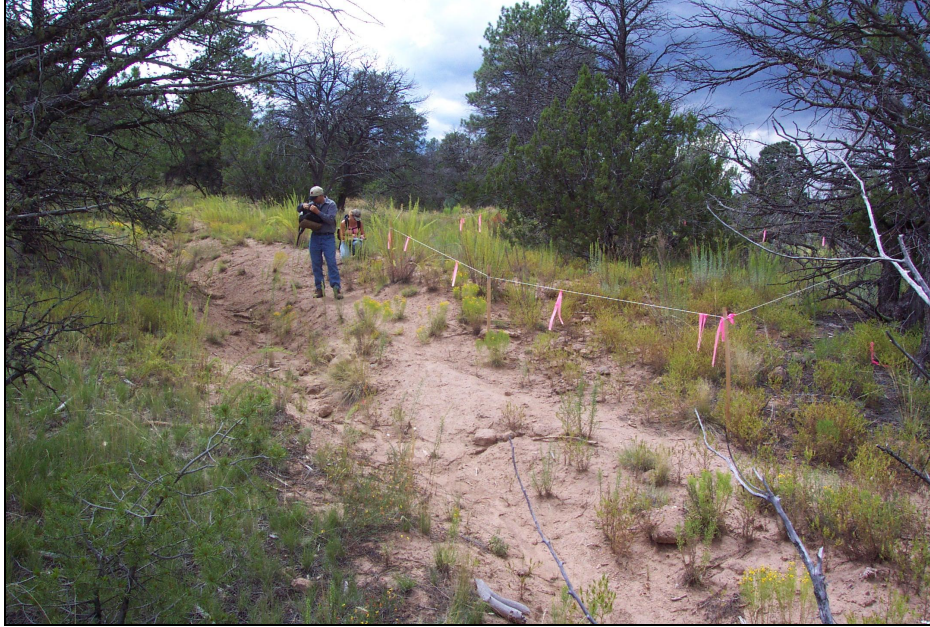
*Trail segment 3-C and LA 21622.* Erosion is the most significant impact to trail segment 3-C and LA 21622 (Figures 7 and 8). A portion of the trail has been washed out by erosion; the Coalition period one- to three-room structure (LA 21622) is also affected by erosion directly to the east and west of the site boundary (identified with string and pink flagging tape in Figures 7 and 8). Assessors recommend rerouting the trail further to the east and placing a check dam and/or other erosion controls along the incised trail segments to protect both the site and the trail from further erosion.

**Figure 7. Trail segment 3-C and LA 21622 with impacts from erosion.**

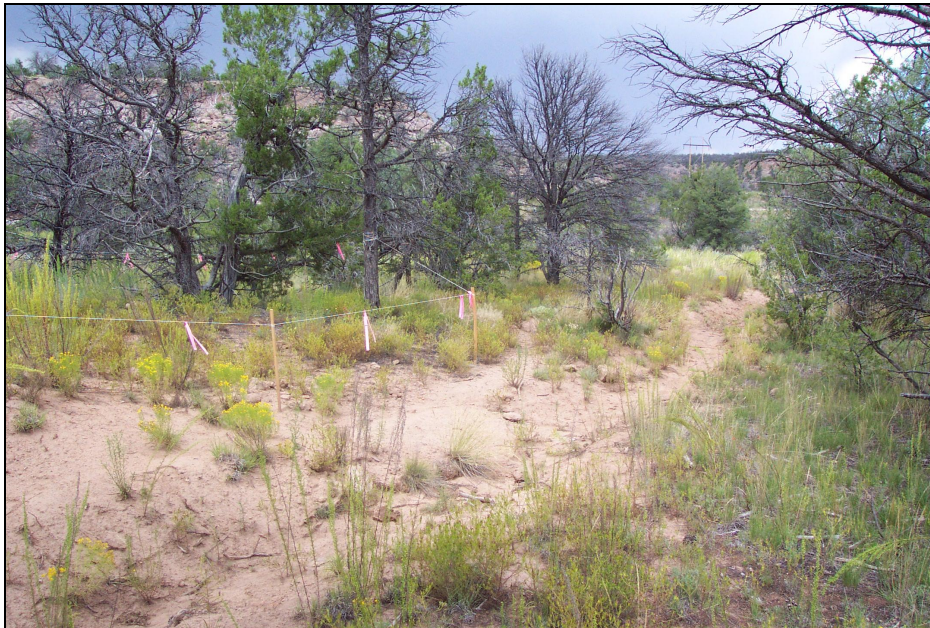
**Figure 8. LA 21622 has been impacted by erosion and trails use.**

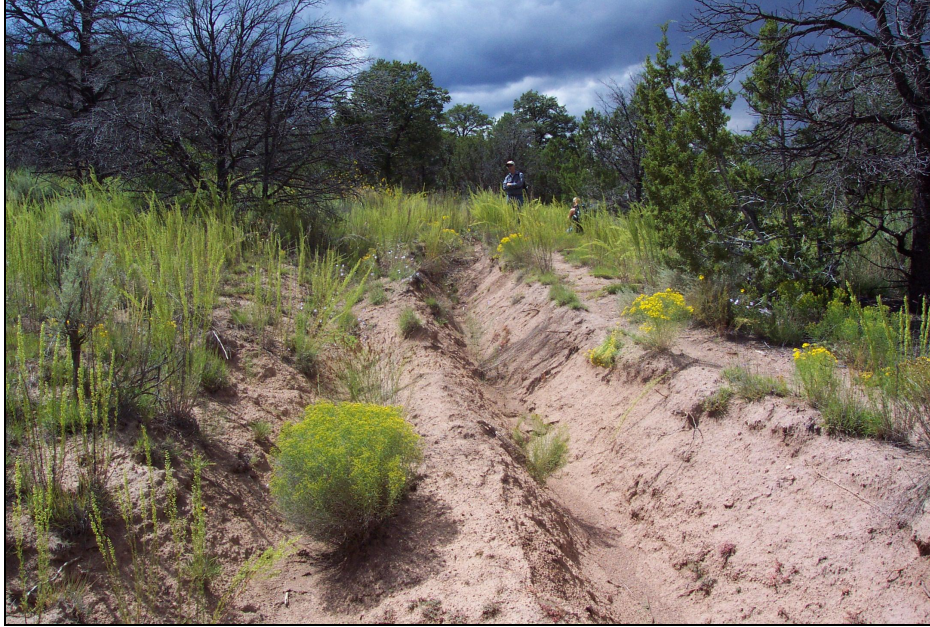
**Figure 9. Heavily eroded trail segment 4-E.**

*Trail segment 4-E.* While there are no cultural resources situated along trail segment 4-E, assessors recommend erosion controls and rerouting of this segment due to extreme impacts from erosion (Figure 9). Assessors recommend rerouting the trail to the northwest and placing check dams within the area. This segment is also along the route of the new power line corridor and may experience further impacts if not rerouted.

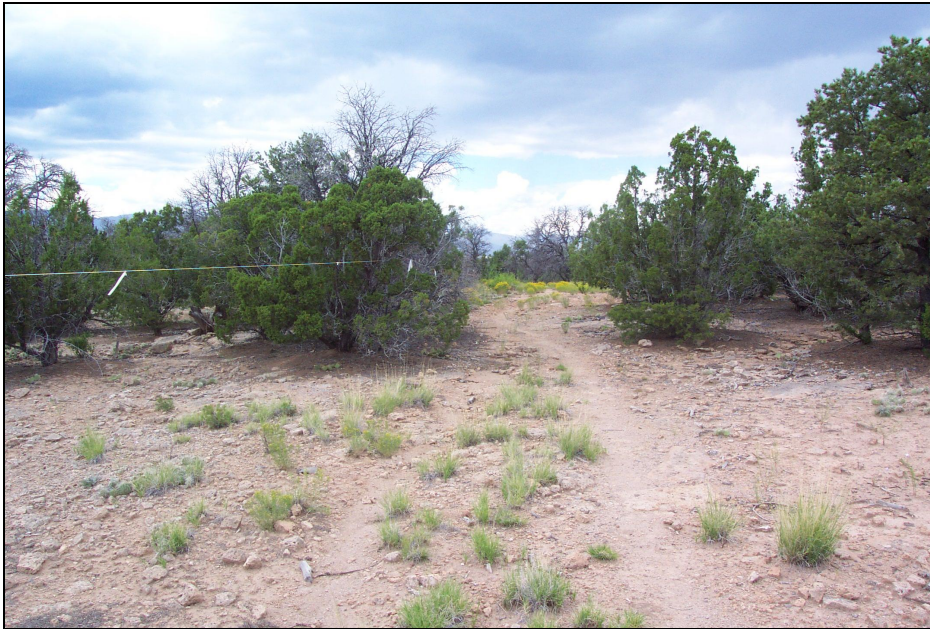
**Figure 10. Trail segment 5-A and LA 139510.**

*Trail segment 5-A and LA 139510.* This trail segment is not subject to heavy recreational use. LA 139510 is a relatively dispersed lithic scatter that has not been dated and has been marked with string and pink flagging tape (Figure 10). Although the trail does cut through a portion of the site's boundary, assessors believe that impacts to the site are minimal. Because the site is situated so close to the trail segment (Figure 10), assessors recommend removal of the boundary string.

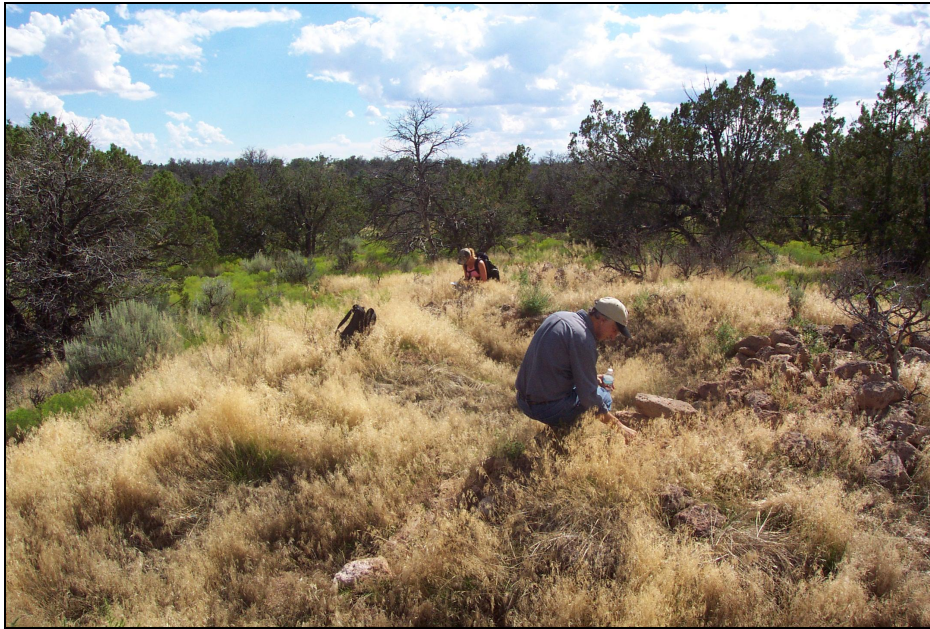
*Trail segments 5-B, 5-C, and 5-D and LA 139572.* Trail segments 5-B, 5-C, and 5-D cut through LA 139572, a large Coalition period pueblo complex (Figure 11). Erosion has impacted the southwest edge of the site, and at least one of the trail segments follows along the boundary string. There is some evidence for older looting activities at the site and very few artifacts are visible on the surface. An absence of sherds and lithics on a large site like this one is indicative of casual collection activities. Because the site is quite large, assessors do not recommend relocating the trail segments, but have suggested continued monitoring of the site.

**Figure 11. Assessors record impacts to trail segments 5-B, 5-C, and 5-D and site LA 139572.**

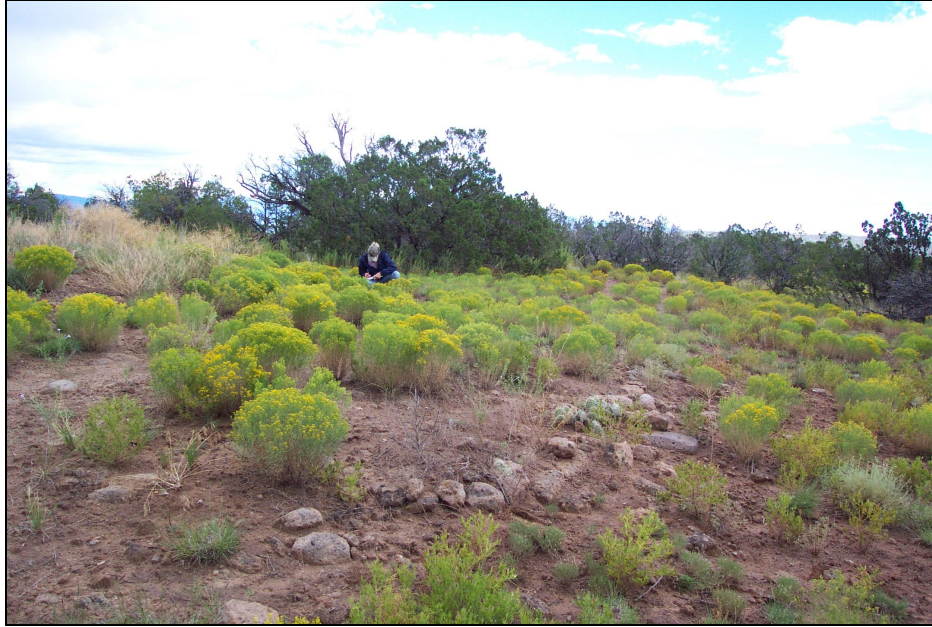
LA 6787A consists of a large Coalition period pueblo complex (Figure 12). At the site two old looters pits appear to have been filled with masonry blocks (Figure 13). Trail segment 5-F bisects LA 6787A and assessors recommend that this portion of the trail be relocated to the south or the north of where it is now, to prevent further damage to the site.

**Figure 12. S. Sherwood, kneeling on trail segment 5-F, records impacts to LA 6787A. Masonry blocks at the bottom of the picture reflect intact archaeological deposits associated with the roomblock.**

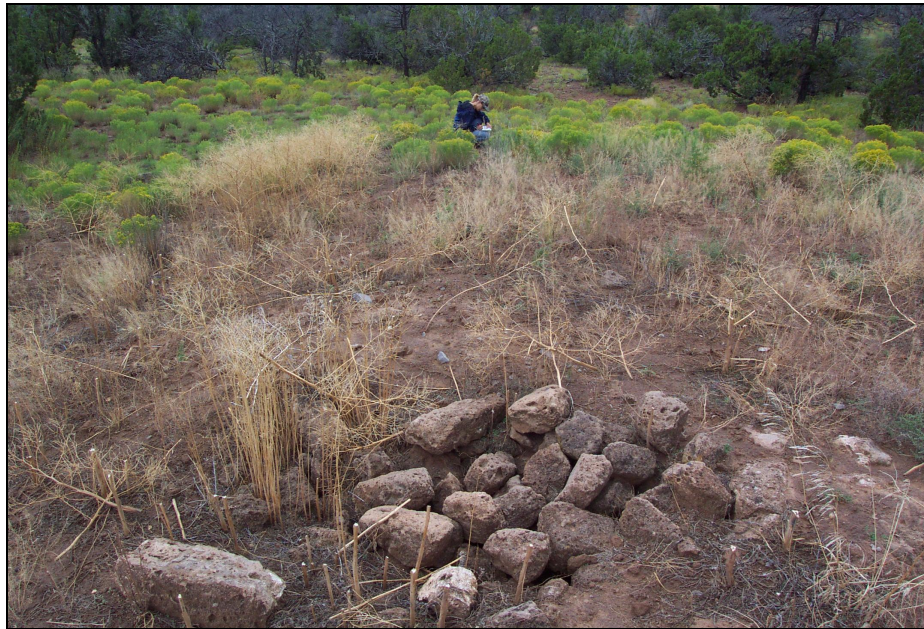
**Figure 13. S. Sherwood assesses trail segment 5-F and site LA 6787A. In the forefront is a cluster of masonry blocks, evidence of looting.**

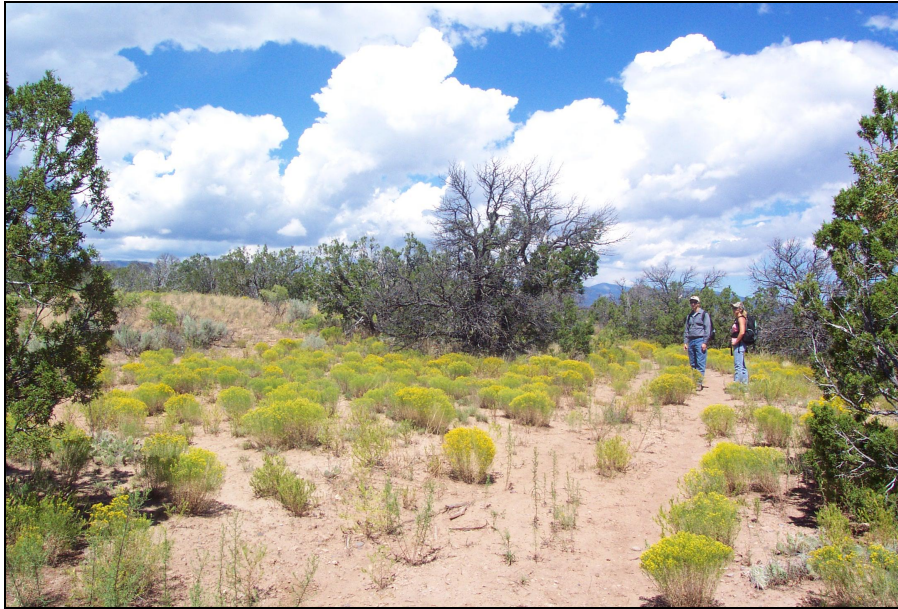
LA 6787B is a Coalition period roomblock with no evidence of looting. Low-level erosion has impacted the southeastern portion of the roomblock (Figure 14). Because erosion at the site is low, damage to the site is minimal and, because it would be quite difficult to reroute this portion of the trail segment, assessors recommend leaving the trail

**Figure 14. Assessors view trail segment 5-F and erosion associated with trails use at LA 6787B.**

in place. However, continued monitoring of the effects of erosion and trails use to the site is recommended.

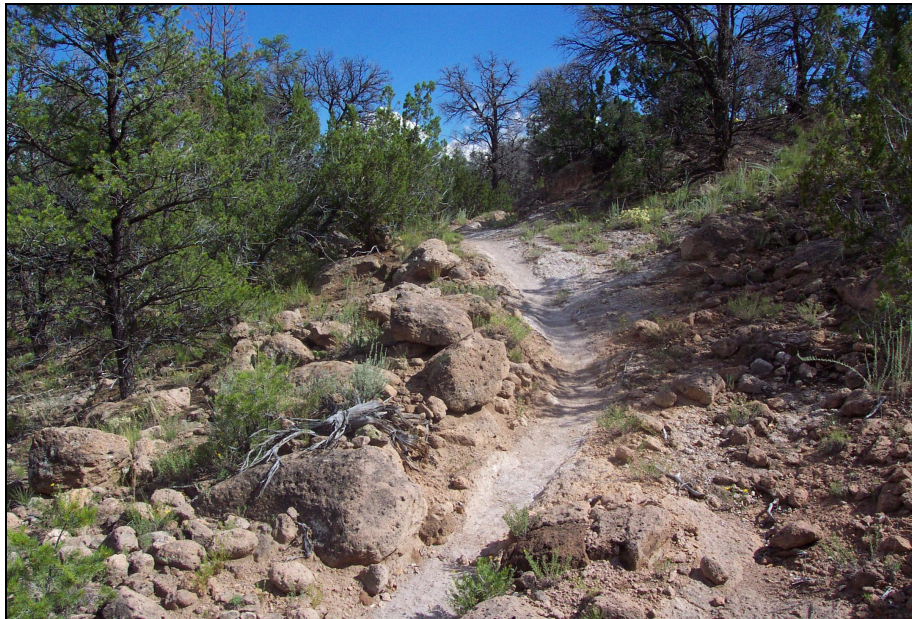
*Trail segment 8-C and sites SWEIS II 8 and LA 139573.* Trail segment 8-C coincides with a Coalition period pueblo roomblock (SWEIS II 8) and LA 139573, a Coalition period trail segment. The roomblock does not appear to have any damage related to trails use. The trail itself is quite eroded because of its age, recreational use, and natural erosion (Figures 15 and 16). Assessors recommend rerouting portions of 8-C to trail segment 7, another established trail situated close to this trail segment, to preserve the Ancestral Pueblo trail segment (Figure 16).

**Figure 15. An eroded portion of trail segment 8-C.**

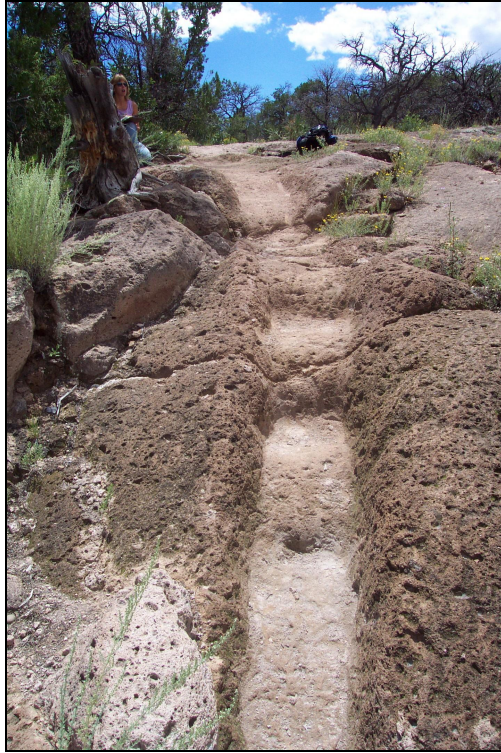
**Figure 16. Ancient segment of 8-C to be closed and the trail rerouted to trail segment 7.**

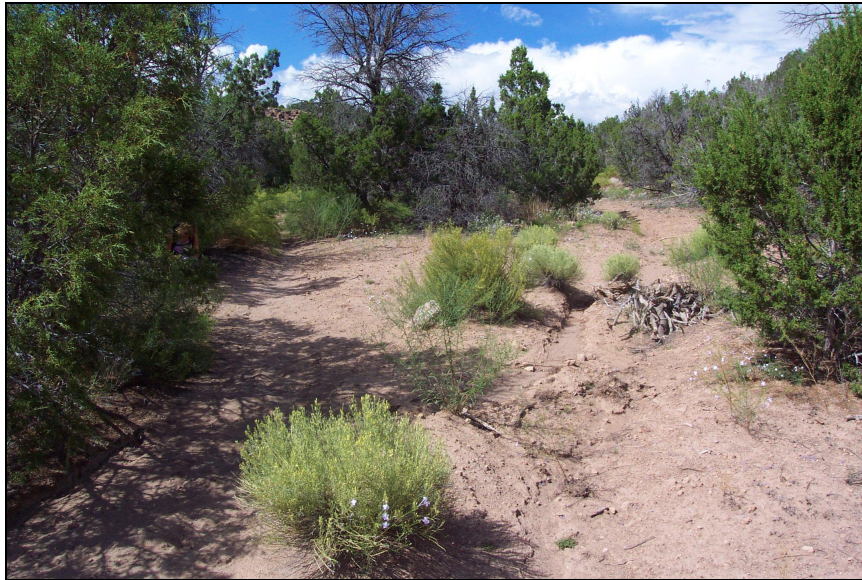
*Trail segments 10-G and 10-H and site A-4.* Recent tree falls and casual erosion controls have impacted trail segments 10 G and H. When a tree fell in one area of the site, trails users rerouted a portion of the trail and began to use the “bypass” route as an alternative (Figure 17). Because these trail segments are relatively well used, assessors recommend removing the perimeter string from site A-4.

**Figure 17. Bypassed portion of trail segment 10-G. Area where site has been blocked off with tree branches is visible on the right side of the photograph.**

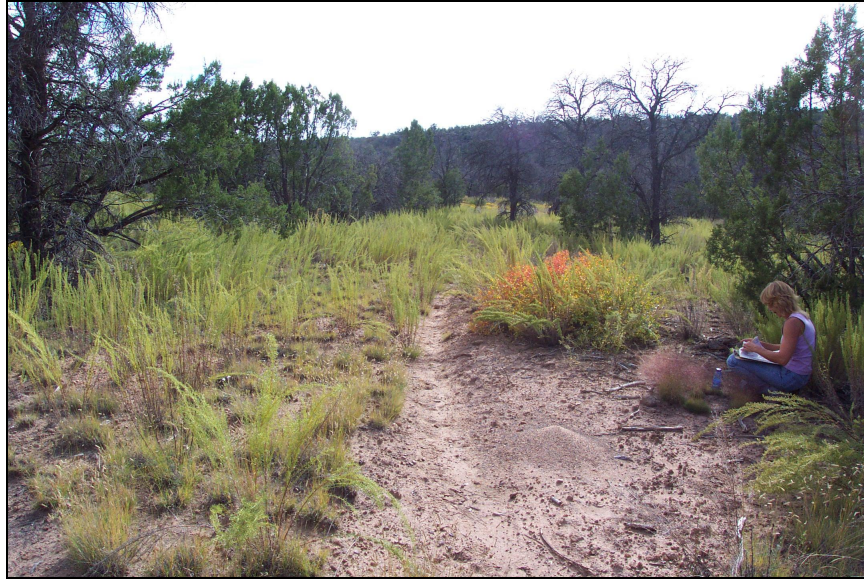
*Trail segment 11-C and LA 139481.* Trail segment 11-C is not subject to heavy recreational use. In some areas, under use of this trail segment has resulted in unmitigated tree fall and debris. Erosion has also impacted portions of the site (Figure 18). LA 139481 is an Archaic period lithic scatter and it is bisected by trail segment 11-C. Because this segment is seldom used and because it impacts LA 139481, assessors recommend closure of the segment.

**Figure 18. S. Sherwood records trail segment 11-C and LA 139481.**

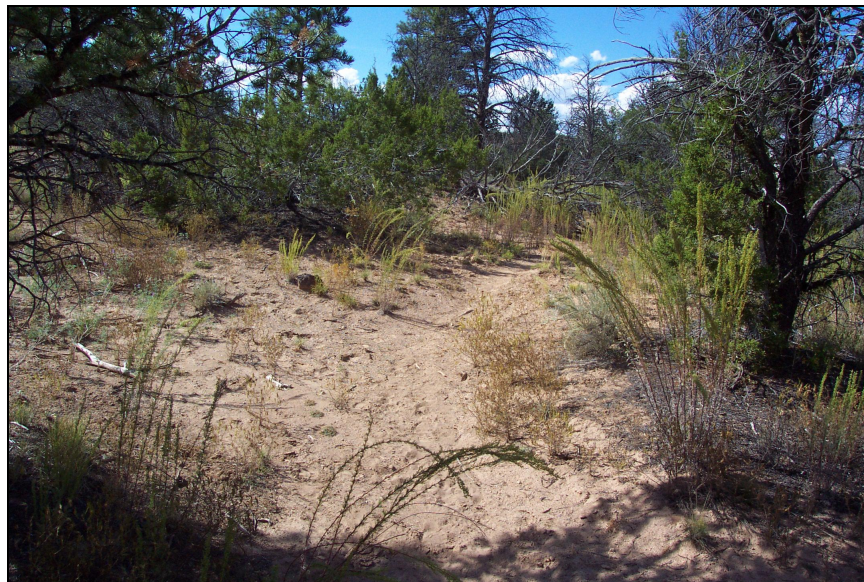
*Trail segment 14-A and LA 139515.* LA 139515 is a rock shelter of undetermined age; trail segment 14-A crosses in front of the shelter. This is a relatively new trail segment and it is not heavily used (Figure 19). For this reason and due to the proximity of the trail to the site assessors recommend that this trail segment be closed and that the more established segment, 13-B, be used as the primary trail in this area.

**Figure 19. Eroded portion of trail segment 14-A and LA 139515.**

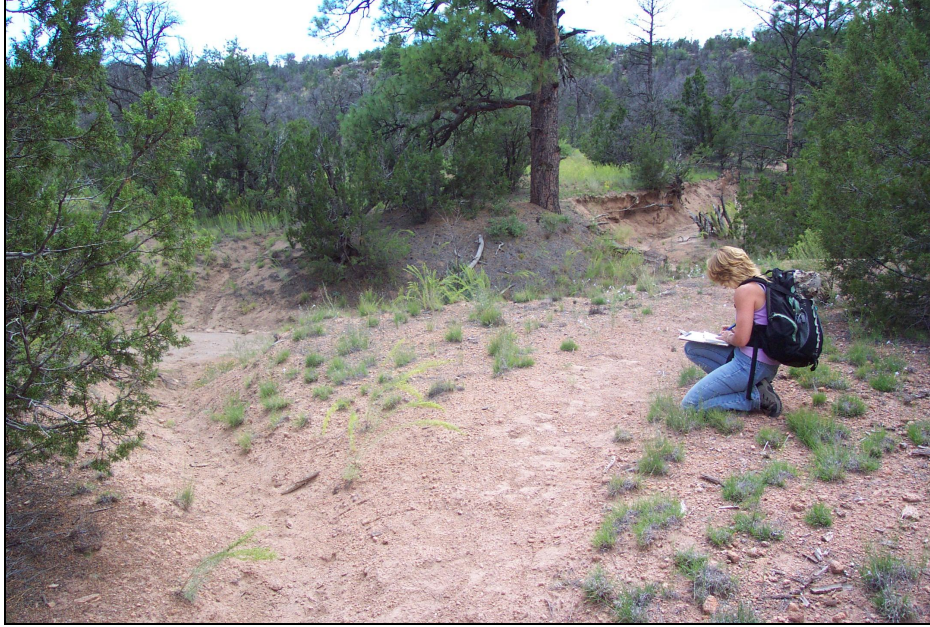
*Trail segments 14-D and 14-E and site A-1.* Site A-1, consisting of an Archaic lithic scatter, is adjacent to the junction of trail segments 14-D, 14-E, and 14-F. Both 14-D and -E are moderately to heavily used segments and run along an alluvial bench above a small stream (Figure 20). Because this trail does have a large number of users, assessors recommend removal of the string that surrounds the site.

**Figure 20. S. Sherwood records impacts to trail segment 14-D and site A-1.**

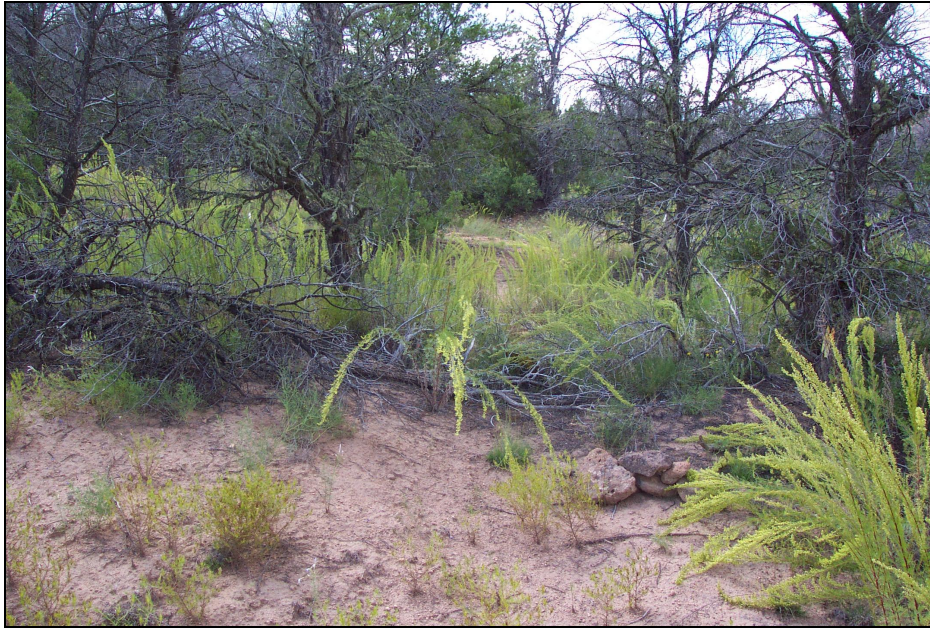
*Trail segment 14-J, LA 139479, and JAM-1.* Trail segment 14-J is moderately used and is moderately to severely eroded in some areas. In addition, there are several tree falls on the trail and it has been rerouted in many areas to avoid these hazards. 14-J is adjacent to two sites, LA 139479 and the newly identified JAM-1. Assessors recommend removal of the perimeter string from LA 139479, a dispersed Archaic period lithic scatter, which is bisected in several places by trail segments. Erosion, tree falls, and trail rerouting have all impacted the site (Figure 21). It also appears that artifacts have been collected from the site, as assessors were unable to identify any artifacts on the trail segments.

**Figure 21. Masonry blocks used to reroute trail segment 14-J after a tree fall.**

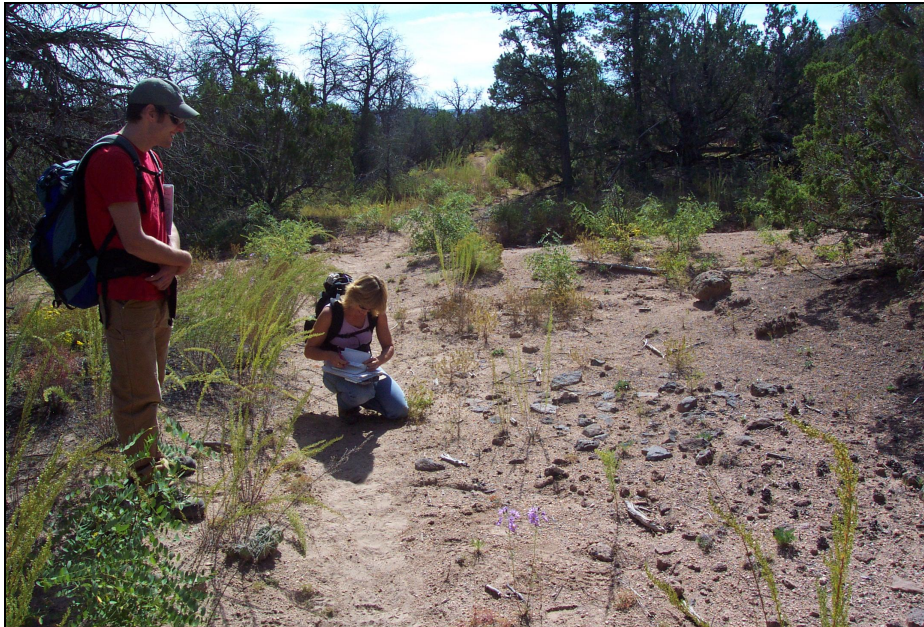
Assessors also identified two roasting pits (JAM-1) next to a well-used portion of trail segment 14-J (Figure 22). The roasting pits are relatively ephemeral and assessors recommend excavation of the two features to avoid further deterioration by erosion and trails use.

**Figure 22. Assessors record trail segment 14-J and JAM-1.**

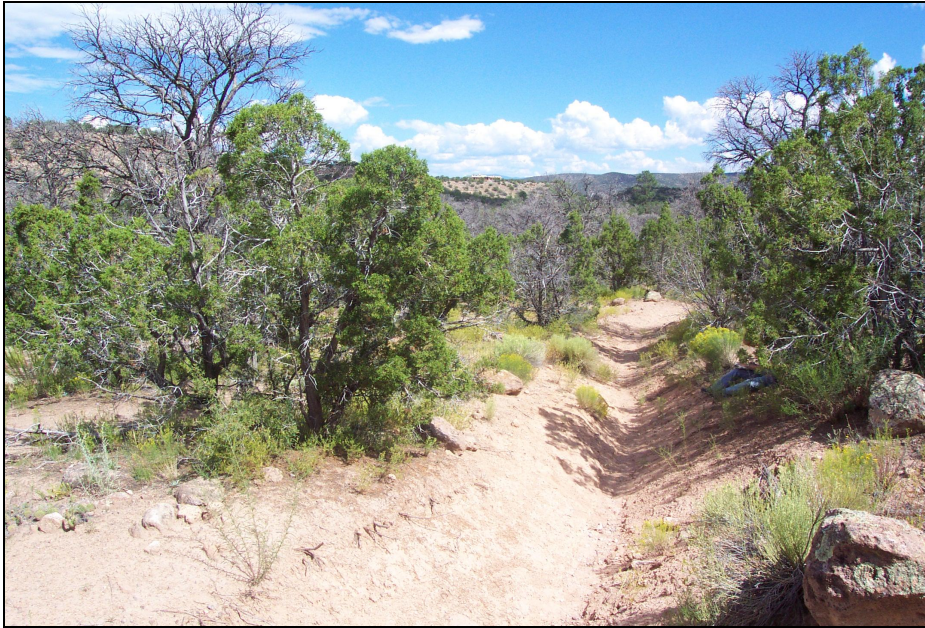
*Trail segment 14-K and site A-3.* Trail segment 14-K is heavily used and has been subject to a great deal of wind and water erosion (Figure 23). The trail is adjacent to site A-3, which is a Coalition period one- to three-room structure. Assessors recommend

**Figure 23. Heavily eroded portion of trail segment 14-K.**

removing perimeter string (Figure 24) from the site and continual monitoring of both the trail segment and the site.

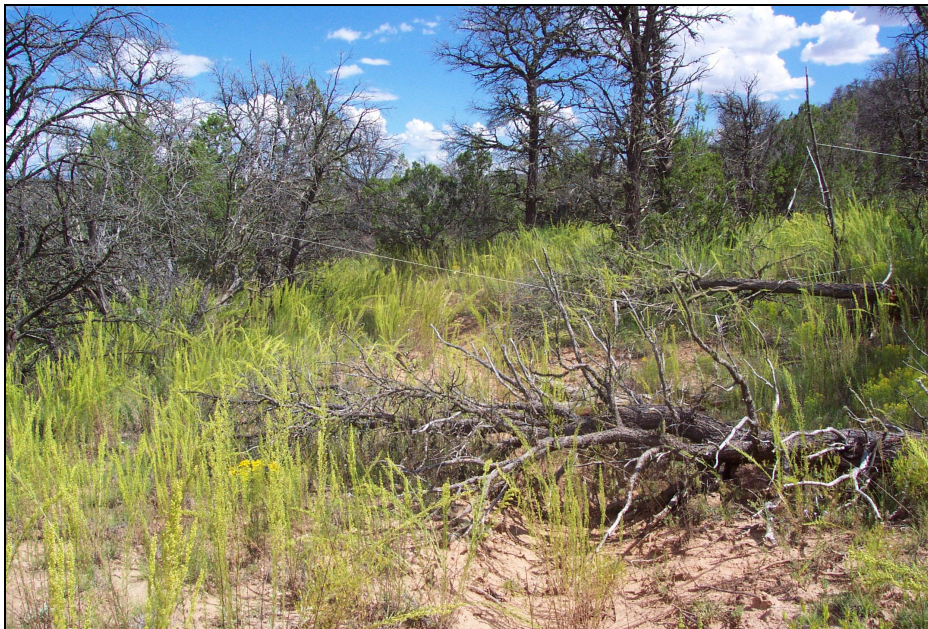
**Figure 24. Tree fall on string surrounding site.**

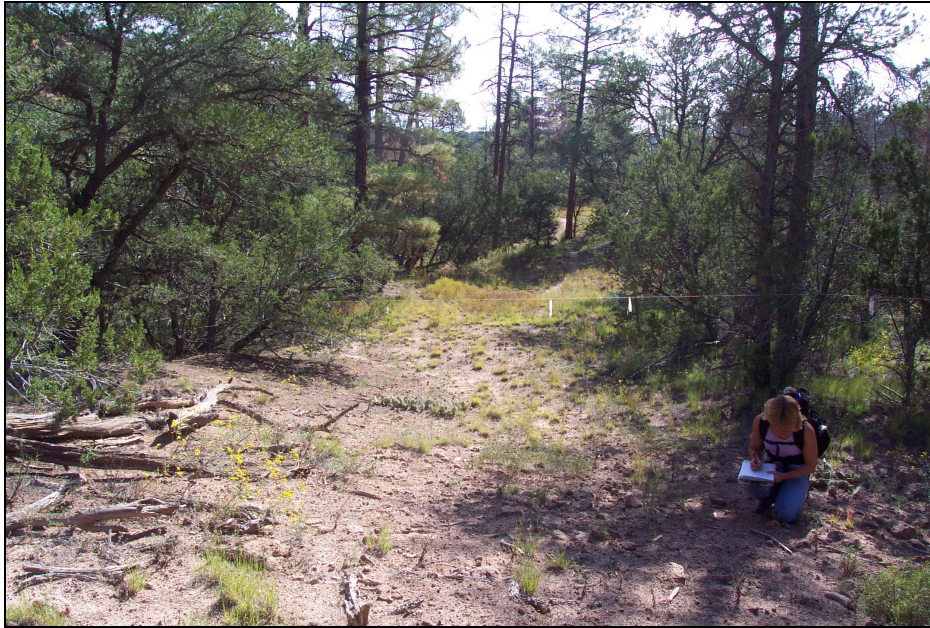
*Trail segment 16-B and LA 139517.* Trail segment 16-B is moderately used and has been impacted by a moderate amount of erosion. 16-B runs next to and through portions of LA 139517, an Archaic period lithic scatter. Assessors recommend removal of the perimeter string from the site (Figure 25).

**Figure 25. S. Sherwood records impacts to trail segment 16-B and LA 139517.**

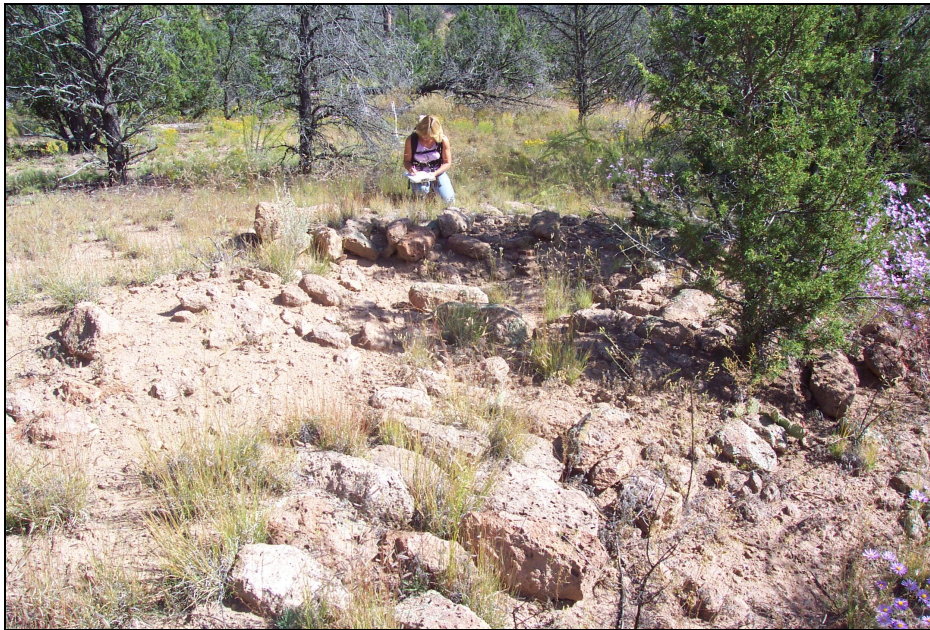
*Trail segment 16-D and LA 139477.* Trail segment 16-D is moderately used and is about 25 feet from LA 139477, a one- to three-room Ancestral Pueblo structure of undetermined age. No artifacts were found at the site that could be used to help date the structures. The site has been subject to recent looting activities (Figure 26).

**Figure 26. S. Sherwood records impacts to trail segment 16-D and LA 139477.**

Assessors suggest that looting has occurred within the past five years. Looters excavated the center of the structure, pushing masonry blocks out to the sides and removing any

artifacts that may have been associated with the site. Assessors recommend removal of the perimeter string from the site to help prevent easy identification and further damage.

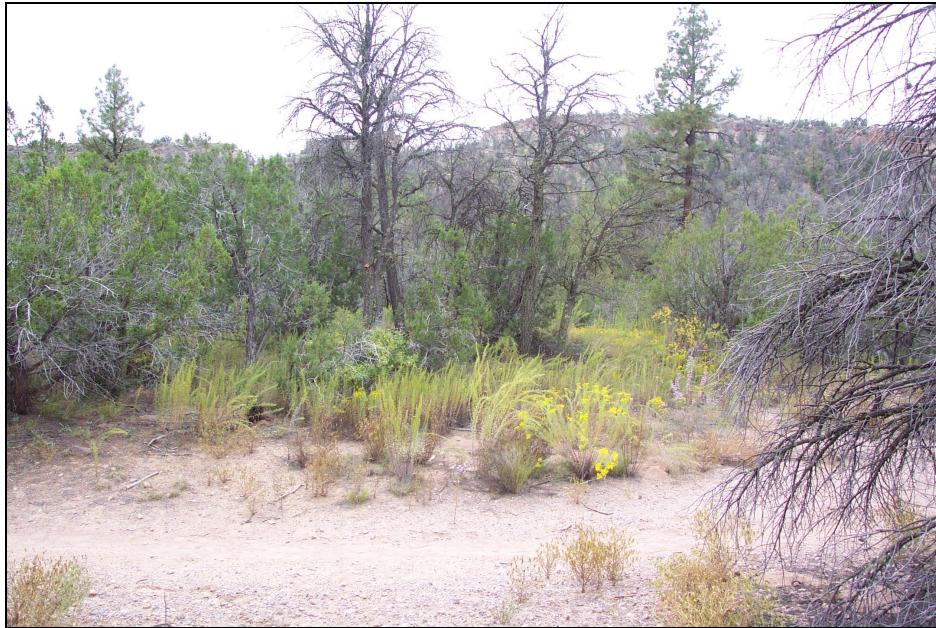
*Trail segment 17-J and LA 139463.* Trail segment 17-J is heavily used and some erosion has occurred as a result of trails use. LA 139463 is a Coalition period Ancestral Pueblo roomblock. Situated to the north of trail segment 17-J, the roomblock is not bisected by the trail and the site has not been impacted by the trail itself. However, the roomblock is devoid of all artifacts, including ceramics and lithics, which is unusual at a Coalition period site of this size, and is usually indicative of casual collection of artifacts. Because it is unlikely that further damage will occur at the site, assessors recommend continual monitoring of the site.

**Figure 27. Trail segment 17-J and a heavily vegetated LA 139463.**

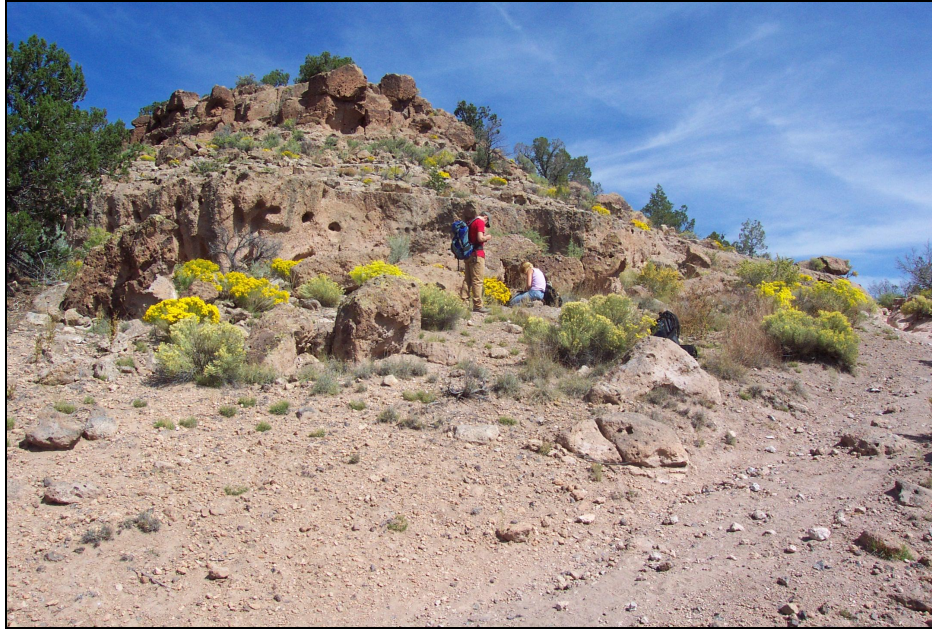
*Trail segments 17-M and 10-G and LA 21661.* The heavily used trail segments 17-M and 10-G follow below LA 21661, a Coalition period cavate (Figure 28). The trail and the cavate have been subject to erosion, which will continue to impact the trail in particular (Figure 29). For this reason, assessors recommend erosion control devices (e.g., check dams, wattles) be placed at various parts of the trail and below the cavate to prevent further damage to the site and the trails. Assessors collected a projectile point from the front of the cavate, but this was the only artifact observed during the site visit.

**Figure 28. Assessors record trail segments 17-M and 10-G (in the forefront) and LA 21661.**

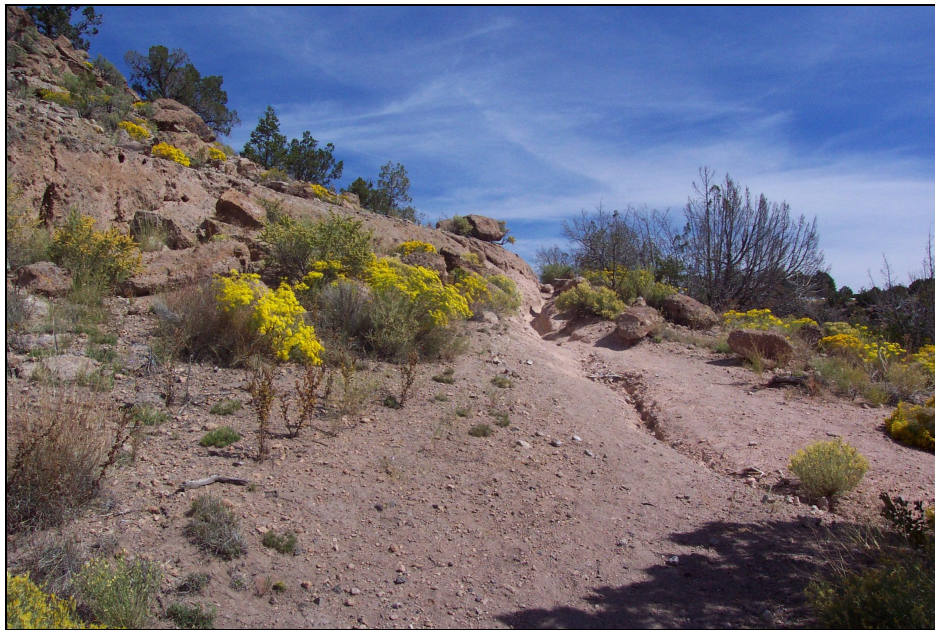
**Figure 29. Heavily eroded portion of trail segment 10-G.**

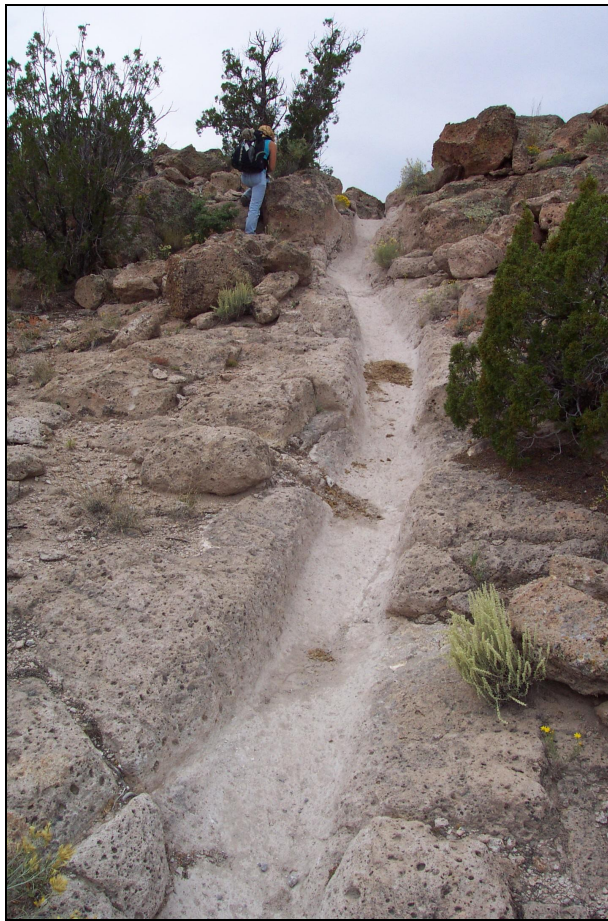
**Figure 30. S. Sherwood stands next to a well-preserved Ancestral Pueblo trail segment that continues to be used.**
