Health Hazard Evaluation Report

HETA 90-376-2106 U.S. DEPARTMENT OF HOUSING AND URBAN DEVELOPMENT HATO REY, PUERTO RICO

HAZARD EVALUATION AND TECHNICAL ASSISTANCE REPORT
HETA 90-376-2106
U.S. DEPARTMENT OF HOUSING AND URBAN DEVELOPMENT
HATO REY, PUERTO RICO
APRIL 1991

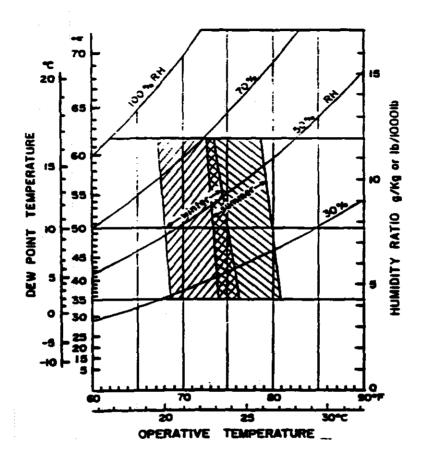
Figure 1 — Acceptable ranges of operative temperature and humidity for persons clothed in typical summer and winter clothing, at light, mainly sedentary, activity. (ASHRAE 55-1981)

On the second and third floors, most locations had a temperature and humidity combination falling outside of, or at the far ends of the operative temperature and humidity range recommended by ASHRAE, as shown in Figure 1.

The environmental measurements indicated that many of the work areas had a temperature and RH combination falling outside of, or at the far ends of, the range recommended by ASHRAE. If the ASHRAE recommendations for summer are used as criteria (since the local climatic conditions create the need for air conditioning all year), air temperatures tended to be cooler than those recommended. The mean temperature for all locations combined was 72.5

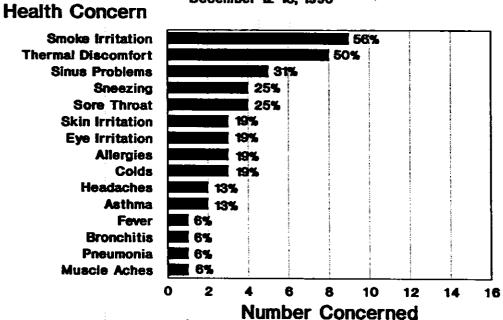
Figure 2 (Out of 16 Persons Interviewed)

The results of the medical interviews are presented in Figure 2. The two most common complaints (smoke irritation and thermal discomfort) were mentioned by 50% or more of those interviewed and were felt by them to contribute to many of the other complaints including sinus problems, sneezing, allergies, asthma, eye irritation, colds, sore throat, and headaches. Thirteen of the 16 interviewed employees reported that their symptoms generally resolved within a few hours after leaving the building and on weekends.

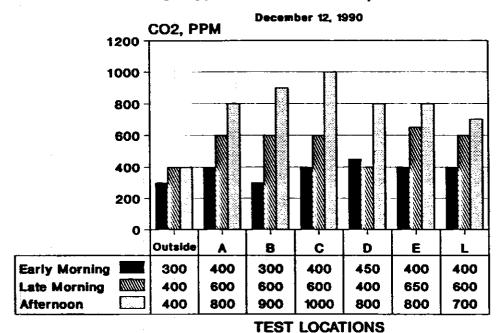
Figure 3a

Figures 3a and 3b present the results of the CO₂ measurements made on floors 1-3. The test location designations correspond to sample locations identified on the floor plans which are included in the Appendix. (While the floor plans are not quality reproductions, the sample locations can be clearly seen.) As can be seen from Figures 3a and 3b, CO₂ concentrations ranged from 400-700 parts per million (ppm) on the first floor (location L), 450-1100 ppm on the second floor (locations F-K), and 300-1000 ppm on the third floor (locations A-E). It should be pointed out, however, that approximately six field investigators (out of eight total employees) from the first floor were not

present on the day that measurements were made; therefore the reported values may not be representative of conditions when all investigators are in the office. In most cases, the CO_2 concentrations were highest during the afternoon, indicating a build-up of CO_2 (primarily from exhaled breath) over the course of the day. Mean CO_2 concentrations for all locations combined were 450, 660, and 860 ppm, for measurements made in the early morning, late morning, and late afternoon, respectively. The relatively high CO_2 concentration measured in Location C (1000 ppm) may reflect the fact that an office luncheon was held in this area and was attended by approximately 20-30 people from surrounding areas, thus, contributing to an increase in the CO_2 concentration. In Location H, where the afternoon CO_2 concentration was measured at 1100 ppm, it was observed that there was no return air system present in this area, a situation which was not observed in the corresponding area on the third floor.

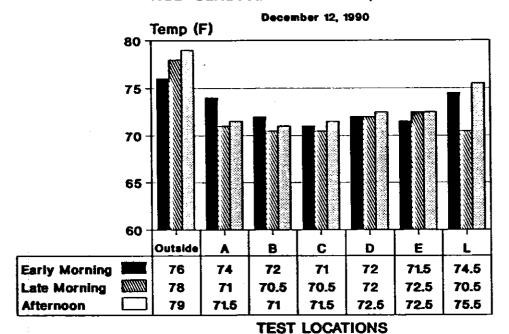
Figure 4a

Air temperature measurements are shown in Figures 4a and 4b. While there was some temperature fluctuation throughout the day in all areas, this variation was generally on the order of a few degrees. For all indoor locations combined, the air temperatures ranged from 70-75.5 degrees Fahrenheit, while outdoor air temperatures ranged from 76 degrees in the morning to 79 degrees in the late afternoon. As shown in Figures 5a and 5b, relative humidity, an indication of the moisture content of the air, ranged from 52-56% on the first floor, 62-71% on the second floor, and 62-71% on the third floor. The outdoor air humidity ranged from 80-85% over the course of the day. While there was very little variation in RH between the second and third floors, the RH measured on the first floor was considerably lower. It should be noted. however, that the first floor space occupied by HUD employees was guite small in comparison to the areas occupied on the second and third floors, requiring a smaller air handling unit. It is unclear from the limited information available, however, whether factors such as the type of unit, chiller water temperature, or the amount of outside air entering or infiltrating the area were important factors influencing the RH.
