NIOSH HEALTH HAZARD EVALUATION REPORT

**HETA #2005-0033-2984 and 2005-0234-2984
Liberty Central School District
Liberty, New York**

November 2005

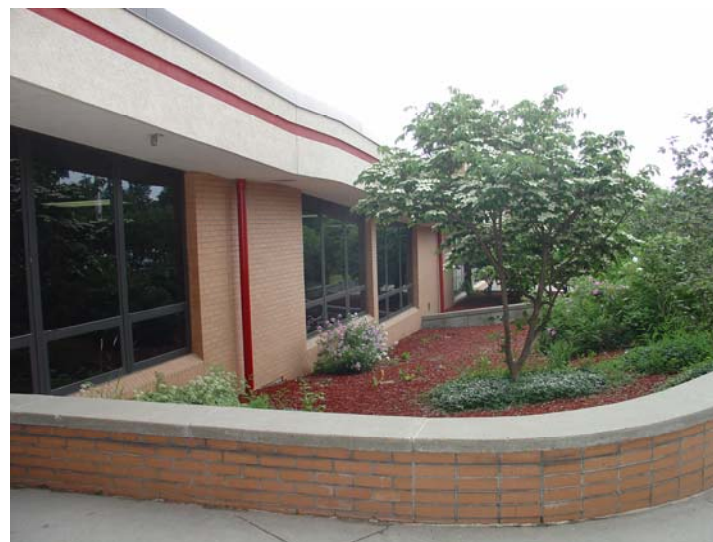
The connecting hallway between the Middle and High Schools had indications of water damage. The landscaping outside this area was graded toward the building and had no French drains or other drainage systems, according to the head custodian (Figure 4). This may allow water to flow into the building, causing water damage.

Figure 4. Corridor connecting Liberty Middle and High Schools.

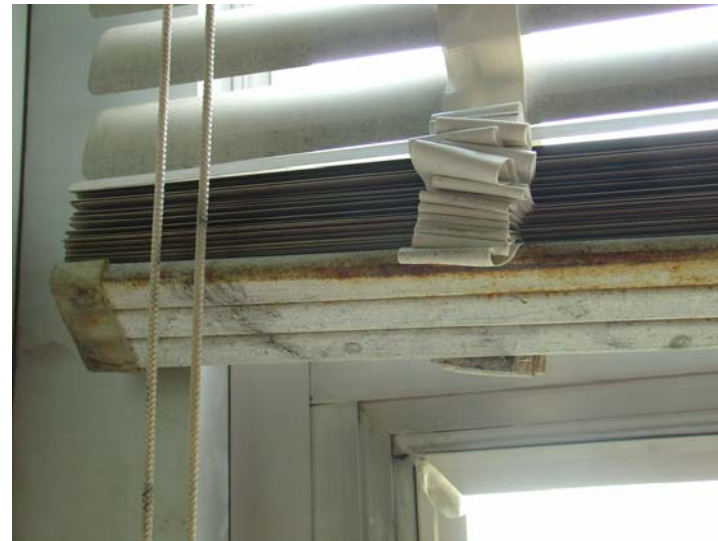
The library had rusty, and possibly moldy, window blinds (Figure 16). The rust appeared to be caused by the blinds sitting in water or staying wet for long periods. We noticed other blinds in various rooms with rust and possible mold, although not to the extent of the library's blinds.

Figure 16. Rust, dirt, and possible mold on an aluminum blind in the High School library.

- Inspect and repair the bridges connecting the two High School buildings. Replace rotted wood and other damaged materials.
- Clean or replace moldy window blinds.
