**AFTER ACTION REPORT**  
**MEC / UXO SURFACE SWEEP ACTIVITIES**  
**FORMER MILITARY ORDNANCE RANGE AREAS**  
**LOS ALAMOS NATIONAL LABORATORIES**  
**LOS ALAMOS, NM**

HydroGeoLogic, Inc.  
2705E Pan American Freeway, NE  
Albuquerque, NM 87107

November 2006

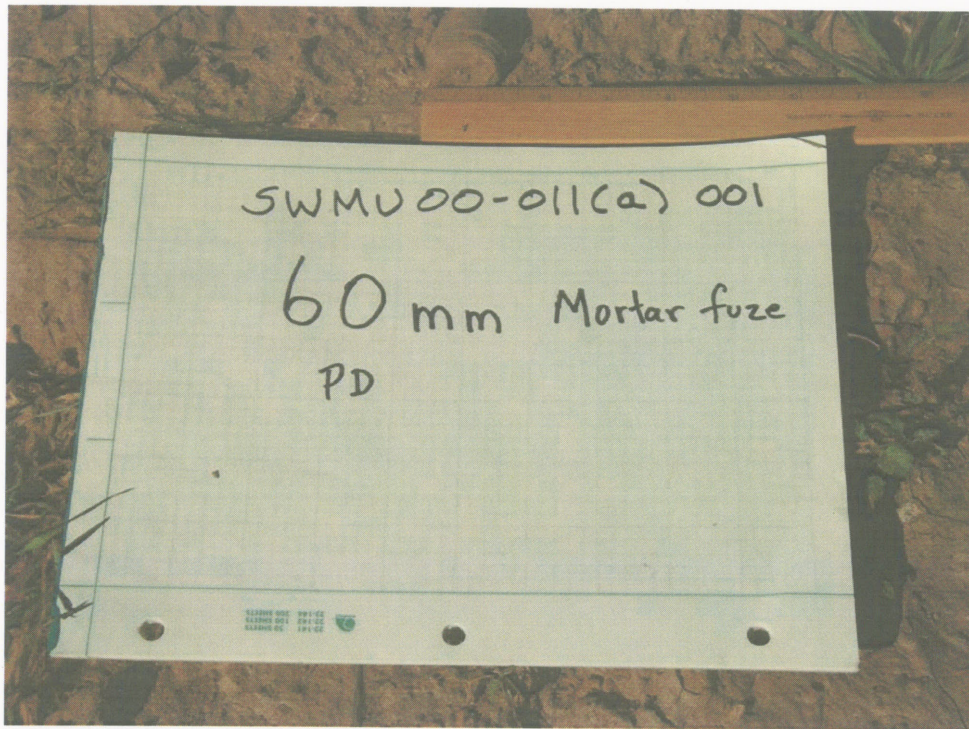
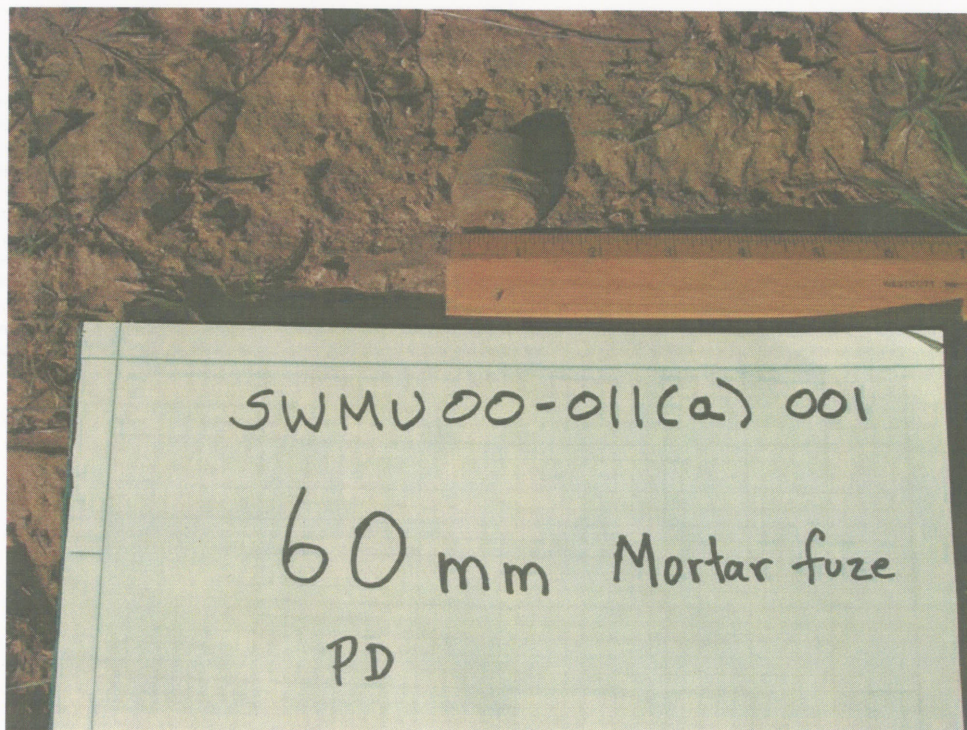
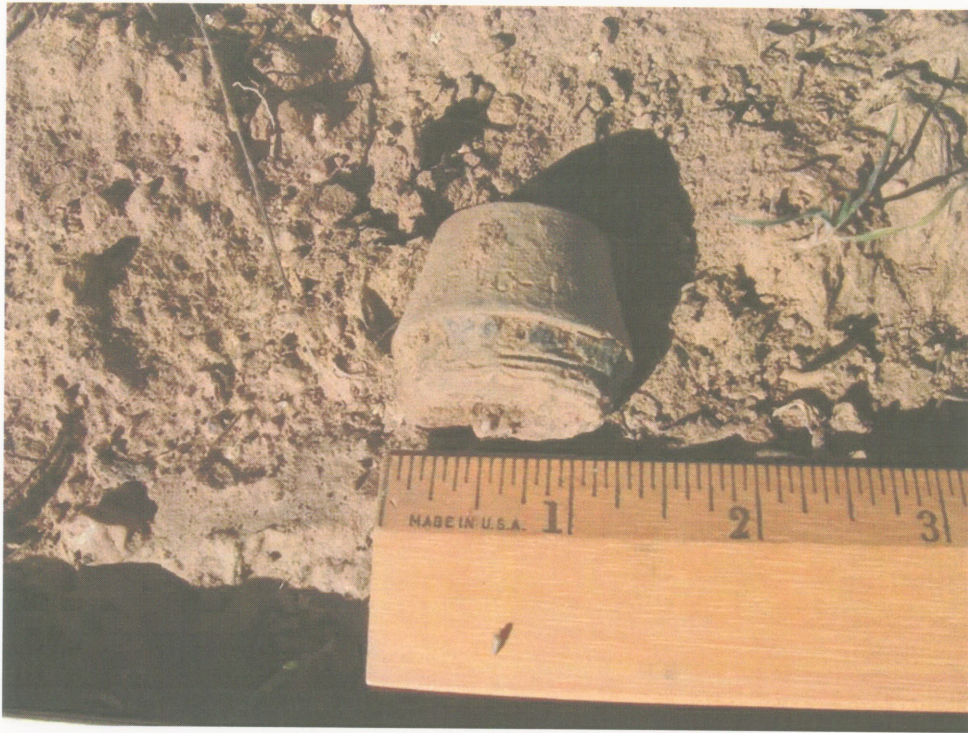
Surface finds of MD indicate fragmentation from mortar / projectile detonations, as well as a possible kick-out remnant (60-mm point detonating fuze discovered in SWMU00-011(a)) from ordnance disposal or open burn / open detonation (OB/OD) activities.

60-mm point detonating mortar fuze found in SWMU-011 (a).

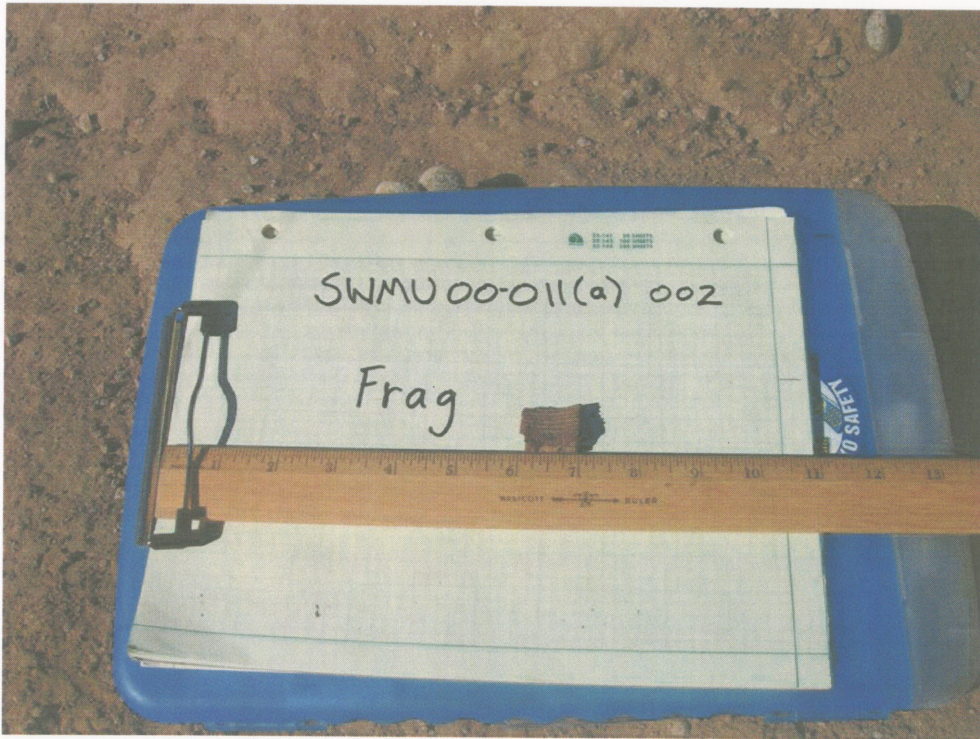
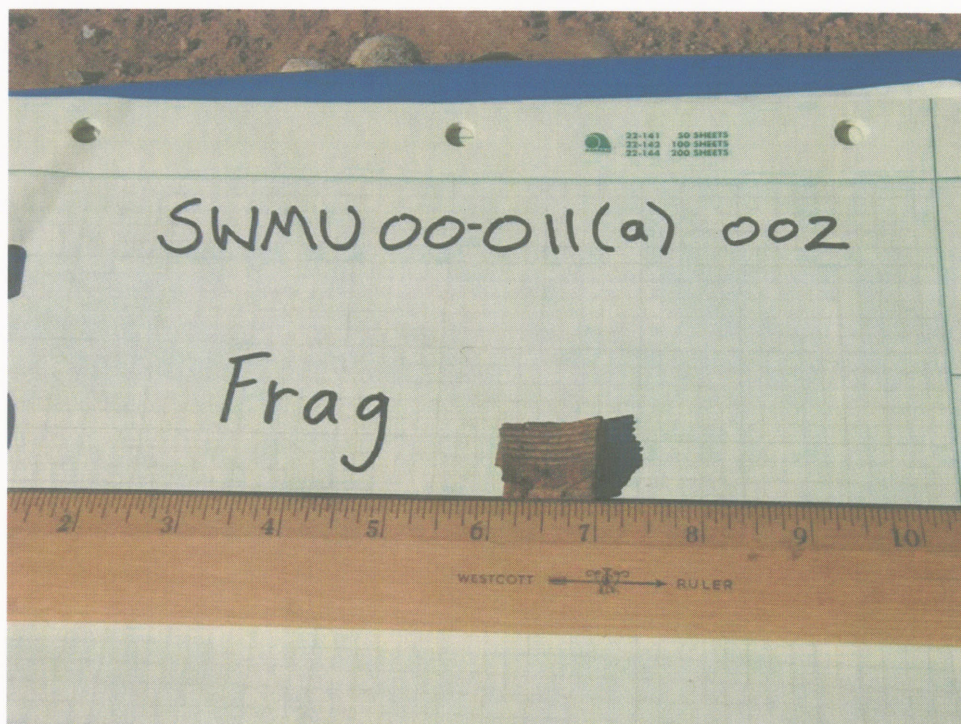
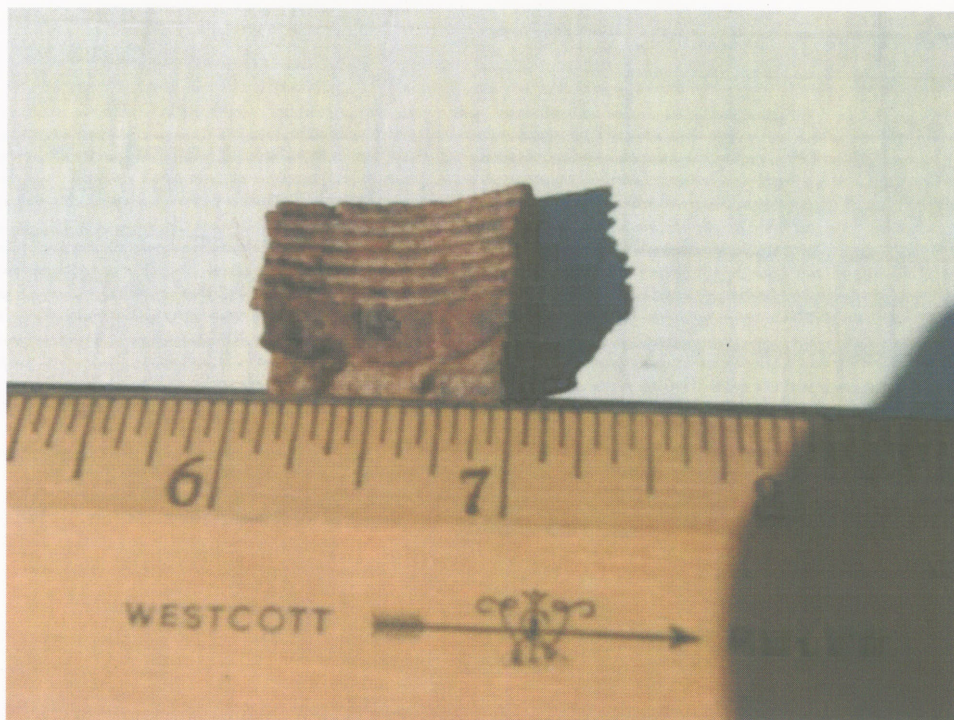
Projectile fragment found in SWMU-011 (a).

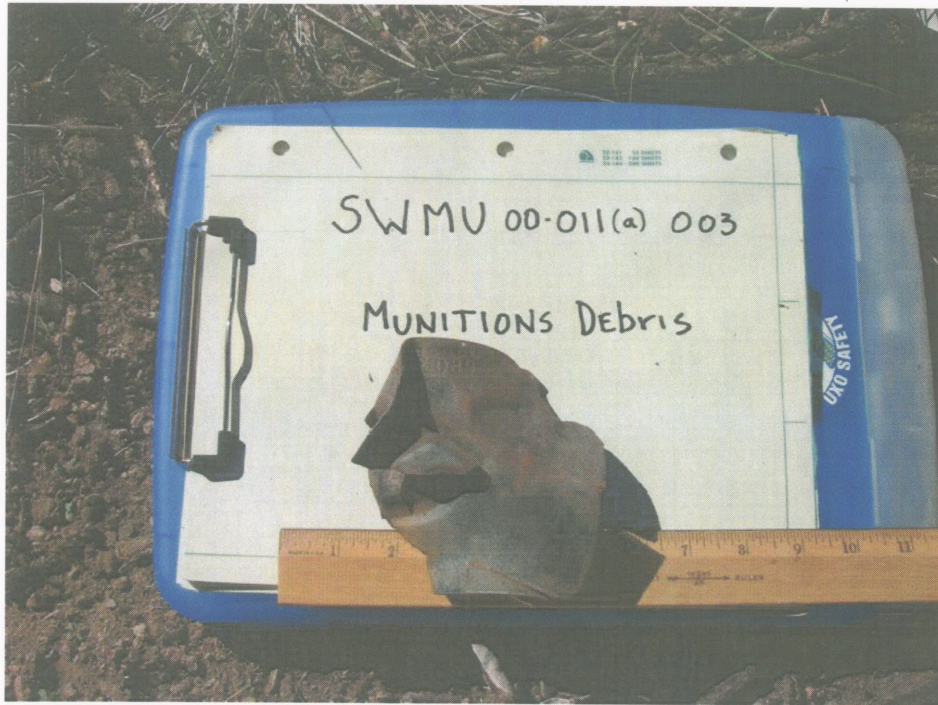
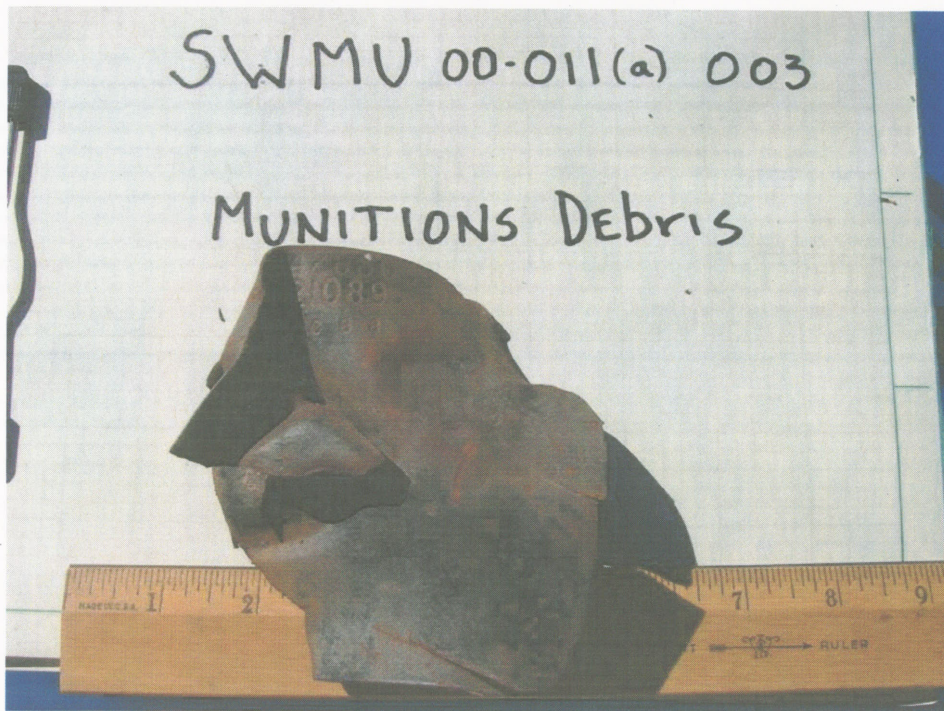
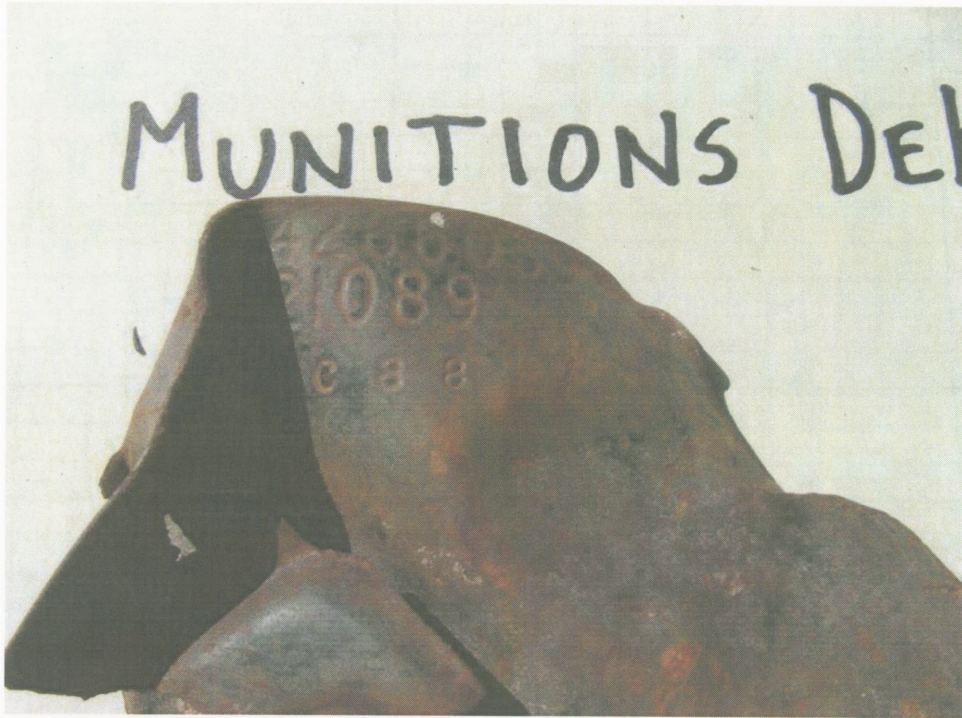
Unidentified item, probable munitions debris fragment found in SWMU-011 (a).

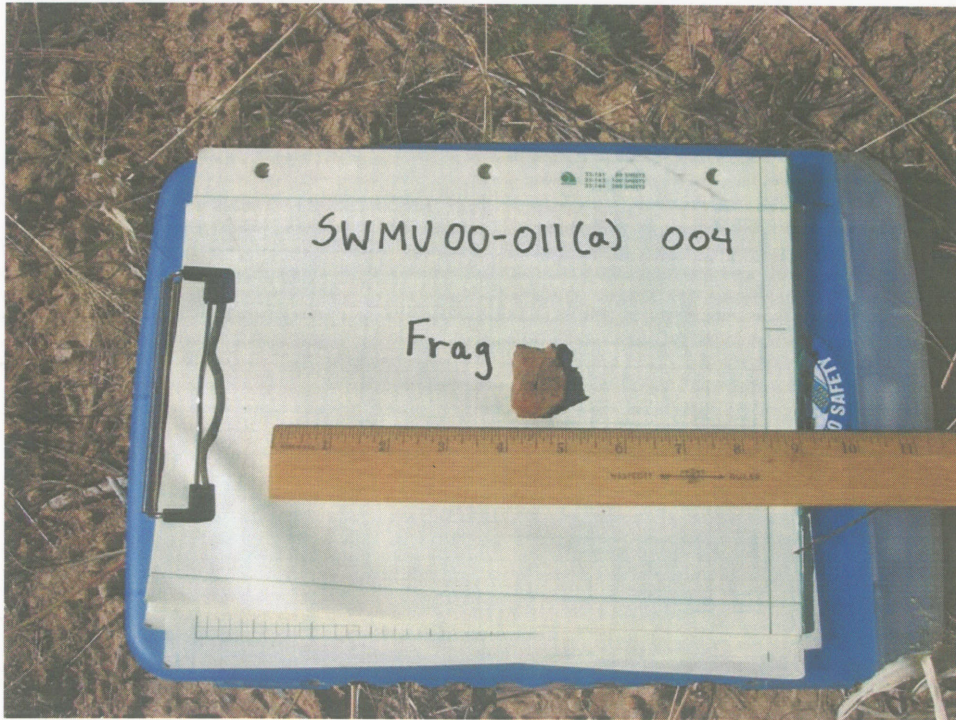
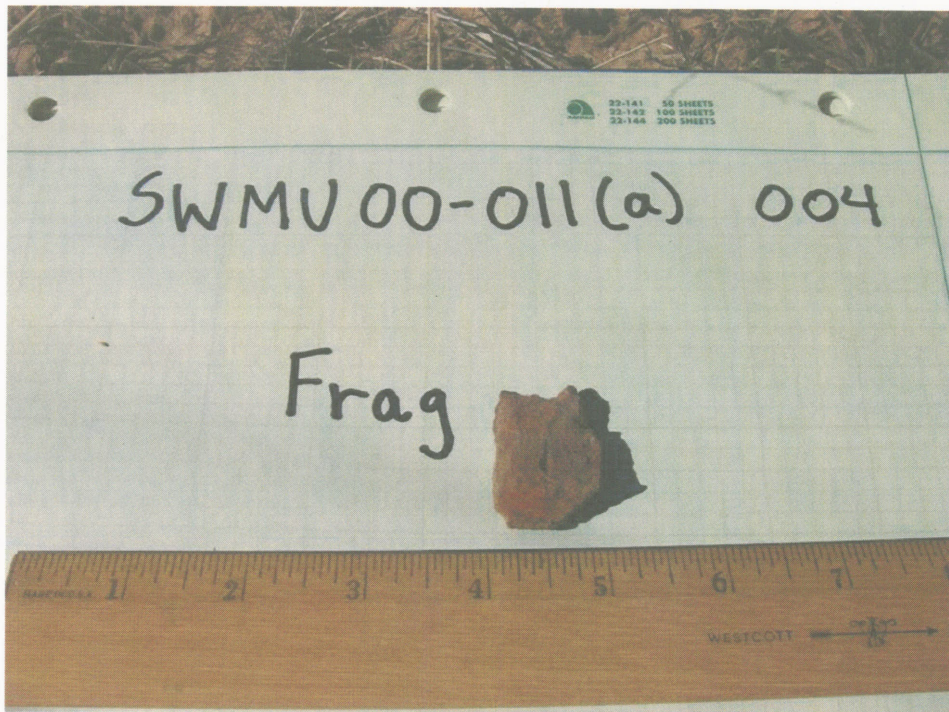
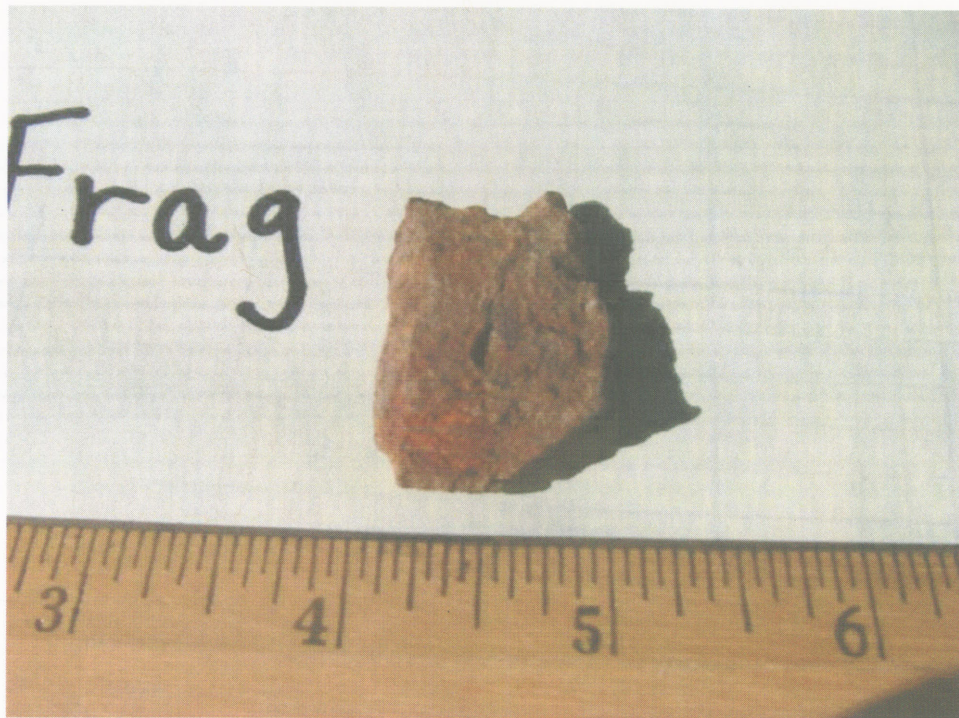
Projectile fragment found in SWMU-011 (a).

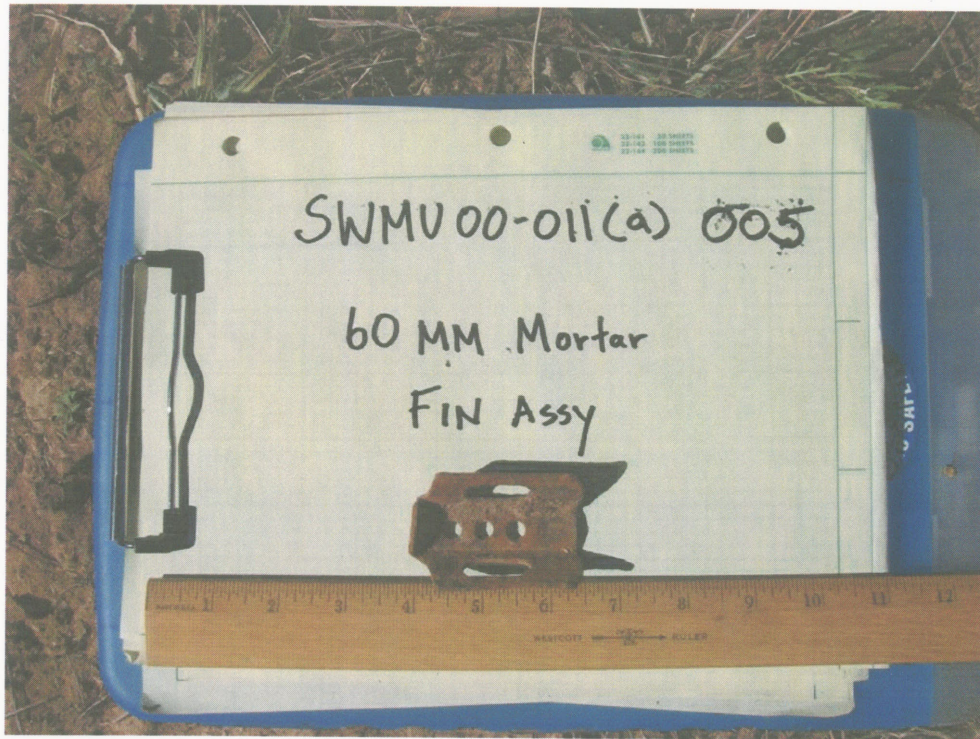
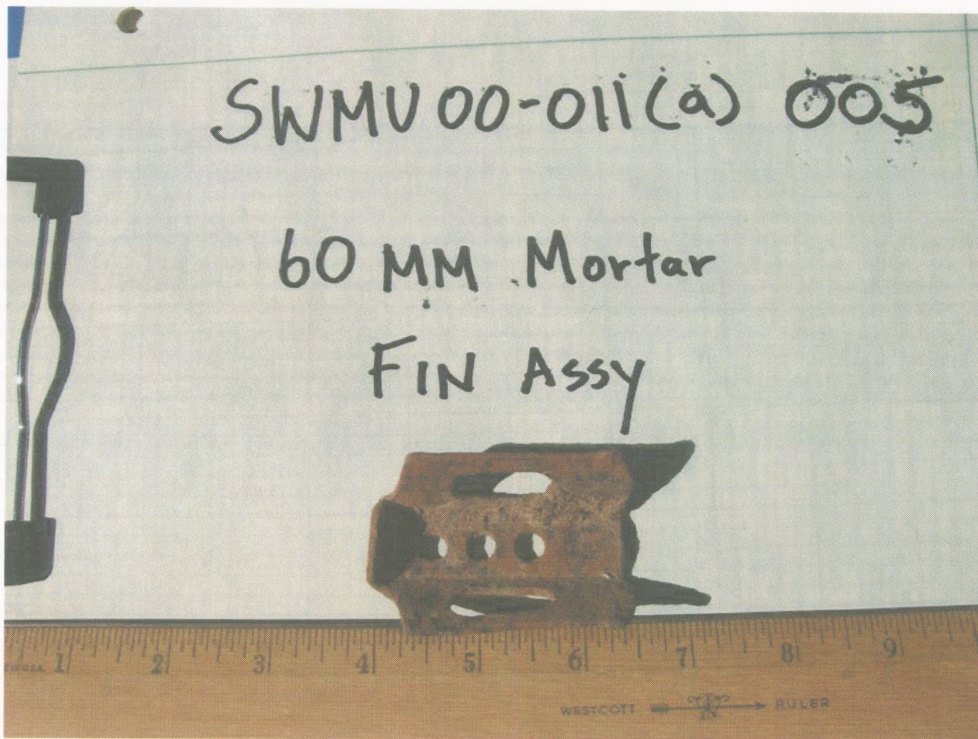
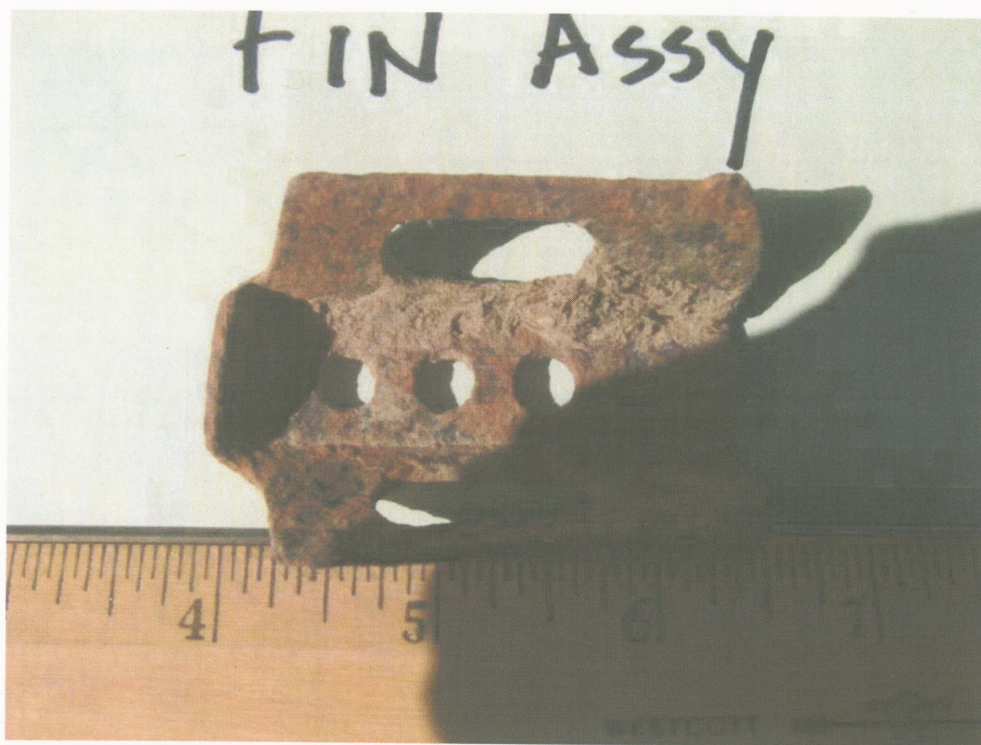
Mortar fin assembly found in SWMU-011 (a).

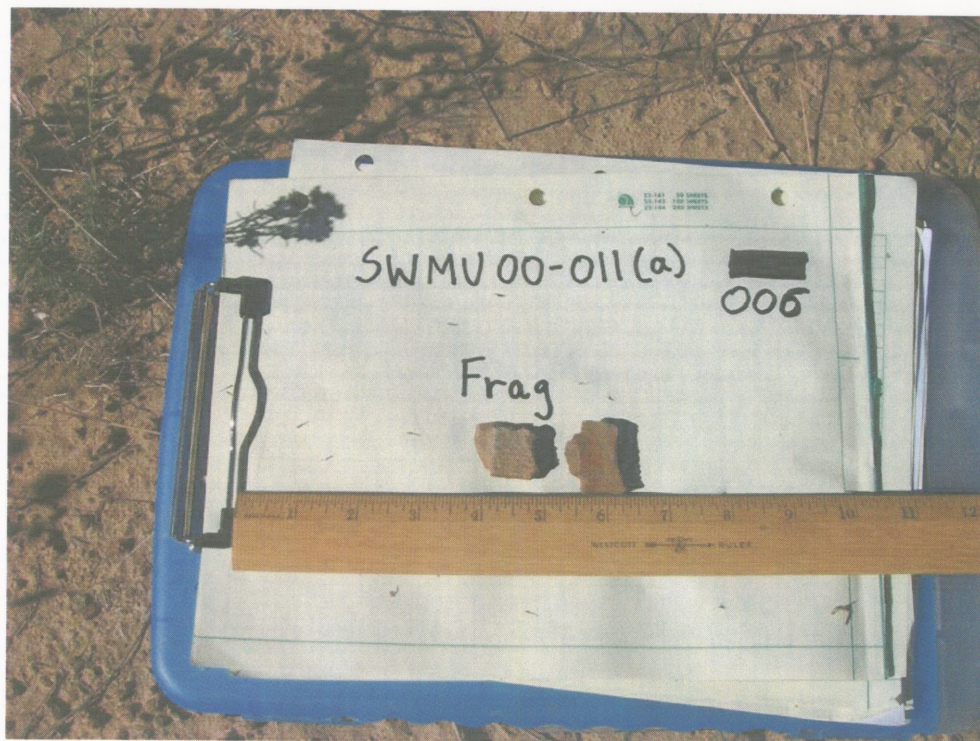
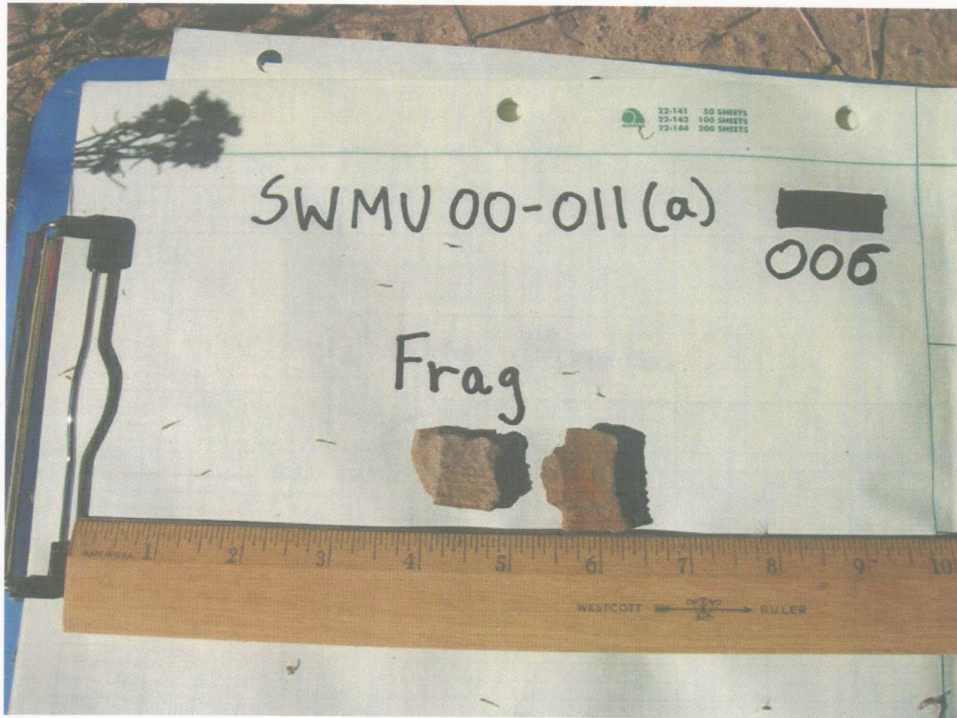
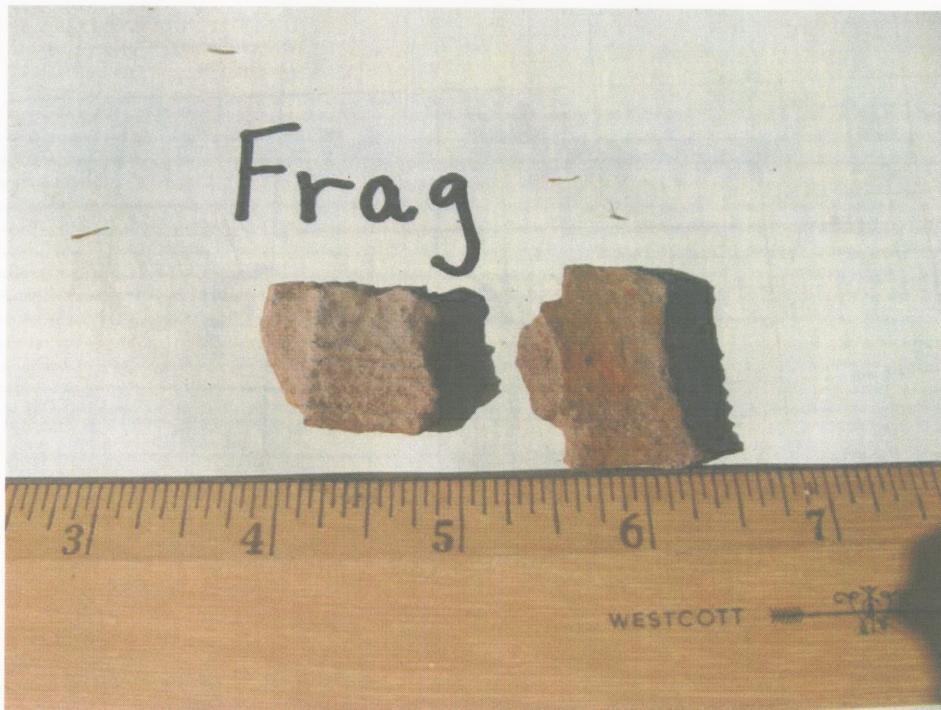
Projectile fragment found in SWMU-011 (a).

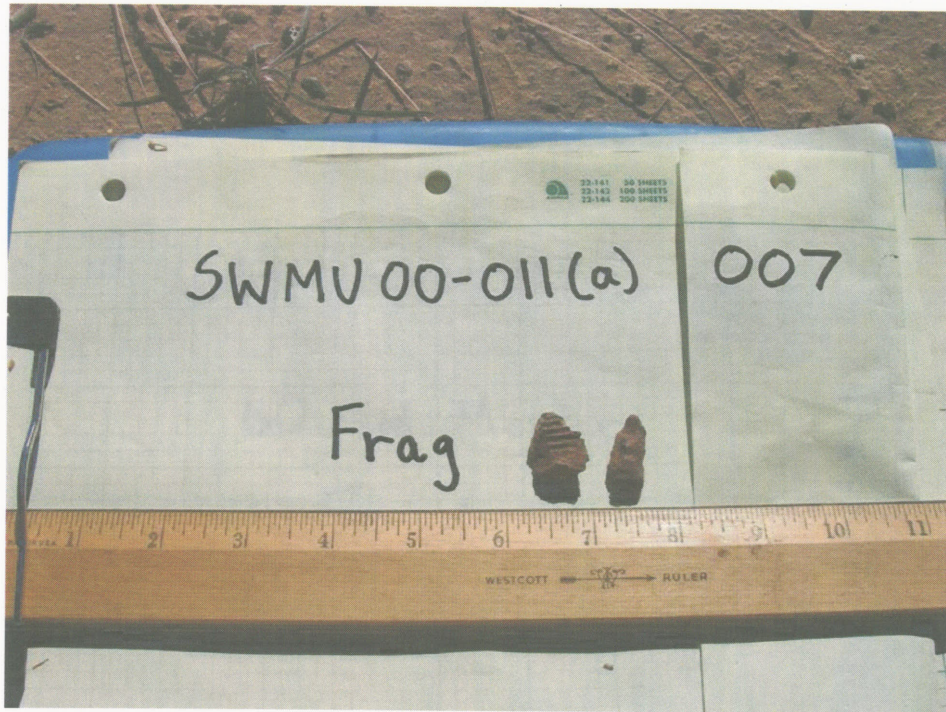
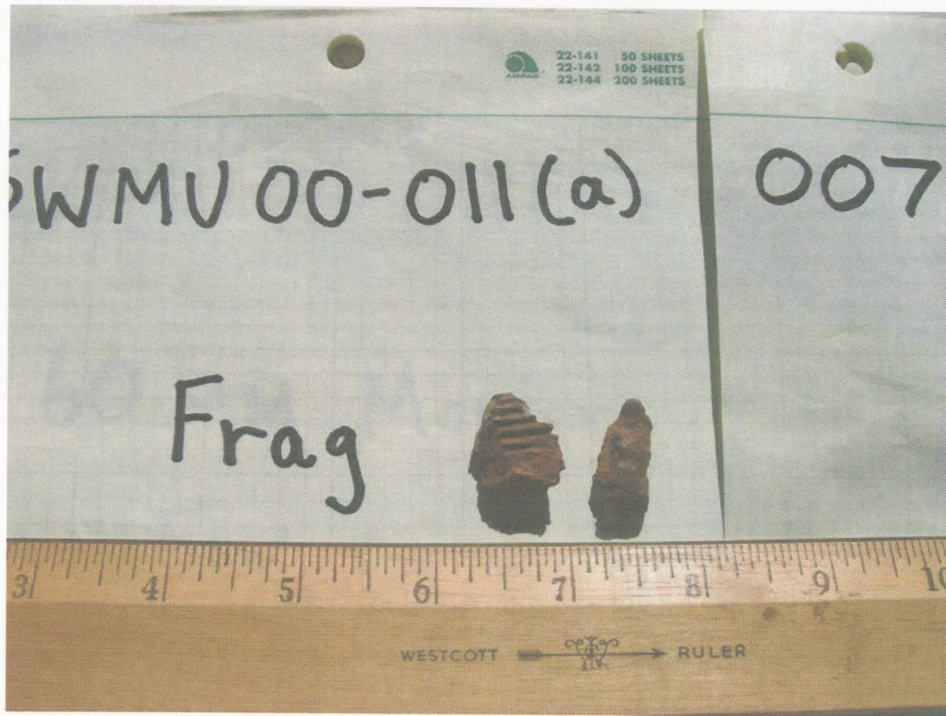
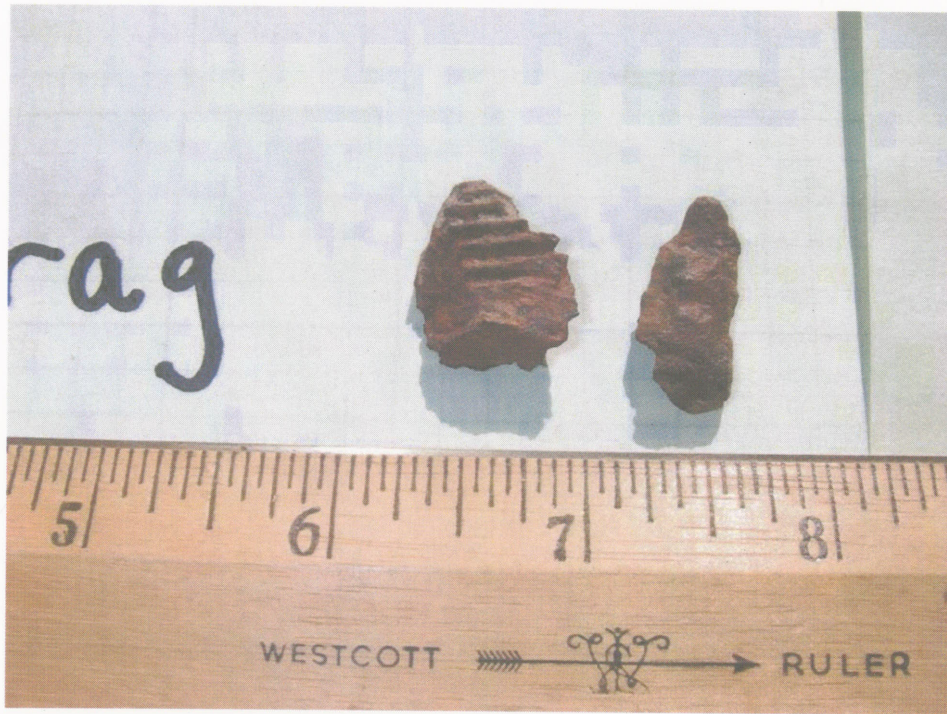
Projectile fragment found in SWMU-011 (a).

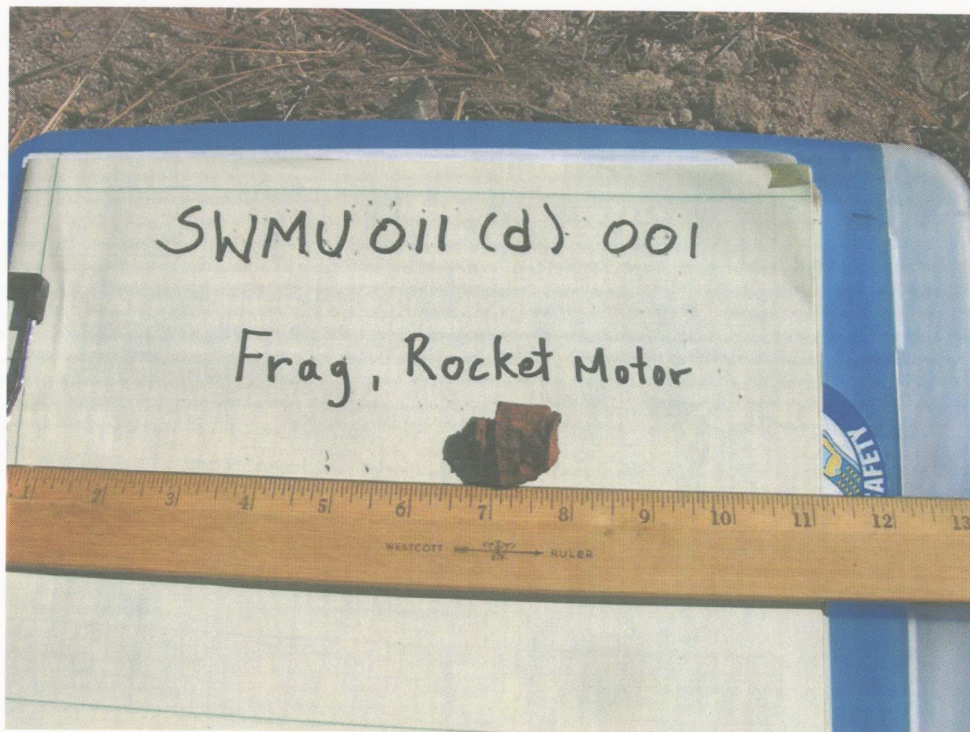
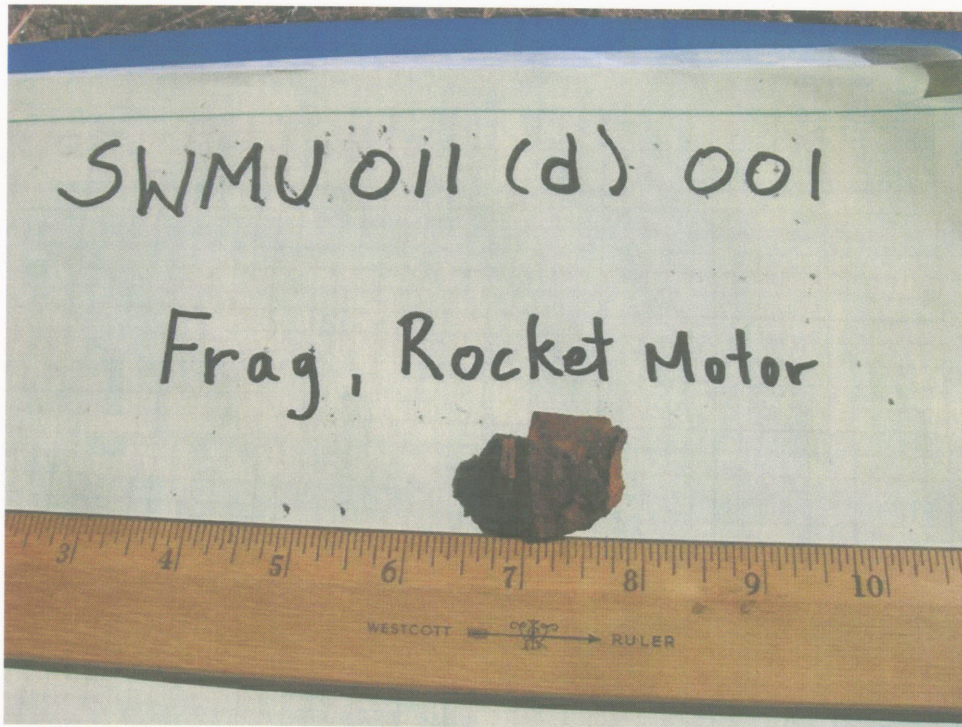
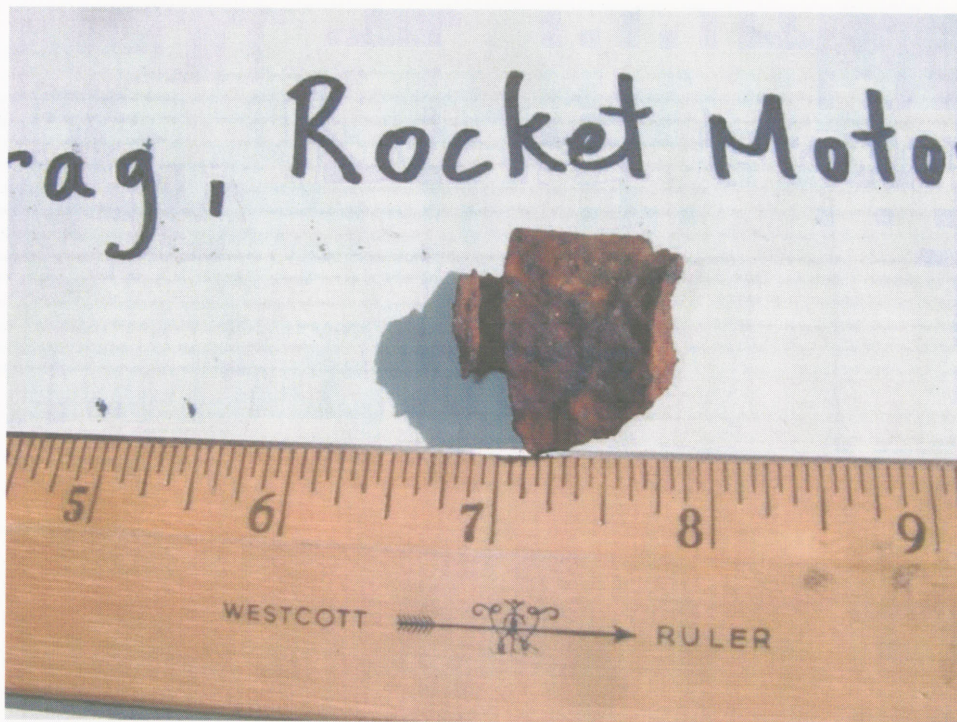
Rocket motor debris found in SWMU-011 (d).

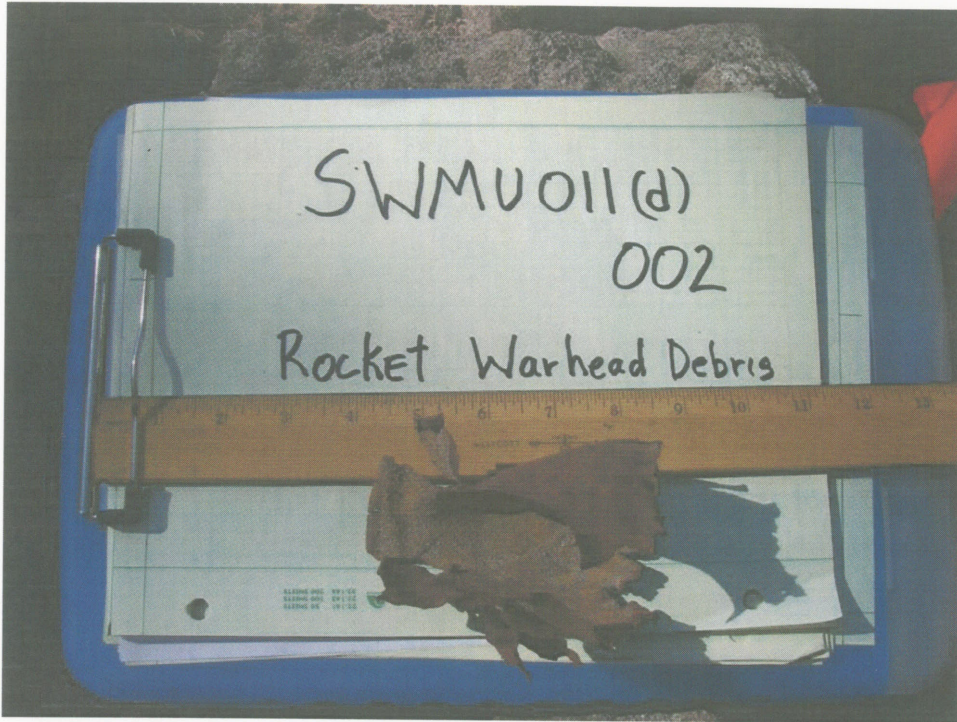
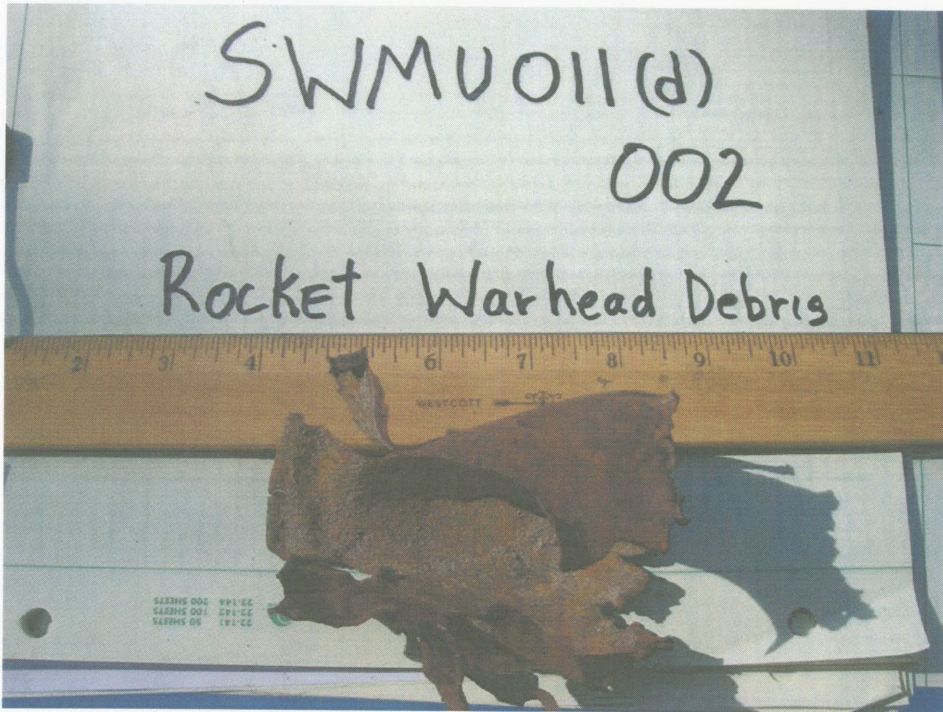
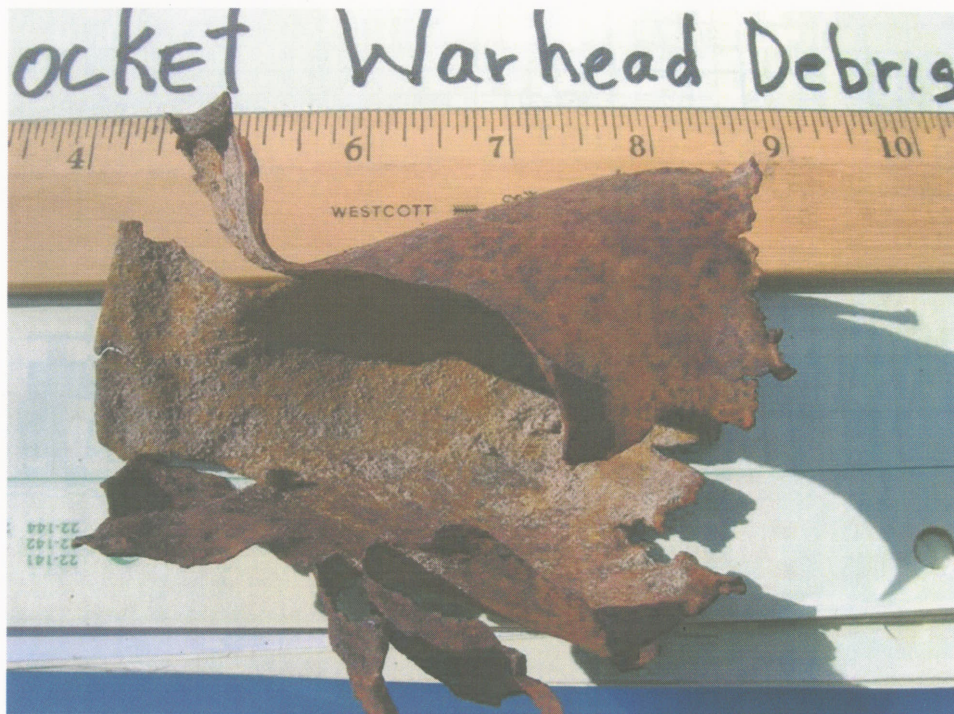
Rocket warhead debris found in SWMU-011 (d).

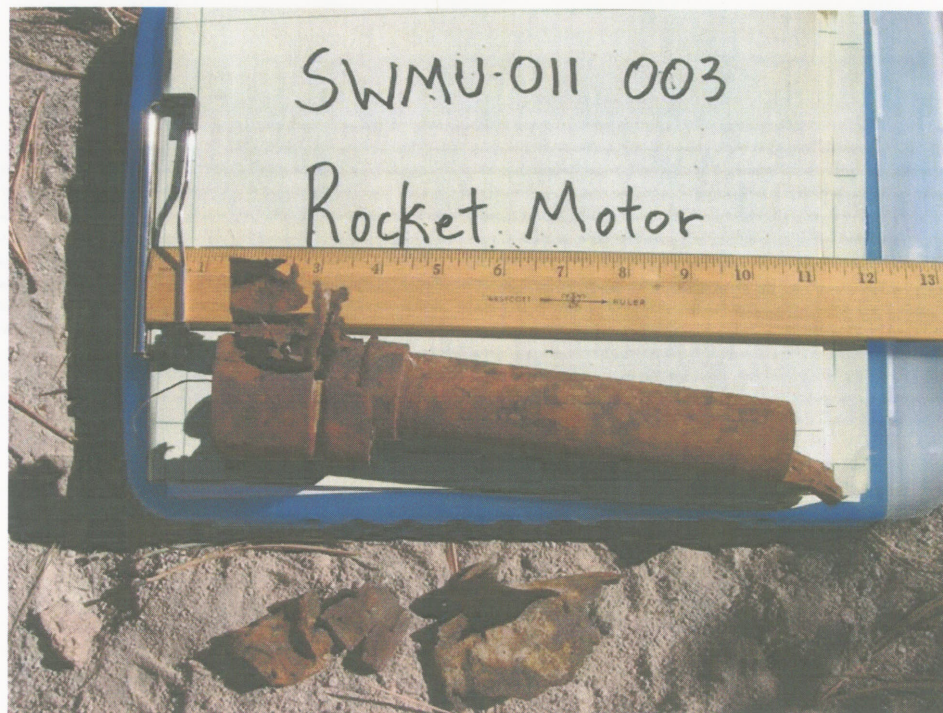
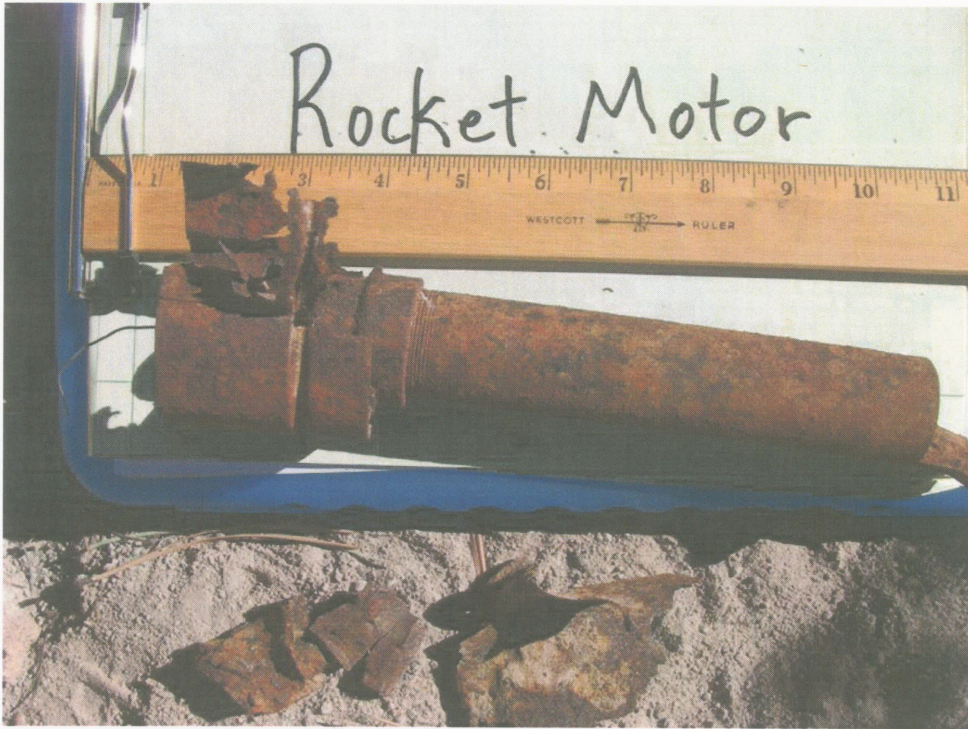
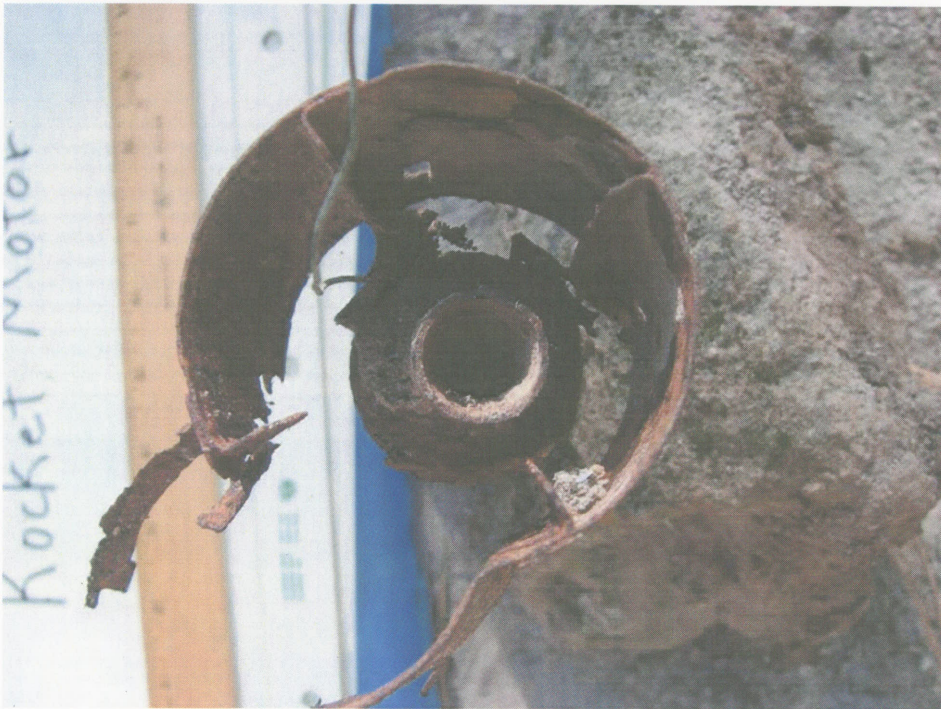
Expendable rocket motor and fragment found in SWMU-011 (d).

Expended rocket motor and fragment found in SWMU-011 (d).

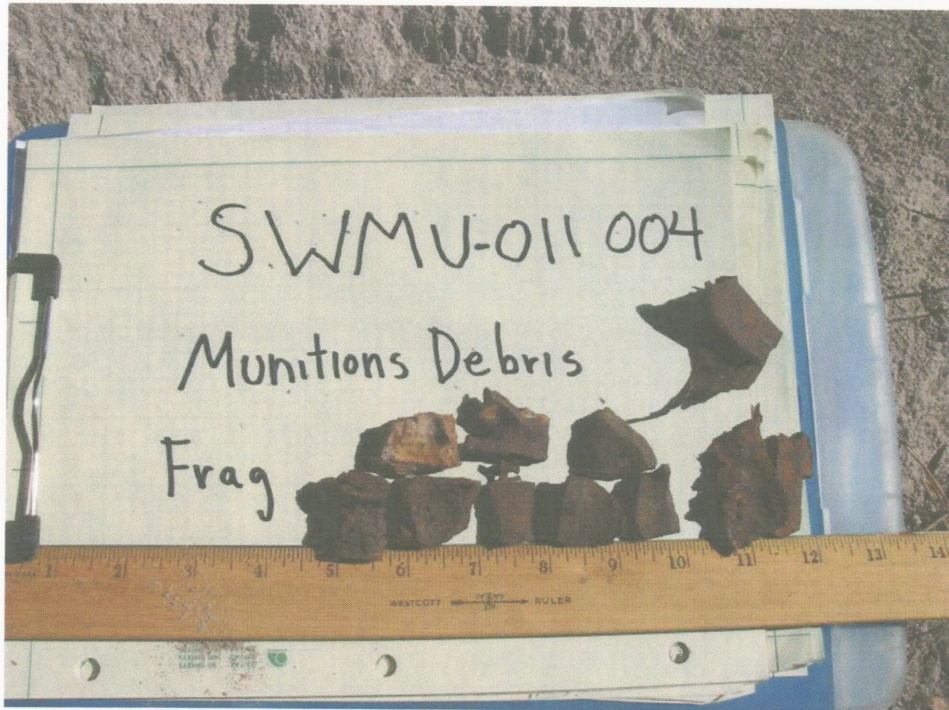
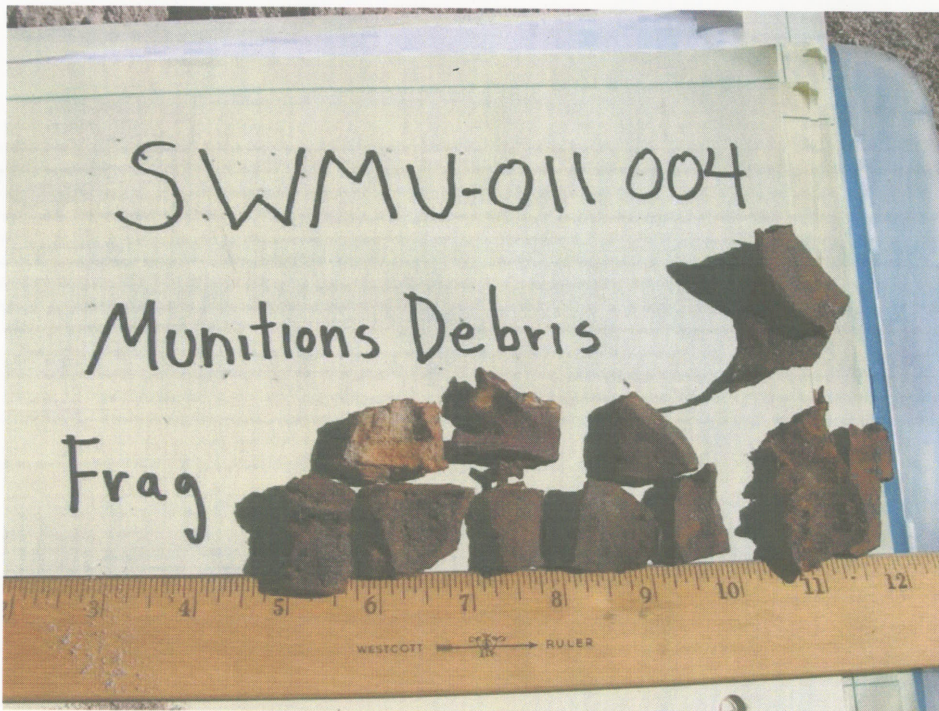
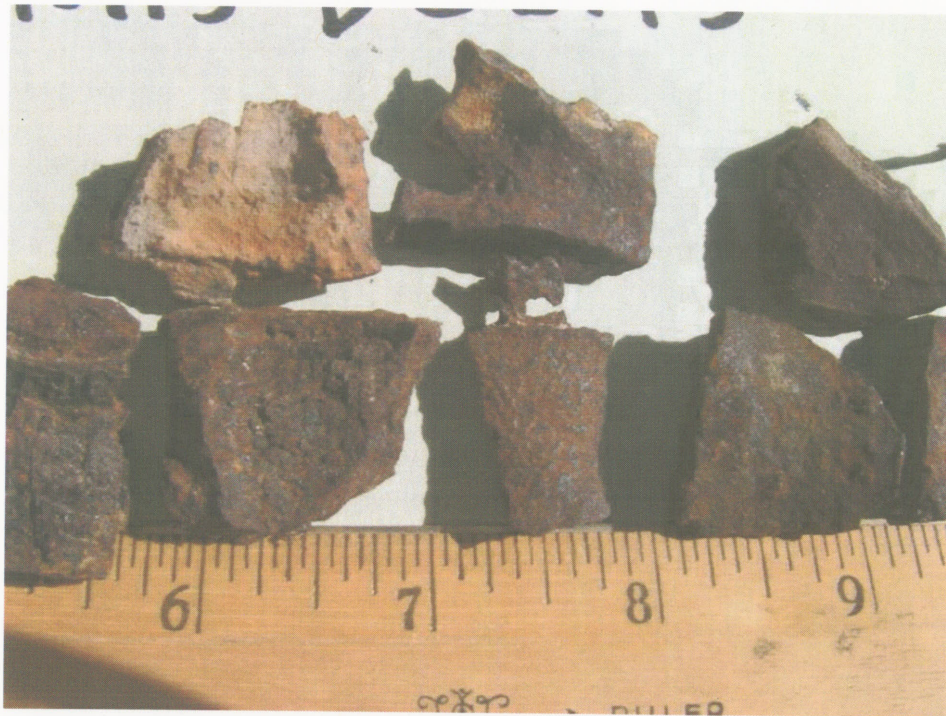
Munitions debris and fragment found in SWMU-011 (d).
