**AFTER ACTION REPORT**  
**MEC / UXO SURFACE SWEEP ACTIVITIES**  
**FORMER MILITARY ORDNANCE RANGE AREAS**  
**LOS ALAMOS NATIONAL LABORATORIES**  
**LOS ALAMOS, NM**

HydroGeoLogic, Inc.  
2705E Pan American Freeway, NE  
Albuquerque, NM 87107

November 2006

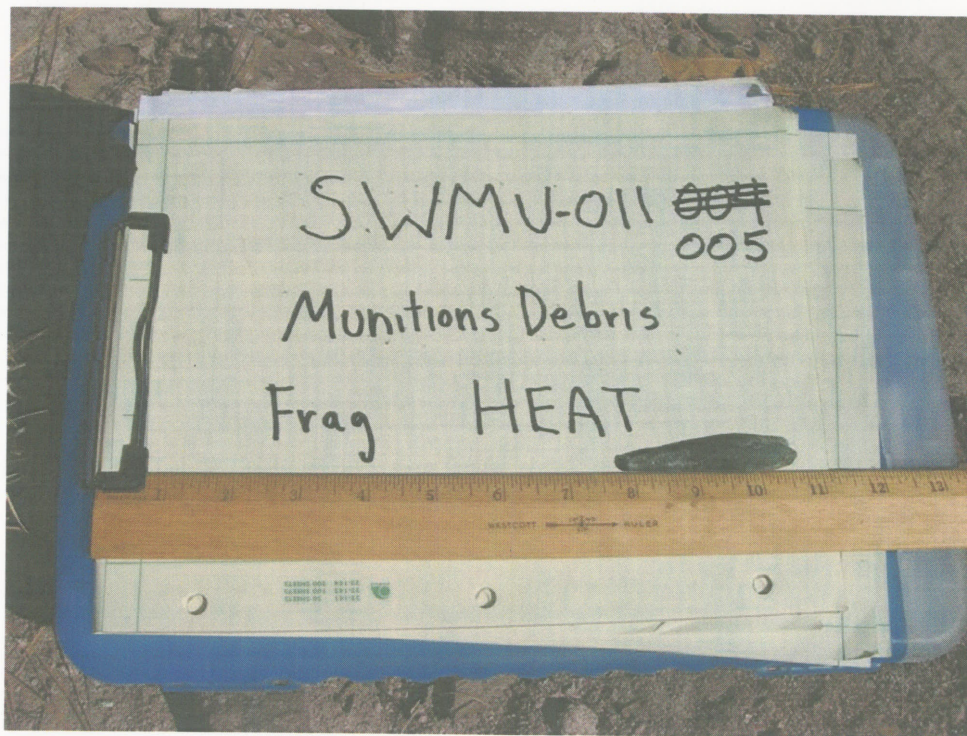
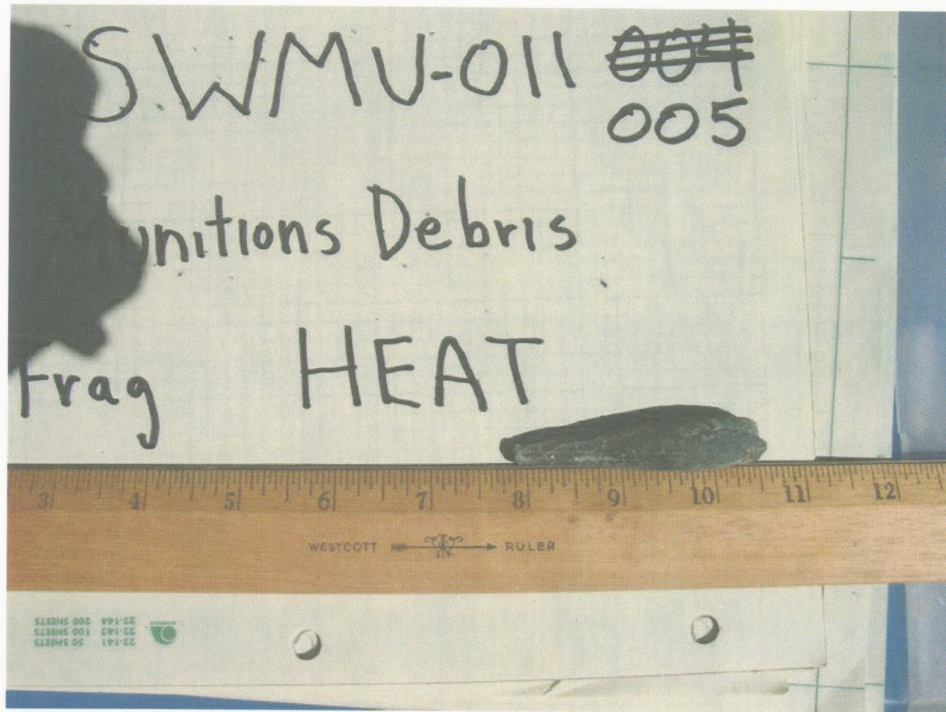
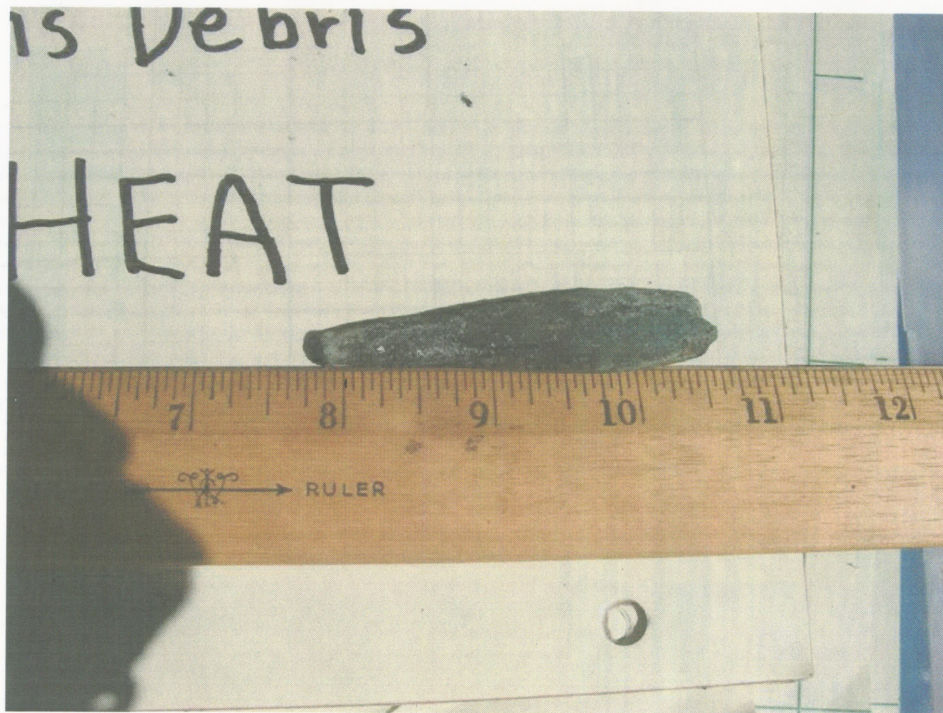
Munitions debris / fragment (high explosive anti-tank) found in SWMU-011 (d).

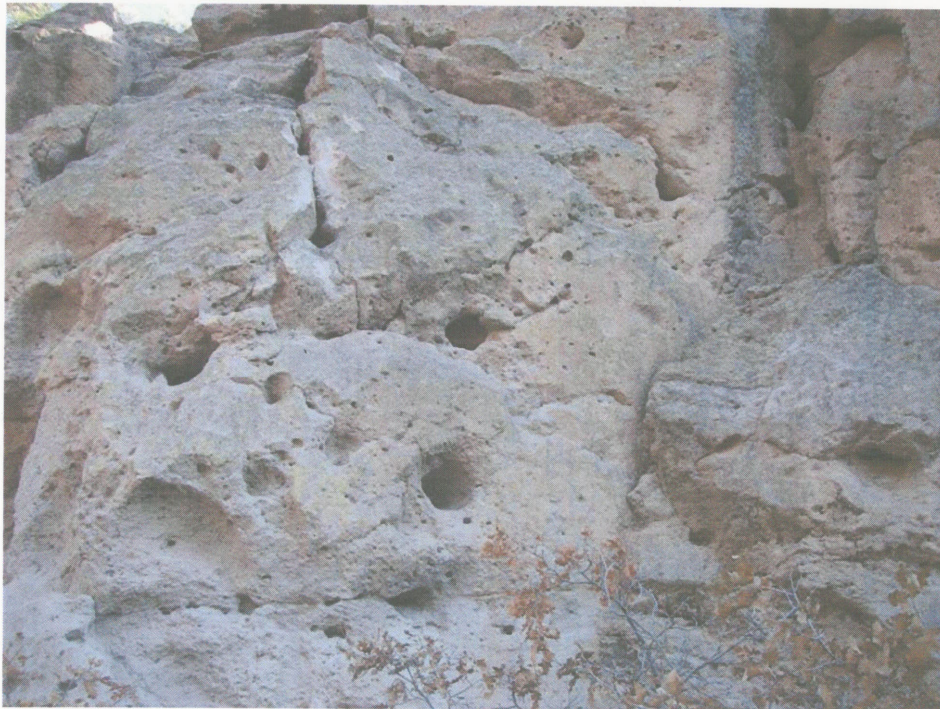
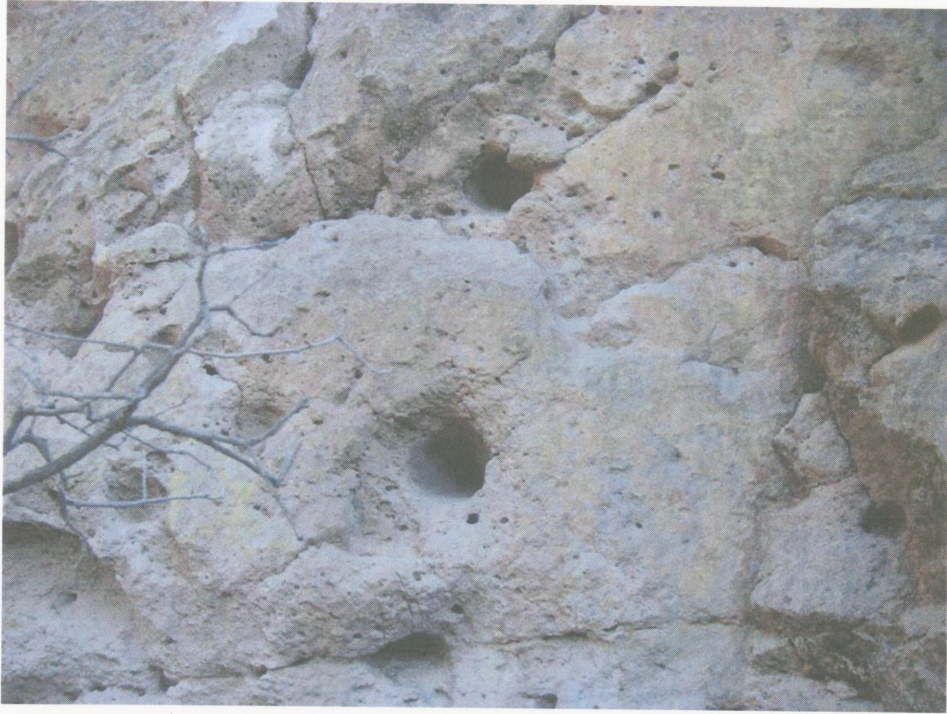
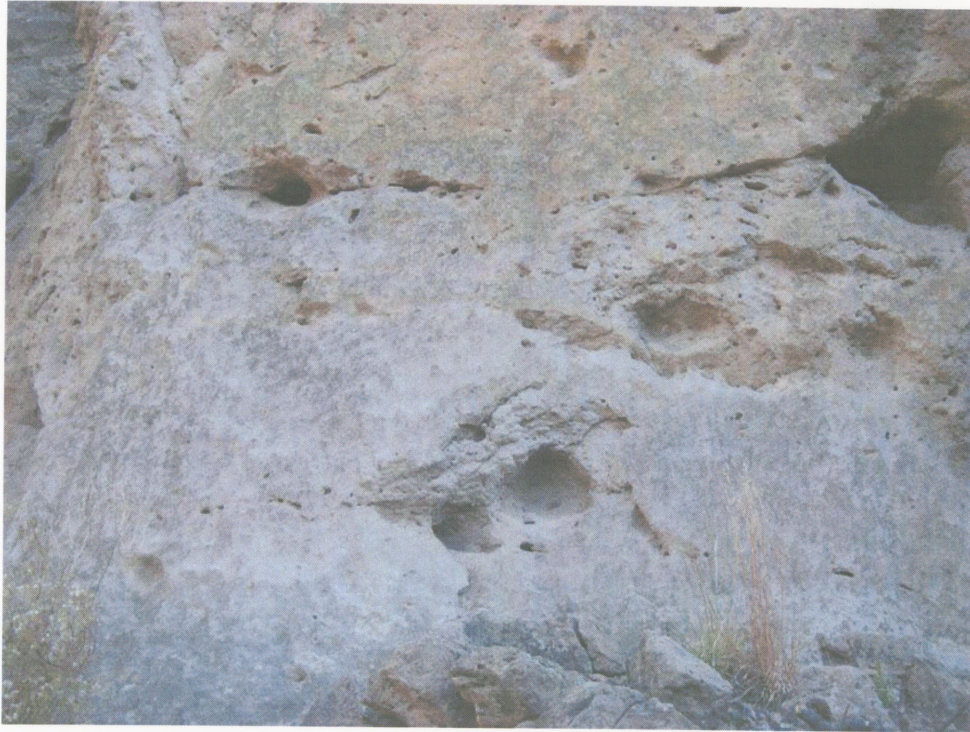
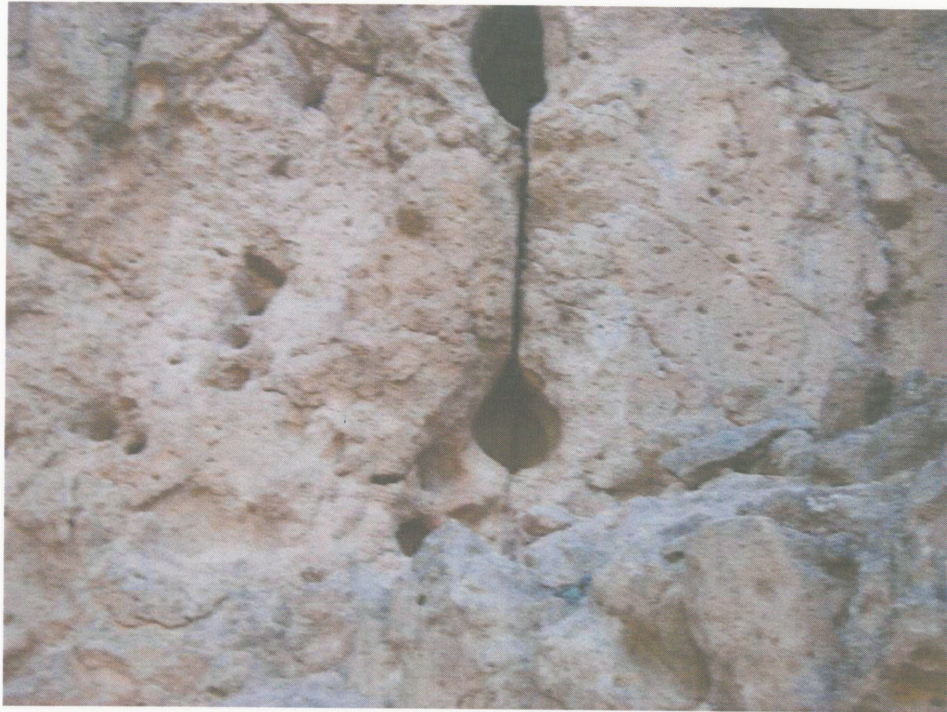
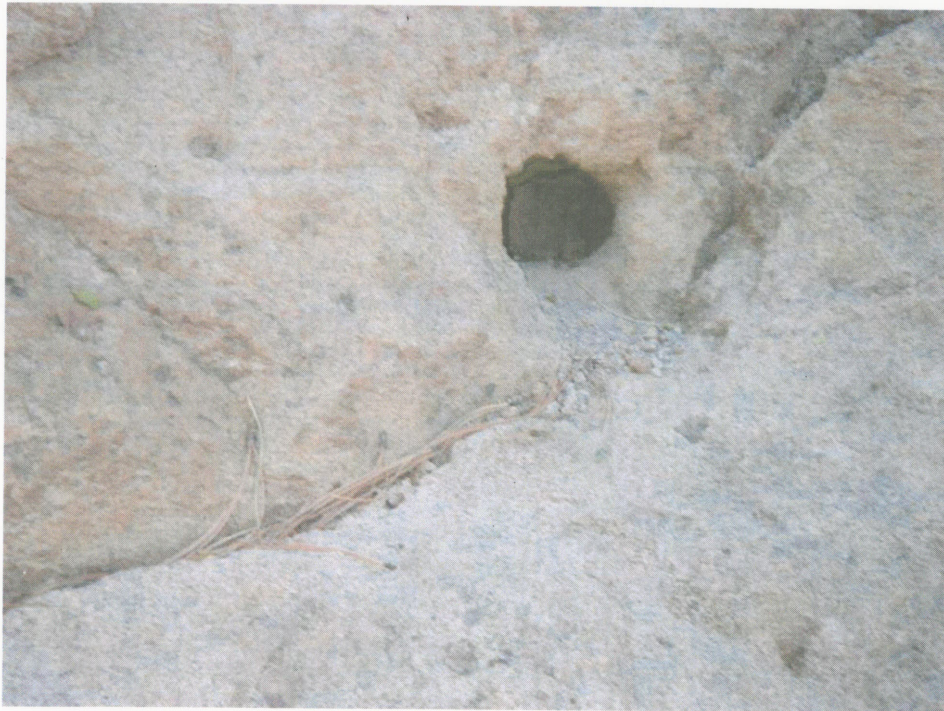
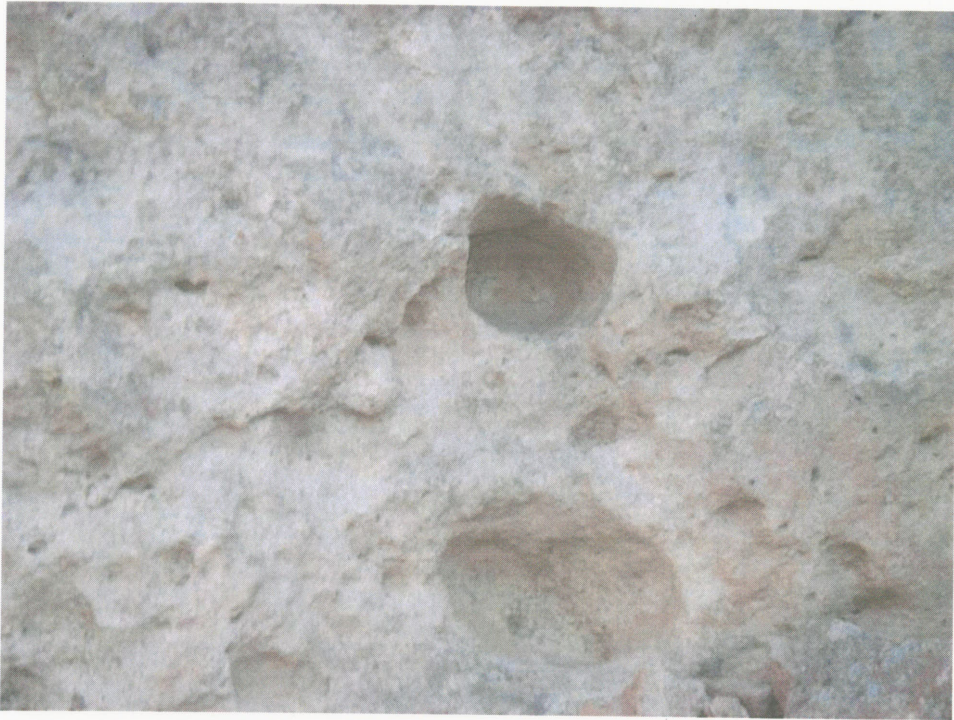
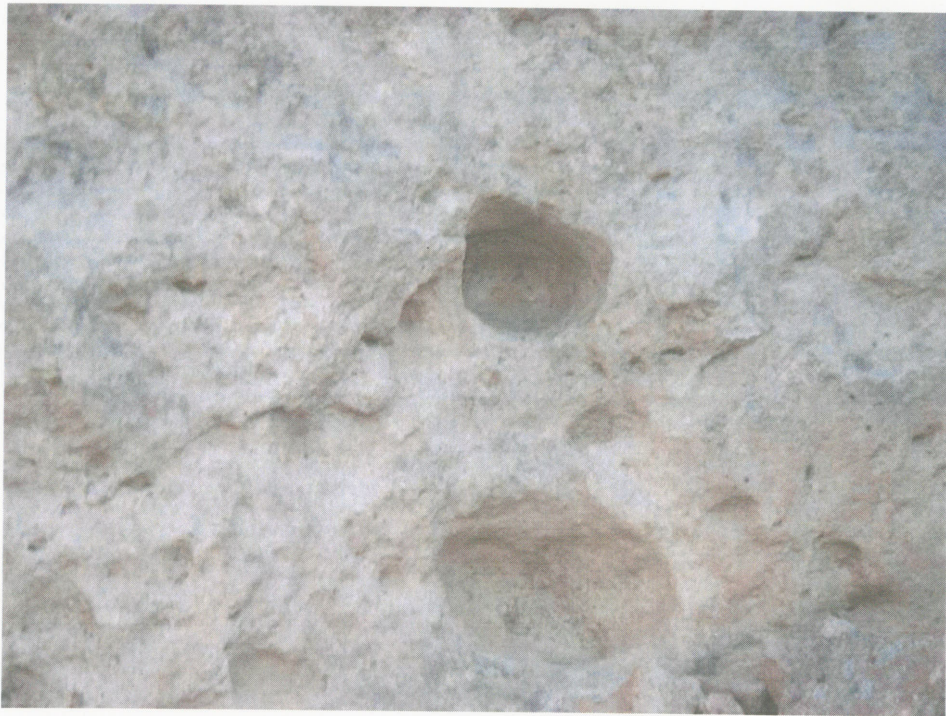
The area of greatest concern is the cliff face and surrounding area below the cliff in SWMU00-011(d) where the greatest concentration of fragmented MD was found, as well as an expended bazooka rocket motor. Additionally, sweeps with a hand-held magnetometer at the base of the cliff indicated possible significant concentrations of subsurface metal with the potential for MD or UXO/MEC hazards to be present.

The cliff faces in both SWMU- 011(d) and 011(e) indicate projectile / mortar penetration in the rock, there is a very good possibility that unexploded rounds are imbedded in the cliff and rocks. These entry holes may be caused from practice rounds, armor piercing or high explosive rounds.

SWMU-011(d) cliff face target area.

Further intrusive investigation of sub-surface anomalies is highly recommended in SWMU-011(a), 011(d) and 011 (e). The digital geophysical mapping data should be evaluated and anomalies picked for intrusive investigation. Data gaps along impact areas and known MD sites should be investigated with a mag and dig approach utilizing hand held magnetometers.

The entry holes possibly caused by military munitions should be investigated to determine if UXO/MEC hazards exist.

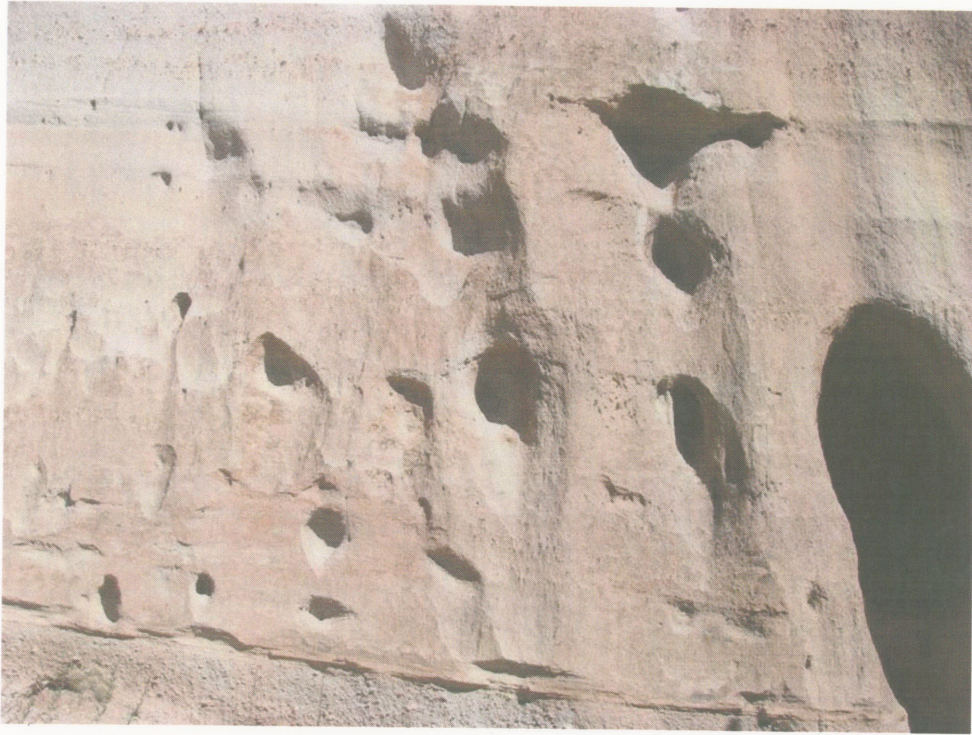
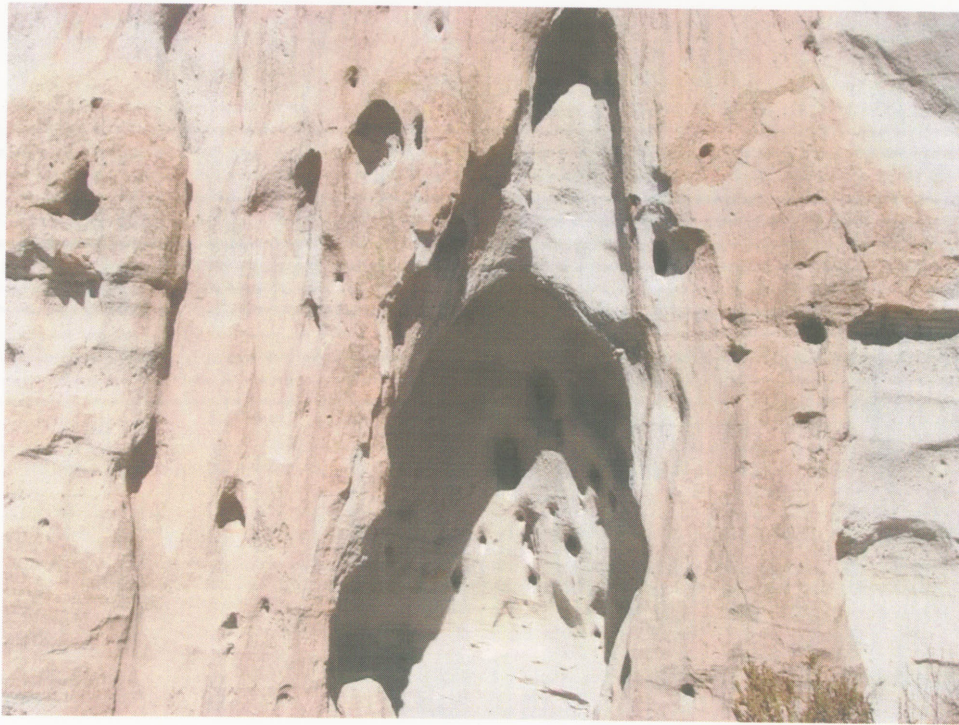
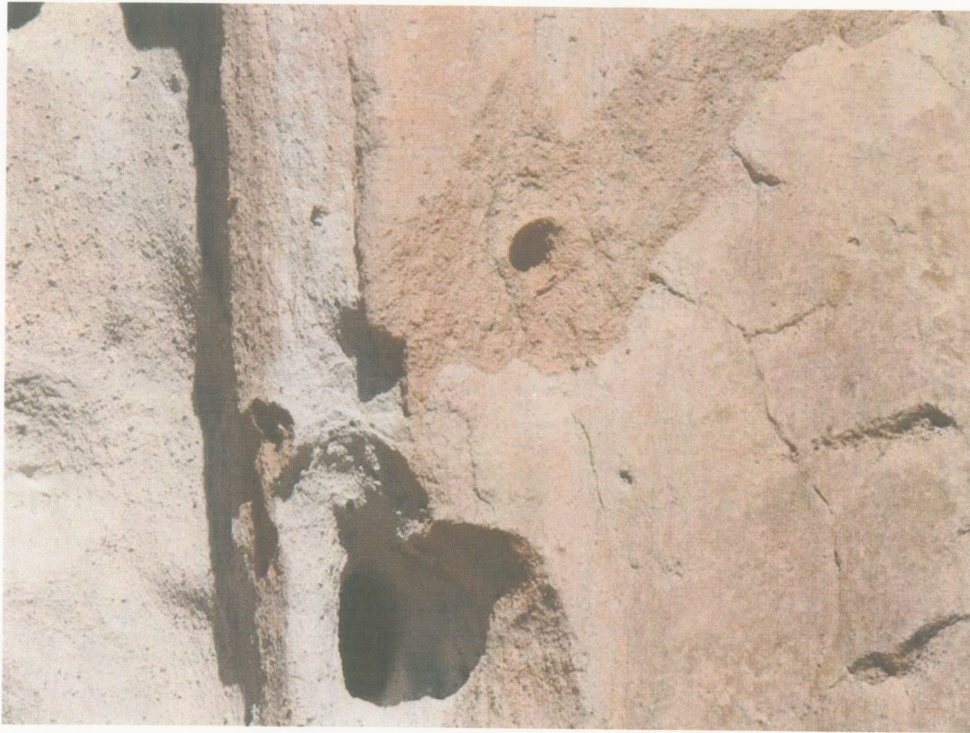
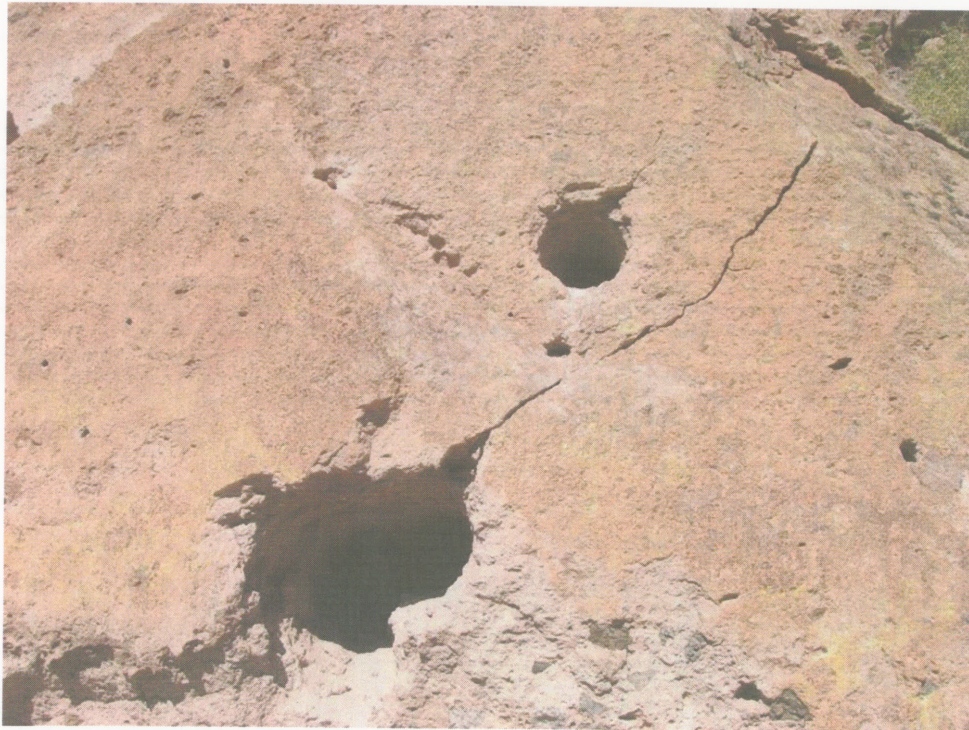
SWMU-011(e) cliff face target area.
